**FOURTH FIVE-YEAR REVIEW REPORT FOR
TAYLOR ROAD LANDFILL SUPERFUND SITE
HILLSBOROUGH COUNTY, FLORIDA**

SEPTEMBER 2018

**U.S. Environmental Protection Agency
Region 4
Atlanta, Georgia**

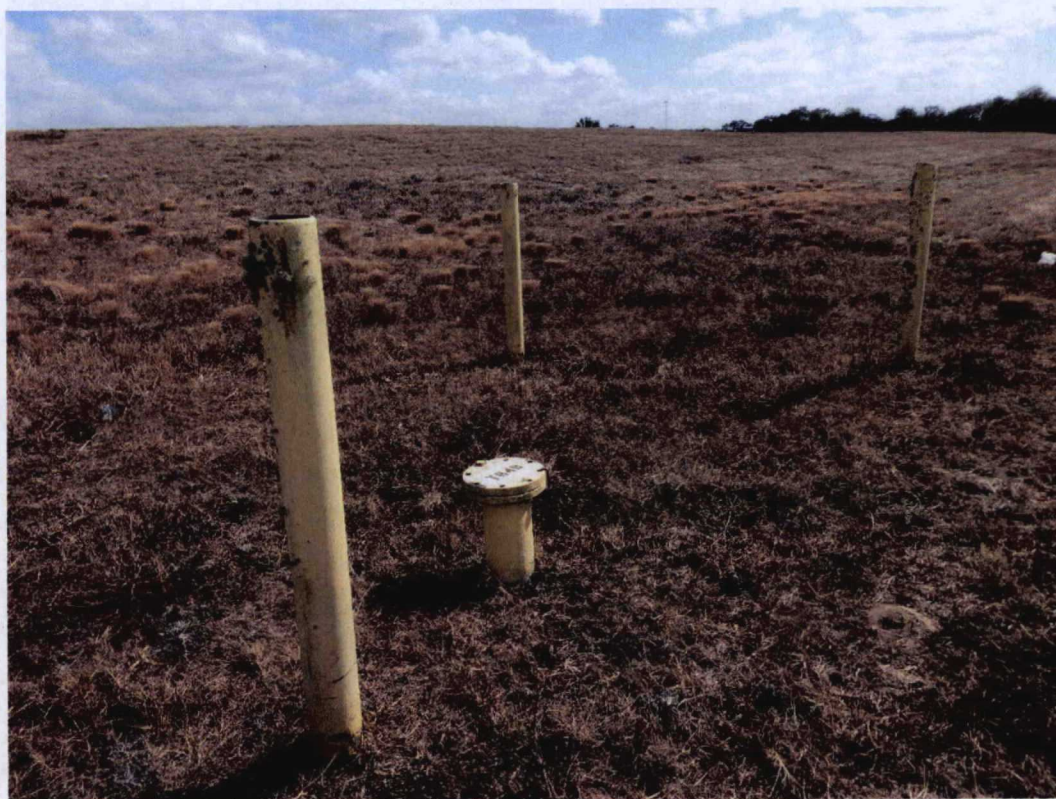
Well TR-4D with Taylor Road Landfill behind

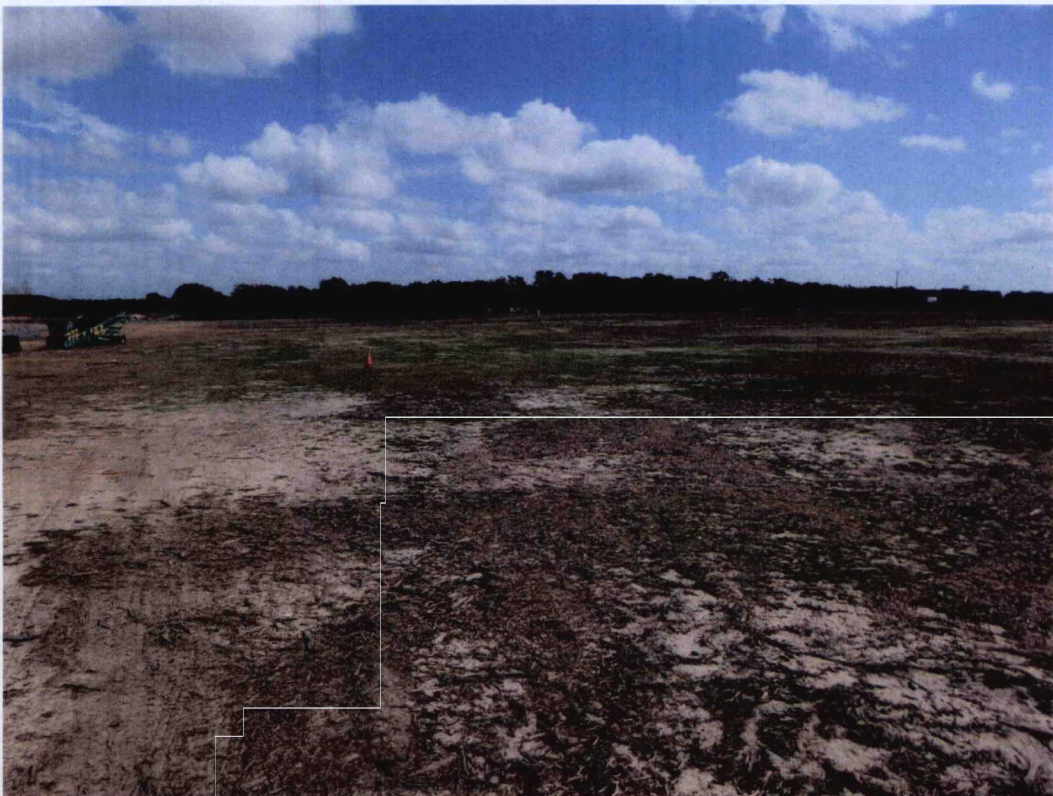
Debris management area north of Taylor Road Landfill

Site inspection participants observed grading activities on a former orchard property north of the Taylor Road Landfill. Hillsborough County indicated that it recently acquired the property and intends to use it as a debris management area. Site inspection participants also observed areas of the Site that are currently in reuse – the community recycling and collection areas on the western side of the Site, the model airplane flying field on the northern part of the Site, and businesses along the southern portion of the Site.

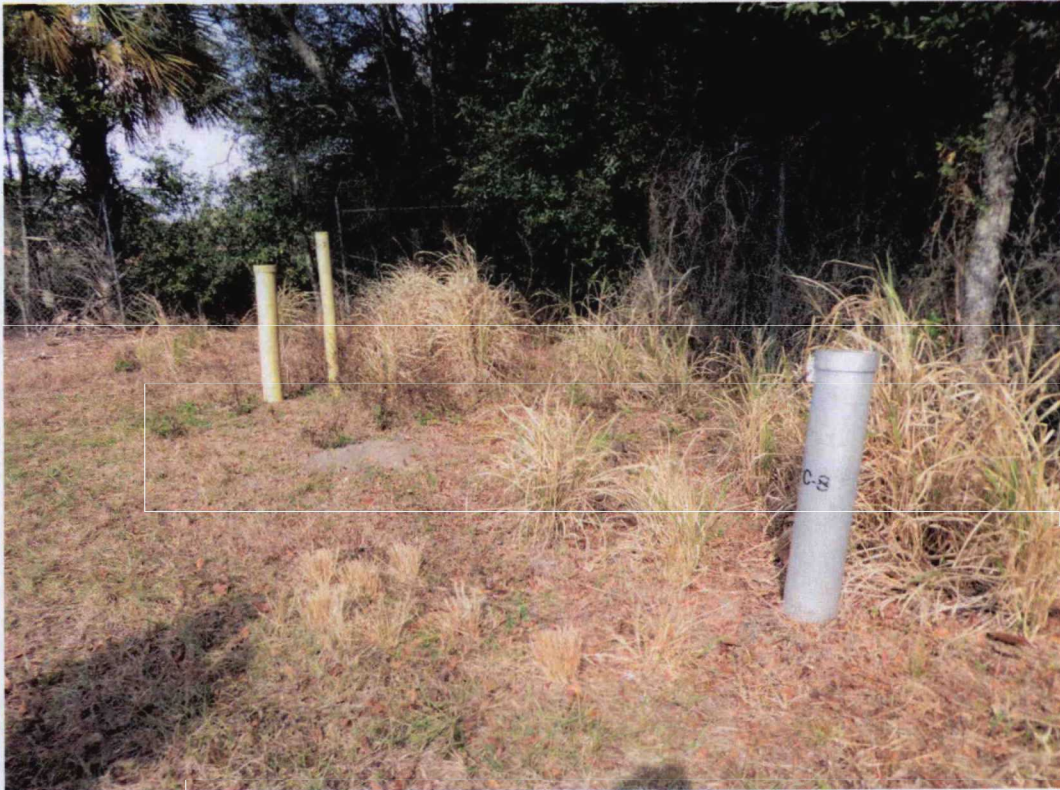
Compliance ring well C-8 on the north end of the Site

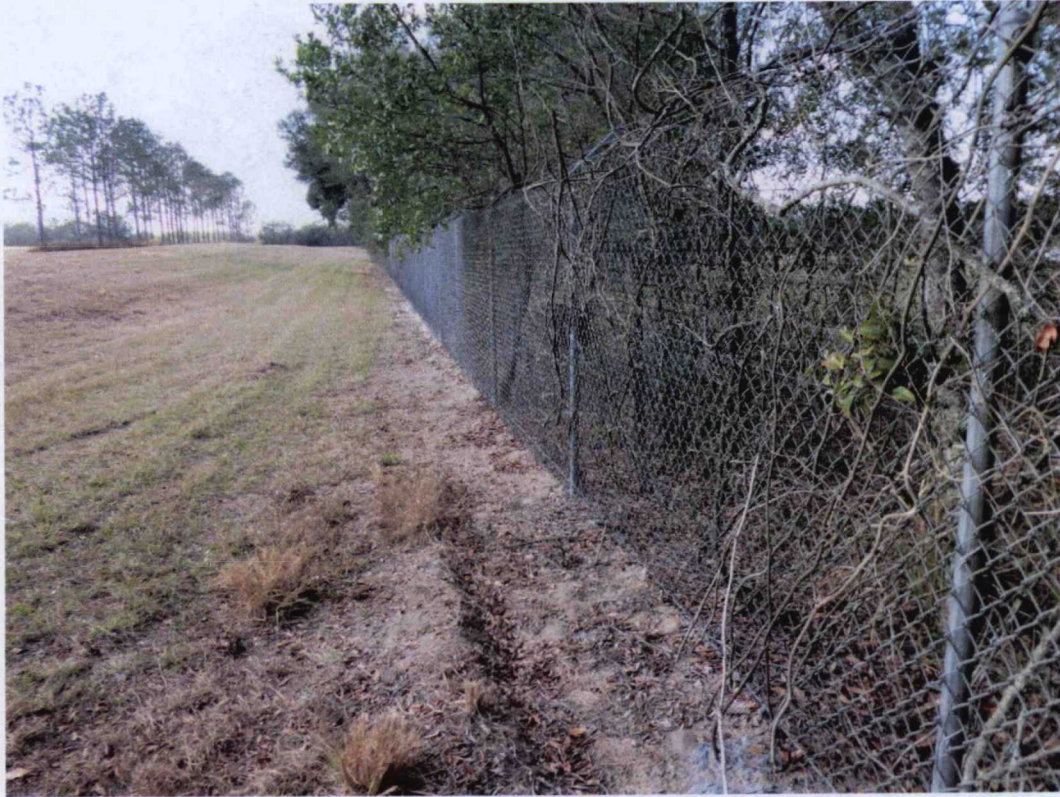
Fencing around the county landfill complex

Remarks: The perimeter fence around the landfill facility was in good condition. The main entrance gate is open during normal business hours to allow public access to the Community Collections Recycling Center. All other gates were locked and secured.
