AT15-007e

March 31, 2016

2013 JX35 AND 2014 – 2016 QX60; CVT JUDDER AND DTC P17F0 OR P17F1 STORED

This bulletin has been amended. Instructions and parts information have been added for installing a new filter screen when the valve body is replaced.
Please discard all previous versions of this bulletin.

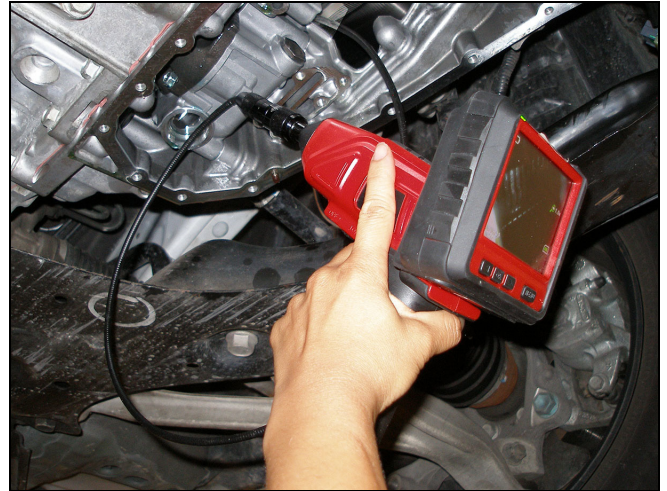
Figure 11

- Holding the borescope with one hand allows for turning the tire with the other hand (see Figure 11).

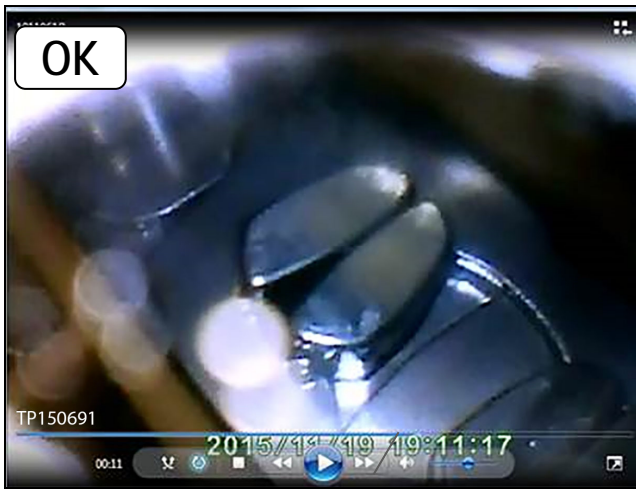
Pictures in Figure 16 and 17 were taken with borescope J-51951.

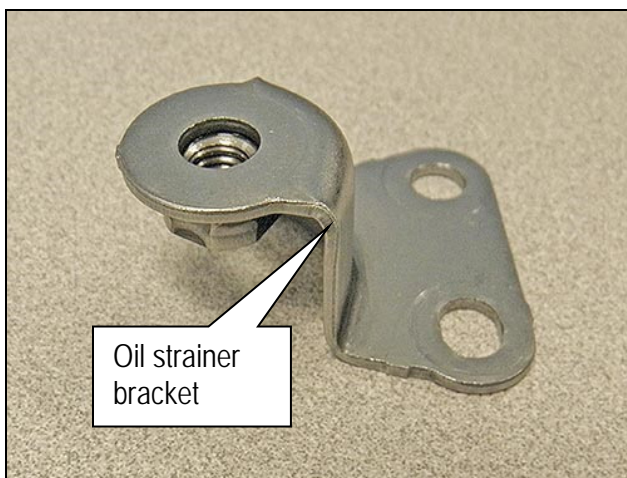
Figure 25

1. Discard the oil strainer bracket (Figure 25).
2. Install a new lip seal. Do NOT reuse the old lip seal (Figure 26).
