Technical Service Bulletin

GROUP CAMPAIGN	NUMBER 22-01-033H
DATE APRIL 2022	MODEL(S) APPLICABLE VEHICLES BELOW

SUBJECT: THETA GDI ENGINE DTC P1326 - ENGINE BEARING INSPECTION / REPLACEMENT (SERVICE CAMPAIGN T3G)

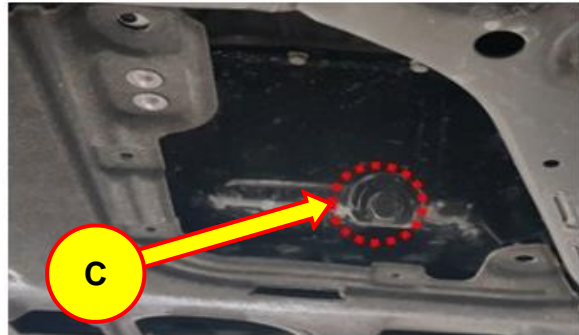
2. Lift up the vehicle and remove the oil drain plug (C).

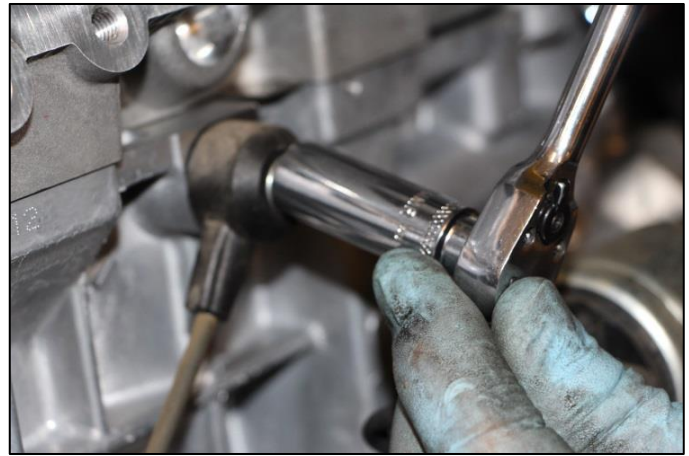
5. Remove and reinstall the engine knock sensor from the old engine to the new engine.

Knock Sensor Fastener Tightening torque:
21Nm (15.5lb-ft)

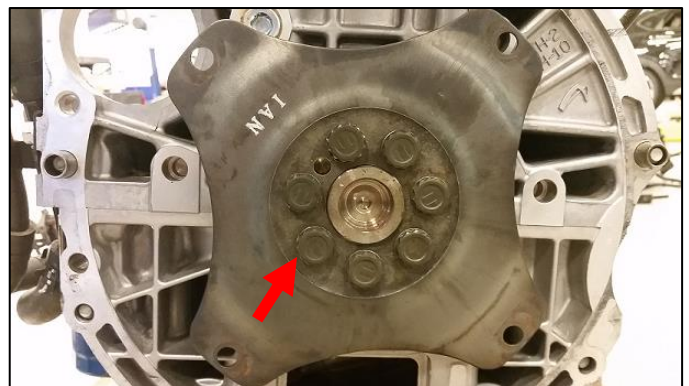
If the crankshaft has drill-through type drive plate mounting holes, then thread-locking sealant must be used to prevent any oil seepage through the (7) drive plate bolts.

- Apply on all threads a low/medium strength thread-locking adhesive that seals fasteners and are tolerant to engine oil.

- Be sure to lightly brush all the bolt threads free of debris/residue and clean off any oil prior to applying the thread-locking sealant for installation.

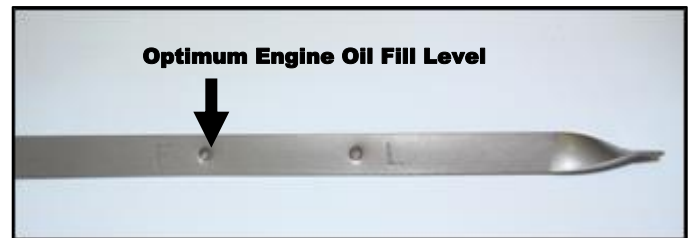
- ❖ Check for any leaks during this time.
- ❖ After the engine has warmed up to normal operating temperature, turn the engine off, wait a few minutes, and then **adjust the engine oil level to near the “F” mark as shown.**
