Wenatchee MP 131 Dry Wash Exposure Evaluation

Chelan County near
Wenatchee, Washington

for
Williams Northwest Pipeline

September 25, 2018

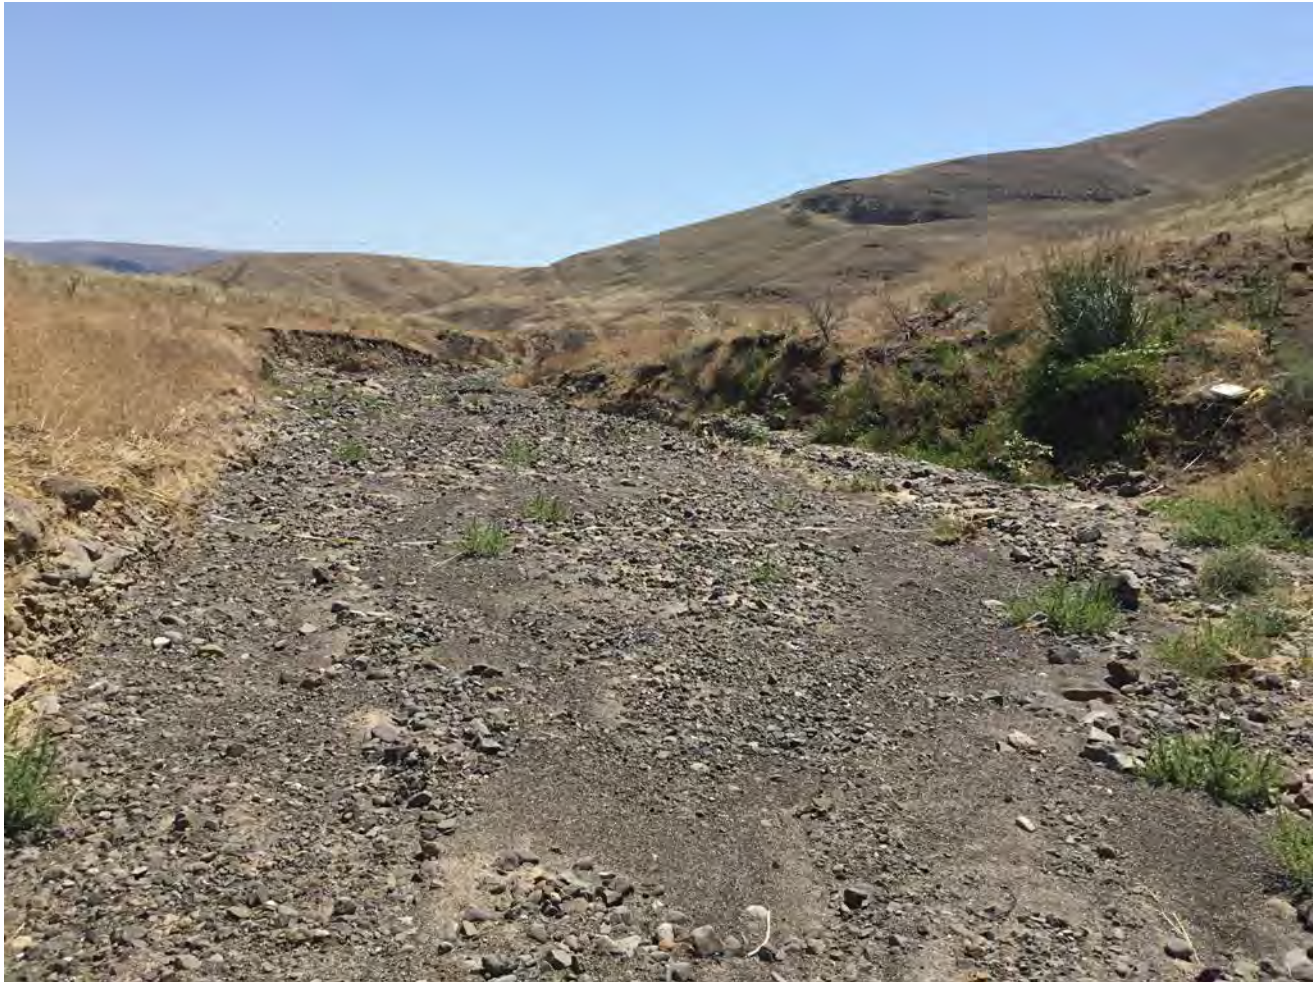
Figure D-1

During the site reconnaissance, we observed the stream to be predominantly plane bed through the reach, void of any evidence of pools or riffles. At the pipe crossing, severe areas of scour exist with freshly exposed vertical walls ranging from 1 to 7 feet in height. The walls are highly unstable and still sloughing into the stream. The channel width at the crossing was observed to be significantly narrower than observed at other stable locations identified both upstream and downstream of the crossing, see Table 2. Evidence of organics can be seen within the vertical scoured walls on channel right at the crossing, indicating the presence of previously placed fill. We assume the fill was placed for the road crossing and potentially for the original pipeline construction (as well as for the repairs in 2014). Stable channel sections were observed both upstream and downstream of the crossing showing very little evidence of scour or bank erosion. These stable sections contain low angle side slopes, wider bankfull widths and provide floodplain access, see Photo D1 in Photograph Log.
