Air tightness measurement for damage analysis

Analysis of the building envelope in case of damage

Case of damage: Moist insulation in collar beam position

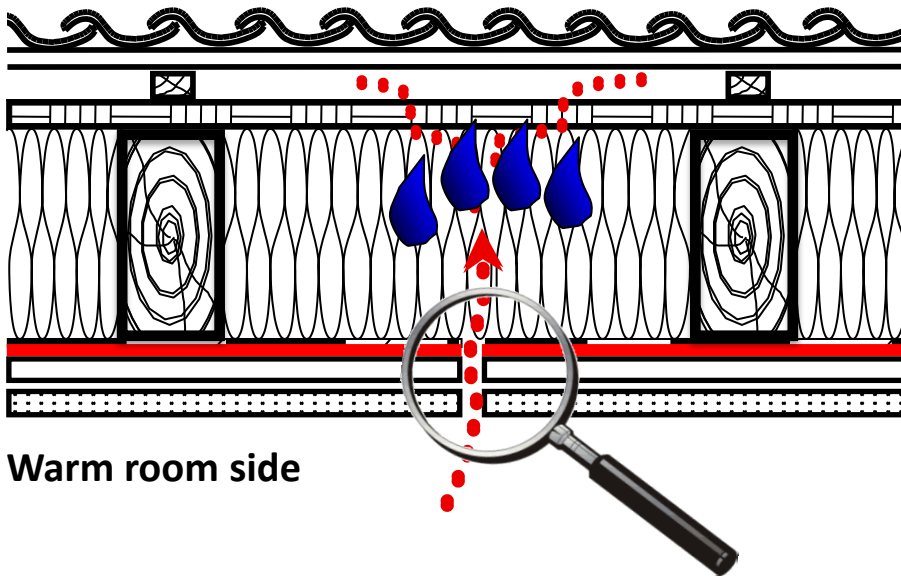
Cold outside

Warm room side

Condensed water on the cold side of the insulation

Airtight barrier

Flow path of warm room air enriched with moisture

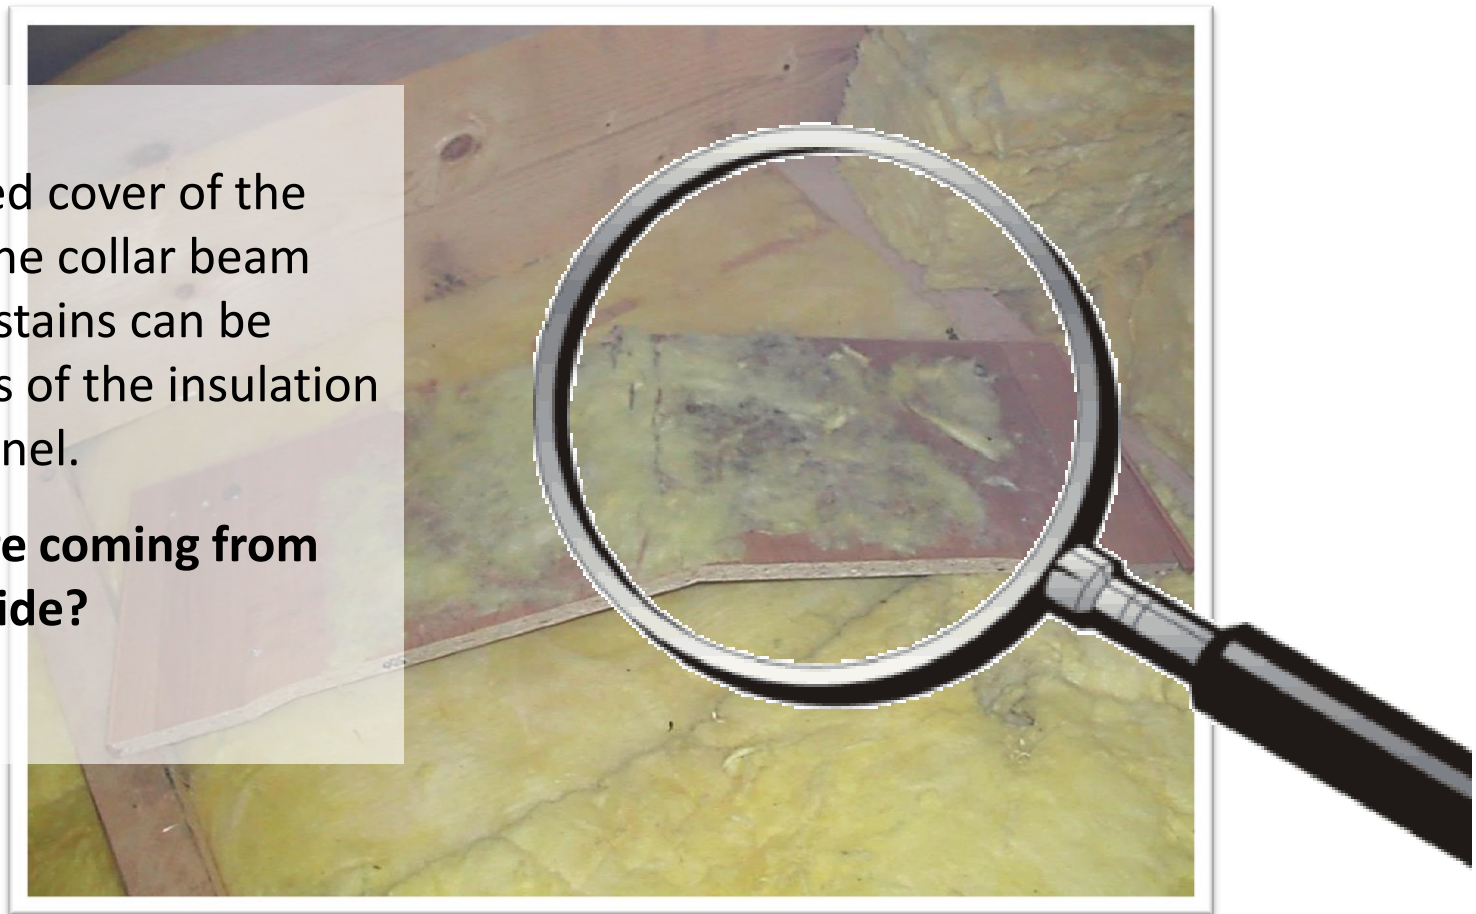
On the inverted cover of the insulation in the collar beam layer, mildew stains can be seen and parts of the insulation stick to the panel.

Is the moisture coming from outside or inside?

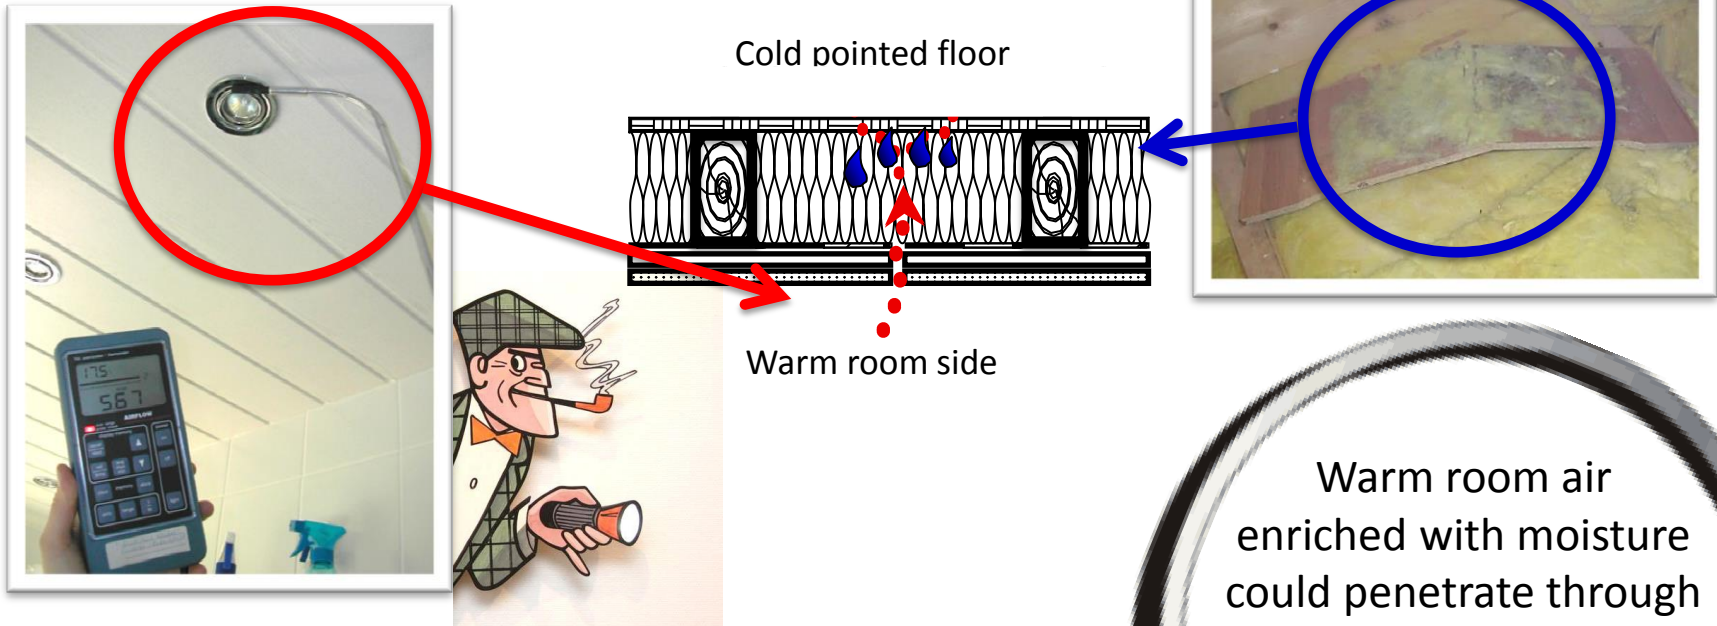
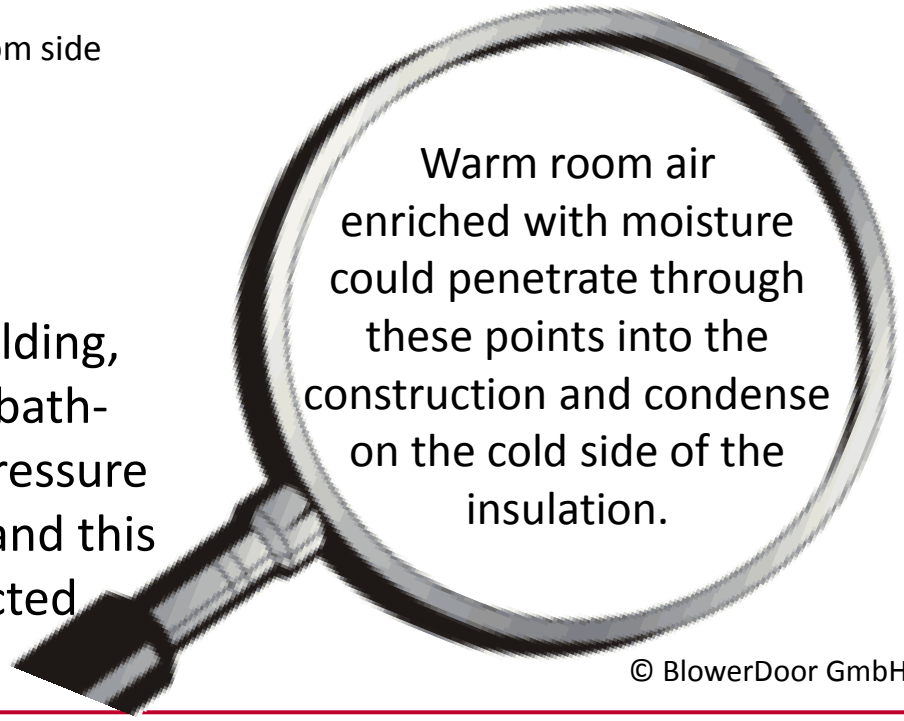
Cause of damp insulation

At a negative pressure of 50 Pa in the building, leaks were detected in the ceiling of the bathroom with the anemometer. At an overpressure of 50 Pa, fog was applied to these areas and this was clearly visible in the area of the affected components in the pointed floor.

Warm room air enriched with moisture could penetrate through these points into the construction and condense on the cold side of the insulation.

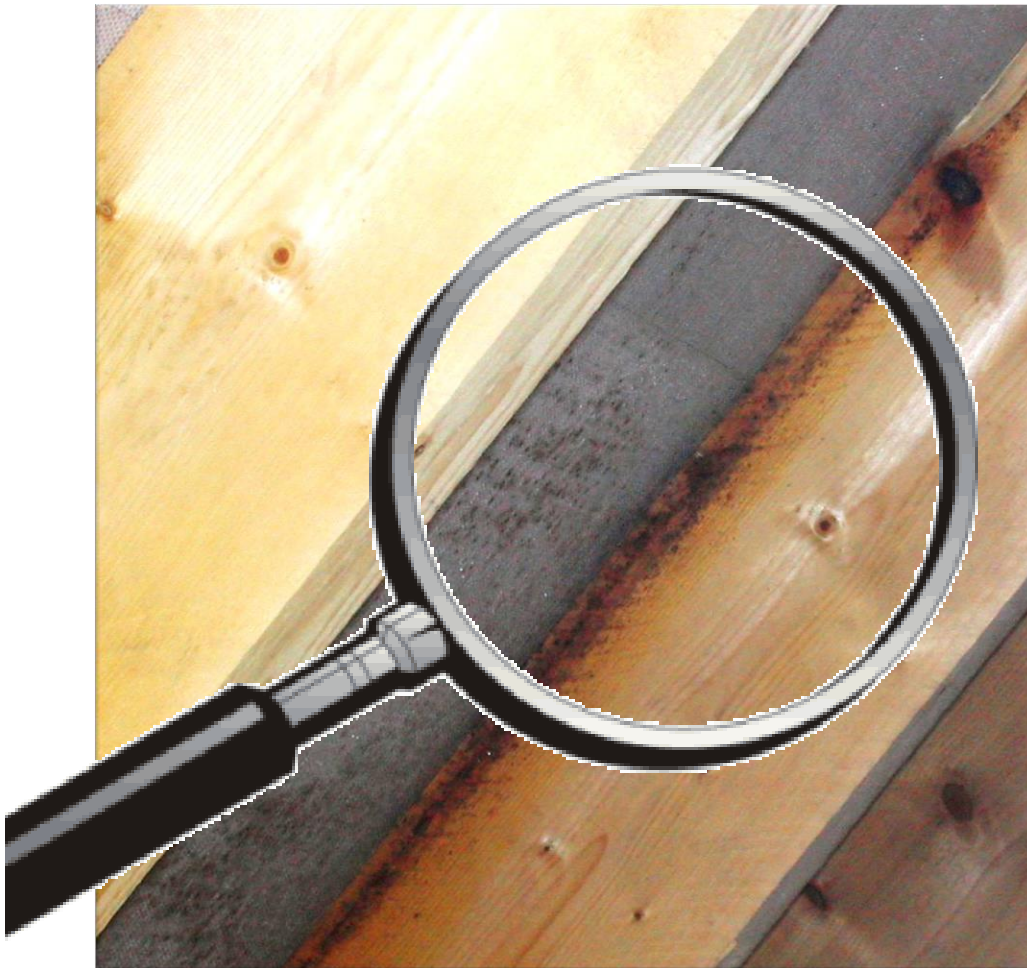
Case of damage: wet underlay and wet rafters

Water droplets have formed on the underside of the under-span track in the uninsulated pointed floor. The rafter is also wet in the area of the spanning web.

Does the moisture come from outside or inside?

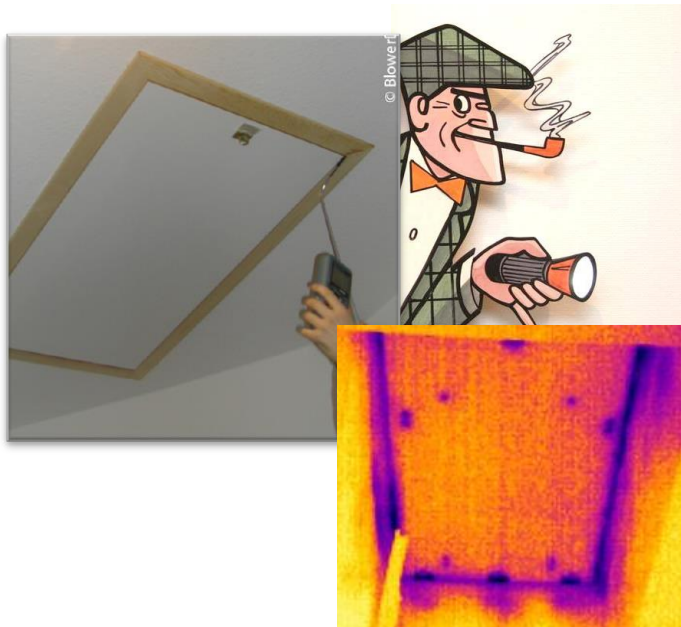
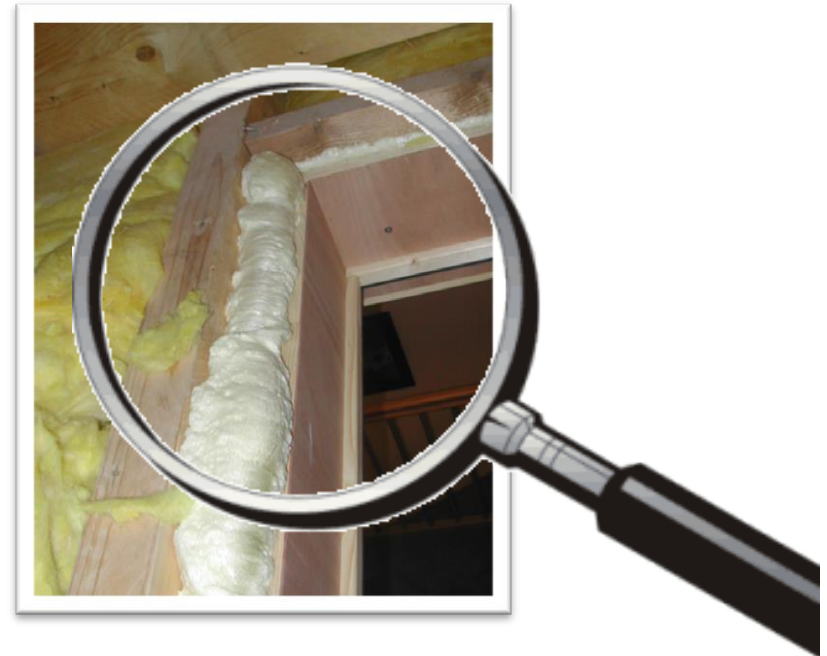
Cause of drop formation

At a negative pressure of 50 Pa in the building, an anemometer and a thermographic camera detected leaks at the joints of the floor hatch and flap.

When the hatch was opened, it turned out that construction foam was used. This is not airtight. The warm room air, enriched with moisture, could flow in masses through these leaks into the pointed floor and condense on the cold underlay.

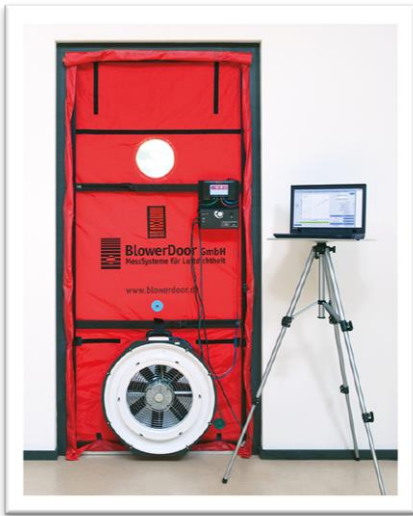
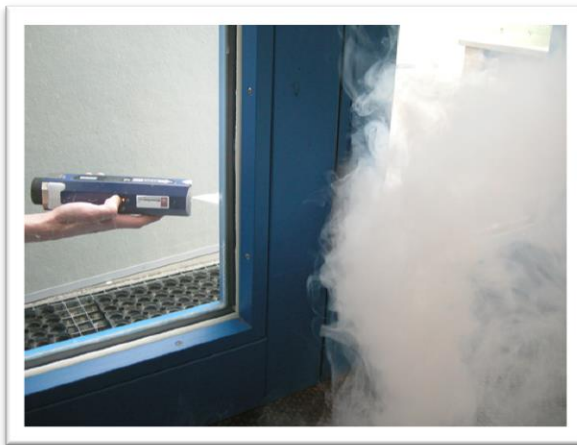
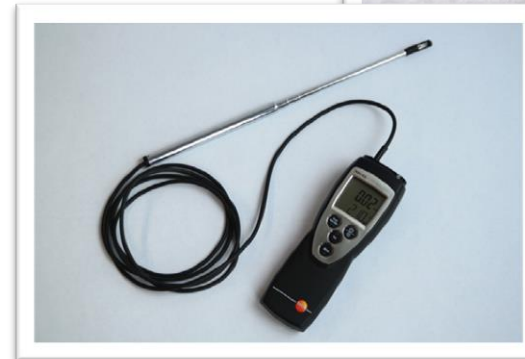
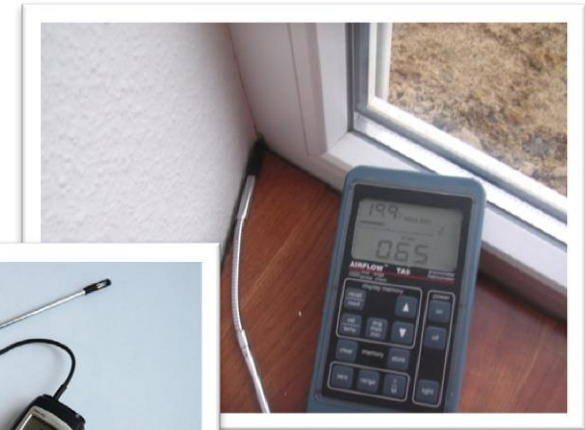
Measuring equipment

- Measuring system BlowerDoor Standard or BlowerDoor MiniFan with DG-1000 or DG-700
- Leak detection device, e.g. anemometer, fog machine, thermography camera ...
