JOURNAL OF THE CSXT® HISTORICAL SOCIETY

_____ Volume 9 Number 2 _____

DEATH ON THE RAILS

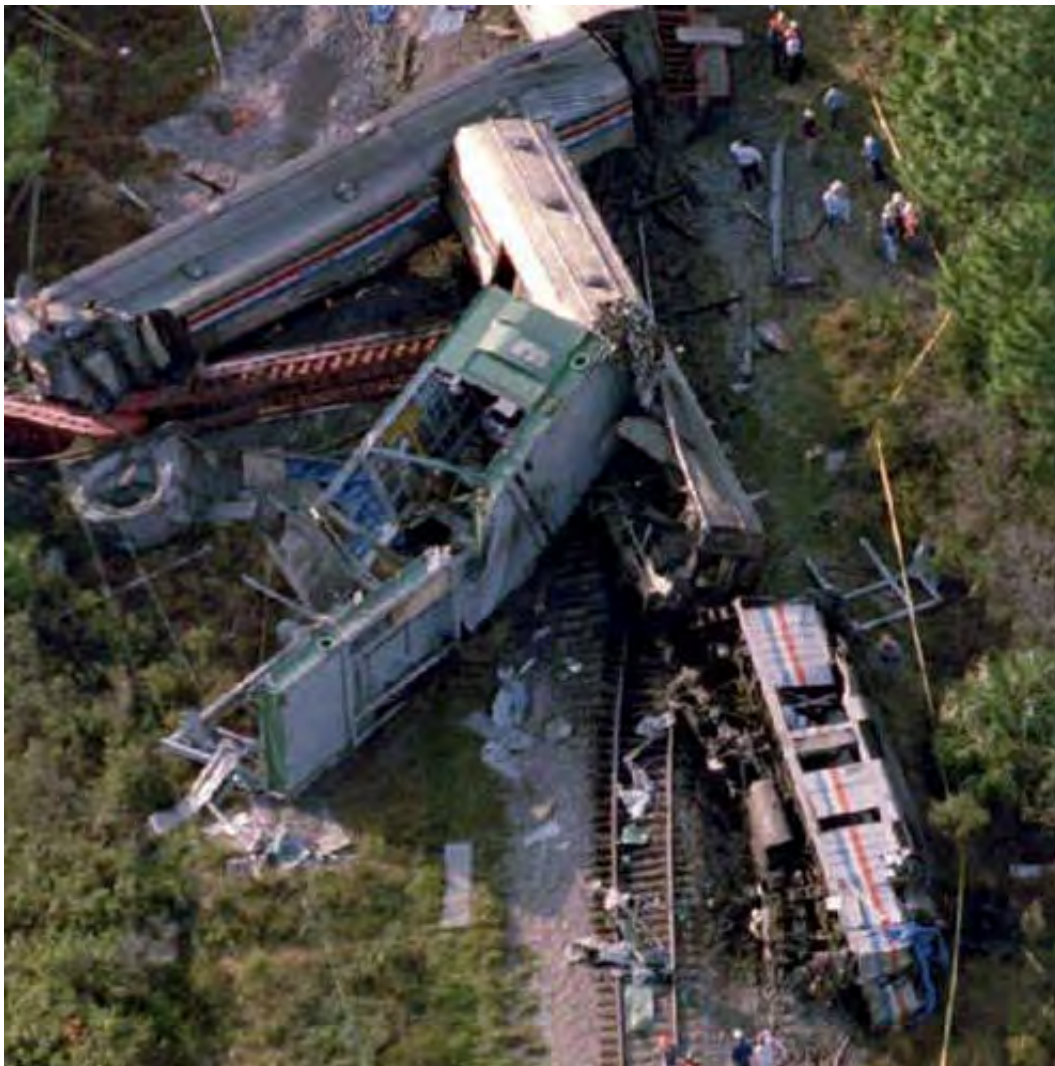
An aerial view of the wreck scene. Amtrak locomotive ATK 357 is in the lower right. Behind her is locomotive ATK 325 with the remains of trailer REAZ 232980 on top of her. Directly behind locomotive ATK 325 is material handling car ATK 1501 and lying at angle to the track is baggage car ATK 1229. (Amtrak)

Locomotive ATK 357 incurred massive damage to its front end. The locomotive “showed contact damage from the right front corner extending inward toward the center line for 9 inches. The sheet metal that covered the right side of the front hood and the control compartment was torn and collapsed inward 1.5 feet. All windows, except on the left side of the control compartment, and both windshields were missing. The seats for the engineer and the assistant engineer had separated from their attachment points. The automatic brake and the emergency valve levers were found in the emergency position. The trucks with their motors received major damage.” The locomotive’s event recorder was inoperable at the time of the incident due to mechanical problems. Amtrak’s locomotives were at this time not required to have operating event recorders.

Locomotive ATK 325 received severe damage to the left side “from the forward control compartment wall extending rearward for the length of the control compartment, which included the engine access door. The damage extended from the roof line downward to the left side sill. The left side windows and the sheet metal below the windows were missing. The trucks with their motors received minor damage.”

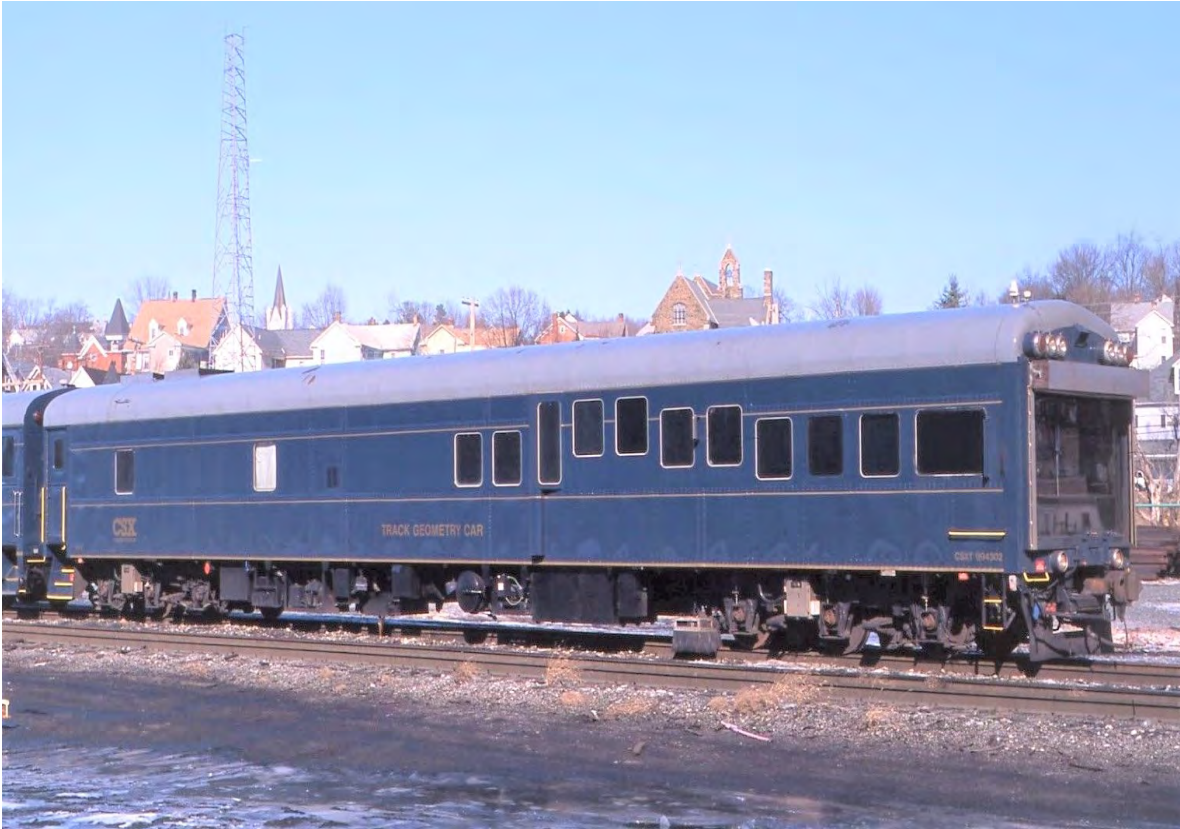
Track Geometry Car testing is nothing new for CSX. As a matter of fact, it has been in use for over 56 years having started on a predecessor road of CSX in 1936. Our Track Geometry Car has progressed from a total mechanical measuring system in the early development, to an electro-mechanical-analog system to it's current digit acquisition system. Our present Track Geometry Car (TGC-2) is a converted six (6) axle coach weighing 86 tons which produces very good track load dynamics.

The Track Geometry Car is equipped with an automatic defect marking system. It sprays a paint mark on the ties in the middle of the track which marks the location of any track geometry defect that exceeds Federal Railroad Administration Track Safety Standards and CSX Engineering Standards.

Division personnel get a panoramic view of the track and right-of-way through the rear observation window. An immediate view on four (4) designated track geometry monitors positioned in the rear offer displays of the strip chart, defect report, mile summary analysis, curve report and graphical display of current defects compared to last test. At the end of a Roadmaster's territory, he is given a copy

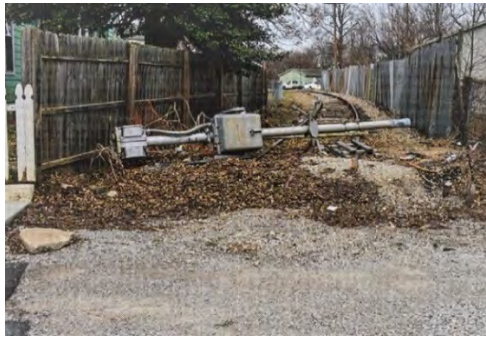
This view of 15th and Beeler in New Albany, Indiana, shows the condition of the CSXT track on February 19, 2020. (Lee Gordon)

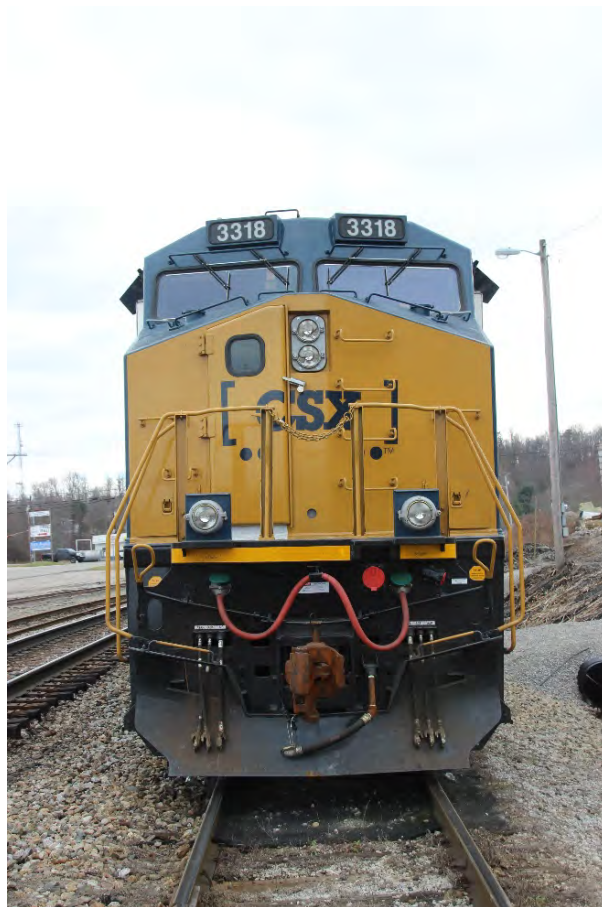
Head-on -view of CSXT 3318 in February 2020.

CSXT has on its roster 225 ET44AH locomotives, CSXT 3250 to CSXT 3474. These locomotives are cataloged by General Electric as ES44AC. CSXT, however, in December 2007 began to call these locomotives ET44AH. The “ET” recognizes that they are GE Evolution Series locomotives; the “44” refers to their 4400 horsepower; the “A” is for AC power and the “H” refers to HTE (high tractive effort) adhesion-management software with which these locomotives are equipped.

CSXT chose to assign their own classification to GE’s evolution series because they differ somewhat from the standard ES44AC as delivered by GE. The CSXT locomotives have received computer software upgrades and increased dead weight. The software upgrades allow these locomotives an increased tonnage rating due to subsystems that produce high levels of tractive effort at low speeds. In order for a locomotive to be classified as an “AH” by CSXT, it has to 1) have an increased nominal weight (currently to 432,000 pounds); 2) steerable trucks; 3) TM3 adhesion control software; 4) software that raises the normal 30,000 traction force to 33,000 pounds-force, which is the maximum amount of tractive effort that each traction motor is permitted to produce; and 5) GE's Rail Cleaner, which directs high-pressure air onto the rails in front of the sand nozzles forward of axle number one.

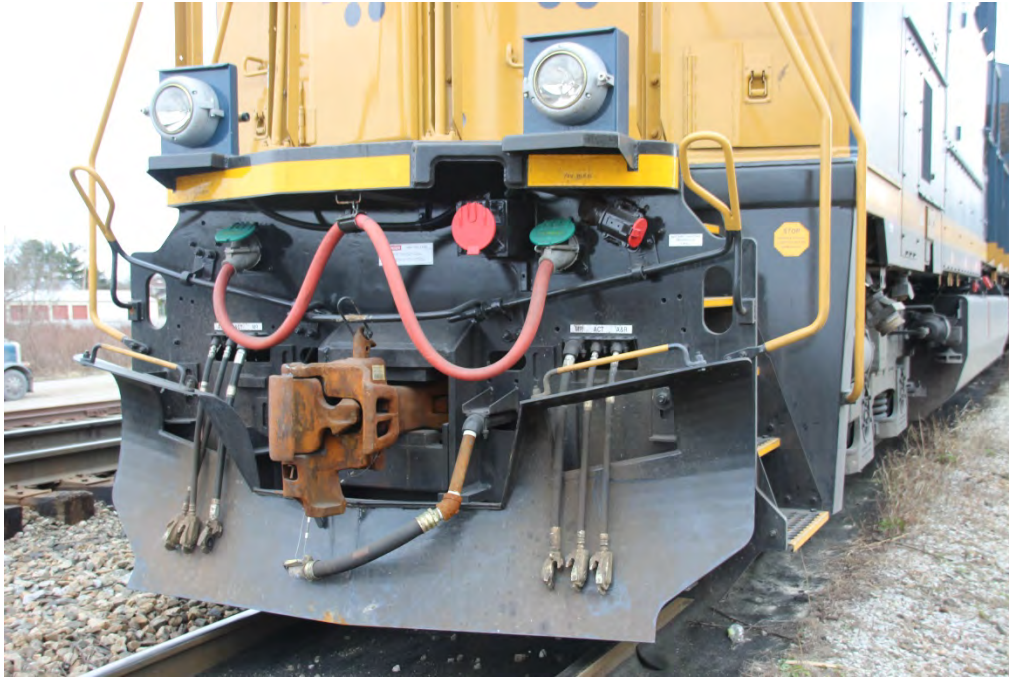
A close-up CSXT 3318 plow

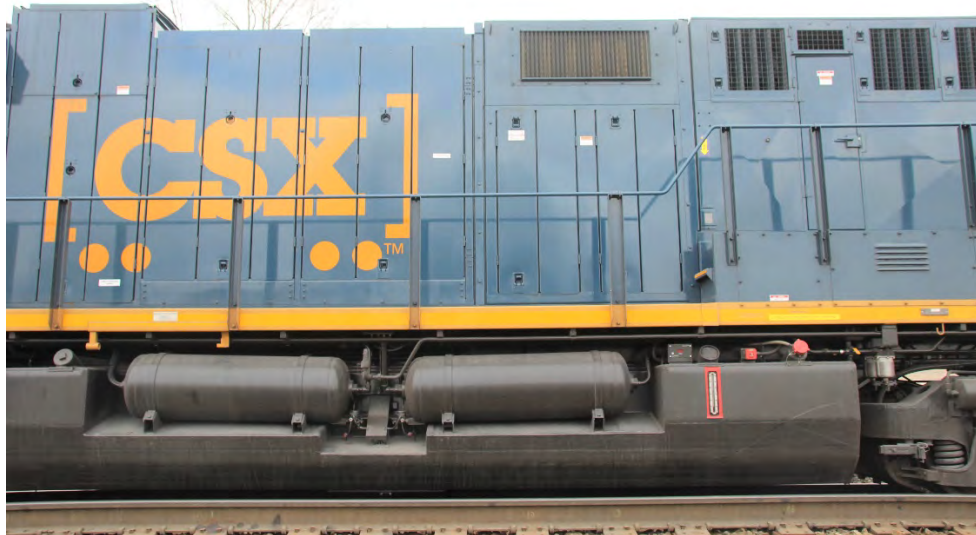
The mid-section of the right side of CSXT 3318 showing fuel tank and air reservoirs

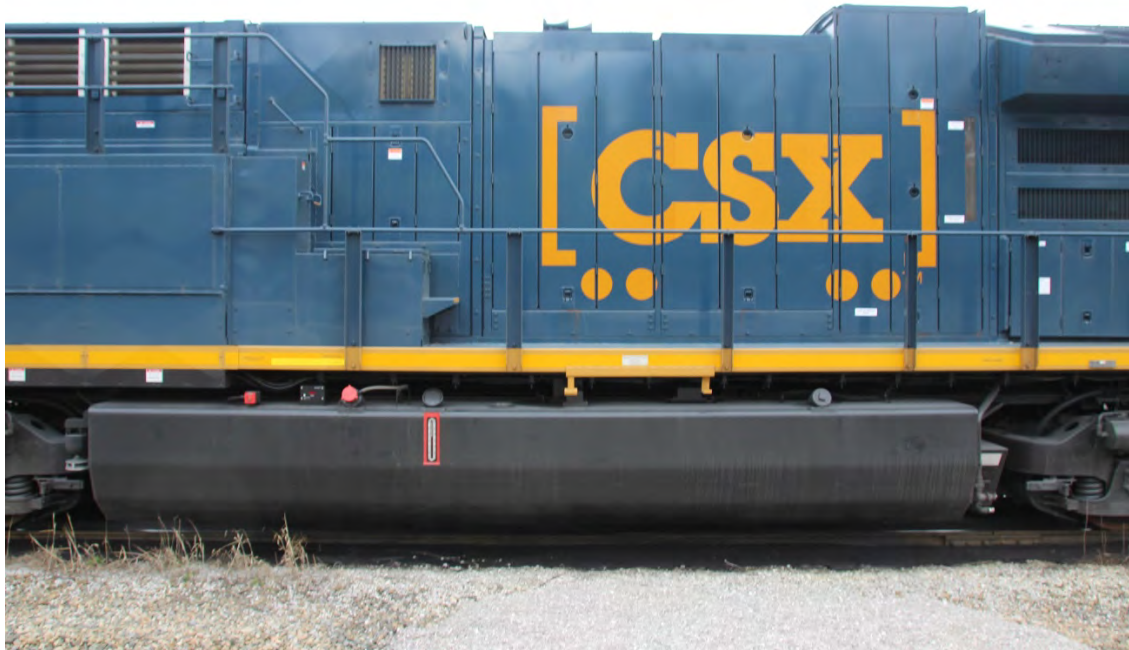
The middle left section of CSXT 3318 showing the fuel tank

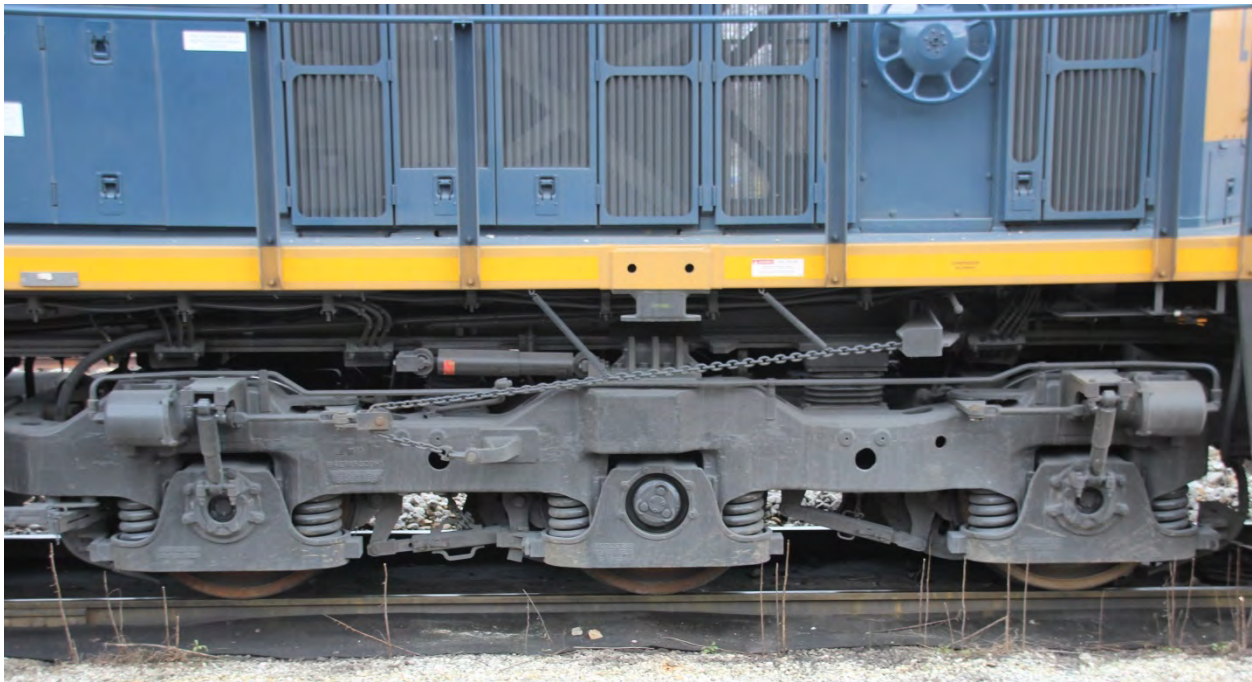
A close-up of the rear truck on CSXT 3318 showing the A1A wheel arrangement

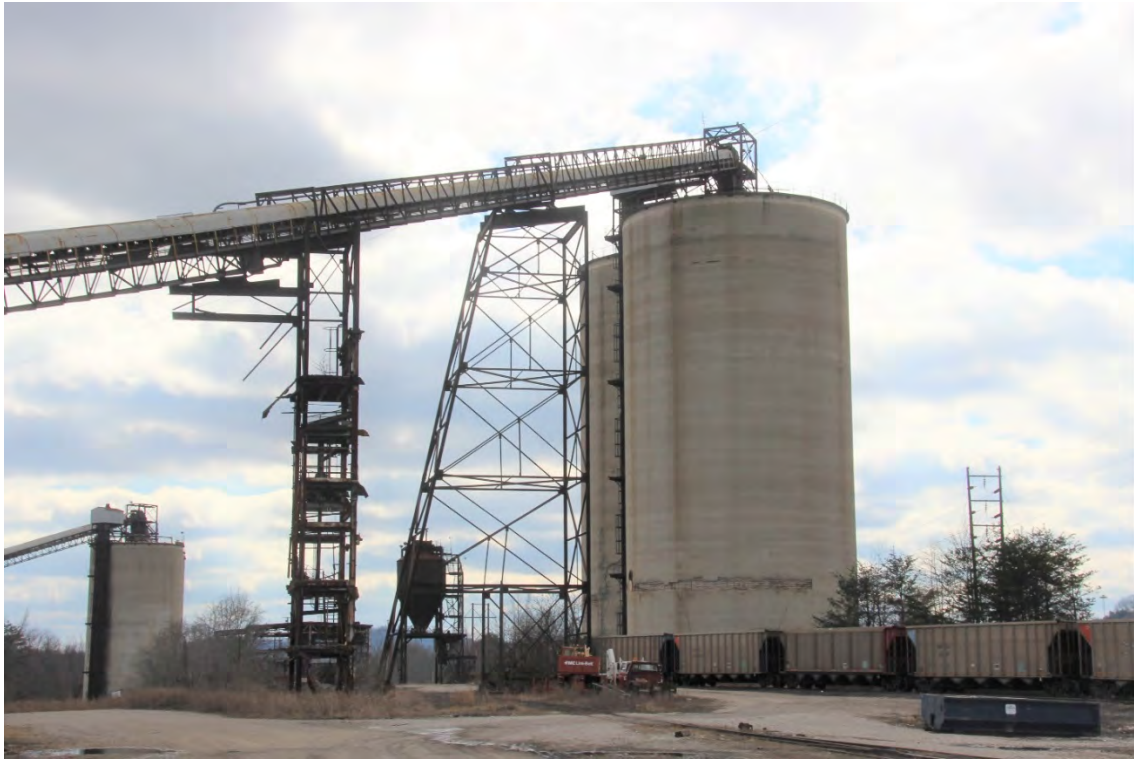
The main coal wash plant. The hopper cars are in storage.

Due to the lack of level land at the Lynch Mine face, U.S. Steel built a coal wash plant to service this mine on the east side of the L&N Corbin Yard. Newly mined coal was transported by rail from the Lynch mine face to the Corbin coal wash plant. After the coal had been treated, non-coal and non-marketable coal was heaped on the site in spoil piles. Arch Mineral continued to operate this coal wash plant until 2010. At this time, the wash plant was closed but its buildings not torn down. At the time of closing, an estimated 41 million tons of recoverable coal was buried in the spoil piles.

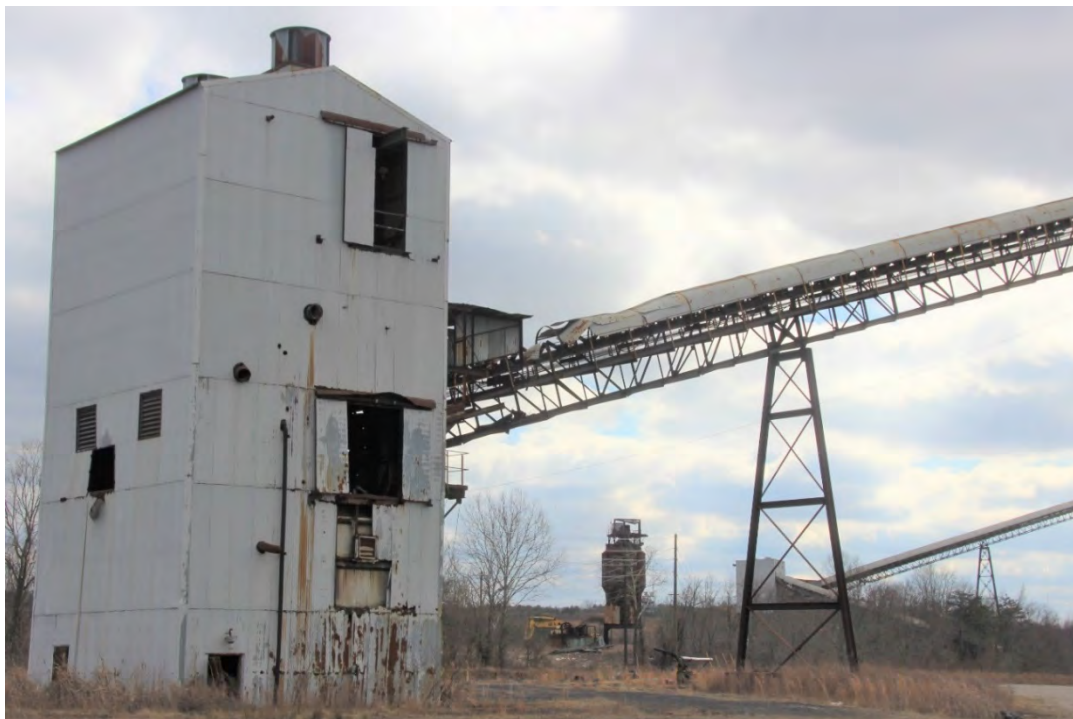
One of the tipples used to feed stockpiled coal to the wash plant

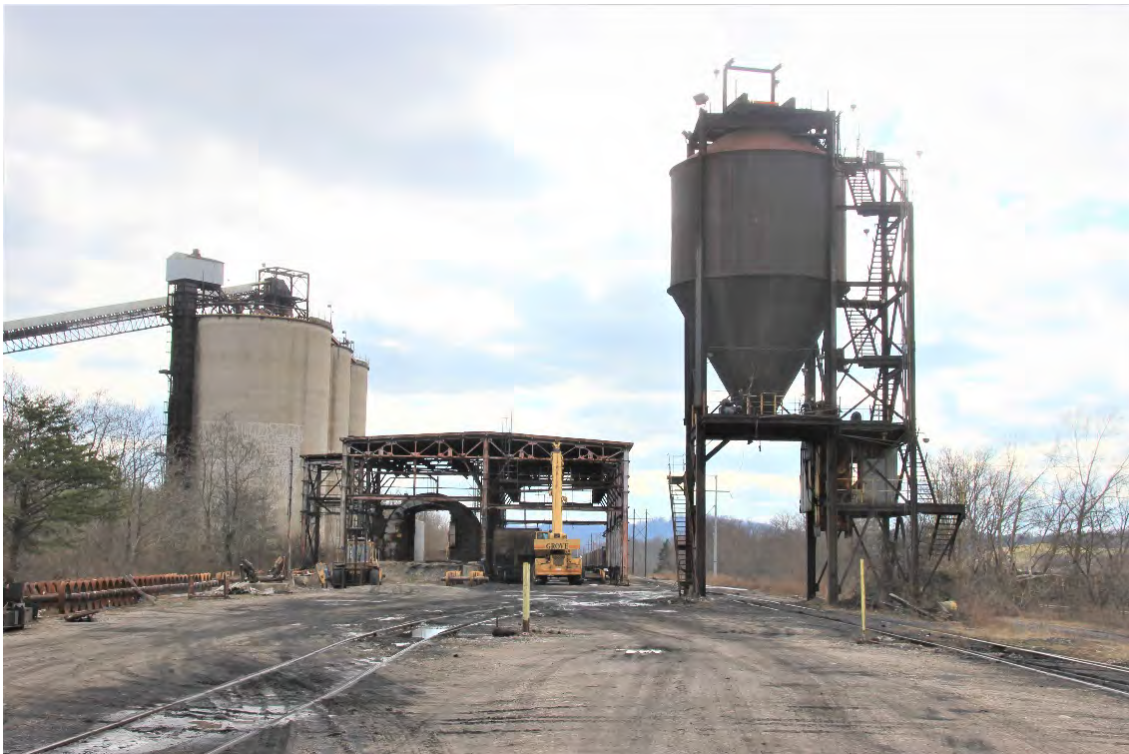
What is left of the US Steel railyard at the wash plant. A rotary dump can be seen in the left bay of the building in the center

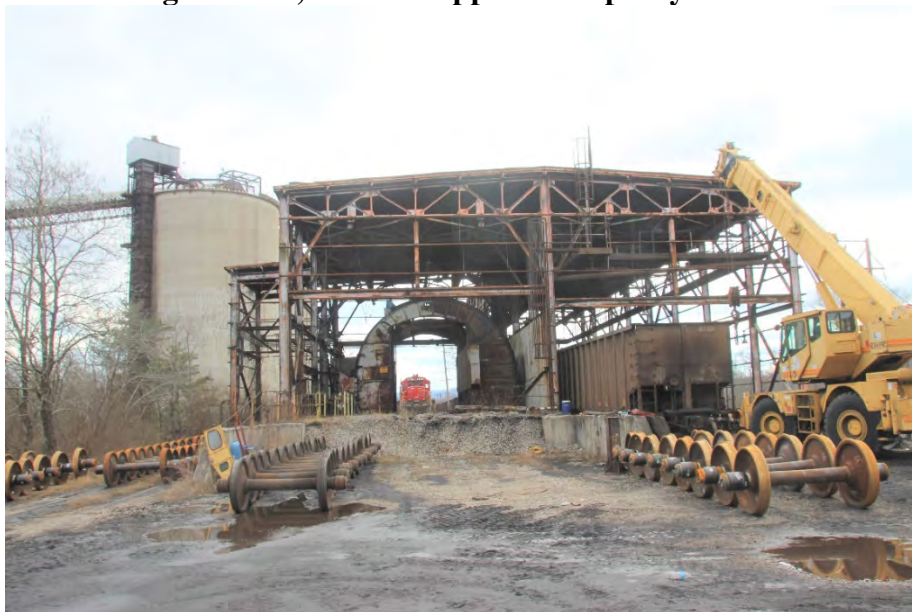
A view of the hopper repair car area. The Progress Rail locomotive is framed by a rotary coal car dumper.

In 2015, when CSXT closed its Corbin Yard repair facilities, there was still a need for a local hopper car repair center. Hopper cars in coal service are constantly experiencing damage to running gear and brake systems. Progress Rail thus leased part of the closed Corbin Coal Wash Plant from ARCH Mineral. A Family Line caboose purchased from CSXT by Progress Rail was transported to the leased work site to serve as a tool room. Work on damaged coal hoppers was undertaken under a roof, but the sides were open to the elements. Progress Rail based a locomotive at the hopper car repair site to retrieve damaged cars from CSXT's Corbin Yard and return repaired cars to the yard.
