<b>Sammamish-Juanita 115kV Transmission Line</b>	
City of Kirkland	
Map 16 of 24	
February 2020	
PSEN0000-0169	<small>DAVID EVANS AND ASSOCIATES INC.</small>

TREE RESTORATION PLAN  
 NE 124TH STREET  
 FOR  
 PUGET SOUND ENERGY  
 CITY OF KIRKLAND, KING COUNTY, WASHINGTON

TREE REPLACEMENT TABLE  
NE 124TH STREET  
FOR  
PUGET SOUND ENERGY  
CITY OF KIRKLAND, KING COUNTY, WASHINGTON

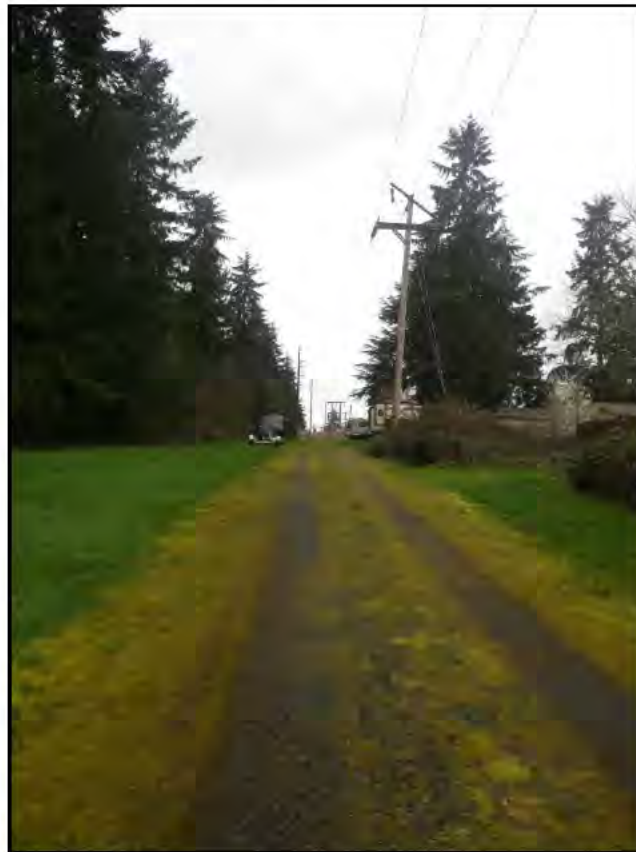
Figure 7-1. Overview of corridor south of Juanita Substation near Pole 4/17, view north.

The transmission line corridor crosses a landscape demonstrative of the extent of historic-period and modern development that has occurred in the region (Figures 7-1 and 7-2; Appendix E). The corridor is capped by PSE substations at either end and loops in a third substation south of NE

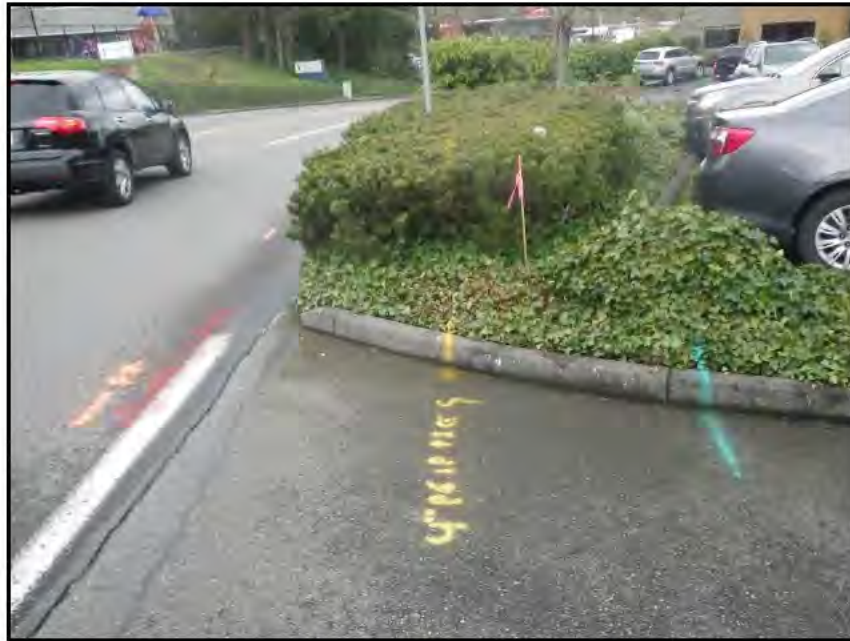
Figure 7-2. Staked location of Pole 3/15, along 120<sup>th</sup> Ave. NE, view west. Note utility locate markings indicating an existing gas line (*yellow*) and sewer line (*green*) adjacent on either side of the proposed pole location. Buried communication (*orange*) and power (*red*) lines are also indicated at the edge of the roadway, south of the proposed pole location.

Markings for buried utilities were prevalent, particularly along the segments of the corridor within street ROWs. For example, proposed pole locations along 120<sup>th</sup> Ave. NE are situated between buried gas and sewer/stormwater lines (see Figure 7-2). Communications lines and sewer/stormwater lines were also marked in the immediate vicinity of proposed pole installation and replacement locations along the north side of NE 124<sup>th</sup> St.

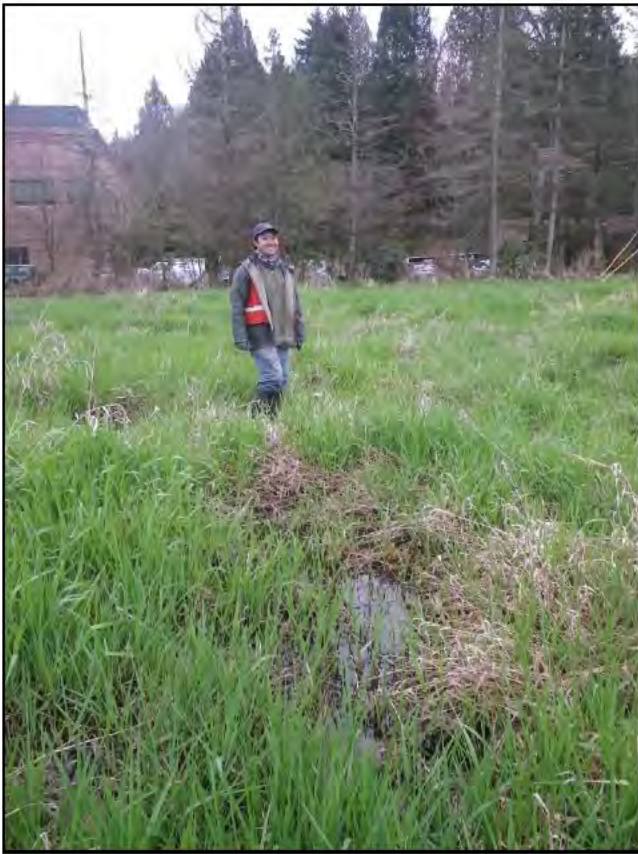
Figure 7-3. Chris Yamamoto surveying area south of Sammamish Substation, view south. Note standing and flowing water.

Vegetation within the corridor consisted of landscaped grass and ornamental trees and shrubs in parking strips along the major roads; wetland plants (reeds, horsetails, cattails) near Juanita Creek, at the north end of the Juanita Tap Line, adjacent to the CKC, and south of the Sammamish Substation (Figure 7-3); and blackberries, alder, and birch trees on portions of the abandoned railroad corridors. Standing and flowing water was noted in wetland portions of the corridor in both 2017 and 2019.

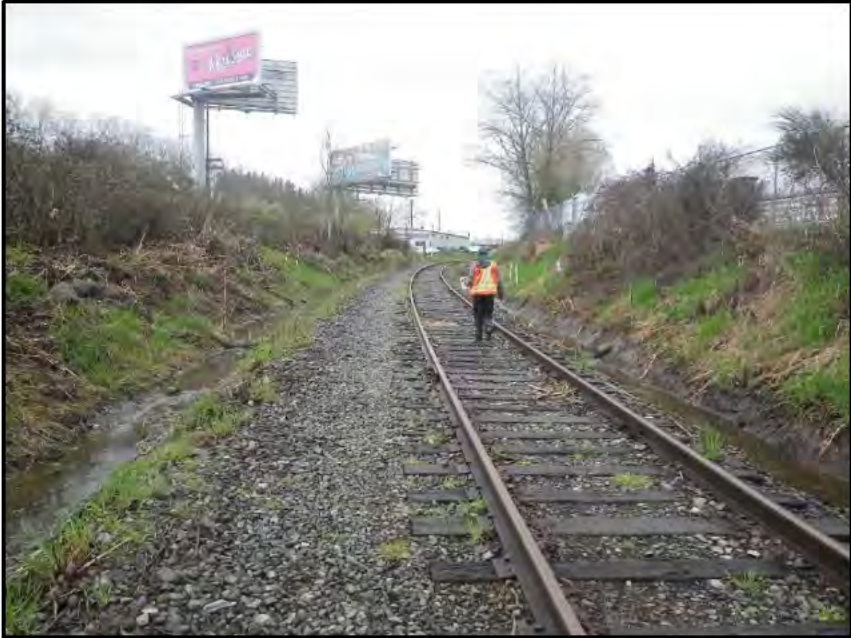
Figure 7-4. Survey along the abandoned, intact railroad line on rerouted segment of the alignment north of pole 2/4, view west.

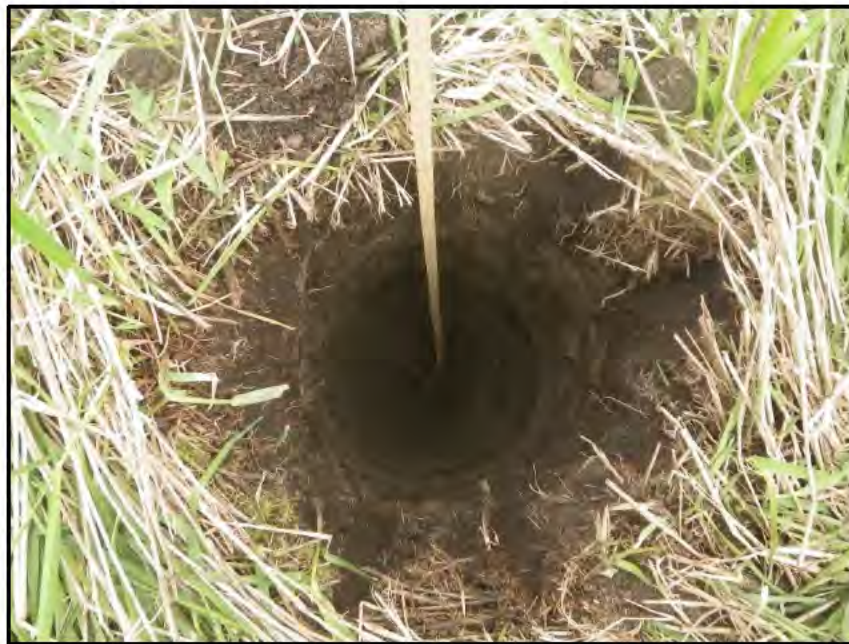
Figure 7-8. Detail of SP 70 (*Pole 1/7*) location, view northeast.

In the upland area, extensive disturbance from previous construction and modern development was evident. In many locations where shovel probe excavation was possible, modern or historic-period fill, generally characterized by sands with high gravel content, extended to the base of the shovel probes. In a few instances, the archaeologists reached glacial sediments directly below the fill.

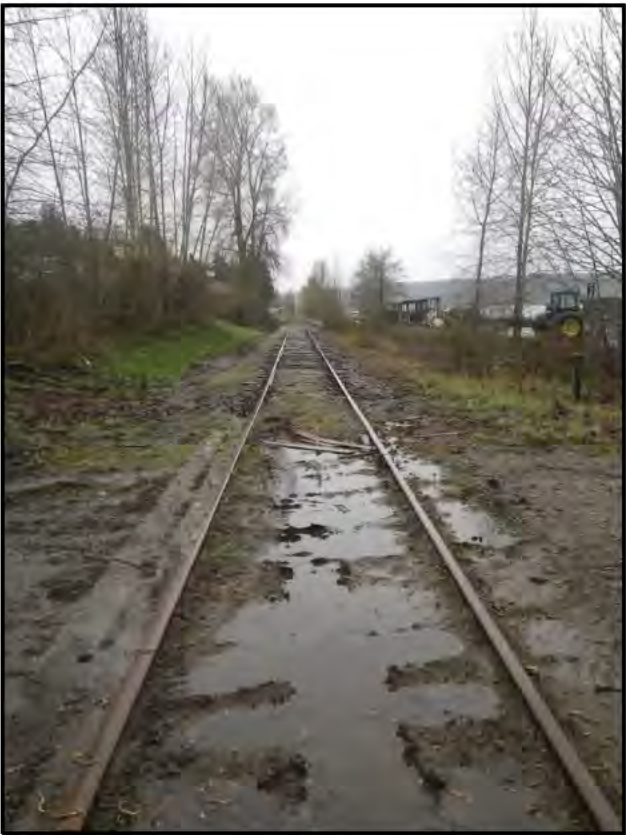
Figure 7-9. Overview of north end of proposed transmission line corridor along former SLS&E line (*archaeological site 45KI451*) (*Section 1*) near Pole 2/1, view north.

The newly recorded segment contains three distinct, continuous sections. Section 1 consists of intact railroad grade with rails, ties, and hardware on a raised railroad ballast berm (Figures 7-9 and 7-10), extending from just north of NE 124<sup>th</sup> St. approximately 1,362 ft to the southeast, parallel to Willows Rd. NE. The surface of the berm is 15 ft wide, raised between 0 and 5 ft above the surrounding landscape. At its widest, the base of the berm measures approximately 18 ft wide. One associated asphalt street crossing with post-mounted flashing light signal was identified at the intersection of the Willows Rd. NE and NE 124<sup>th</sup> St.

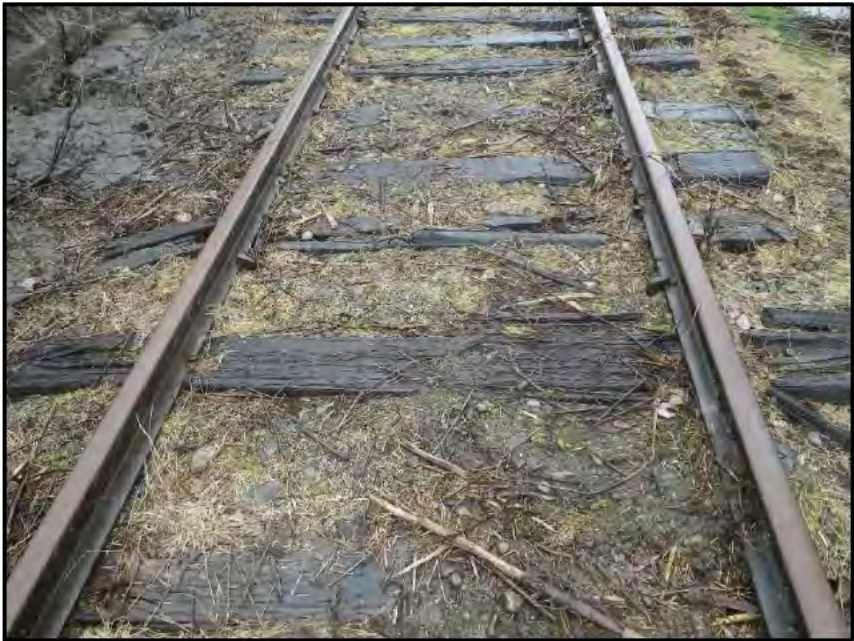
Figure 7-10. Closeup of intact rails and ties in new segment of Site 45KI451 (*near Pole 1/11*), view north

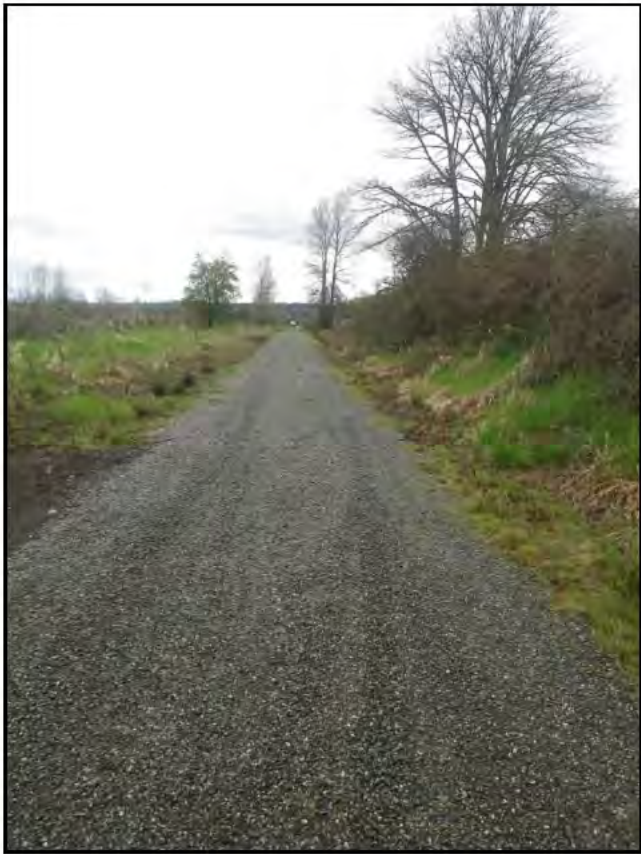
Figure 7-11. Overview of former SLS&E line (*archaeological site 45KI451*) (*Section 2*) adjacent to Sammamish Valley Park near Pole 1/8, view south.

Section 2 is a remnant railroad grade consisting of raised berm that has been converted into a modern gravel access road for approximately 1,173 linear ft, from the end of Section 1 to the intersection with NE 116<sup>th</sup> St. (Figure 7-11). The rails, ties, and hardware have been removed and/or possibly buried beneath modern gravel used to widen the corridor in this area. Road construction machinery was staged in a parking area along the corridor north of NE 116<sup>th</sup> St. in 2019.

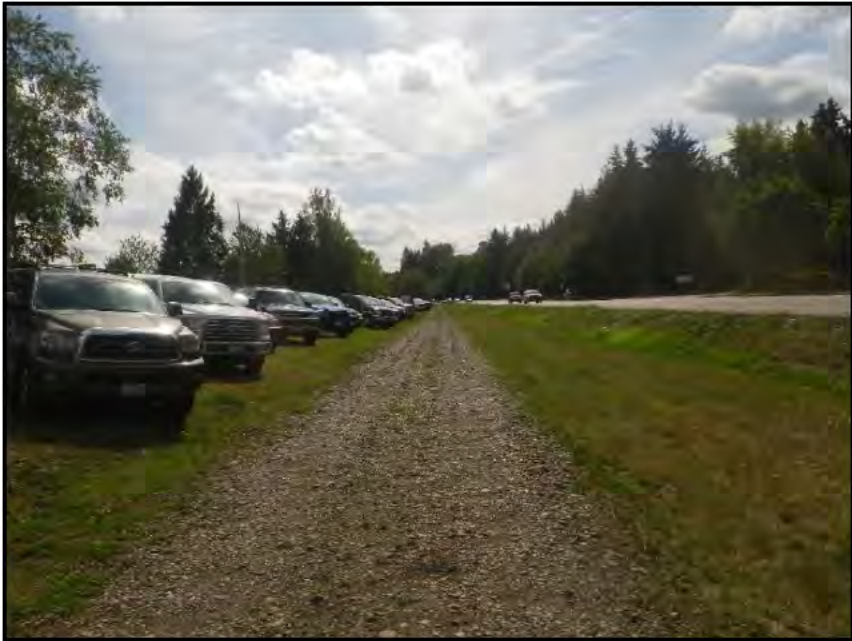
Figure 7-12. Overview of former SLS&E line (*archaeological site 45KI451*) (*Section 3*) adjacent to Willows Run Golf Course, view south.

Section 3, approximately 5,850 ft long and 12 ft wide at the surface, is remnant railroad grade without rails, ties, or hardware that has been modified with the surrounding landscaping. The height of the berm varies from 0–7 ft above grade. Near the Willows Run Golf Course parking area, the grade has been flattened and the corridor is used as overflow parking for golfers (Figure 7-12). In front of Overlake Christian Church, at NE 100<sup>th</sup> Ct., the berm is raised above the adjacent ditch and landscaped manicured lawn, to approximately 5 ft high (Figure 7-13).

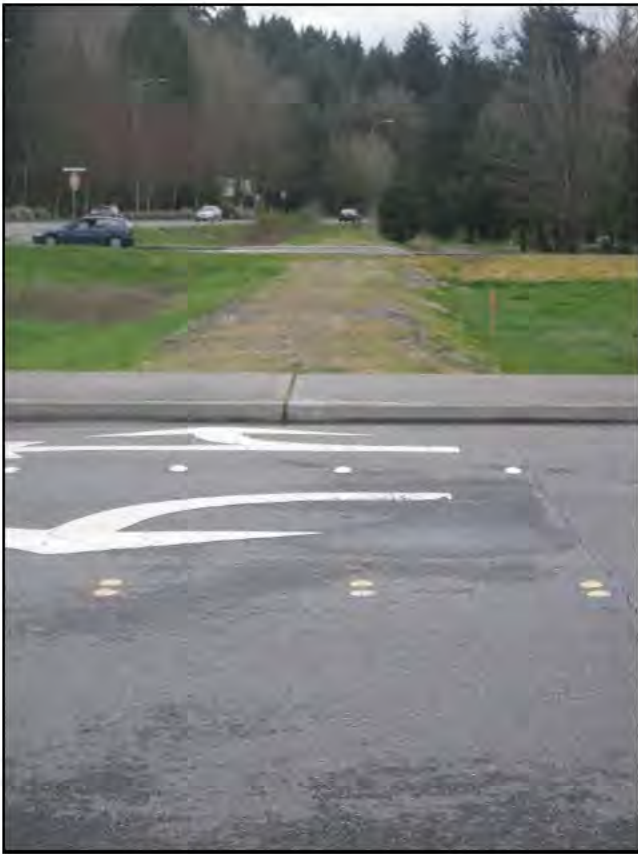
Figure 7-13. Abandoned railroad grade with rails and ties removed, in new segment of Site 45KI451 (near Pole 0/9), view north.

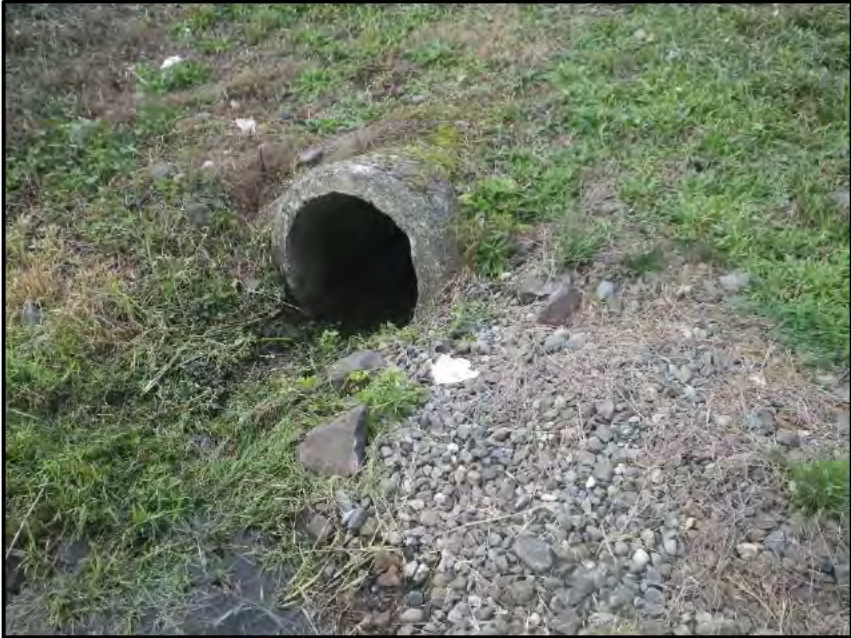
Figure 7-14. Cylindrical concrete pipe culvert at base of railroad berm in new segment of Site 45KI451, view southwest.

HRA noted five concrete pipe culverts installed through the railroad berm to allow for cross drainage at the base of the berm. Each single pipe culvert is circular in shape with a 3 ft diameter (Figure 7-14). Cement pipe culverts were manufactured beginning in the mid- to late nineteenth century. This technology is still being manufactured and installed for irrigation and drainage purposes in the present (Hill and Griffith Company 2016). Due to the height of water in the ditches and the slope of the grade, two smaller stormwater culverts installed through the railroad berm were not observed during the survey.

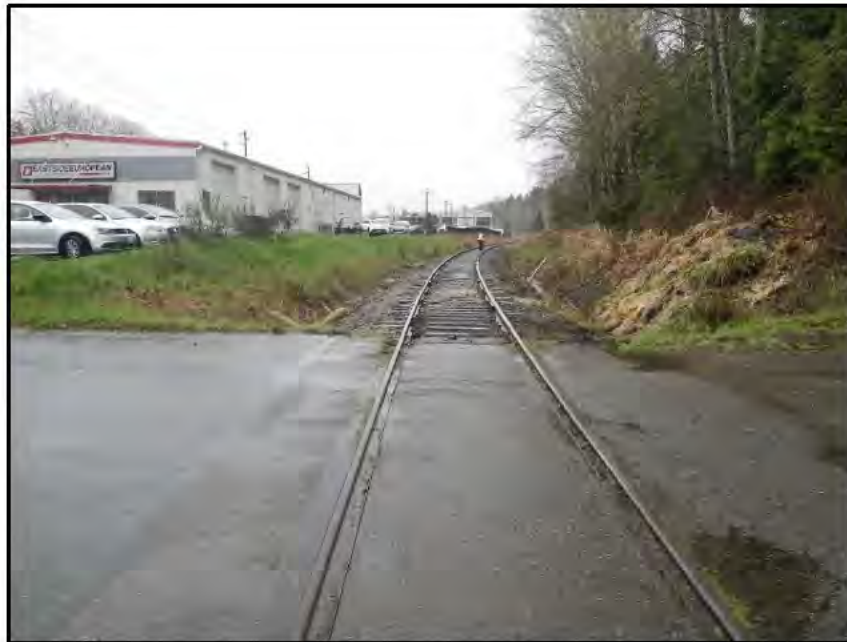
Figure 7-15. Segment of Site 45KI1274 with intact rails and ties, view west. Note asphalt street crossing in foreground.

This abandoned railroad corridor is the former NPRR Lake Washington Beltline that once operated between Renton, Bellevue, and Woodinville. This segment of the line is in the city of Kirkland and the former grade is now part of the CKC. The segment extends 7,519 ft, from approximately I-405 heading northeast, to just south of 139<sup>th</sup> Ave. NE. Sections within this segment of Site 45KI1274 exhibited different material characteristics. The eastern end, between 132<sup>nd</sup> Ave. NE and Willows Rd. NE had intact rails, ties, and hardware (Figures 7-4, 7-15, and 7-16). In the western section, between NE 116<sup>th</sup> St. and 132<sup>nd</sup> Ave. NE, the rails, ties, and hardware were removed, and the grade was converted to the CKC (Figures 7-17 and 7-18). A small portion of the site is covered with grass sod in a traffic median at the intersection of NE 124<sup>th</sup> St. and Totem Lake Blvd. NE. Areas along the CKC that approached or crossed streets, sidewalks, and driveways are paved. One asphalt street crossing with post-mounted signal and a stop sign was identified where 135<sup>th</sup> Ave. NE intersects the alignment (see Figure 7-16). One asphalt street crossing with cantilever flashing signal was identified at the intersection with 132<sup>nd</sup> Ave. NE.

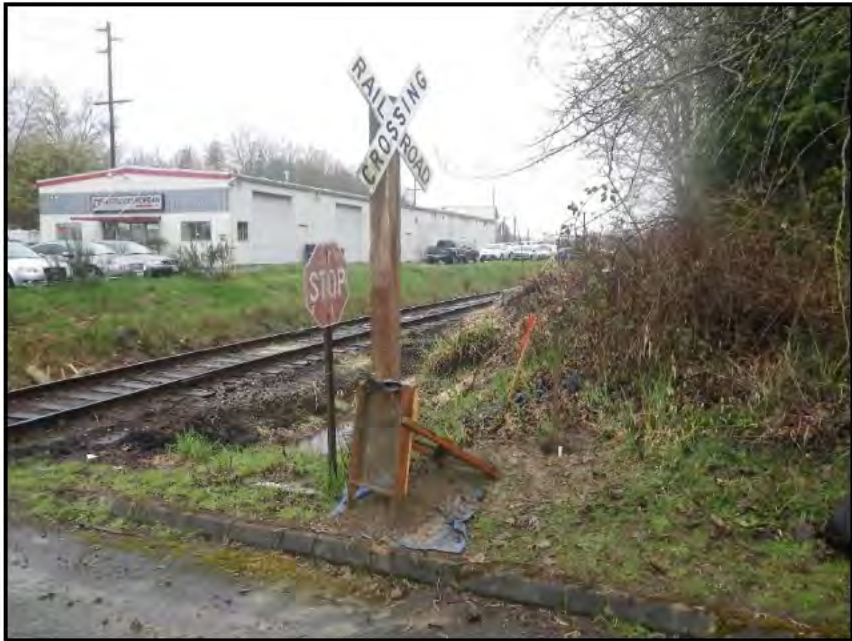
Figure 7-16. Overview of intact rails and ties with post-mounted crossing sign near Pole 2/9, view southwest.

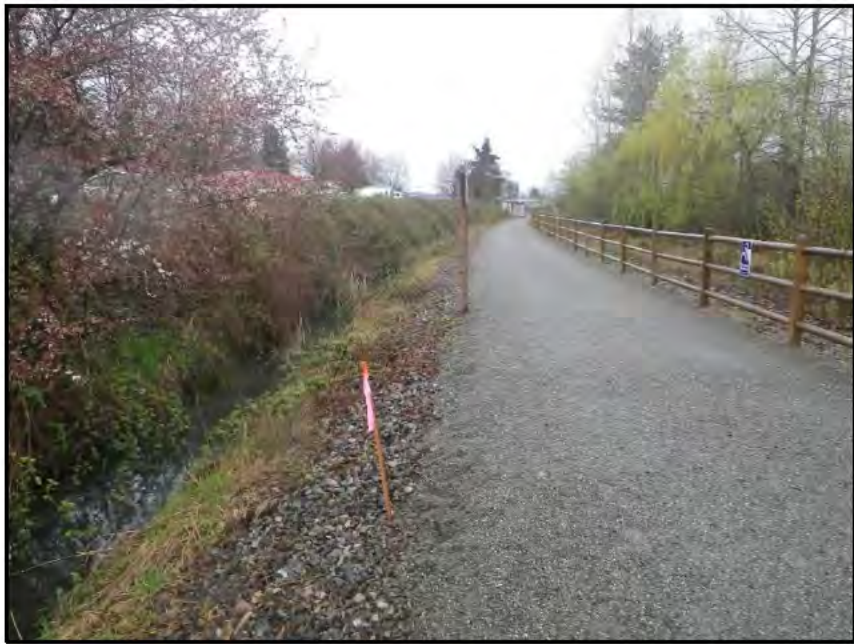
Figure 7-17. Alignment of Site 45KI1274, repurposed as the CKC, near Pole 2/15, view east.

The intact portion of the grade was trapezoidal in cross-section. Vertical depth of grade varied from a flat surface in the graveled portion (western end) to approximately 10 ft high in the far eastern end (Figures 7-17 through 7-19). The grade's width varied from 18–25 ft. The rails were approximately 2.5 inches wide and held together intermittently with fishplates (joints) and bolts. Iron spikes fastened the rails in place to the ties. The wooden ties were treated with creosote and measured approximately 8 ft 8 inches by 8.5 inches by 7.25 inches, with gaps of 10–24 inches between ties.

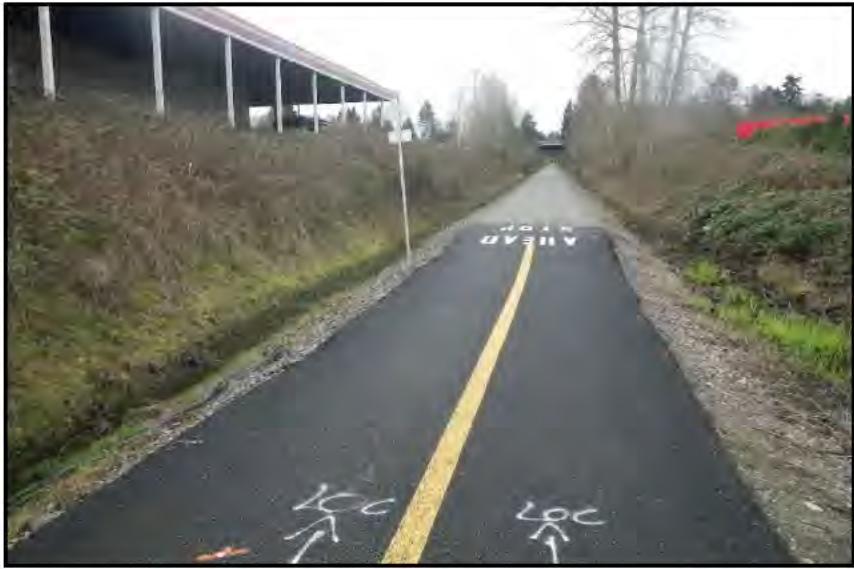
Figure 7-18. Segment of Site 45KI1274 with rails and ties removed, converted to the CKC, view southwest.

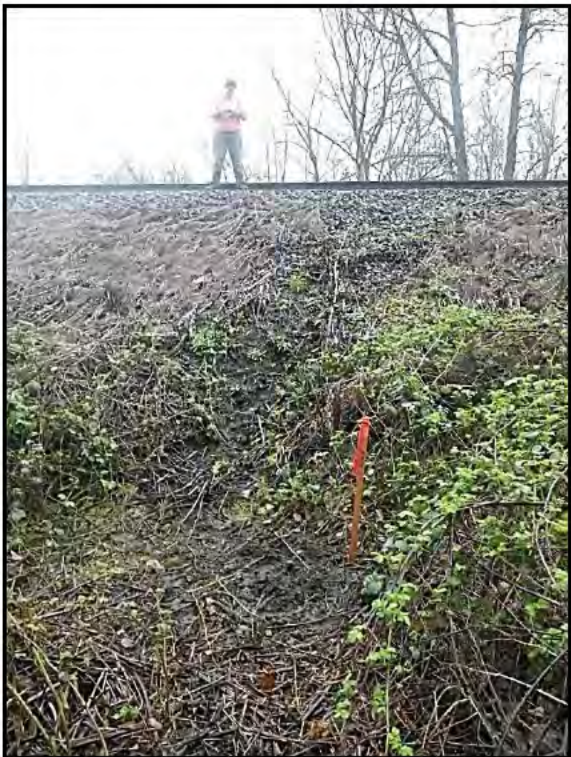
Figure 7-19. Segment of Site 45KI1274 with Mary Leinart on grade, view south.

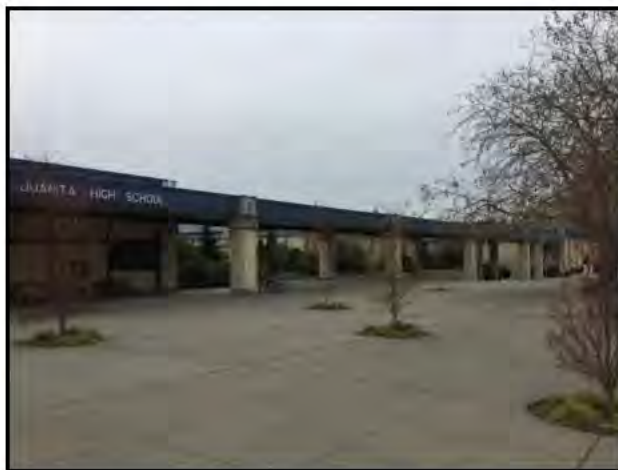
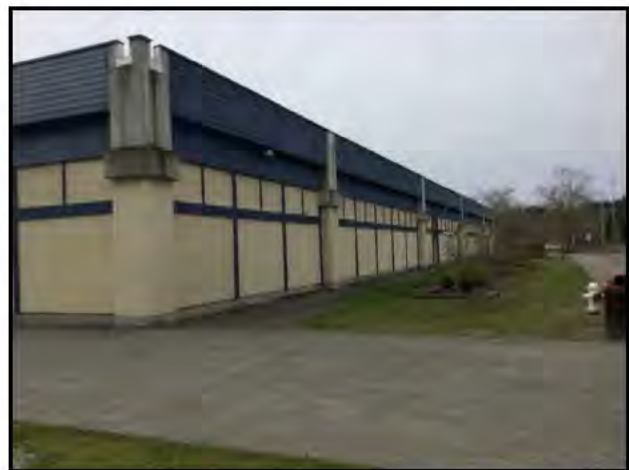
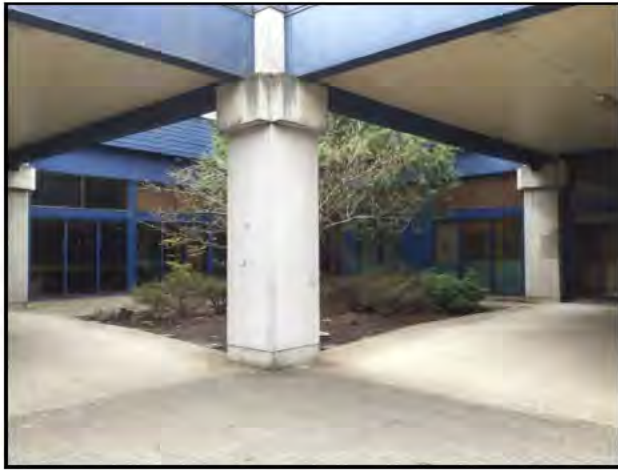
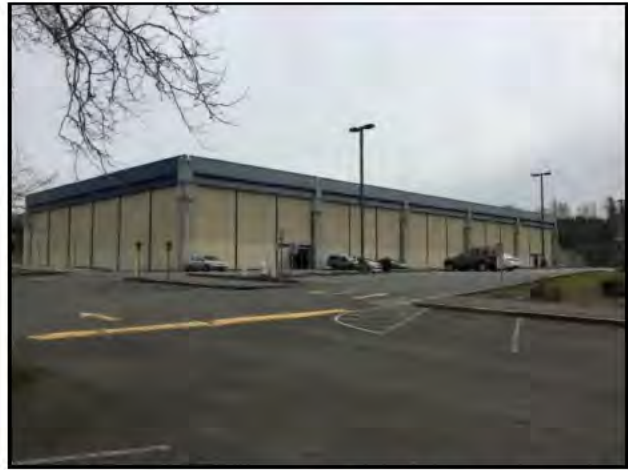
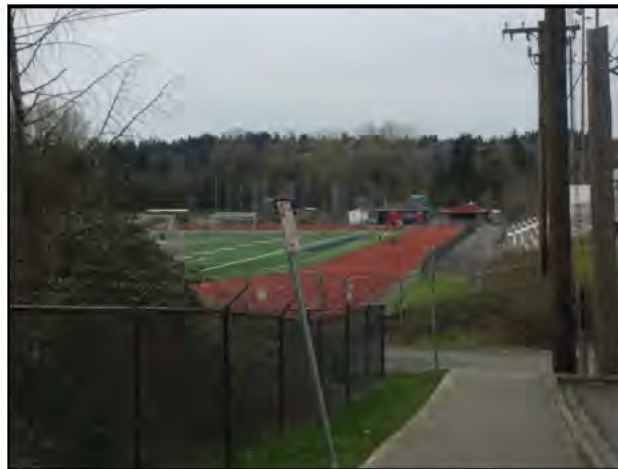
Figure 7-20. 10601 NE 132<sup>nd</sup> St., view southwest

Figure 7-21. The north face of the main school building at 10601 NE 132<sup>nd</sup> St., view southwest.

Figure 7-22. Courtyard of the main school building at 10601 NE 132<sup>nd</sup> St., view southwest.

Figure 7-23. The gymnasium at 10601 NE 132<sup>nd</sup> St., view southeast.

Figure 7-24. Trach-and-field complex at 10601 NE 132<sup>nd</sup> St., view northwest.

Built in 1971, the Juanita High School at 10601 NE 132<sup>nd</sup> St. is a complex of 12 one-story buildings: the main school building, a gymnasium, an aquatics center, and nine accessory buildings. Of these, only six are visible from the ROW: the main school building, the gymnasium, a modular classroom, and three buildings associated with the school track (Figures 7-20–7-24). The school building and gymnasium are Modern in style with International, Gothic Revival, and Stick elements. The primary entrance of the main building fronts north toward NE 132<sup>nd</sup> St. It is irregular in plan, with classrooms and halls built around multiple courtyards. The sprawling building sits on a poured-concrete foundation and is clad in stucco and stick work forming geometric cubes. The main school building is topped by a mansard roof, clad in horizontal boards where the overhang overlaps with the building face, and rolled asphalt on the flat top. The facade features a recessed primary entry beneath a deep colonnade that extends to the large fieldhouse on the west end of campus. Fenestration includes banks of metal-framed windows in the interior courtyard, arranged in such a way as to echo the geometric shapes of the stick work on the building's faces. Key architectural ornamentation includes poured-concrete, crenelated column heads above pilasters spaced evenly throughout all faces of the building. The gymnasium is rectangular in plan and features the same ornamentation as the school building. The modular building is on the northeast corner of the campus. It is one story and has a flat roof. The remaining three buildings are part of a track-and-field complex and are minimally visible. They are arranged side by side on the west end and appear to be Utilitarian in style. The building to the north has a front-facing gable roof and a large opening on the east face that likely opens for the building to sell concessions. The middle building features a hip roof, a doorway on the north end, and a roll-up door on the south. The building on the south is a small building with a shed roof. No additional architectural details were visible.

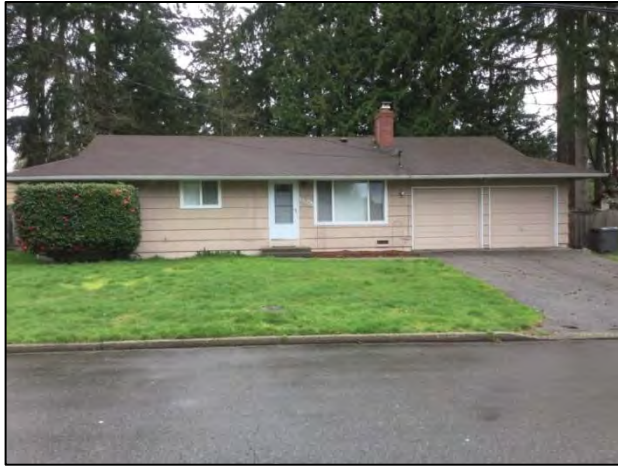
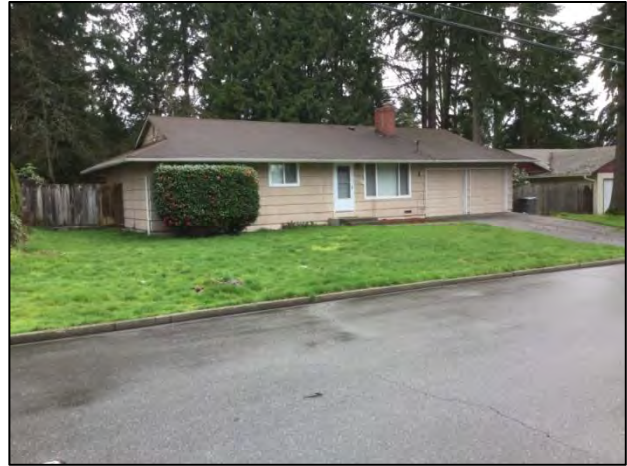
Figure 7-25. 13028 109<sup>th</sup> Ave. NE, view east.

Figure 7-26. 13028 109<sup>th</sup> Ave. NE, view southeast.

Built in 1963, the single-family dwelling fronting west at 13028 109<sup>th</sup> Ave. NE is a one-story Modern Ranch house (Figures 7-25 and 7-26). The rectangular building is 940 square (sq) ft, sits on a poured-concrete foundation, is clad in cedar-shake siding, and is topped by a gable-on-hip roof. The facade features a central doorway accessed via a cement two-step slab. South of the entry is a two-bay attached garage with original doors. Fenestration includes a vinyl three-light window south of the door and a smaller vinyl slider to the north. The house has moderate overhanging eaves. Unadorned secondary elevations are visible on the north and south. No associated structures are visible on the parcel from the ROW.

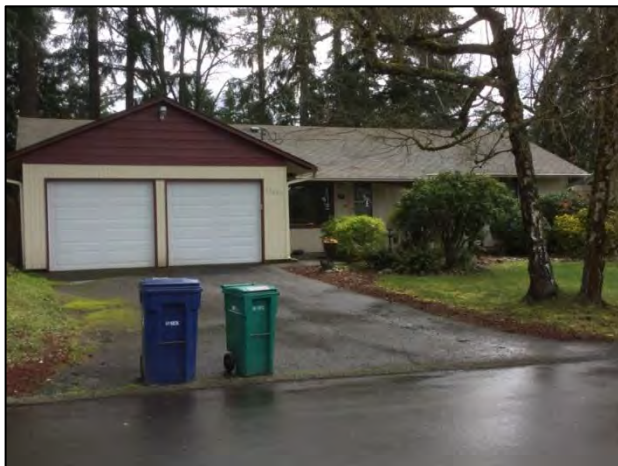
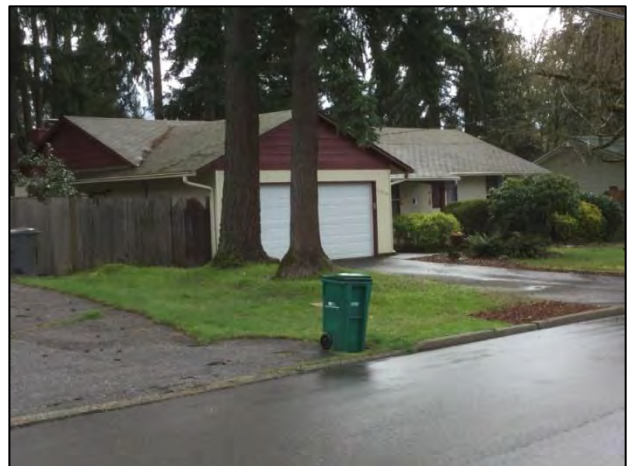
Figure 7-27. 13020 109<sup>th</sup> Ave. NE, view southeast.

Figure 7-28. 13020 109<sup>th</sup> Ave. NE, view southeast.

Built in 1963, the single-family dwelling fronting west at 13020 109<sup>th</sup> Ave. NE is a one-story Modern Ranch house (Figures 7-27 and 7-28). The L-shaped building is 980 sq ft with a projecting two-bay garage with vinyl roll-up doors on the north end. The building sits on a poured-concrete foundation, is clad in vertical board siding, and is topped by a cross-gabled roof with asphalt-composition cladding. The facade features a central door with a screen door beneath an overhang. Fenestration includes vinyl sliders south of the door and a three-light vinyl window between the door and the projecting garage. The house has minimal eaves on all but the west portion over the doorway and windows. Partially visible behind a fence is an unadorned secondary elevation that appears to include fenestration and a doorway. No associated structures are visible on the parcel from the ROW.

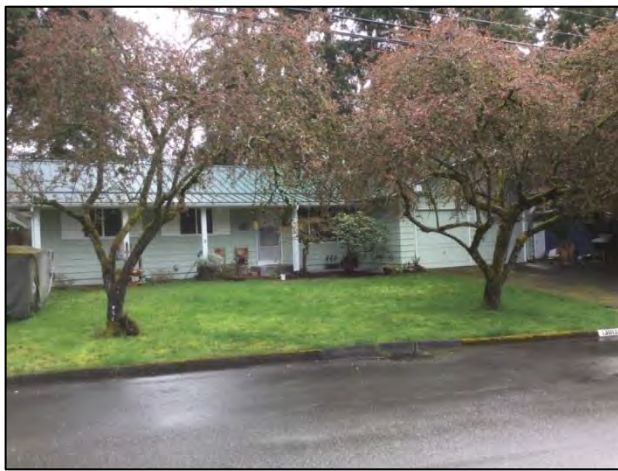
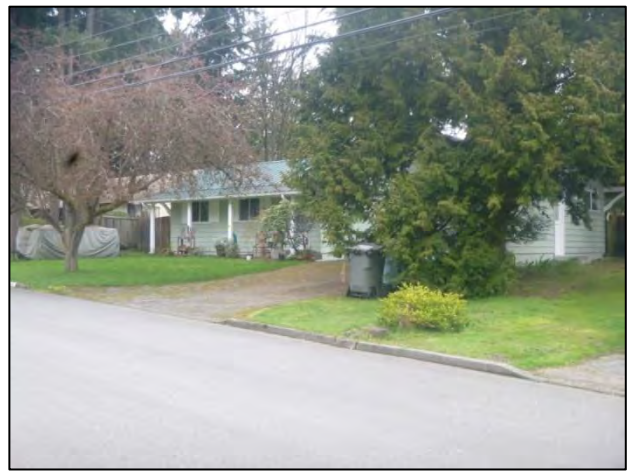
Figure 7-29. 13012 109<sup>th</sup> Ave. NE, view southeast.

Figure 7-30. 13012 109<sup>th</sup> Ave. NE, view northeast.

Built in 1963, the single-family dwelling fronting west at 13012 109<sup>th</sup> Ave. NE is a one-story Modern Ranch house (Figures 7-29 and 7-30). The L-shaped building is 1,140 sq ft with a projecting two-bay garage with original doors on the south end. The building sits on a poured-concrete foundation, is clad in lap siding, and is topped by a cross-gabled roof with standing-seam metal cladding. The facade features a central door accessed by a two-step cement stair beneath an overhang from the roof supported by four simple wood posts. Fenestration includes two vinyl sliders with shutters north of the door and a three-light vinyl window between the door and the projecting garage. The house has moderate eaves with exposed rafters over the garage. A secondary elevation is partially visible on the north, behind a fence, and appears to include fenestration and a doorway. No associated structures are visible on the parcel from the ROW.

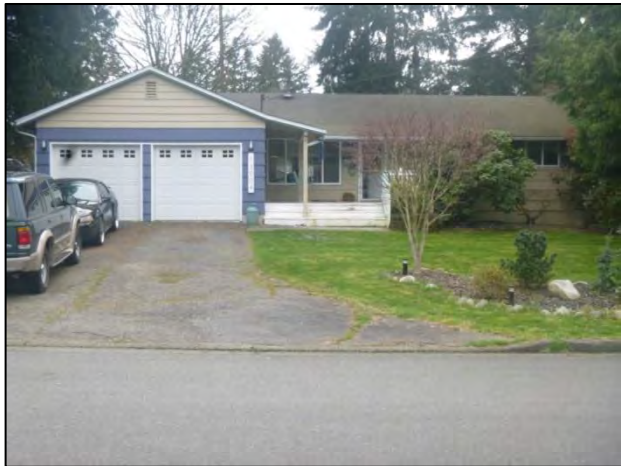
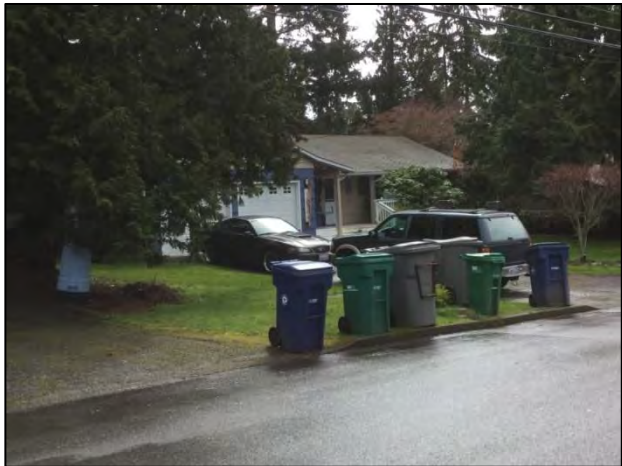
Figure 7-31. 13004 109<sup>th</sup> Ave. NE, view east.

Figure 7-32. 13004 109<sup>th</sup> Ave. NE, view southeast.

Built in 1963, the single-family dwelling fronting west at 13004 109<sup>th</sup> Ave. NE is a one-story Modern Ranch house (Figures 7-31 and 7-32). The L-shaped building is 1,140 sq ft with a double garage (with replacement doors) projecting west on the north side of the facade. The building sits on a poured-concrete foundation, is clad in cedar shake with drop siding in the gable over the garage, and is topped by a cross-gabled roof with asphalt-composition cladding. The facade features a central doorway accessed by wood decking. An extension from the garage gable partially covers the entry. Fenestration includes a large vinyl slider window between the door and garage extension, and two vinyl sliders with shutters on the south end. The house has moderately overhanging eaves on the primary massing and minimal eaves on the front gable. An unadorned secondary elevation is visible on the south side. No associated structures are visible on the parcel from the ROW.

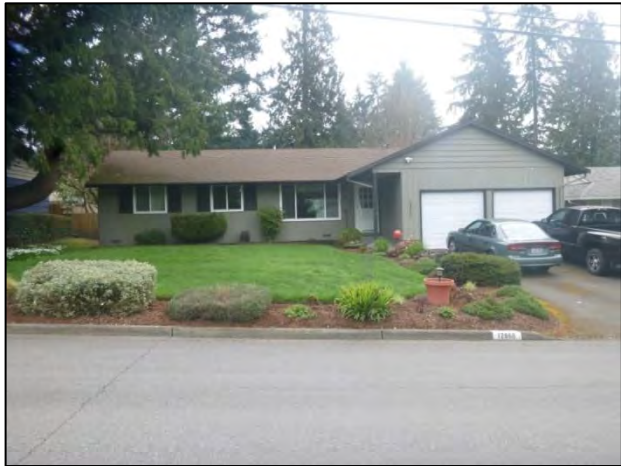
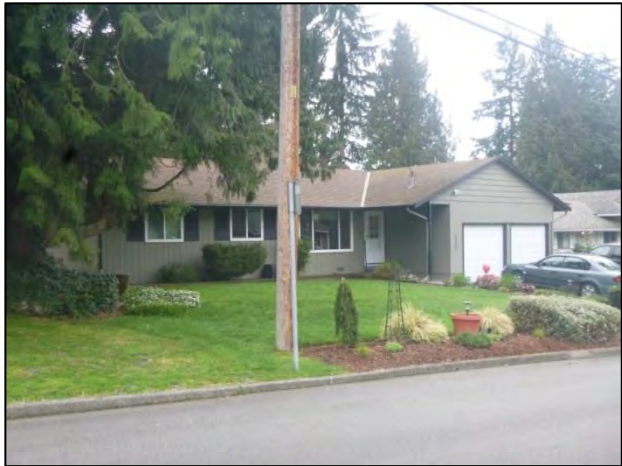
Figure 7-33. 12860 109<sup>th</sup> Ave. NE, view east.

Figure 7-34. 12860 109<sup>th</sup> Ave. NE, view southeast.

Built in 1963, the single-family dwelling fronting west at 12860 109<sup>th</sup> Ave. NE is a one-story Modern Ranch house (Figures 7-33 and 7-34). Irregular in plan, the building is 1,720 sq ft with a double garage projecting west on the south side of the primary facade and a large addition off the northeast corner of the house. The building sits on a poured-concrete foundation, is clad in vertical board with drop siding in the gable over the garage, and is topped by a cross-gabled roof with asphalt-composition cladding. The facade features a covered walkway formed by an extension from the garage gable. Fenestration includes a three-light vinyl window immediately north of the door, and two vinyl sliders with shutters beyond. The house has moderately overhanging eaves on the primary massing and minimal eaves on the front gable. A secondary elevation is visible on the south side and includes a doorway and two vinyl sliders. No associated structures are visible on the parcel from the ROW.

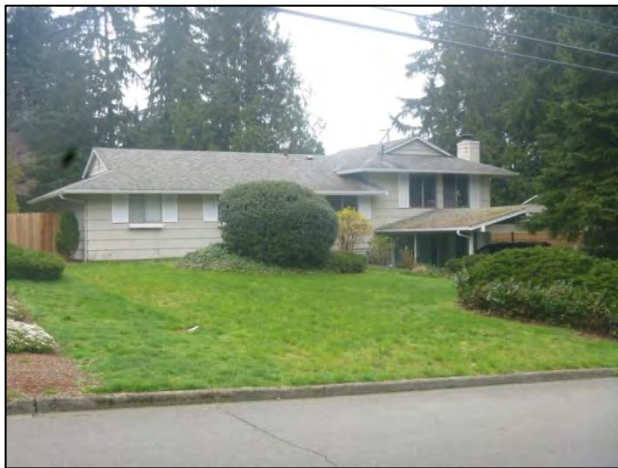
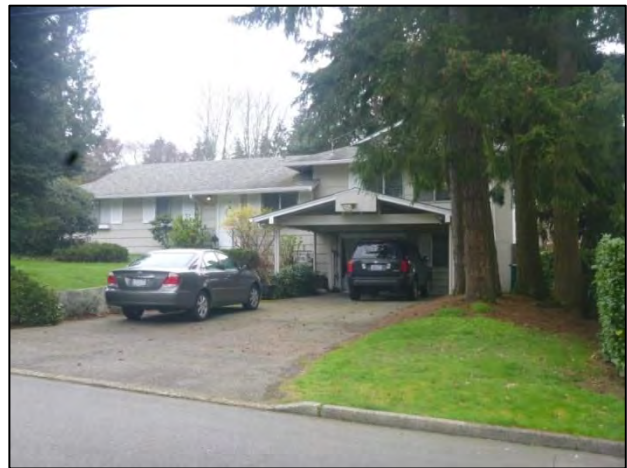
Figure 7-35. 12852 109<sup>th</sup> Ave. NE, view southeast.

Figure 7-36. 12852 109<sup>th</sup> Ave. NE, view northeast.

Built in 1963, the single-family dwelling fronting west at 12852 109<sup>th</sup> Ave. NE is a two-story, Modern Tri-Level Split Ranch house (Figures 7-35 and 7-36). The rectangular building is 1,900 sq ft, sits on a poured-concrete foundation, is clad in cedar shake, and is topped by a gable-on-hip roof with a forward-facing gable canopy addition on the south end of the primary facade. The facade features a doorway accessed by concrete stairs. Fenestration includes aluminum sliders on either side of the door, with additional windows of the same type above the carport and one additional window on ground level, adjacent to a single garage door. The house has moderate eaves with exposed beams in the carport. Secondary elevations are minimally visible behind fencing and mature trees. No associated structures are visible on the parcel from the ROW.

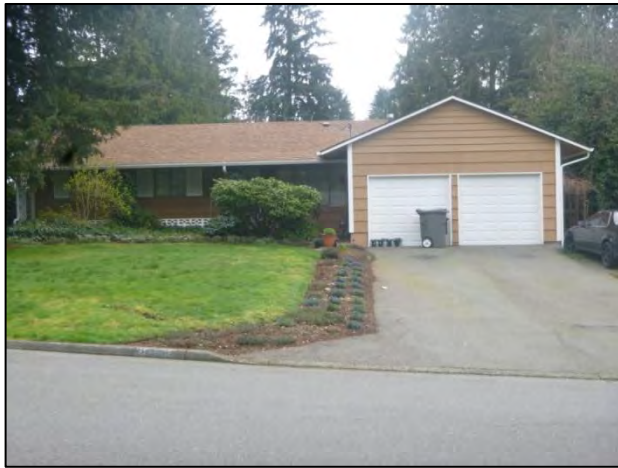
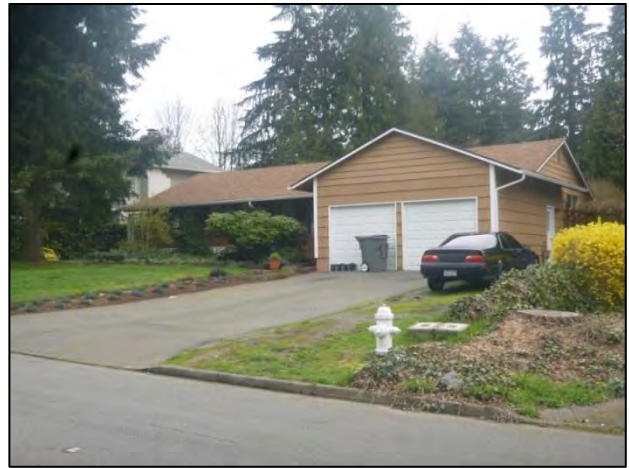
Figure 7-37. 12844 109<sup>th</sup> Ave. NE, view east.

Figure 7-38. 12844 109<sup>th</sup> Ave. NE, view northeast.

Built in 1963, the single-family dwelling fronting west at 12844 109<sup>th</sup> Ave. NE is a one-story Modern Ranch house (Figures 7-37 and 7-38). The L-shaped building is 1,140 sq ft with a two-bay garage with vinyl doors projecting west on the south side of the primary facade. The building sits on a poured-concrete foundation, is clad in cedar shake with drop siding in the gable over the garage, and is topped by a cross-gabled roof with asphalt-composition cladding. The facade features a central doorway, two metal-frame windows with shutters north of the door, and a three-light metal-framed window between the doorway and the projecting garage. The house has moderately overhanging eaves on the primary massing and minimal eaves on the front gable. A secondary elevation is visible on the south side and includes a doorway and single slider window that appears to be metal-framed. No associated structures are visible on the parcel from the ROW.

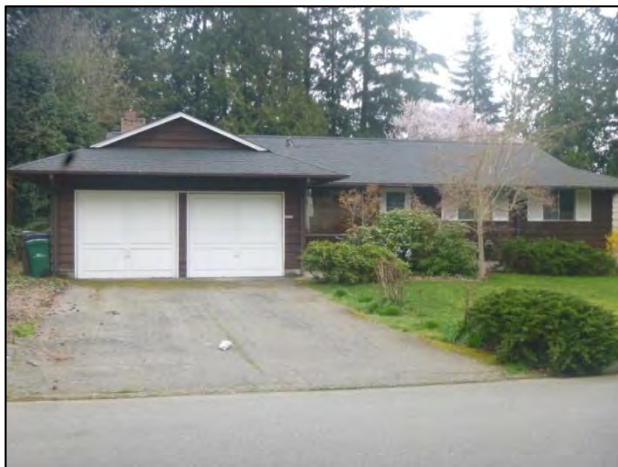
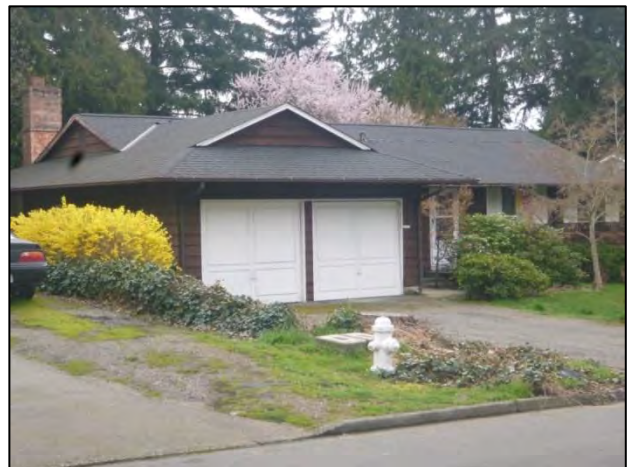
Figure 7-39. 12836 109<sup>th</sup> Ave. NE, view east.

Figure 7-40. 12836 109<sup>th</sup> Ave. NE, view southeast.

Built in 1963, the single-family dwelling fronting west at 12836 109<sup>th</sup> Ave. NE is a one-story Modern Ranch house (Figures 7-39 and 7-40). The L-shaped building has a projecting gable on the north end, sits on a poured-concrete foundation, is clad in lap siding, and is topped by a cross-gable-on-hip roof with asphalt-composition cladding. The facade features a central, simple doorway with a two-bay garage on the north end that appears to retain its original doors, two aluminum sliders south of the doorway, and a large, fixed-pane aluminum-framed window to the north between the door and the garage. The house has moderate eaves and a chimney on the north end of the east elevation. An unadorned secondary elevation is visible on the south. No associated structures are visible on the parcel from the ROW.

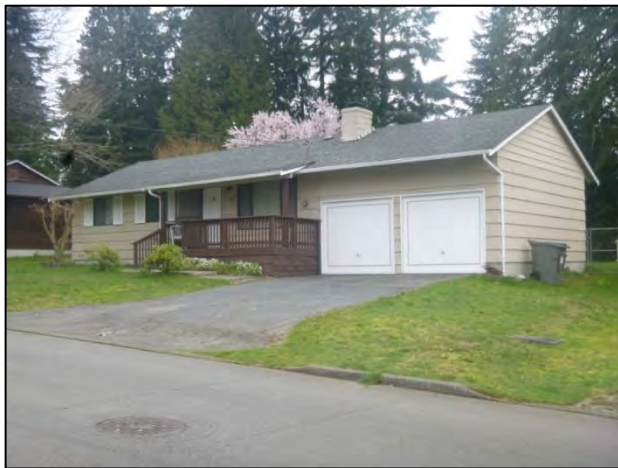
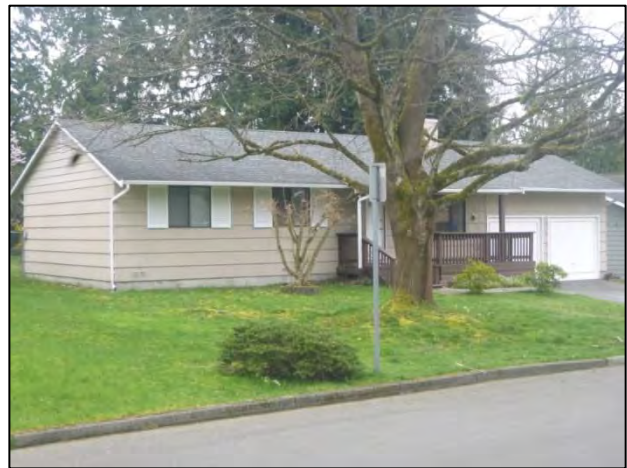
Figure 7-41. 12830 109<sup>th</sup> Ave. NE, view northeast.

Figure 7-42. 12830 109<sup>th</sup> Ave. NE, view southeast.

Built in 1963, the single-family dwelling fronting west at 12830 109<sup>th</sup> Ave. NE is a one-story Modern Ranch house (Figures 7-41 and 7-42). The rectangular building is 940 sq ft, sits on a poured-concrete foundation, is clad in cedar shake, and is topped by a side-gabled roof with asphalt-composition cladding. The facade features a central doorway beneath a slight shed-roof extension, accessed via a wood stairway. A two-bay garage with original roll-up doors is on the south end of the facade. Fenestration includes two metal-frame sliders with shutters north of the door and a three-light metal-frame window to the south. The house has moderate overhanging eaves and a central chimney. Unadorned secondary elevations are visible on the north and south. No associated structures are visible on the parcel from the ROW.

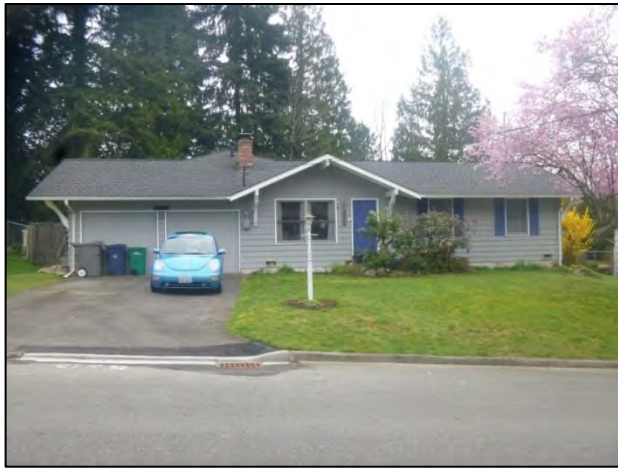
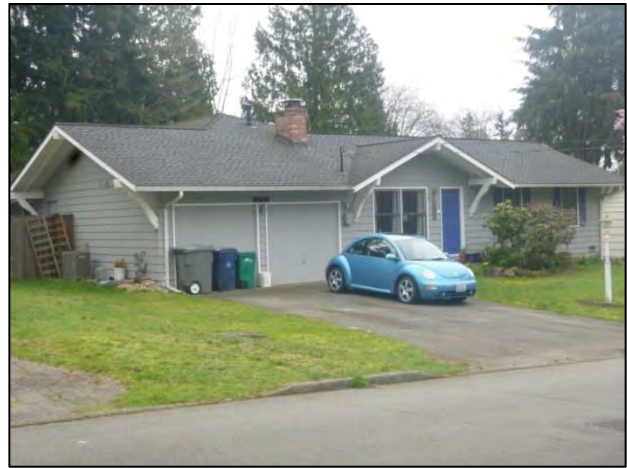
Figure 7-43. 12822 109<sup>th</sup> Ave. NE, view east.

Figure 7-44. 12822 109<sup>th</sup> Ave. NE, view southeast.

Built in 1963, the single-family dwelling fronting west at 12822 109<sup>th</sup> Ave. NE is a one-story Modern Ranch house (Figures 7-43 and 7-44). Irregular in plan, the building is 1,750 sq ft with a large addition off the northeast corner of the house, sits on a poured-concrete foundation, is clad in lap siding, and is topped by a cross-gabled roof with asphalt-composition cladding. The facade features a central doorway beneath a front-gabled roof extension. A two-bay garage with what appear to be original roll-up doors is north of the entry. Fenestration includes side-by-side sash windows north of the door and two sash windows with shutters to the south. The house has deep overhanging eaves, exposed beams and knee braces, and a central chimney. An unadorned secondary elevation is visible on the north. No associated structures are visible on the parcel from the ROW.

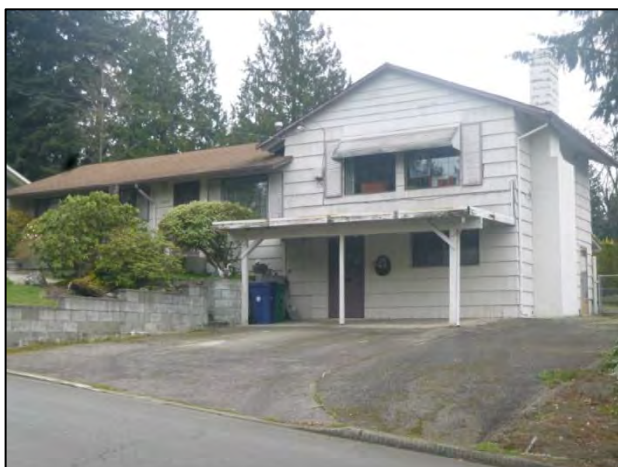
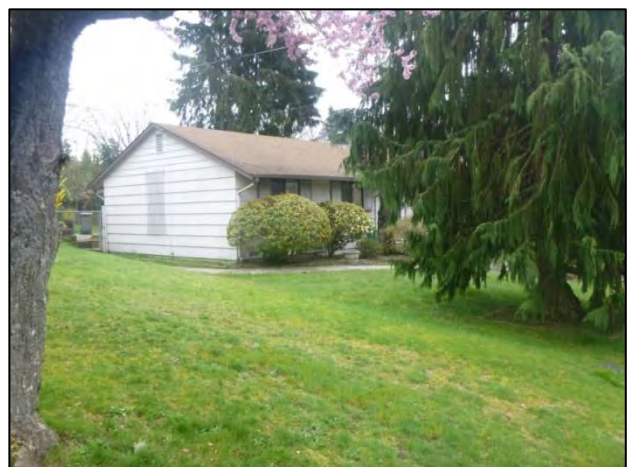
Figure 7-45. 12814 109<sup>th</sup> Ave. NE, view northeast.

Figure 7-46. 12814 109<sup>th</sup> Ave. NE, view southeast.

Built in 1963, the single-family dwelling located fronting west at 12814 109<sup>th</sup> Ave. NE is a two-story, Modern Tri-Level Split Ranch house (Figures 7-45 and 7-46). The rectangular building is 1,900 sq ft, sits on a poured-concrete foundation, is clad in cedar shake, and is topped by a cross-gabled roof with a flat-roof canopy on the south end of the primary facade. Concrete stairs access a doorway in the facade, and fenestration includes aluminum sliders on either side of the door, with additional windows of the same type above the carport and one additional window on ground level, adjacent to a single garage door. The house has moderate eaves (except on the front-gabled portion on the south with minimal eaves) with exposed beams in the carport. Secondary elevations are visible on north, which is unadorned, and the south, which features a chimney. No associated structures are visible on the parcel from the ROW.
