**Surface Water, Groundwater, and
Sediment Transport Monitoring,
Water Year 2010, Grady Ranch,
Marin County, California**

Balance Hydrologics, Inc.

March 2011

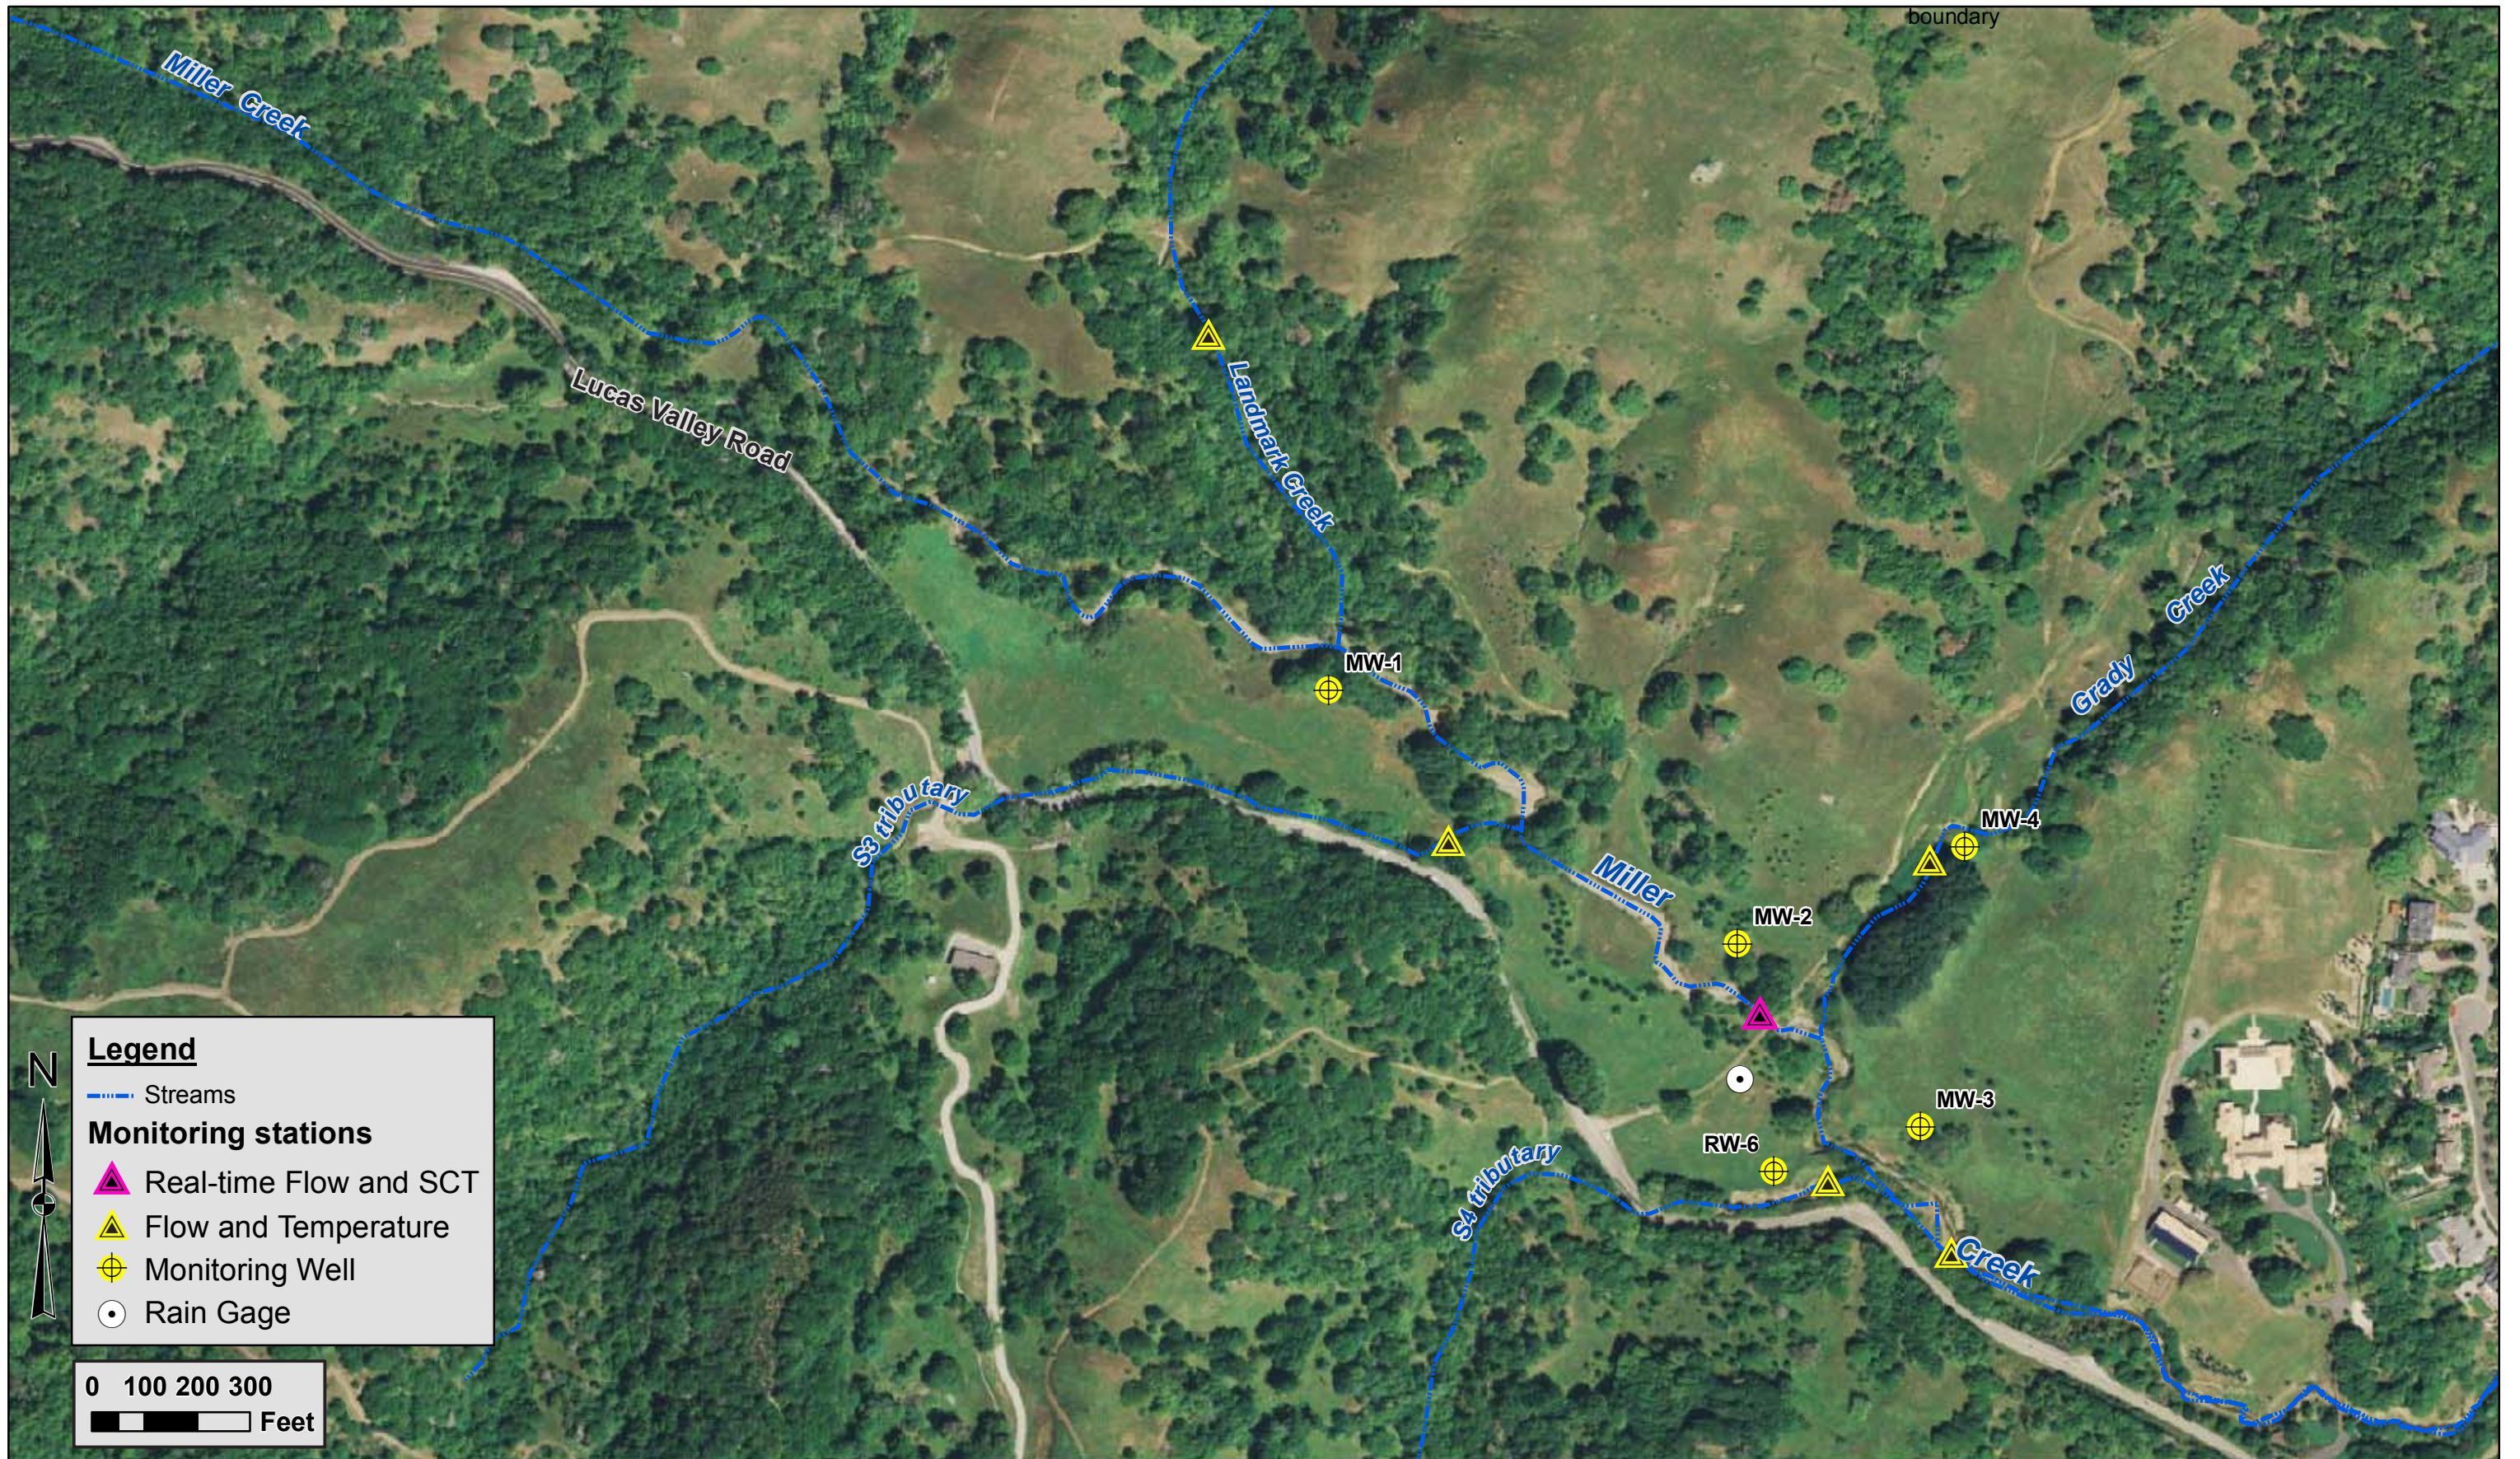
Figure 3. Monitoring stations at Grady Ranch, Marin County, California.

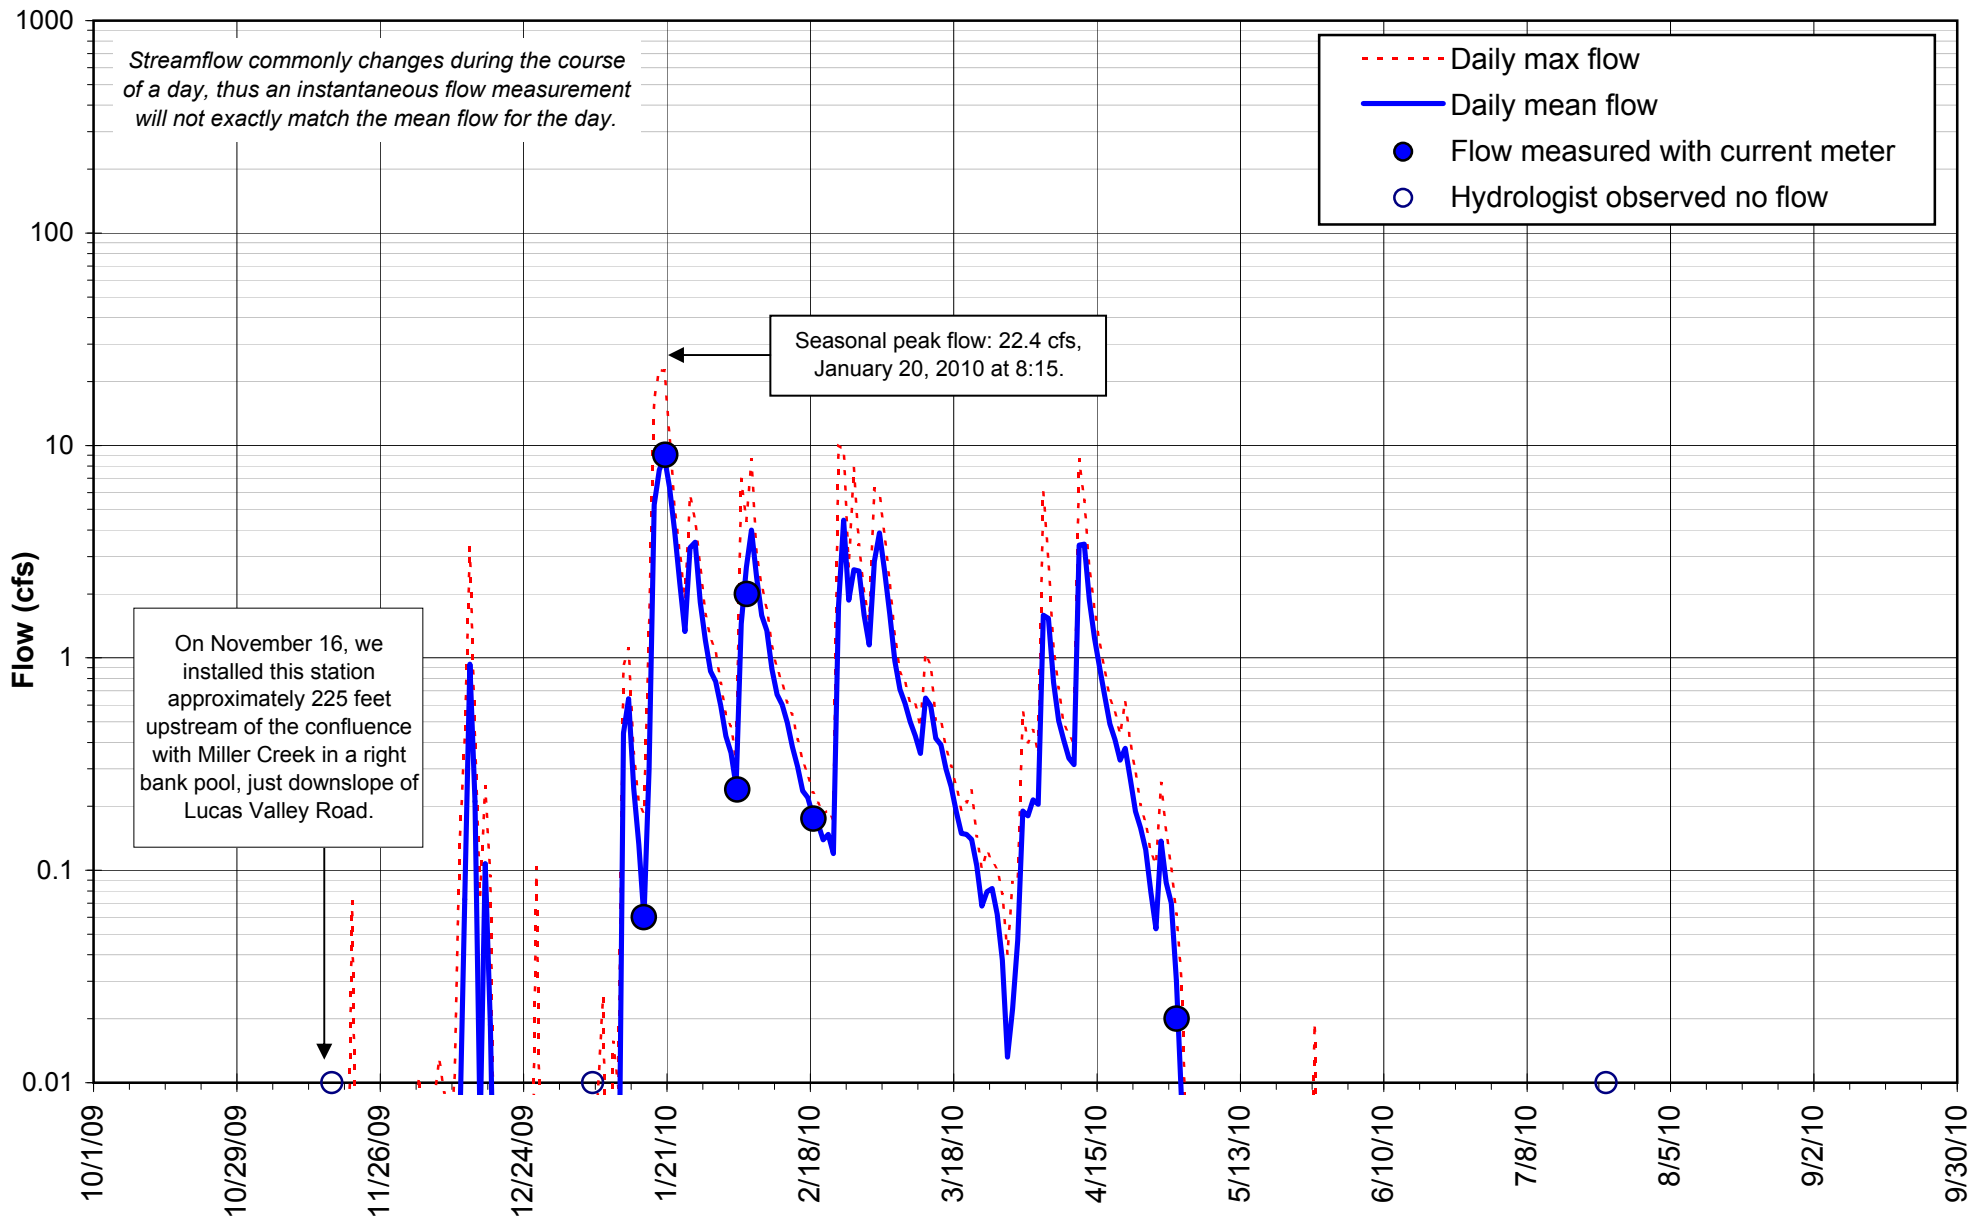
Figure 9. Annual hydrograph for S4 Tributary, water year 2010, Marin County, California. The channel briefly wetted following the first significant early-season October 13th storm. Flows were sustained from January 12th through May 1st.

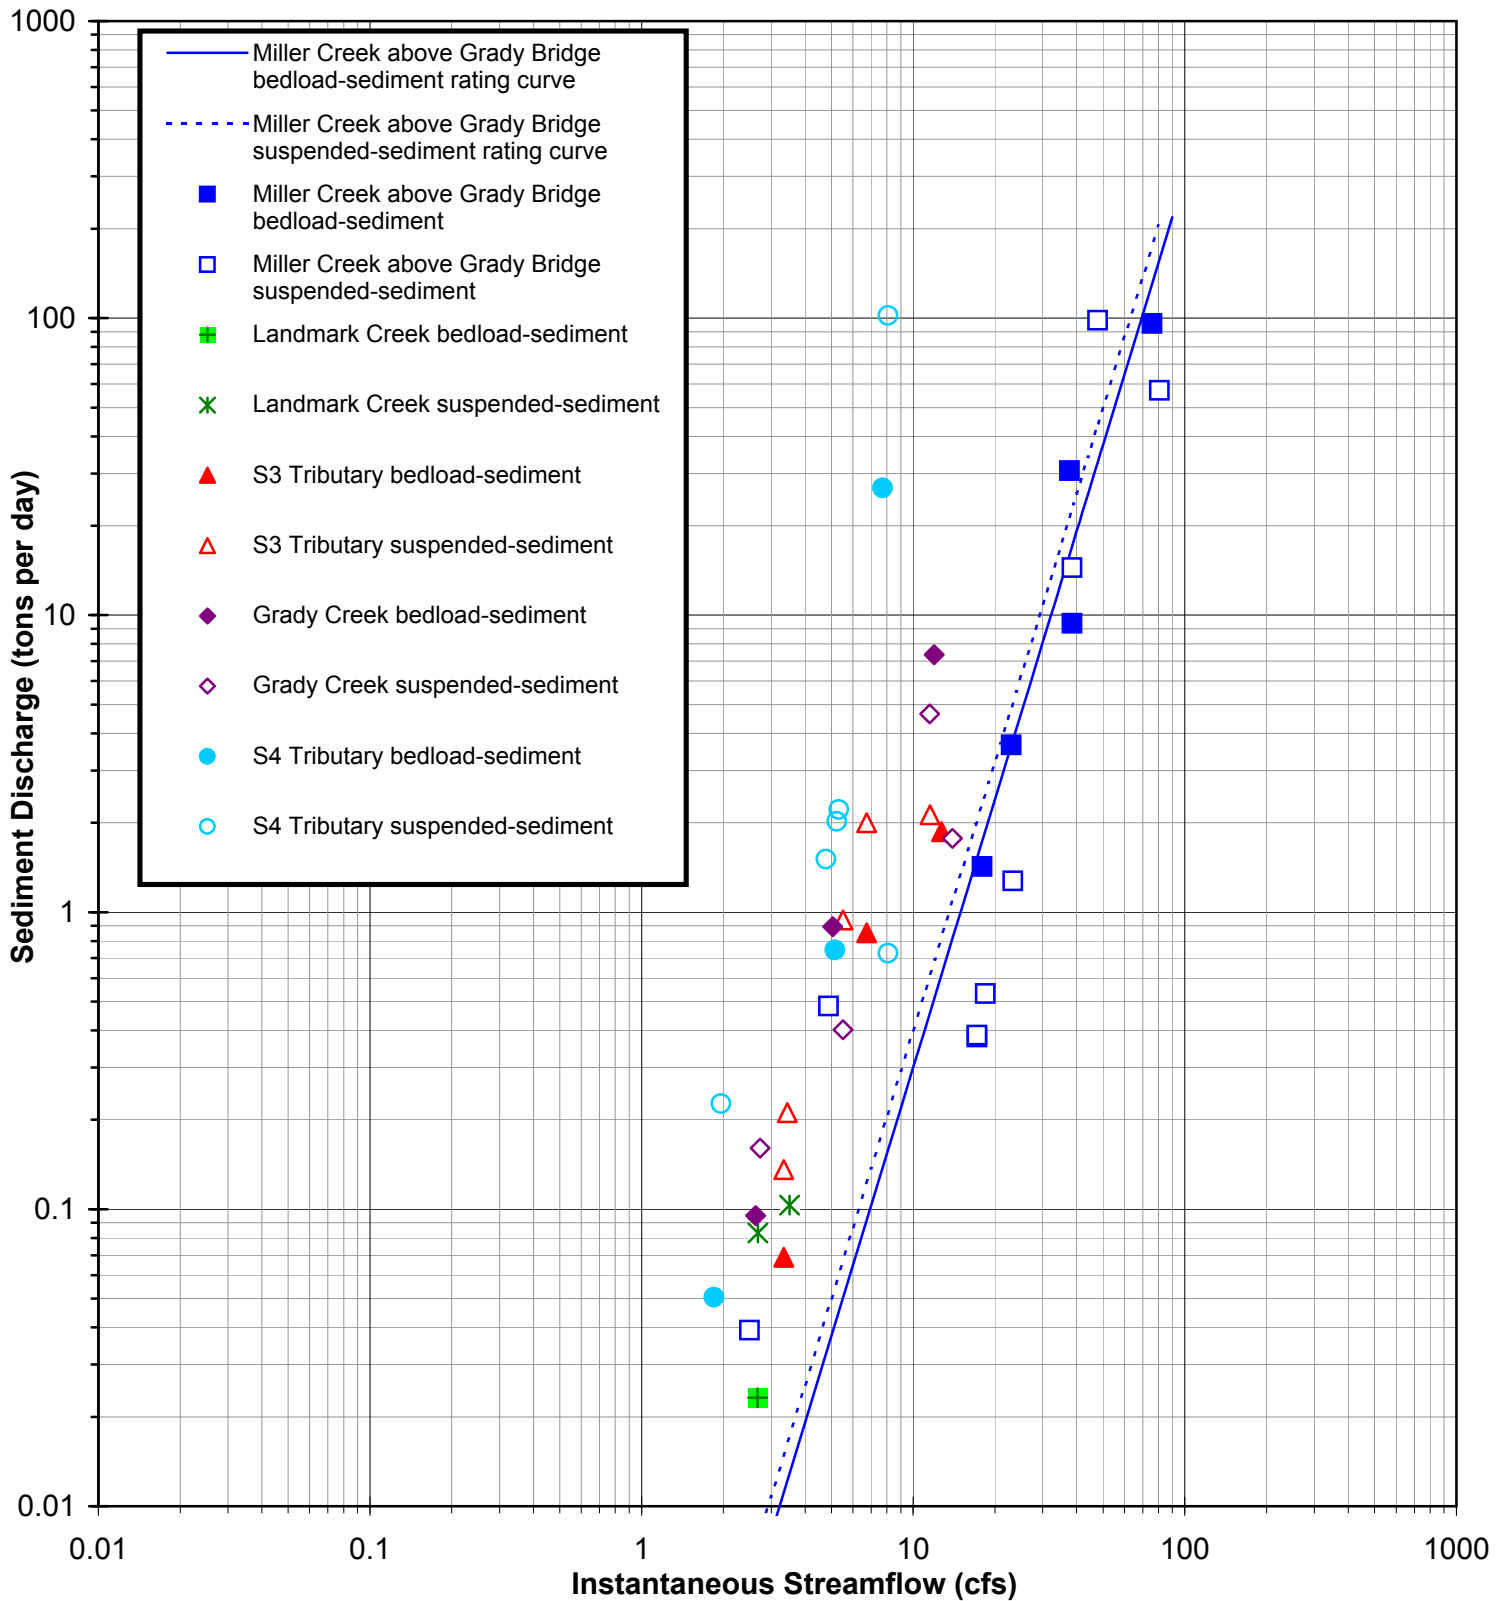
Figure 13. Sediment-discharge measurements for Miller Creek and tributaries water year 2010, Grady Ranch, Marin County, California. These first-year measurements suggest that S4 tributary transports higher rates of sediment than the other tributaries, potentially when upstream banks fail. Preliminary rating curves are illustrated for the Miller Creek station.

Landmark Creek, S3 Tributary, Grady Creek, and S4 Tributary have higher rates of transport at any given flow than Miller Creek, a much larger watershed (Figure 13). This condition is a typical and nearly universal throughout Marin County (c.f., Hecht, 1983) and the Bay Area (c.f., Hecht and Owens, 2006) given that smaller watersheds have briefer, flashier hydrographs flowing through smaller, steeper channels.

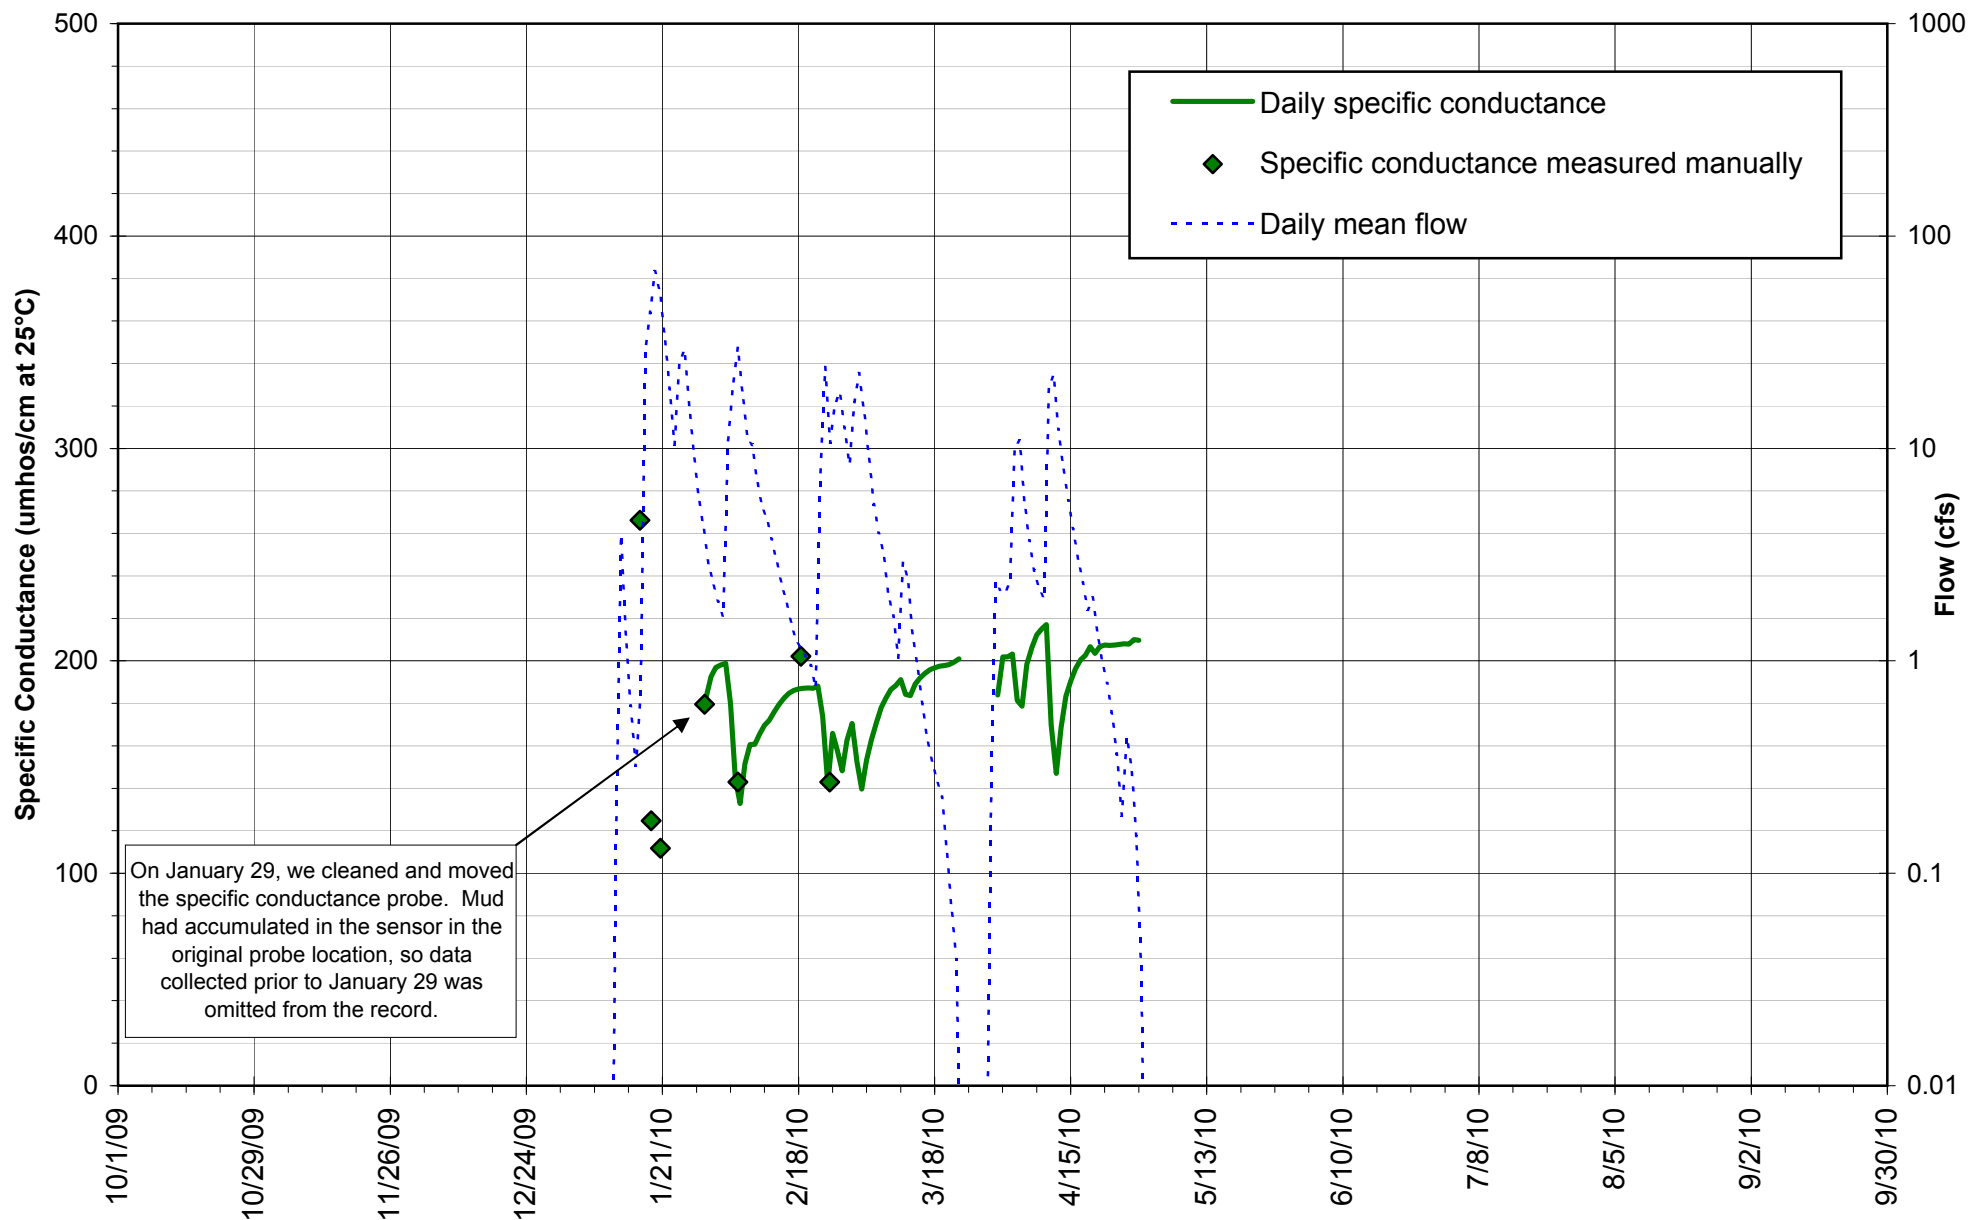
Figure 15. Specific conductance record at the Miller Creek above Grady Bridge station, water year 2010, Marin County, California. Specific conductance during baseflow recession is similar to other central Marin streams, such as San Geronimo Creek, suggesting that flow emanates from the alluvial aquifer rather than deeper bedrock sources. During storms, specific conductance recedes with runoff.

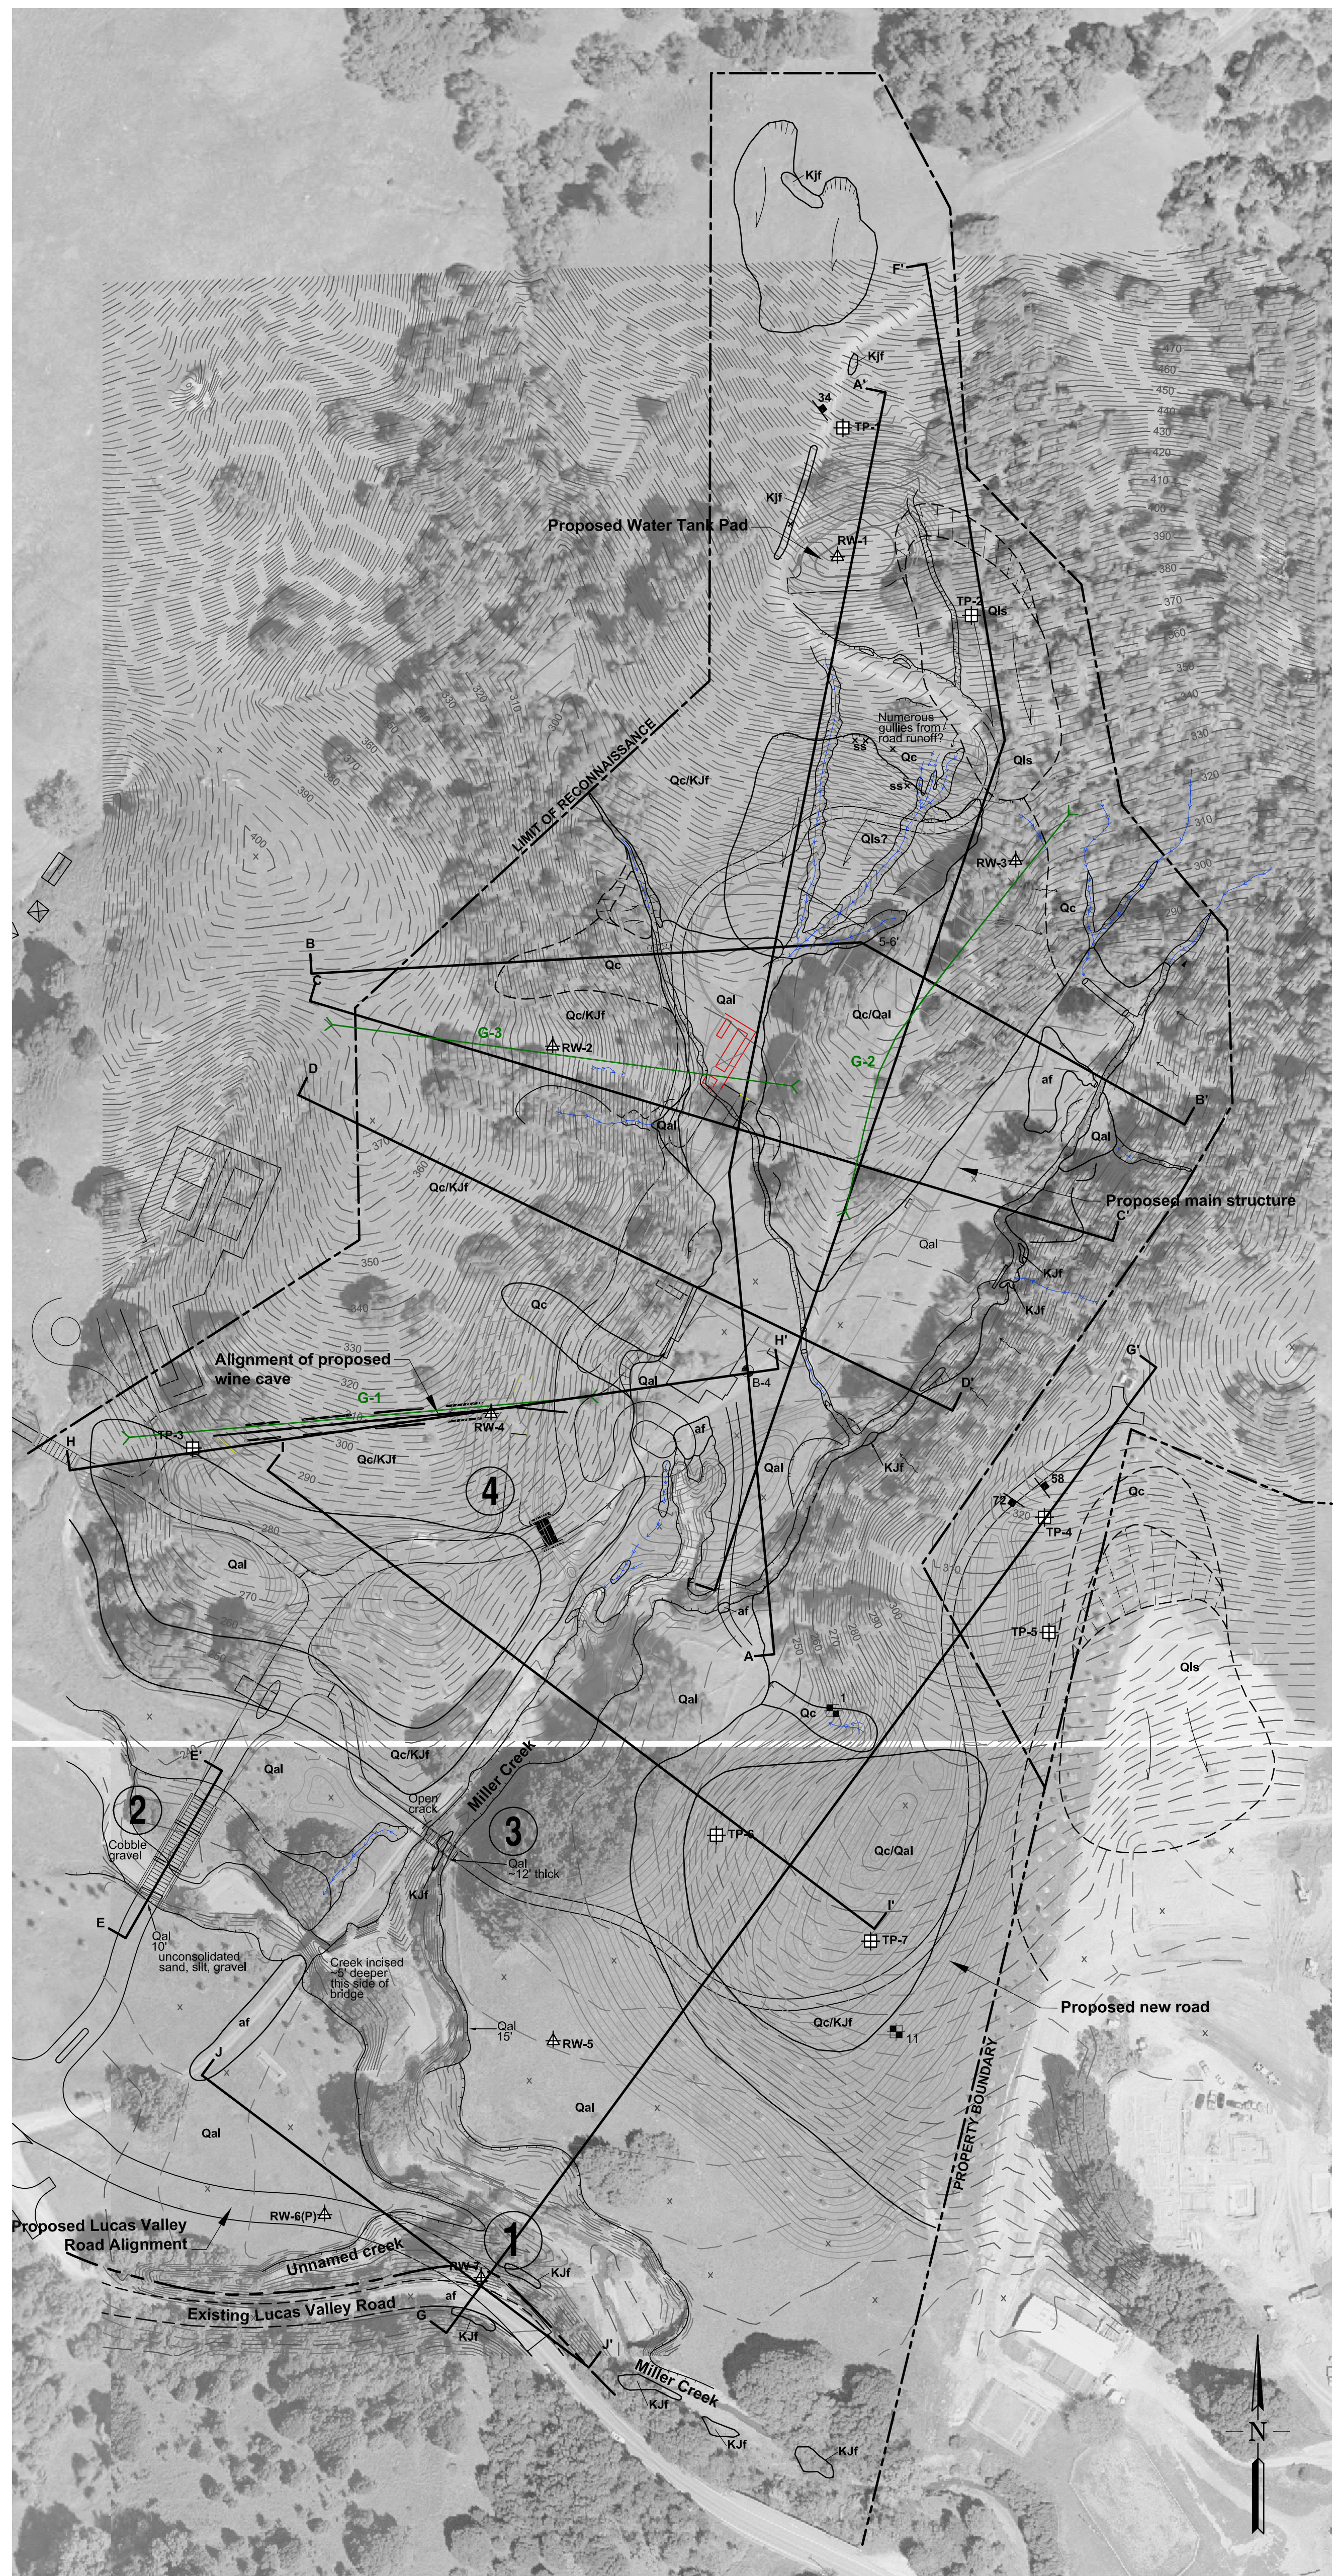
GEOLOGIC MAP, SITE PLAN, GRADING PLAN

**Geology Plate (AMEC Geomatrix, November 2008),
boring logs (August 2009), and
supplemental seismic refraction lines (October 2009)**

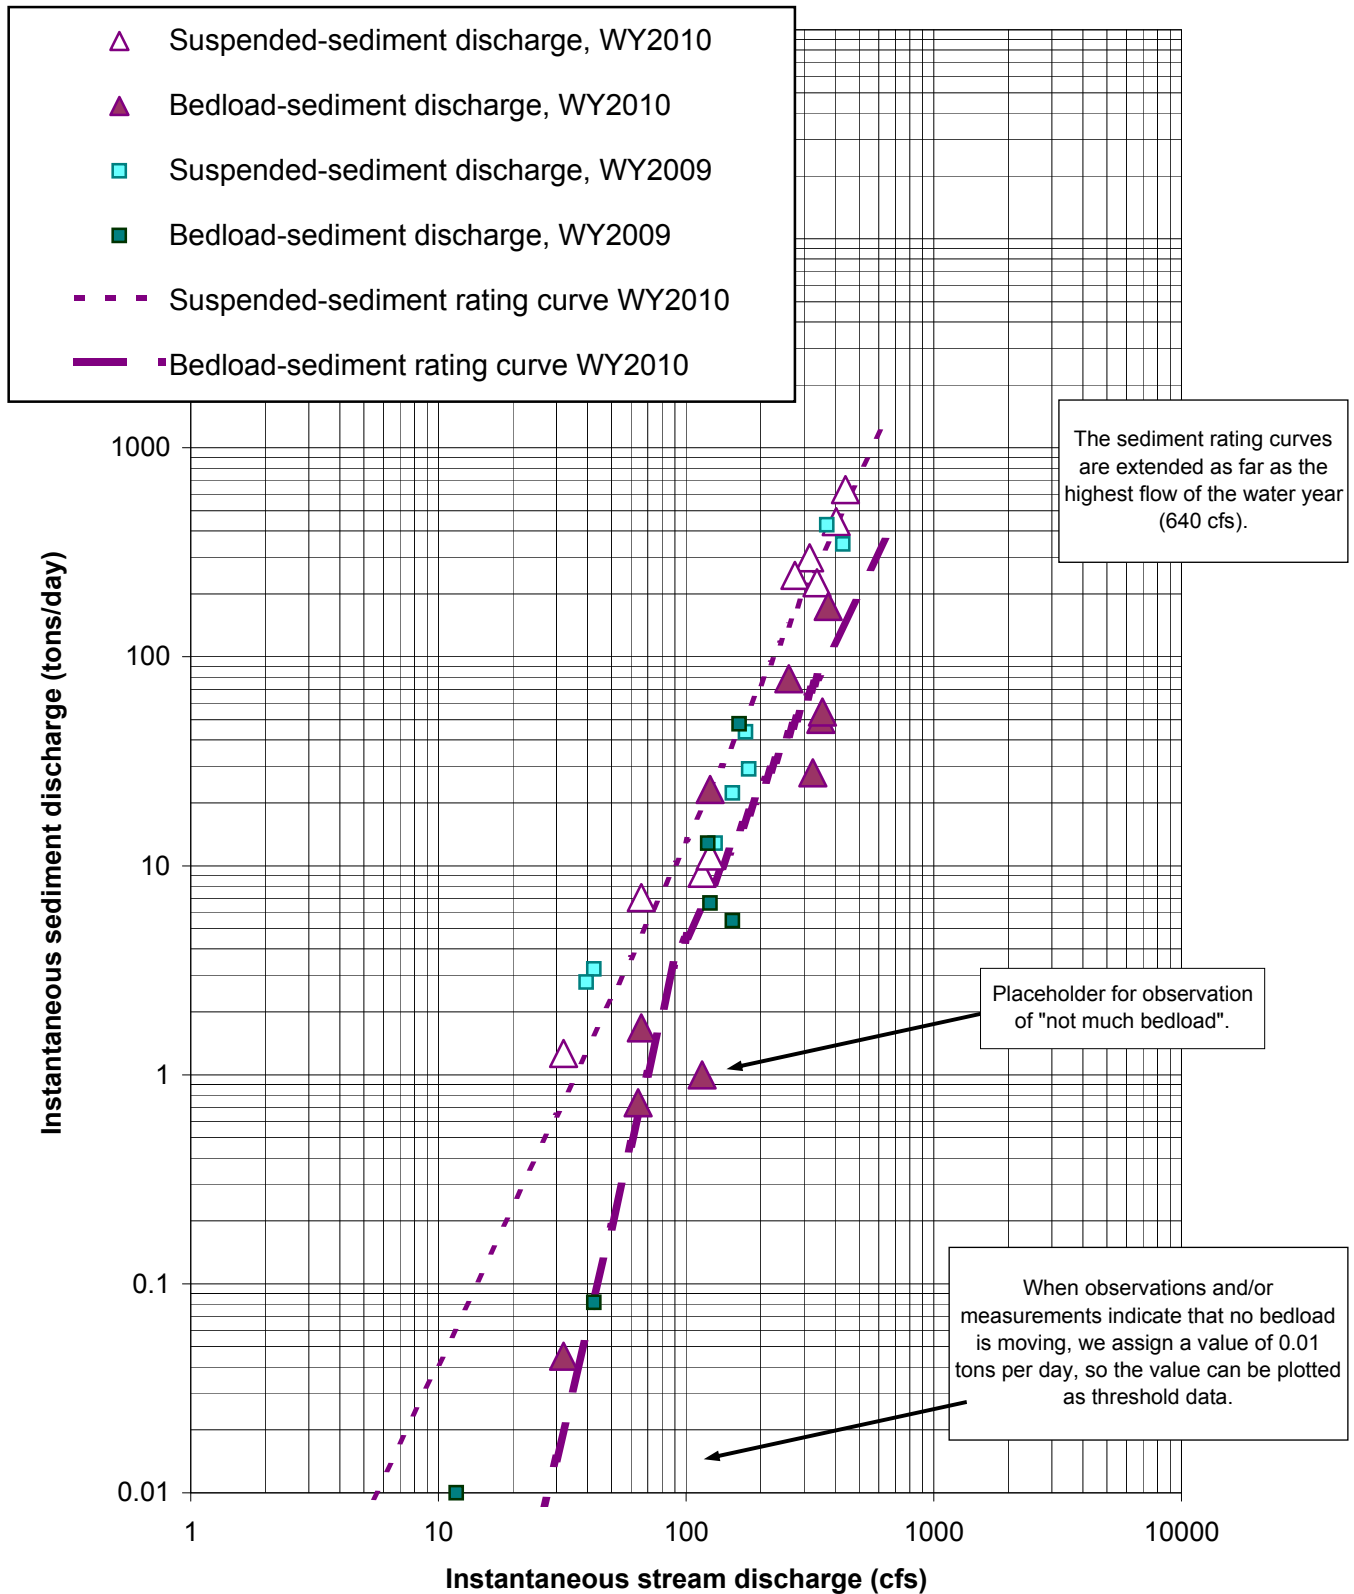
These data suggest that more suspended-sediment is moved by the creek than bedload sediment at all flow levels.
