**TERRAPIN MONITORING AT THE PAUL S. SARBANES ECOSYSTEM
RESTORATION PROJECT AT POPLAR ISLAND**

2012

**Final Report submitted to the
United States Army Corps of Engineers**

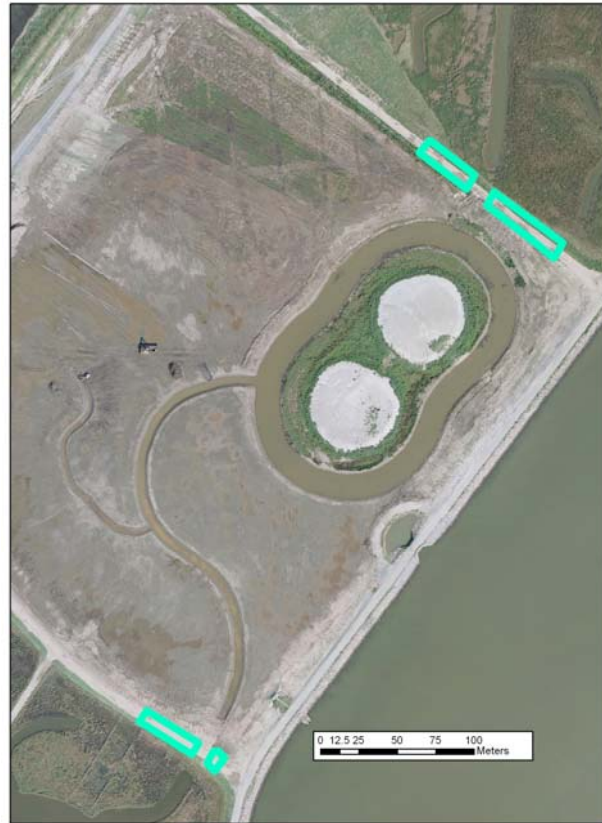
Figure 6. Aerial photo of the cross dikes between Cells 1A/B and B/C (still under construction) highlighting potential nesting areas that could be expanded and maintained vegetation free with minimal danger of erosion.

The northeast expansion of Poplar Island provides an opportunity and the recommendation to create dedicated terrapin nesting habitat in the sheltered areas of Poplar Harbor between Poplar Island and Jefferson Island. In particular, areas to be built to the northeast of Jefferson Island would be ideal for creating terrapin nesting habitat. The creation of these nesting areas could help offset the natural loss of nesting habitat that has occurred on the outside of Cell 3C in recent years. Although this area of the expansion is proposed to be an upland cell, the creation of offshore bulkheads and backfilling of sand as illustrated in Figure 7 could provide a large amount of terrapin nesting habitat in an area where terrapins have been captured in high concentrations. Building structures such as those illustrated in Figure 7 on the outside of the barrier dike would preclude the need to build additional fencing to prevent turtles from getting into the cells under construction. Furthermore, nesting areas without marsh and beach grasses could be provided for terrapin nesting habitat within the cells under construction. Because terrapins avoid nesting in areas with dense vegetation (Roosenburg 1996), providing open, sandy areas on the seaward side of the dikes should reduce efforts by terrapins to enter cells under construction to find suitable, open areas.

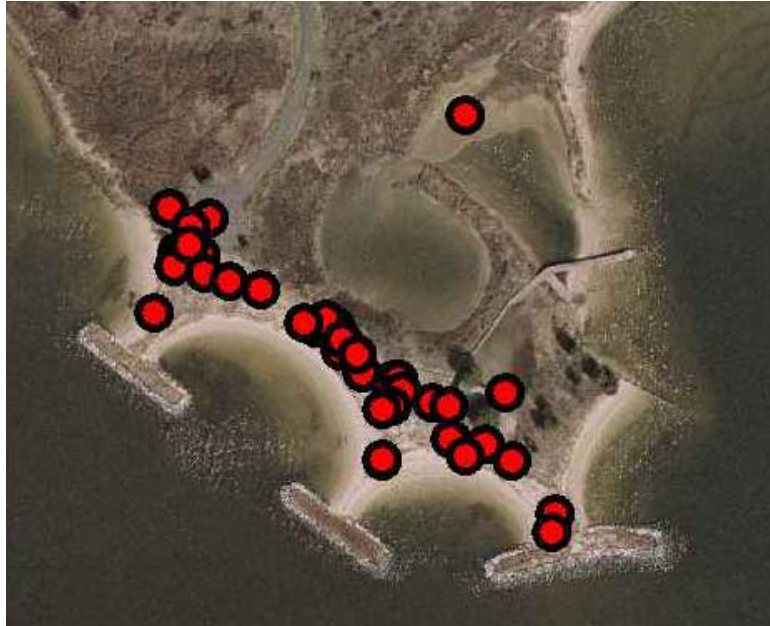
Figure 7 – Shoreline stabilization and the creation of terrapin nesting habitat in Calvert County Maryland – Red dots indicate terrapin nests.

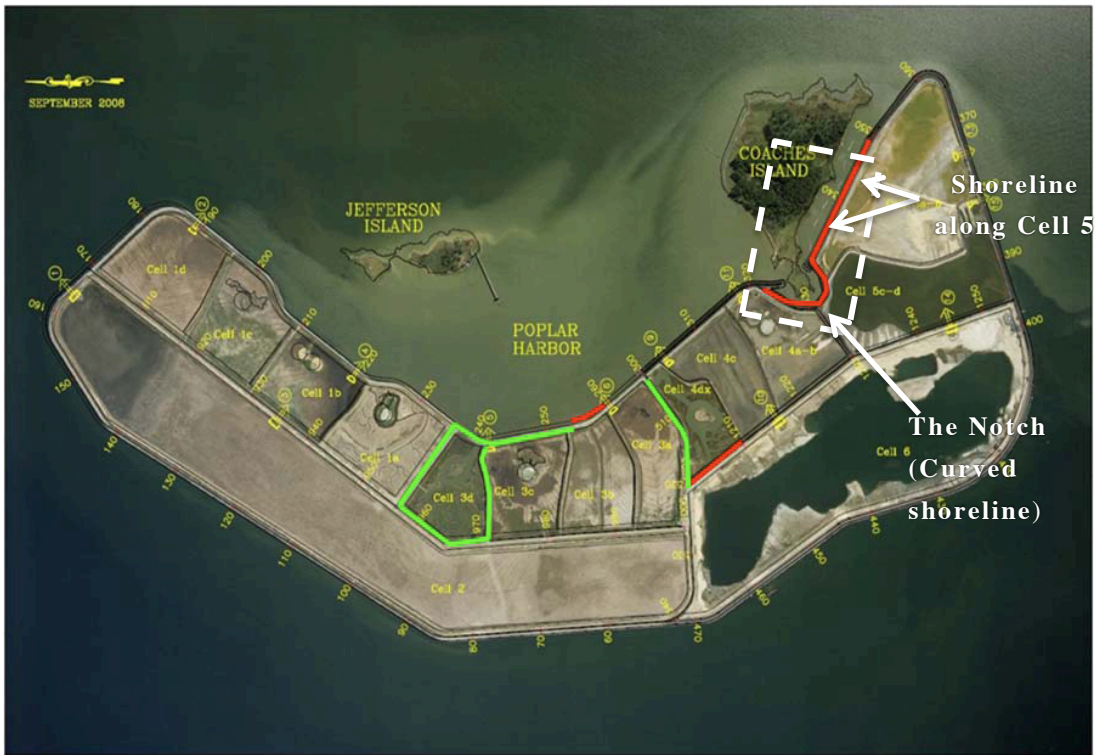
Figure 3. Poplar Island. Areas of high nesting activity are highlighted by red. Nests have been found in areas highlighted by green. Study area is indicated by the white box.

To prevent the island from eroding again, a containment dike composed of large rocks was built around the majority of Poplar’s perimeter. The dike prevents terrapin movement and nesting. However, the containment dike is constructed of sand in the area where the nearby Coaches Island shields the Poplar Island shoreline. The sandy and relatively open area extends through the Notch, which curves around a small peninsula from Coaches Island, and down the outside edge of Poplar’s Cell 5.

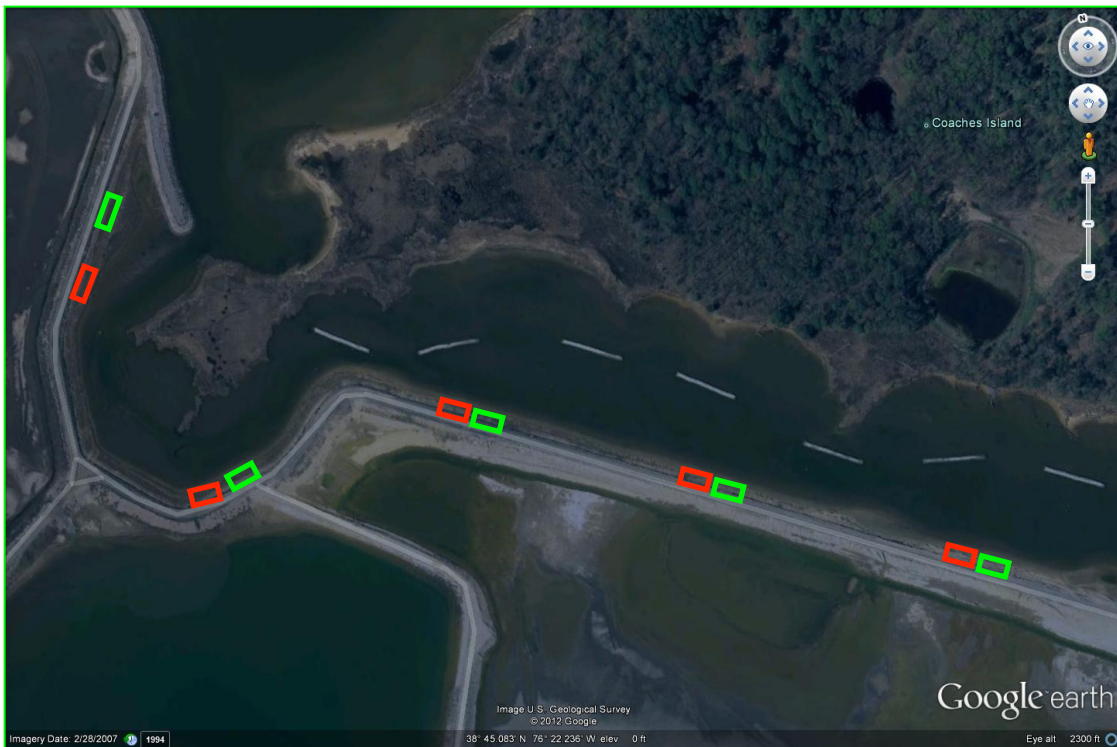
Figure 4. View of the Notch (curved shoreline) and Cell 5. Blocks, or plot sets, 1-5 are shown from left to right. Red rectangles indicated control plots; green rectangles indicate experimental plots with vegetation removed.

rototiller. The five control plots remained unmanipulated. We separated adjacent control and experimental plots by at least five meters to prevent edge effects. We spaced the sets of plots widely along the Notch and Cell 5 and did not clear vegetation to the shoreline to minimize habitat impacts. Terrapins typically nest above the mean high tide line, so removal of vegetation from low-lying areas of shoreline was not necessary.

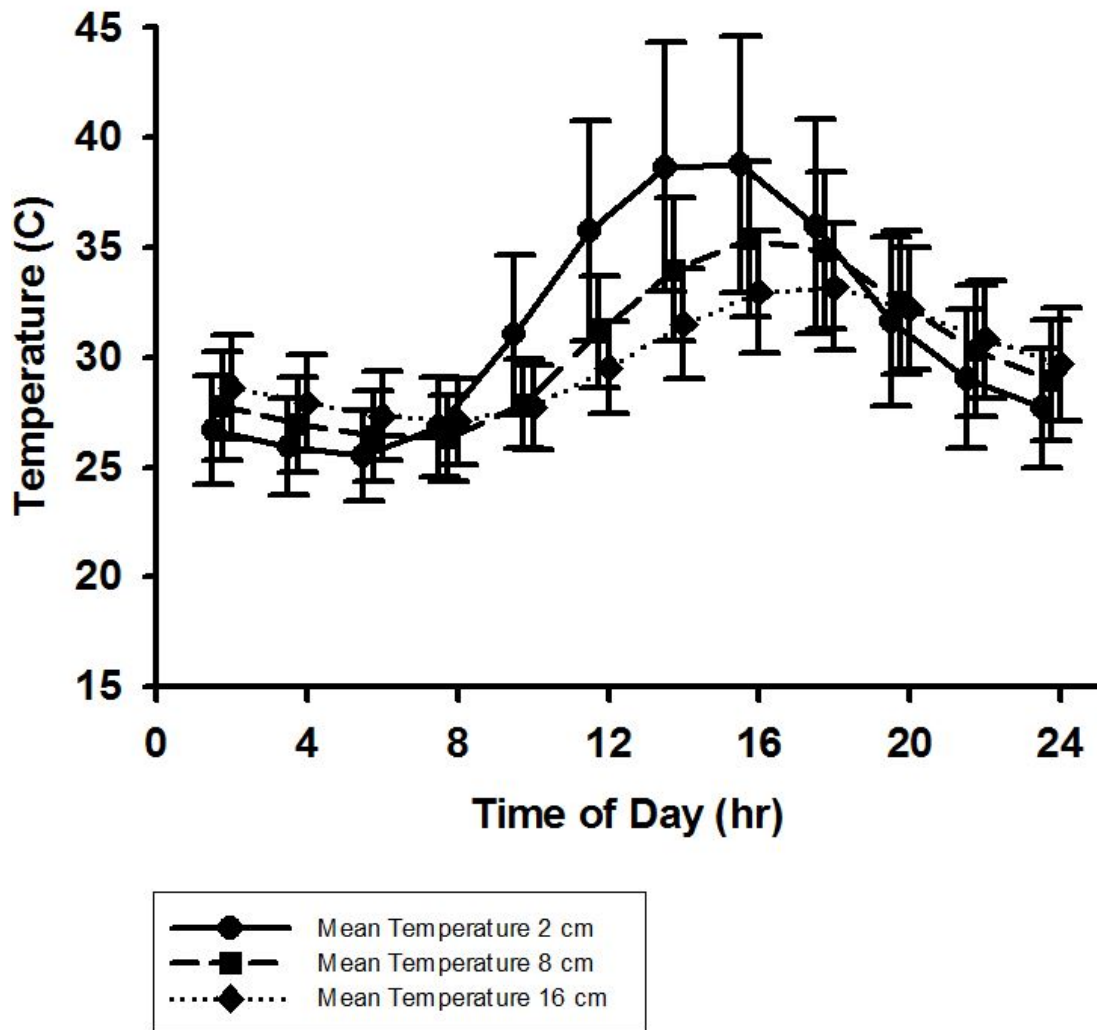
Figure 9. Mean daily temperatures for all experimental plot loggers during July. Solid lines indicate temperatures for 2 cm loggers, dashed lines show 8 cm logger temperatures, and dotted lines show 16 cm logger temperatures.

Temperature gradients for both sets of plots revealed similar daily trends from July-August (July temperatures in Figures 9 and 10; August and September temperatures in Figures S9-S12). Surface loggers (2 cm depth) exhibited the greatest daily variation: they displayed maximum temperatures between 1:00-2:00 pm and minimums between 4:00-5:00 am and displayed a wider range of temperatures than both 8 cm and 16 cm loggers. The bottom depth loggers (16 cm) fluctuated least of the three depths. They reached both maximum and minimum temperatures four hours after surface loggers reached their extremes. Additionally, the deepest loggers showed the smallest range of overall temperatures among all logger depths. Loggers buried 8 cm deep showed intermediate daily trends between the surface loggers and bottom depth loggers with regard to the range of temperatures reached as well as time of day they were recorded.

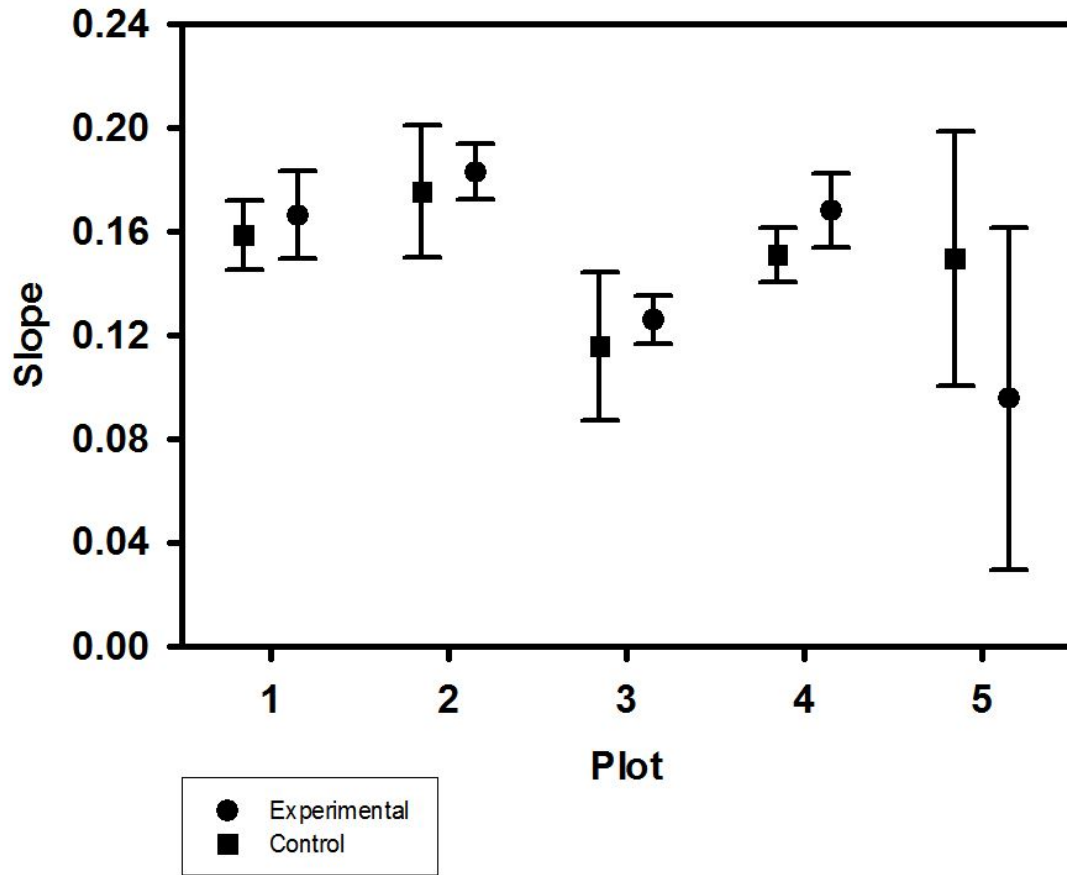
Figure S1. Mean slope (Five measurements per plot).

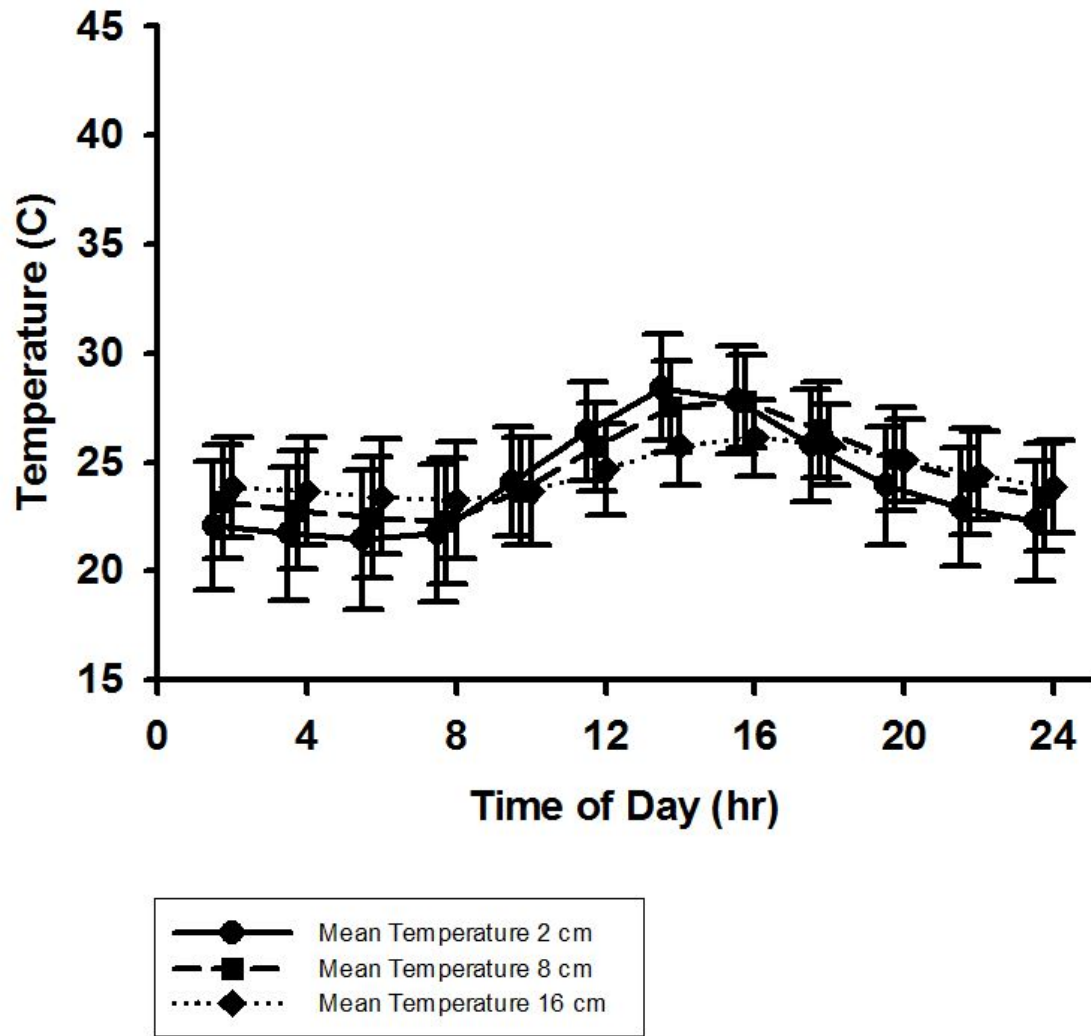
Figure S10. Mean daily temperatures for all control plot loggers during September.
