## ATTACHMENT 1 TO AEP:NRC:8054-02

I&M is performing design modifications as described below to address the concerns identified in GL 2004-02. The noted completion dates for modifications that have not yet been installed are in accordance with the extensions documented in Reference 16.

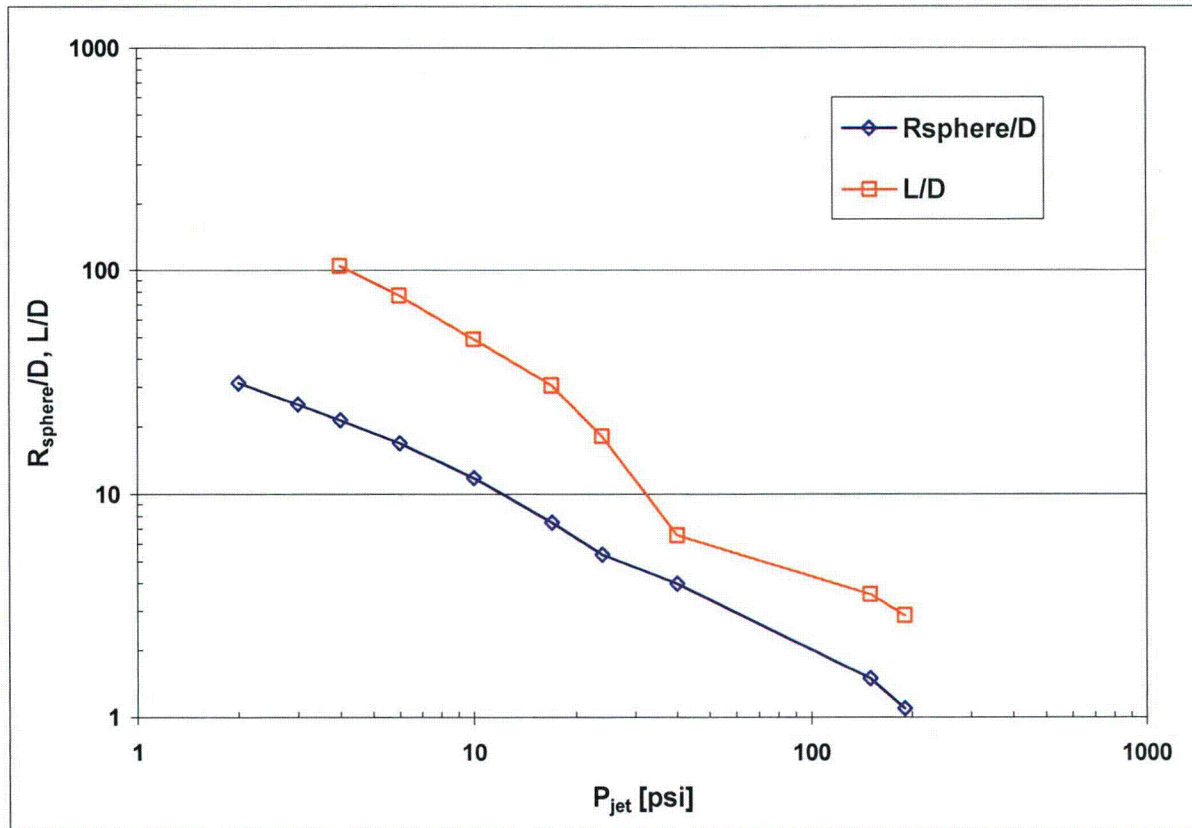
**Figure 3b3-1: Comparison of  $R_{\text{sphere}}/D_{\text{break}}$  and  $L/D_{\text{break}}$  for PWR Cold Leg Breaks**

These data are plotted in Figure 3b3-1. By use of Figure 3b3-1, the three parameters ( $P_{jet}$ ,  $L/D_{break}$ , and  $R_{sphere}/D_{break}$ ) can be determined. If one of the three parameters is known, the remaining pair can be determined graphically from Figure 3b3-1 or by interpolating the corresponding data in the tables above. Further, because the parameters are non-dimensional, the relationship holds for applications to determine the ZOI for a pipe break in a plant or a simulated pipe break in a test facility. The difference in the two is the diameter used to represent the discharge jet, the diameter of the cold leg or the diameter of the test nozzle.

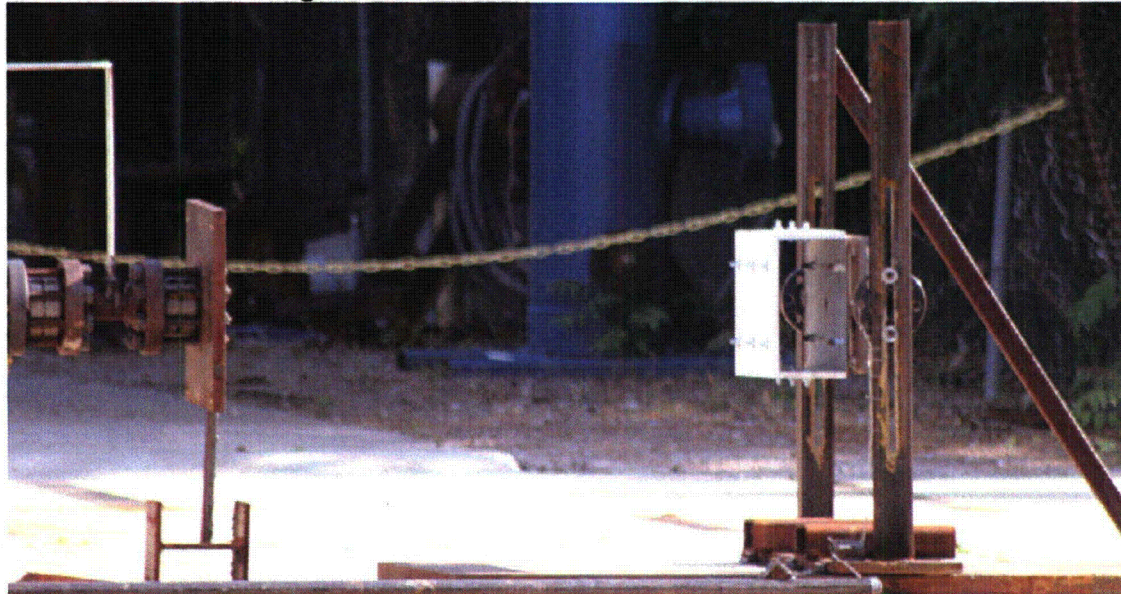
**Figure 3b3-2 Marinite Test Orientation M-1**

The tests conducted on the Marinite were performed in three distinct orientations. In the first orientation (M-1), the longitudinal axis of the specimen was at a right angle to the jet centerline, with the centerline of the jet directed at the vertical center of the test specimen. In the second orientation (M-2), the support was axis rotated 45° toward the discharge nozzle (front face of specimen angled to the ground), the longitudinal axis was perpendicular to the jet centerline, and the jet centerline was aligned with the seam area between the front face and the side face materials. In the third orientation (M-3), the support axis was rotated 90° (front face of specimen pointed downwards), the longitudinal axis was perpendicular to the jet centerline, and the jet centerline was aligned with the seam area between the front face and side face materials. Figures 3b3-2 through 3b3-4 provide pictures of these configurations.

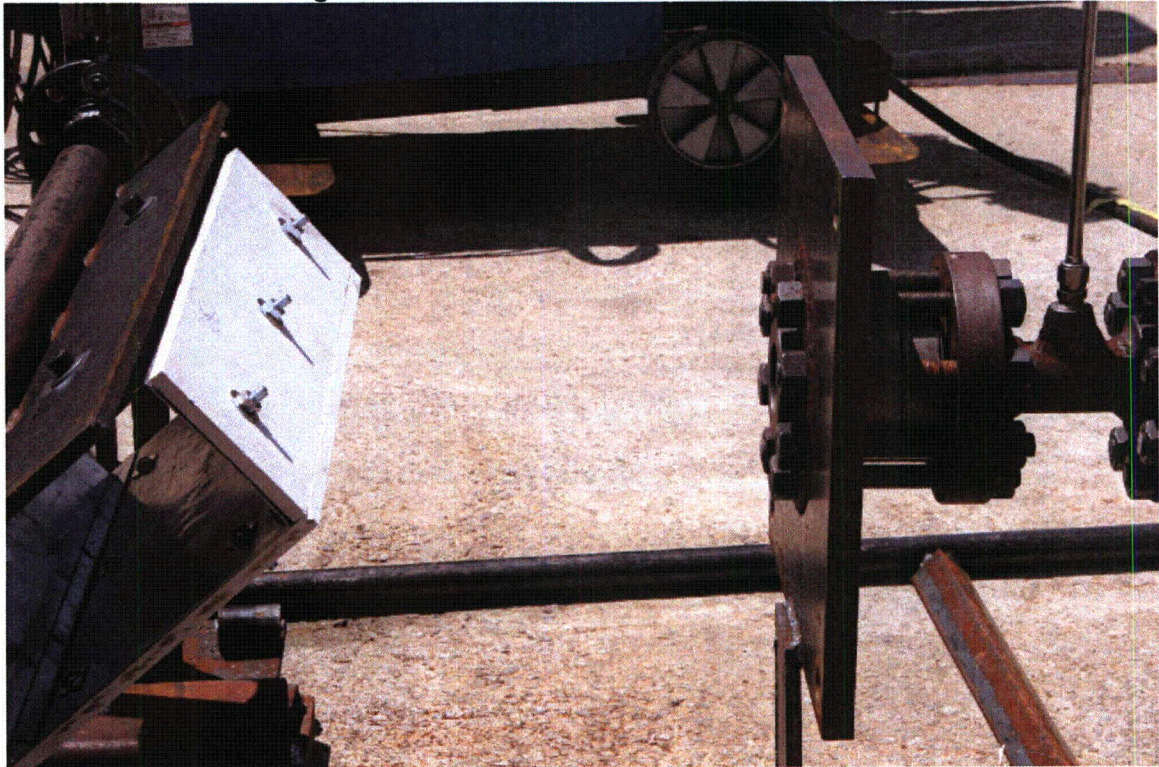
**Figure 3b3-3 Marinite Test Orientation M-2**

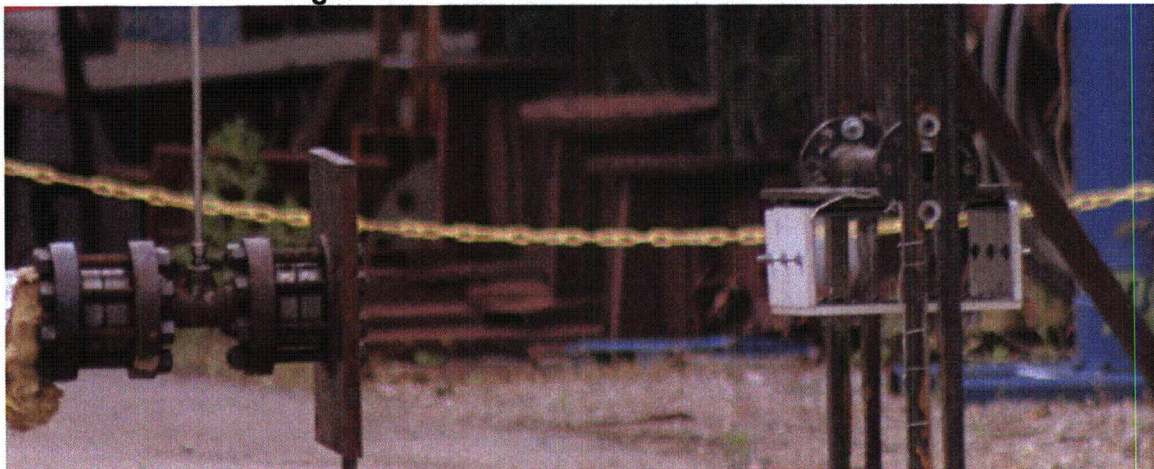
**Figure 3b3-4 Marinite Test Orientation M-3**

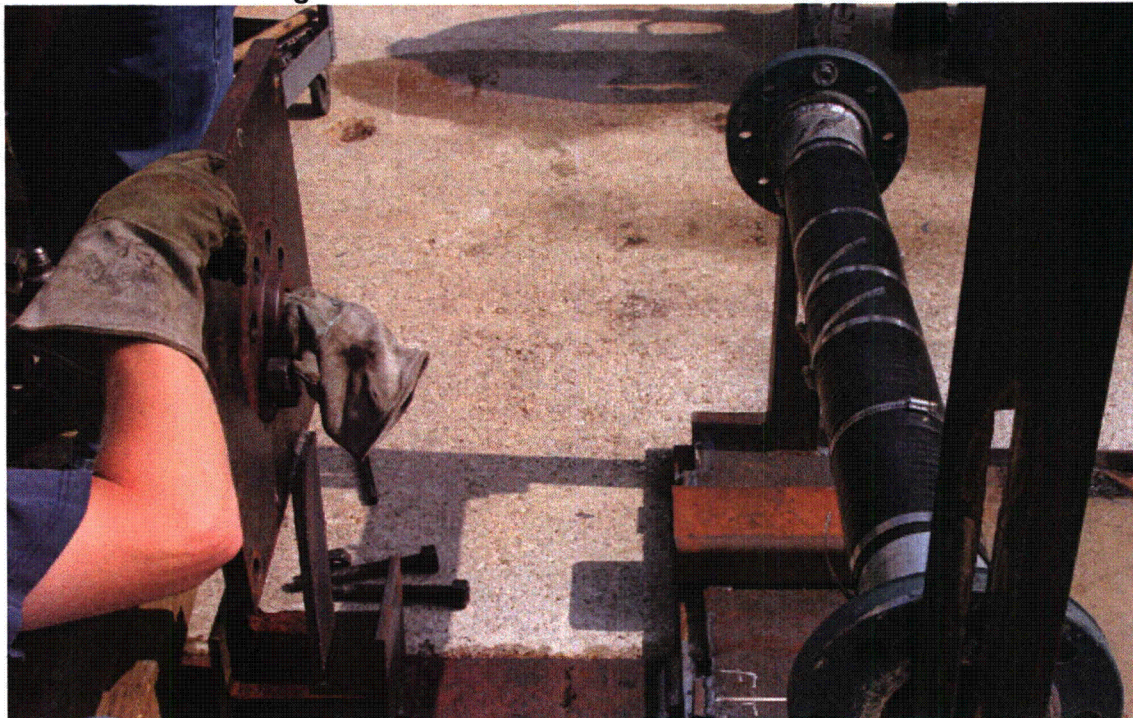
**Figure 3b3-5 Scotch 77 Test Orientation T-1**

The first test conducted was of the 75% overlap configuration, with a T-1 orientation. This test was not representative of CNPs current installation but was conducted as a sensitivity test for determining the impact of an installation in this configuration.

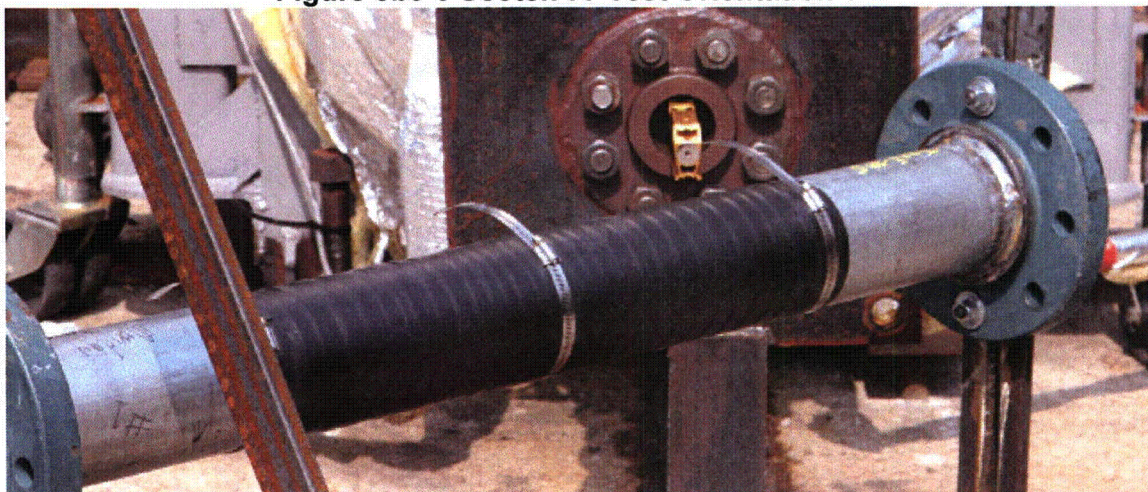
**Figure 3b3-6 Scotch 77 Test Orientation T-2**

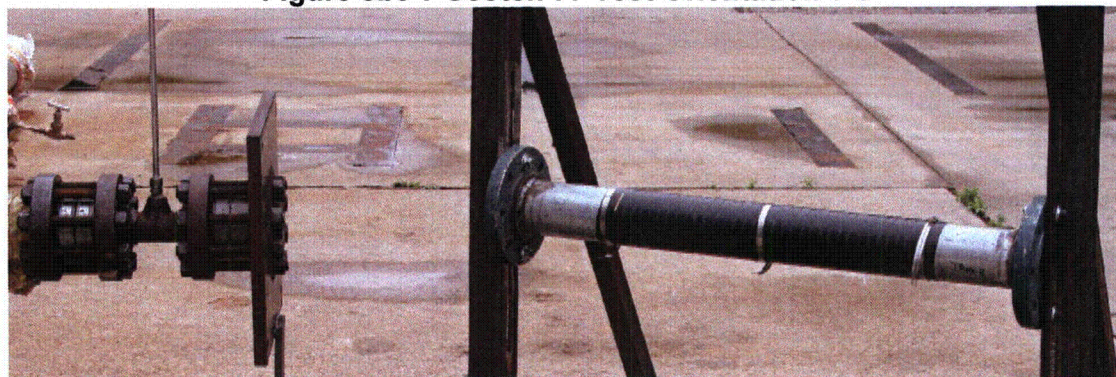
**Figure 3b3-7 Scotch 77 Test Orientation T-3**

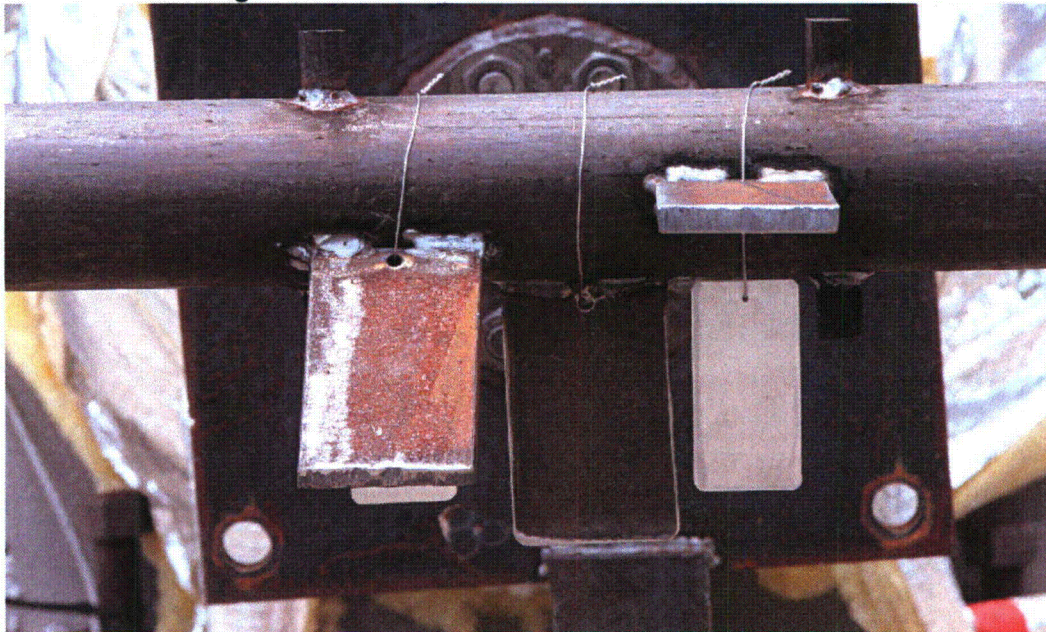
**Figure 3b3-8 Electromark Labels Test Orientation L-1**

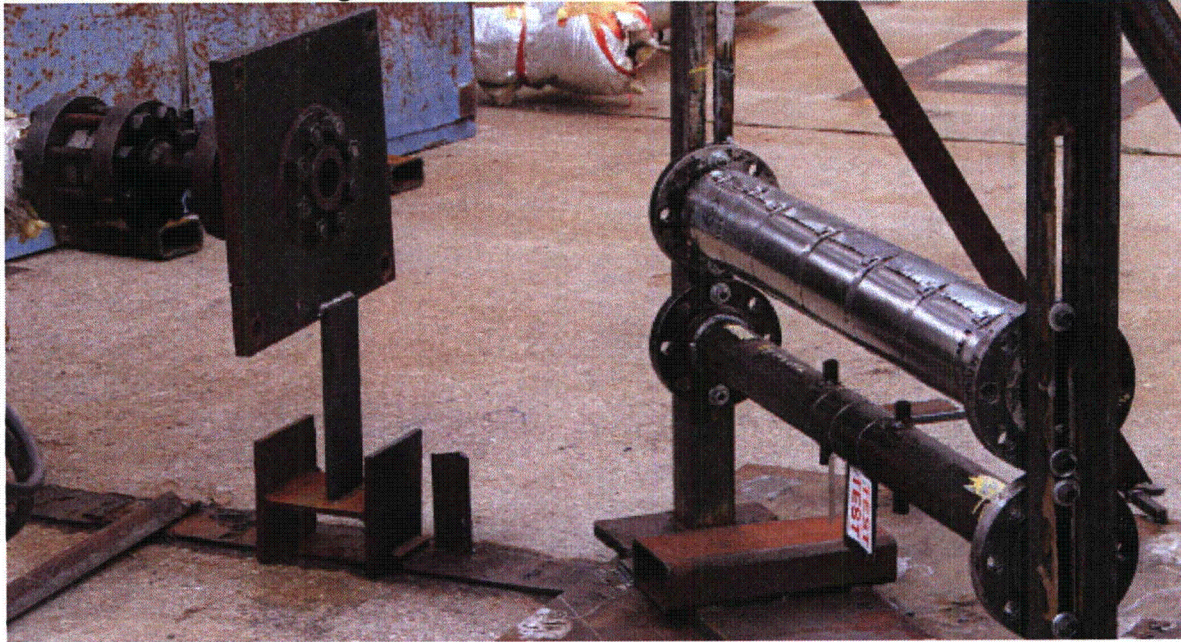
**Figure 3b3-9 Electromark Labels Test Orientation L-2**

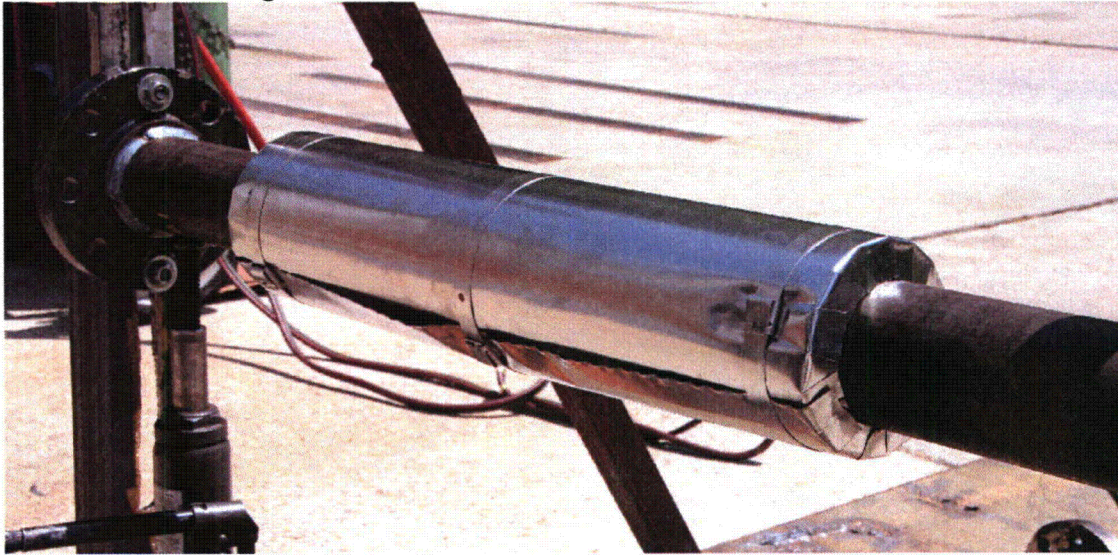
**Figure 3b3-10 Jacketed Armaflex Insulation Test 1**

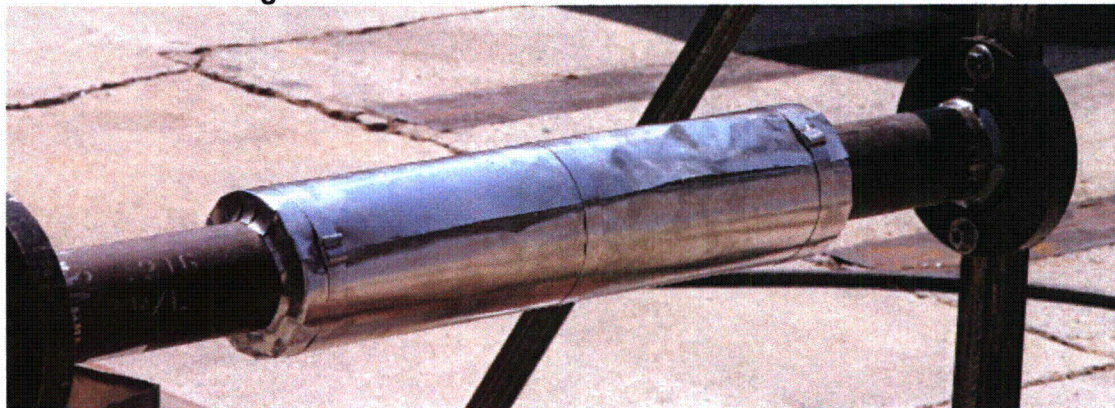
A 2 ft single jacketed Armaflex insulation specimen was mounted in a horizontal configuration with the centerline of the jet perpendicular to, and at the vertical mid-plane of the specimen. The jacketing was installed with an approximate 2 in overlap, with the overlap seam approximately 45° above the centerline facing the nozzle. Two bands were applied approximately 1 in from each end of the specimen, and one band was applied near the center of the specimen. The distance from the nozzle to the specimen was 49 in. Refer to Figure 3b3-11 for a picture of this configuration.

**Figure 3b3-11 Jacketed Armaflex Insulation Test 2**

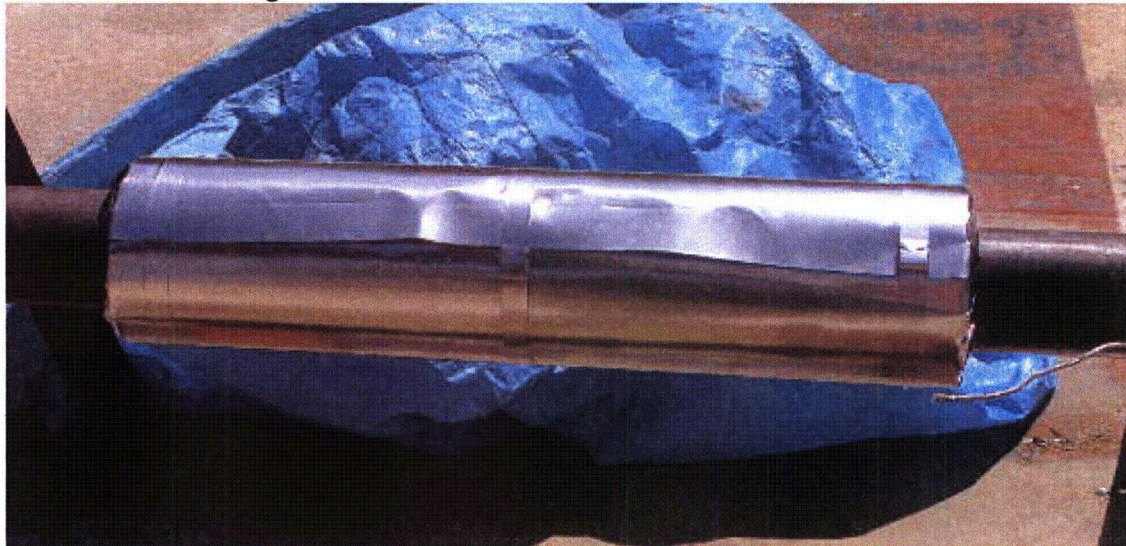
A 2 ft single jacketed Armaflex insulation specimen was mounted in a horizontal configuration with the centerline of the jet perpendicular to and at the vertical mid-plane of

**Figure 3b3-12 Jacketed Armaflex Insulation Test 3**

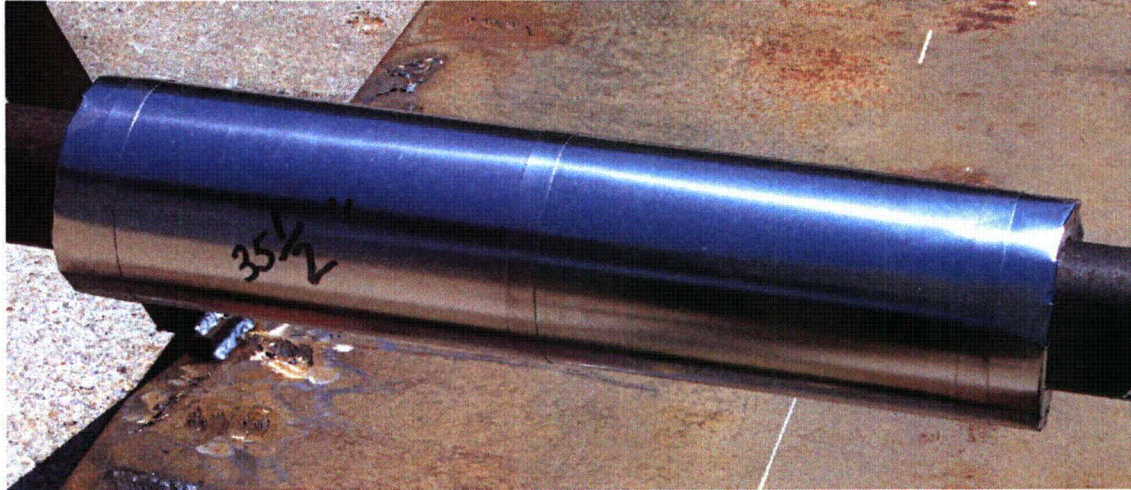
A 2 ft single jacketed Armaflex insulation specimen was mounted in a horizontal configuration with the centerline of the jet perpendicular to and at the vertical mid-plane of the specimen. The jacketing was installed with an approximate 2 in overlap, with the overlap seam on the bottom side of the specimen, oriented away from the jet. The center of the nozzle was aligned with the center band, with all clamps facing away from the jet. Two bands were applied approximately 1 in from each end of the specimen and one band was applied near the center of the specimen. The distance from the nozzle to the specimen was 35 1/2 in. Refer to Figure 3b3-13 for a picture of this configuration

**Figure 3b3-13 Jacketed Armaflex Insulation Test 4**

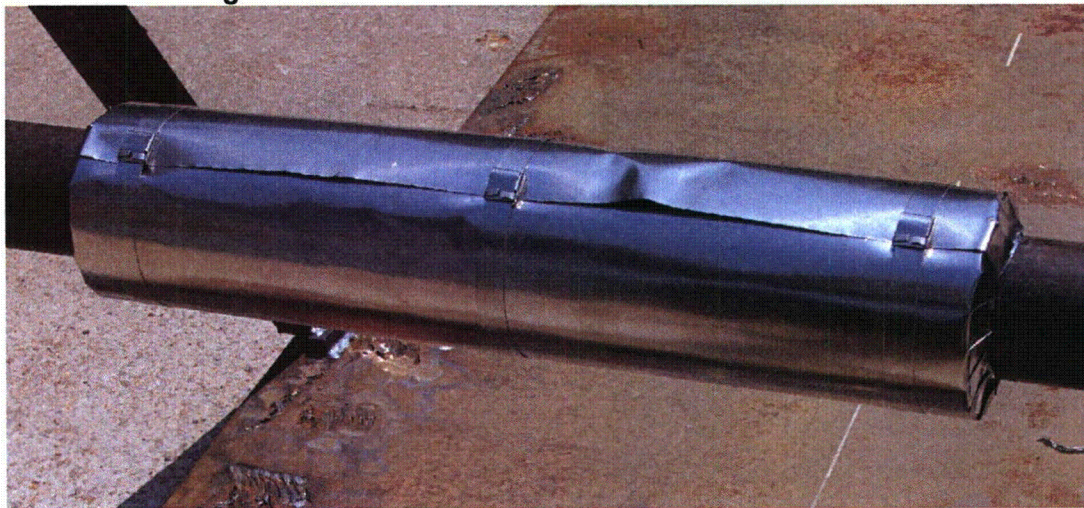
A 2 ft single jacketed Armaflex insulation specimen was mounted in a horizontal configuration with the centerline of the jet perpendicular to and at the vertical mid-plane of the specimen. The jacketing was installed with an approximate 2 in overlap, with the overlap seam approximately 1 1/2 in above the centerline facing the nozzle. The center of the nozzle was aligned with the center band, approximately 1 1/2 in below the clamp. Two bands were applied approximately 1 in from each end of the specimen and one band was applied near the center of the specimen. The distance from the nozzle to the specimen was 35 1/2 in. Refer to Figure 3b3-14 for a picture of this configuration.

**Figure 3b3-14 Jacketed Armaflex Insulation Test 5**

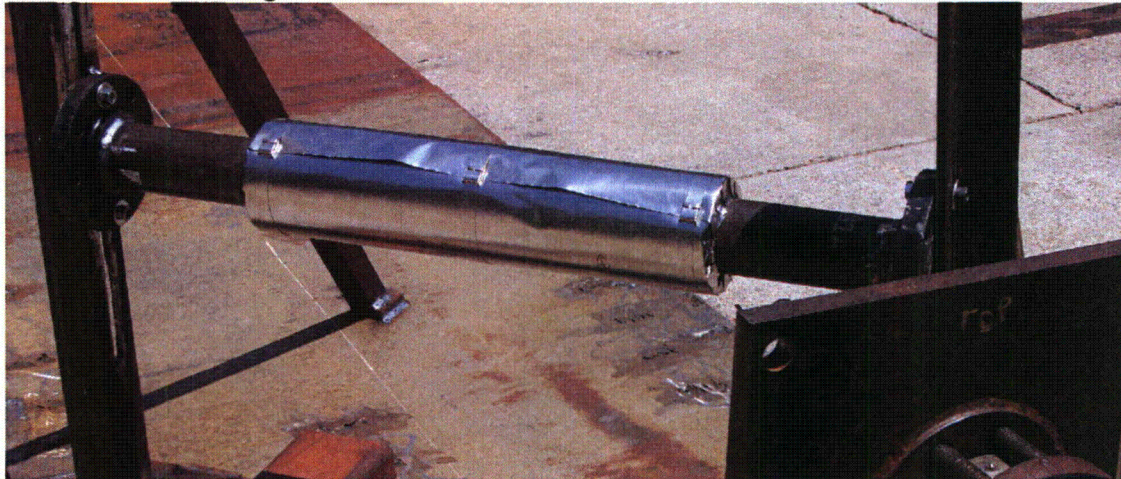
A 2 ft single jacketed Armaflex insulation specimen was mounted in a horizontal configuration with the centerline of the jet at a 45° angle to and at the vertical mid-plane of the specimen. The jacketing was installed with an approximate 2 in overlap, with the overlap seam approximately 1 1/2 in above the centerline facing the nozzle. The center of the nozzle was aligned with the center band, approximately 1 1/2 in below the clamp. Two bands were applied approximately 1 in from each end of the specimen and one band was applied near the center of the specimen. The distance from the nozzle to the specimen was 27 in. The center of the jet was aligned with the point approximately 6 in from the end that was nearest the nozzle. Refer to Figure 3b3-15 for a picture of this configuration.

**Figure 3b3-15 Jacketed Armaflex Insulation Test 6**

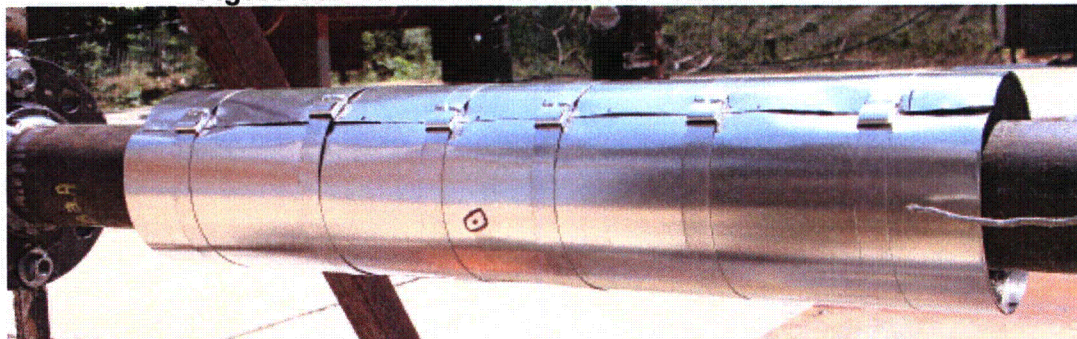
A 2 ft double jacketed Armaflex insulation specimen was mounted in a horizontal configuration with the centerline of the jet perpendicular to and at the vertical mid-plane of the specimen. The distance from the nozzle to the specimen was approximately 21 7/8 in. The open edge (seam) of the jacketing was located approximately 1 1/2 in above the jet centerline facing the jet. The test specimen was prepared such that there were 2 layers of jacketing, each having a minimum overlap of 2 in. The inner layer was not banded. The layers were arranged such that they were approximately diametrically opposed, with the exposed seam aligned such that it was approximately 45 degrees above the center of the jet. The banding was applied starting at approximately 1 in from each end of the insulation to the edge of the band, with four additional bands placed approximately every 4 in. The clamps for the bands were placed such that they were approximately centered over the exposed seam. Refer to Figure 3b3-16 for a picture of this configuration.

**Figure 3b3-16 Jacketed Armaflex Insulation Test 7**

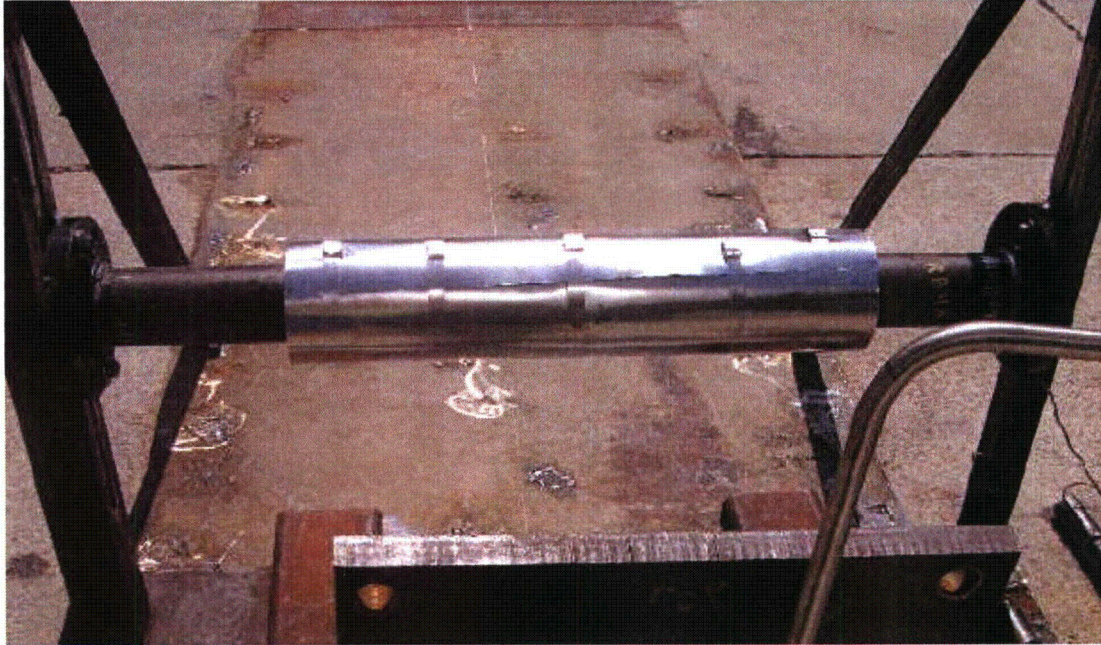
A 2 ft double jacketed Armaflex insulation specimen was mounted in a horizontal configuration with the centerline of the jet perpendicular to and at the vertical mid-plane of the specimen. The distance from the nozzle to the specimen was approximately 21 5/8 in. The test specimen was prepared such that there were 2 layers of jacketing with the inner layer having a minimum overlap of 2 in and the outer layer having a minimum overlap of 6 in. The inner layer had the end bands placed approximately 4 in from each end of the insulation with one additional band placed near the center of the specimen. The bands were clamped with random orientation of the clamps. The outer layer of jacketing had the end bands between 1 1/2 to 2 in from each end of the insulation with additional bands spaced approximately 3 1/2 to 4 in apart for the second bands in from each end and the remaining band approximately 5 1/2 in from the second bands. The objective was to avoid having bands on the outer layer on top of bands on the inner layer. The layers were arranged such that they were approximately diametrically opposed, with the exposed seam aligned such that it was approximately 45 degrees above the center of the jet. The clamps for the bands were placed such that they were approximately centered over the exposed seam. Refer to Figure 3b3-17 for a picture of this configuration.

**Figure 3b3-17 Jacketed Armaflex Insulation Test 8**

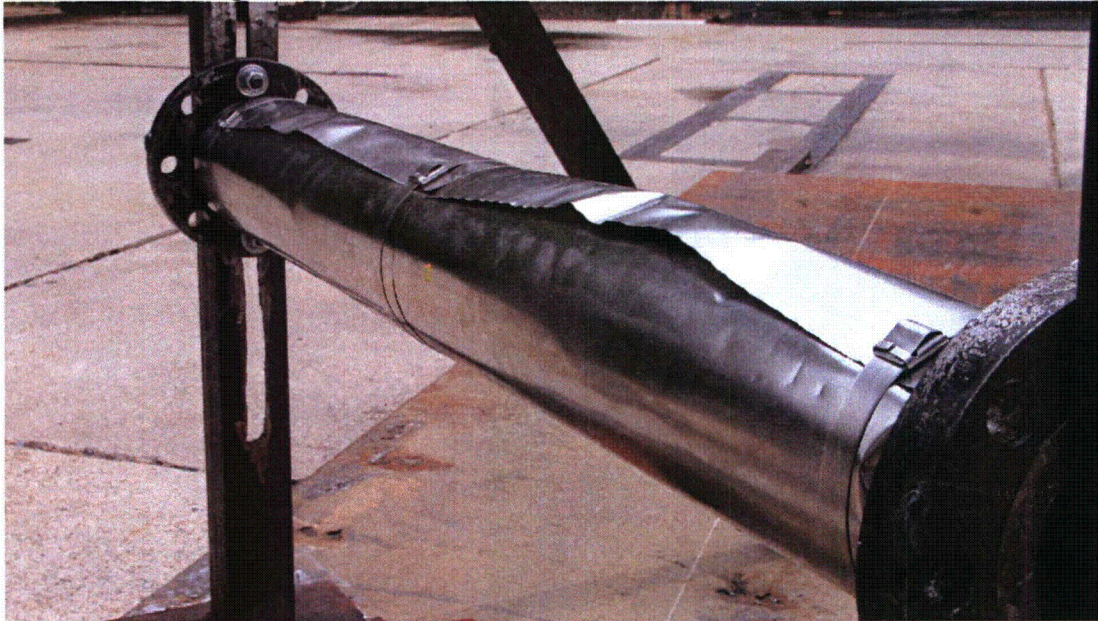
A 40 in single jacketed Armaflex insulation specimen was mounted in a horizontal configuration with the centerline of the jet at a 45° angle to and at the vertical mid-plane of the specimen. The specimen was prepared with two single layers of jacketing with an axial overlap of approximately 2 in. Two bands were applied approximately 1 1/2 in from each end of the specimen and one band was applied near the center of the specimen. The distance from the nozzle to the specimen was approximately 40 1/4 in. The center of the nozzle was aligned with the point approximately 18 1/2 in from the end that was nearest the nozzle. This point was approximately 2 in from the axial overlap seam (nearest the nozzle), and approximately 2 in from the axial seam. Refer to Figure 3b3-18 for a picture of this configuration.

**Figure 3b3-18 Jacketed Armaflex Insulation Test 9**

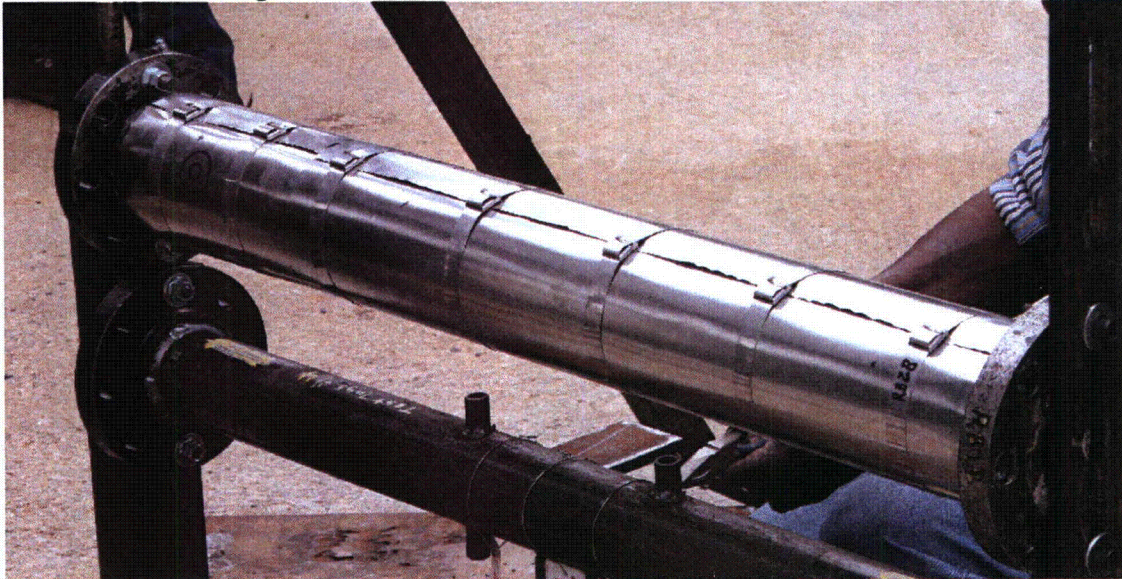
A 40 3/4 in double jacketed Armaflex insulation specimen was mounted in a horizontal configuration with the centerline of the jet at a 45° angle to and at the vertical mid-plane of the specimen. The specimen was prepared with a banded axially overlapping inner jacket (2 in overlap) with a circumferential overlap of 2 in. The outer jacket had a 6 in overlap for both the axial and circumferential seams. The axial seam for the inner jacket was approximately 180° from the outer jacket seam. The axial overlap of both the inner and outer jackets were such that the outer layer of the overlap was facing the direction of the nozzle. The distance from the nozzle to the specimen was approximately 25 in. The center of the nozzle was aligned with a point approximately 5 in from the end of the specimen nearest the nozzle. This was approximately 6 to 7 in from the axial seam for the outer jacket. The outer jacket was banded with seven bands and clamps at distances ranging from 4 1/2 in to 7 3/8 in, with the tighter spacing upstream of the jet centerline. The specimen was rotated such that the outer jacket axial overlap seam was at an approximate 45 degree angle up from the centerline of the jet. Refer to Figure 3b3-19 for a picture of this configuration.

**Figure 3b3-19 Jacketed Armaflex Insulation Test 10**

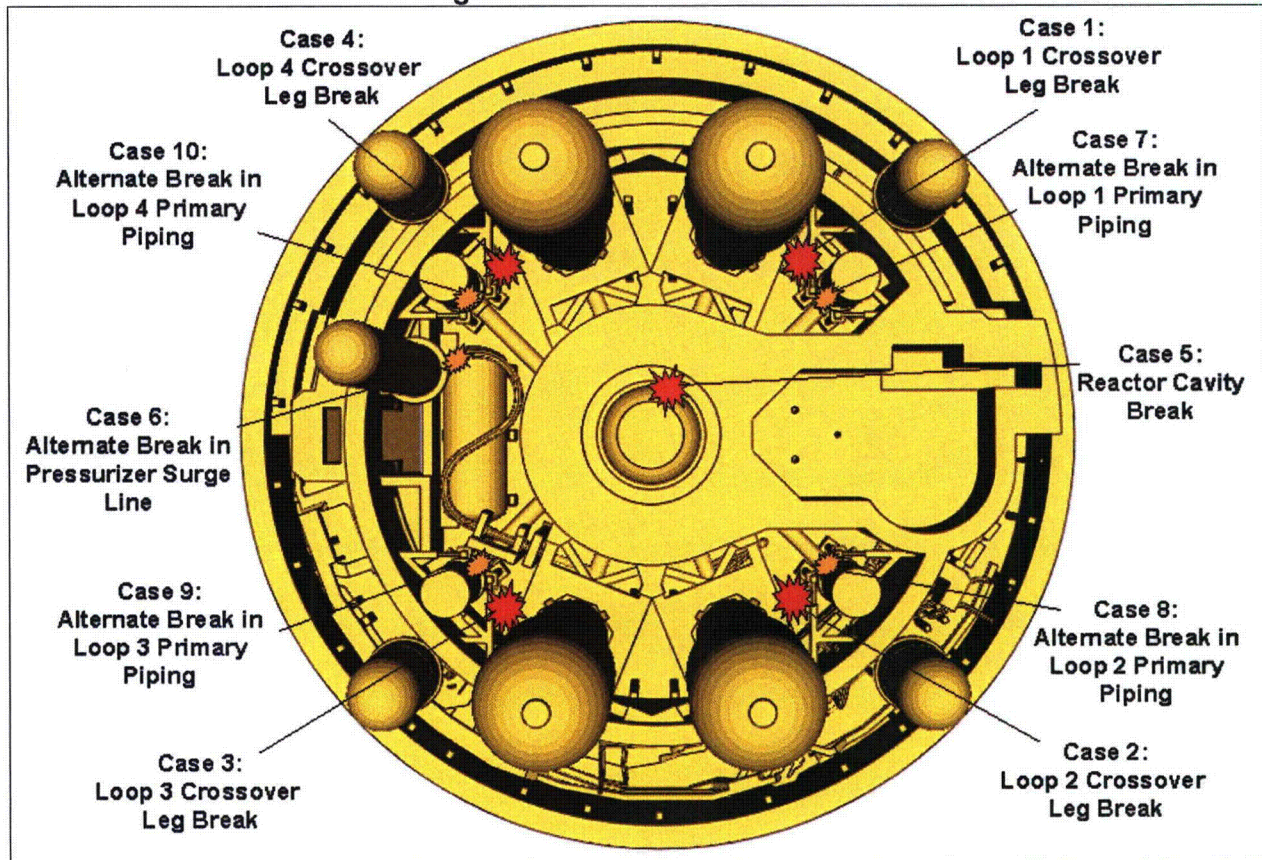
Figure 3e1-1 Break Locations

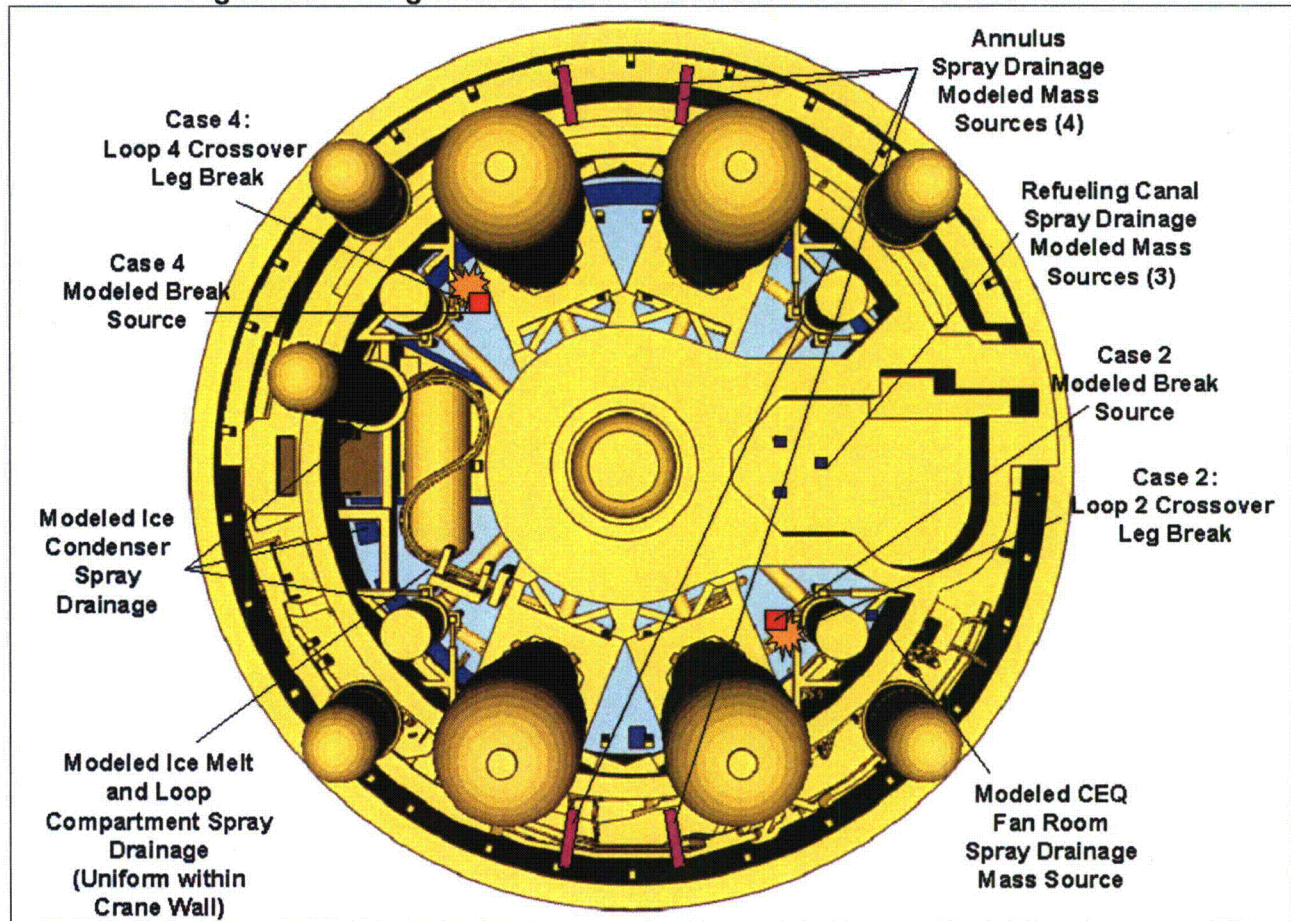
**Figure 3e1-2 Significant Features Modeled for Pool Fill Simulations**

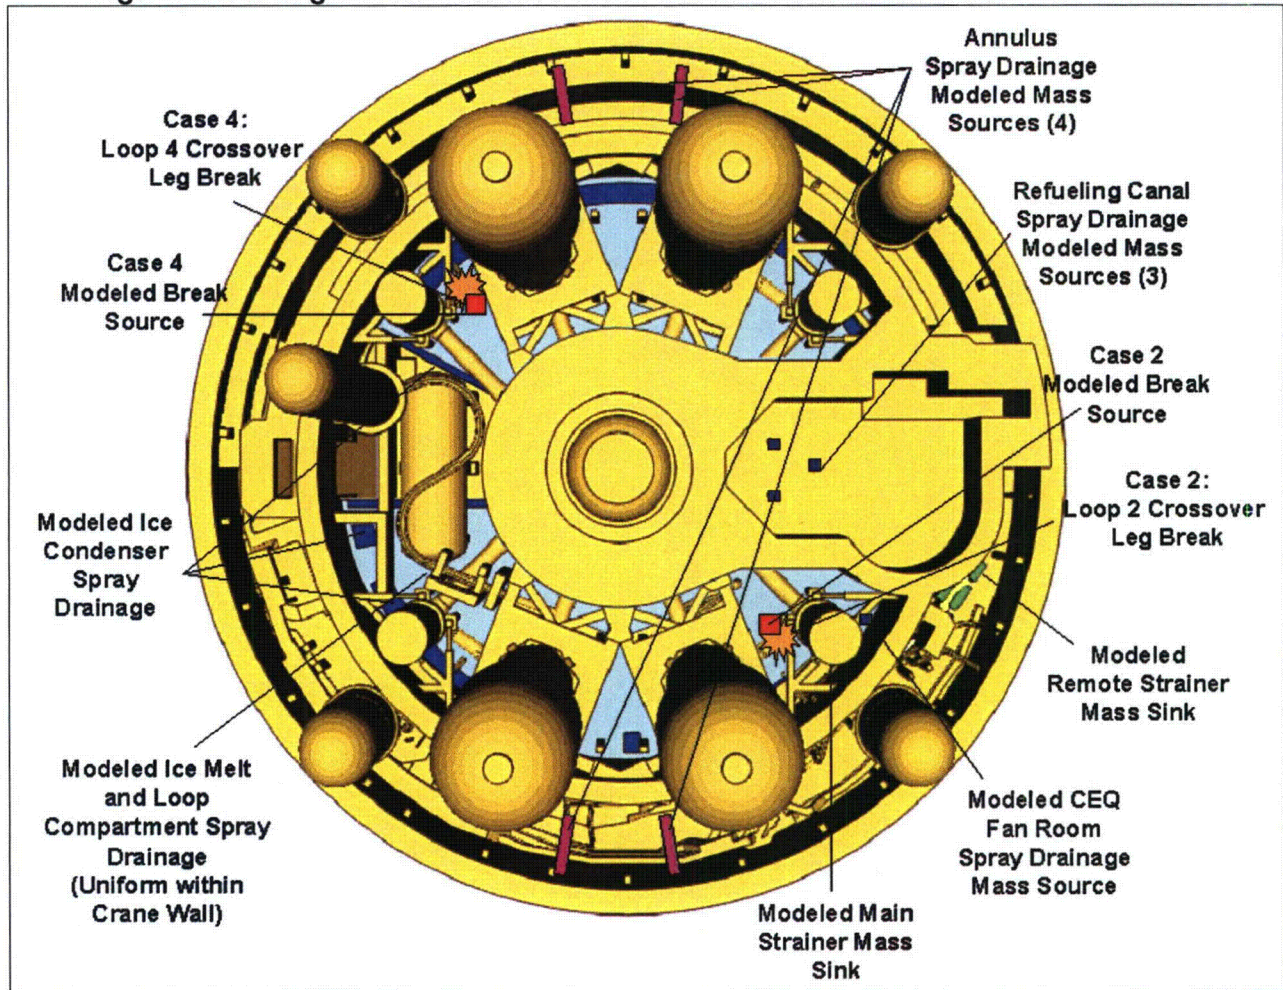
Figure 3e1-3 Significant Features Modeled for Recirculation Pool Simulations

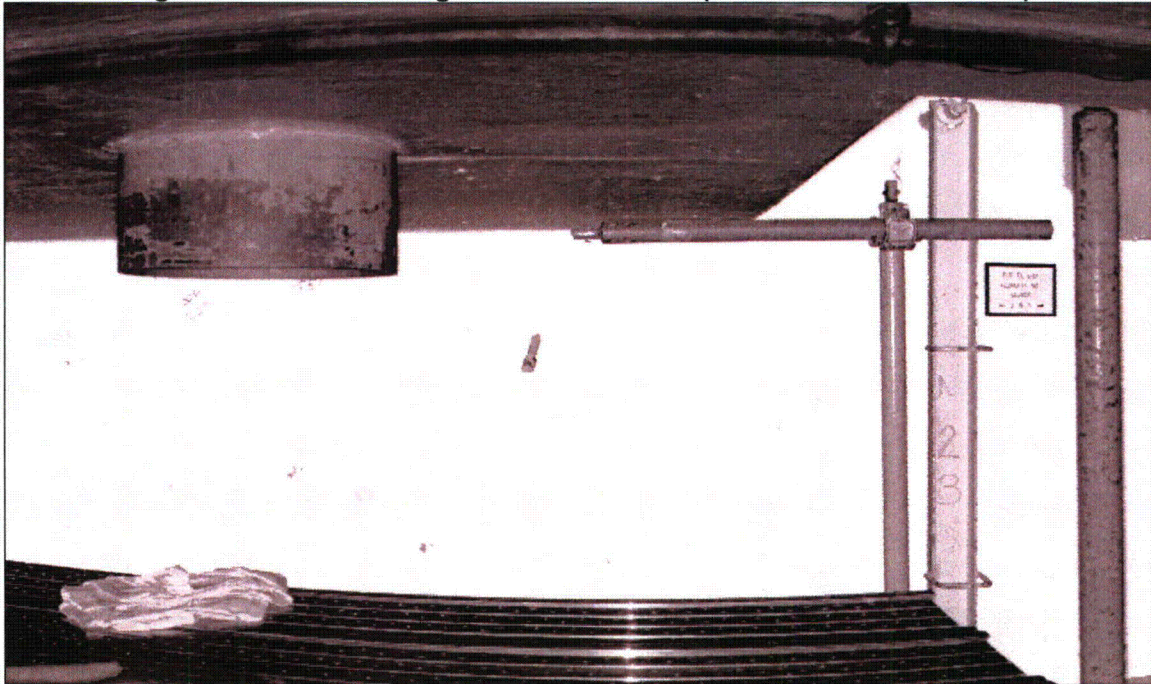
**Figure 3e1-4 Refueling Canal Drain Line (from laser scan model)**

Note: Bottom of drain is shown in upper left section of the picture.

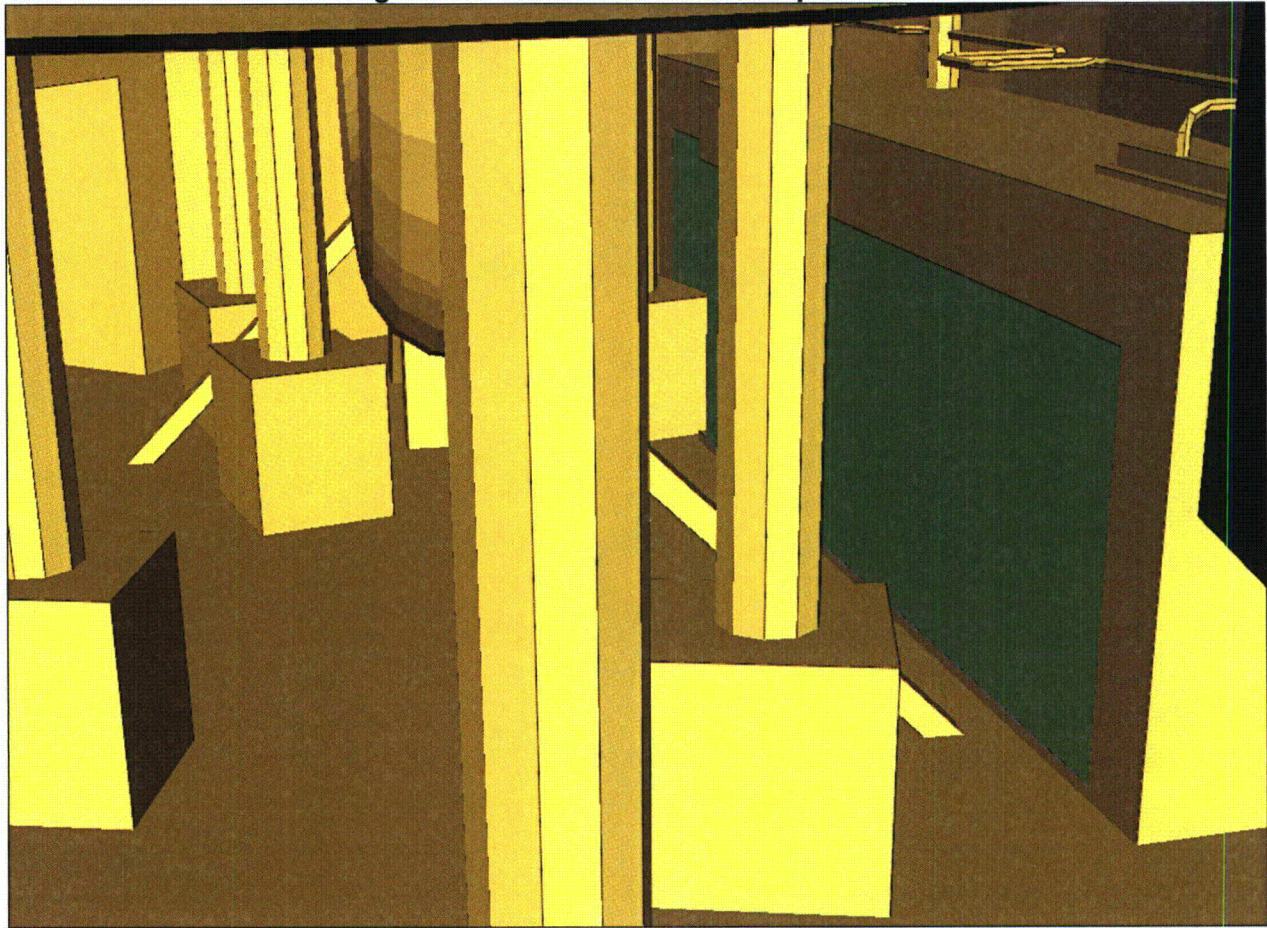
**Figure 3e1-5 Main Strainer Sump Mass Sink**

For the pool fill CFD model, a series of two dimensional baffles with a K-factor (resistance factor) of 5.95 were used to model the main strainer. To simplify the analysis of the remote strainer, a baffle with a composite K-factor of 7.80 (accounting for the pressure losses due to the remote strainer and the remote strainer waterway) was placed in the hole in the crane wall where the remote strainer waterway passes through the crane wall to the recirculation sump. The remote strainer and waterway geometry was not included in the pool fill CFD model. The columns shown in Figure 3e1-6 were removed in Unit 2 and will be removed in Unit 1 as a part of the plant modification to install the remote strainer. However, given the size of these columns compared to the overall flow path, this change did not significantly affect the debris transport analysis.

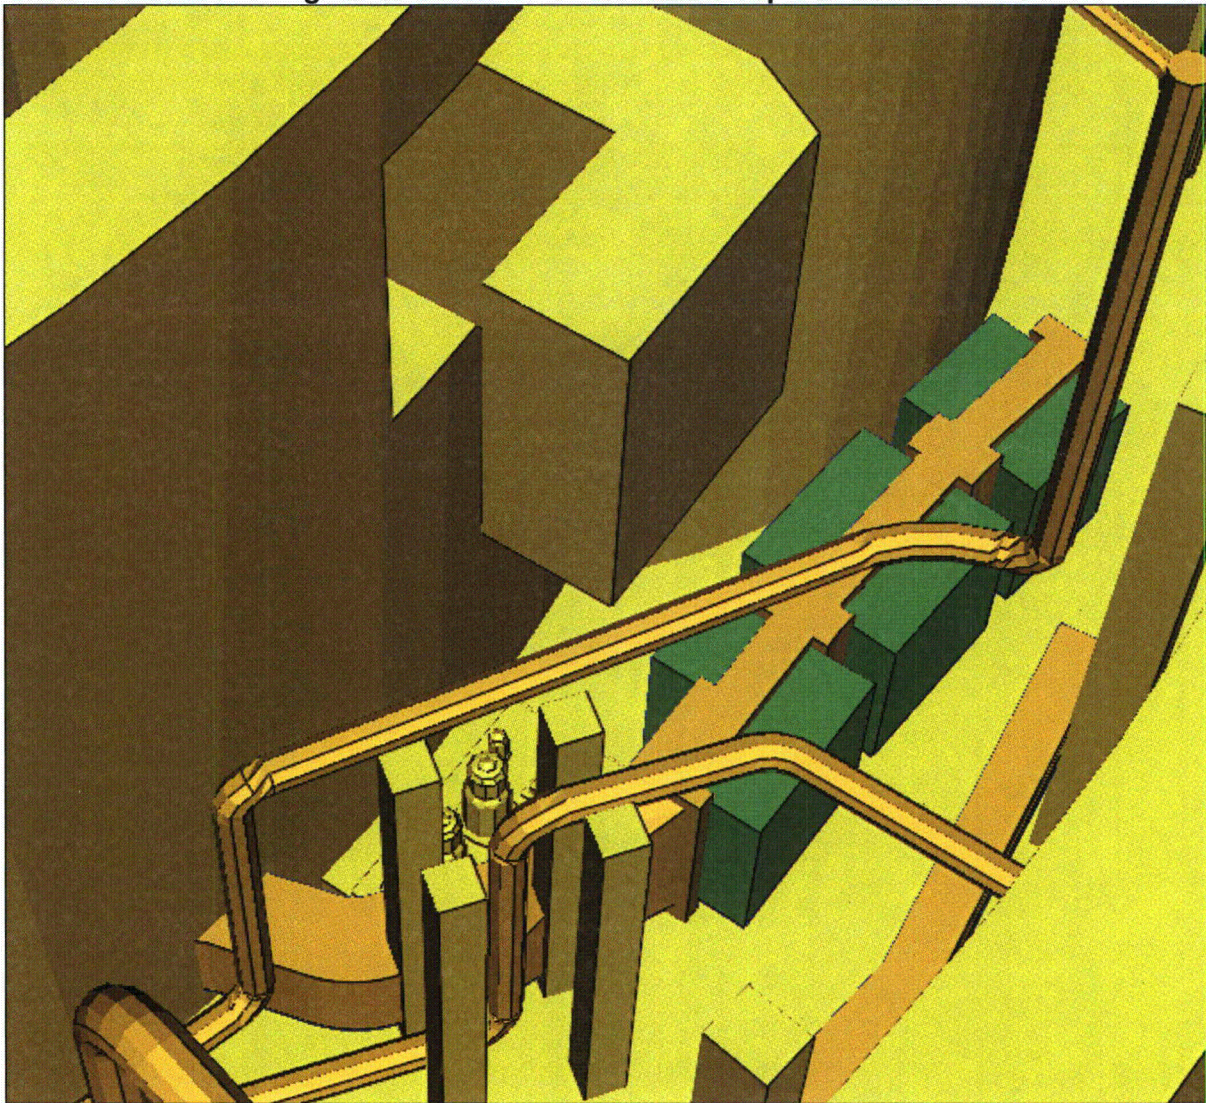
**Figure 3e1-6 Remote Strainer Sump Mass Sink**
