## ATTACHMENT 1 TO AEP:NRC:8054-02

I&M is performing design modifications as described below to address the concerns identified in GL 2004-02. The noted completion dates for modifications that have not yet been installed are in accordance with the extensions documented in Reference 16.

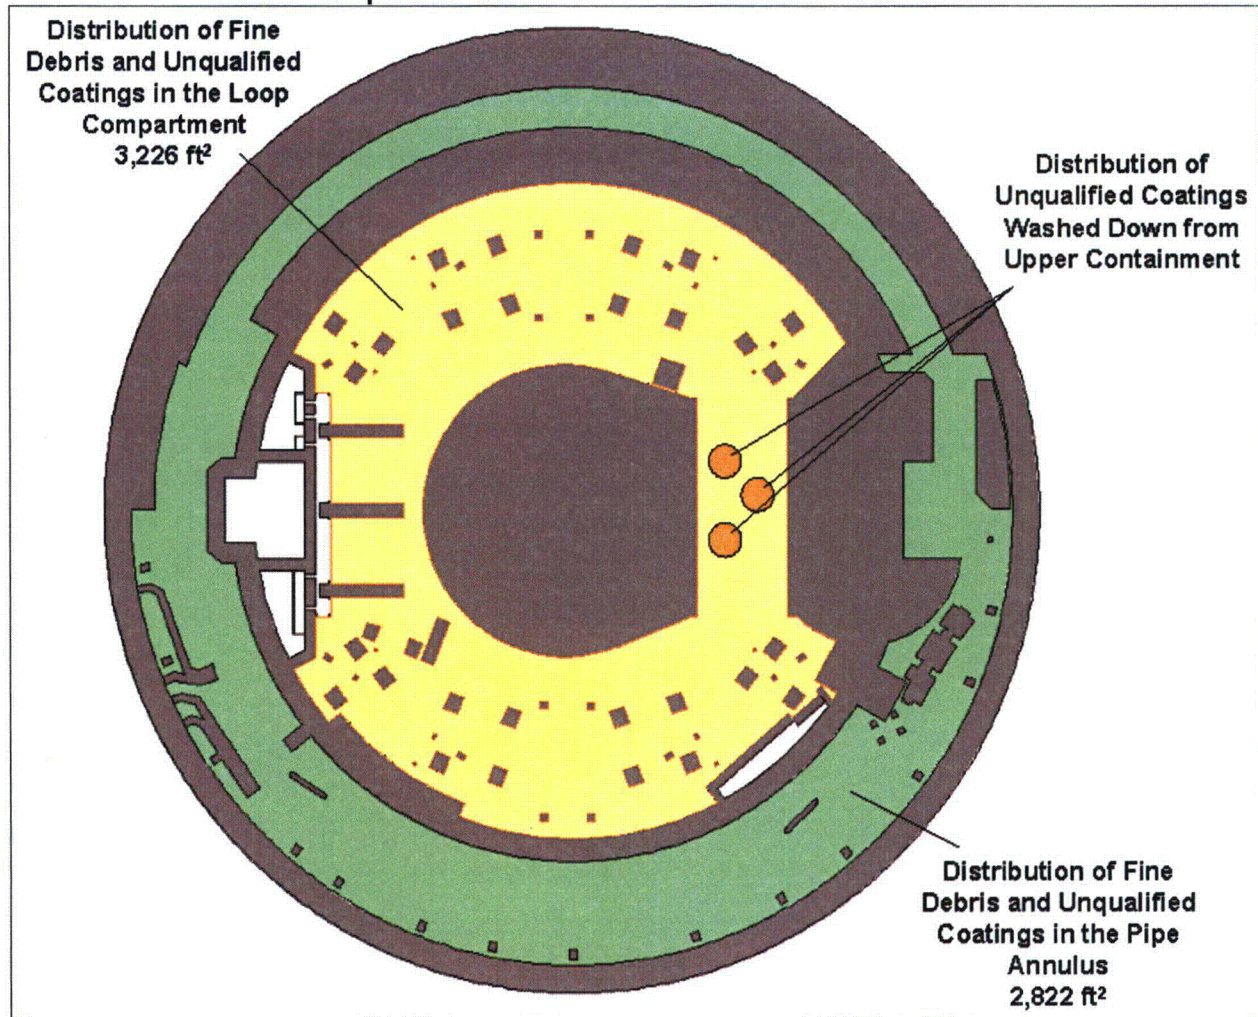
**Figure 3e1-9 Distribution of Fine Debris and Unqualified Coatings in the Loop Compartment and Annulus at Start of Recirculation**

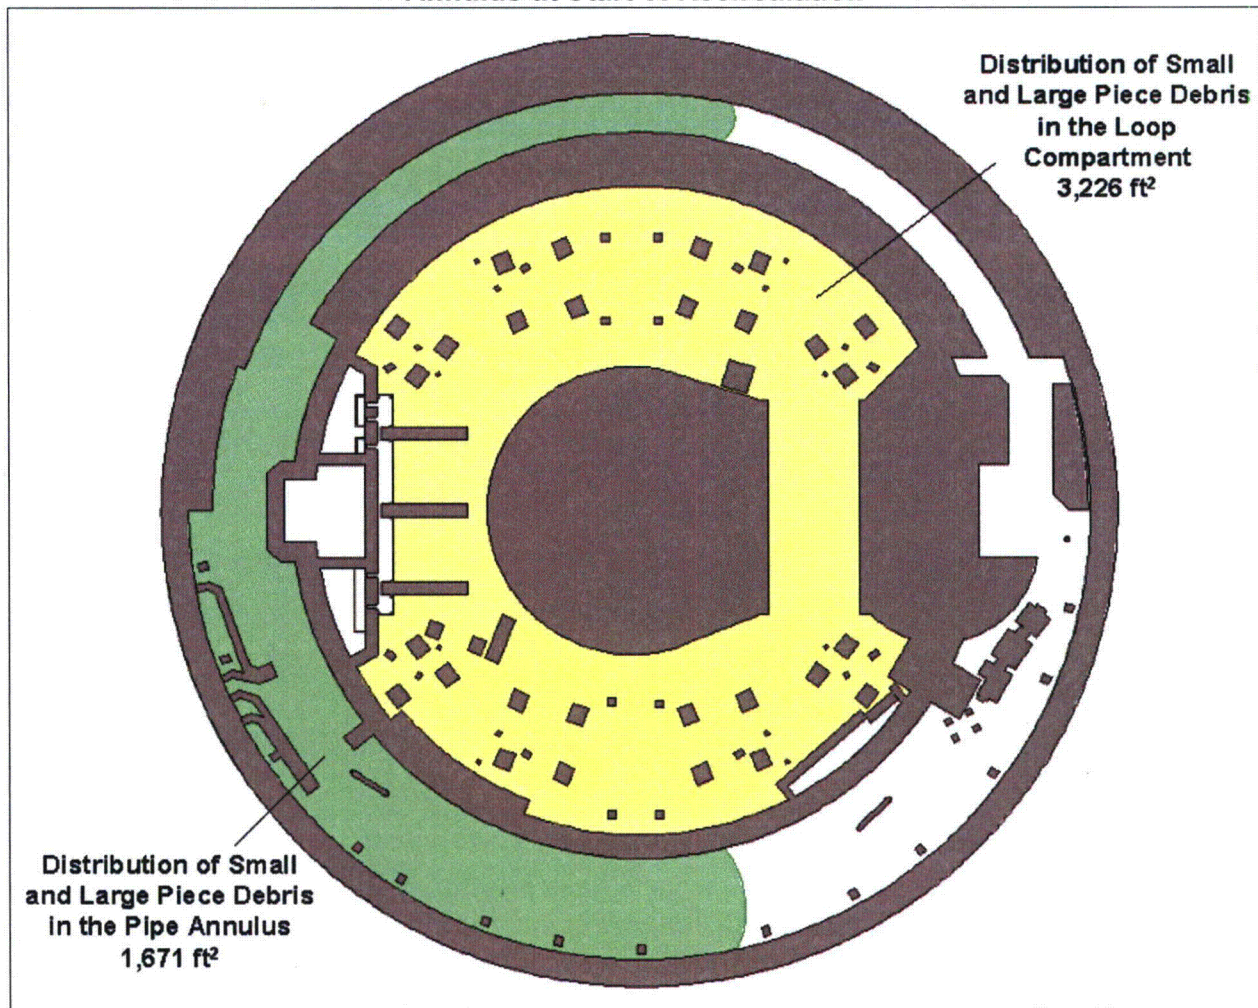
**Figure 3e1-10 Distribution of Small and Large Piece Debris in the Loop Compartment and Annulus at Start of Recirculation**

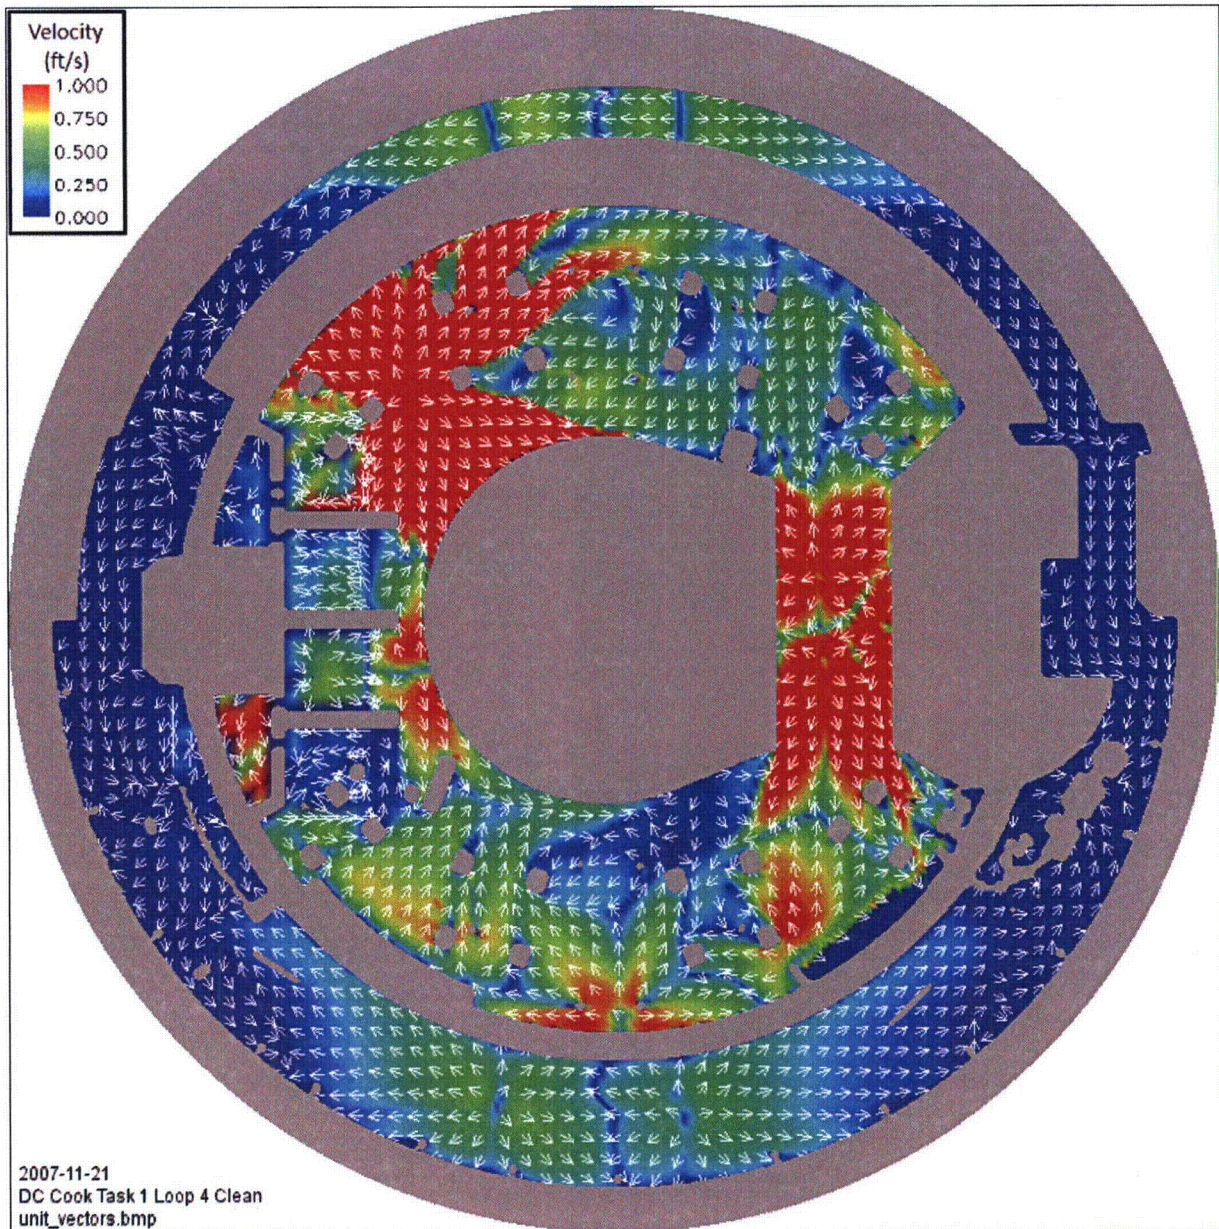
**Figure 3e1-11 Vectors Showing Pool Flow Direction for Loop 4 Break with Clean Main Strainer**

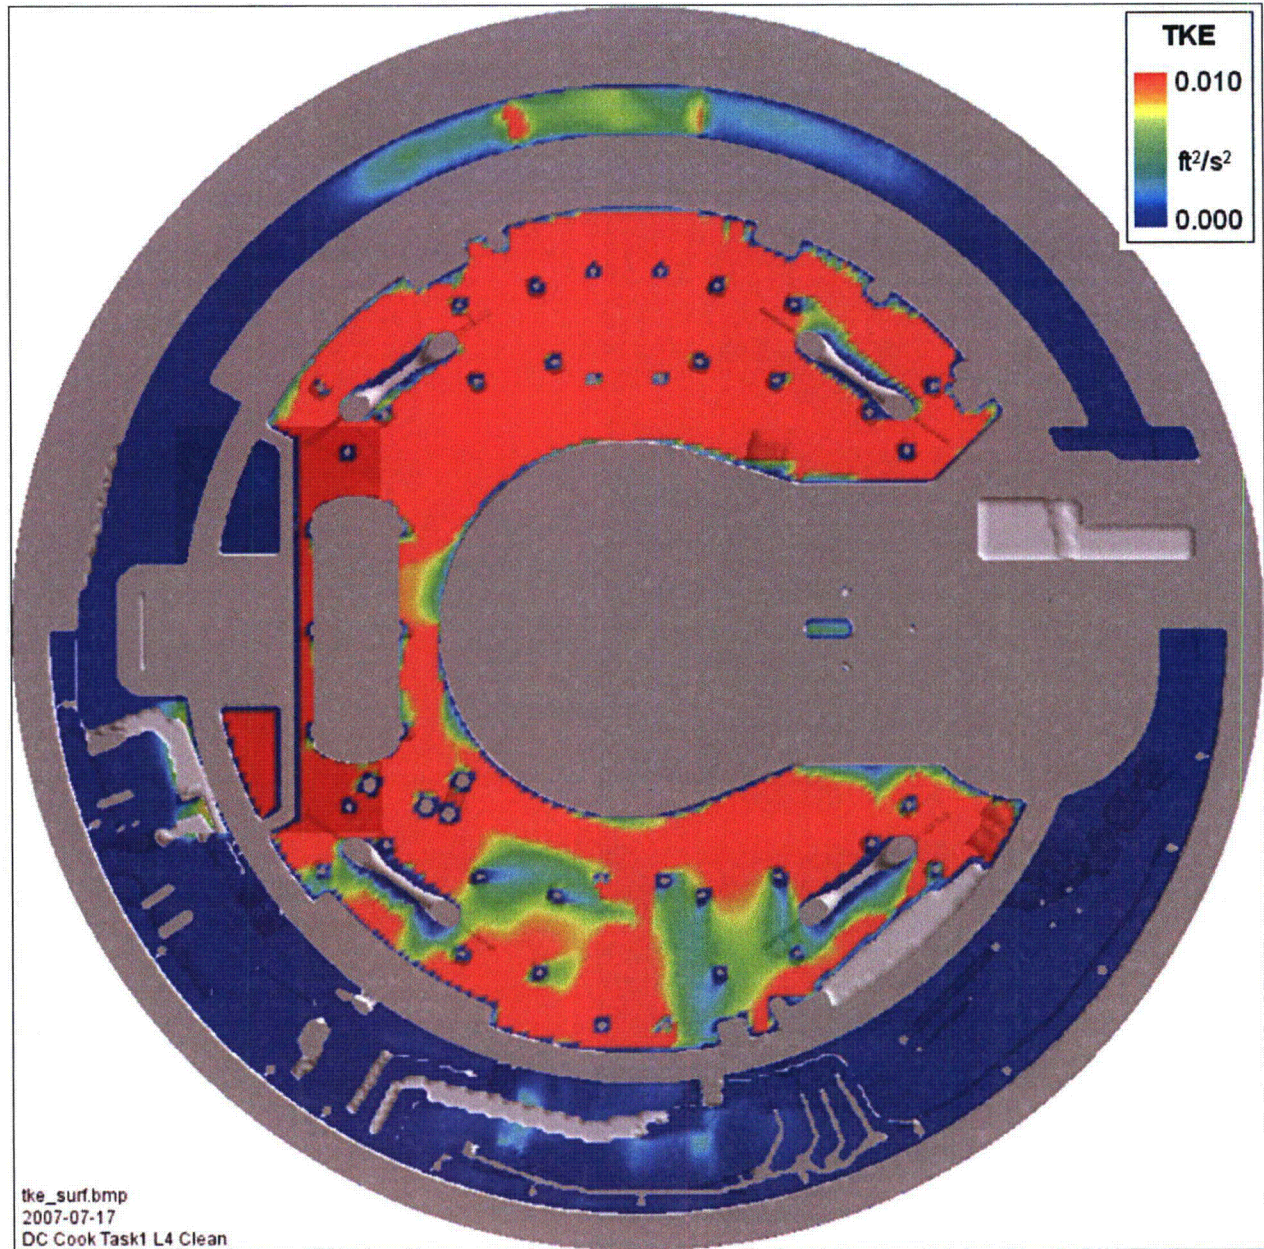
Figure 3e1-12 Relative TKE at Pool Surface Showing General Areas of Turbulence for Loop 4 Break with Clean Main Strainer

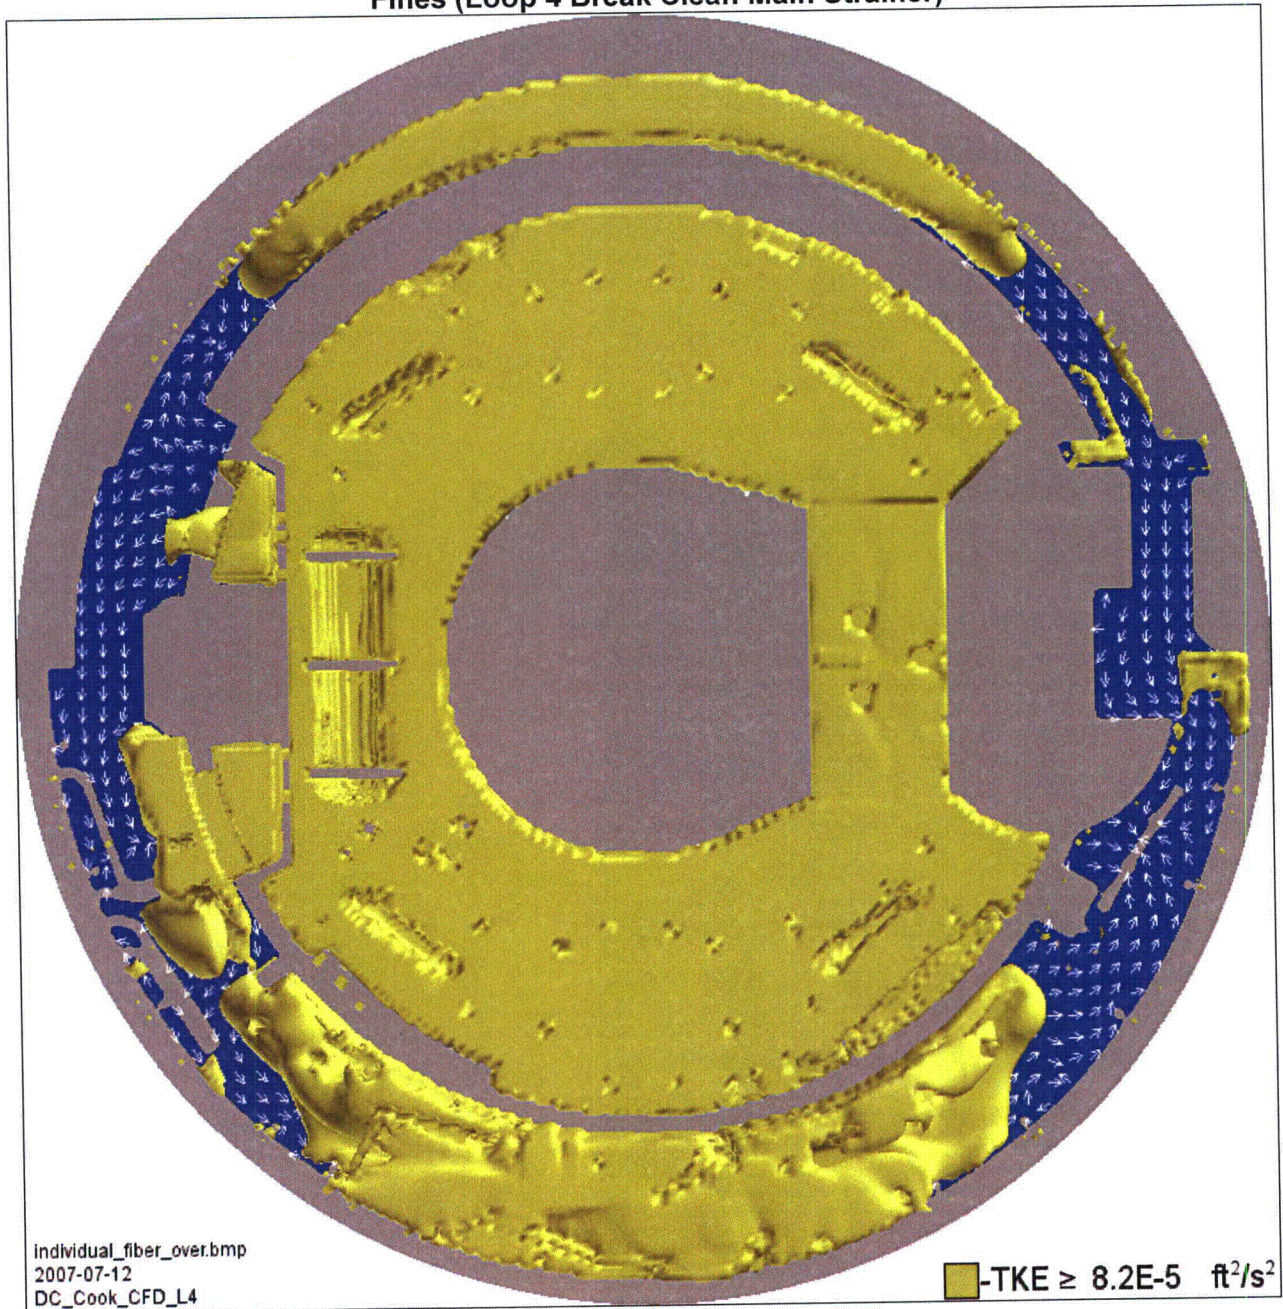
Figure 3e1-13 provides an example of the type of figures that were developed for determination of the areas where transport, tumbling, or suspension of a particular debris source would be expected to occur as described previously in this section.

**Figure 3e1-13 TKE with Limit Set at Suspension of Individual Fibers and Particulate Fines (Loop 4 Break Clean Main Strainer)**

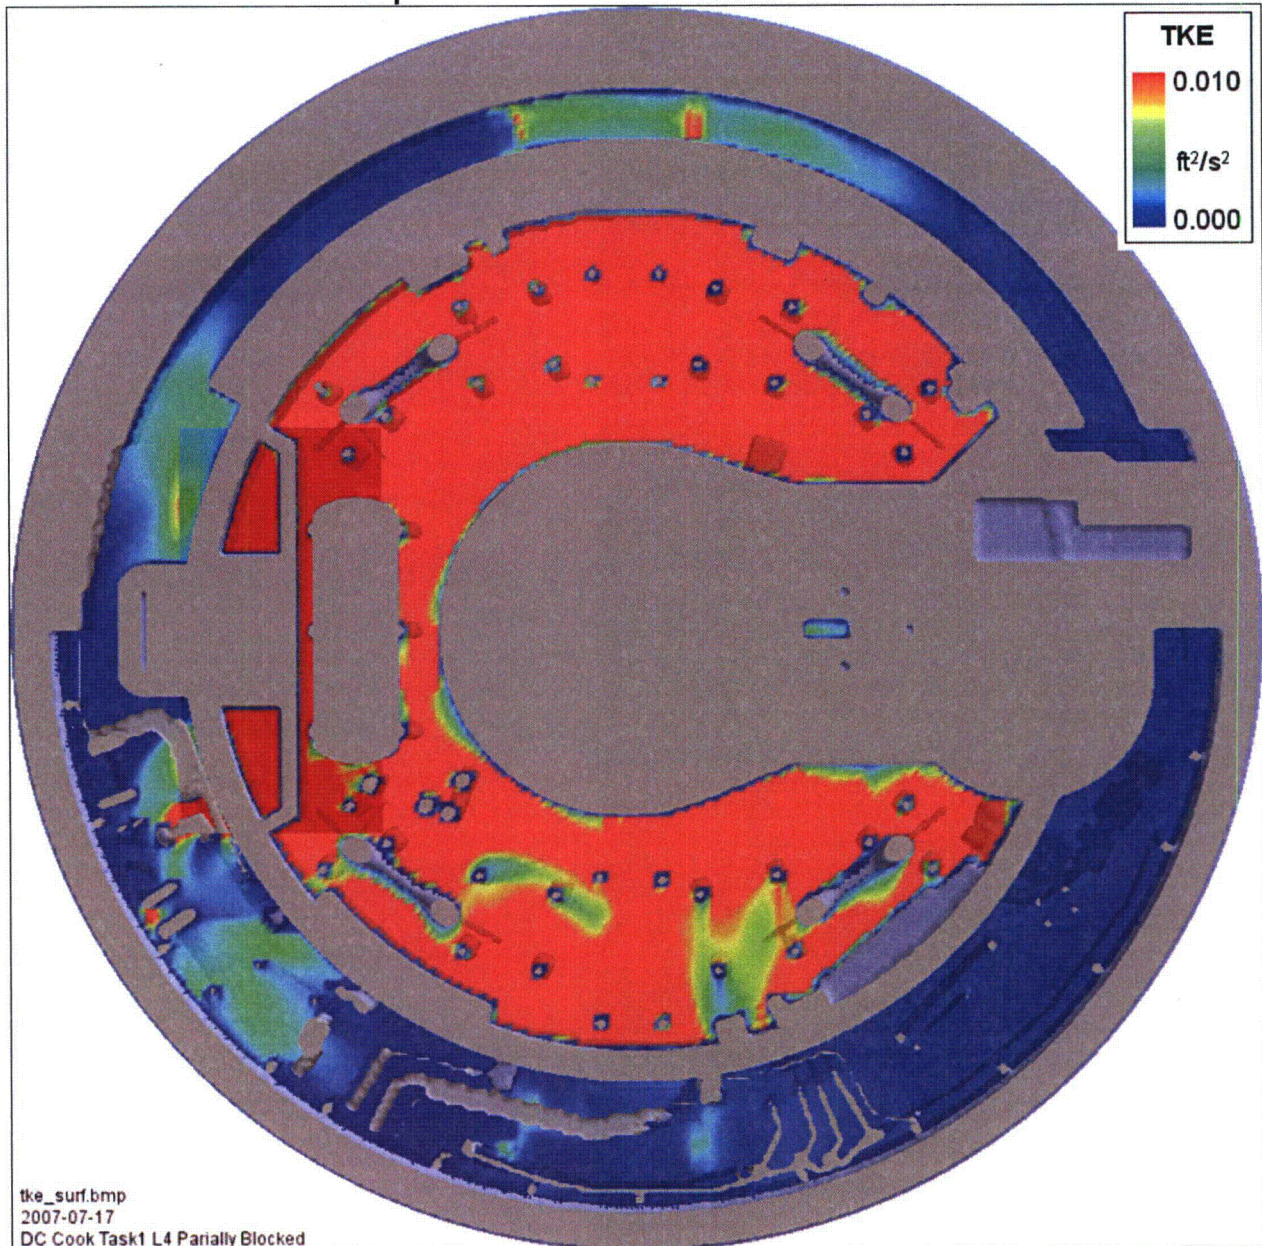
**Figure 3e1-15 Relative TKE at Pool Surface Showing General Areas of Turbulence for Loop 4 Break with 90% Blocked Main Strainer**

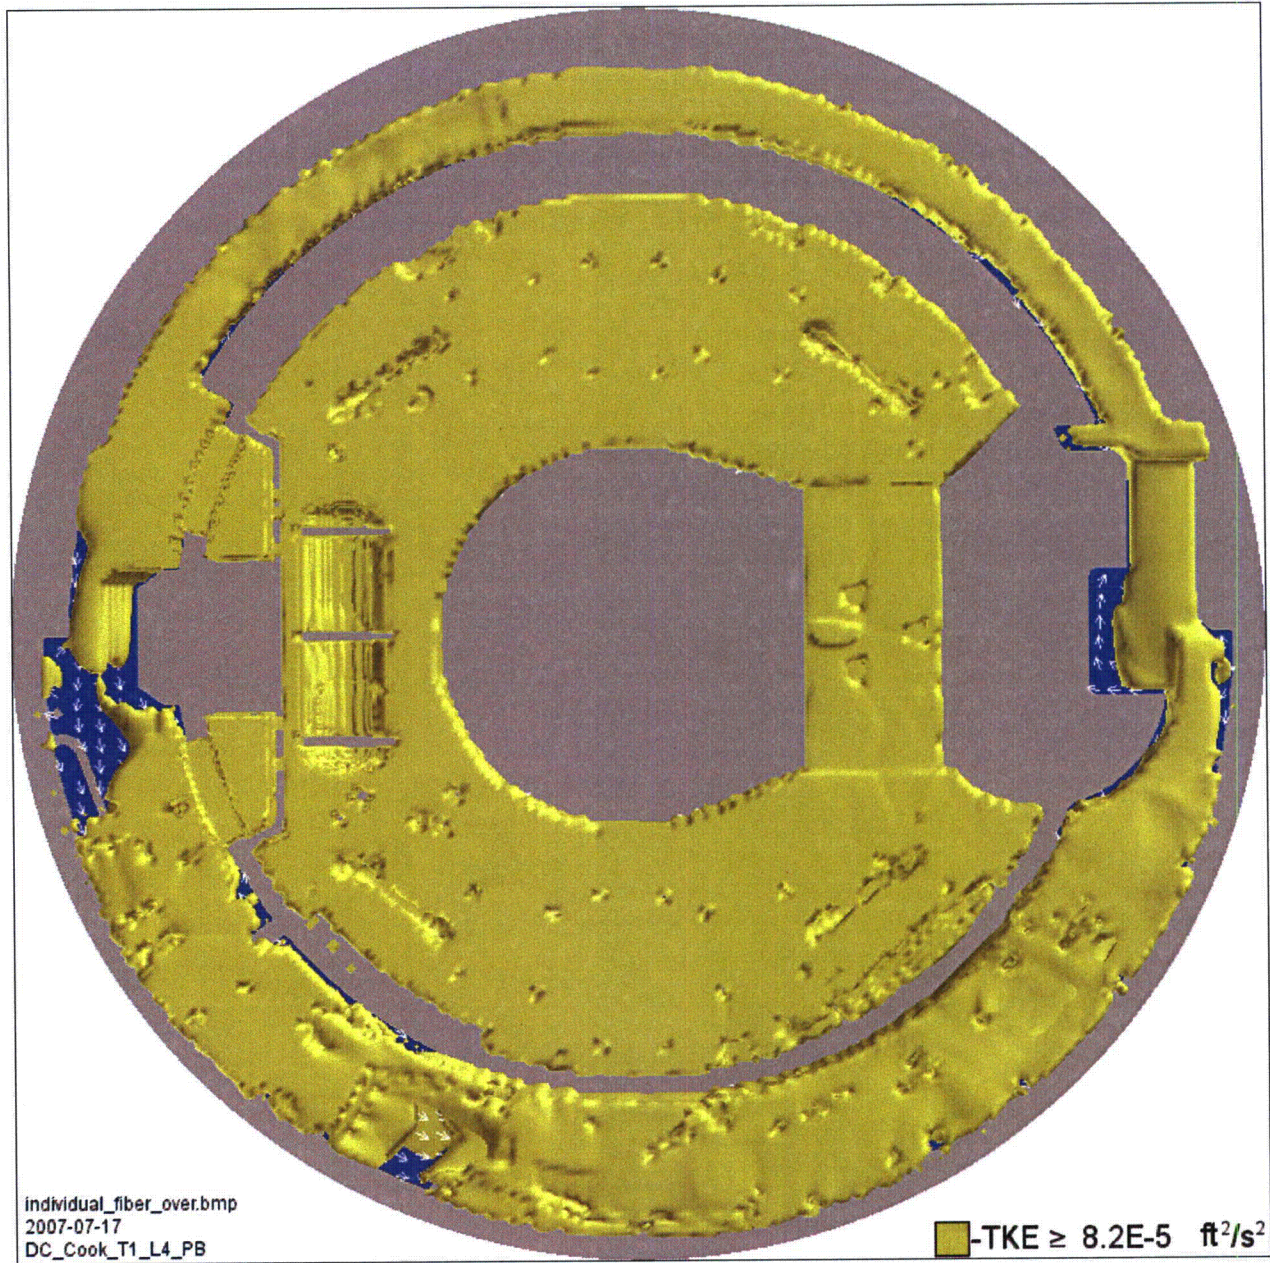
Figure 3e1-16 provides the TKE information associated with latent fibers and particulate fines for the Loop 4 break, 90% blocked main strainer case.

**Figure 3e1-16 TKE with Limit Set at Suspension of Individual Fibers and Particulate Fines (Loop 4 Break 90% Blocked Main Strainer)**
