## ATTACHMENT 1 TO AEP:NRC:8054-02

I&M is performing design modifications as described below to address the concerns identified in GL 2004-02. The noted completion dates for modifications that have not yet been installed are in accordance with the extensions documented in Reference 16.

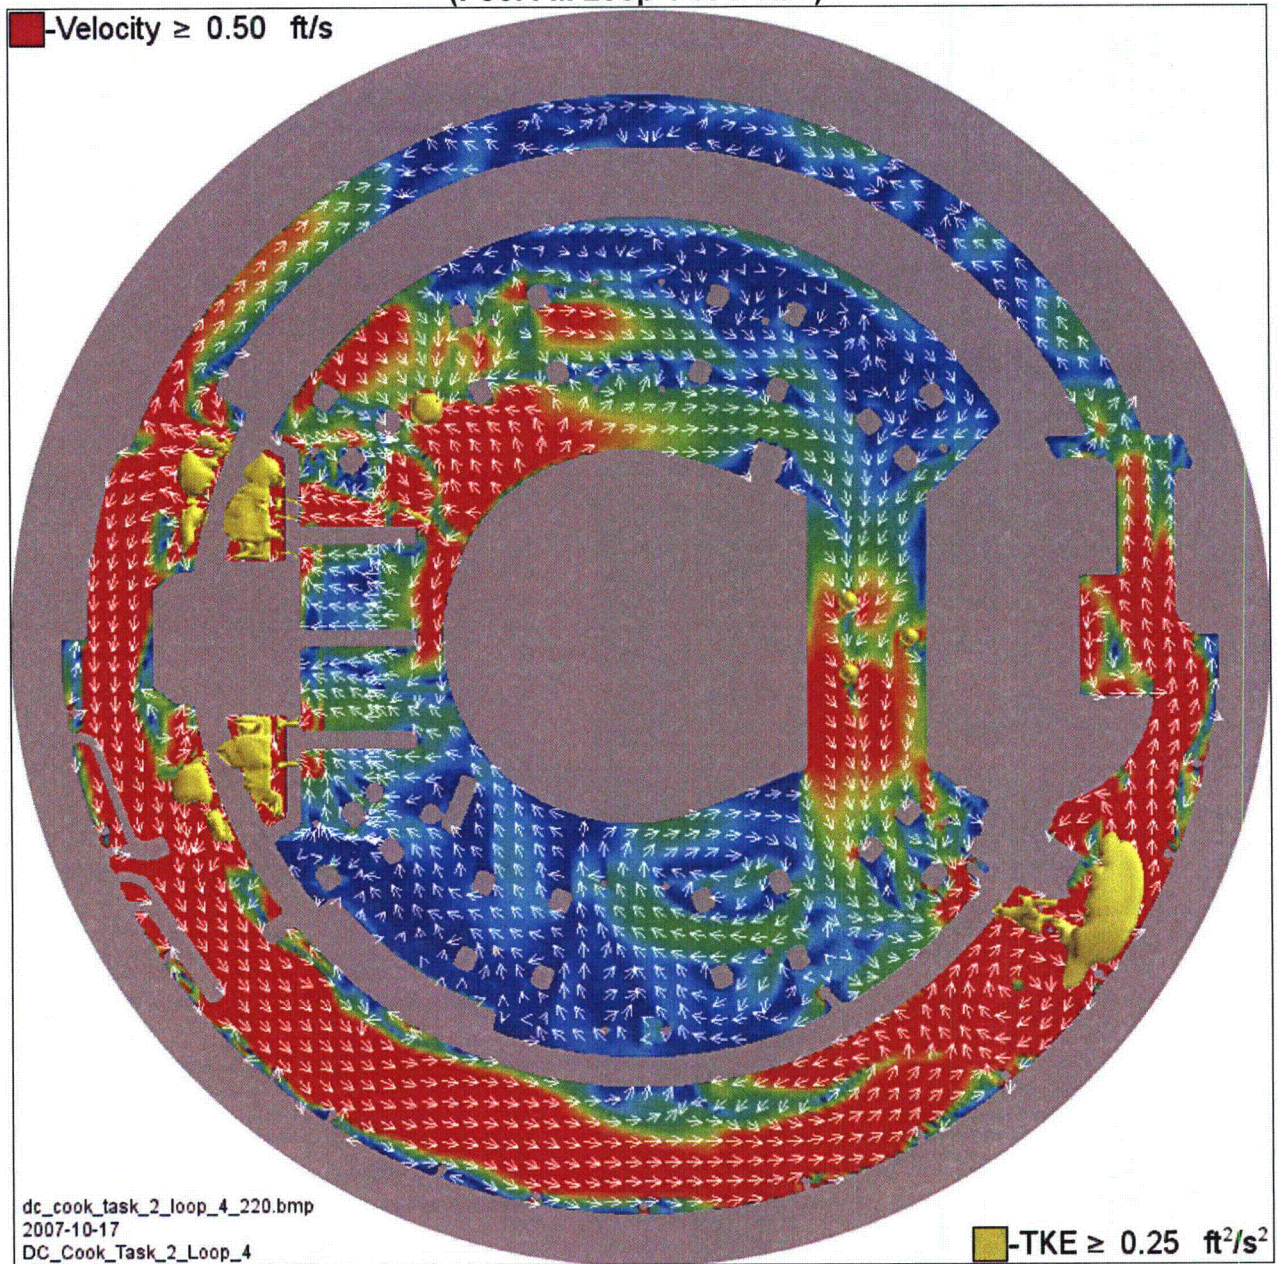
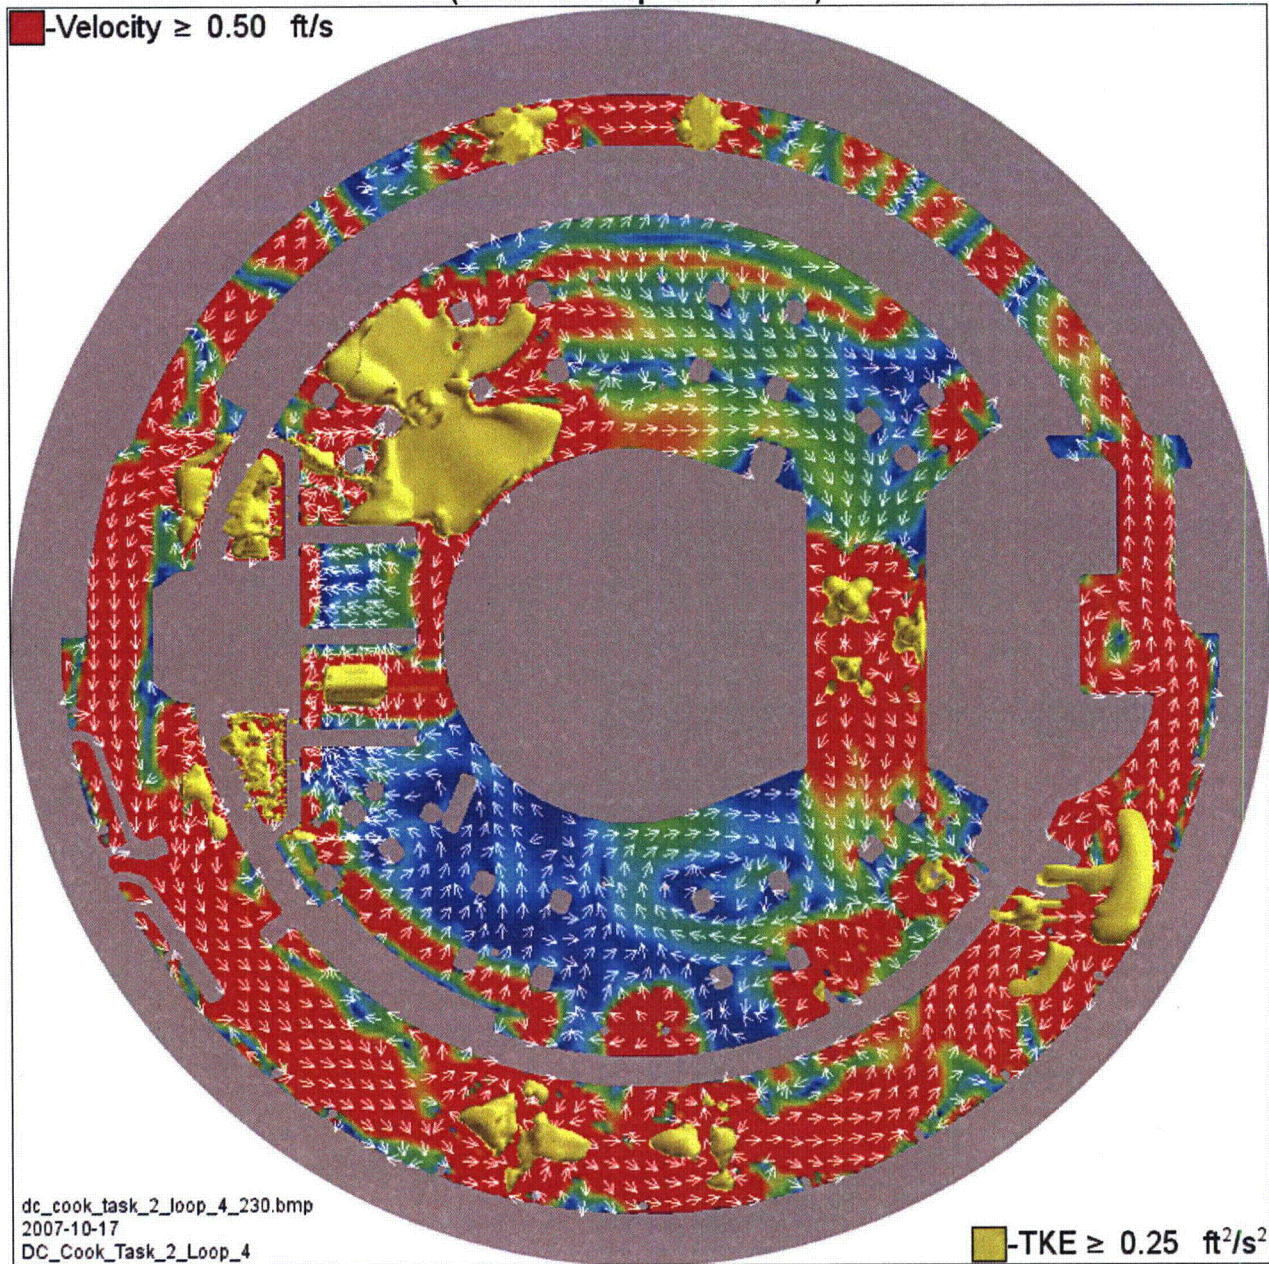
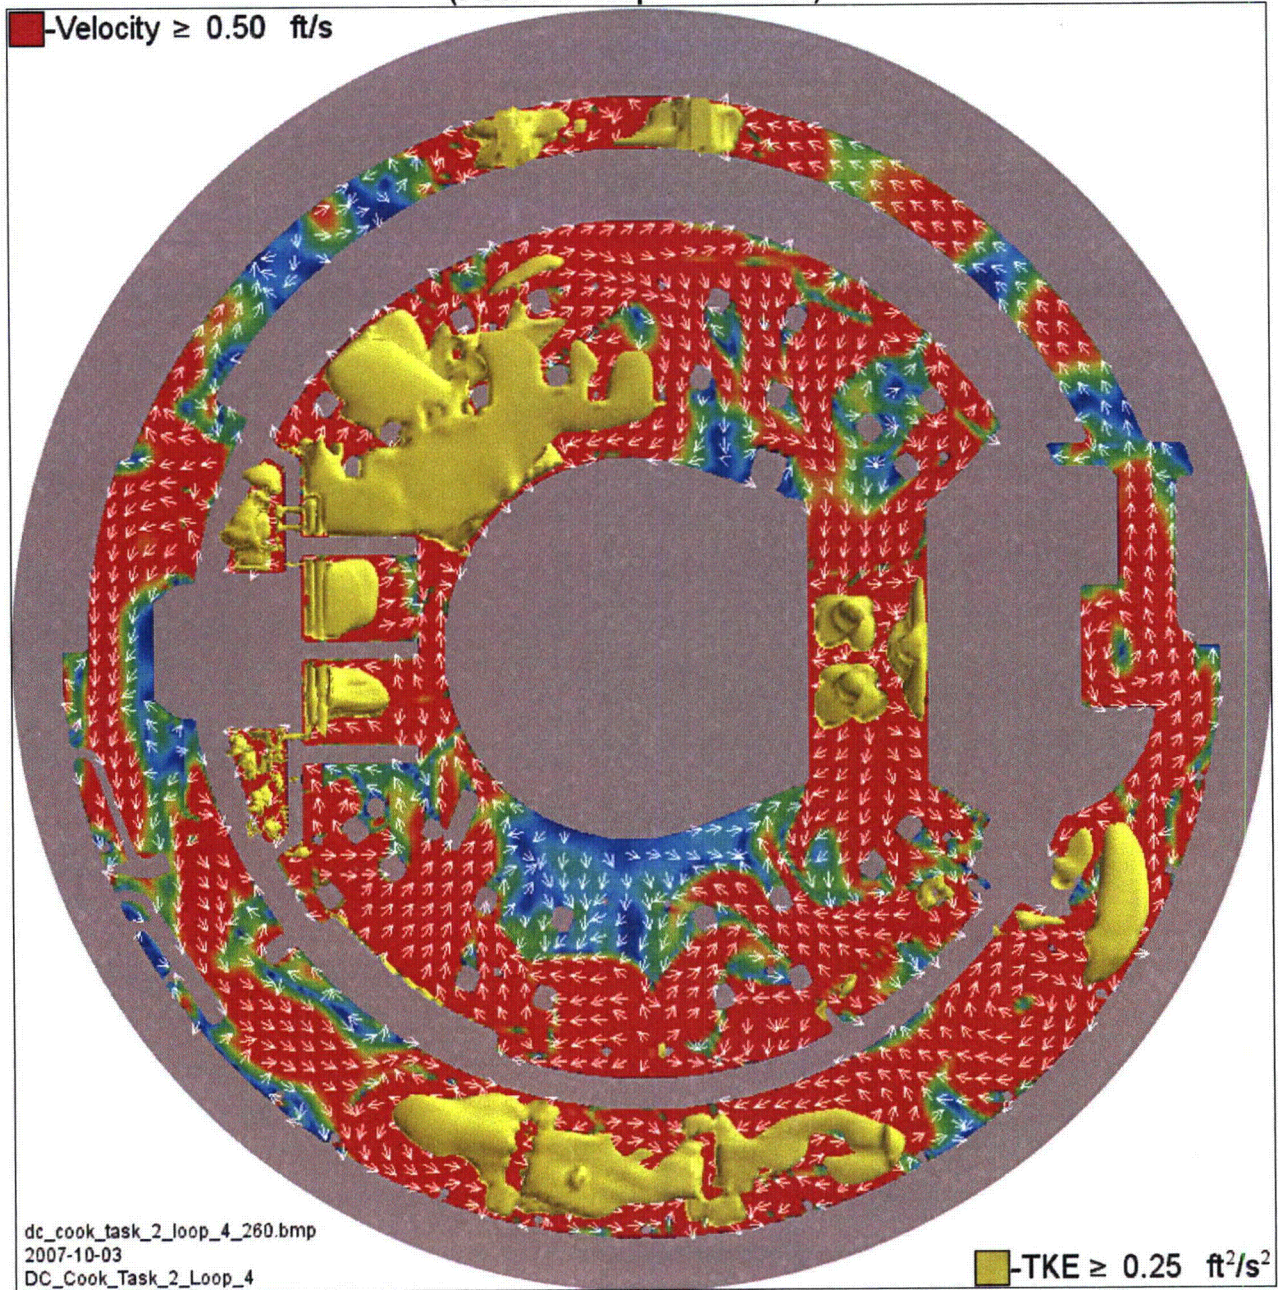
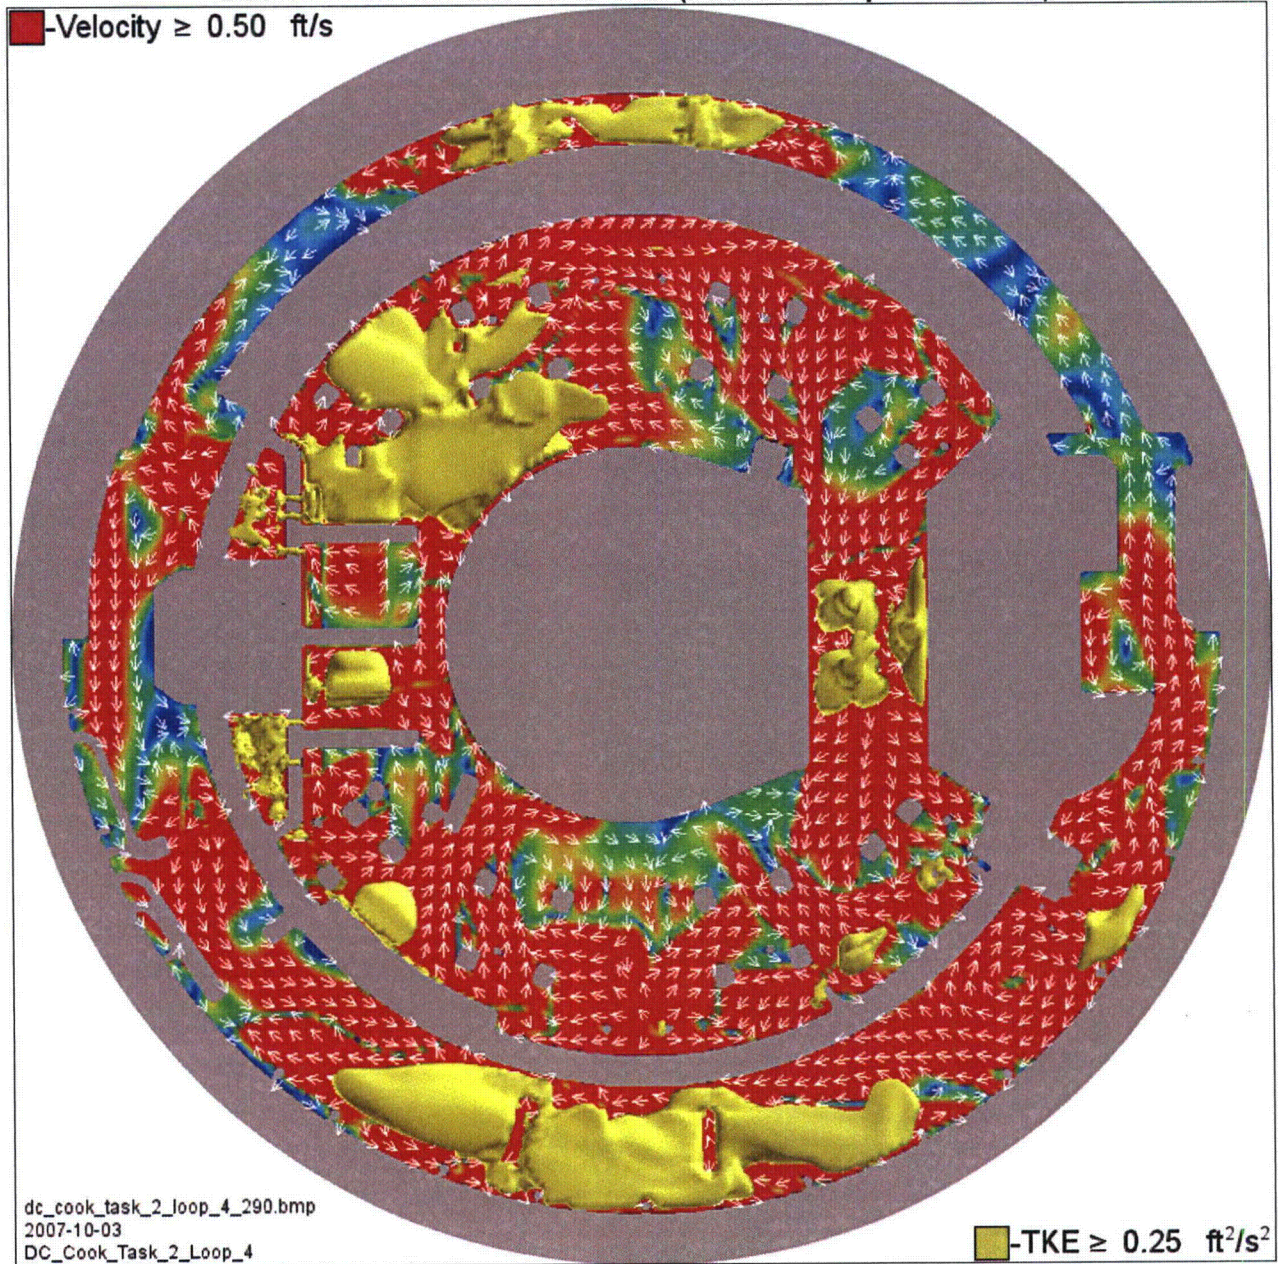
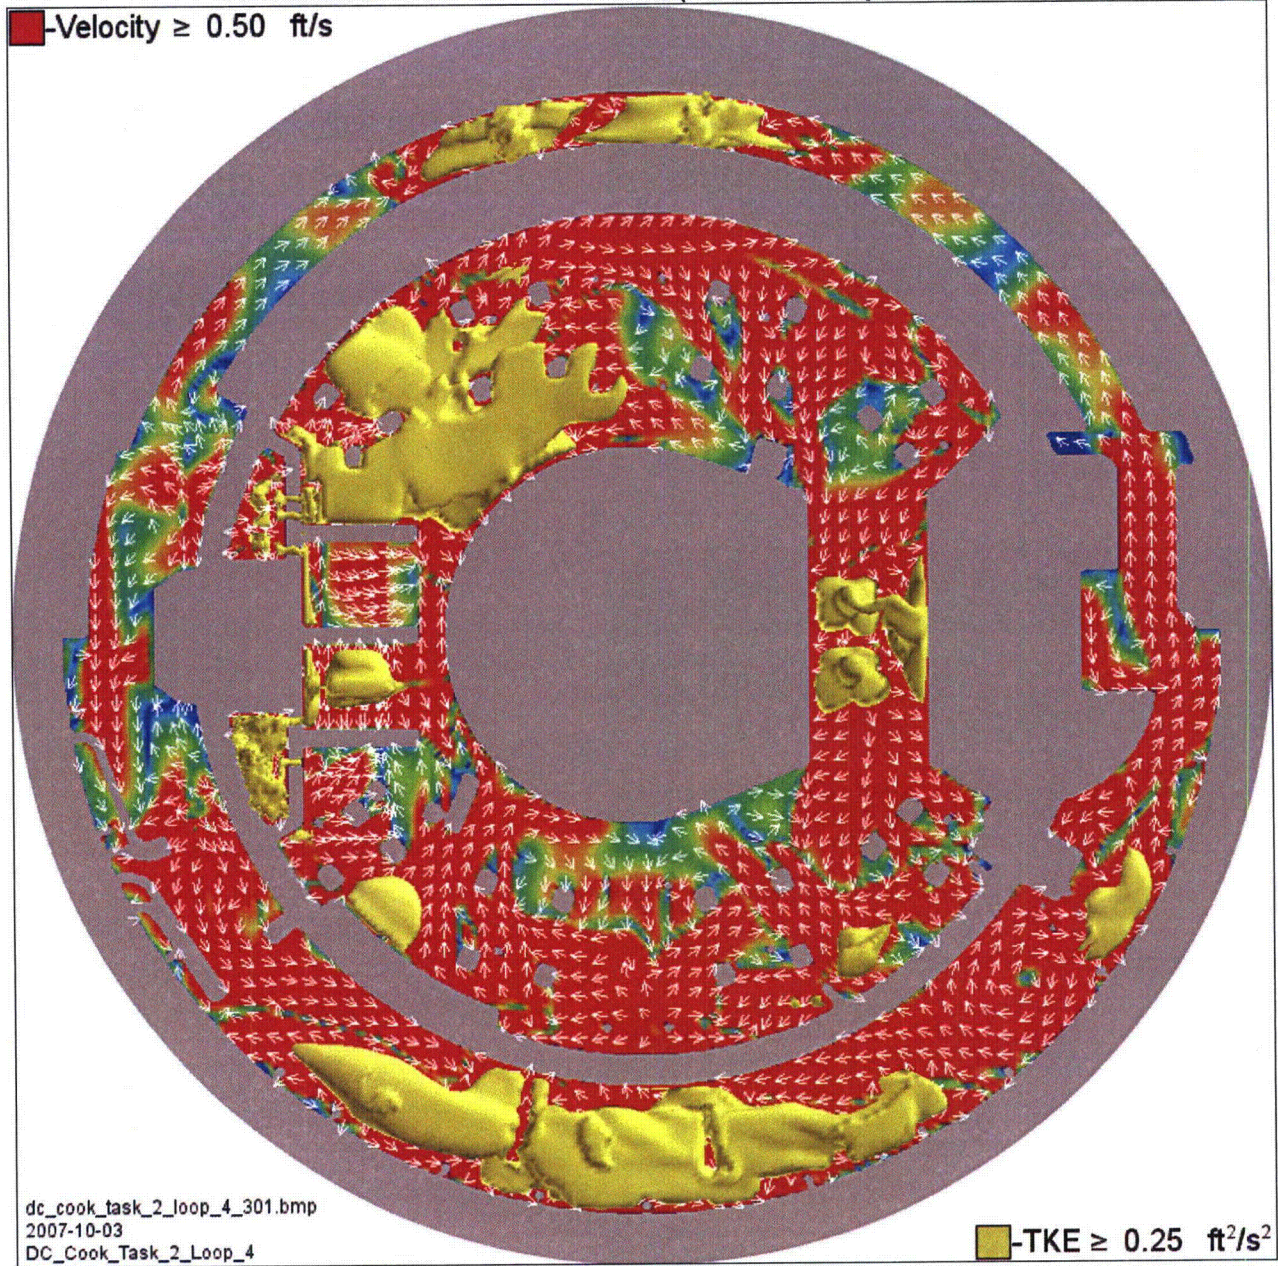
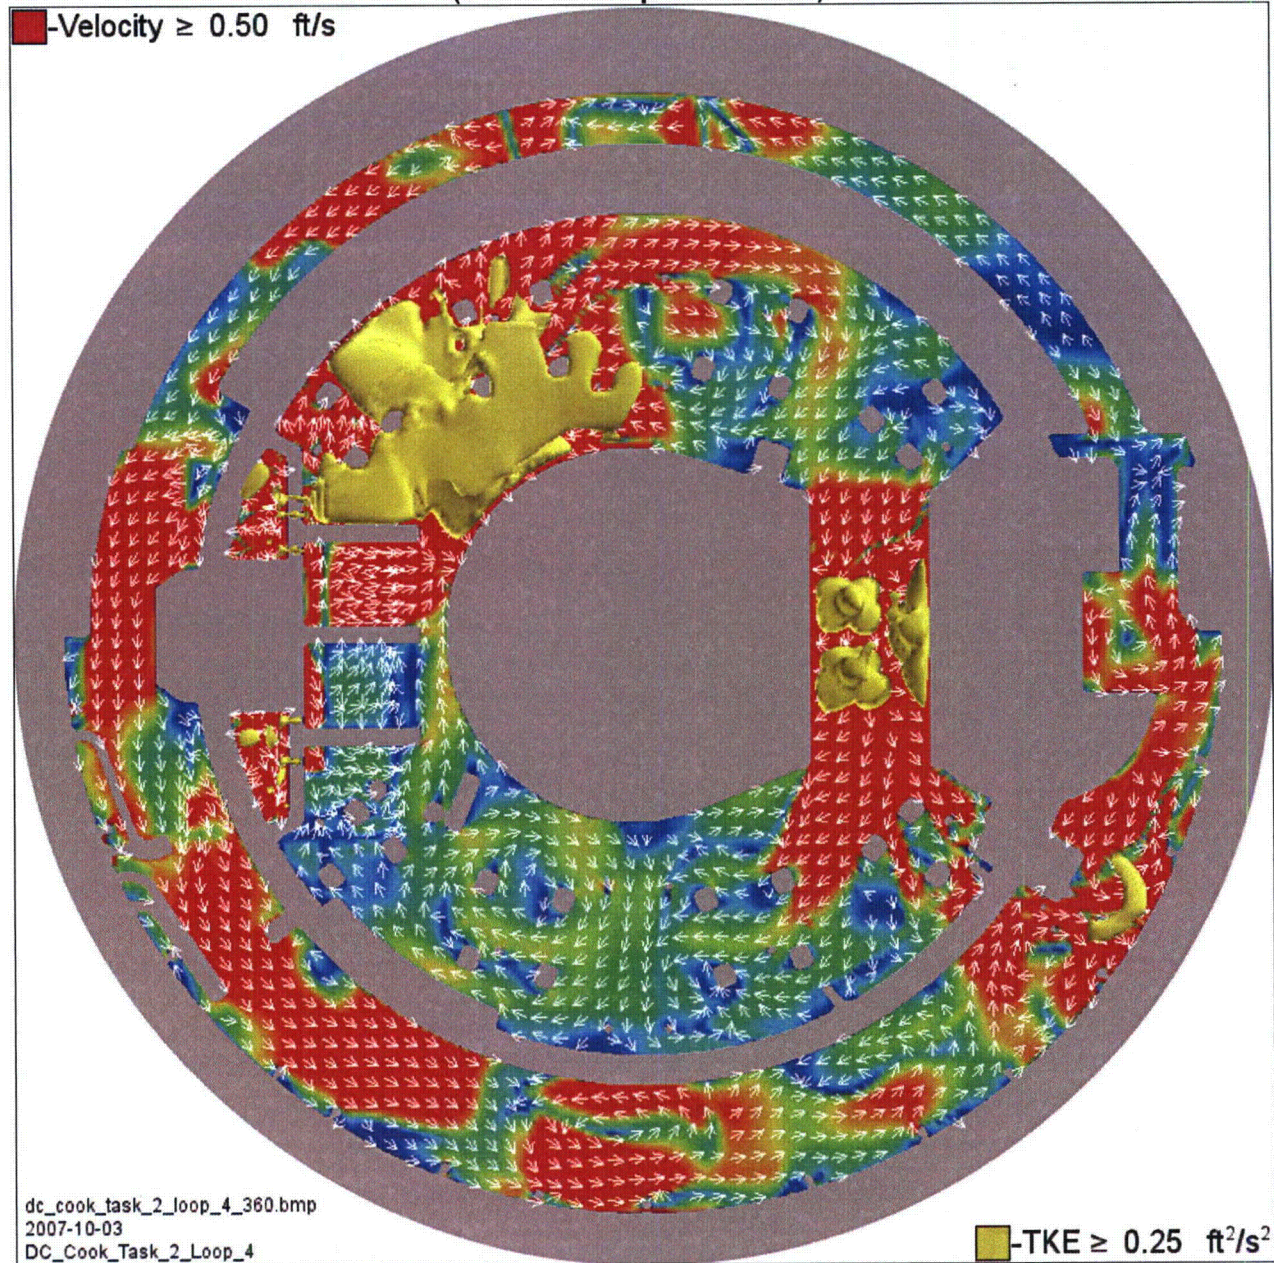
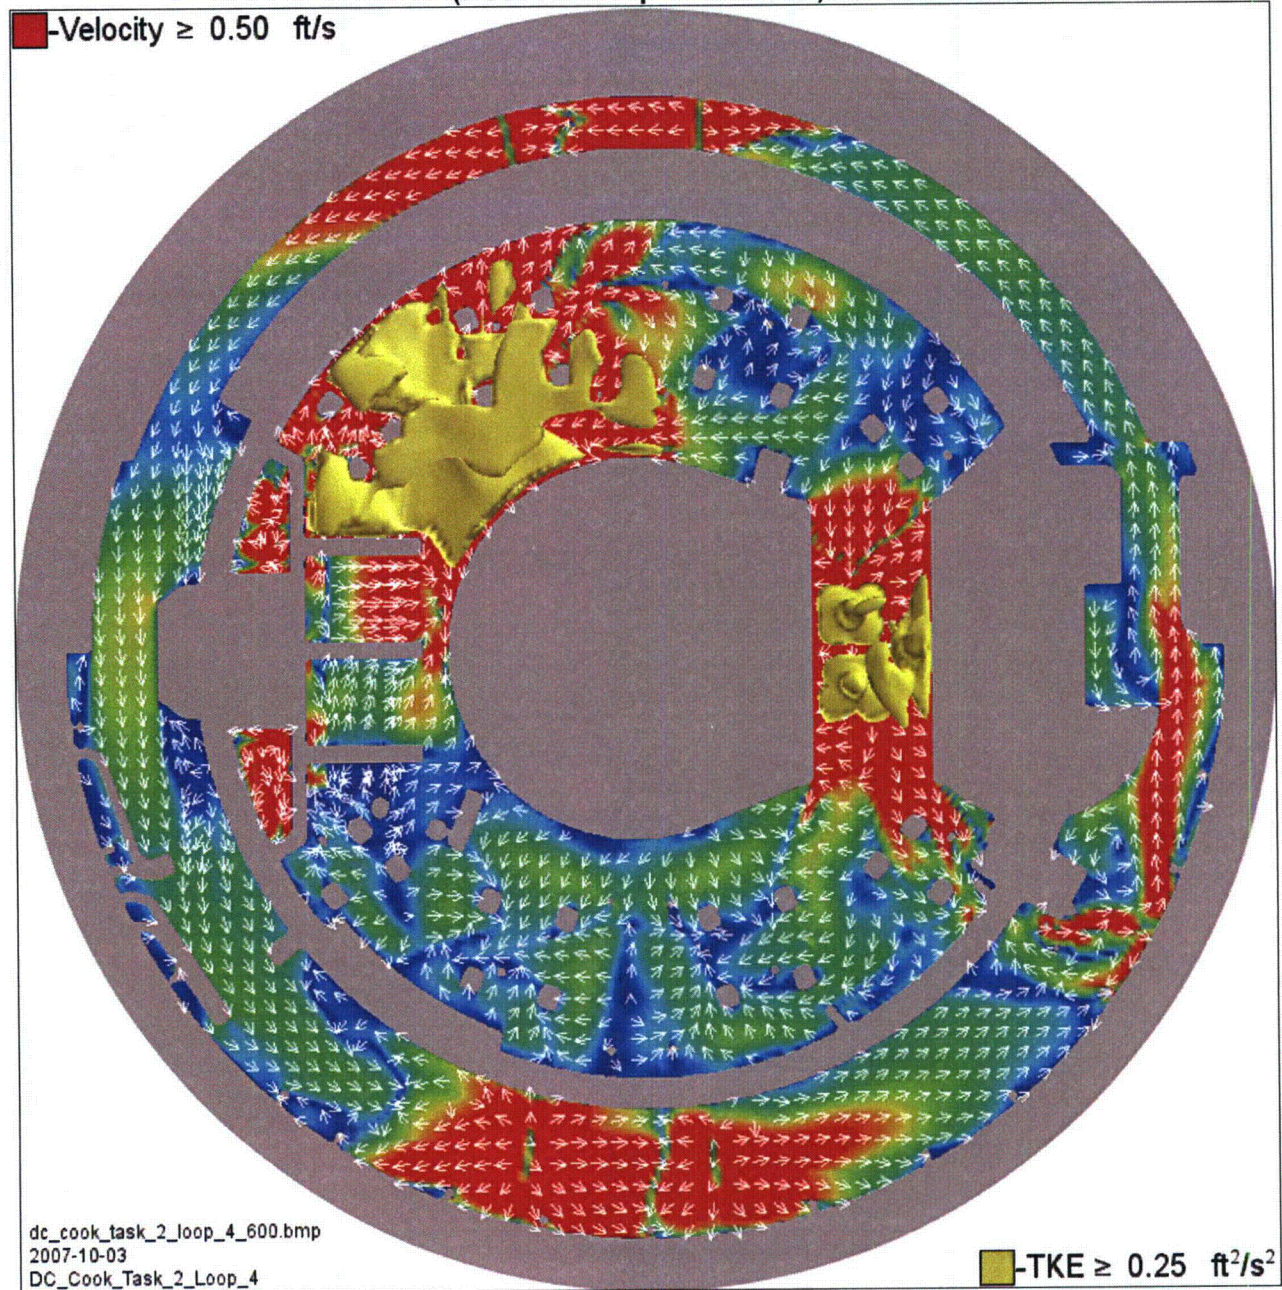
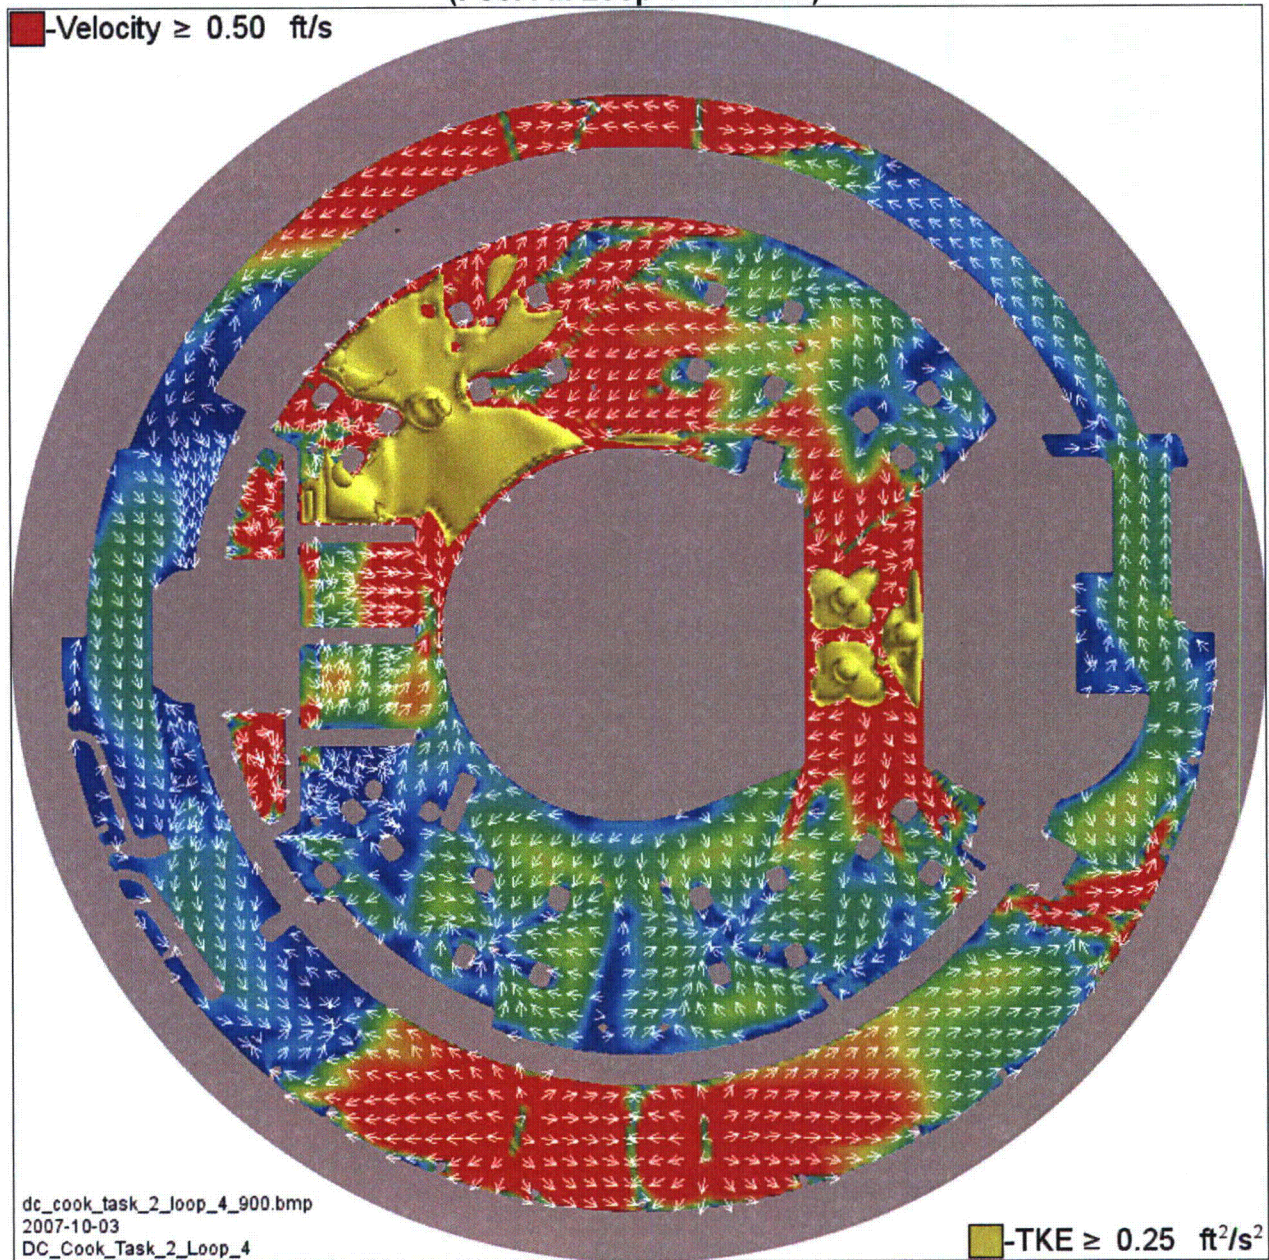
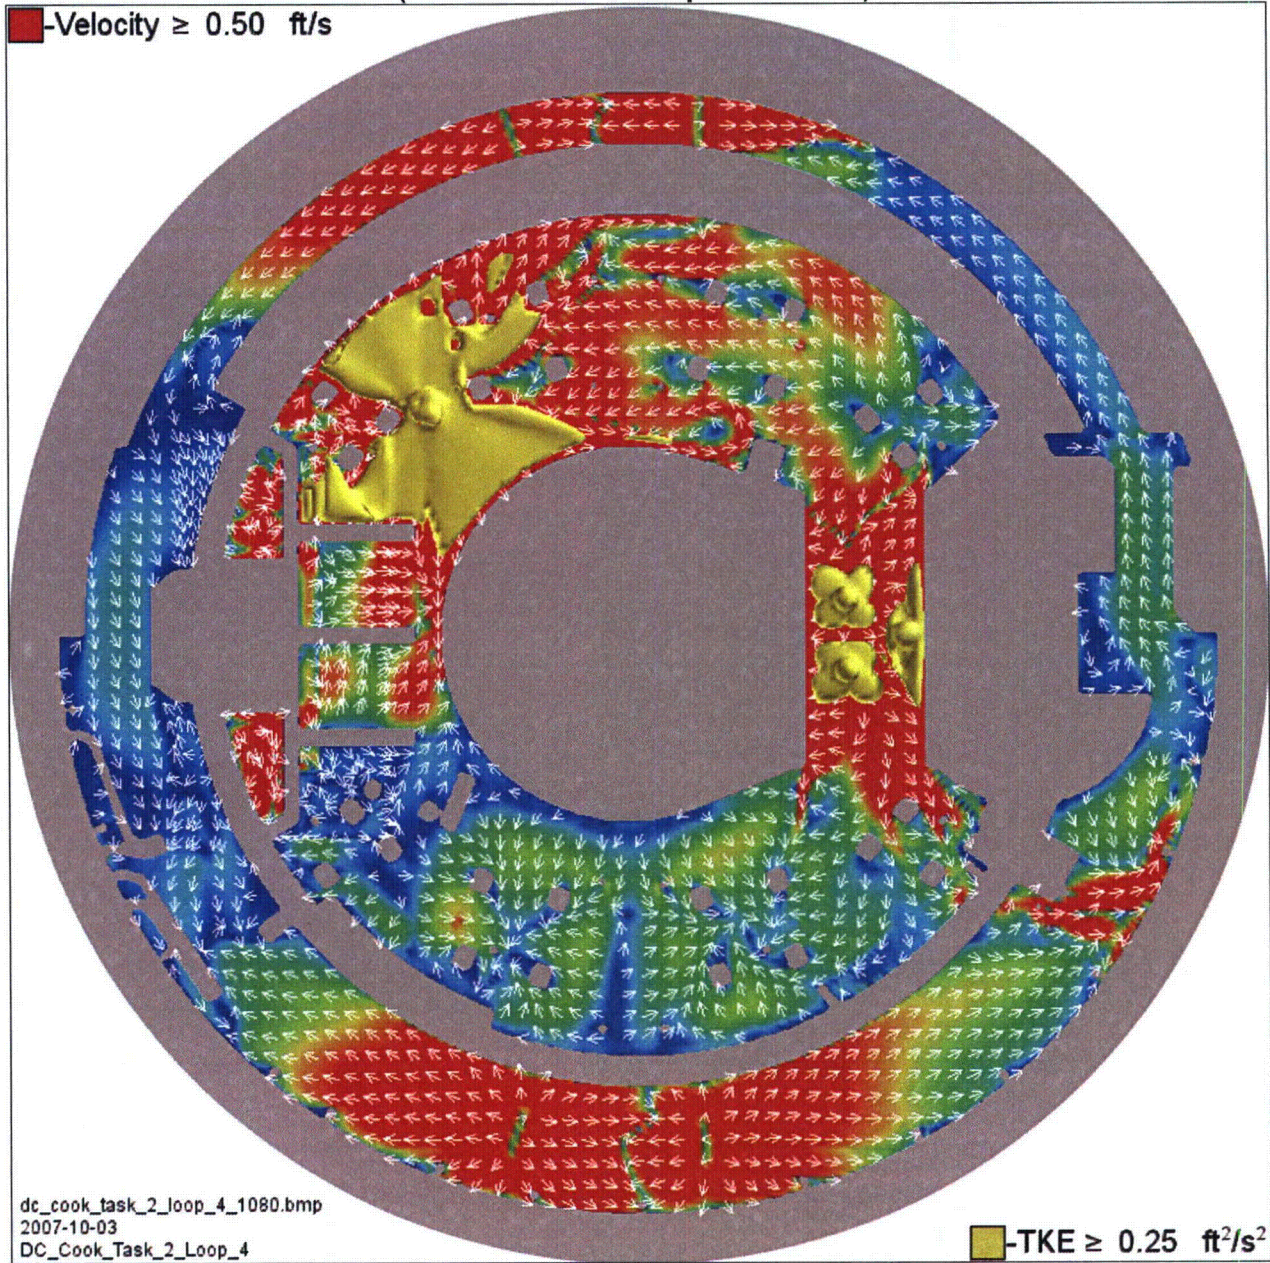
Figure 3e1-17 TKE and Velocity in the Pool at 220 Seconds - Just Before Restarting to Increase the Break, Spray, and Ice Melt Kinetic Energy (Pool Fill Loop 4 CFD Run)

**Figure 3e1-18 TKE and Velocity in the Pool at 230 Seconds - Just After Restarting to Increase the Break, Spray, and Ice Melt Kinetic Energy (Pool Fill Loop 4 CFD Run)**

Figure 3e1-19 TKE and Velocity in the Pool at 260 Seconds  
(Pool Fill Loop 4 CFD Run)

Figure 3e1-20 TKE and Velocity in the Pool at 290 Seconds - Just Before Restarting to Decrease the Ice Melt Flow Rate (Pool Fill Loop 4 CFD Run)

Figure 3e1-21 TKE and Velocity in the Pool at 301 Seconds - Just After Restarting to Decrease the Ice Melt Flow Rate (Pool Fill Loop 4 CFD Run)

Figure 3e1-22 TKE and Velocity in the Pool at 360 Seconds  
(Pool Fill Loop 4 CFD Run)

Figure 3e1-23 TKE and Velocity in the Pool at 600 Seconds  
(Pool Fill Loop 4 CFD Run)

Figure 3e1-24 TKE and Velocity in the Pool at 900 Seconds  
(Pool Fill Loop 4 CFD Run)

Figure 3e1-25 TKE and Velocity in the Pool at 1,080 Seconds  
(End of Pool Fill Loop 4 CFD Run)

Figures 3e1-17 through 3e1-25 (attached to the end of this section) show velocity contour plots just above the floor (1.5 in) with a TKE iso-surface approximately representative of the TKE required to suspend the various types of debris pieces for various intervals during the pool fill phase.
