LOS ANGELES
POWER DIVISION

DEFICIENCY EVALUATION REPORT

1. REPORT NO. 81-14

2. PROJECT - NAME/JOB NUMBER <u>PVNGS/10407</u>	3. UNIT <u>3</u>	4. Q CLASS <u>Q</u>	5. REFERENCE DOCUMENTS <u>NCR C-C-2643</u>
--	---------------------	------------------------	---

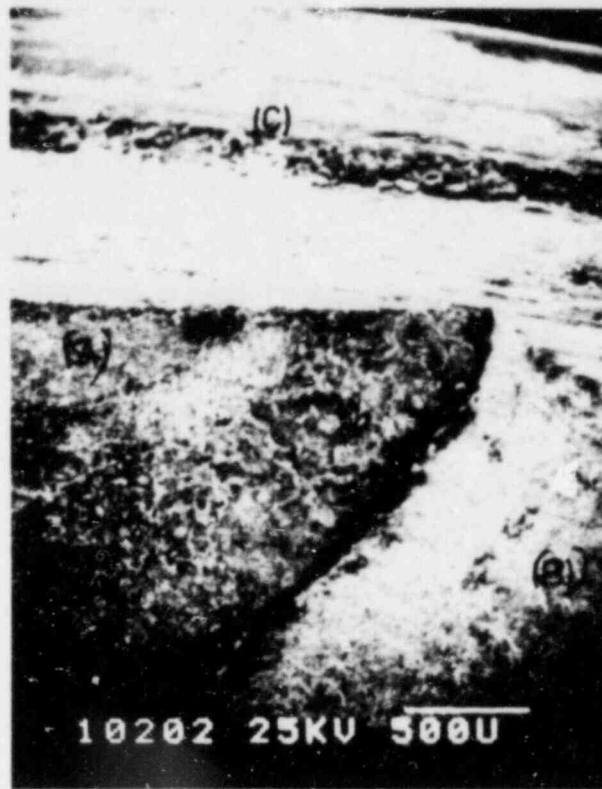
Figure 3.(a) SEM Fractograph of Fracture Transition.

Fracture surface location is Detail Area C of Figure 2.
Fracture transition is from Area A (intergranular mode, Figure 3.(b))
to Area B (dimpled rupture mode, Figure 3.(c)) pitting corrosion
is evident in the threads (Area C).

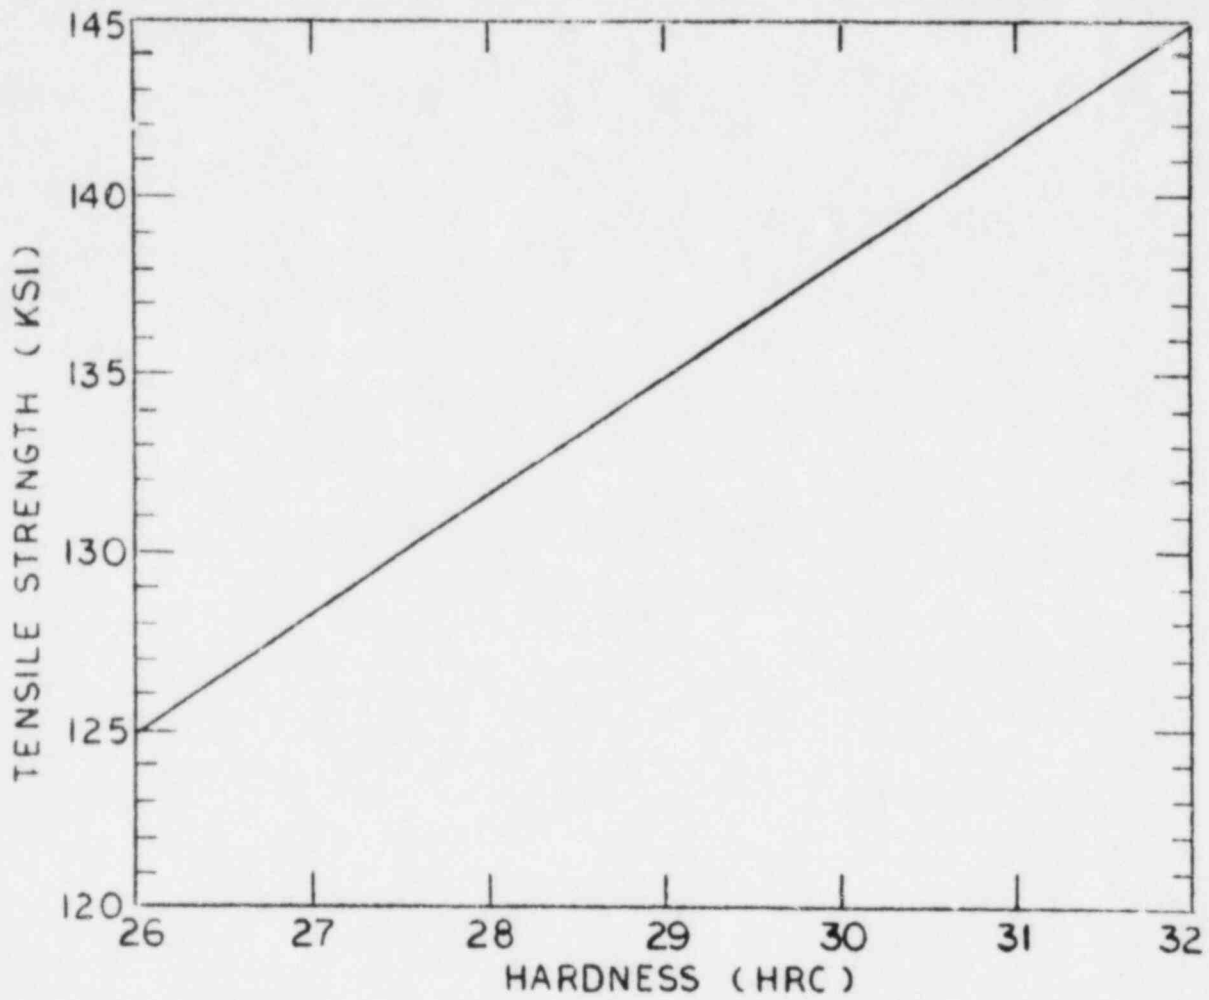
FIGURE 3

TENSILE STRENGTH AS A FUNCTION OF HARDNESS
FOR QUENCHED AND TEMPERED STEELS (8)

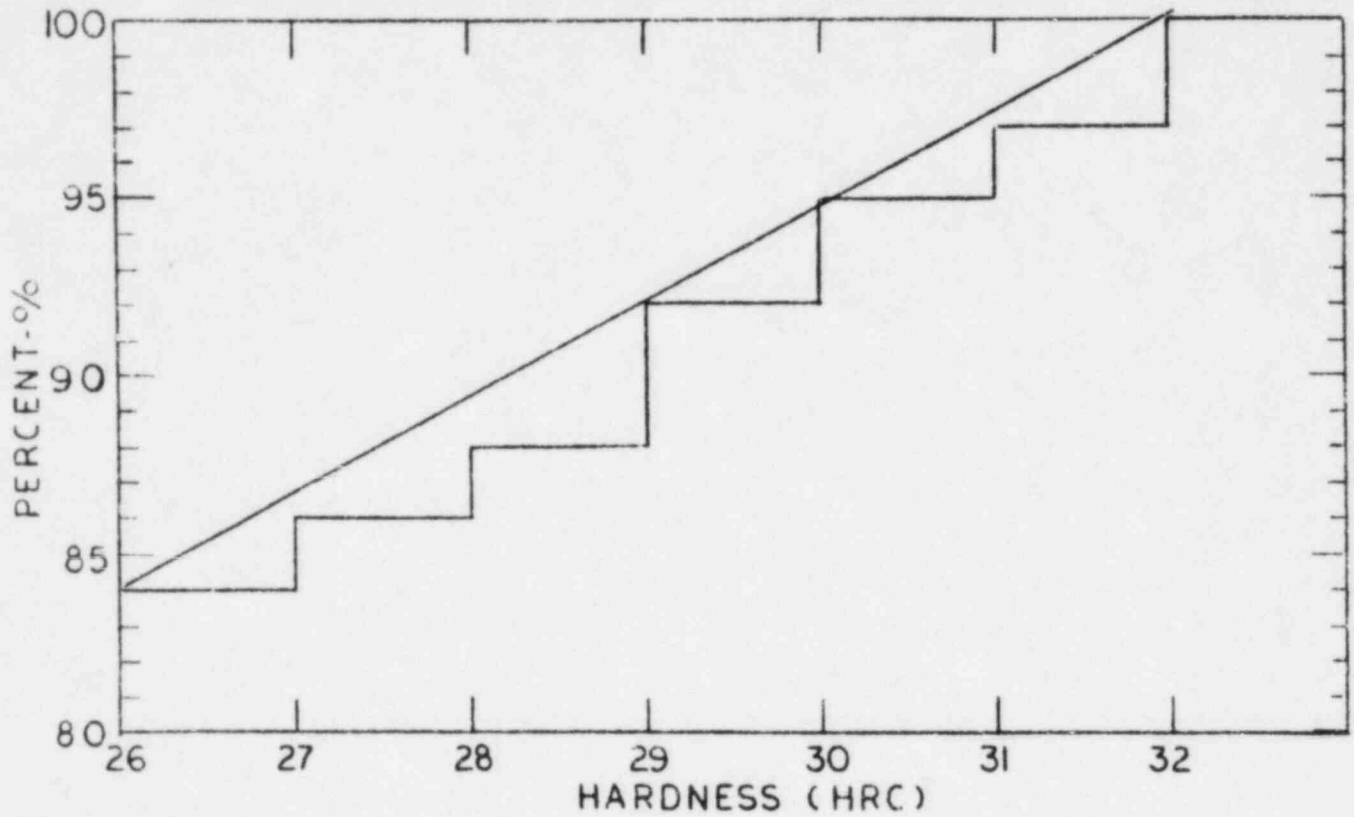
FIGURE 6

ALLOWABLE LOADS IN TERMS OF PERCENT OF ACCEPTABLE
LOAD AT HRC-32 BASED ON STRENGTH REDUCTION AT
REDUCED HARDNESS
