TEST OF THE INTEGRATED CONTROL SYSTEM AT
DAVIS-BESSE NUCLEAR POWER STATION TO DETERMINE
THE ICS RESPONSE WHEN POWER IS LOST AND
SUBSEQUENTLY RESTORED.

ICS LOSS AND RESTORATION OF POWER (TP 851.28)

SUMMARY OF TEST RESULTS

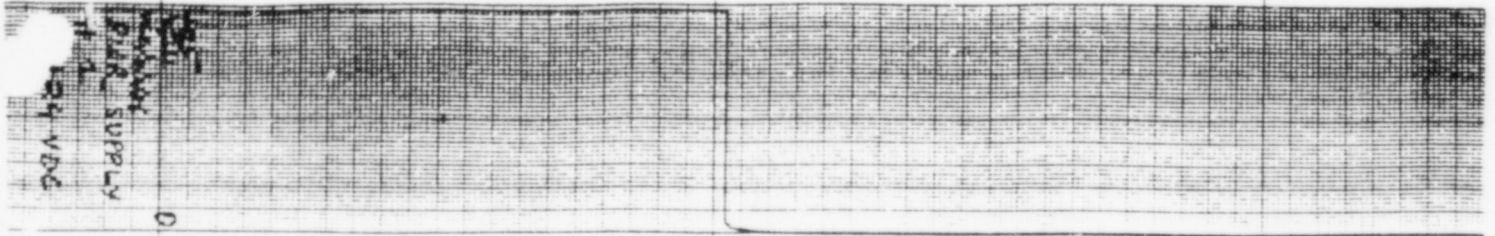
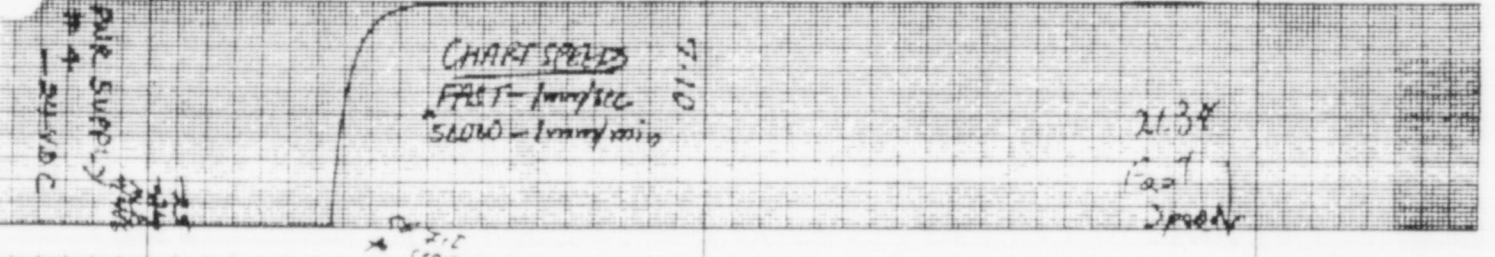
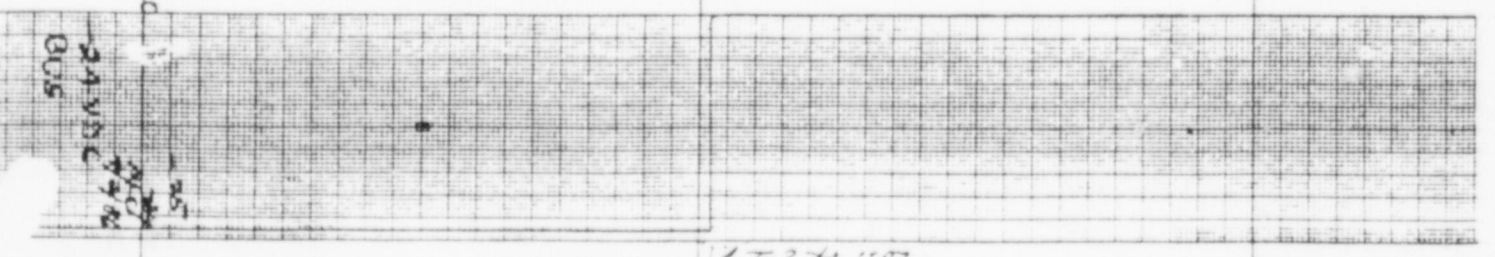
7.10 - Loss of AC Power (80%)
 Time - 21:16 Date 3/17/86

1. Upon loss of AC power, the H/A stations for main and startup feedwater valves and the turbine bypass valves failed to 50% position.
2. Observation at the gauges indicated a pressure of approximately 9 psig for the main and startup feedwater valves which was in agreement with the 50% position on the H/A stations. However, gauges for the turbine bypass valves indicated 0 psig to the valve positioners which verified the proper operation of solenoid valves SV SP13A1 through B3 to close the valves on loss of power.

5. Observations at the gauges located at the valves showed instantaneous change in the readings which leads to the conclusion that E/P converters do not wander around upon loss of AC power.

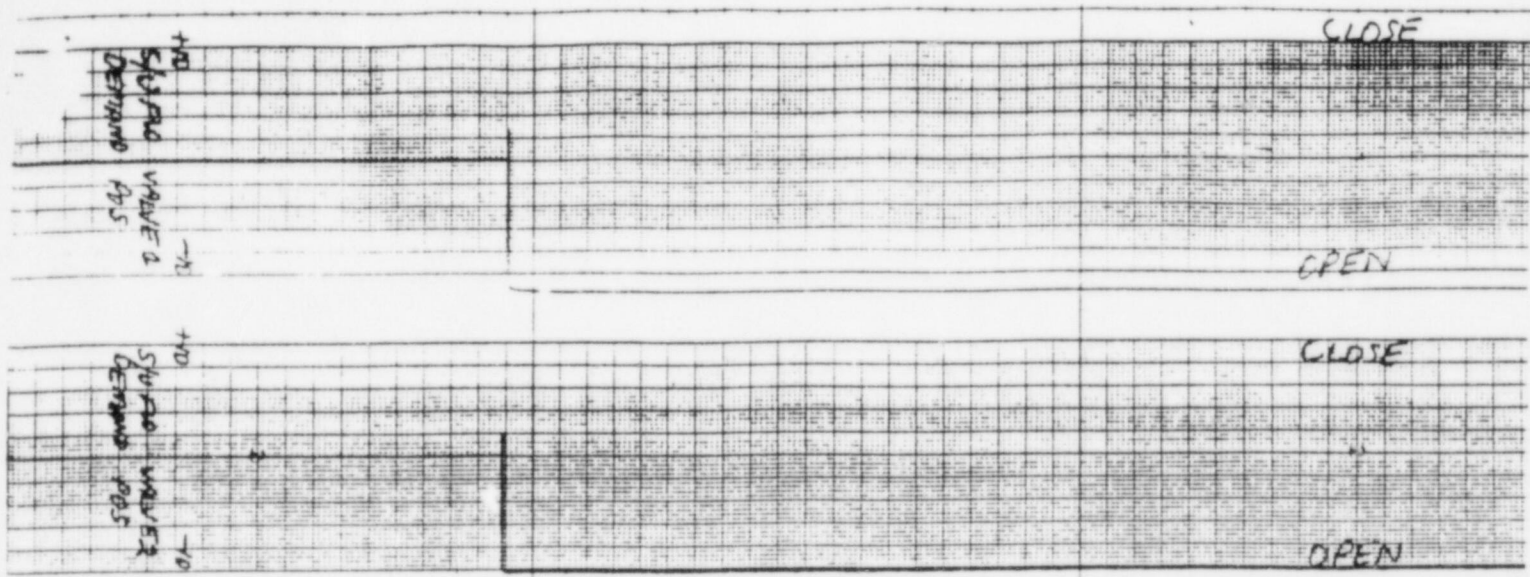
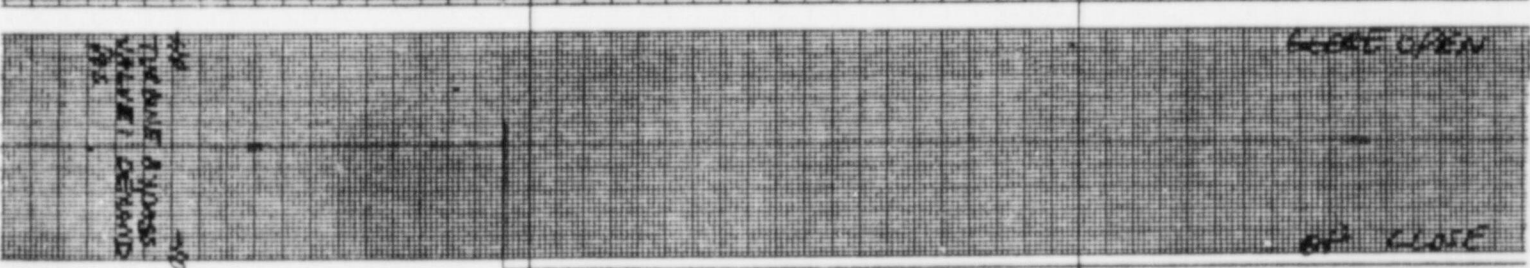
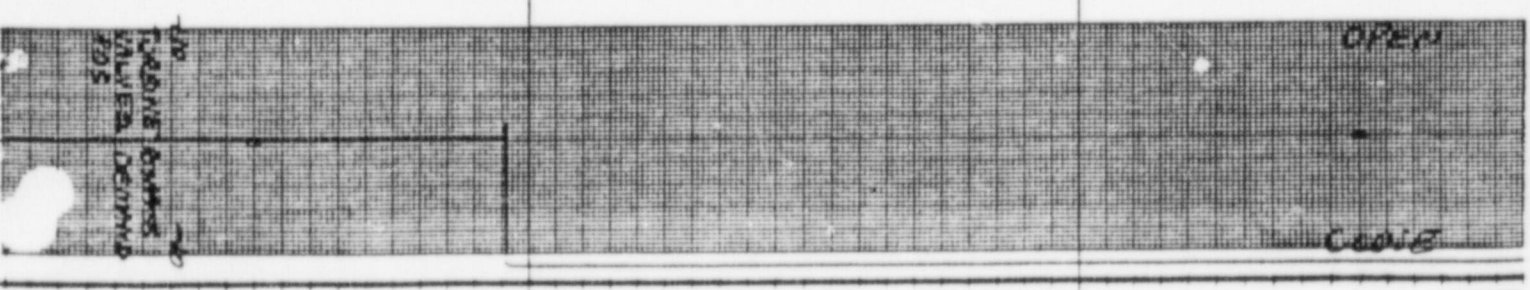
7.11 - RESTORATION OF AC POWER (80%)
 TIME - 21:36 DATE: 3-17-86

3. Upon restoration of AC power, the H/A stations for main and startup feedwater valves returned to 100% position whereas the turbine bypass valves H/A stations returned to 0%. The 100% position on the main and startup feedwater valves and 0% on the turbine bypass valves were -10 VDC out of the analog memory modules.

6. The outputs of the memory modules overshoot before settling to the final position. The amount and direction of overshoot varies in each case but the settling time is ≤ 5 seconds. However, the effect of this overshooting will not be seen by the valves due to the slow response time of the valves. The valves will follow a gradual transition from the initial to the final position.

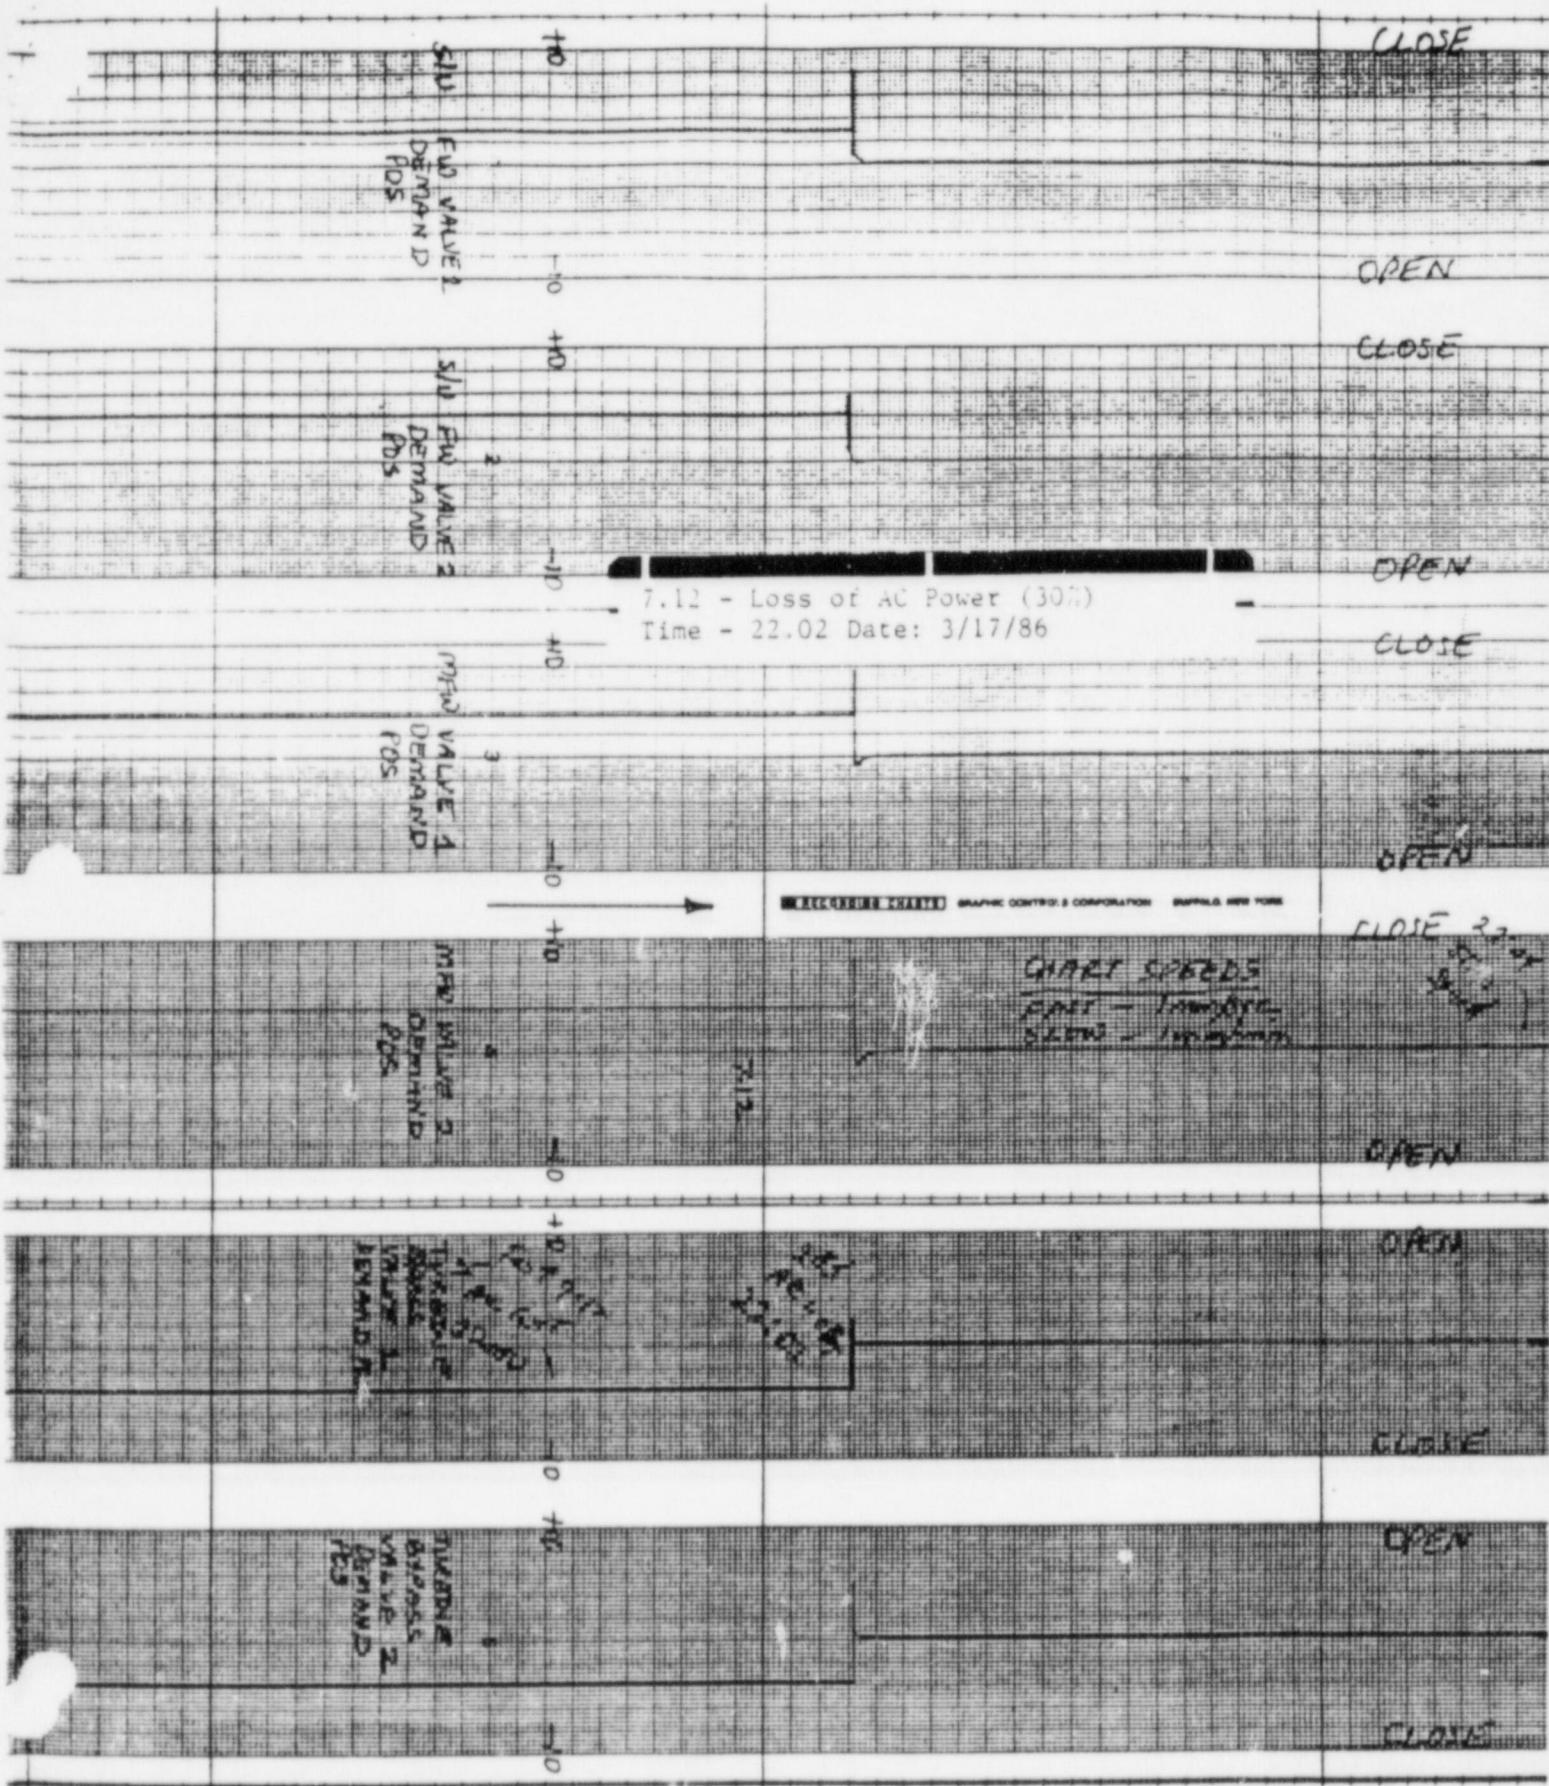
7.12 - Loss of AC Power (30%)
Time - 22:02 Date 03/17/86

22:02
2nd AC Lost

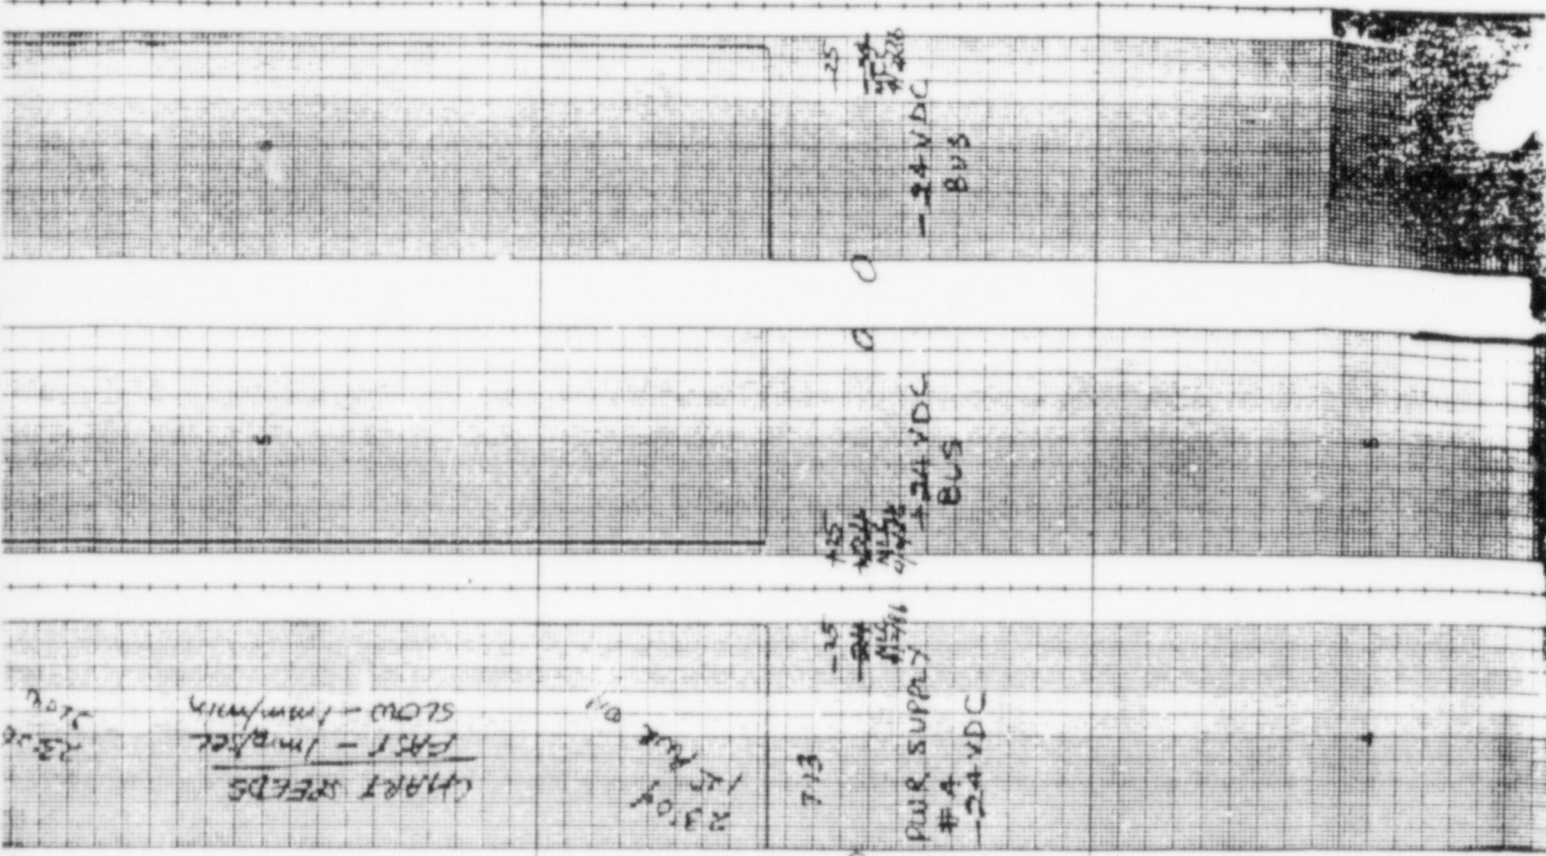
7.13 - Restoration of AC Power (30%)
Time - 23:04
Date: 03/17/86

7.13 23:05

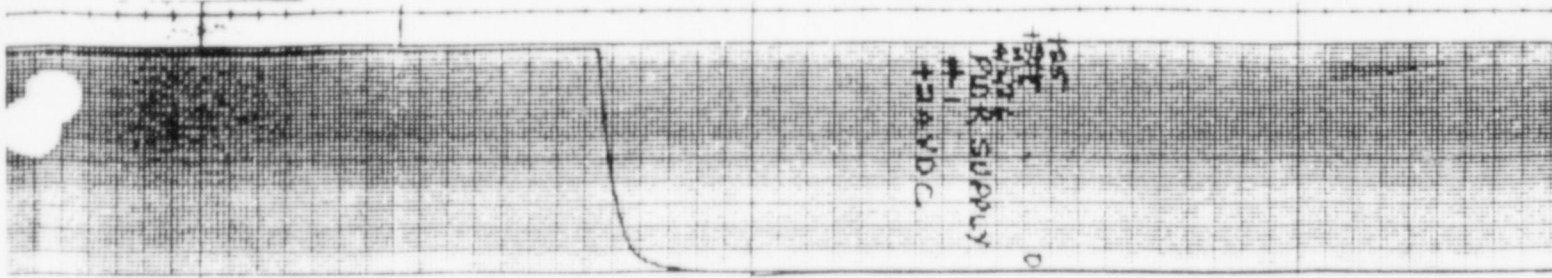
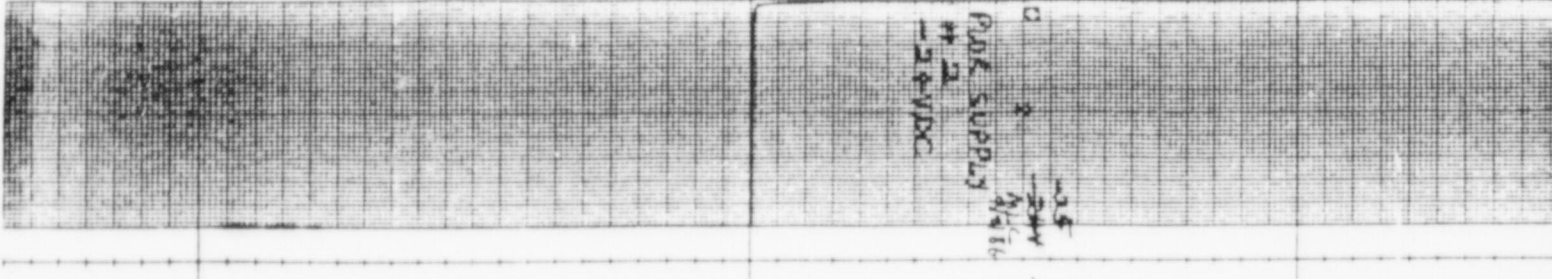
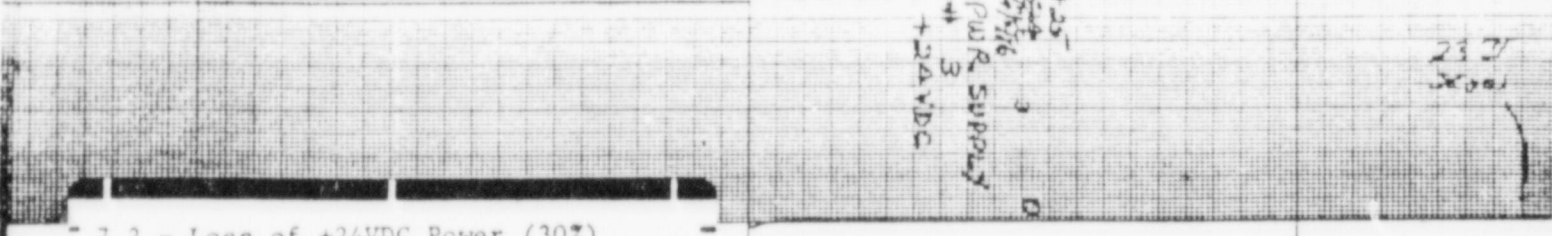
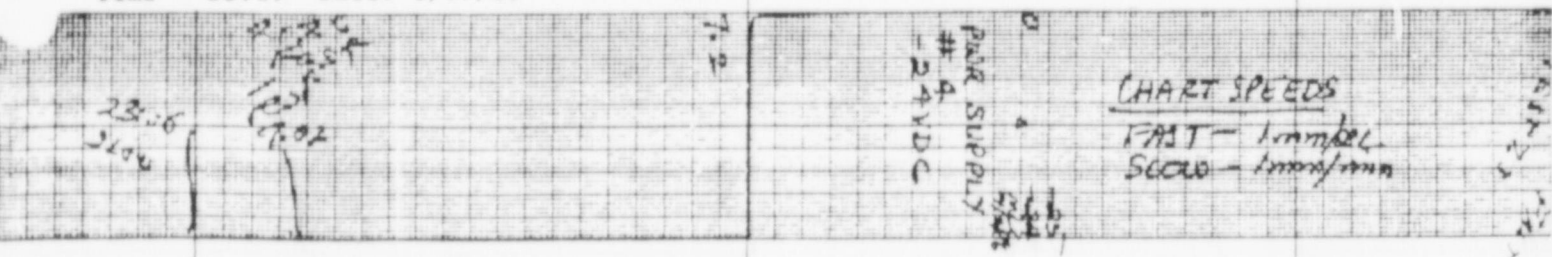
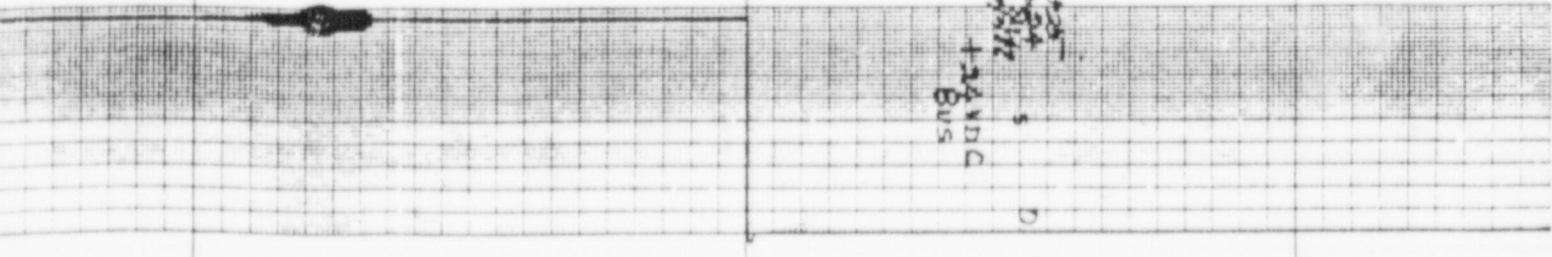
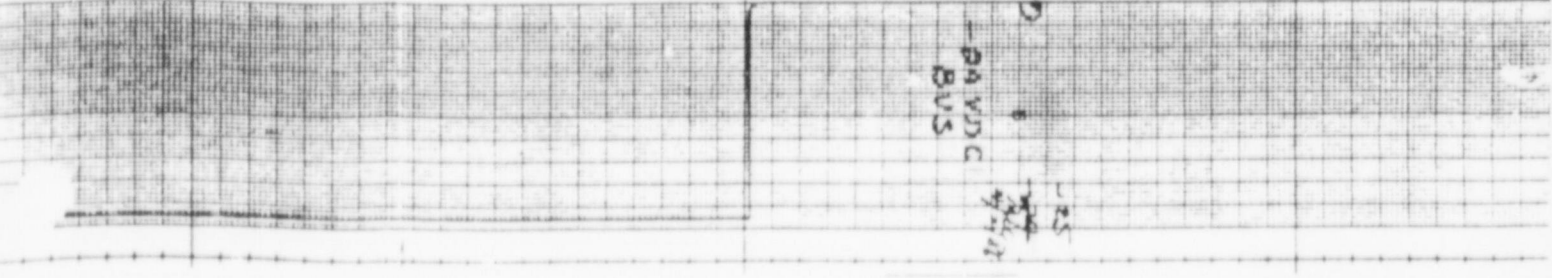
7.2 - Loss of +24VDC Power (30%)
Time - 23.29 Date: 3/17/86

1. The H/A stations failed to 50% in all cases of loss of DC power except for the H/A stations for atmospheric vent valves remained at their original settings. The atmospheric vent valve H/A stations are AC supplied RU6000 control stations which are different from the other regular H/A stations.

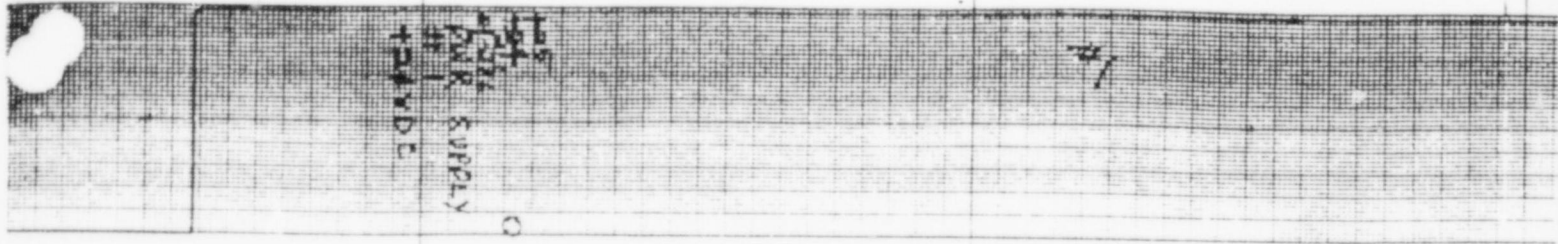
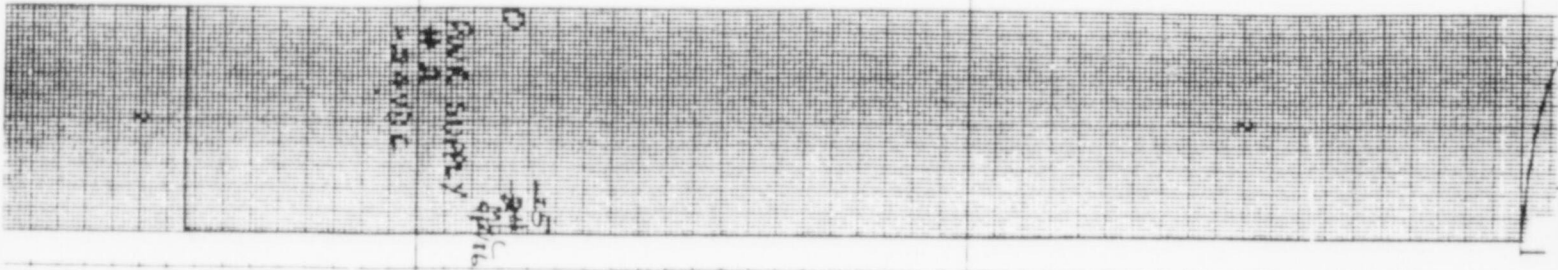
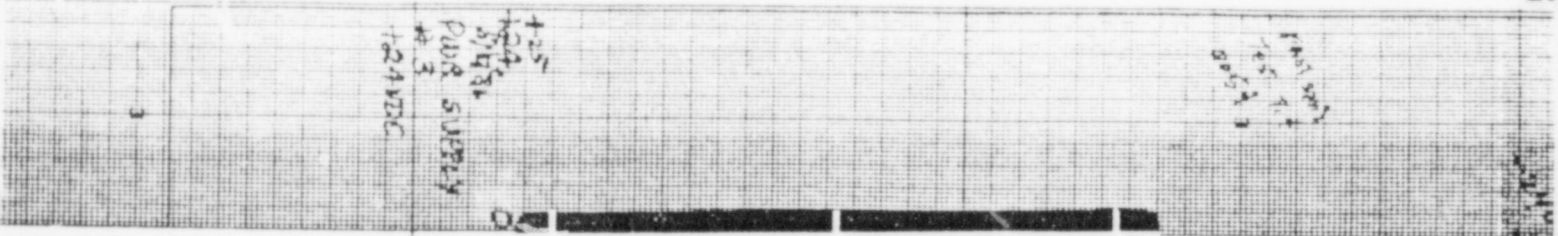
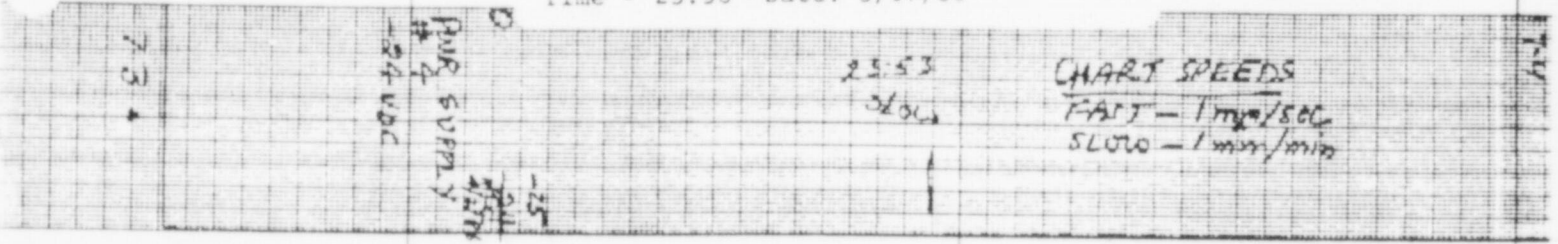
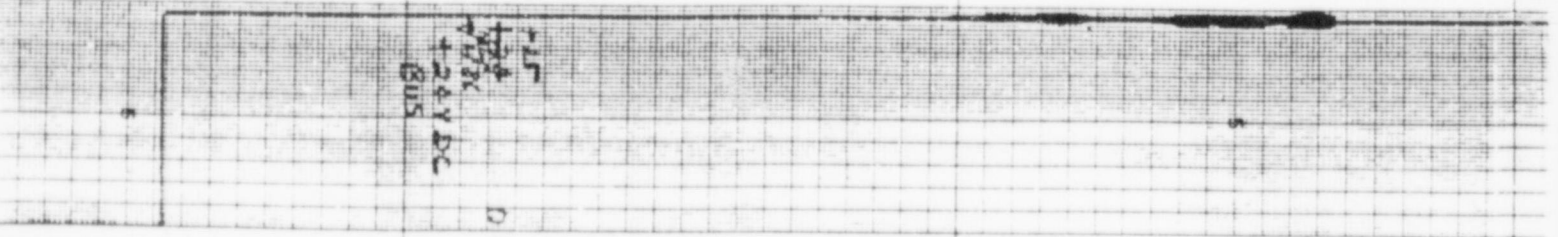
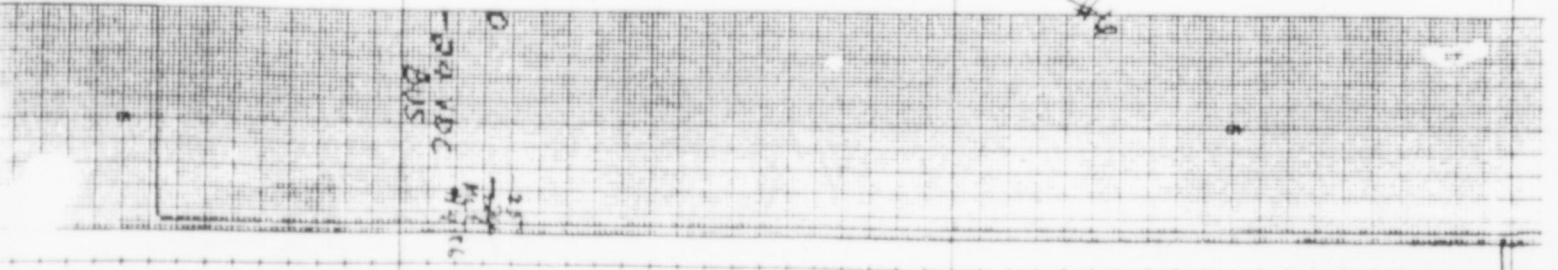
7.3 - Restoration of +24VDC Power (30%)
Time - 23:50 Date: 3/17/86

3. Upon restoration of DC power, in all cases, the H/A stations for startup and main feedwater valves went to 100%, the atmospheric vent valves remained at the initial settings; whereas, the remaining H/A stations went to 0%.

5. The outputs of the memory modules overshoot in a similar manner to the loss of AC power. However, the settling to the final position took between 8-20 seconds. In these cases, also, the valves would follow a gradual transition to the final position due to the slow response time of the valves.
