**Appendix D.5 – Cultural and Historic Investigation and Evaluation Jewell
Watershed Dam Sites #1, #2, #3 and #5
Supplemental Watershed plan and Environmental Assessment**

ARCHEOLOGICAL RESOURCE ASSESSMENT

Jewell Brook Watershed Sites 1, 2, 3 & 5

Jewell Brook Watershed, Sites 1, 2, 3 and 5, Town of Ludlow, Windsor County, Vermont
 Phase IA Archeological Assessment

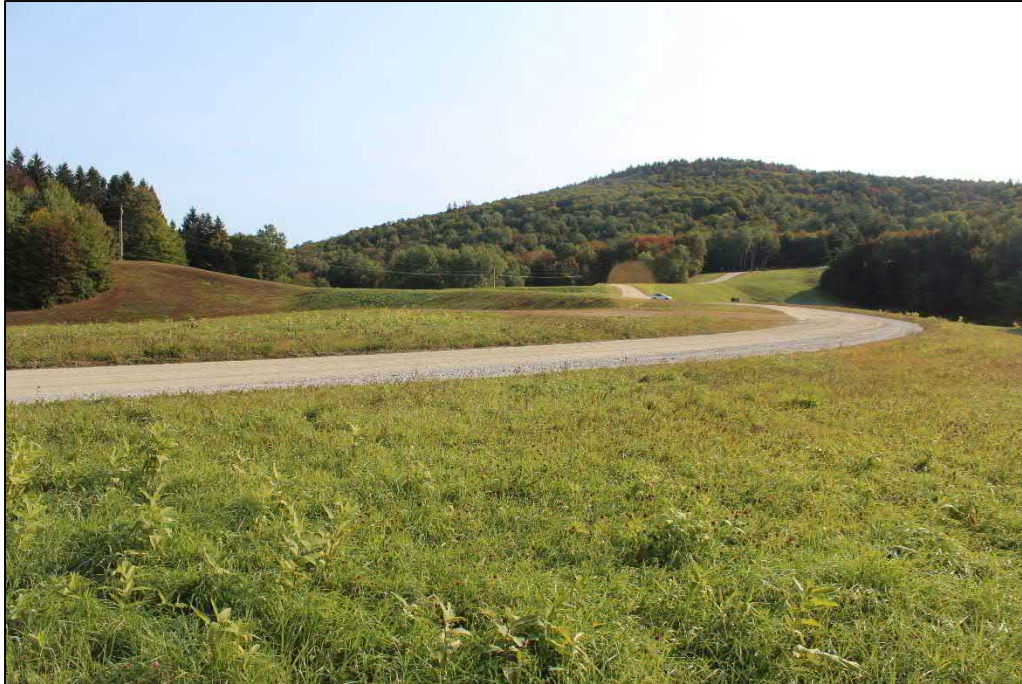
Photo 1. Site 1. Note heavily modified landscape. View to the east.

Site 1 is on a relatively broad area with steep slopes up to Route 100 to the east and more varied topography extending to the north, south and west surrounding the reservoir, beyond which the landscape slopes down to the north and up steeply to the west and south (Photos 1 and 2). The reservoir, built in 1966, is held back by a large earthen embankment along the north side of the reservoir with the water returning to Jewell Brook to the north of the embankment through a toe drain. A road is located on top of the embankment to provide access to properties to the west of the reservoir. In order for this facility to be constructed, the alignment of Route 100 was shifted to the east to its present location. The former alignment of Route 100, now known as Wright Road south of the reservoir and Brooks Road to the north, extends north and south of the reservoir, but a section was flooded by the reservoir. A secondary spillway is located west of the reservoir, extending in a northern direction to pass below and west of the State Register listed 1830 Joseph Harris Farm (VHSSS #1410-89). Wooded areas are present around much of the edges of the APE. To the east of the reservoir a steep wooded slope rises to Route 100. There are wooded areas along most of the north side of the APE that generally slope down to the north. A small wooded area in the southwest corner of the APE retains some level terraces with intact soil stratigraphy with a small dried up beaver pond and some wet areas at the base of those terraces.

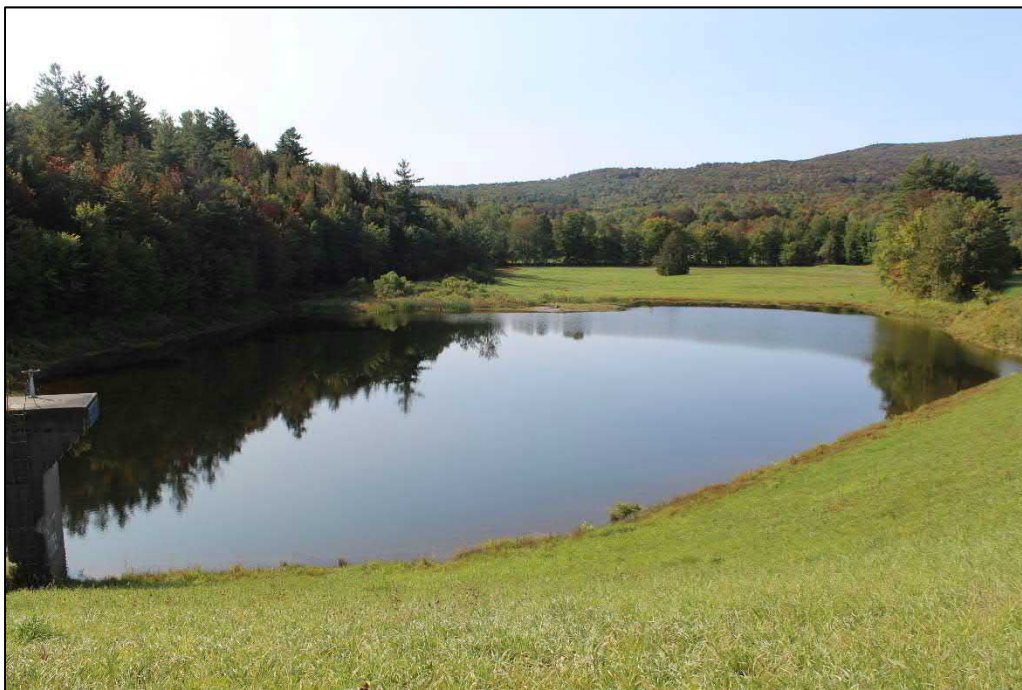
Photo 2. Site 1, existing reservoir in area of the farmstead and schoolhouse. View to the south.

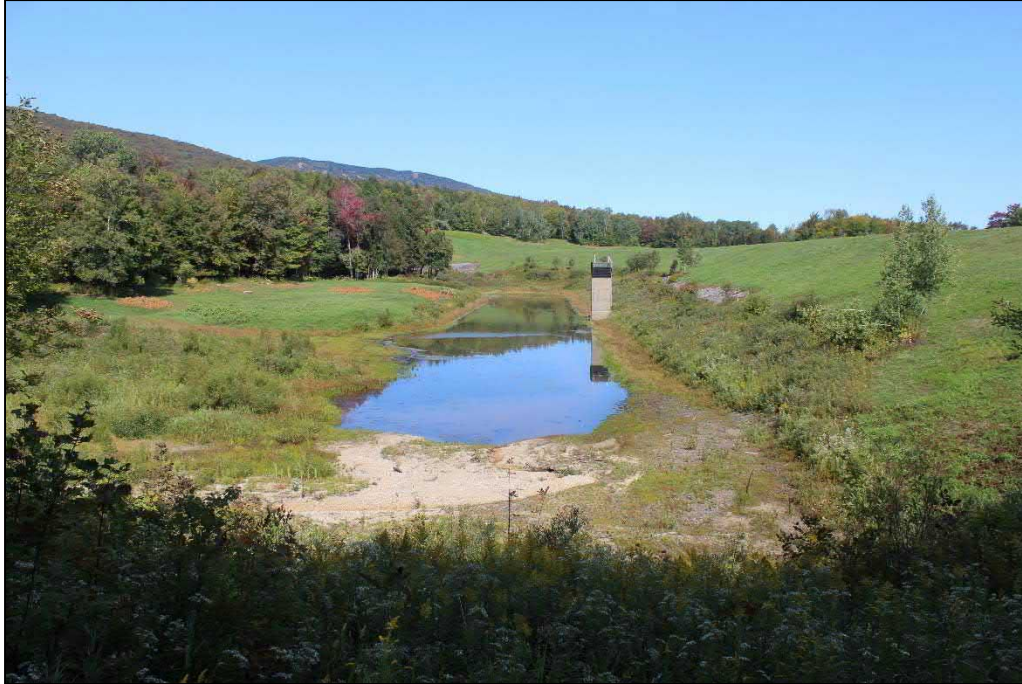
Photo 3. Site 2, overview of reservoir and dam to the right. View to the north.

Site 2 is located directly north of Site 1, but is oriented perpendicular to Grant Brook that flows from the west toward Jewell Brook to the east (Photo 3). The site was constructed in 1969, according to a plaque at the entrance to the site. The reservoir is a long narrow body of water behind the dam that rises to the east, with a relatively small open area around the dam. A secondary spillway curves around the north end of the dam in a broad swath. As with Site 1, construction at Site 2 removed a section of a 19th-century road from use, creating Snell Spring Road to the east and Site 1 Road to the west, on each side of the south end of the reservoir.

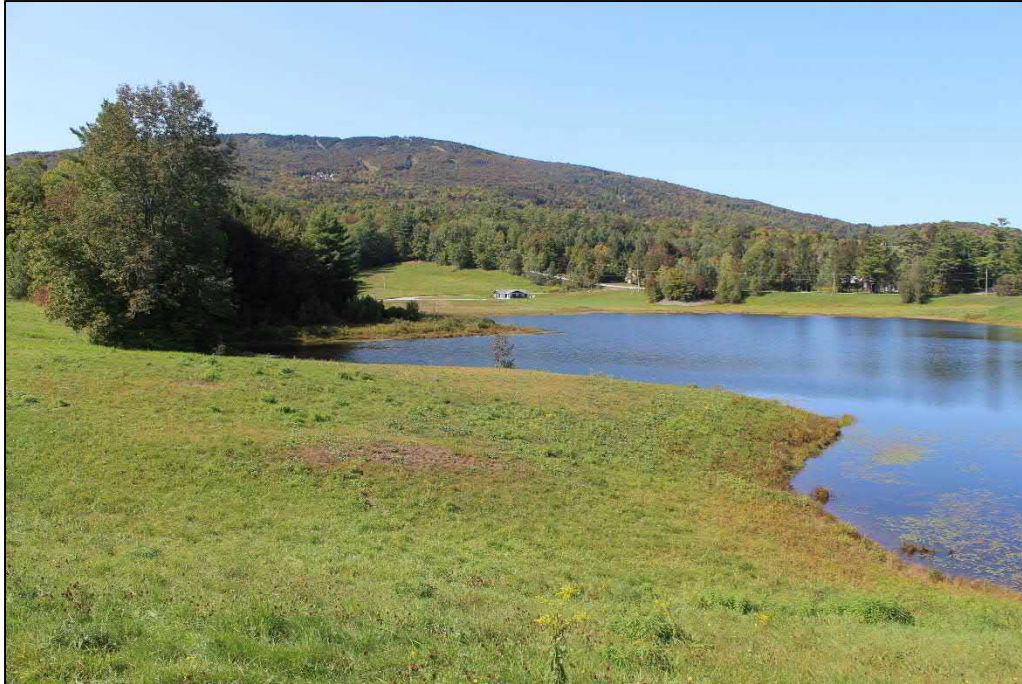
Photo 4. Site 3, note wooded area on the left with recreation area in the center background. View to the northwest.

Site 3 is located adjacent to the south side of West Hill Road and hosts the West Hill Recreation Area (Photo 4). The reservoir is used for swimming and fishing, there are basketball courts, picnic pavilion, hiking trails and other facilities. Hiking trails run around the reservoir through wooded and open areas. The dam is located along the northeast side of the reservoir with two small drainages flowing into the area from the west. Most of the area is surrounded by open fields, largely modified during construction of the facility. However, the southwest area of the APE is wooded around the drainages that feed the reservoir.

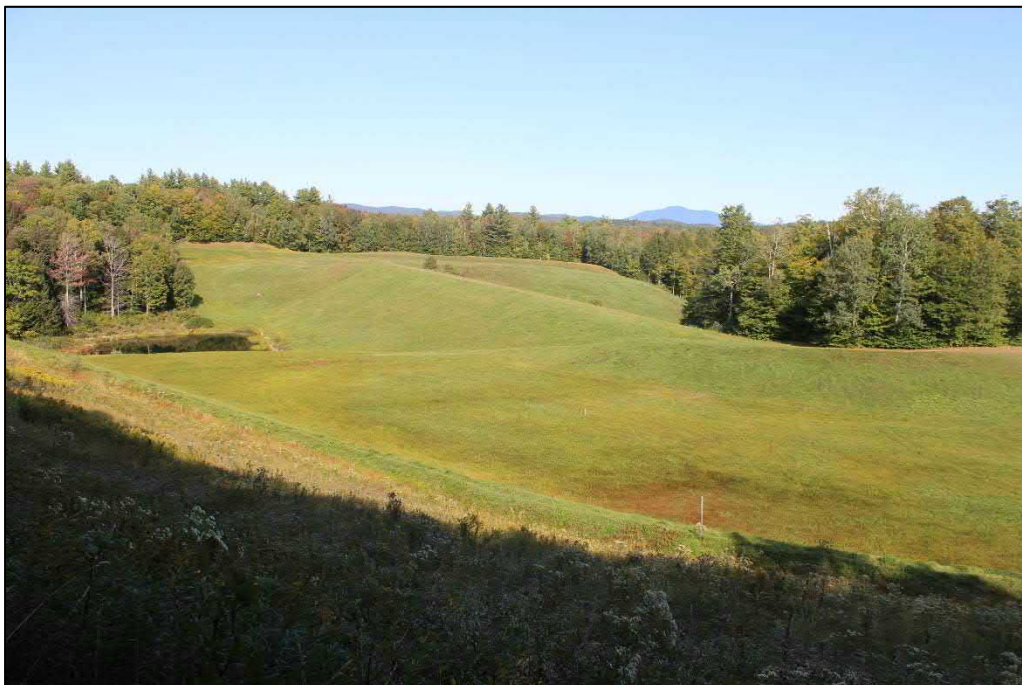
Photo 5. Site 5, note heavily modified landscape. View to the northwest.

Site 5 is located south of Site 3, along Sanders Brook (Photo 5). It consists of a small reservoir surrounded by a monumental dam to the northeast and two secondary spillways to the northwest and southeast. Most of the periphery of the APE is wooded with outlet channel being in a generally cleared corridor. Most of the wooded areas around the edges of the APE are fairly level or gently sloped while the two sides of Sanders Brook upstream of the reservoir form steep drops to the brook before it enters the reservoir. A steeply sloped landform near the center of the APE is also wooded.

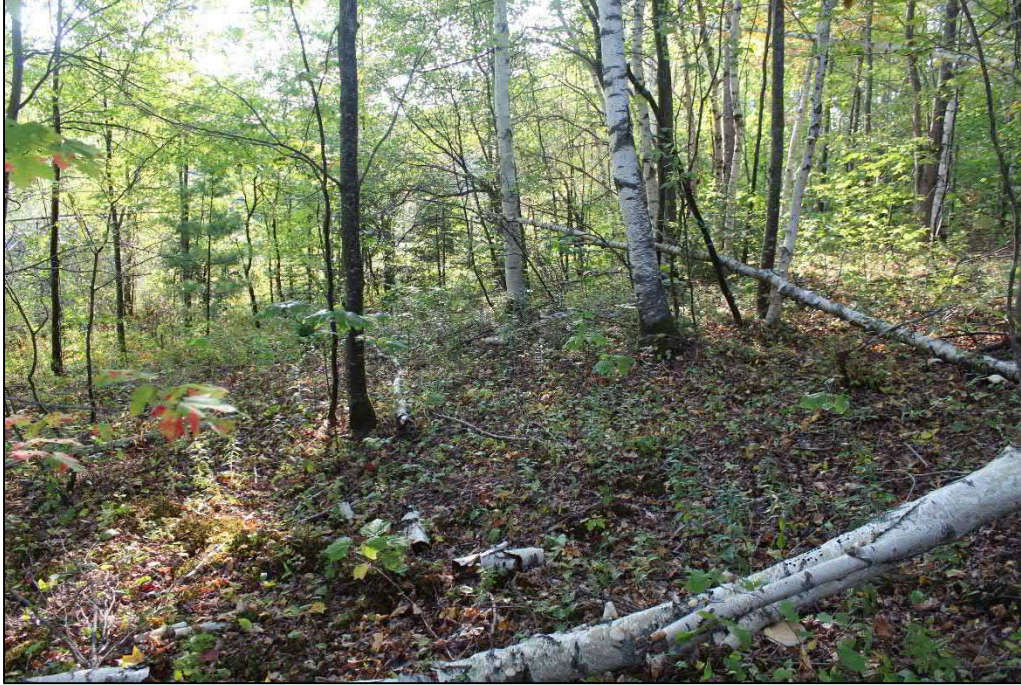
Photo 6. Site 1, ASA 1, terrace overlooking wetland. View to the southeast.

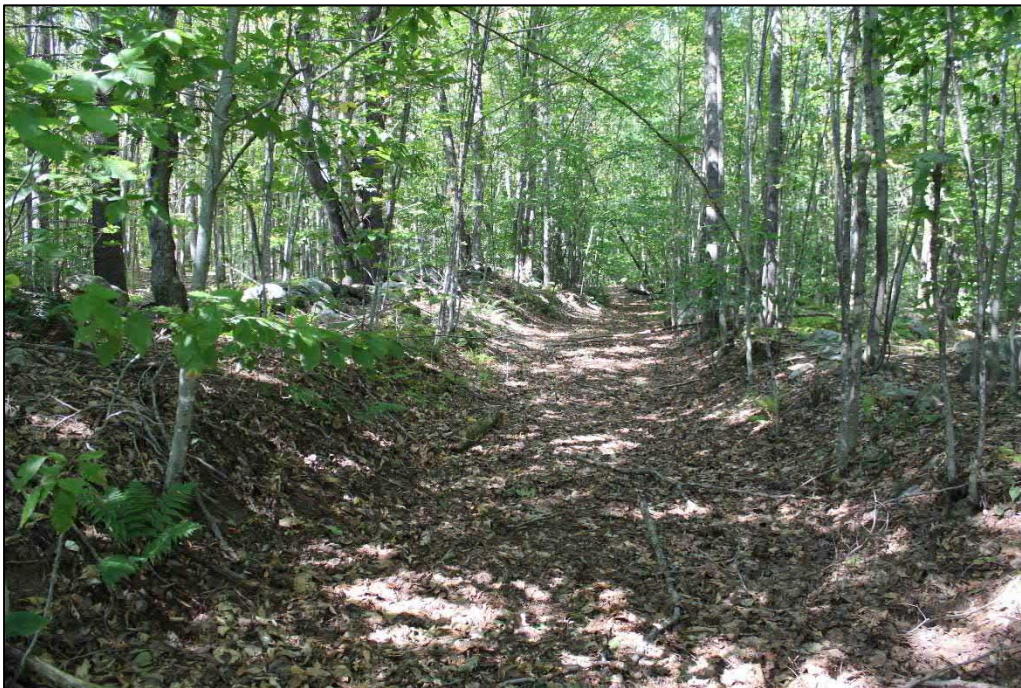
Photo 7. Site 2, old road bed extending west from the APE. Level terrain of ASA 2 is located to the right. View to the west.

The Site 2 archeological potential is includes ASA 2 to the west side of the APE north of an old road bed (Map 2b; Photo 7). This area becomes increasingly broken up and undulating to the north, but retains potential for precontact and historic archeology. In addition, the concrete water supply channel in the east side of the APE is an archeological feature designated ASA 3 (Photo 8). Elsewhere in the APE is heavily disturbed or sloped.

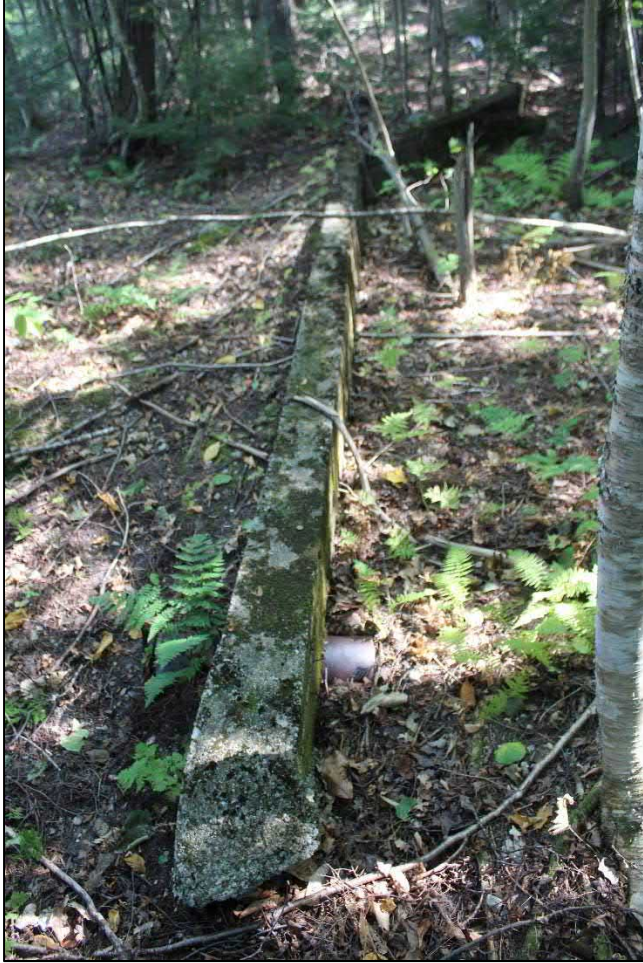
Photo 8. Site 2, water supply channel (ASA 3) adjacent to south side of entrance road. View to the east.

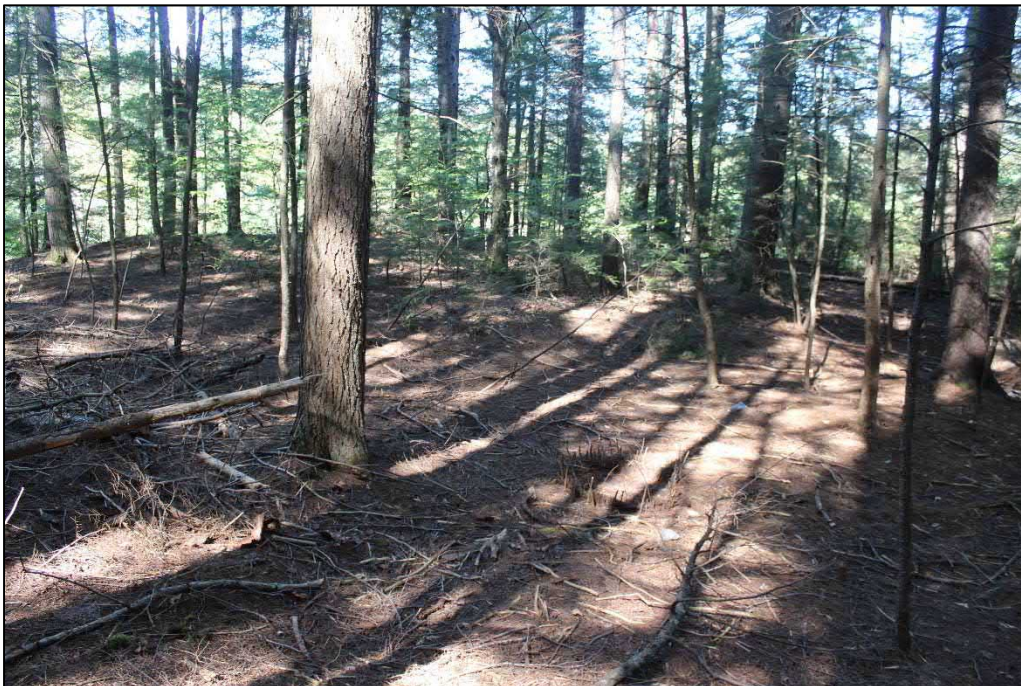
Photo 9. Site 3, ASA 4 terrace along brook and reservoir. View to the east.

Site 3 retains precontact archeological potential in two locations along the southwest side of the APE (Map 2c). At the south end of the recreation area there is a trail that enters a wooded area (ASA 4; Photo 9). Level topography on either side of the drainage through that area is sensitive for precontact sites. On a terrace overlooking the former course of the drainage that is dammed by the project is another area of archeological potential (ASA 5; Photo 10). Otherwise, the APE is either heavily disturbed or sloped.

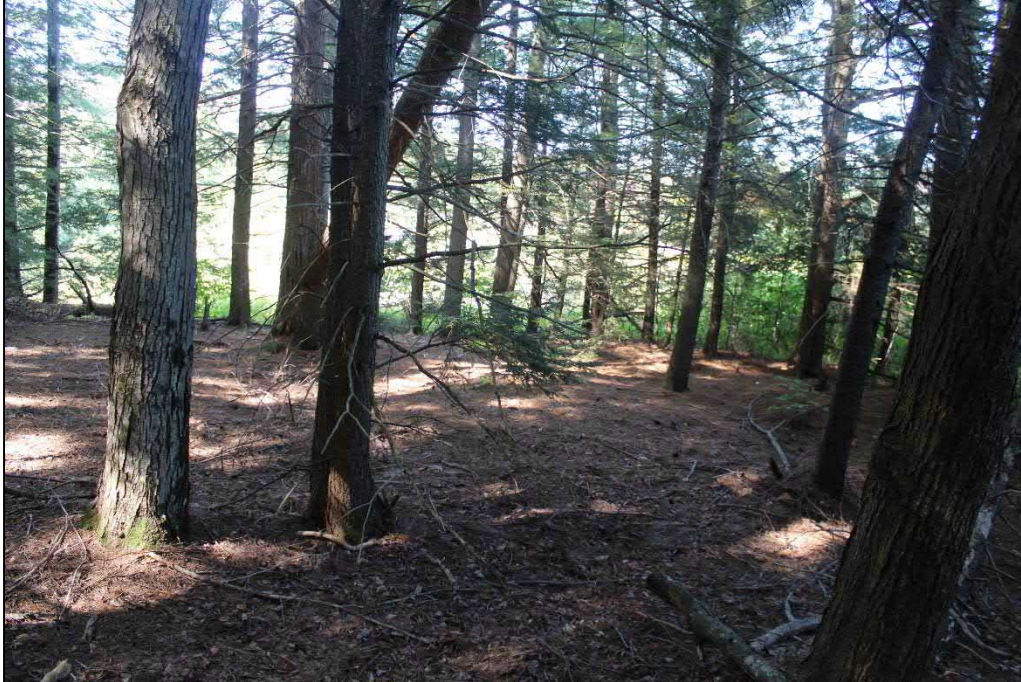
Photo 10. Site 3, ASA 5, terrace overlooking reservoir and former brook channel. View to the north.

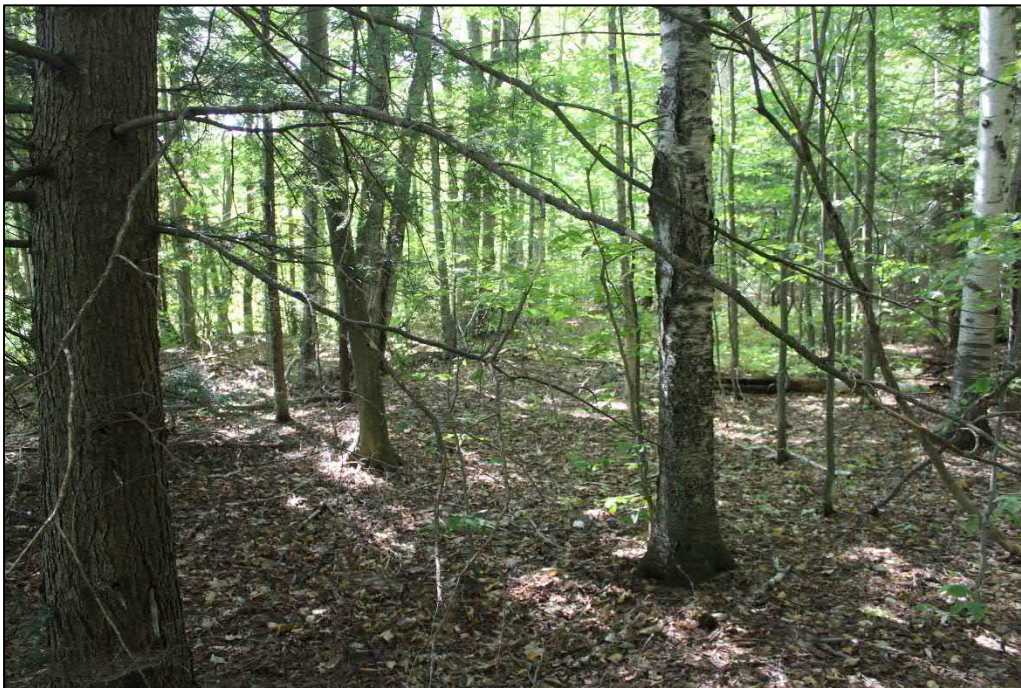
Photo 11. Site 5, ASA 6 on either side of West Hill Road where it meets the project. View to the south.

Site 5 is located in an area of generally steep topography that has been heavily modified by the project. However, a few areas of level terrain are found in wooded areas around the south, east and west edges of the APE (Map 2d). These areas are located high above the former brook course (ASA 6 and 7; Photos 11 and 12) and may have been sites of precontact occupation.

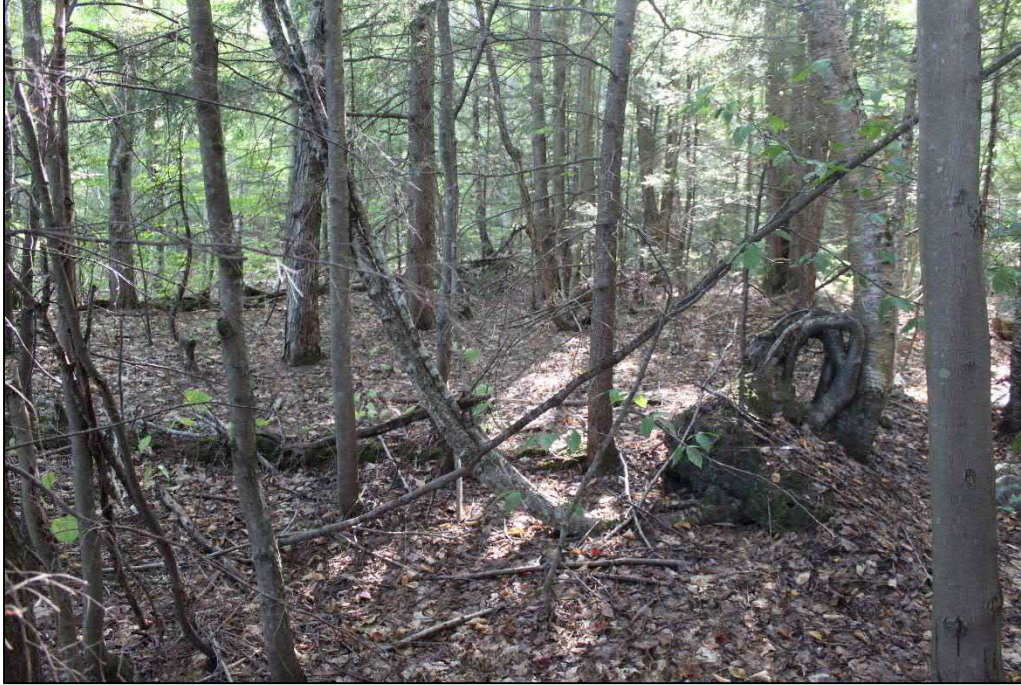
Photo 12. Site 5, ASA 7 on the south side of the APE. View to the southeast.

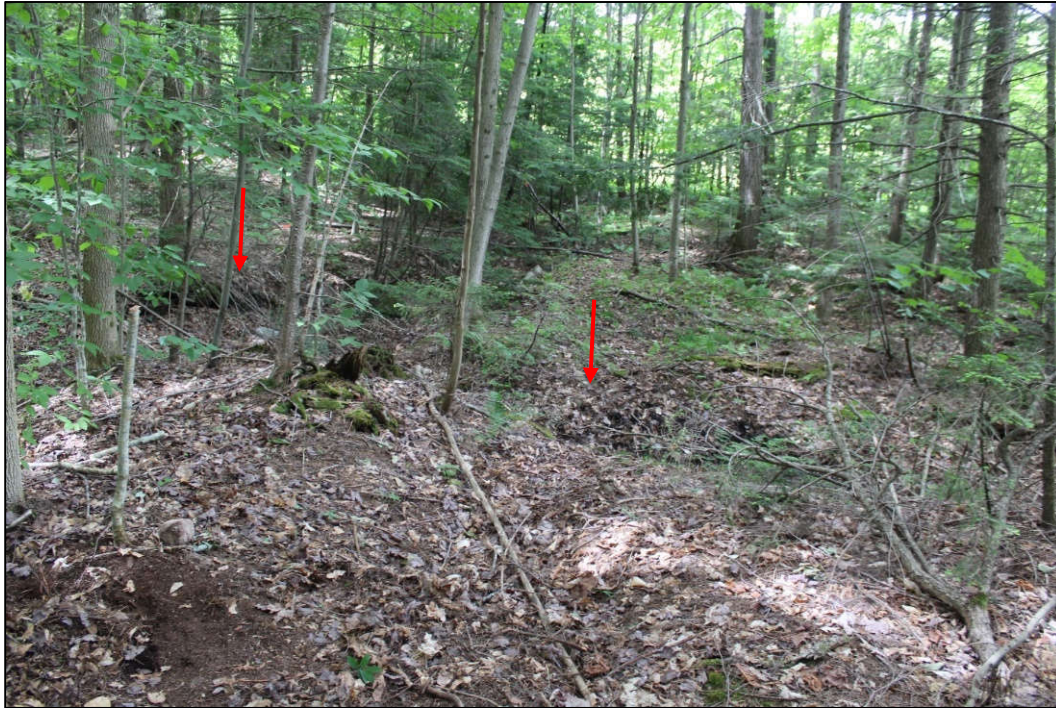
Photo 1. Dam 2, ASA 3. Note ditches associated with the early 20th-century town water system (red arrows). The concrete wall is located along the right side of the ditch that runs from middle left to upper center. A ditch that runs from left to right appears to be an overflow drainage. View to the west.

ASA 3 is currently heavily wooded with extensive disturbance related to construction of the early 20th-century water system features noted during ARA site visit (Photo 1; Map 2a). There are several areas of saturated soil due to the springs that flow from the hill to the west. Those water sources were directed to these features to collect water for the town water system.

According to Chuck Craig of the Town of Ludlow (personal communication, 2022-07-01), the features identified at ASA 3 are part of an extensive water collection system that the town relied on for its sole water source from the early 20th century until Dam #2 was constructed c. 1967. The system consisted of pipes drawing water from small reservoirs and cisterns located along the foot of the slope southeast of the APE. A system of ditches (earthen and one with a concrete side) and pipes carried water from these features along the south side of Snell Spring Road to a small water treatment building (Photo 3) that once stood on the site of the current large water treatment plant (Photo 4). That original building was moved to the edge of the cleared area around the treatment plant and until recently was used for storage but is now deteriorating.

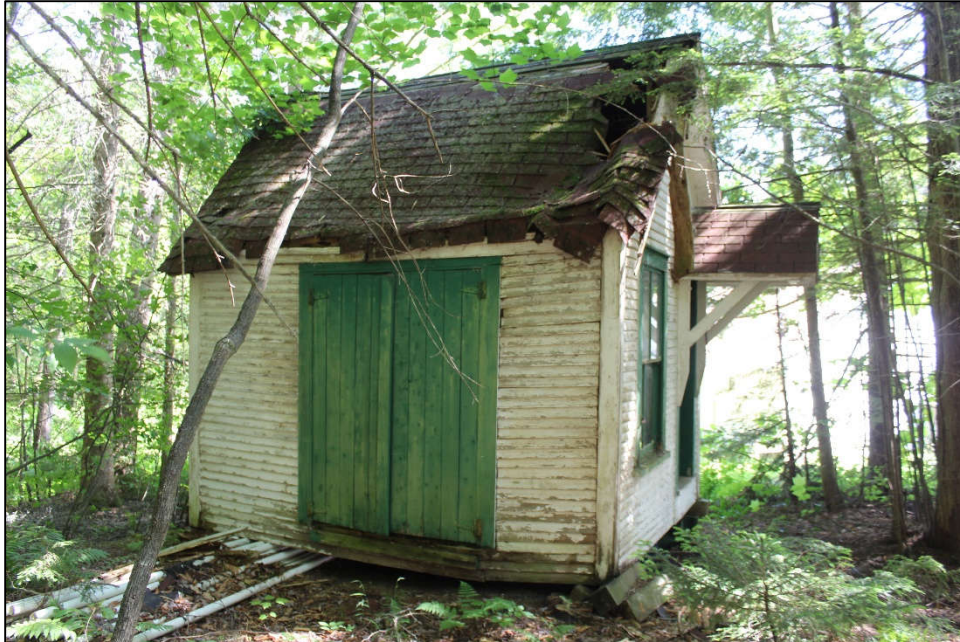
Photo 2. Dam 2, former water treatment building moved from its original location and used for storage, outside of the project APE. View to the northeast.

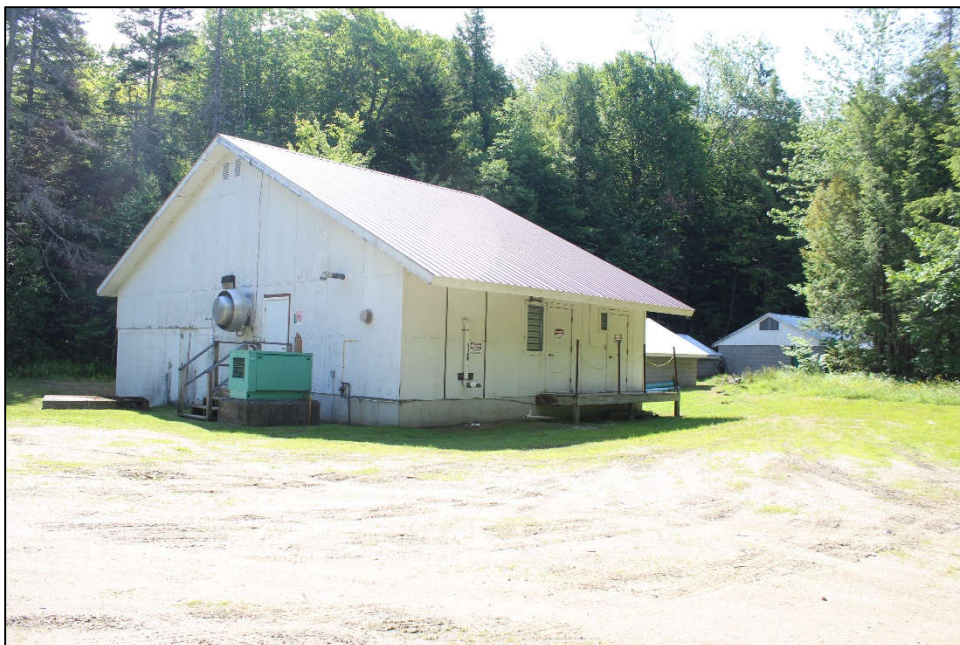
Photo 3. Dam 2, current water treatment plant and site of the original treatment building (on left side of photo), outside of the project APE. View to the southeast.

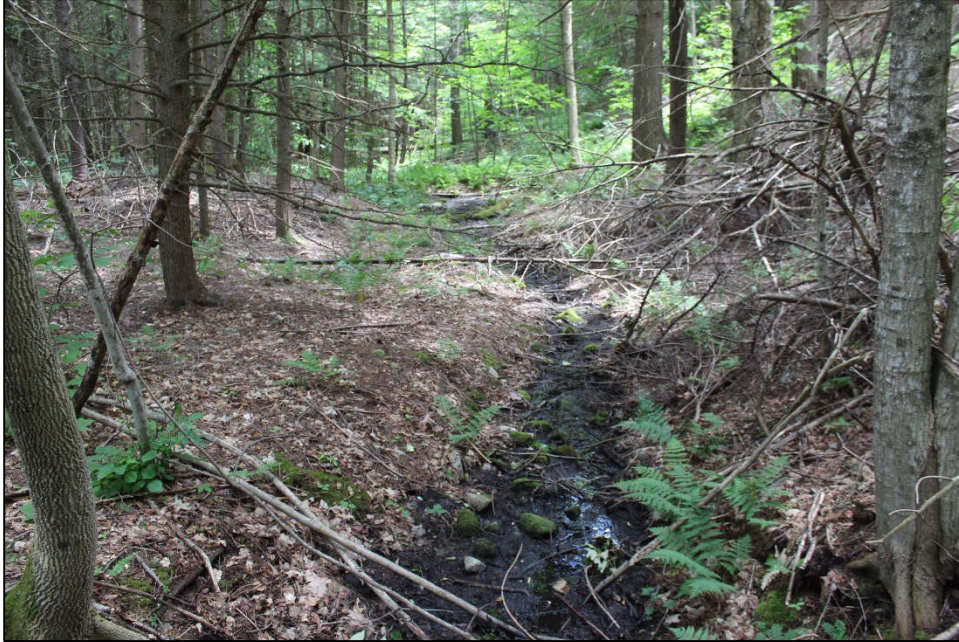
Photo 4. Dam 2, excavated ditch to direct surface water toward the water treatment facility, outside of project APE. View to the east.

During a site visit with Mr. Craig, many of the features of this system were examined, most located outside of the project APE. Within ASA 3, the features associated with this system include several ditches (Photo 4), the concrete wall along one of them (Photo 5), two alignments of 4-inch iron piping (Photos 6 and 7) and a small reservoir that overlaps the southwest corner of the ASA (Photo 8). That area was the subject of the Phase IB survey at Dam #2 and is illustrated on Map 2b.

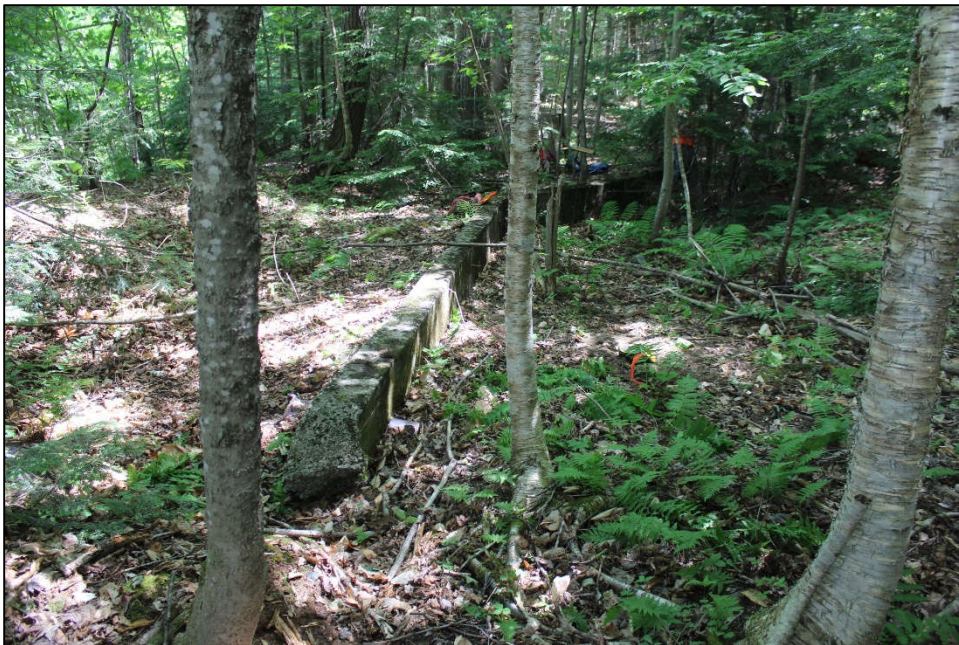
Photo 5. Dam 2, north end of ditch system with concrete wall forming the north side of this ditch, in the west end of the APE. View to the east.

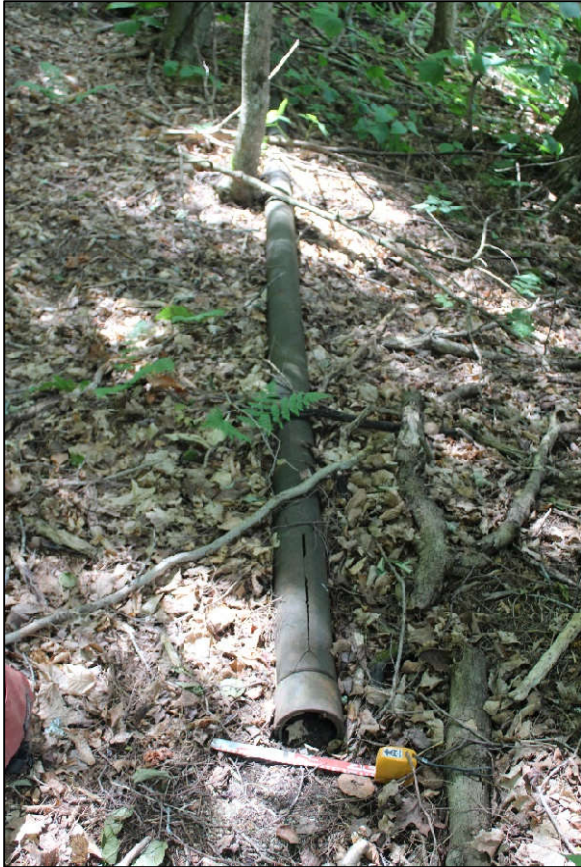
Photo 6. Dam 2, western pipe alignment between excavated reservoir and concrete wall, in the west end of the APE. View to the south.

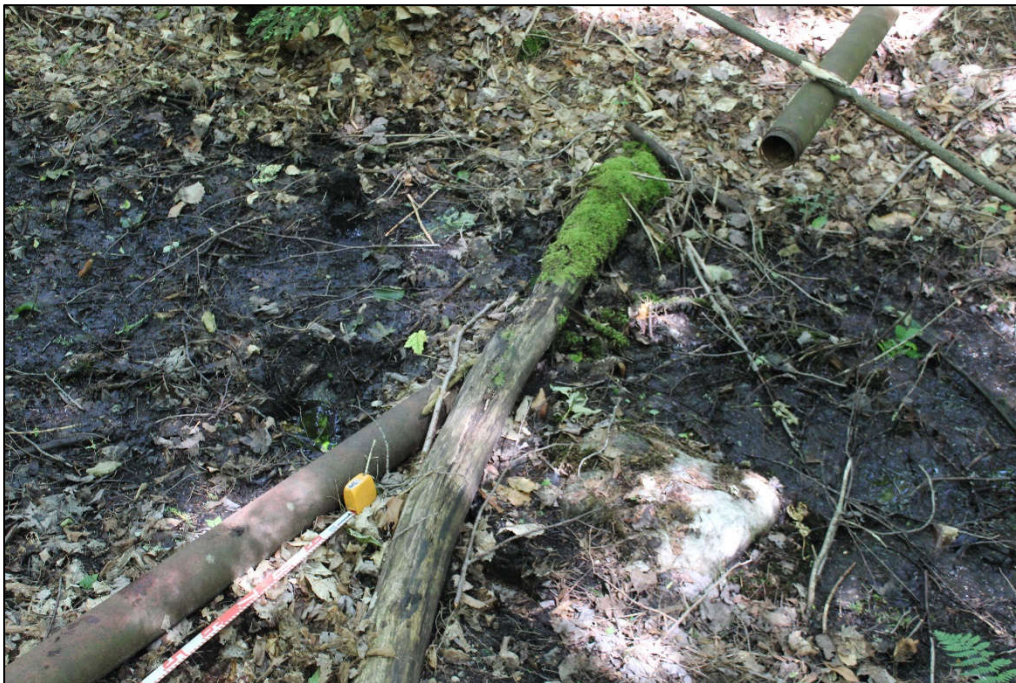
Photo 7. Dam 2, eastern pipe alignment crossing water collection ditch, in the east end of the APE. View to the south/southwest.

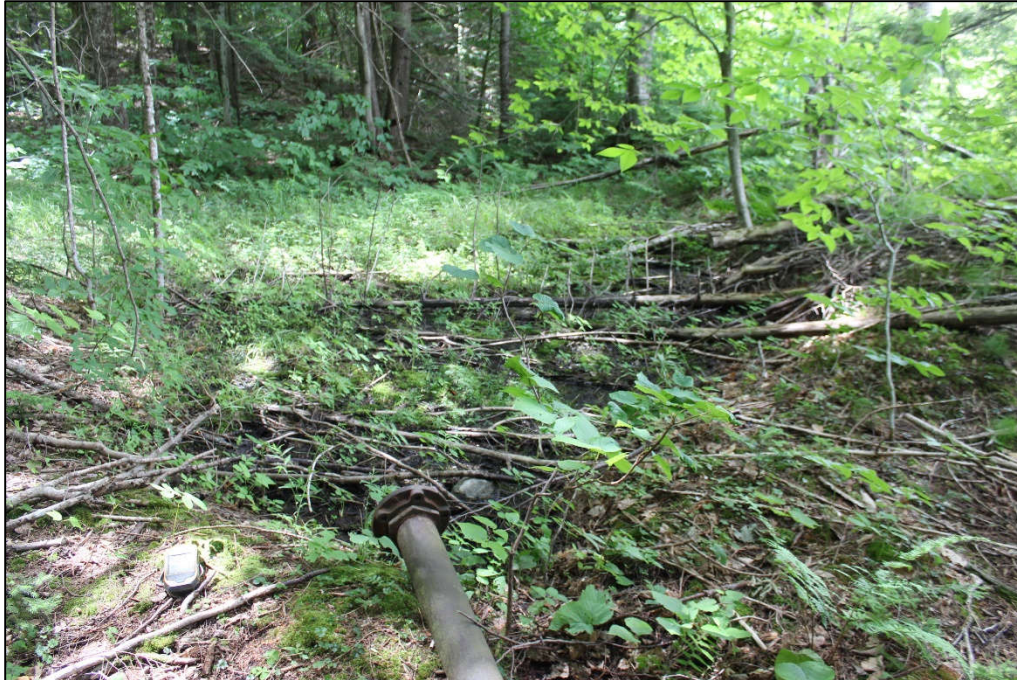
Photo 8. Dam 2, western pipe alignment end at small, excavated reservoir in the southwest corner of ASA 3. View to the southwest.

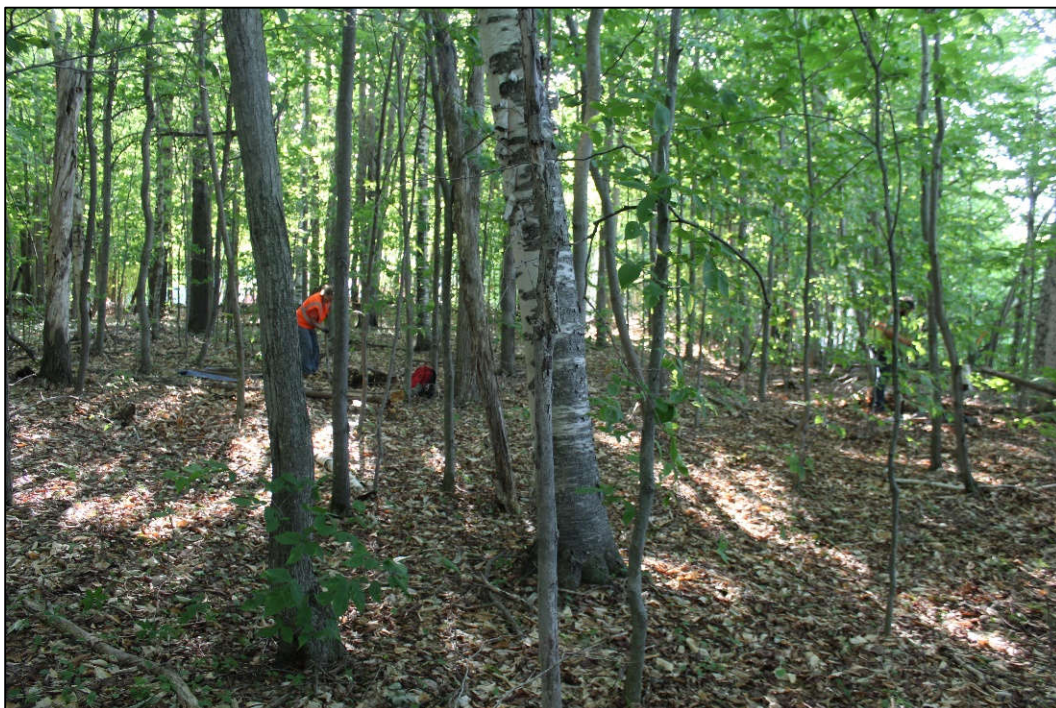
Photo 9. Dam 5, ASA 6. Note level portion of the APE to the left and gradual slope down to the clearing associated with the Dam 5 facility. View to the east.

ASA 6 is a broad wooded area overlooking the Sanders Brook drainage (Photo 9; Map 3). Prior to construction of the dam, Sanders Brook flowed through the area to the west and south of ASA 6 with a gradual slope separating ASA 6 from the edge of a terrace directly adjacent to the brook (Hartgen 2020:Appendix). West Hill Road provides access to the facility from the north, passing through ASA 6.

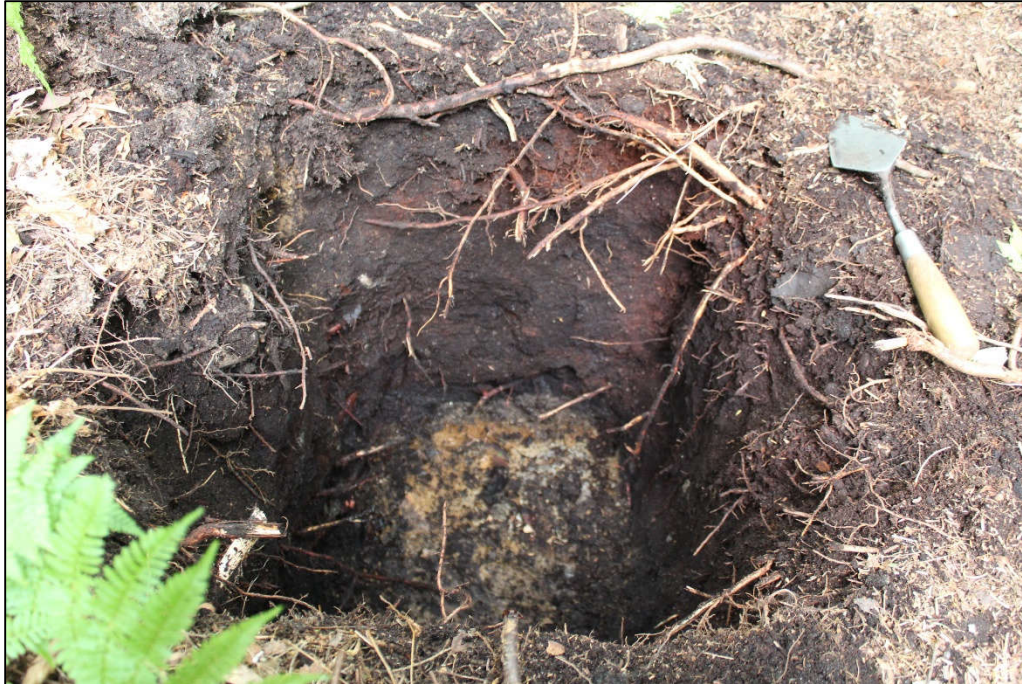
Photo 10. Dam #2, ASA 3, Test 7, north profile. Note thick A horizon over sand and gravel C horizon.

The tests typically encountered a thick A horizon of very dark brown to black silty loam with gravel ranging from 23 to 68 centimeters (9 to 27 in) in depth with an average of 38 centimeters (15 in). No clear B horizon was identified in any of the tests (Photo 10). The C horizon consisted of yellowish brown to gray sand and gravel. The average test depth was 58 centimeters (23 in). No artifacts were encountered in the shovel tests at ASA 3.

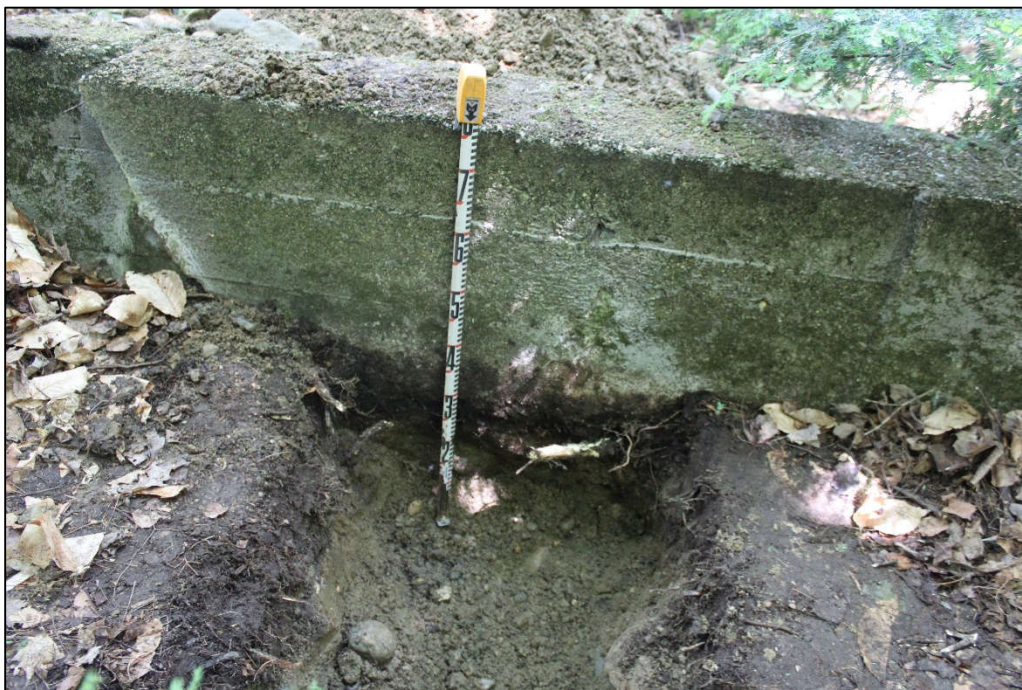
Photo 11. Dam #2, ASA 3, Test 2, placed against the south side of the concrete wall in the north end of the APE. Note dense sand and gravel beneath thin A horizon with concrete resting on gravel within the ditch. View to the north/northwest.

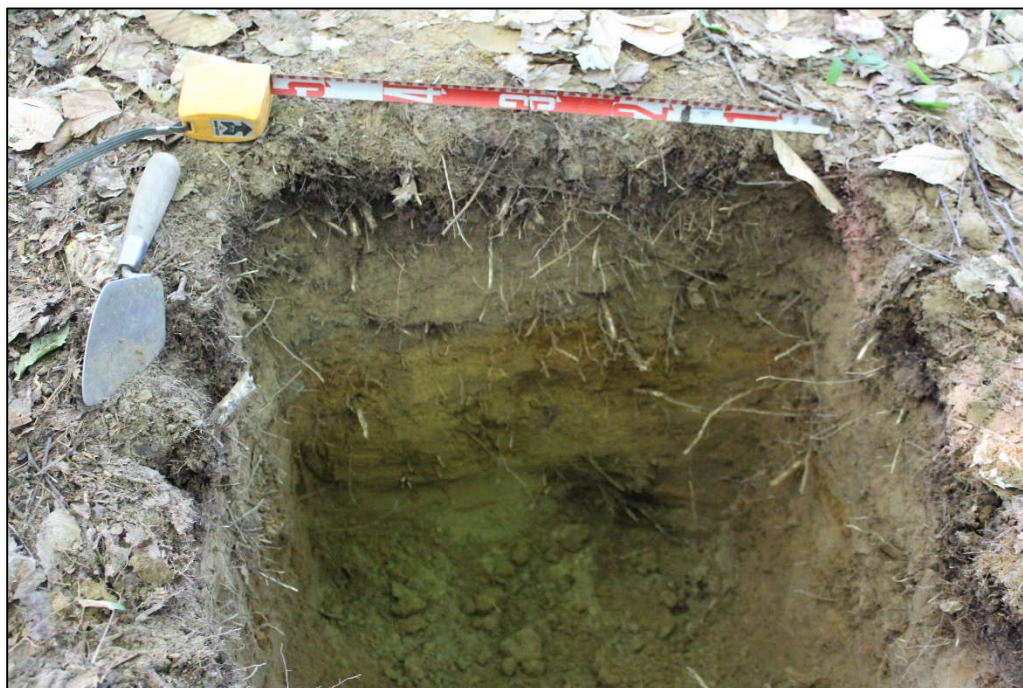
Photo 12. Dam #5, ASA 6, Test 30, south profile. View to the south.

At ASA 6, the area east of West Hill Road was found to have recent trash scattered across the area. These items included a few auto parts, a camp chair and some glass, plastic and ceramics. These items are not deemed to be significant, but likely deposited from impromptu camping and general disposal in the recent past.

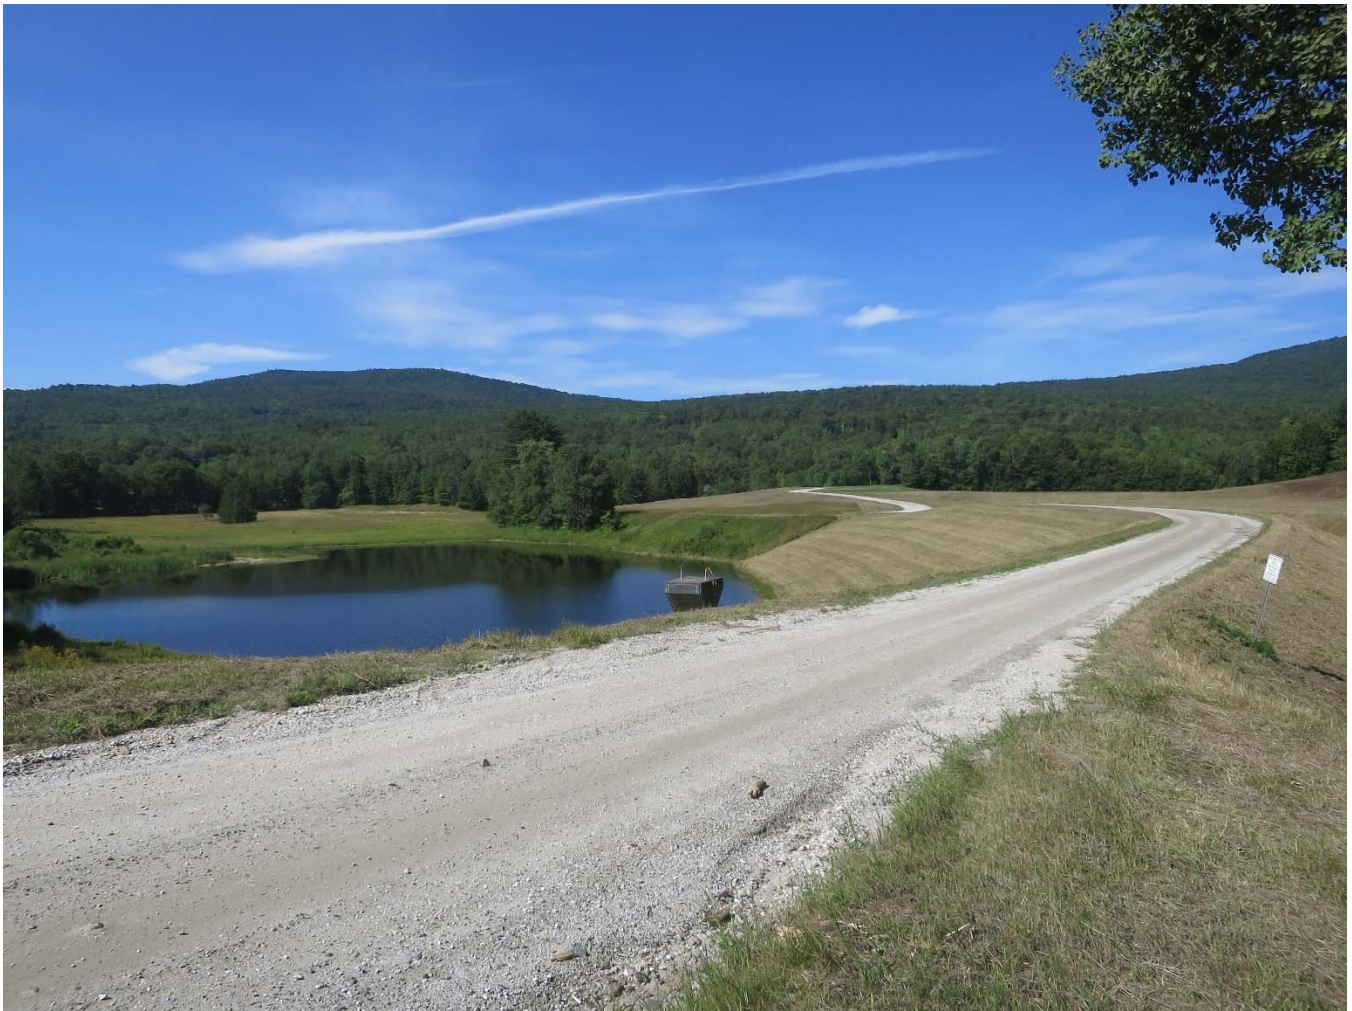
1. View west, showing the earthen dam and reservoir at Site 1. The top of the intake structure is visible at the center of this view, August 2022.

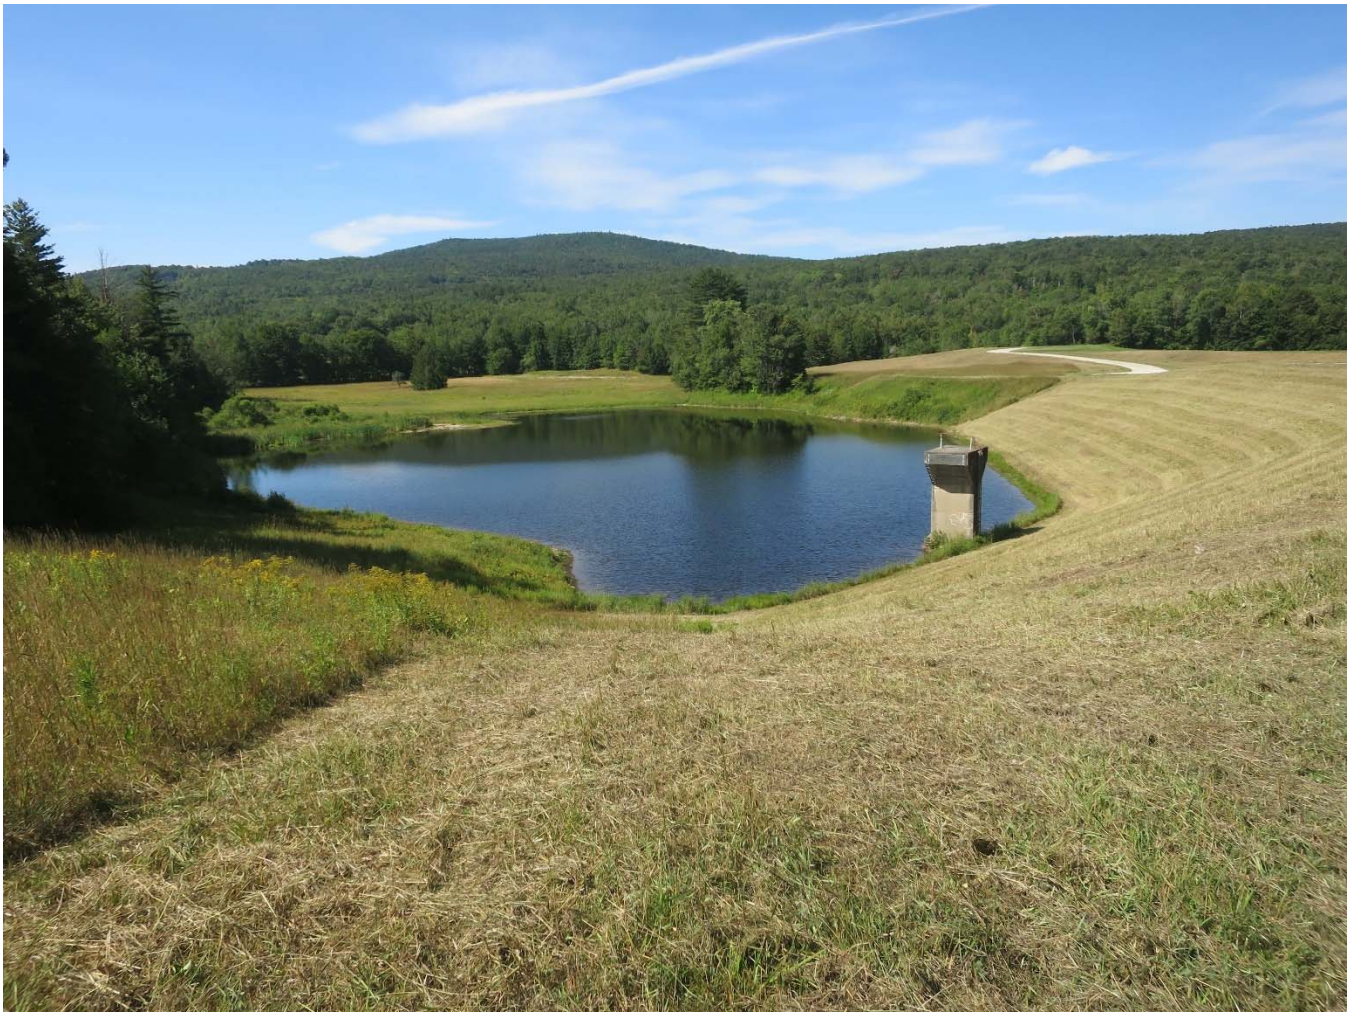
2. View west, showing reservoir and the intake structure, August 2022.
