**Appendix D.5 – Cultural and Historic Investigation and Evaluation Jewell
Watershed Dam Sites #1, #2, #3 and #5
Supplemental Watershed plan and Environmental Assessment**

ARCHEOLOGICAL RESOURCE ASSESSMENT

Jewell Brook Watershed Sites 1, 2, 3 & 5

Jewell Brook Watershed, Sites 1, 2, 3 and 5, Town of Ludlow, Windsor County, Vermont
 Phase IA Archeological Assessment

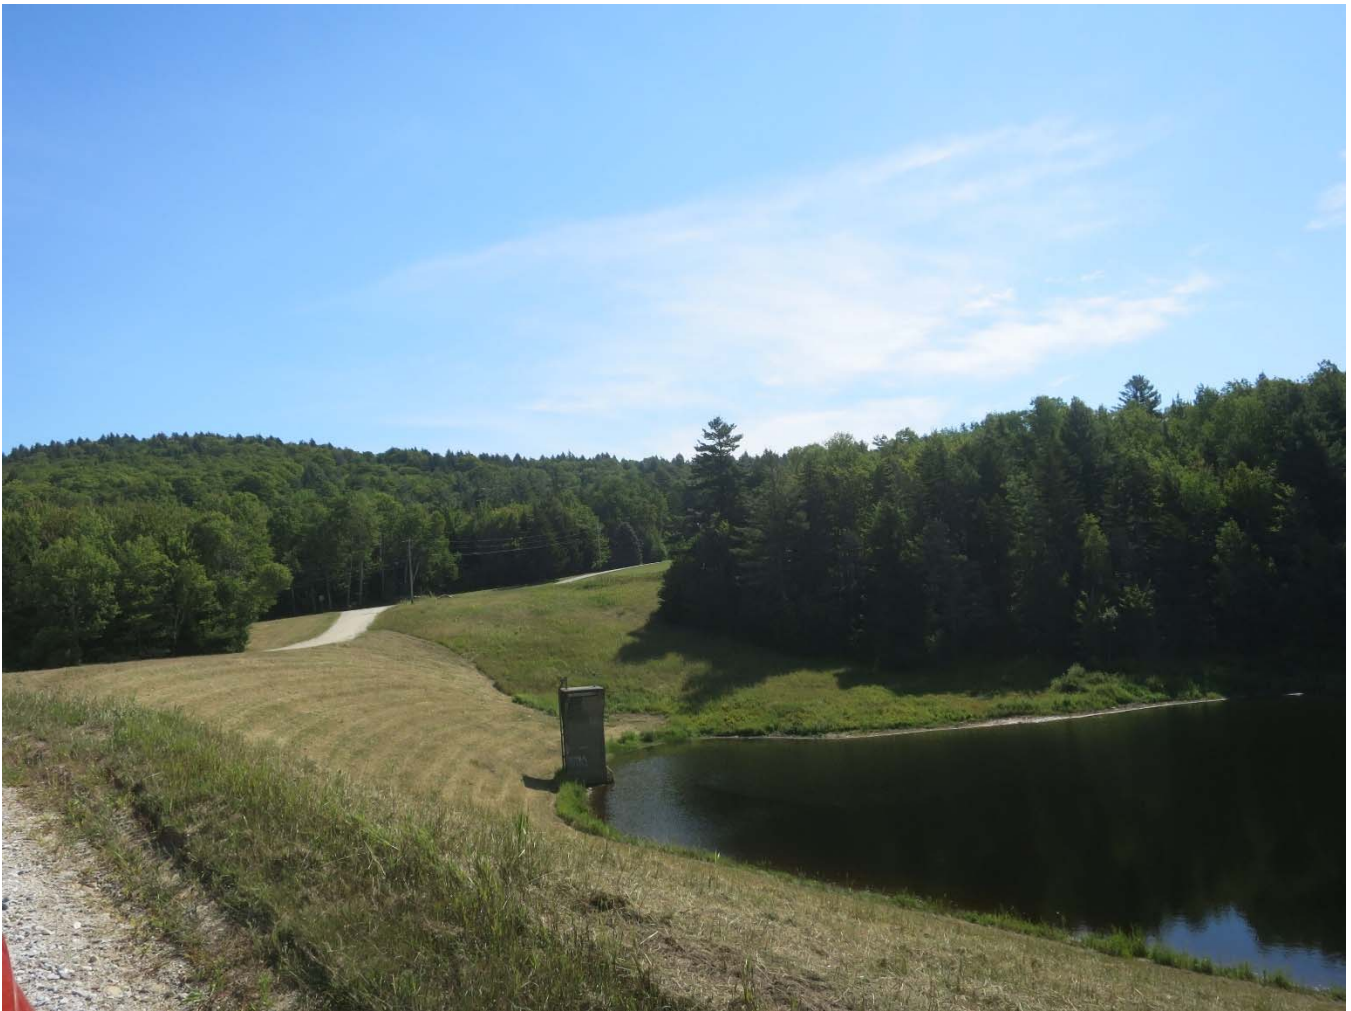
3. *View east, showing the approach road, at center left, and the intake structure, August 2022.*

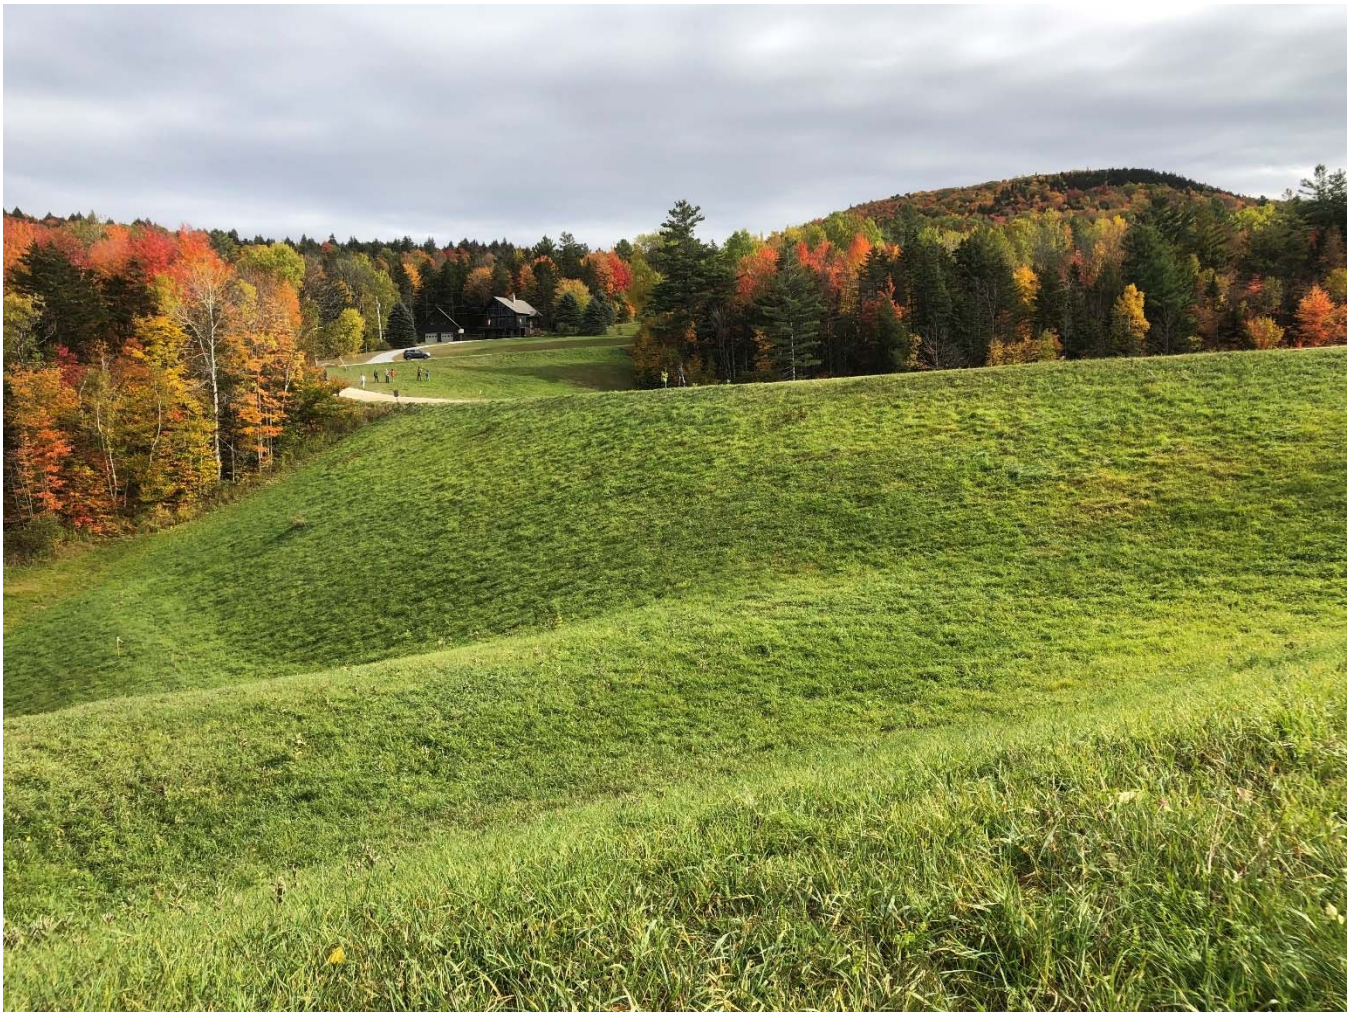
4. View east-southeast, showing the earthen dam and the approach road, October 2019. A nearby dwelling is seen in the distance.

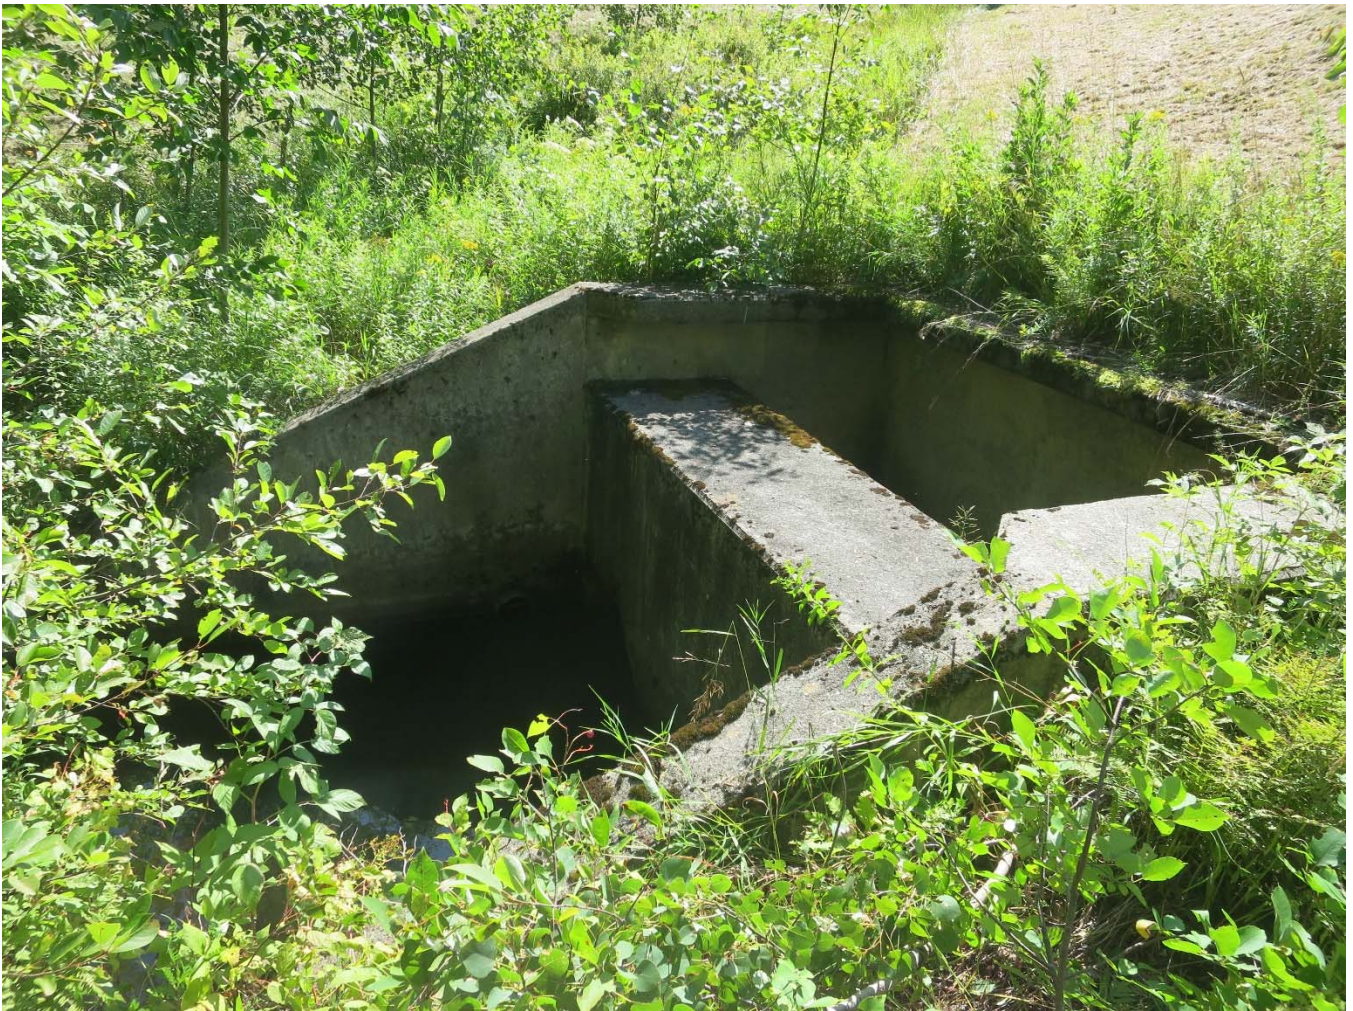
5. *View southeast, showing the stilling basin and outlet, August 2022.*

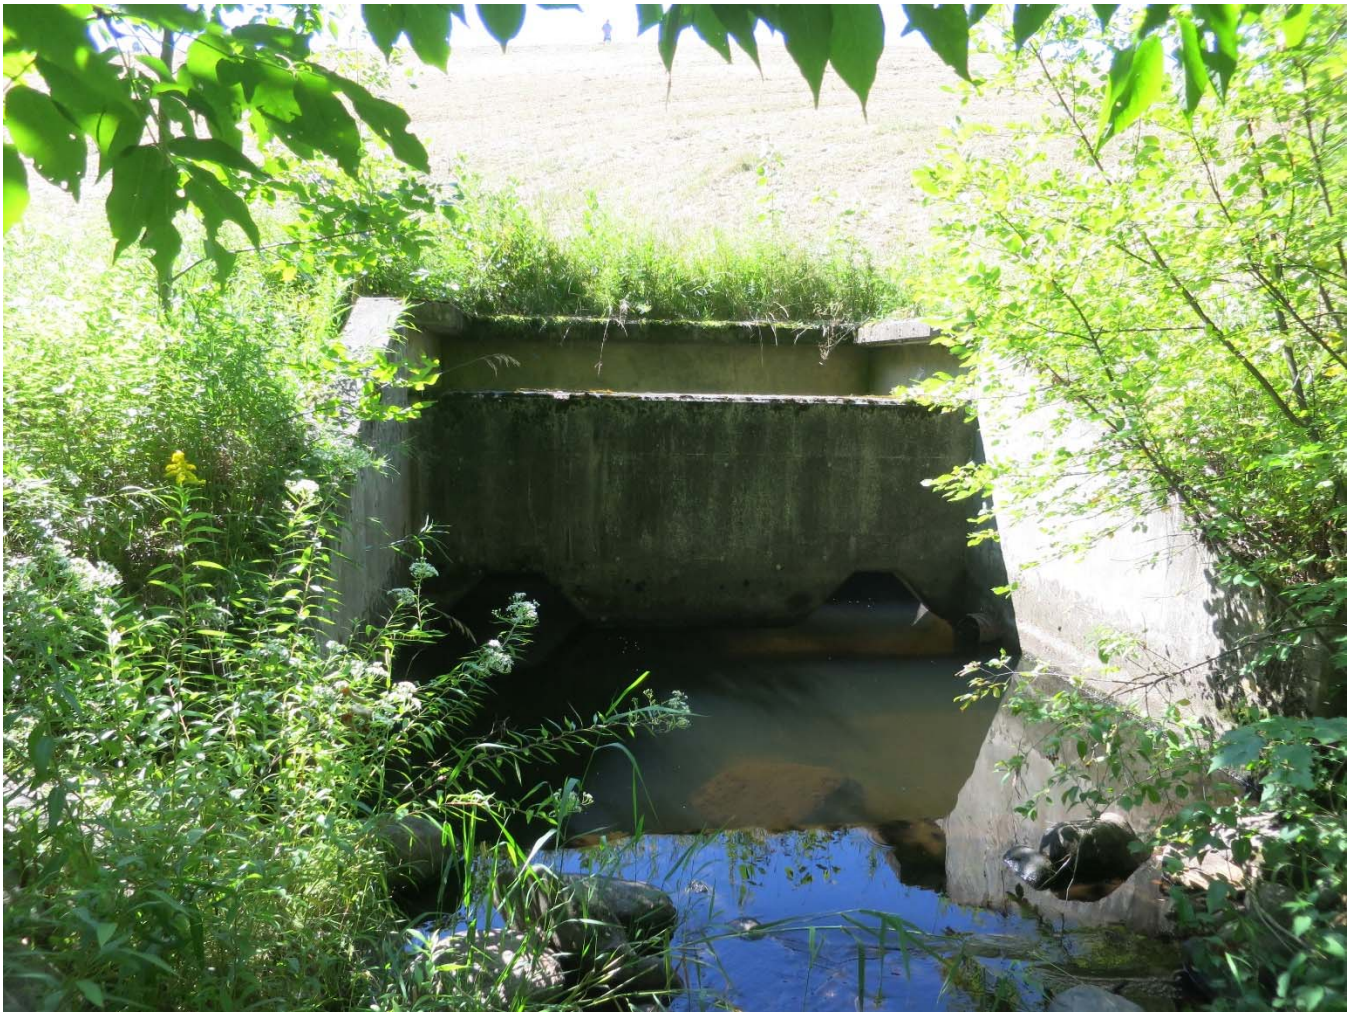
6. *View south, showing the stilling basin and outlet structure, August 2022.*

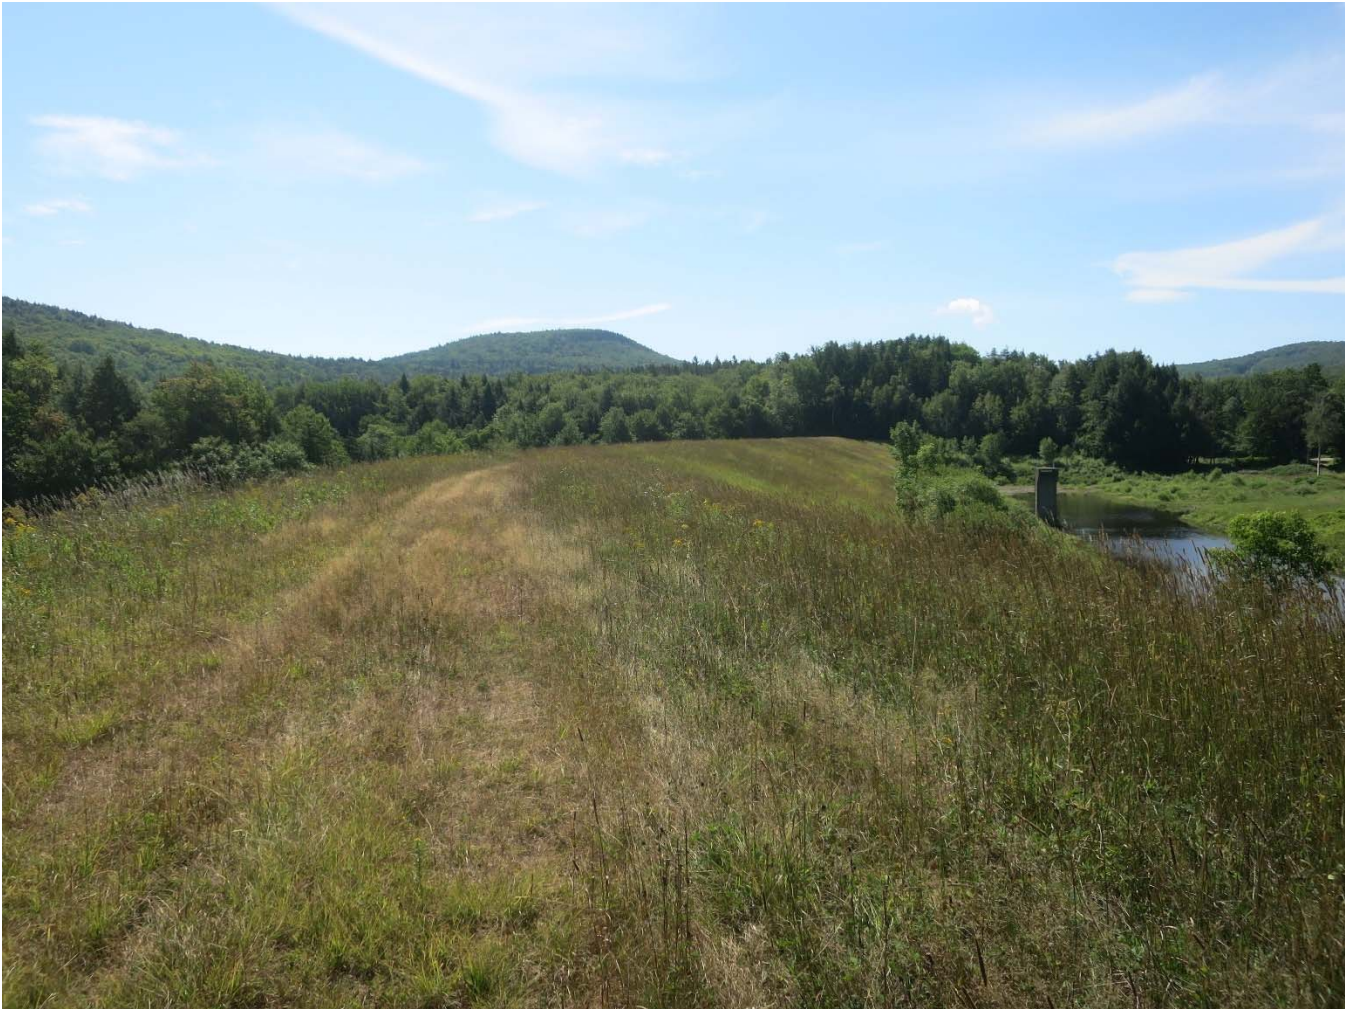
7. View south-southeast of the earthen dam at Site 2, with reservoir and intake at right, August 2022.

Site 2 consists of an intermediate sized, high hazard potential (Class 1) compacted earth embankment dam with toe/trench/spring drain system, 1,110 feet in length and 70 feet in height. It was constructed using 237,050 cubic yards of fill. It covers a drainage area 1,113 acres in extent, and has a capacity to contain 278.2-acre-feet of flood storage before cresting over its emergency spillway.

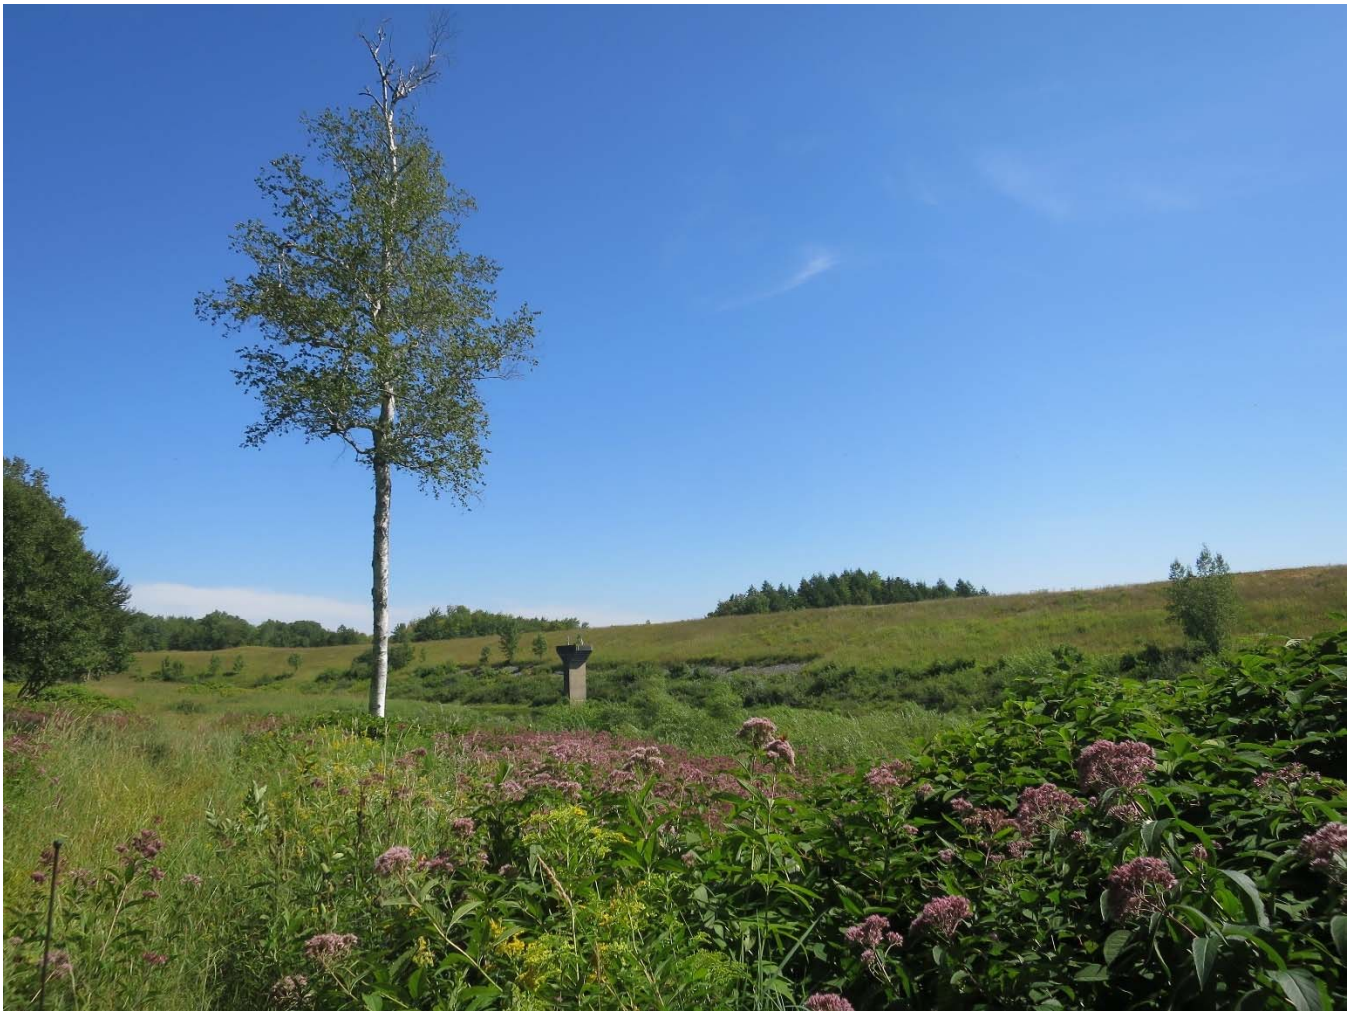
8. *View northeast of the earthen dam, showing the landscape context and intake, at center, August 2022.*

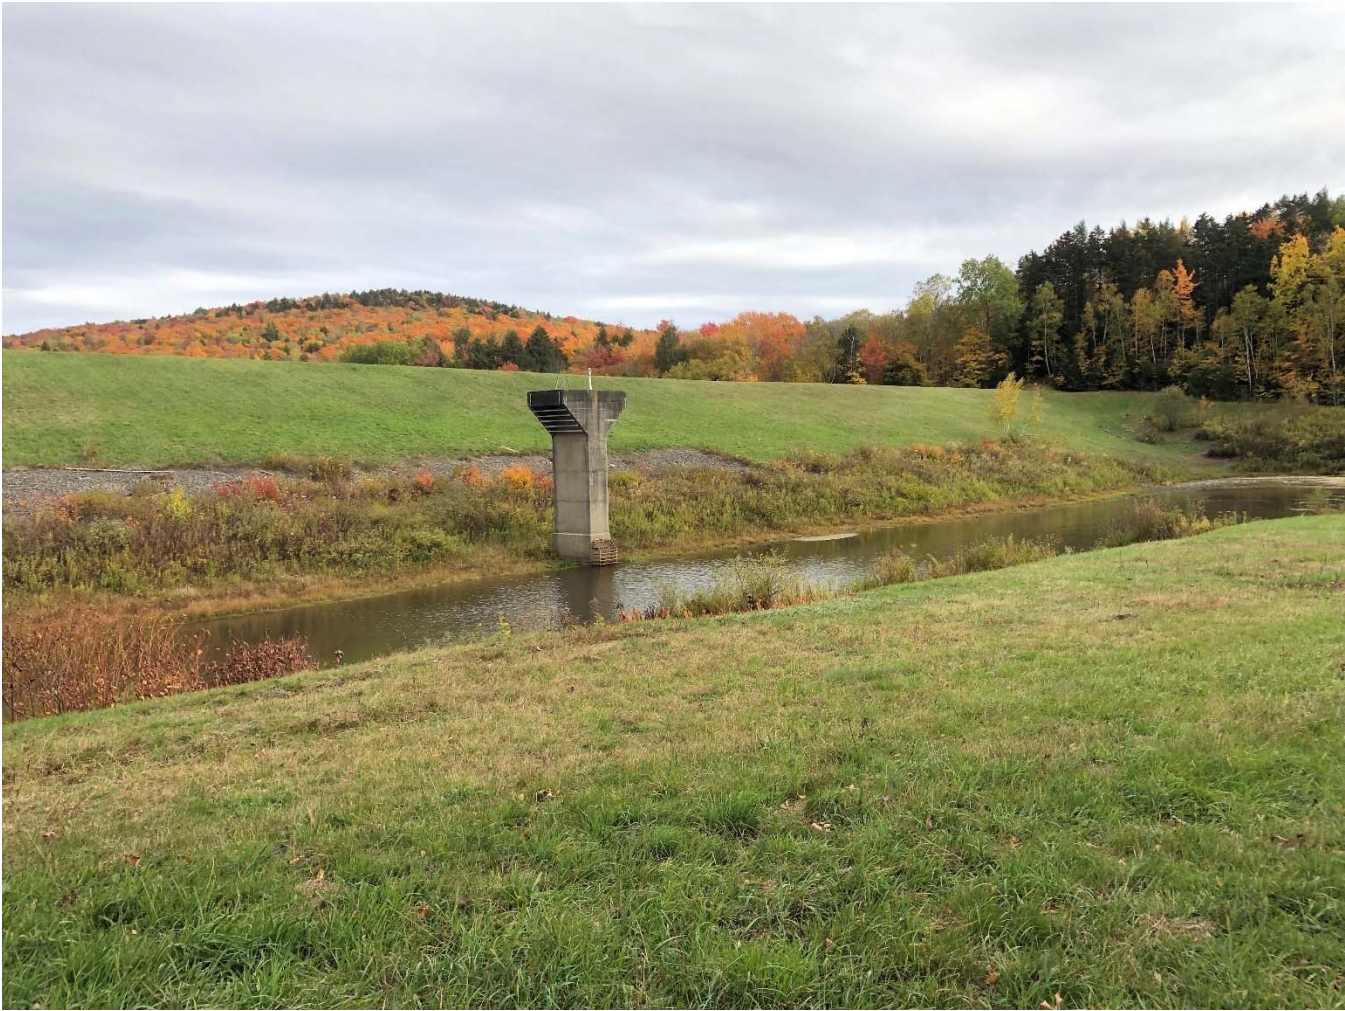
9. *View of the reservoir with intake structure at center, October 2019.*

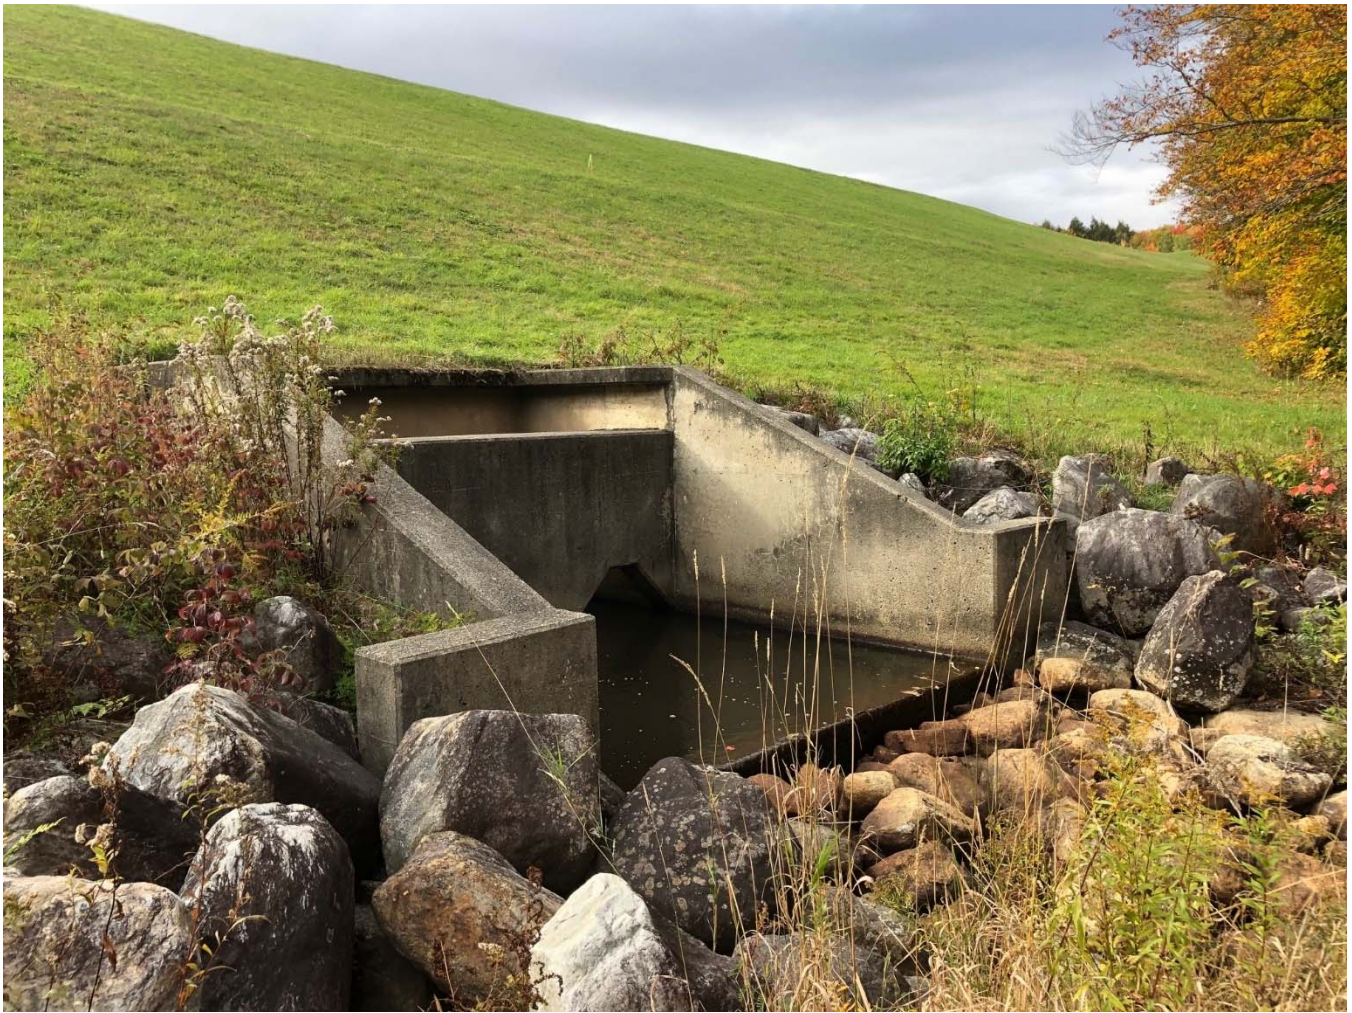
10. *View of the stilling basin and outlet structure, looking west, October 2019.*

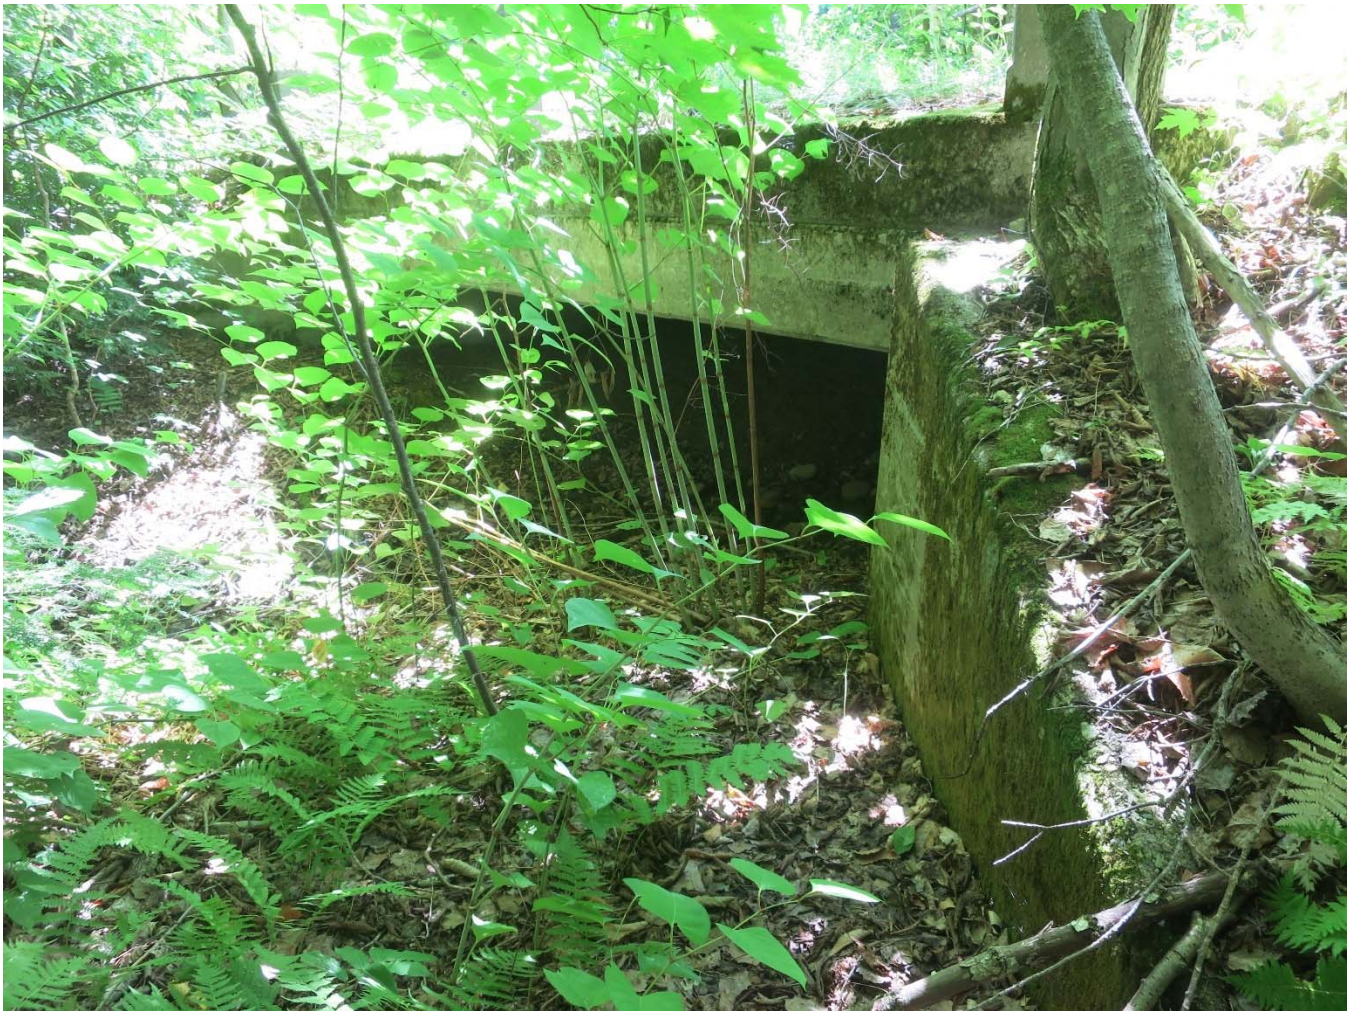
11. *View of the small approach bridge, showing its north façade and one of two wing walls, looking south, August 2022.*

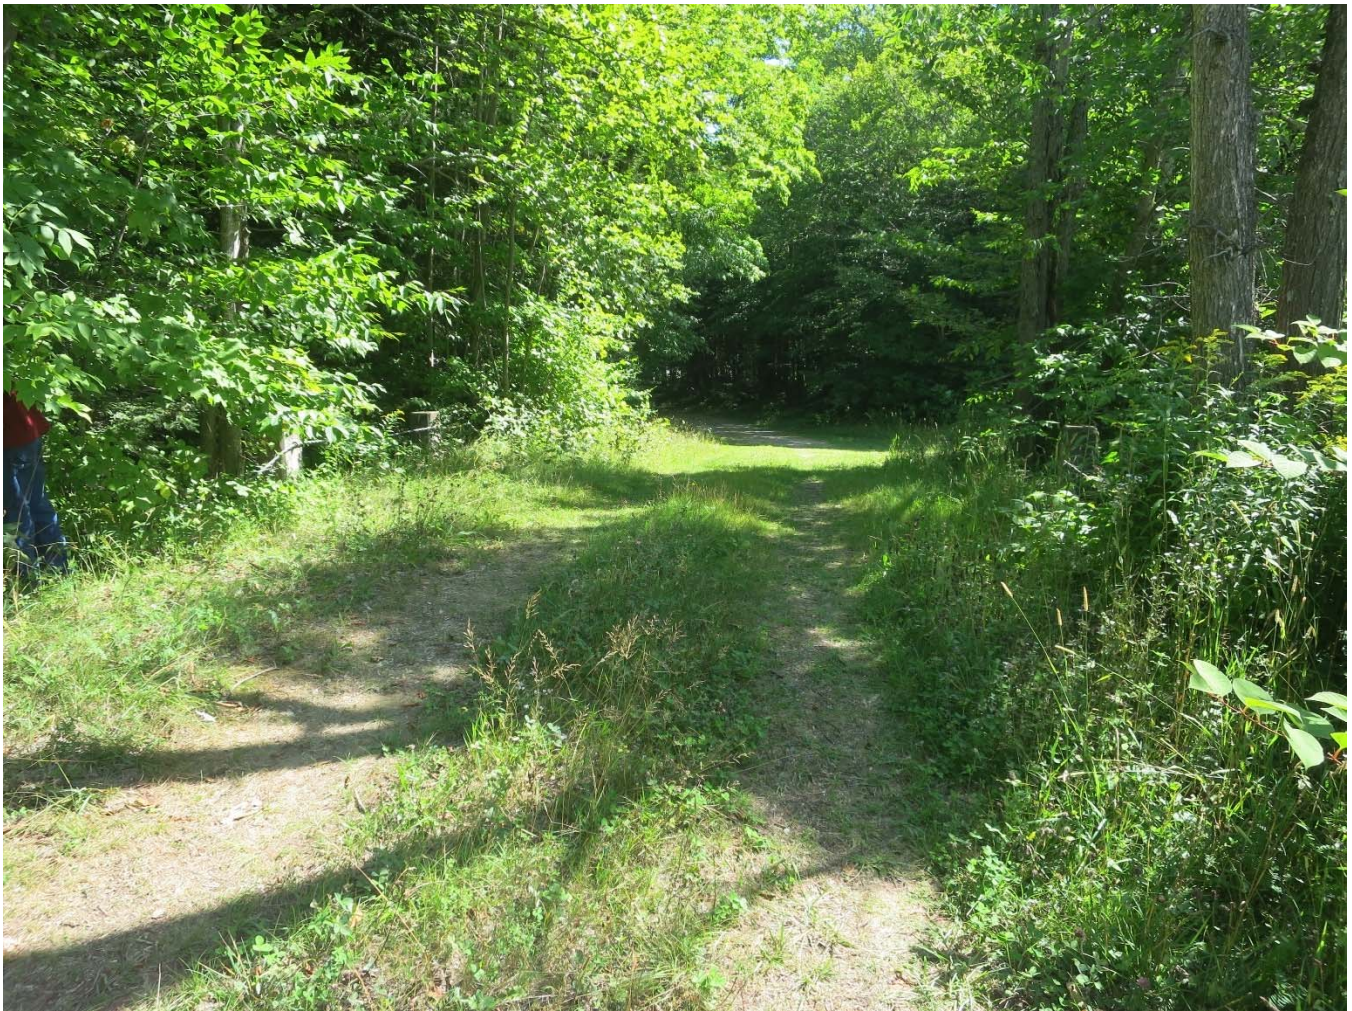
12. View east of the road crossing at the bridge, with concrete and cable railings shown, August 2022.

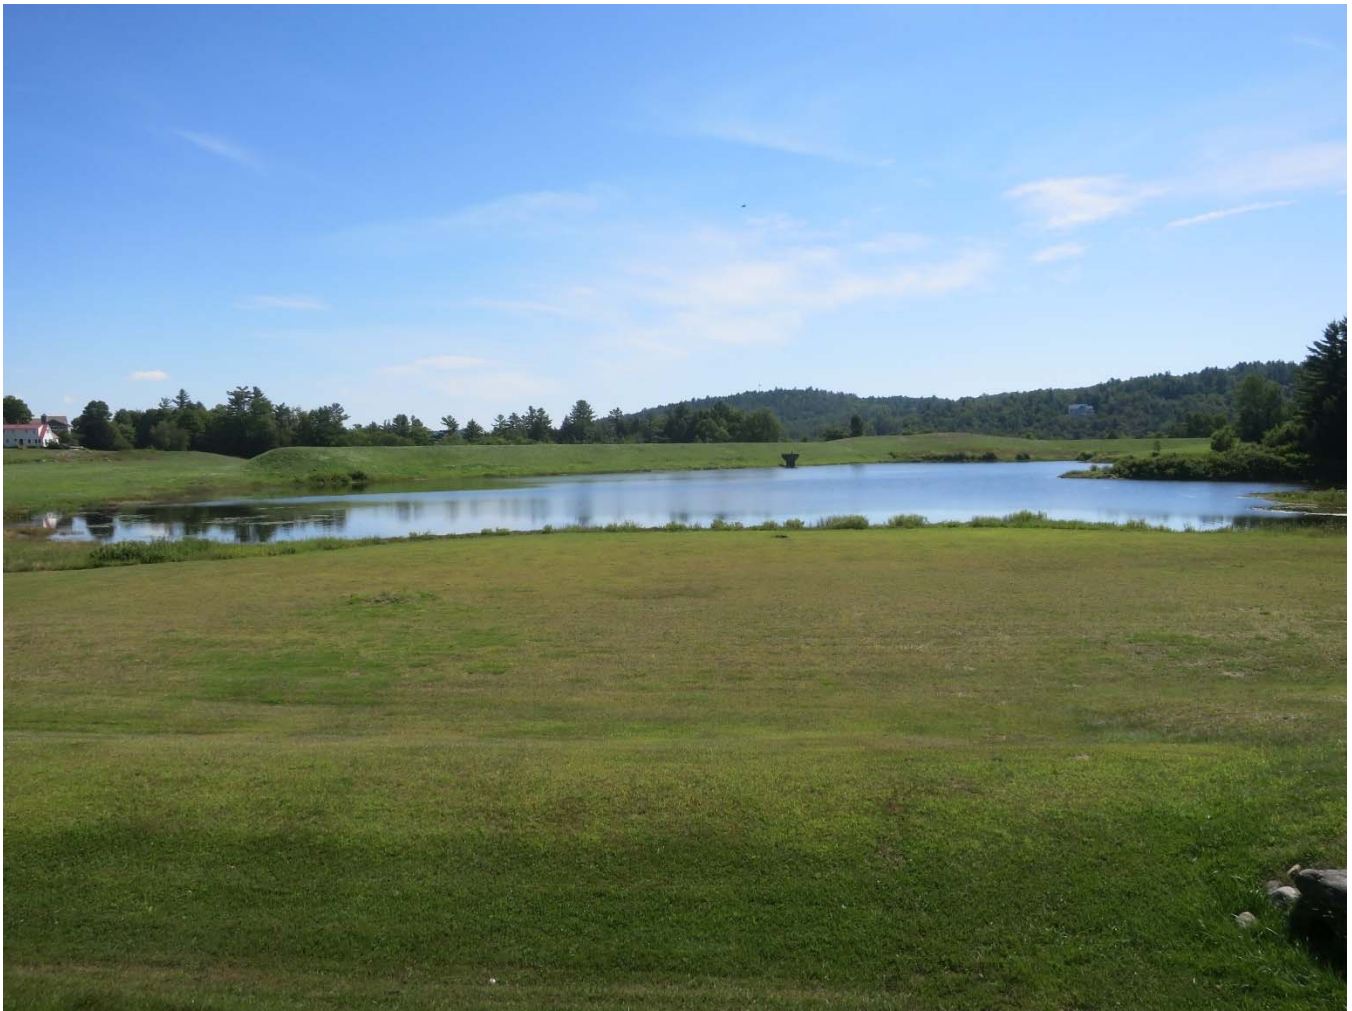
13. View east-southeast of Site 3, showing reservoir and earthen dam, in the background, August 2022.

The floodwater control features at Site 3 include an intermediate-sized high hazard potential (Class 1) compacted earth embankment dam with toe/trench drain system, 670 feet in length and 64 feet in height. The dam was constructed using 173,500 cubic yards of fill. It serves a drainage area 840 acres in extent and has a capacity of 336.3 acre-feet of floodwater storage before cresting over its emergency spillway.

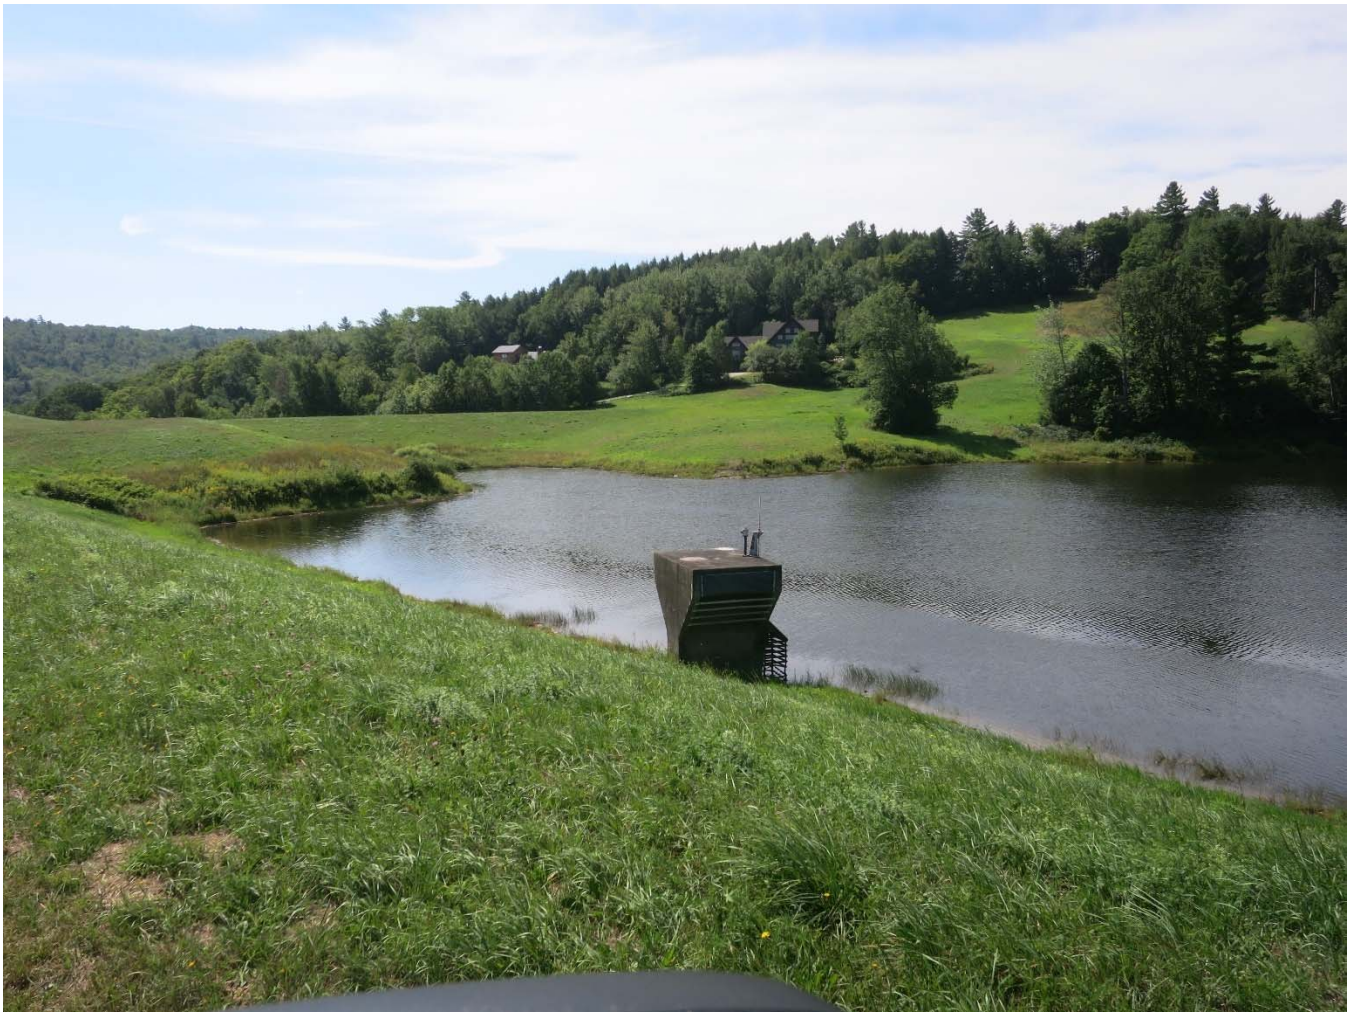
14. View south-southeast from top of earthen dam, showing intake structure at center and nearby dwellings, in the background, August 2022.

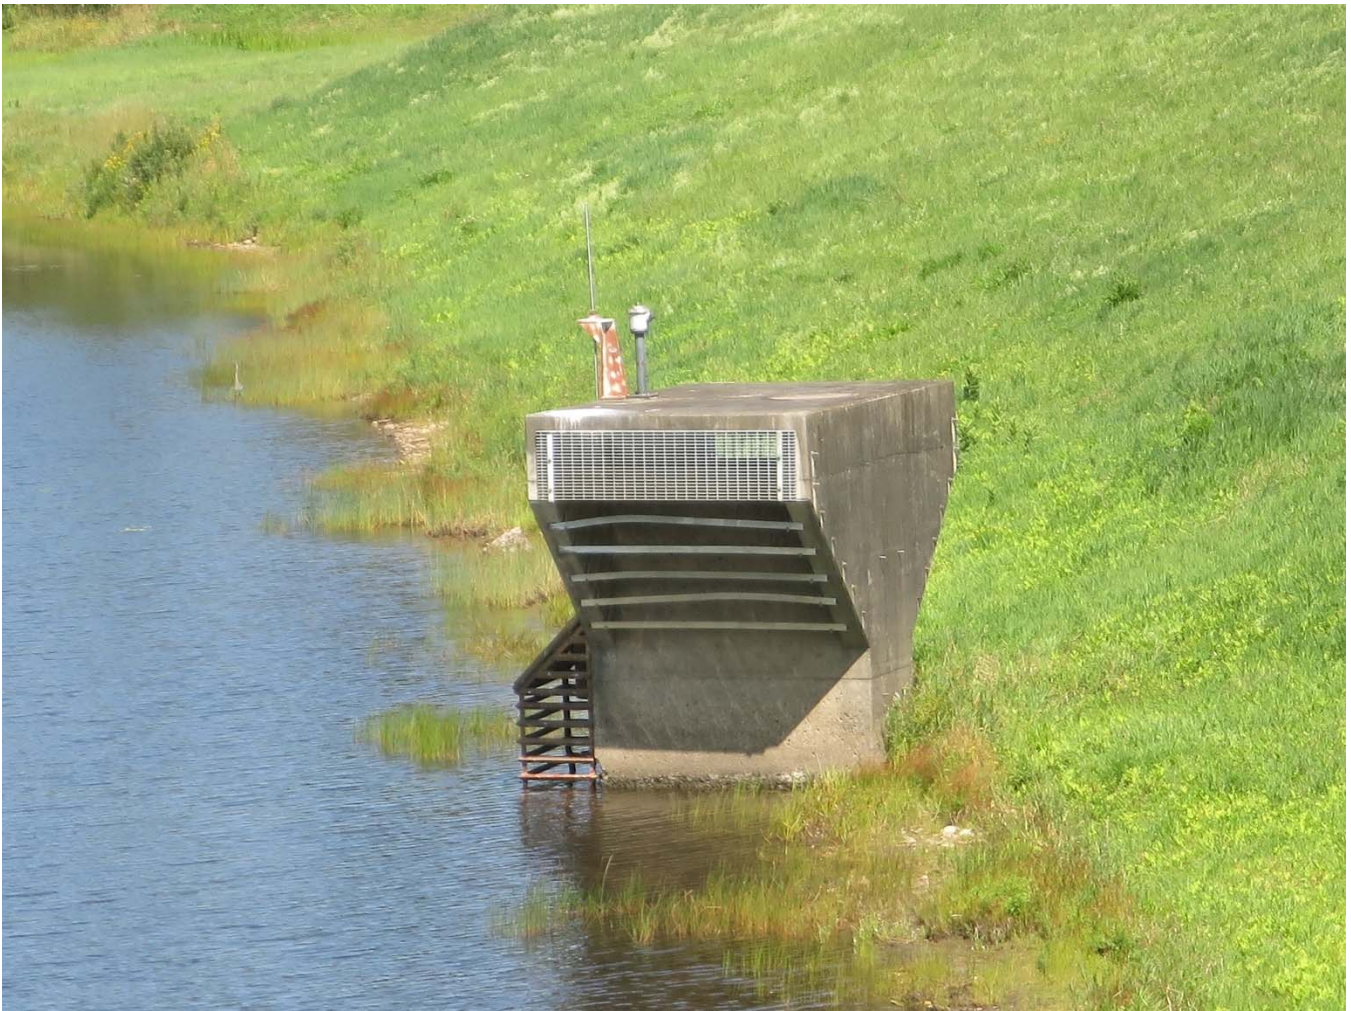
15. *View north-northwest, showing intake structure, August 2022.*

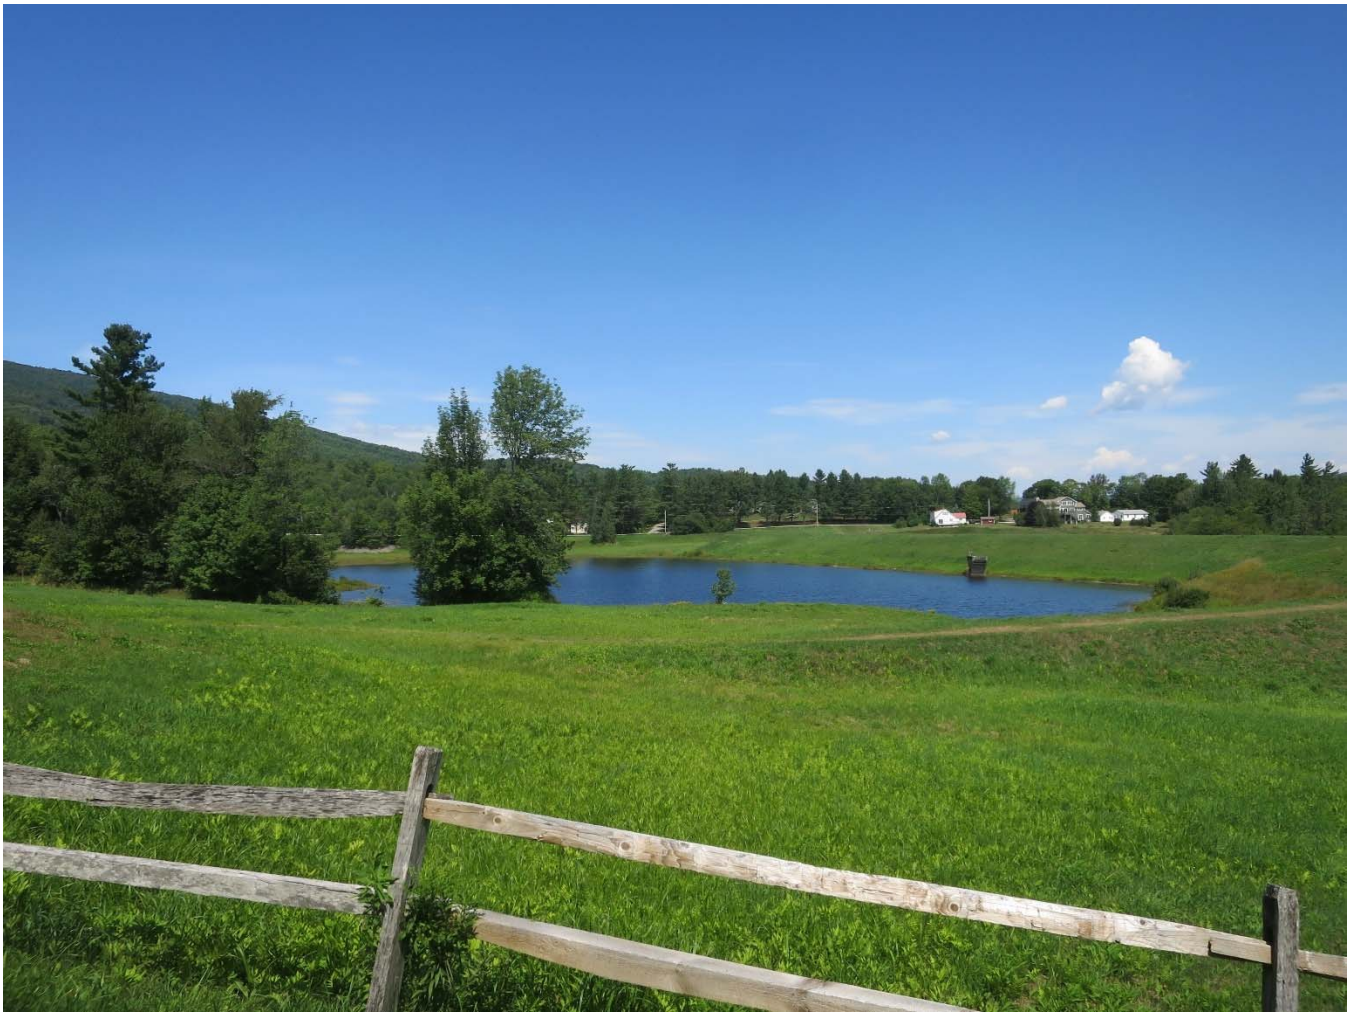
17. View north from a nearby private road, looking toward the reservoir and earthen dam, August 2022.

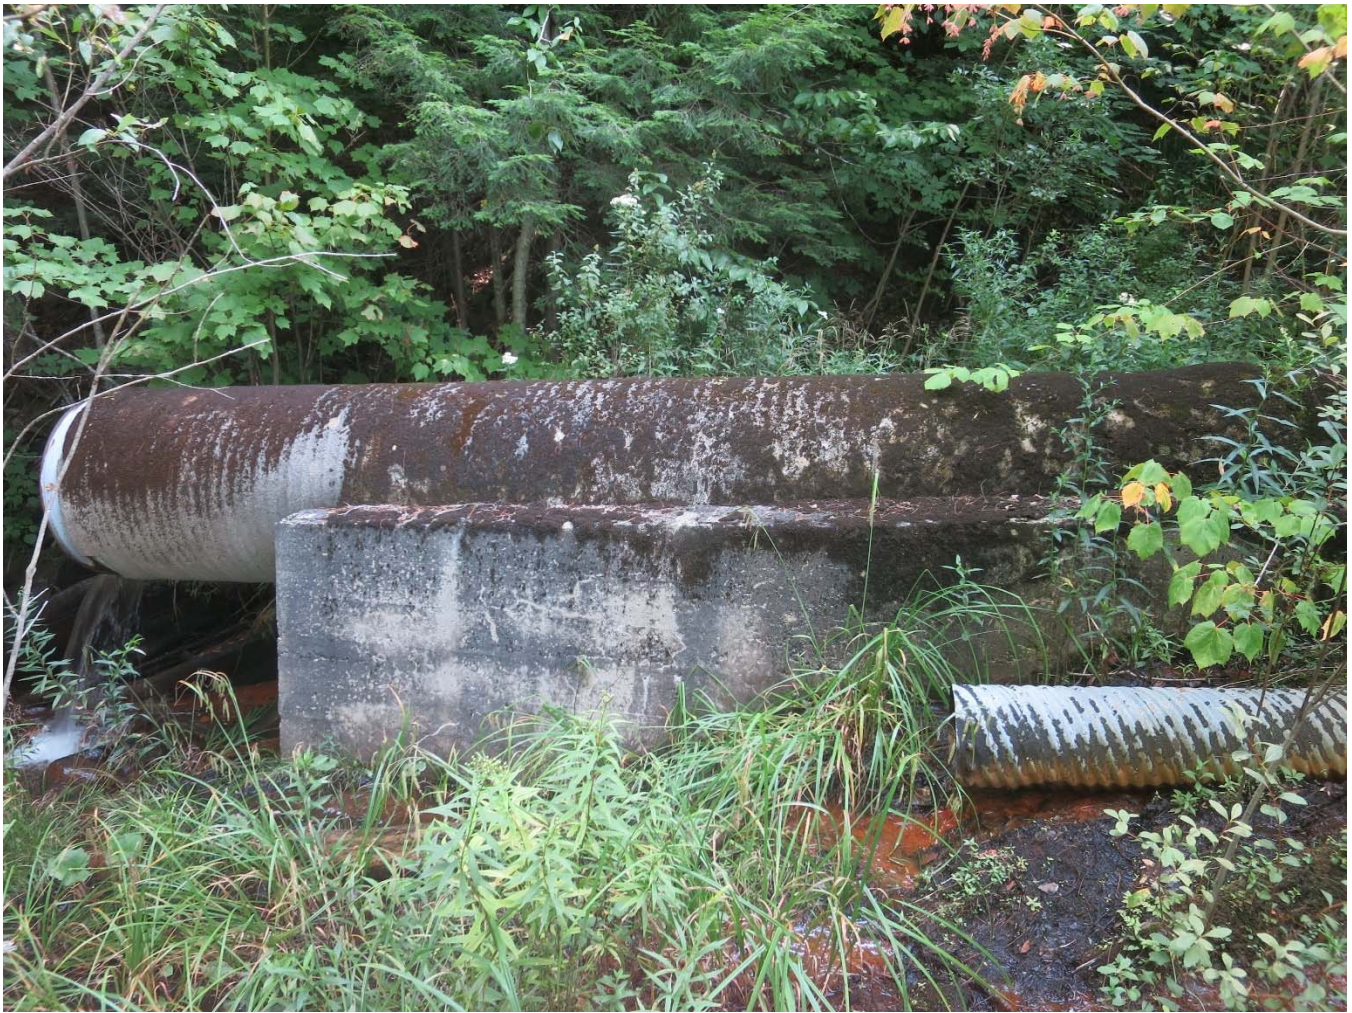
18. View south-southeast, showing concrete and corrugated metal outlet pipes, the former embedded in a concrete cradle, August 2022.

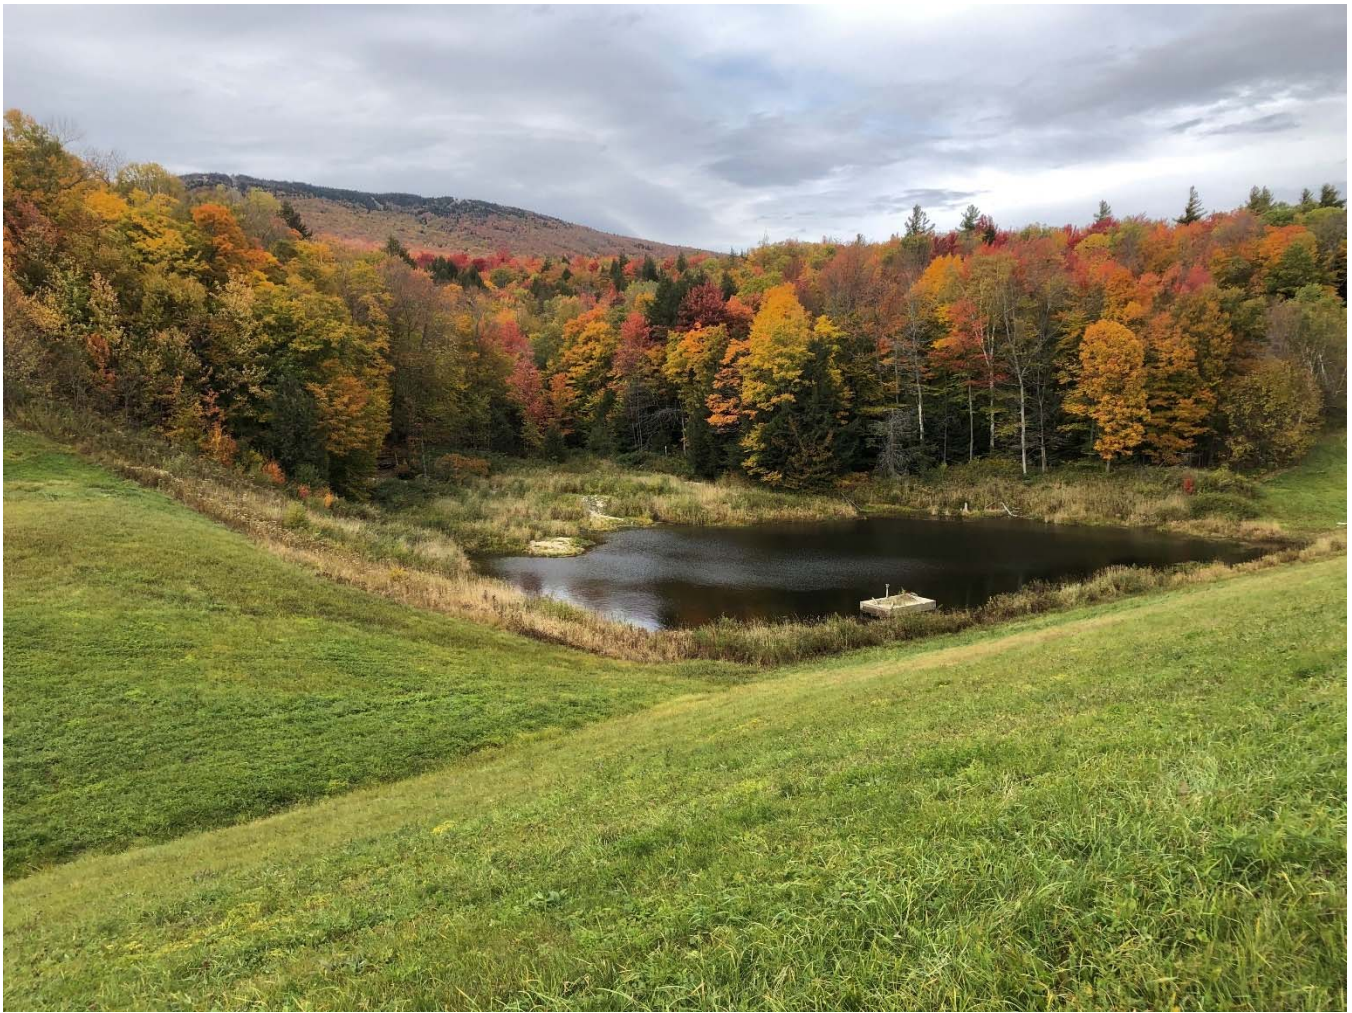
21. *View north from the earthen dam, showing the reservoir with intake structure, at center right, October 2019.*

Site 5 includes a large high hazard potential (Class 1) earthen embankment dam with toe/trench drain system. The dam measures 660 feet in length and is 112 feet high. The dam was constructed using 235,000 cubic yards of fill and serves a drainage area 1,114 acres in extent. It has a 185.6-acre-feet water storage capacity before cresting over its emergency spillway.
