**Appendix D.5 – Cultural and Historic Investigation and Evaluation Jewell
Watershed Dam Sites #1, #2, #3 and #5
Supplemental Watershed plan and Environmental Assessment**

ARCHEOLOGICAL RESOURCE ASSESSMENT

Jewell Brook Watershed Sites 1, 2, 3 & 5

Jewell Brook Watershed, Sites 1, 2, 3 and 5, Town of Ludlow, Windsor County, Vermont
 Phase IA Archeological Assessment

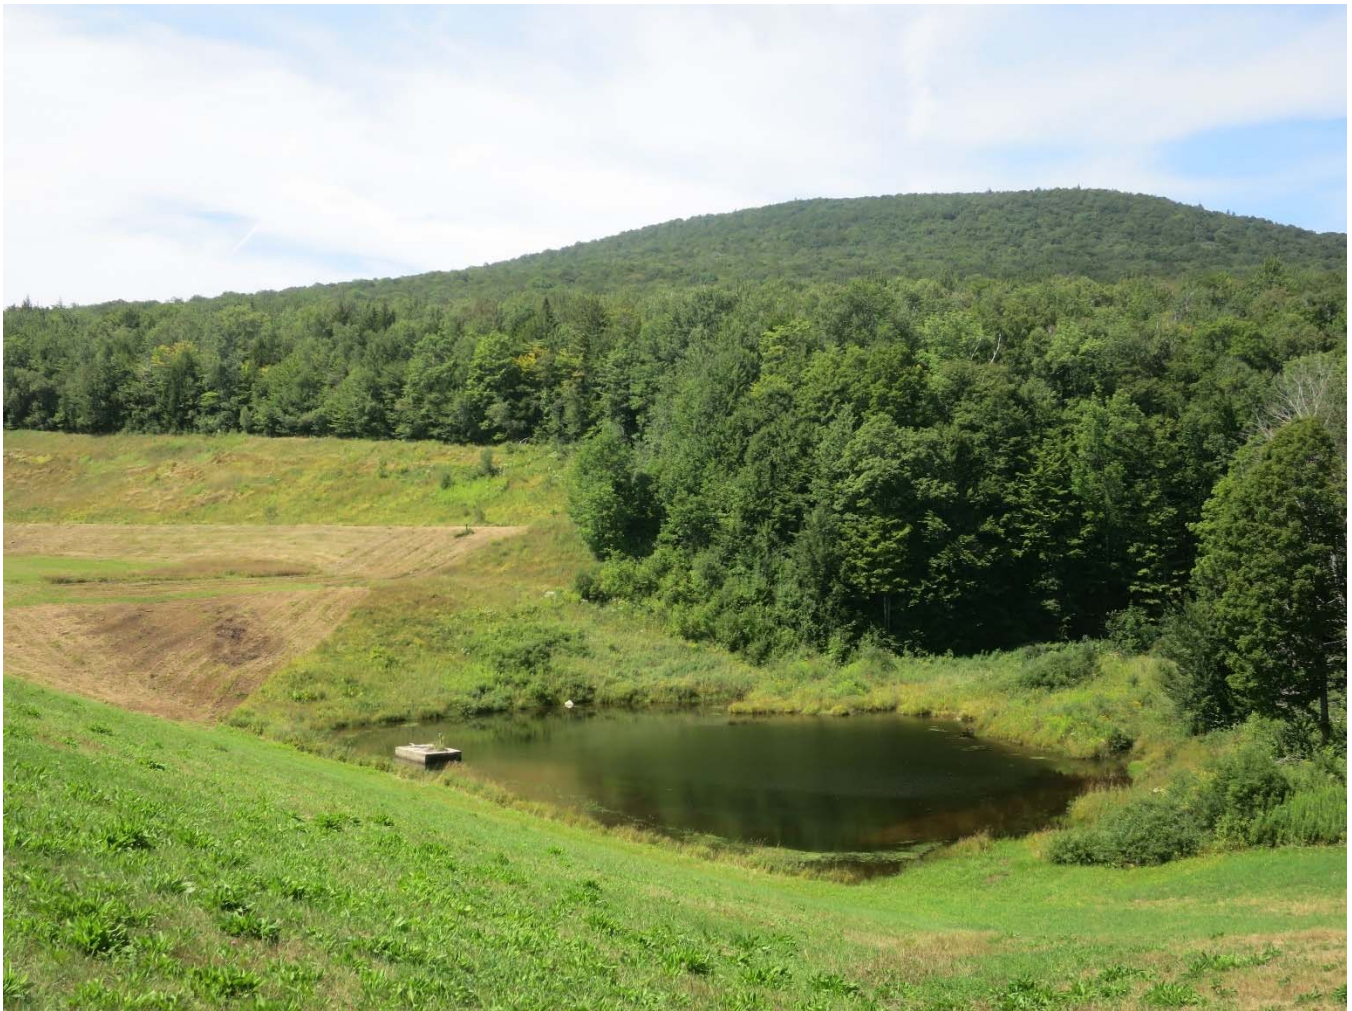
22. View west from the top of the dam, showing the reservoir, with embankment in background, August 2022.

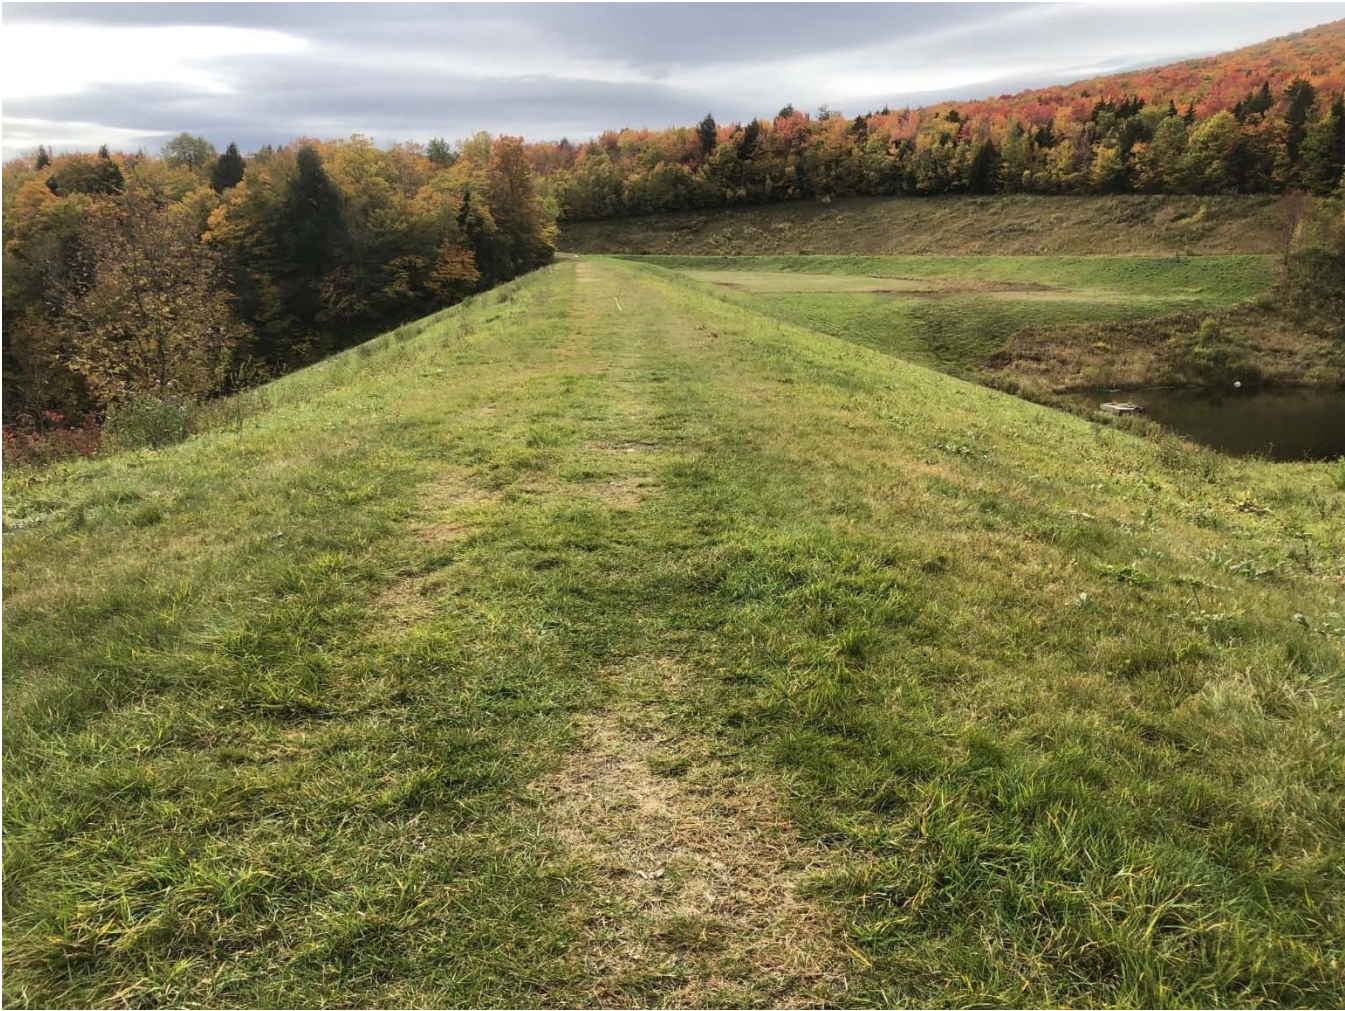
23. *View south-southwest from the top of the earthen dam, October 2019.*

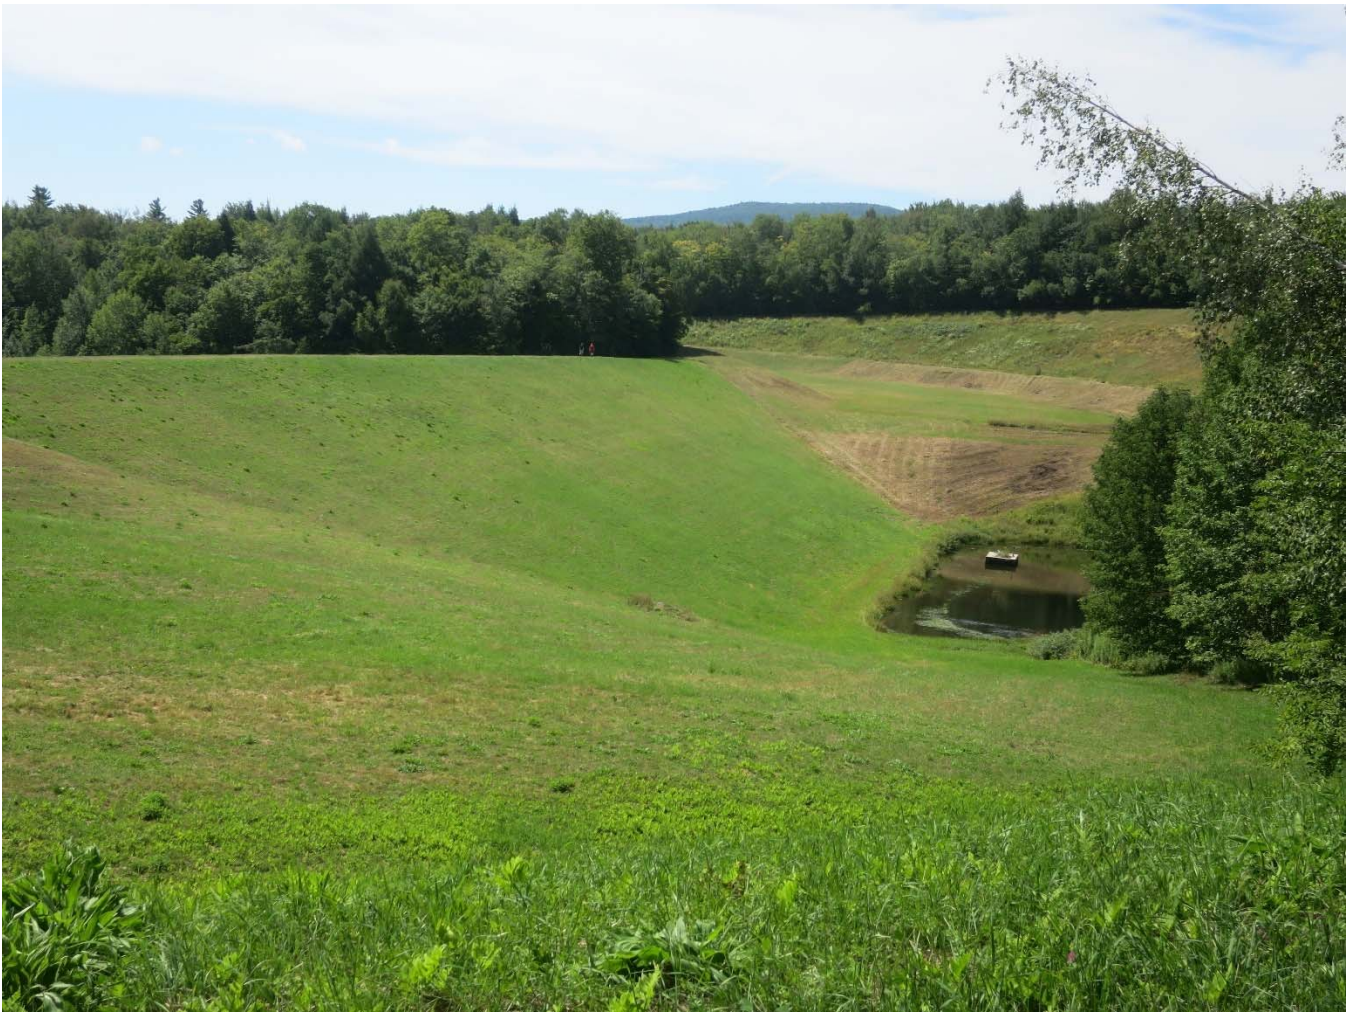
24. *View southwest showing the earthen dam and a portion of the reservoir, August 2022.*

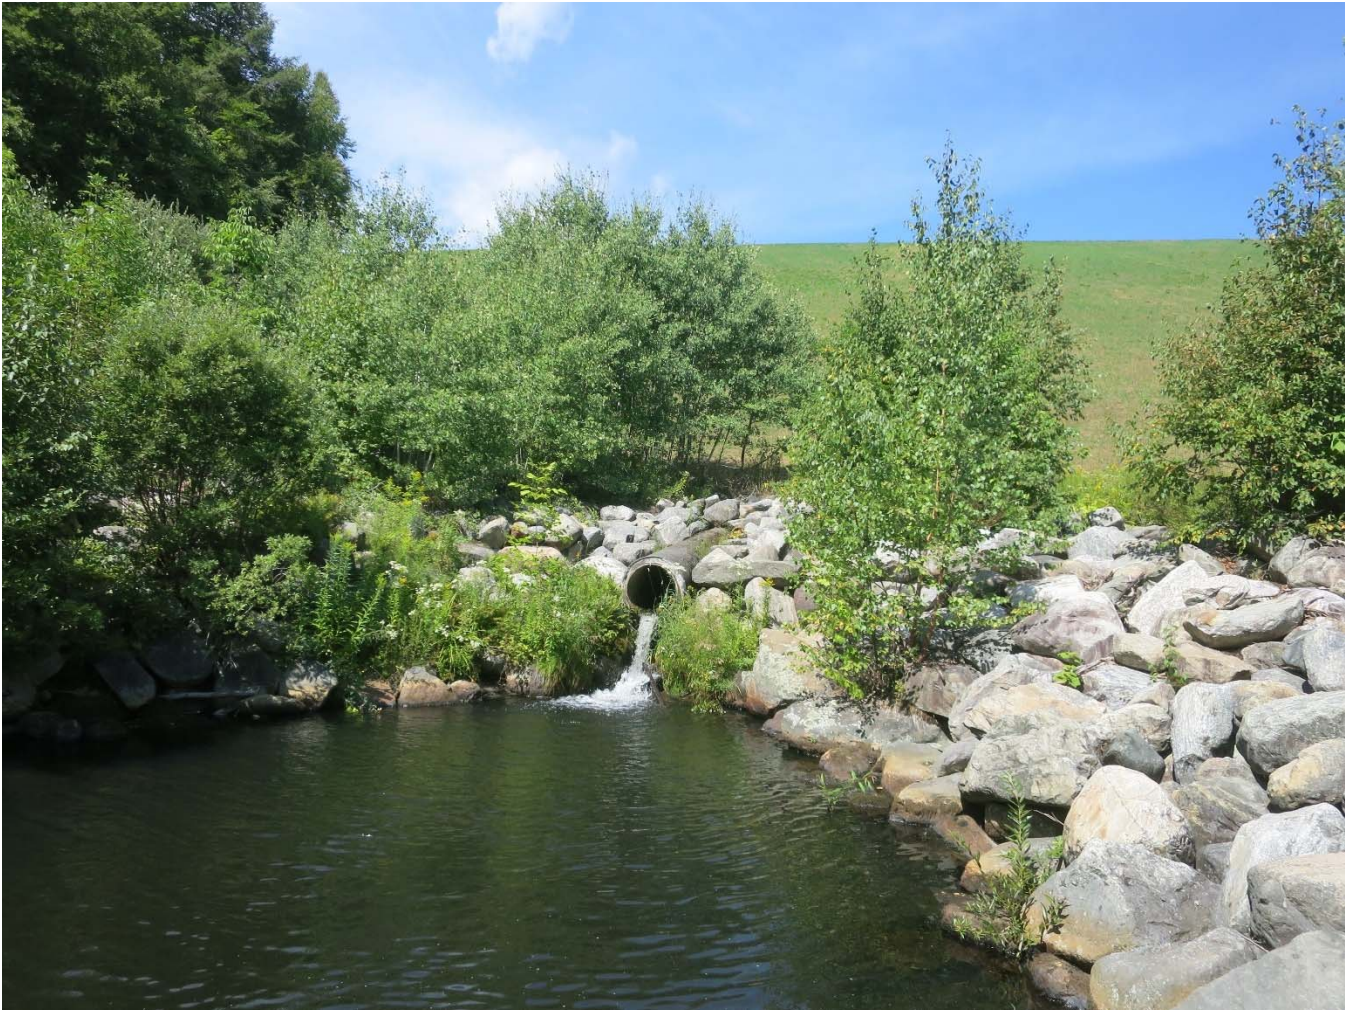
25. *View west-northwest, showing the concrete outlet pipe, August 2022.*
