LED System Performance in a Trial Installation—One Year Later

Host Site: Yuma Border Patrol, Yuma, Arizona

Yuma Border Patrol Area Lighting Retrofit LED System Performance in a Trial Installation – One Year Later

PNNL-24253

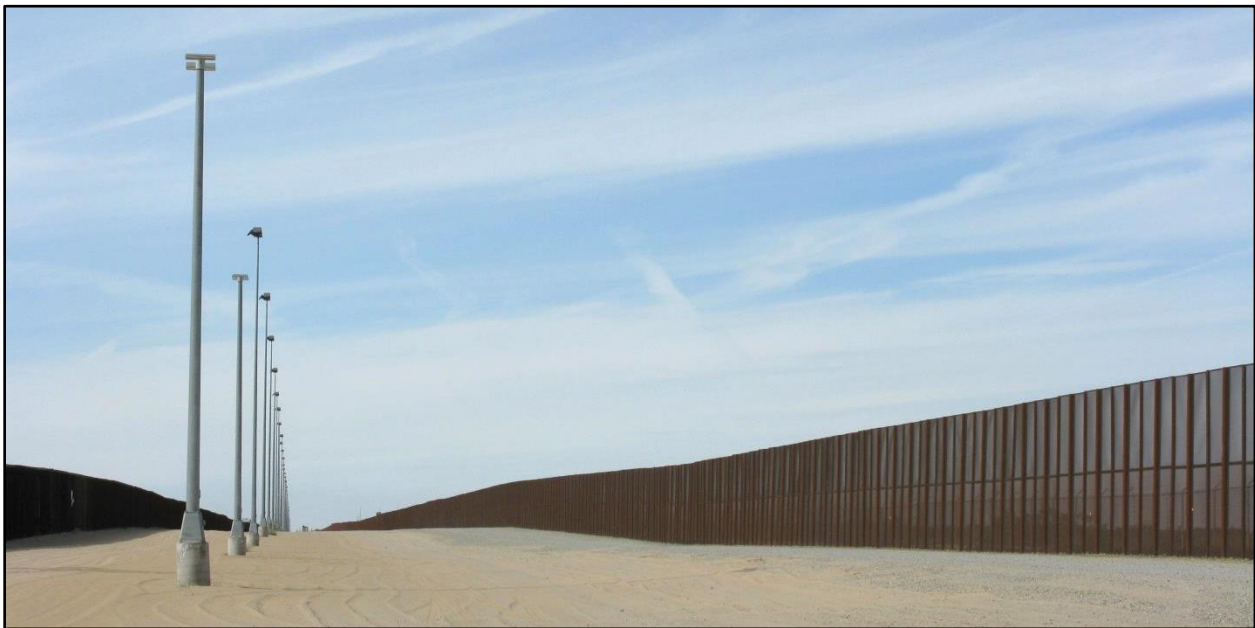
Figure 1. Trial Demonstration Site on the U.S.-Mexico Border: Daytime. Photo taken from the east end of the 7.2 mile area between poles 205 (not pictured) and 204 (pictured, front), looking west. The QMH luminaires are mounted on the poles at a height of 64 ft and the LED luminaires are mounted at 40 ft—a difference that is visible in this image. The primary fence is on the left and the secondary fence is on the right.

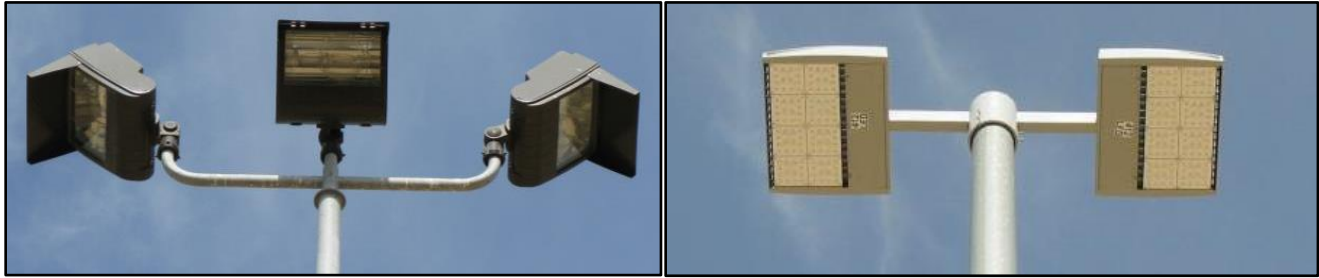
Figure 2. Incumbent QMH Luminaires (left) and LED Luminaires (right). A custom tenon was necessary to fit the diameter of the pole after the pole was cut to 40 ft, because the diameter of the tapered pole narrowed as the height increased. The QMH luminaires were originally installed with the lens tilted up from horizontal and shielded with visors to minimize stray light.

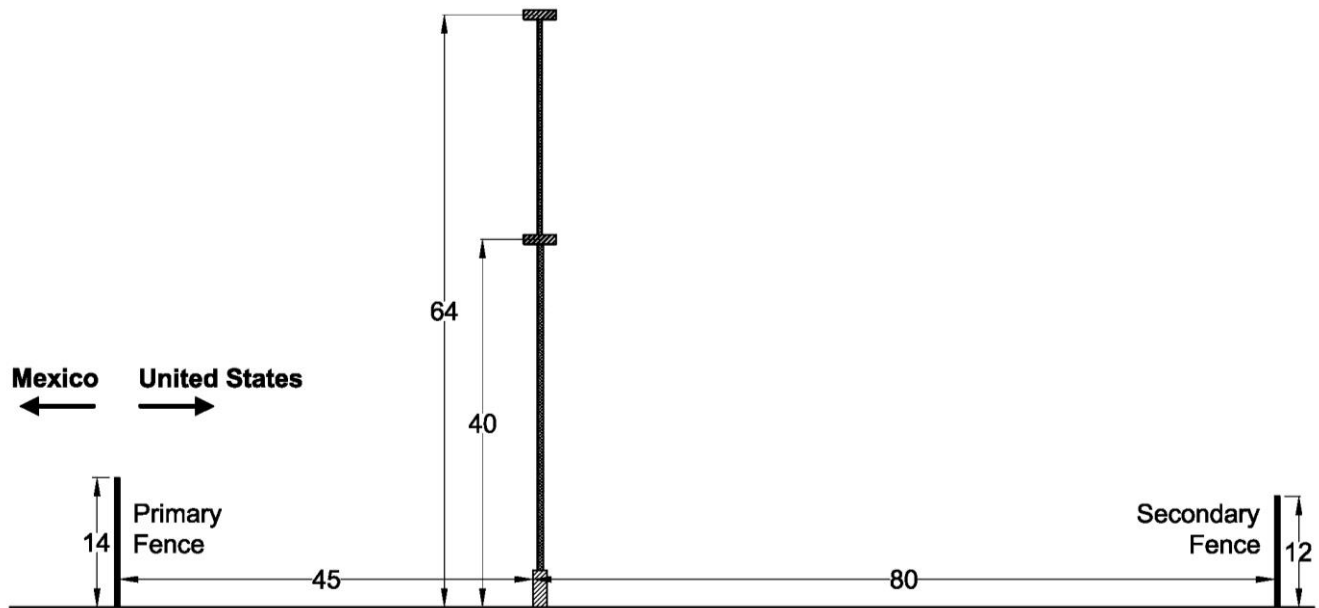
Figure 3. Schematic Elevation of the Yuma Sector Border Patrol Area East of the San Luis Port of Entry. The dimensions are not exact, but are representative of the 7.2 mile border area east of the POE. All dimensions are in feet. The elevation near the secondary fence was approximately 2 to 4 ft higher than the base of the concrete pole pedestal.

This tactical border application was a challenge for LED luminaire technology because it required high luminous flux in a region with high ambient temperature and solar radiation. The 180 ft pole spacing and 125 ft spacing between the primary and secondary fences required each LED luminaire to cover approximately 11,250 ft² at a 40 ft mounting height. The 125 ft width is split by the pole line with a 45 ft distance to the primary fence and an 80 ft distance to the secondary fence, as illustrated in Figure 3. The 14 ft corrugated metal primary fence blocks

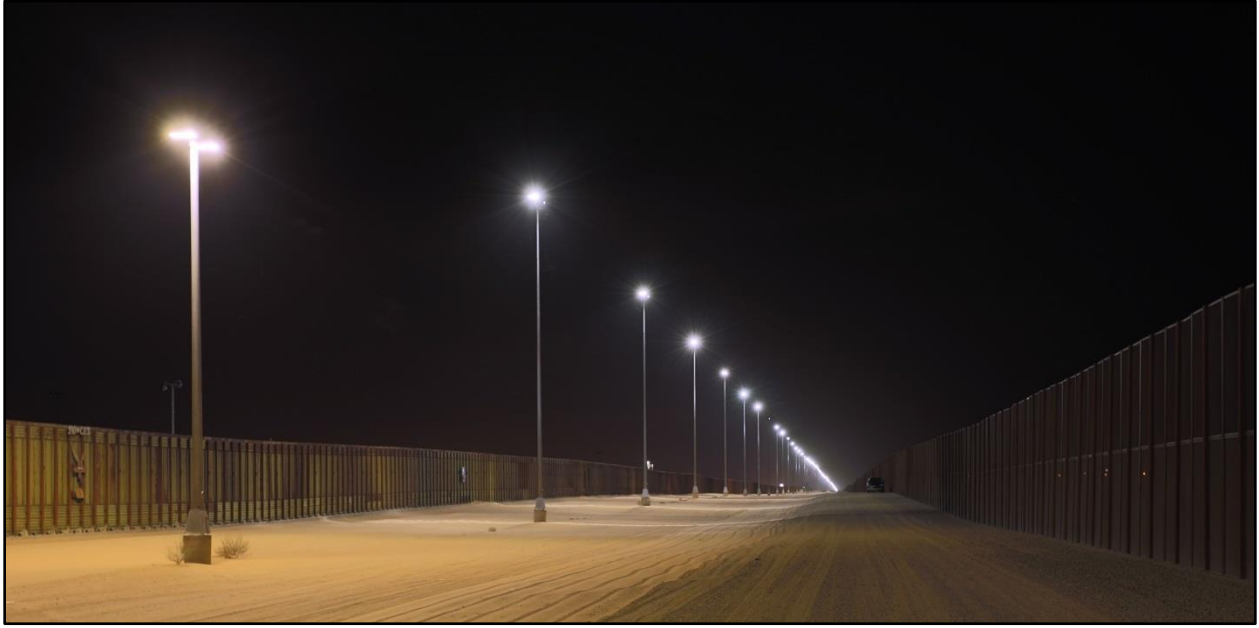
Figure 4. Trial Demonstration Site on the U.S.-Mexico Border: Nighttime. The 24 ft difference in height is visible in this image. The primary fence is on the left and on the right is the secondary fence—less noticeable in this image due to the relatively low light level on the fence.

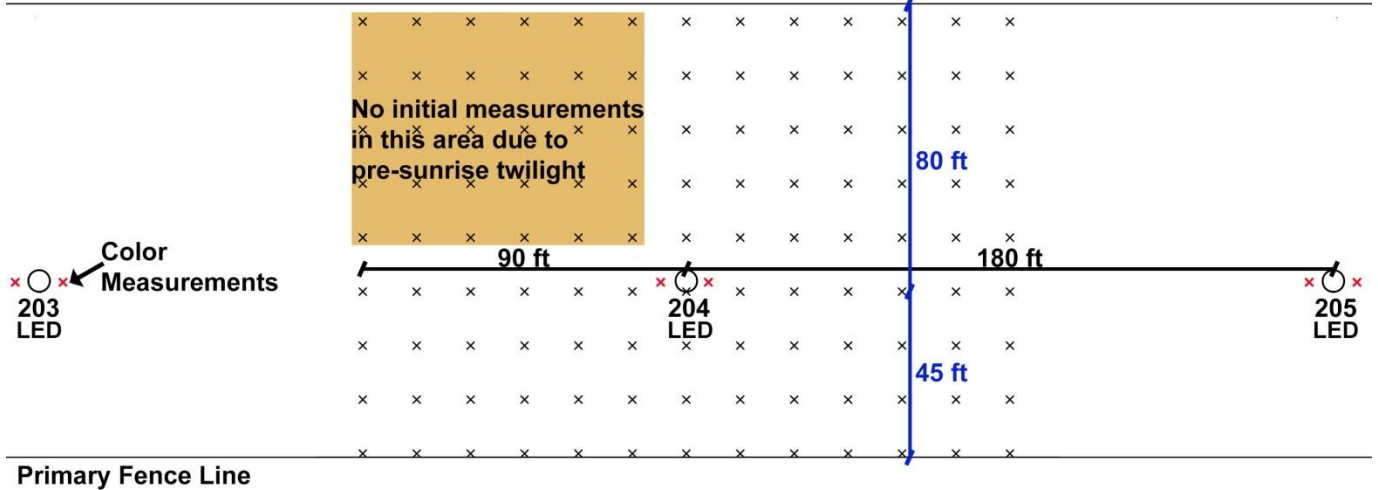
Figure 5. Layout of Grid Measurements. The measurements between poles 203 and 205 were recorded in a rectangular grid from the middle of the primary (south) face of the concrete pole pedestal at pole 204, with uniform 15 ft spacing in both directions. The horizontal measurements were recorded approximately 9.5 in. above the ground and the illuminance meter was leveled for each measurement with a tripod head. Vertical illuminance measurements were recorded at heights of 4 and 8 ft at the fence, along the same column as the horizontal illuminance measurements. A single color measurement was recorded under each LED luminaire, 36 ft below the luminaire.

The same measurement procedure was used for the initial, 2500 hour, and 5000 hour illuminance measurements. The measurements were recorded at points in a rectangular grid that was initiated from the middle of the primary (south) face of the concrete pole pedestal at pole 204, with measurement points spaced uniformly at 15 ft intervals in both directions (north-south and east-west) as illustrated in Figure 5. The horizontal measurements were recorded approximately 9.5 in. above the ground and the illuminance meter was leveled for each measurement with a tripod head. This measurement setup is shown in Figure 6. Leveling was necessary because of the unevenness of the sandy terrain. Vertical illuminance measurements were recorded at heights of 4 and 8 ft at the fence, in line with the columns of horizontal illuminance measurements. The illuminance meter was not leveled for each vertical measurement; however, the illuminance meter plane was approximately parallel to the vertical fence plane. The 15 ft spacing of the measurement columns was marked with spray paint on the primary and secondary fences during the initial set of measurements, and these same markings were used for the 2500 and 5000 hour measurements.

A total of 117 horizontal and 52 vertical measurements were recorded between poles 203 and 205, centered on pole 204. The measurements extended 90 ft east (halfway toward pole 205) and 90 ft west (halfway toward pole 203) of pole 204. Only 81 initial horizontal measurements were recorded because the sun began to rise before the measurements could be completed.

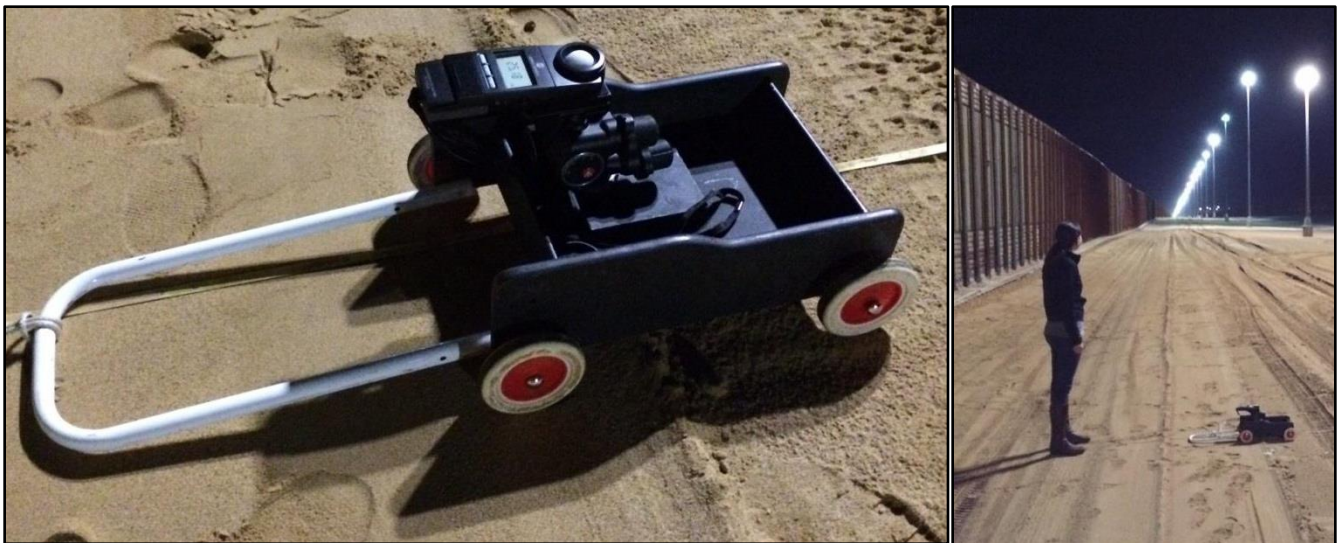
Figure 6. Illuminance Measurement Wagon. The illuminance meter was mounted on a tripod head, and the tripod head was attached to the base of the wagon. The knobs of the tripod head were used to adjust the front and lateral tilt of the illuminance meter to level the meter—with reference to the tripod head's leveling bubble.

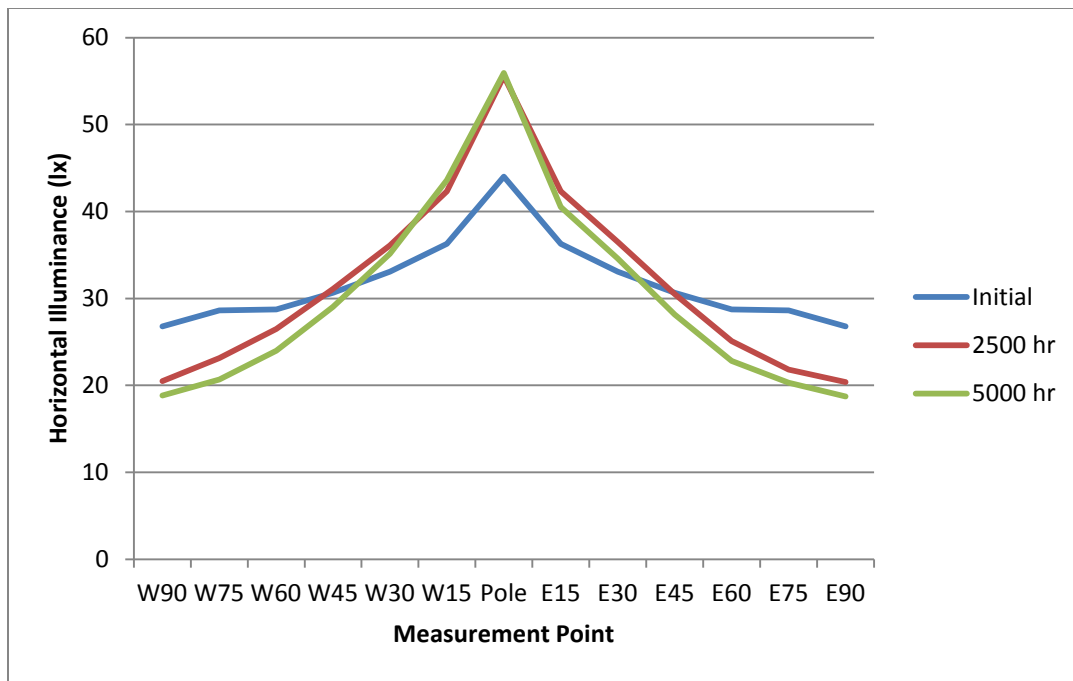
Figure 10. Measured Illuminances along East-West Line Centered at Pole 204 at Three Different Measurement Times. Illuminance values increased near the pole compared to the initial values, but decreased farther away from the pole. The numeric values in the labels along the horizontal axis indicate the distance from the pole in feet, and the letter indicates the direction from the pole. Illuminance values were normalized for a 25 °C (77 °F) condition.

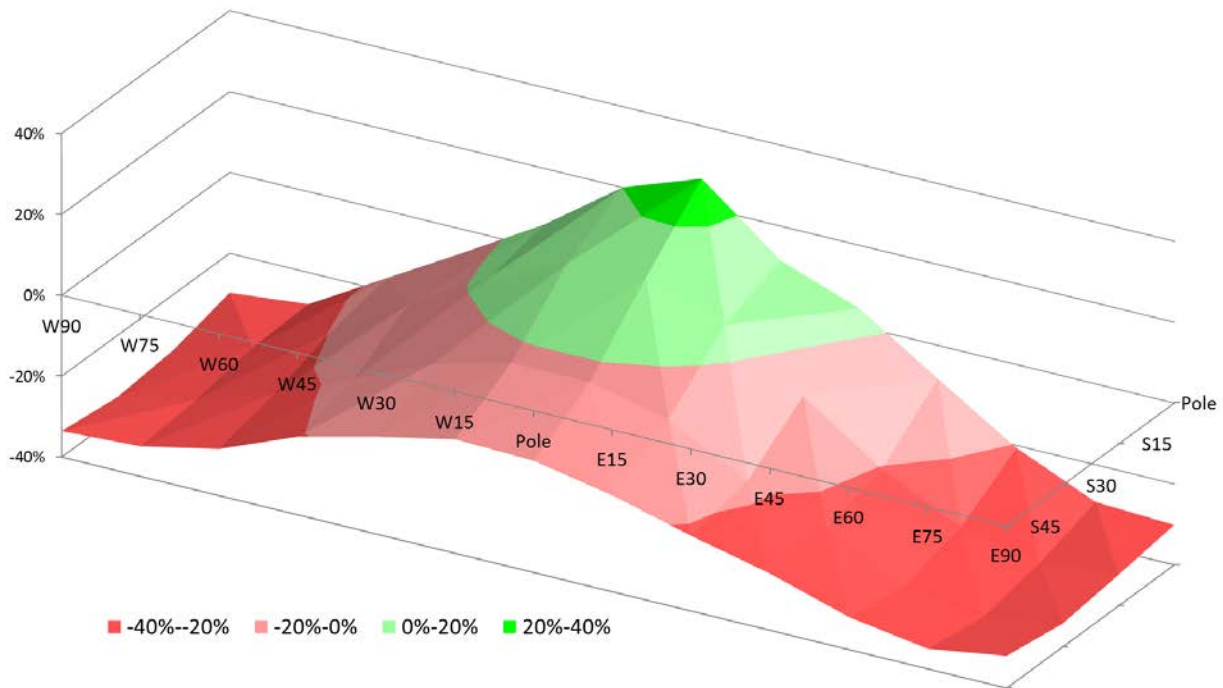
Figure 11. Relative Change in Illuminance between Initial and 5000 Hour Measurements. Green indicates areas where the illuminance increased and red indicates areas where the illuminance decreased. A uniform decrease in illuminance would appear as a flat plane below the 0% plane; the shape of this graph shows that the distribution of illuminance has changed. The numeric values in the labels along the horizontal axes indicate the distance from the pole in feet, and the letter indicates the direction from the pole. The primary fence at the U.S.-Mexico border stands just south of the measurement line shown as S45.

The reductions in average illuminance in the areas near the primary fence are a concern, since that is the primary task area for this application. However, average illuminance does not completely characterize the change in illuminance for this application. The averages indicate what is happening overall, but do not reveal the change in distribution over the 22,500 ft² area measured around pole 204. As stated in the fourth bullet above, this change in distribution increased illuminance near the pole and decreased illuminance farther away from the pole. Figure 10 shows this change in distribution for the measurements taken along the east-west line that includes pole 204, and Figure 11 shows a three-dimensional pseudo-color plot of the illuminance changes between 0 and 5000 hours.

The green areas shown in Figure 11 indicate areas where the measured illuminances after 5000 hours were greater than those measured at 0 hours, with the light green areas indicating zones where illuminance increased by 0% to 20% and dark green indicating the few points closest to the pole where the illuminance increased by more than 20%. The light red (pink) areas indicate zones where the illuminance decreased by 0% to 20% (shown as -20% in the legend) and the dark red areas farthest from the pole show those points where illuminance decreased by more than 20%. As discussed in Section 5, this pattern of changes in illuminance would not be expected from normal LED lumen depreciation—those changes would occur uniformly throughout the measurement area.

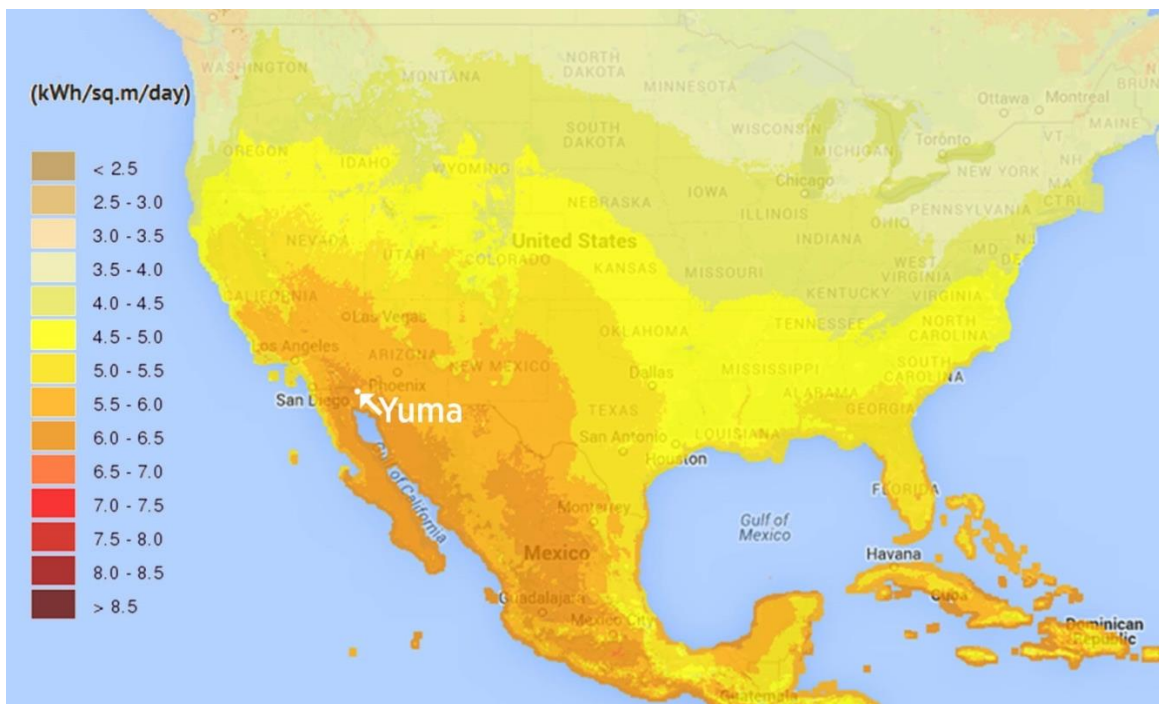
Figure 15. Average Annual Global Horizontal Irradiance (GHI) Grid (Source: National Renewable Energy Laboratory National Solar Radiation Data Base Data Viewer (mapsbeta.nrel.gov/nsrdb-data-viewer/)). GHI includes both diffuse and direct irradiance for a horizontal collector.

The Yuma site is an extreme environment, which is one of the reasons that the DOE chose to study this installation. The luminaires in Yuma rarely get a break from the heat: high ambient temperatures and direct solar radiation heat up the luminaires throughout the day, and at sunset the LED luminaires turn on and generate internal heat just as the solar radiation stops and the ambient temperature begins to decrease. For a typical year, as determined from Typical Meteorological Year 2 (TMY2) data sets,⁸ the maximum temperature at sunset in this area is approximately 38 to 44 °C (101 to 112 °F) and the minimum is approximately 2 to 6 °C (36 to 43 °F).⁹ The average nighttime temperature is 17 to 20 °C (63 to 68 °F). The high nighttime temperatures combined with some of the highest levels of solar radiation in the United States, as illustrated in Figure 15, result in a challenging environment for LED luminaires.

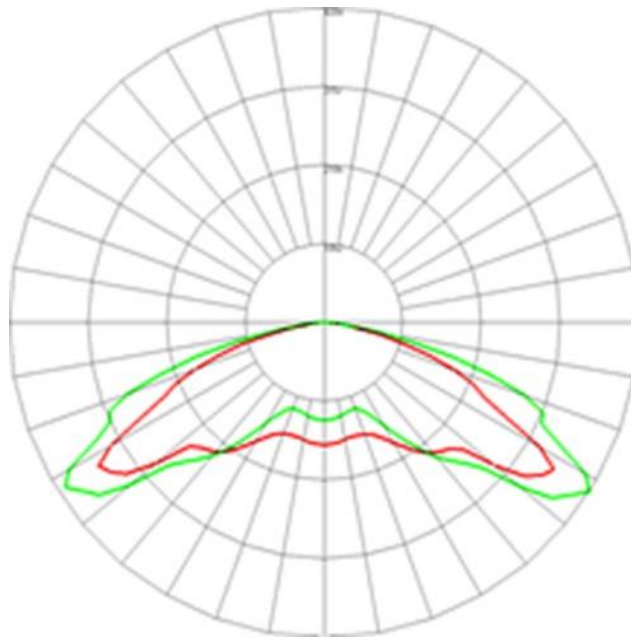
Figure 16. Distribution Effects of Dirt for an LED Streetlight Luminaire from the I-35W Bridge. The red plot shows the luminous intensity distribution from the “as is” or dirty luminaire prior to cleaning, and the green plot shows the distribution from the same luminaire after cleaning. For further information, download the Long-term Testing Results for the 2008 Installation of LED Luminaires at the I-35W Bridge in Minneapolis report developed by the DOE SSL Program: http://www1.eere.energy.gov/buildings/ssl/pdfs/gateway_i-35w_phasel1.pdf.

In addition to an overall reduction in light output, dirt accumulation on luminaires also tends to alter the light distribution by making it more diffuse. For optics such as those common to exterior luminaires that spread the light over large areas by delivering high intensity at high angles, this diffusion tends to increase the luminous intensity at low angles (close to nadir) and decrease the intensity at high angles. For example, Figure 16 shows the effect of dirt accumulation on the luminous intensity distribution from a luminaire tested in its dirty and clean conditions as part of a prior GATEWAY study. A change in distribution of this nature was also observed at the Yuma installation, where the illuminances increased at measurement points close to the pole and decreased farther away from the pole. Consequently, PNNL researchers believe that dirt accumulation on the LED luminaires at least partly explains the illuminance changes measured at the installation.
