Foxglove Solar, LLC

PERMIT BY RULE

Small Renewable Energy Project (Solar) Permit By Rule

Date: February 2021

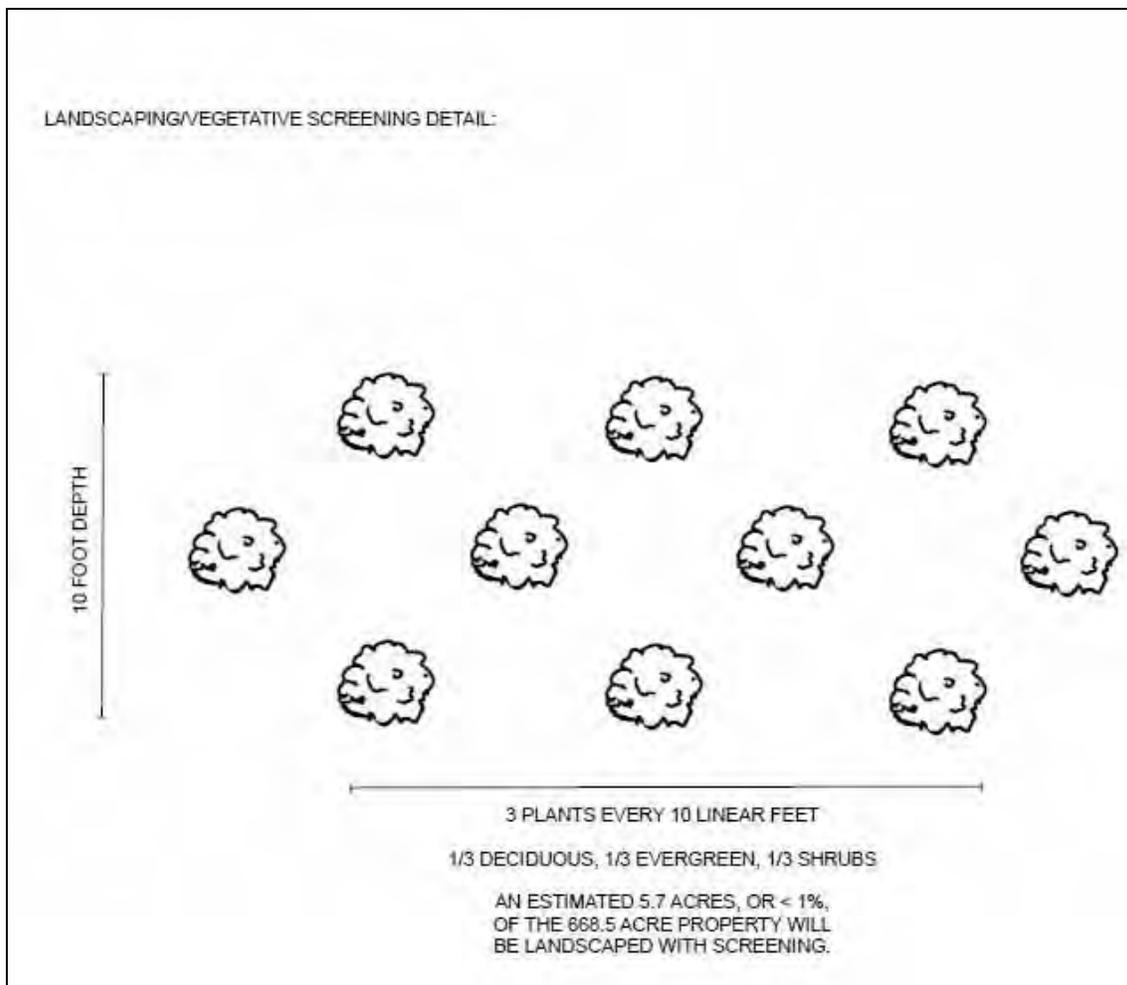
Figure 1: Landscape/vegetative screening detail. Source: Urban Grid

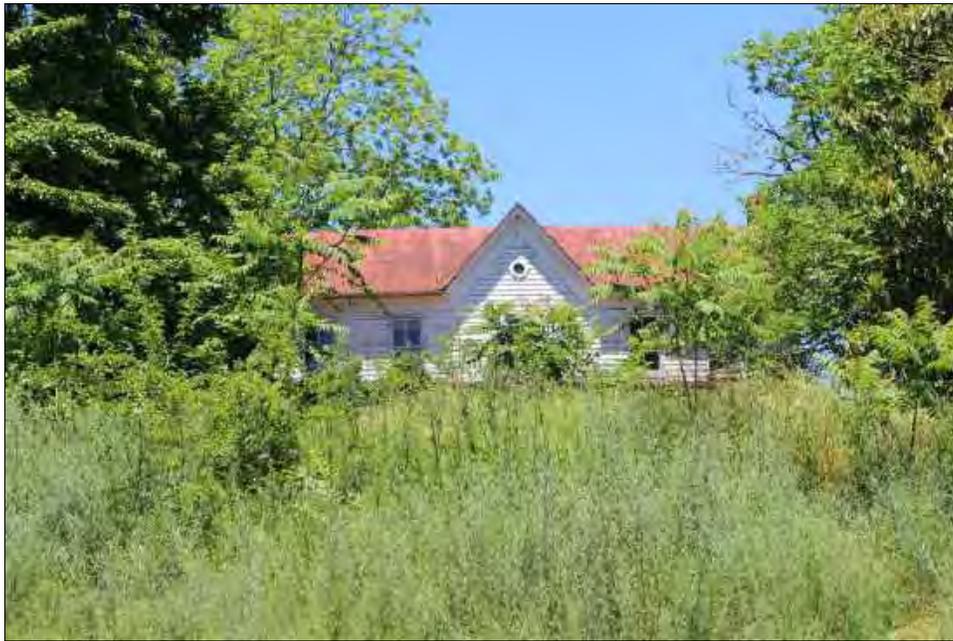
Figure 2: Location of Ash House in relation to the project area showing proposed vegetative screening. Source: Urban Grid

The revised project site plan accounts for visibility from this resource and includes the retention of 50-feet of existing mature woodland along the perimeter of the portion of the project area to be developed with solar panels (Figure 2). No improvements will take place within the portion of the project area where existing vegetation is thinner and/or does not provide complete screening. As such, the existing vegetation to be retained as a screening buffer is anticipated to provide adequate cover in all seasons, and therefore, the Foxglove Solar project is recommended to pose no more than a minimal impact on the Ash House.

Viewshed assessment found that the historic rural landscape around the resource is relatively intact, however, the setting is compromised by a wide high-voltage transmission line corridor that crosses through the open field to the north of the property. Inspection from the road in front of the house revealed that the rolling terrain and intervening treeline inhibit wide views of the project area. Much of the project is set on the opposite side of a wooded ridge from the Ash House which screens it from view, however a narrow portion of the project area may be visible where the treeline does not continue. The rolling topography, however, still breaks up the viewshed.

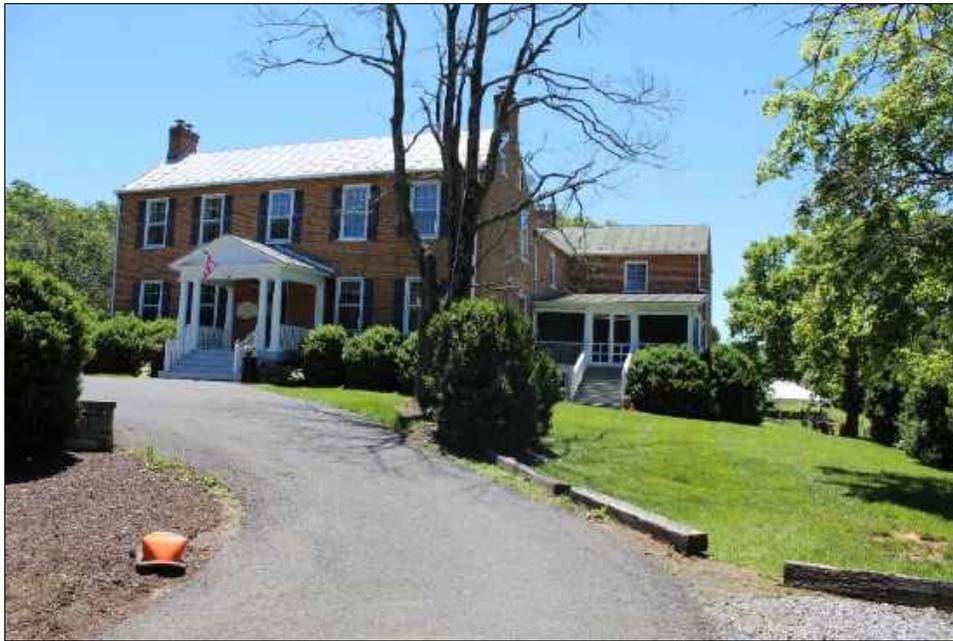
Figure 3: Location of Valerie Hill in relation to the project area showing setback and proposed vegetative screening. Source: Urban Grid

The revised project site plan accounts for visibility from this resource and as such, no improvements will take place within the portion of the project area immediately adjacent to, or in close proximity of the resource (Figure 3). The nearest improvements will be set back over 1,000 feet from the edge of the property; beyond a ridge, and behind an existing utility-scale transmission line. A supplemental landscape buffer will be planted along the perimeter of the improvements. As such, the distance and additional vegetative buffer are anticipated to provide year-round screening of the project, and therefore, the Foxglove Solar project is recommended to pose no more than a minimal impact on Valerie Hill.

Viewshed assessment found that the historic rural landscape around the resource is relatively intact, however, the property now functions as a winery and tasting room. Inspection from the road in front of the property revealed that the vegetation throughout the property, including the tree-lined driveway interrupt views towards the project area, however, it remains visible. Likewise, vantage points from within the property, including the parking lot in front of the dwelling and the outdoor seating area to the side have clear visibility of the adjacent portion of the project area, although wide views are interrupted by vegetation on the property and the rolling terrain of the project area.

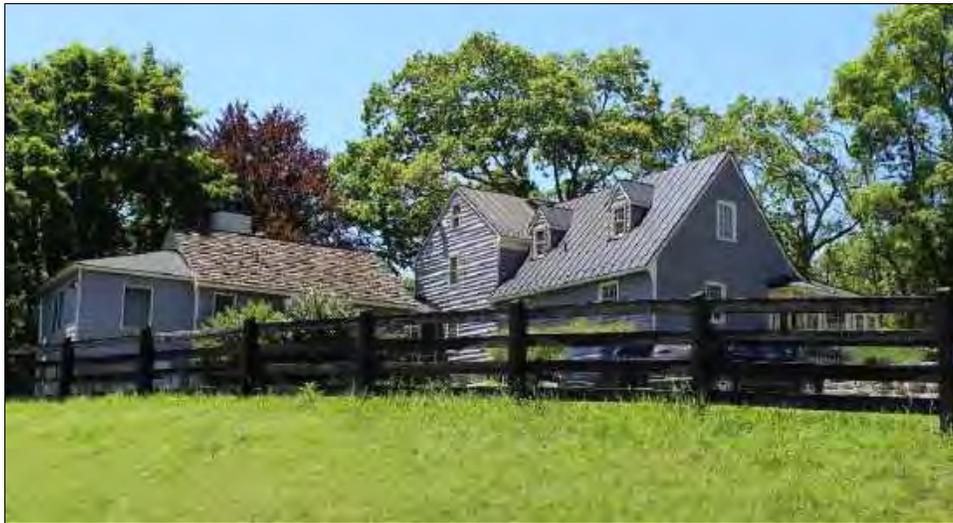
Figure 4: Location of John Chumley House in relation to the project area showing intervening distance and vegetation. Source: Urban Grid

The John Chumley House is located near the front edge of the Vaucleuse property, furthest from the project area (Figure 4). It is bordered by a thick wooded area, downhill from a ridge that extends through the property that inhibits distant views in the direction of the project area. As such, the overall property in which the resource is set was determined to have no more than a minimal impact, and this individual building is set within a portion of that property with substantial vegetative and screening, the Foxglove Solar project is recommended to pose no more than a minimal impact on the John Chumley House.

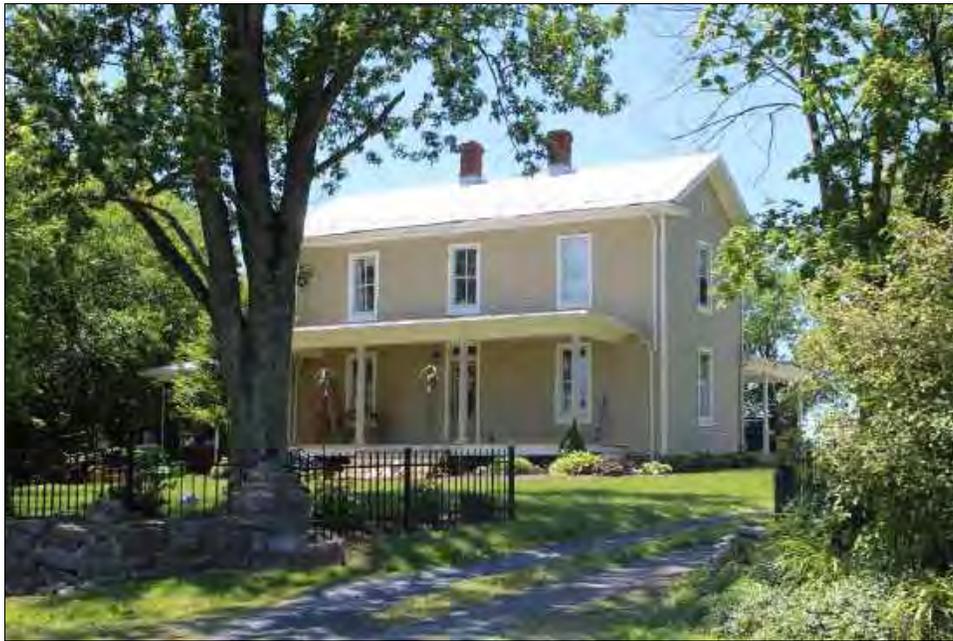
Figure 5: Location of Shiley Farm in relation to the project area showing proposed setback and vegetative screening. Source: Urban Grid

The revised project site plan accounts for visibility from this resource and includes the retention of a setback of improvements from the edges of the project area in the vicinity of the property ranging from 50-feet to 200-feet. Additionally, a ten-foot wide supplemental vegetative buffer will be planted around the perimeter of all project improvements to provide screening in all seasons (Figure 5). As such, there will be a change in viewshed from the resource due to the introduction of vegetative screening to the rear and across the street to the front, however, project improvements are anticipated to be largely screened. Therefore, the Foxglove Solar project is recommended to pose a moderate impact on the Shiley Farm.

Viewshed assessment found that the historic rural landscape around the resource is intact although it is flanked by nonhistoric homes set on small lots. The dwelling rests atop a slight knoll on a lushly landscaped yard. Inspection from the road in front of the property revealed unobstructed views of the project area across the street, however the ridge atop which the home rests and extends parallel to the road screens visibility of the portion of the project area behind the house. Inspection from the driveway bordering the edge of the property revealed visibility of the project area both to the front and rear of the house. As the project area is immediately adjacent to the rear of the resource and across the road to the front, it is visible from public ROW in front of the property as well as within the property and project improvements may also be expected to be visible.

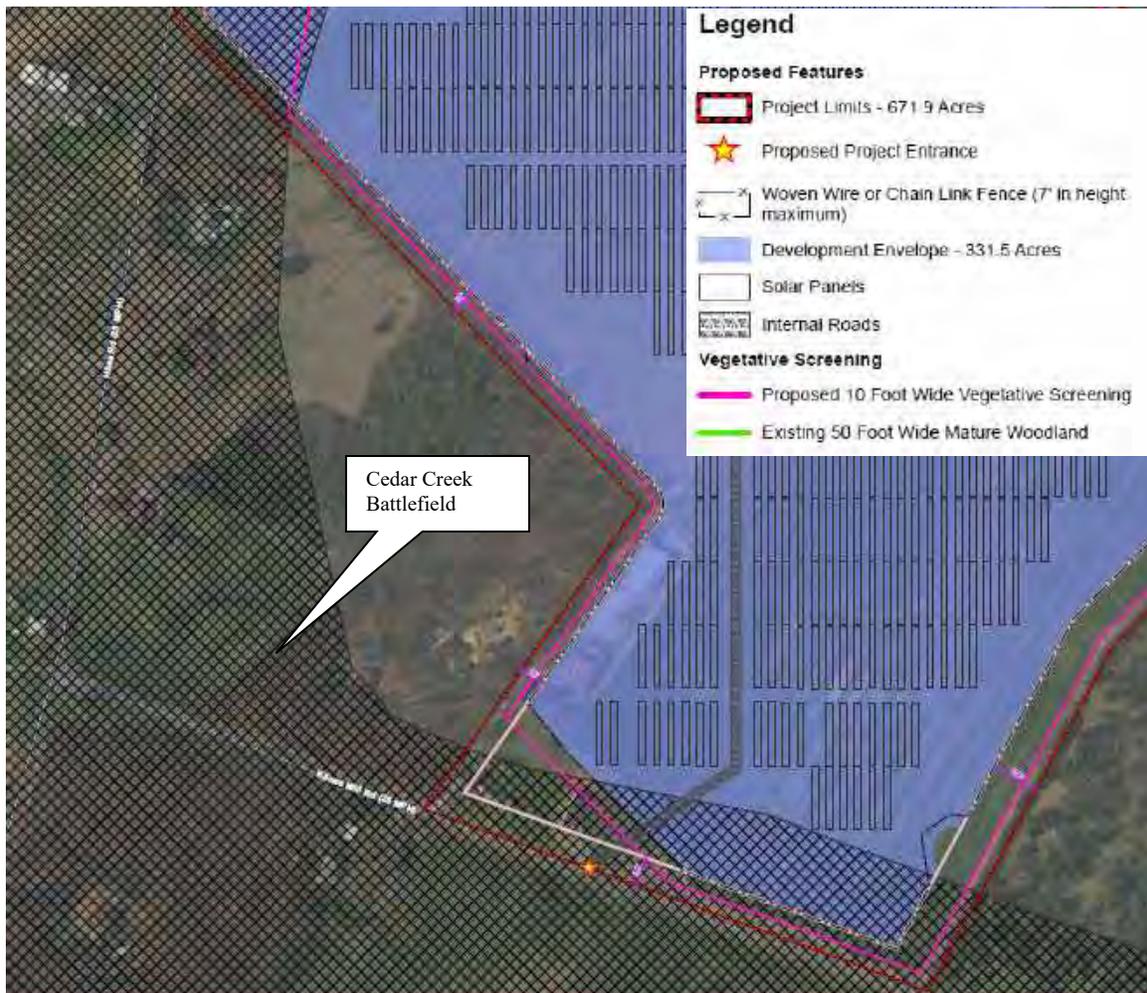
Figure 6: Detail of Cedar Creek Battlefield in relation to the project area showing proposed solar array setback and vegetative screening. Source: Urban Grid

Improvements related to the Foxglove Solar project are proposed to take place within the landscape to the north of the battlefield. The battlefield immediately borders the southern edge of the project area and slightly overlaps it along Hites Road and Klines Mill Road. The landscape within the portion of the battlefield in the vicinity of the project area is generally characterized by rolling terrain with a mix of open pasture and a patchwork of wooded area and treelines.

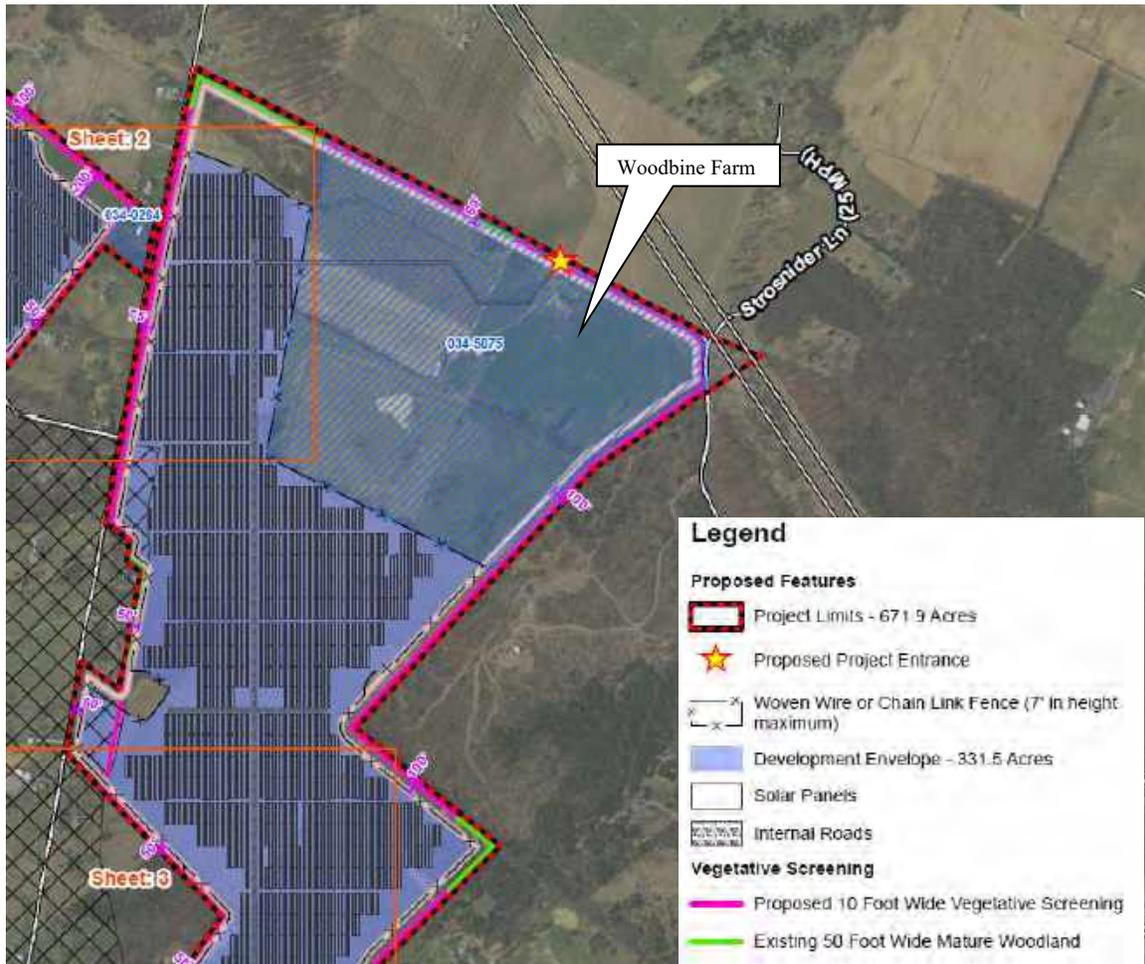
Figure 7: Location of Woodbine Farm in relation to the project area showing setback and proposed vegetative screening. Source: Urban Grid

Although the Foxglove Solar Project area includes the Woodbine Farm property, improvements related to the project are proposed to take place within the landscape to the west and south of the property. The property is immediately adjacent to project area along these borders, although the barn of primary significance is set centrally within the property and is nearly 0.25 mile away. The landscape of the property and the portion of the project area bordering it is generally characterized by rolling terrain currently under a mix of orchard and pasture.

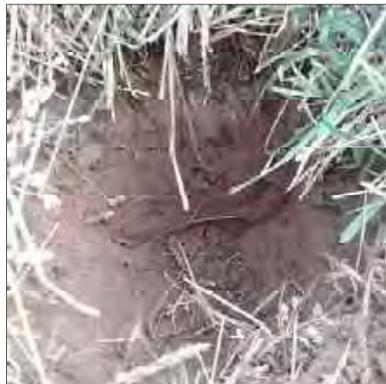
Figure 8-12: Soil profile of Shovel Test C3.

10YR 4/4 silty loam
0-22 cm

7.5YR 5/8 silty clay
22-33 cm

Subsurface testing revealed that the soils were extremely rocky, as indicated by the fact that many shovel test pits terminated at bedrock, and in many cases, bedrock was directly under the surface of the root matt. Depths to subsoil or bedrock ranged from 4 cm to 37 cm. A typical profile representative of the stratigraphy in Area A consisted of 22 cm of 10YR 4/4 dark yellowish brown

silty loam over 7.5YR 5/8 strong brown silty clay (Figure 8-12). No artifacts or features were identified in Area A, no further work is recommended.

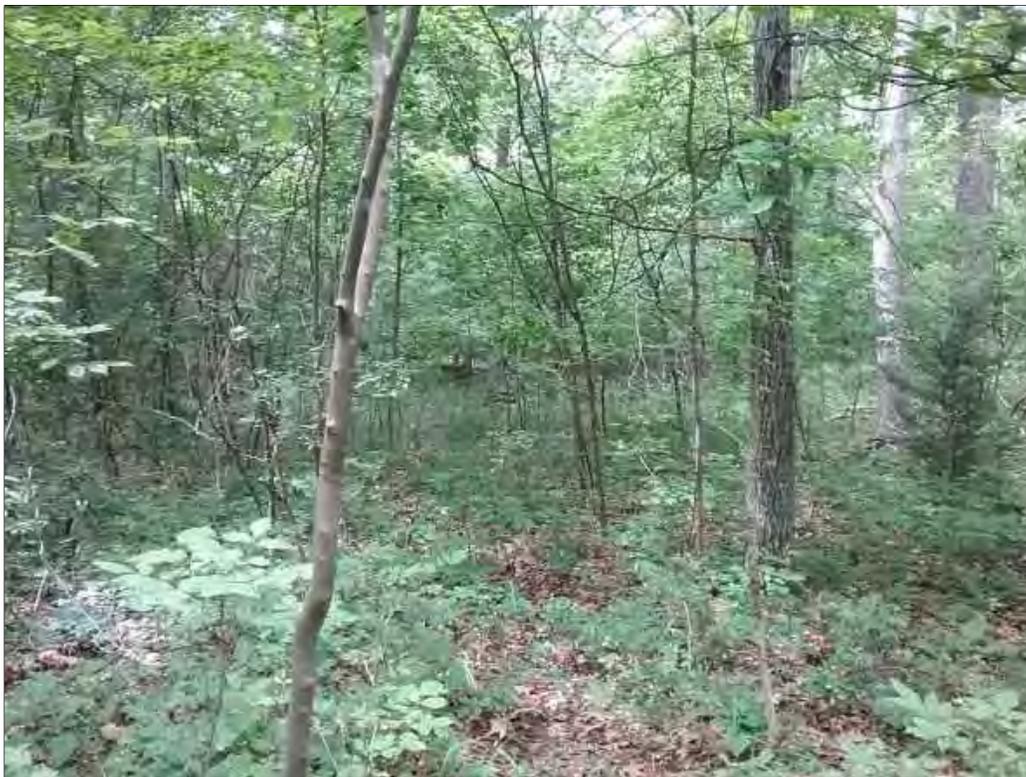
Figure 8-16: Photo illustrating western terrain slope at location of Judgmental shovel test pit 1.

One judgmental shovel test pit was excavated on the ridge north of Grid B1. A grid was not excavated on this ridge because most of the landform consisted of exposed bedrock and sloped to the west (Figure 8-16). The excavated shovel test pit consisted of 13 cm of 7.5YR 4/4 brown silty loam over 5YR 5/8 yellowish red mottled with 7.5YR 6/6 reddish yellow silty clay which came down to bedrock (Figure 8-17).

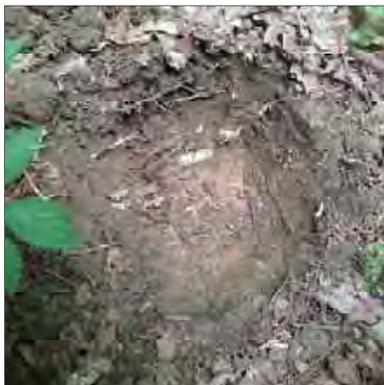
10YR 4/4 silty loam
0-13 cm

5YR 5/8 and 7.5YR
6/6 silty clays
13-20 cm

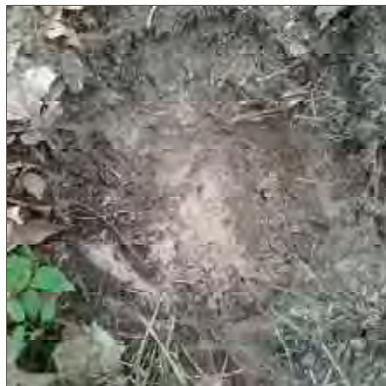
10YR 4/6 silty loam
0-17 cm

7.5YR 5/8 silty clay
17-27 cm

In Grid C1, depths of shovel test pits ranged from 5 cm to 32 cm to subsoil or bedrock. In many cases, bedrock was encountered just beneath the removal of the sod cap, thus accounting for shallow shovel test pits depths such as 5 cm to subsoil. A typical profile representative of the stratigraphy in Area C consisted of 17 cm of 10YR 4/6 dark yellowish brown silty loam over 7.5YR 5/8 strong brown silty clay (Figure 8-20).

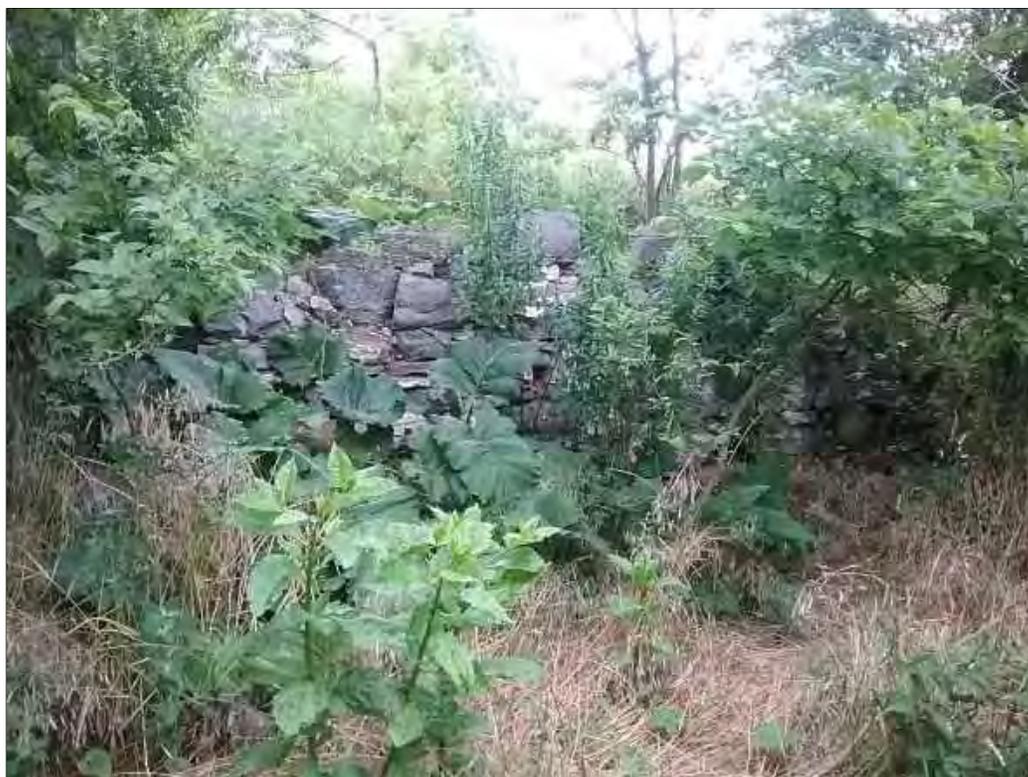
Figure 8-36: Stone foundation, facing northeast.

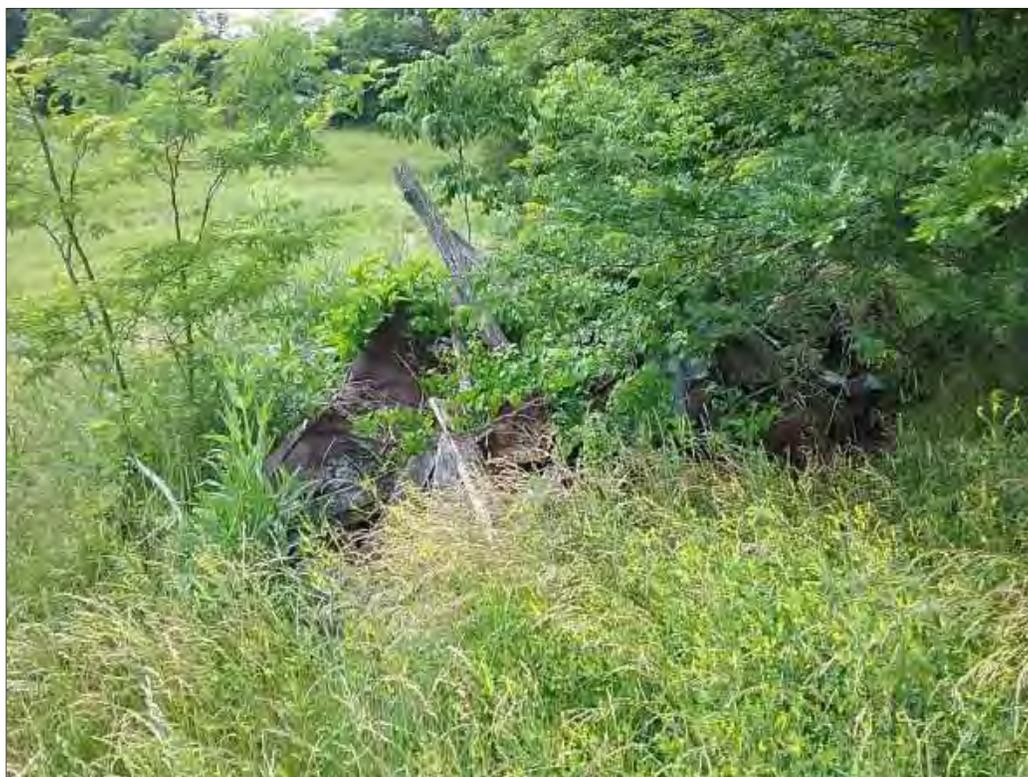
Figure 8-37: Collapsed structure, facing southwest.

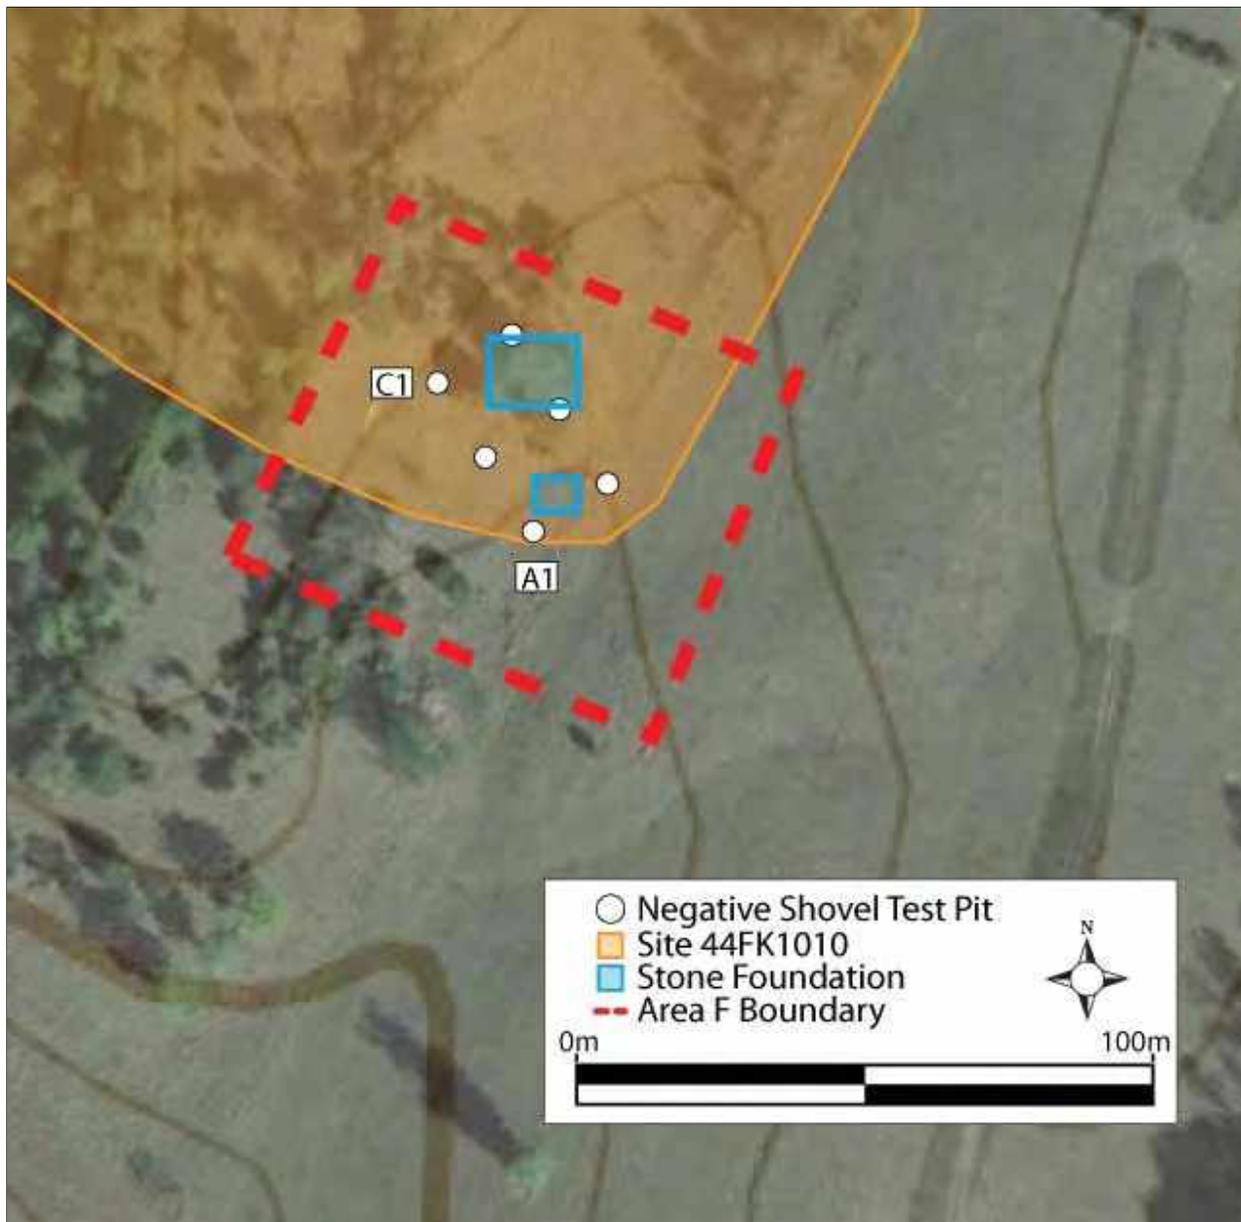
Figure 8-38: STP map of Area F.

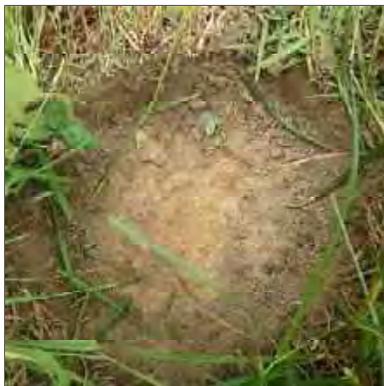
Figure 8-39: Soil profile of Shovel Test B1.

10YR 4/4 silty loam
0-3 cm

5YR 6/8 clay
3-8 cm

In Grid F1, depths of shovel test pits ranged from 2 cm to 4 cm to subsoil or bedrock. A typical profile representative of the stratigraphy in Area F consisted of 4 cm of 10YR 4/4 silty clay loam dark yellowish brown over 5YR 6/8 yellowish red clay (Figure 8-39).

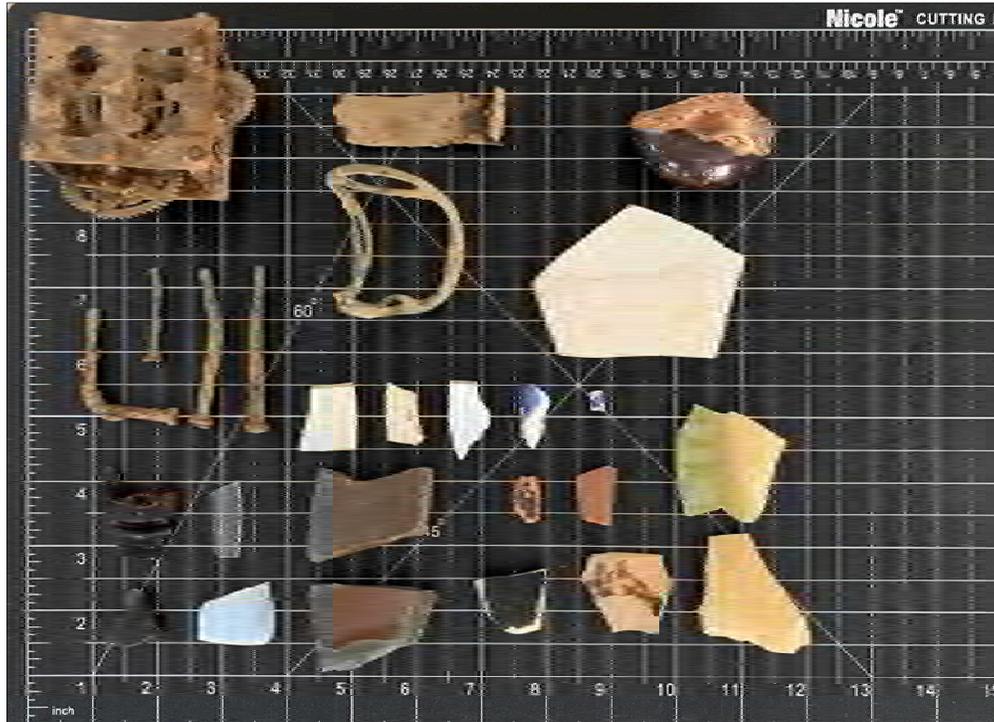
Figure 8-40: Artifacts collected at Site 44FK1010.

Site 44FK1010 is located on a knoll in the western center of the northernmost parcel of the project area. The site is clustered around the ruins of a circa 1830s single dwelling – The Miller House – and its associated outbuildings (VHDR #034-0254). VDHR #034-5085 – The Miller Cemetery – is also located within this archaeological site. The site consists of a total of 36 positive shovel test pits and a total of 235 artifacts, including aqua window glass, barbed wire, nail cut nails, redware with lead glaze, handmade brick, shell edge pearlware, an earthenware agateware doorknob, colorless vessel glass, window glass, milk glass with a molded decoration, Chinese porcelain with a transfer print, molded colorless vessel glass, whiteware with a molded rim, whiteware, wire nails, a zinc lid jar, wrought nails, an iron sheet, stoneware with Albany slip, plaster, lime, an iron chain, American gray salt glaze stoneware, yellowware, the inner workings of a clock, and hard paste porcelain (Figure 8-40) (see Appendix B for a full list of artifacts).

Surface features and architectural resources identified within the site include: 1) the remains of the circa 1830 Miller House, measuring 3 meters by 5.5 meters (10 feet by 18 feet); 2) the Miller Cemetery (VHDR #034-5085) which measures approximately 9 meters (30 feet) north-south by 19.5 meters (64 feet) east-west; 3) a stone foundation measuring approximately 12 meters by 15 meters (40 feet by 50 feet); 4) a ruined shed measuring approximately 2.4 meters by 2.4 meters (8 feet by 8 feet); 5) a second ruined shed measuring approximately 1.8 meters by 1.8 meters (6 feet by 6 feet); 6) a rubble pile and partial brick foundation representing the remains of some small structure measuring approximately 1.8 meters by 3.65 (6 feet by 12 feet); 7) remains of two stone walls, consisting of one stone wall which runs approximately 274 meters (900 feet) of stacked stone running north-south along the western edge of the site which turns and runs approximately 43 meters (142 feet) east-west towards the primary structure of VDHR #034-0254 and a second stacked stone wall north of the first one measuring approximately 112 meters (367 feet) north-south and then turns to run east-west towards the primary structure of VDHR #034-0254 for approximately 53 meters (175 feet); 8) an old road trace; and 9) a pipe in the ground dating to 1897.

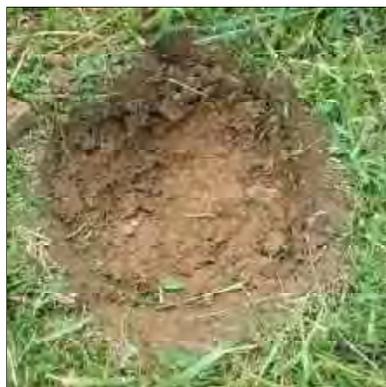
Figure 8-47: Soil profile of Shovel Test B1.

10YR 4/4 silty loam
0-8 cm

10YR 5/8 silty clay
loam
8-18 cm

In Grid H1, depths of shovel test pits ranged from 2 cm to 15 cm to subsoil or bedrock. A typical profile representative of the stratigraphy in Area H consisted of 8 cm of 10YR 4/4 silty loam dark yellowish brown over 10YR 5/8 yellowish brown silty clay (Figure 8-47). Several shovel test pits came down to bedrock.

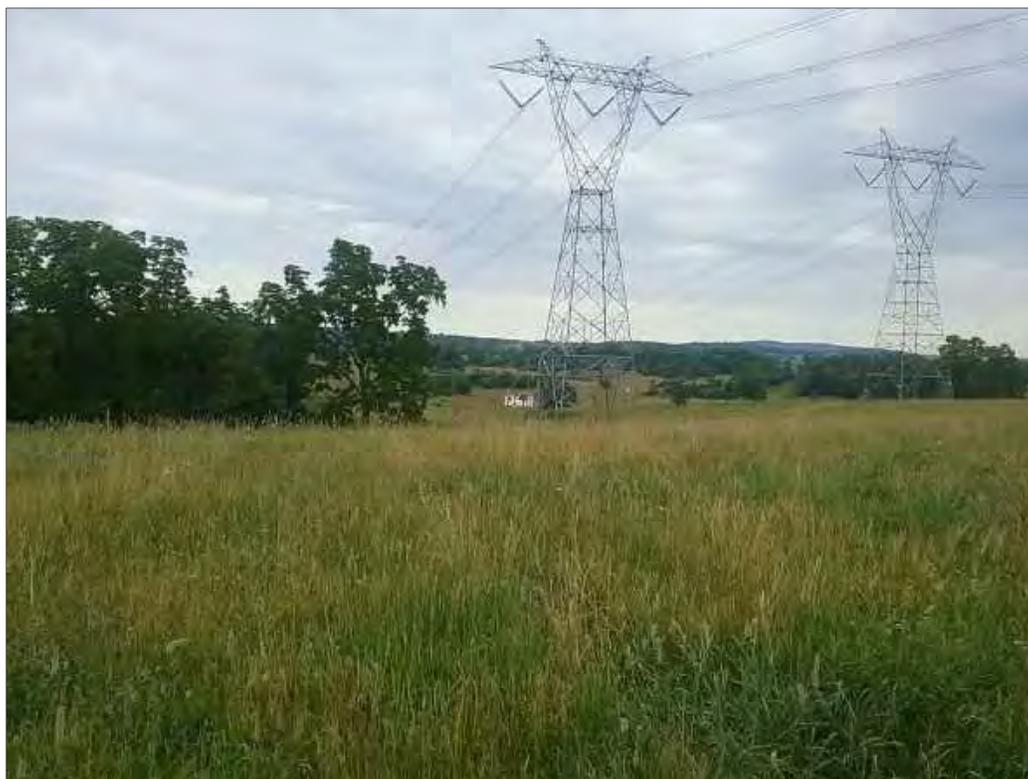
Figure 8-51: Powerline in the northern portion of Area K, facing north.

Area K is in the center of the northernmost parcel in the project area. A powerline runs southwest-northeast along the northern edge of the area, and an access road runs north-south through the ridge which makes up much of the area (Figure 8-51). The area is currently acting as a cattle pasture.

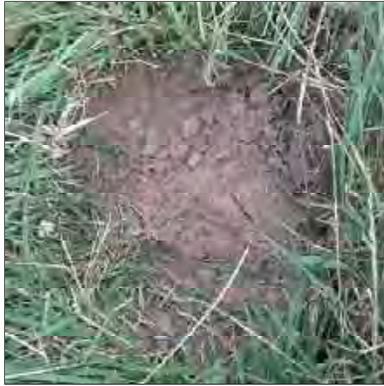
Figure 8-54: Soil profile of Shovel Test B2.

10YR 4/4 silty loam
0-10 cm

7.5YR 5/8 silty clay
10-11 cm

In Grid K1, depths of shovel test pits ranged from 2 cm to 14 cm to subsoil or bedrock. A typical profile representative of the stratigraphy in Area K consisted of 10 cm of 10YR 4/4 silty loam dark yellowish brown over 7.5YR 5/8 strong brown silty clay (Figure 8-54). Several shovel test pits came down to bedrock.

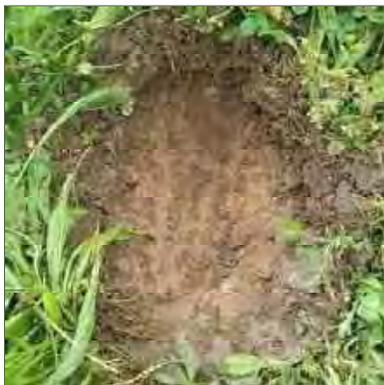
10YR 4/4 silty loam
0-10 cm

7.5YR 5/8 silty clay
10-11 cm

One judgmental shovel test pit – labeled judgmental shovel test pit 1 – was excavated in Area L to confirm the disturbance suggested by the presence of gravel, barns, and paddock activity (Figure 8-60). This shovel test pit consisted of 4 cm of 10YR 4/4 silty clay loam dark yellowish brown with approximately 30 percent gravel which came down to 10YR YR 6/8 brownish yellow with approximately 20 percent gravel (Figure 8-61). The presence of gravel and the lack of topsoil confirmed the disturbance level of this area. No artifacts were collected and no further work was conducted.

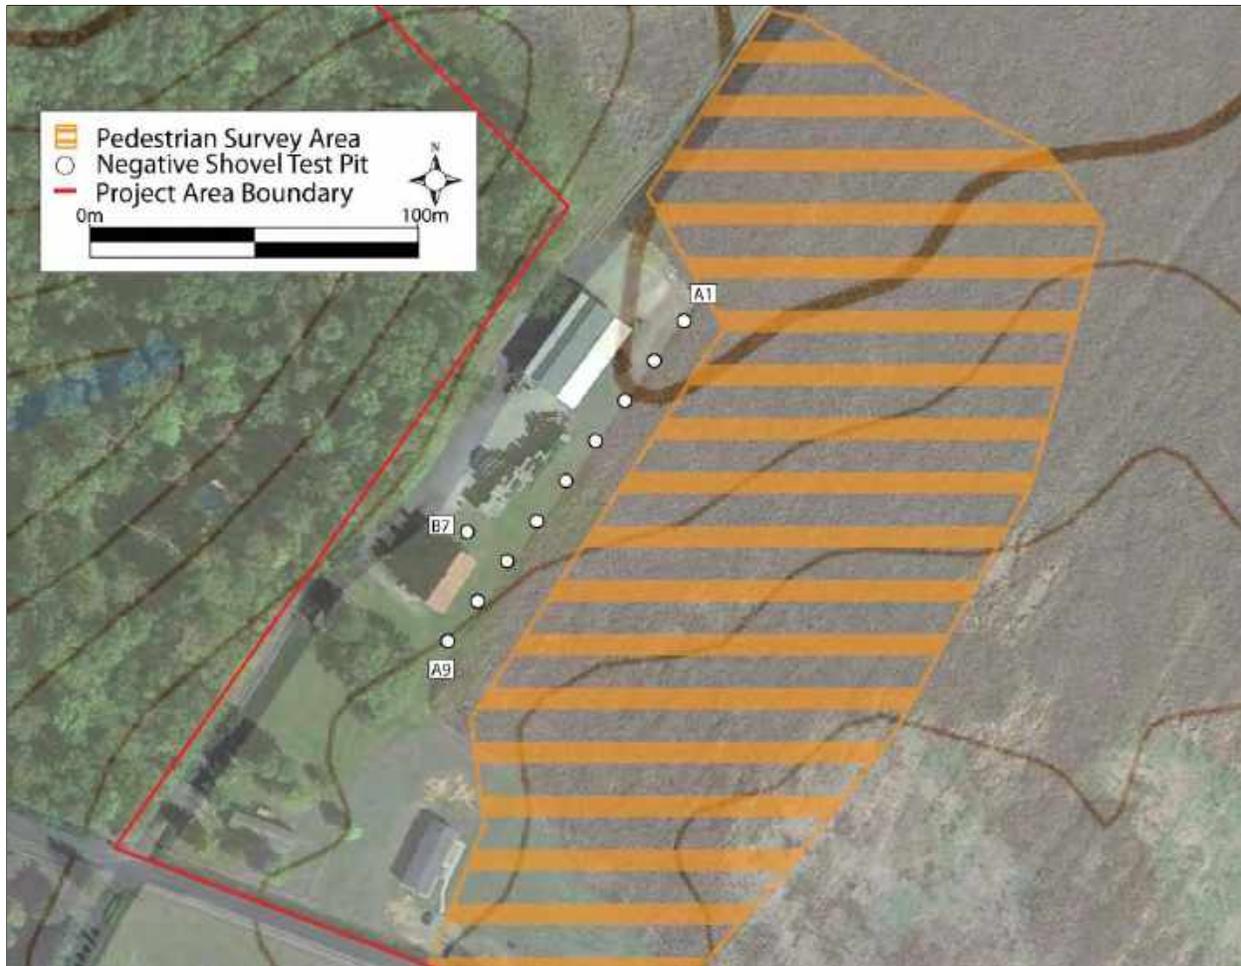
Figure 8-73: Detail map of Area O, showing shovel test pits.

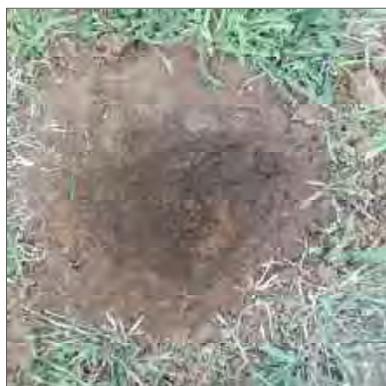
Figure 8-74: Soil profile of Shovel Test A4.

10YR 4/4 silty clay
0-25 cm

10YR 6/8 silty clay
25-30 cm

In Grid O1, depths of shovel test pits ranged from 2 cm to 25 cm to subsoil. A typical profile representative of the stratigraphy in Area O consisted of 25 cm of 10YR 4/4 dark yellowish brown silty clay loam over 10YR 6/8 brownish yellow silty clay which came down to bedrock (Figure 8-74). No artifacts were recovered, and no further work is recommended for this area.

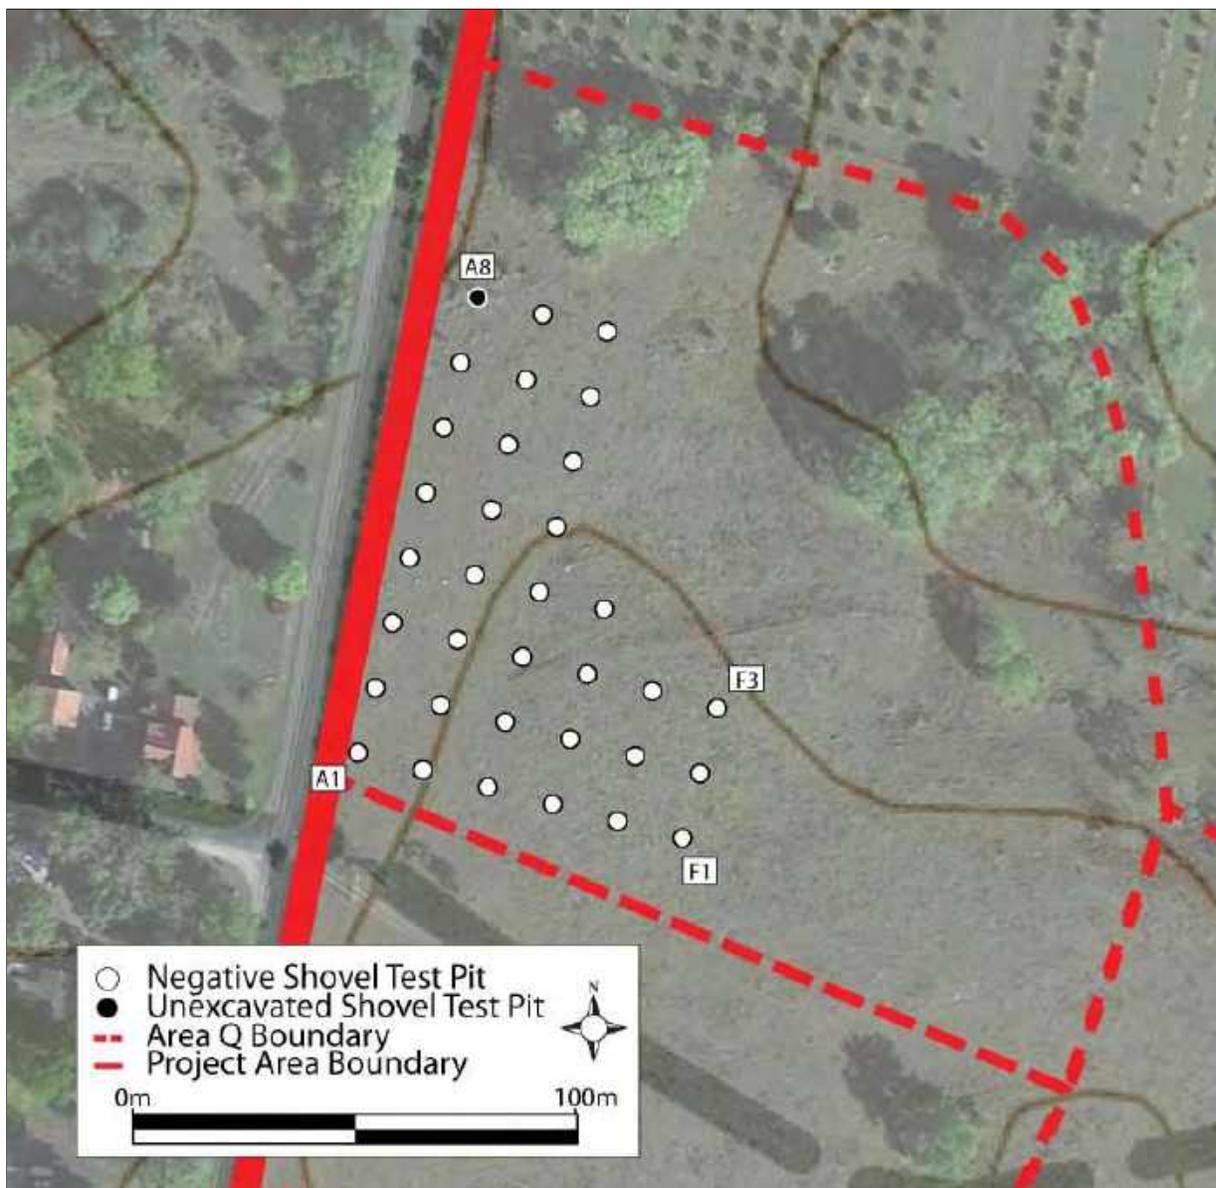
Figure 8-80: STP map of Area Q.

A total of 34 shovel tests were laid out at 15-meter (50-foot) intervals in six (6) transects labeled A through F (Figure 8-80). One shovel test pit was left unexcavated due to the presence of exposed bedrock on the surface. No artifacts were recovered, and shovel test pits were shallow.

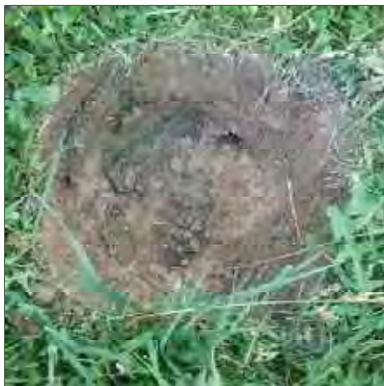
7.5YR 4/4 silty clay
0-13 cm

5YR 5/8 silty clay
13-26 cm

In Grid Q1, depths of shovel test pits ranged from 3 cm to 21 cm to subsoil, with several of the shallower shovel test pits terminating at rock impasses. A typical profile representative of the stratigraphy in Area Q consisted of 13 cm of 7.5YR 4/4 brown silty clay over 5YR 5/8 yellowish red silty clay (Figure 8-81). No artifacts were recovered, and no further work is recommended for this area.

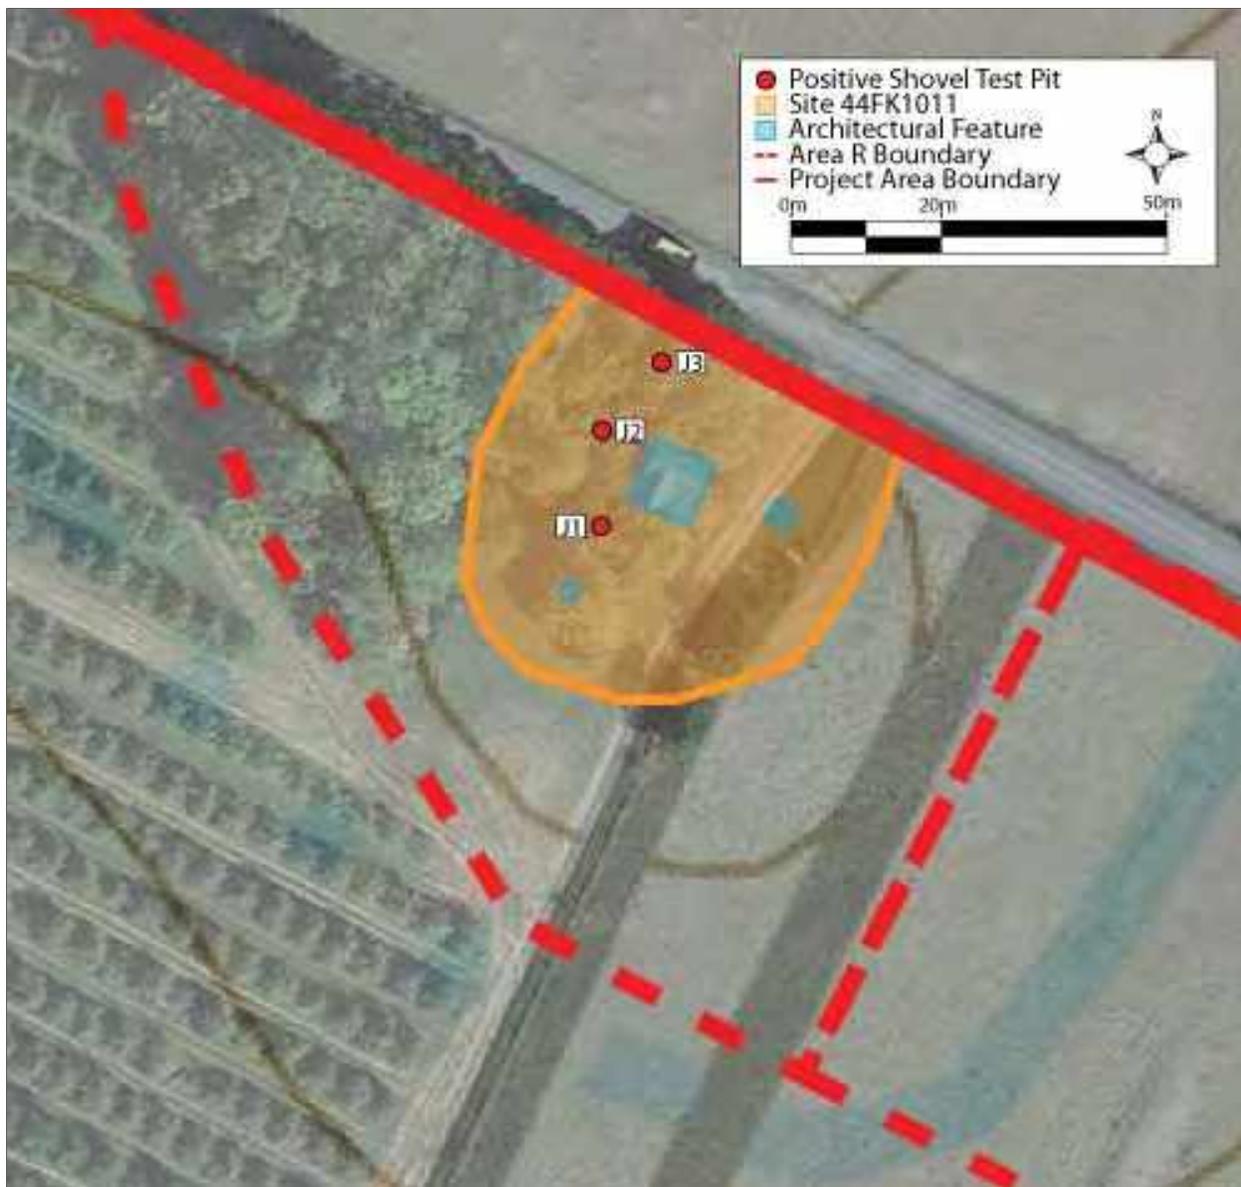
Figure 8-86: STP map of Area R.

A total of three judgmental shovel test pits were excavated where disturbance allowed (Figure 8-86). The placement of a grid in this location was impossible due to the presence of dumped garbage and debris. All shovel test pits contained garbage, including plastic; however all shovel test pits also contained cultural material including a metal plate, glass, and ceramic.

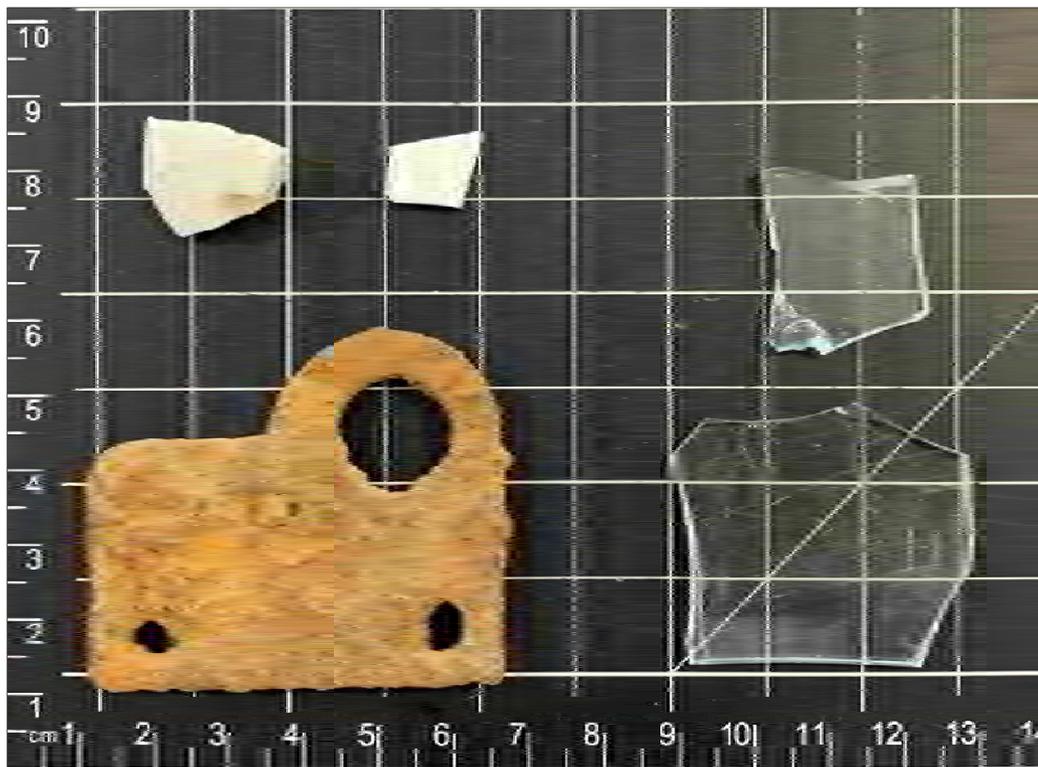
Figure 8-88: Artifacts collected at Site 44FK1011.

Site 44FK1011 consists of a total of eight (8) collected artifacts which are concentrated in the yard space of part of a previously identified architectural resource – VDHR 034-5075 – Each shovel test pit excavated in this area contained cultural material associated with this site, along with debris such as plastic. Artifacts collected include porcelain, aqua window glass, an iron lock plate, European hard paste porcelain, and colorless vessel glass (Figure 8-88) (see Appendix B for a complete list of artifacts). Due to the disturbance as confirmed by visual inspection and by the presence of debris in the excavated shovel test pits, it is unlikely that further excavation of this site will provide any valuable historical data. This site is recommended as not eligible for inclusion in the NRHP.
