Foxglove Solar, LLC

PERMIT BY RULE

Small Renewable Energy Project (Solar) Permit By Rule

Date: February 2021

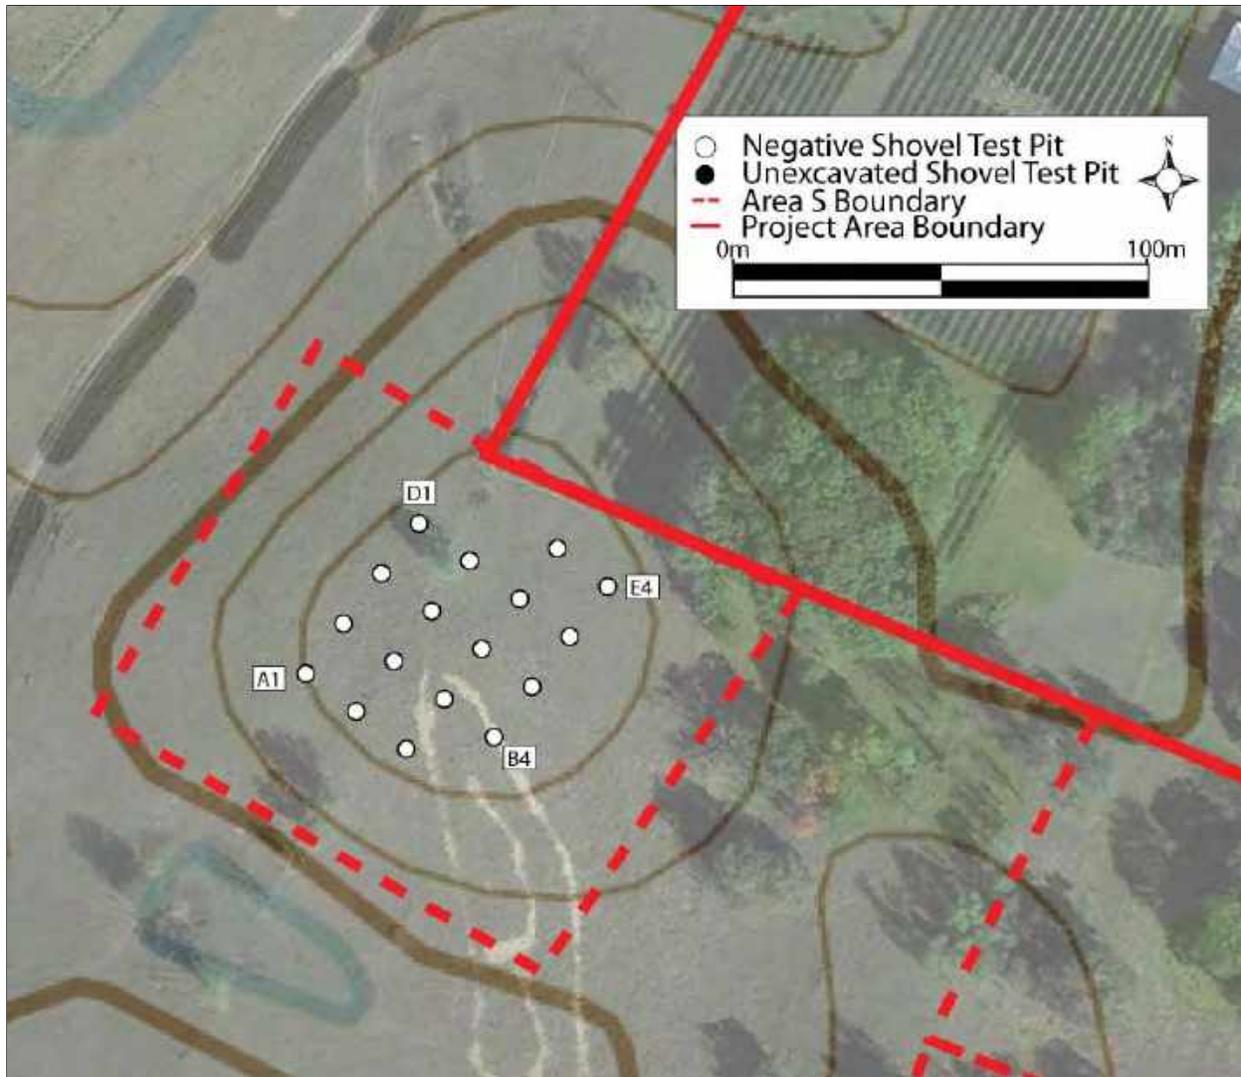
Figure 8-90: STP map of Area S.

A total of 17 shovel tests were laid out at 15-meter (50-foot) intervals in five (5) transects labeled A through E (Figure 8-90). Modern wire was noted in shovel test pit B2, which was located near a row of trees. This wire most likely was associated with a since demolished wire fence and was not collected. No other cultural material was identified.

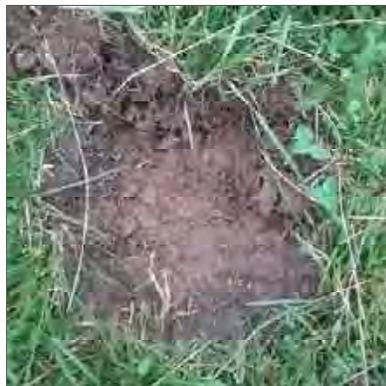
10YR 4/4 silty clay
0-10 cm

7.5YR 5/8 silty clay
10-18 cm

In Grid S1, depths of shovel test pits ranged from 2 cm to 20 cm to subsoil, with several of the shallower shovel test pits terminating at rock impasses. A typical profile representative of the stratigraphy in Area S consisted of 10 cm of 10YR 4/4 dark yellowish brown silty clay over 7.5YR 5/8 strong brown silty clay (Figure 8-91). Other than the abovementioned wire, no cultural material was recovered, and no further work is recommended for this area.

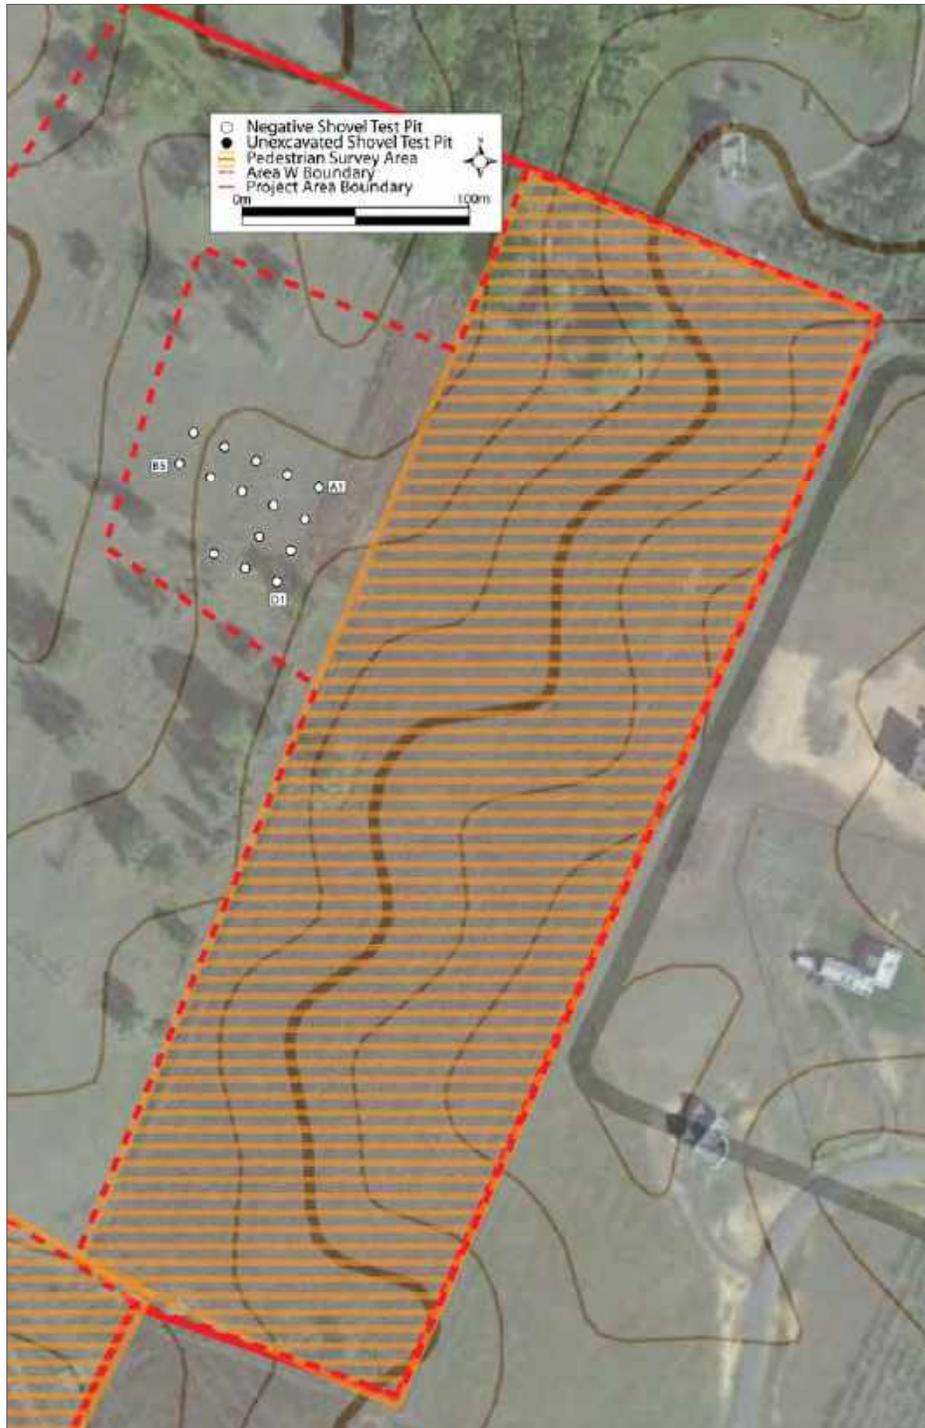
Figure 8-107: STP map of Area W.

A total of 15 shovel tests were laid out at 15-meter (50-foot) intervals in four (4) transects labeled A through D (Figure 8-107). No artifacts were noted or collected.

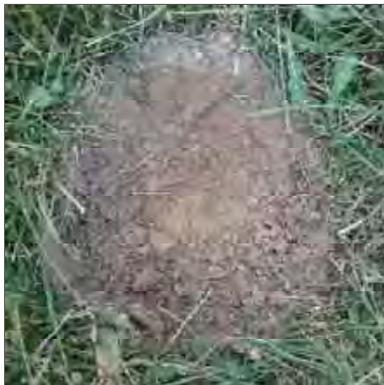
Figure 8-108: Soil profile of Shovel Test C1.

In Grid W1, depths of shovel test pits ranged from 2 cm to 14 cm to subsoil, with many shovel test pits terminating at bedrock. A typical profile representative of the stratigraphy in Area W consisted of 8 cm of 10YR 4/6 dark yellowish brown silty loam over 10YR 6/3 pale brown silty clay and bedrock (Figure 8-108). No cultural material was recovered.

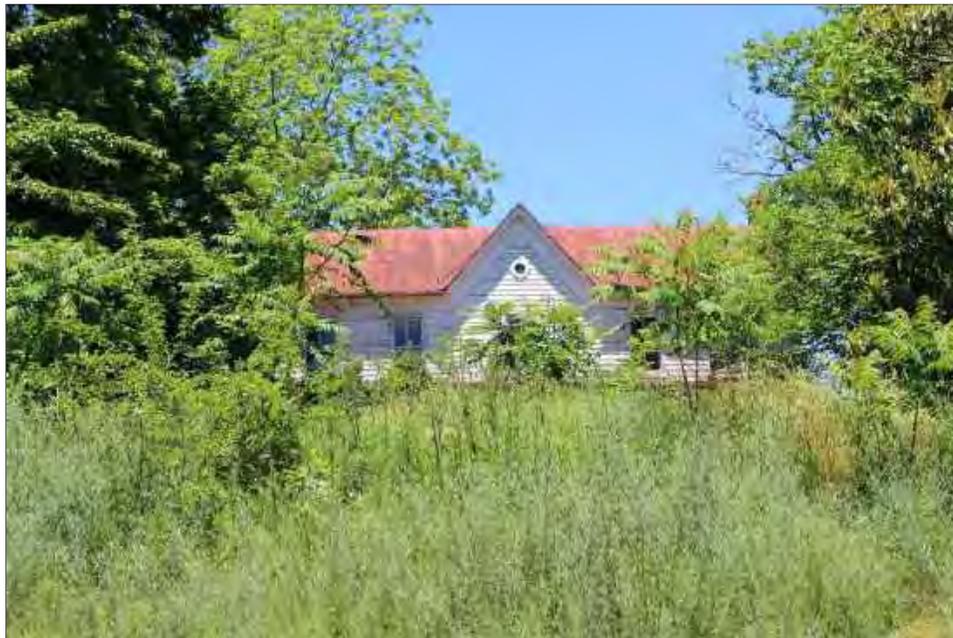
VDHR# 034-0076
Ash House, 6124 Middle Road

This single dwelling was built in 1891 according to local records and exhibits a Folk Victorian style. The two-story building has a rectangular I-house main block with an offset two-story rear wing. The wood frame structural system is clad with weatherboard and rests on an obscured foundation. It is topped by a side-gable roof with central front cross-gable covered with standing seam metal that is pierced by interior end brick chimneys at each end of the ridge. The main entrance is set centrally on the front and is sheltered by a full-width one-story porch. Fenestration consists of two-over-two double-hung sash windows. The building is ornamented with a compound roof cornice and frieze, as well as a lunette in the central cross gable.

This property is an example of a typical turn-of-the-twentieth century rural dwelling in the region. The home reflects a Folk Victorian style as applied to an I-house. It also includes a large collection of contemporary barns and outbuildings. Overall, the property represents an intact turn-of-the-century farm in the region and was therefore deemed potentially eligible for listing in the NRHP by the VDHR in 2009. At this time, the complex appears to retain similar integrity as at that time and as such, D+A recommends it continue to be considered *potentially eligible for listing in the NRHP*.

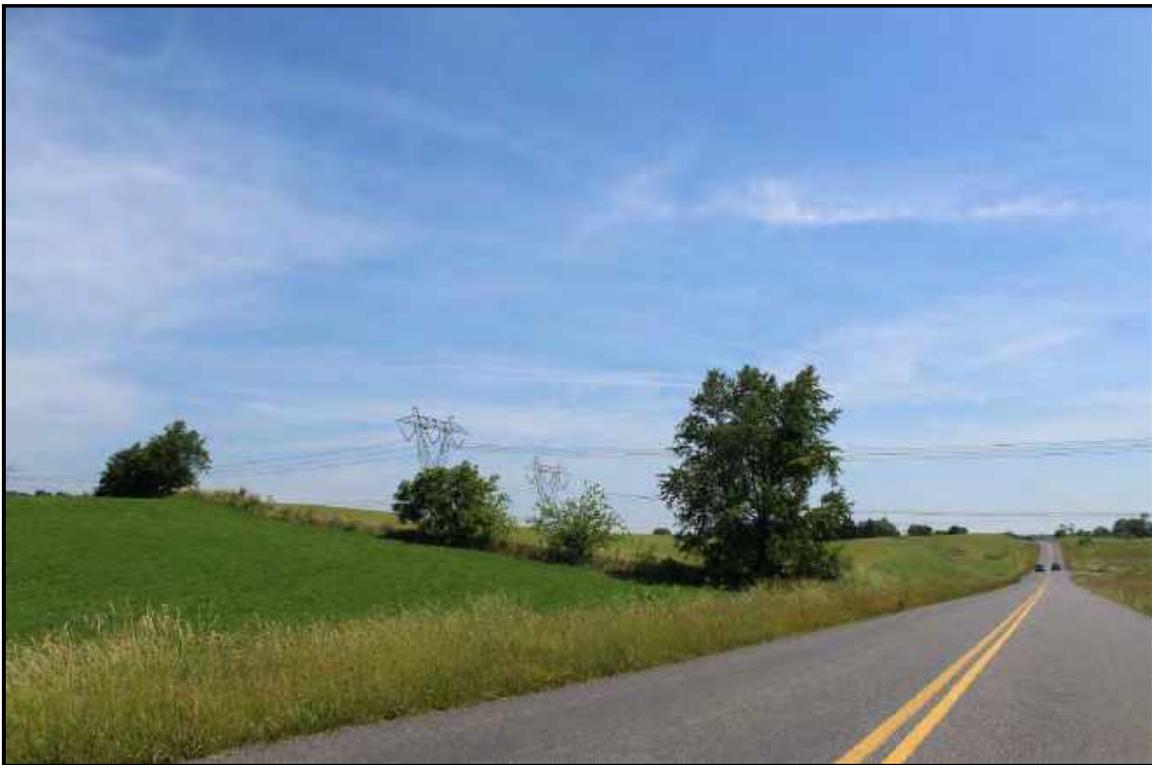
Figure 8-120: View 2- View of existing transmission line in Ash House setting, facing north.

This assessment found that the historic rural landscape around the resource is relatively intact, however, the setting is compromised by a wide high-voltage transmission line corridor that crosses through the open field to the north of the property. The primary dwelling sits near the road in a copse of trees with a collection of barns and outbuildings set to the rear. The building complex is currently overgrown with vegetation which limits visibility of the house and buildings from the road. Inspection from the road in front of the house revealed that the rolling terrain and intervening treeline inhibit wide views of the project area. Much of the project is set on the opposite side of a wooded ridge from the Ash House which screens it from view, however a narrow portion of the project area may be visible where the treeline does not continue. The rolling topography, however, still breaks up the viewshed.

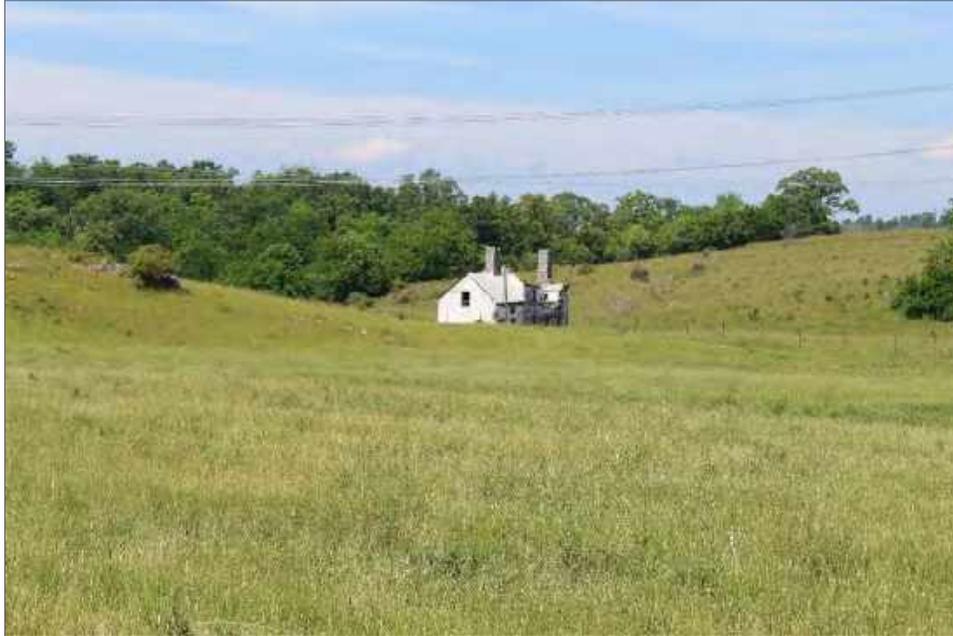
This resource was previously recorded as a circa 1770 Vernacular dwelling with early-nineteenth century Federal additions. Inspection of the home at this time reveals the house recently sustained substantial fire damage and remains in a ruinous condition.

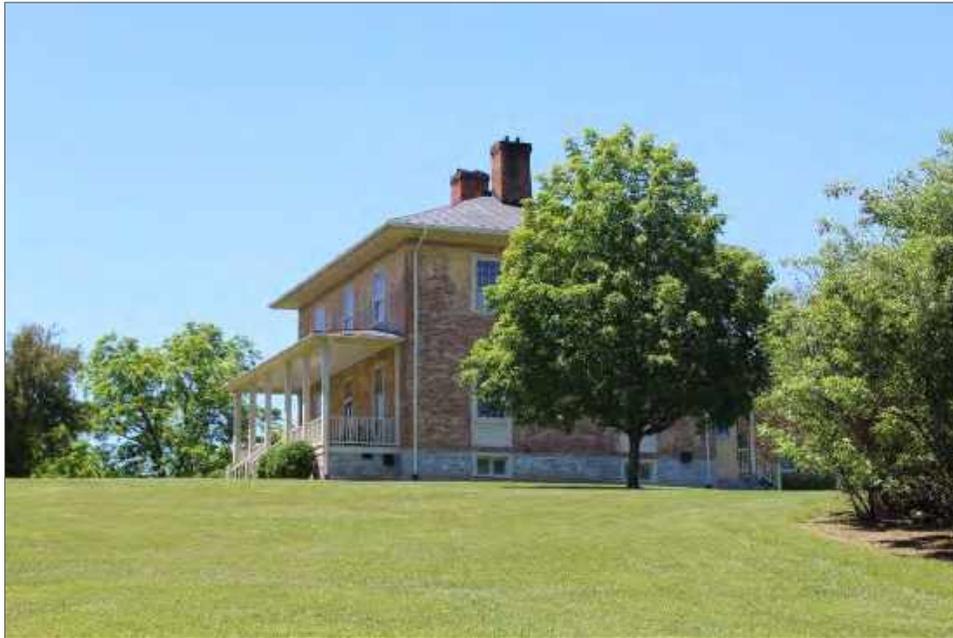
VDHR# 034-0138**Vaucluse, 515 Vaucluse Springs Road**

This single dwelling was built circa 1810 according to previous study and exhibits a Federal style. It was substantially renovated in 1995. The two-story building has a three-bay, double-pile main block with an offset two-story rear addition attached by a one-story hyphen. The brick structural system is laid in a Flemish Bond and rests on a continuous stone foundation. It is topped by a hipped roof covered with standing seam metal that is pierced by a pair of central interior brick chimneys on the side slopes. The main entrance is set centrally on the front and is sheltered by a full-width one-story porch. Fenestration consists of twelve-over-twelve double-hung sash windows. The building is finely ornamented.

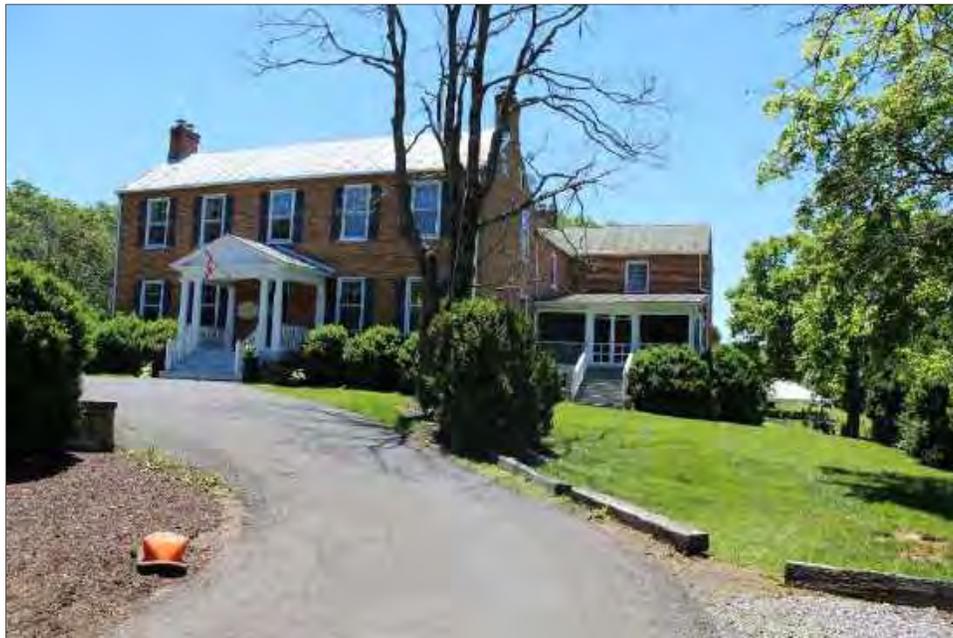
Valerie Hill, 1687 Marlboro Road

This single dwelling that now functions as a winery tasting room, was built in 1807 according to the property owners and exhibits a Federal style. It appears to have been renovated and expanded over time. The two-story building has a five-bay main block with an offset two-story rear wing and addition attached to the side of that. The brick structural system is laid in a 5:1 American Bond and rests on a continuous brick foundation. It is topped by a side-gabled roof covered with standing seam metal that is pierced by end wall chimneys at the ridge. The main entrance is set centrally on the front and is sheltered by a partial-width one-story gabled portico. Fenestration consists of six-over-six double-hung sash windows. The building is ornamented with a variety of Neoclassical influences.

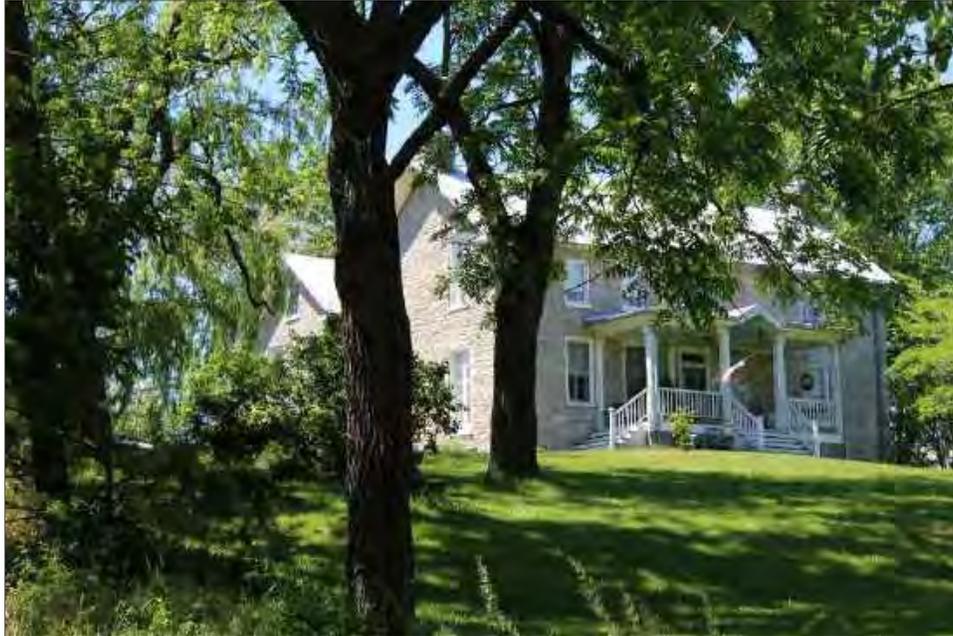
VDHR# 034-0140
Buffalo Marsh, 697 Clark Road

This single dwelling was built in 1827 according to local records and exhibits a Federal style. The two-story building has a five-bay, double-pile main block with a central two-story rear wing. The stone structural system is coursed and rests on a continuous stone foundation. It is topped by a side-gabled roof covered with standing seam metal that is pierced by interior end chimneys at each end of the ridge. The main entrance is set centrally on the front and is sheltered by a partial-width one-story porch. Fenestration consists of six-over-six double-hung sash windows as well as four-light casement windows. The building is ornamented with stone jackarches and a porch that appears to be a late-nineteenth century addition.

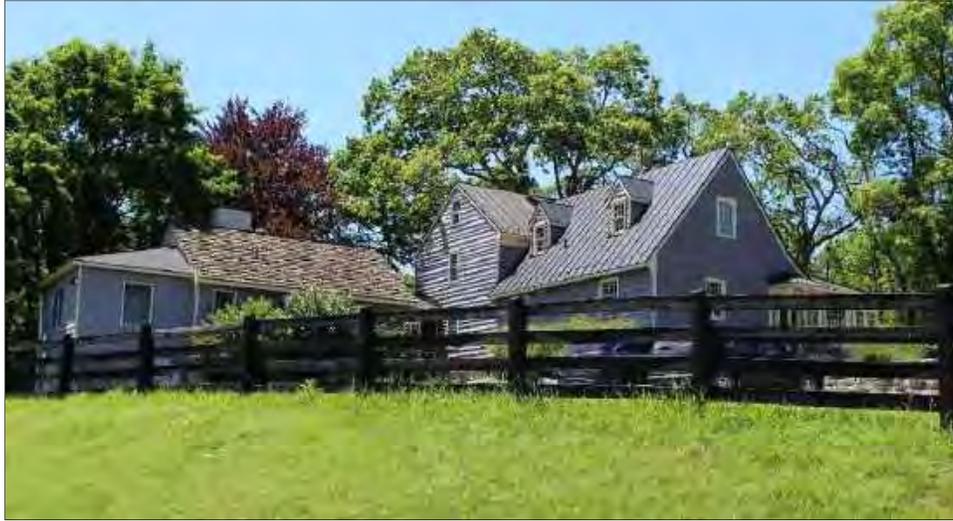
VDHR# 034-0220**John Chumley House, 231 Vauclose Springs Road**

This single dwelling was built circa 1820 according to previous study and exhibits a Vernacular design. The home was relocated to its current site and rebuilt in 1963. The one-and-a-half-story building has a compound form created by multiple additions to all sides of the main block. The wood frame structural system is clad with weatherboard and rests on an obscured foundation. It is topped by a gable roof covered with standing seam metal that is pierced by gabled window dormers. The main entrance is offset on the north end of the building and is sheltered by a small portico. Fenestration consists of eight-over-eight double-hung sash windows. The building is moderately embellished.

This property is an early-nineteenth century dwelling that was relocated to its current site in 1963. The building is now located on the Vauclose property which originally contained a late-eighteenth century dwelling and a mill. In 1963, the property was owned by artist John Chumley who moved this dwelling and several other cottages to the property to create a large bed and breakfast complex. The Vauclose property has been determined eligible by the VDHR for its architecture and history, and although this building is located within the complex, it is considered noncontributing because it was nonhistorically relocated there. On its own, however, this building was considered potentially eligible for listing in the NRHP by the VDHR in 1996 for distinctive architecture, despite its relocation. At this time, the building appears to have been further renovated, and enlarged, further obscuring its historic form and character. Coupled with its already compromised integrity from relocation, the building is now considered *not eligible* for listing in the NRHP individually or as part of the Vauclose property.

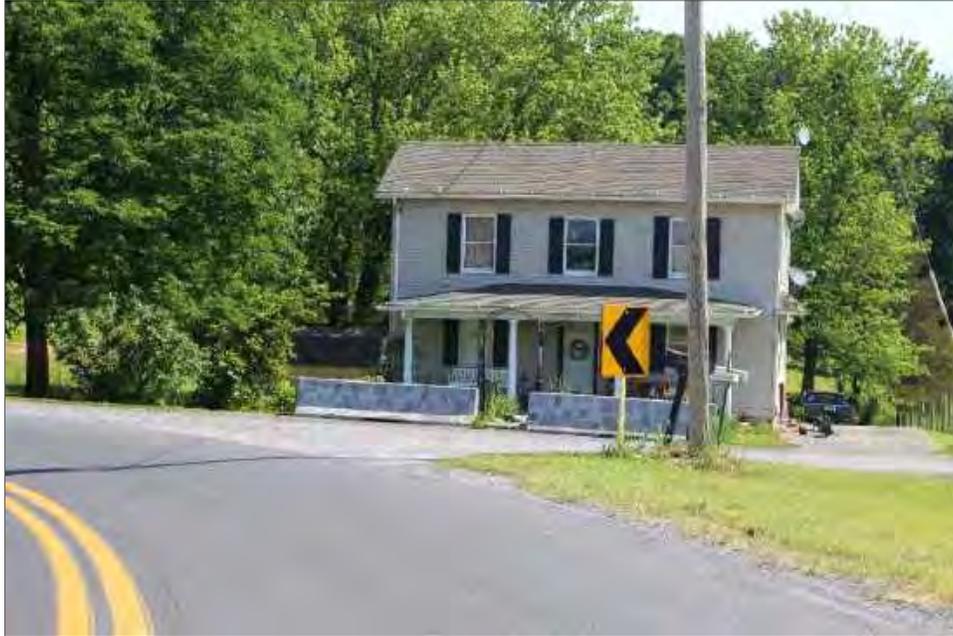
VDHR# 034-0232
House, 1595 Hites Road

This single dwelling was built in 1911 according to local records and exhibits no discernable style. The two-story building has a three-bay main block with a large full-width addition to the rear and an additional one-story offset addition beyond that. The wood frame structural system is clad with vinyl siding and rests on an obscured foundation. It is topped by a side-gable roof covered with asphalt shingles. The main entrance is set centrally on the front and is sheltered by a full-width hipped roof porch. Fenestration consists of one-over-one double-hung sash windows. The building is minimally embellished with window shutters and Doric porch columns.

This property is an example of a typical early-twentieth century rural dwelling in the region. The house reflects no discernable style and has little architectural distinction. A single outbuilding on the property could not be seen for inspection. Overall, the property does not embody distinctive characteristics or possess significant or unique architectural or design features and reconnaissance-level research revealed no known significant historical associations. The building is located in an area of discontinuous historic resources, and is, therefore, considered *not eligible* for listing in the NRHP on an individual basis or as part of a historic district.

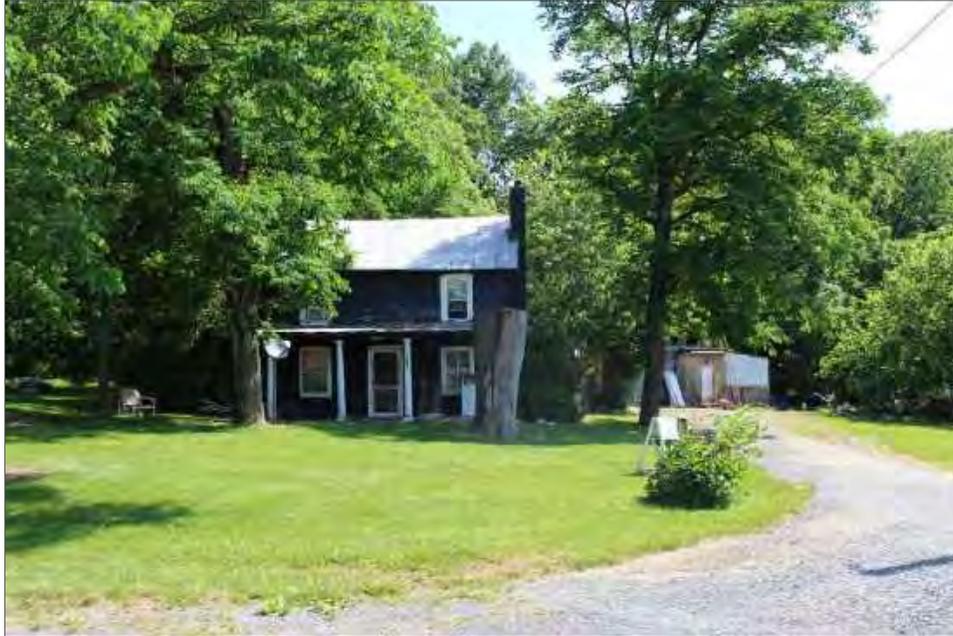
VDHR# 034-0233
House, 1561 Hites Road

This single dwelling was built in 1910 according to local records and exhibits no discernable style. The two-story building has a three-bay form. The wood frame structural system is clad with weatherboard and rests on an obscured foundation. It is topped by a side-gable, saltbox roof covered with standing seam metal that is pierced on the front slope by an exterior end concrete block chimney. The main entrance is set centrally on the front and is sheltered by a full-width hipped roof porch. Fenestration consists of two-over-two and six-over-six double-hung sash windows. The building is minimally embellished with gabled window lintels and Doric porch columns.

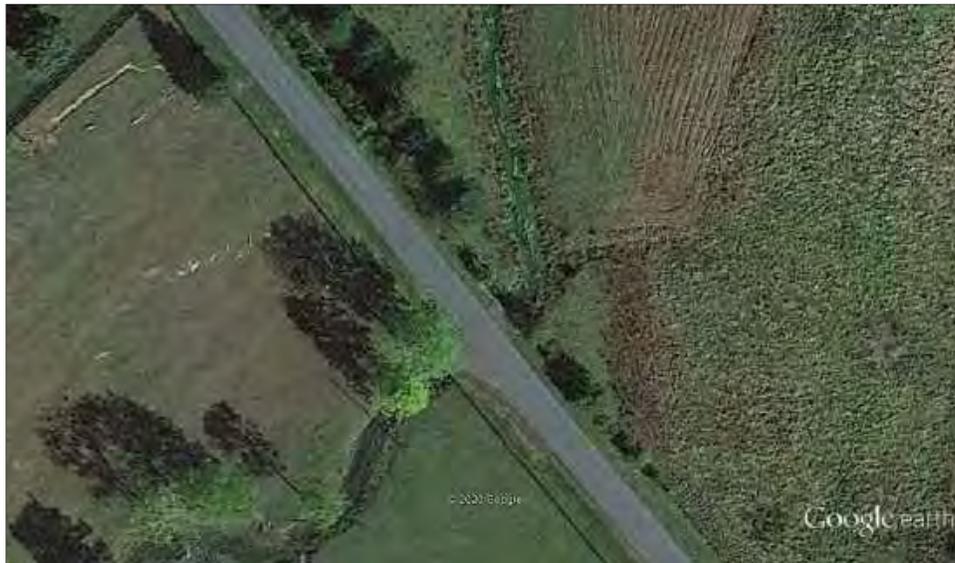
VDOT Bridge #6108 was previously recorded as a slab-style bridge built in 1927. That structure has since been demolished and replaced by a culvert crossing in 1994. No evidence of the original bridge remains.

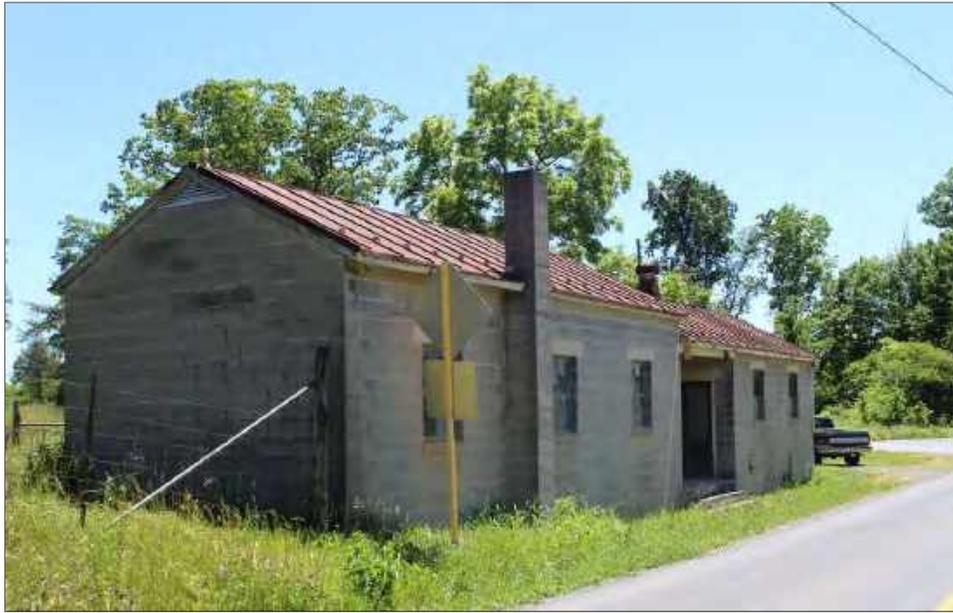
Commercial Building, Hites Road

This former commercial building was constructed c.1940 according to site inspection and exhibits no discernable style. The building appears to no longer be used commercially. The one-story concrete block structure consists of two blocks with different level roof lines. The building sits on a continuous foundation. The entrance is inset on the southern block. Fenestration consists of two-over-two double-hung sash windows with a concrete lintel. A side-gable roof, with standing seam metal, covers the building. The roof is pierced by a concrete block chimney and a metal flue.

This resource is located at the northeast corner of Hites Road (Route 625) and Vaocluse Road (Route 638) on a small rural lot. It sits near the road on a mostly grassy property. A gravel drive enters the property south of the building from both roads. A grassy lawn extends from the sides and back of the building. Set to the rear of the building is a frame equipment shed.

This property is an example of a typical mid-twentieth century rural commercial building in the region. The building reflects no discernable style with little architectural distinction. It appears to no longer function as a commercial building. Overall, the property does not embody distinctive characteristics or possess significant or unique architectural or design features and reconnaissance-level research revealed no known significant historical associations. The property is located in an area of discontinuous historic resources, and is, therefore, considered *not eligible* for listing in the NRHP on an individual basis or as part of a historic district.

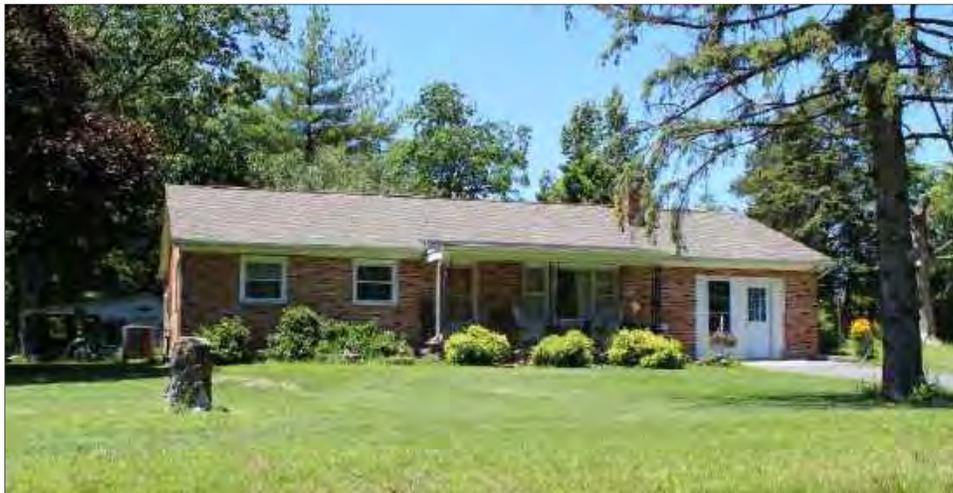
VDHR# 034-5321
House, 722 Hites Road

This single dwelling was built in 1966 according to local records and exhibits a Ranch style. The one-story building has a rectangular form with an integral attached garage to the side that has been converted to living space. The masonry structural system is clad with brick laid in a stretcher bond and rests on a continuous foundation. The main entrance is on the east façade and is protected by a two-bay porch. Decorative metal posts support the shed roof of the porch. There is a second entrance at the northern end in, what appears to be, an enclosed garage. Fenestration consists of one-over-one and six-over-six double-hung sash windows and a picture window flanked by double-hung windows. A side-gable roof, with asphalt shingles, covers the house. The front slope of the roof is pierced by a brick chimney.

The property located on the west side of Hites Road on a small rural lot. It sits near the road on a grassy yard with landscaping along the front of the building. The front of the property is delineated by a low stone wall. A paved driveway extends to the former attached garage on the north end of the house. The yard is landscaped with a grass lawn, foundation plantings, and trees. There are two outbuildings in the backyard.

This property is an example of a typical mid-twentieth century rural dwelling in the region. The building reflects a Ranch style with little architectural distinction. It includes a small collection of typical domestic sheds and outbuildings. Overall, the property does not embody distinctive characteristics or possess significant or unique architectural or design features and reconnaissance-level research revealed no known significant historical associations. The property is located in an area of discontinuous historic resources, and is, therefore, considered *not eligible* for listing in the NRHP on an individual basis or as part of a historic district.

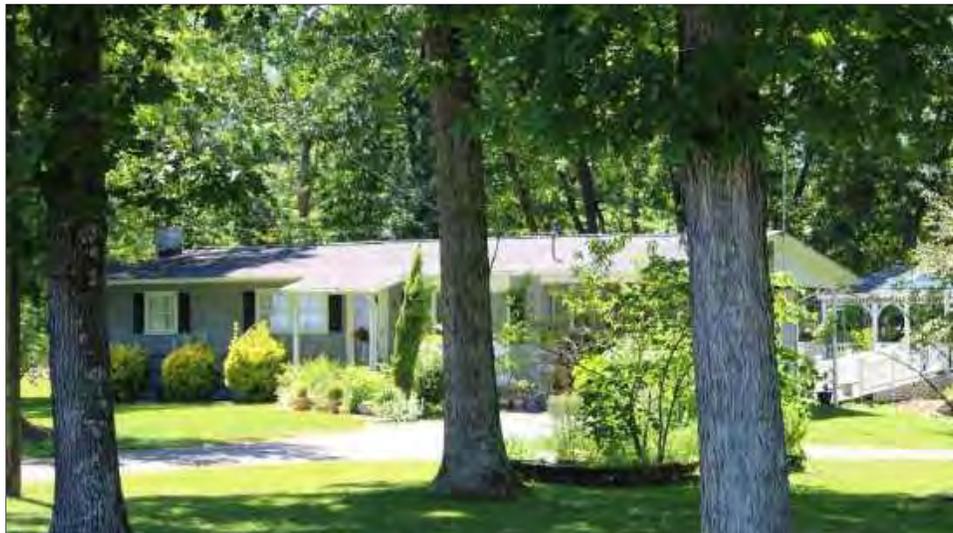
VDHR# 034-5322
House, 996 Hites Road

This single dwelling was built in 1961 according to local records and exhibits a Ranch style. The one-story building has a T-form with an integral attached carport to one side. The wood frame structural system is clad with asbestos shingles and rests on a continuous foundation. The main entrance is set on the east façade and is protected by a small portico. Square posts support the shed roof of the porch. Fenestration consists of single and paired eight-over-eight double-hung sash windows, with faux shutters, and bay window with casement windows. A side-gable roof, with asphalt shingles, covers the dwelling. A concrete block, exterior end chimney pierces its slope.

The property sits on the southwest corner of Hites and Clark roads on a small rural lot. The house sits back from the road on a grassy yard with trees and landscaping scattered throughout. A gravel driveway extends from Hites Road to the integral carport at the north end of the house. It then curves to a garage at the northwest and exits onto Clark Road. A prefabricated gazebo is set in the backyard behind the house.

This property is an example of a typical mid-twentieth century rural dwelling in the region. The building reflects a Ranch style with little architectural distinction. It includes a small collection of typical domestic sheds and outbuildings. Overall, the property does not embody distinctive characteristics or possess significant or unique architectural or design features and reconnaissance-level research revealed no known significant historical associations. The property is located in an area of discontinuous historic resources, and is, therefore, considered *not eligible* for listing in the NRHP on an individual basis or as part of a historic district.

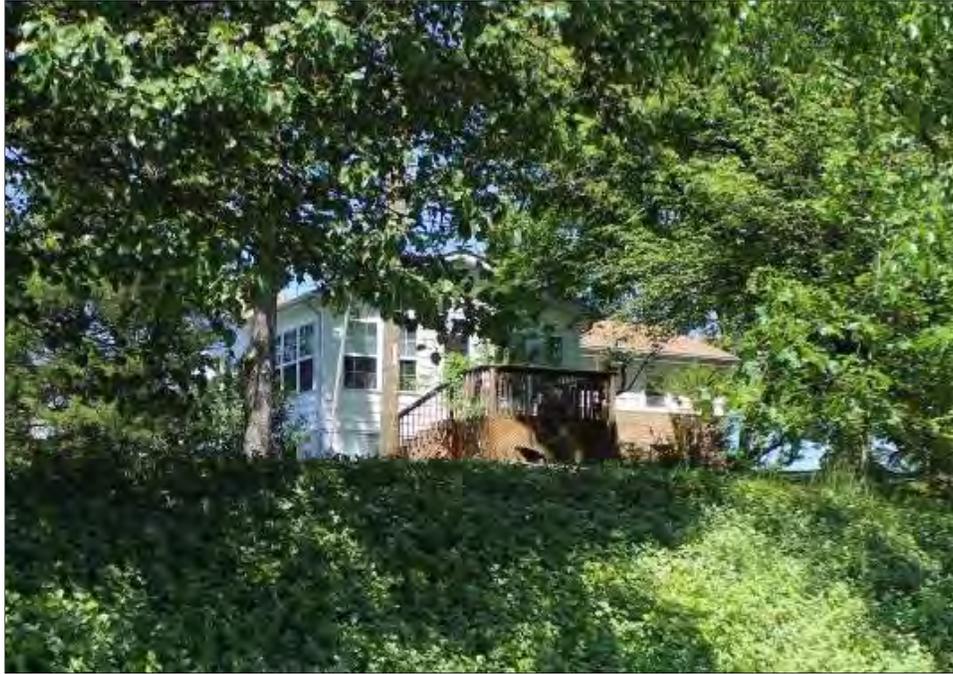
VDHR# 034-5324
House, 609 Clark Road

This single dwelling was built in 1960 according to local records and exhibits no discernable style. The one-story dwelling has a T-plan created by an enclosed former front porch. The wood frame structural system is clad with aluminum siding and brick veneer, and rests on a raised concrete block foundation. The main entrance is on the south façade and is approached by a wood deck. Fenestration consists of single, paired, and ribbon six-over-six double-hung sash windows. A cross-gable roof, with asphalt shingles, covers the building. A chimney pierces the slope of the roof.

The property is set on the north side of Clark Road on a large rural property. The home rests near the road in a copse of trees atop a slight berm. A paved driveway extends from the road, past the west side of the house to a large barn set to the rear. The grass yard is landscaped with shrubs and trees. Surrounding the homesite and building complex are open agricultural fields.

This property is an example of a typical mid-twentieth century rural dwelling and farm in the region. The building reflects no discernable style with little architectural distinction. It includes a single contemporary barn as the only secondary resource. Overall, the property does not embody distinctive characteristics or possess significant or unique architectural or design features and reconnaissance-level research revealed no known significant historical associations. The property is located in an area of discontinuous historic resources, and is, therefore, considered *not eligible* for listing in the NRHP on an individual basis or as part of a historic district.

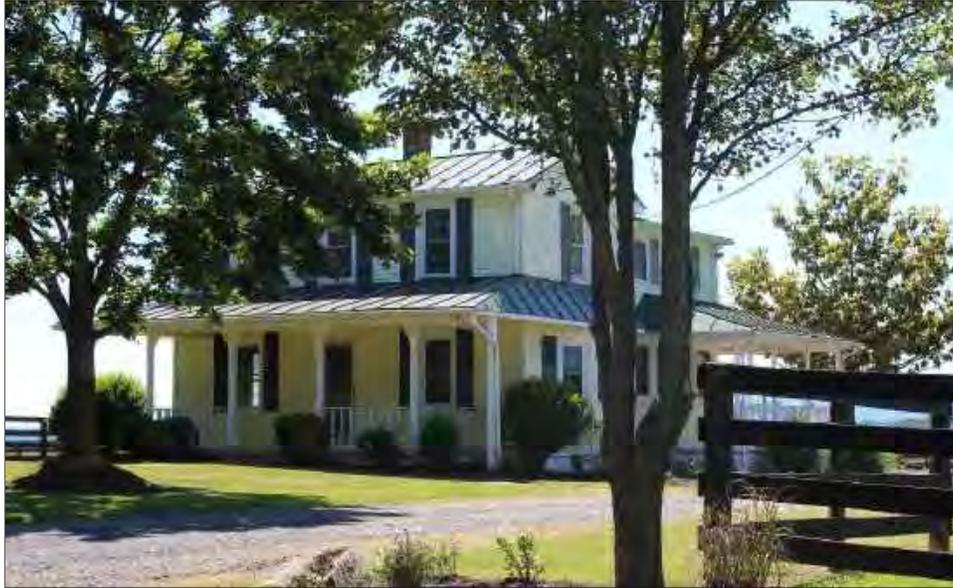
VDHR# 034-5325
House, 1196 Hites Road

This single dwelling was built in 1901 according to local records and exhibits a Vernacular design. The two-story building has an I-house front block with central rear wing. The wood frame structural system is clad with vinyl siding and rests on a continuous foundation. The main entrance is centered on the east façade and is protected by a full-width, one-story porch. The shed roof of the porch is supported by square posts with decorative brackets. There is an additional one-story porch off of the rear ell. Fenestration consists of four-over-four double-hung sash windows with faux shutters. A cross-gable roof, with standing seam metal, covers the building. A brick chimney pierces the ridge of the roof.

The property is situated on the west side of Hites Road on a large rural property. The home sits near the road on grassy homesite with trees and landscaping scattered throughout. A gravel driveway extends from the road, along the north side of the dwelling to a parking area and a garage at its rear, as well as additional outbuildings. The homesite and building complex are enclosed by a post and rail fence and a large orchard borders it the sides and rear.

This property is an example of a typical early-twentieth century rural dwelling and farm in the region. The building reflects a Vernacular design with little architectural distinction that has been nonhistorically remodeled. It includes a small collection of typical domestic and agricultural outbuildings. Overall, the property does not embody distinctive characteristics or possess significant or unique architectural or design features and reconnaissance-level research revealed no known significant historical associations. The property is located in an area of discontinuous historic resources, and is, therefore, considered *not eligible* for listing in the NRHP on an individual basis or as part of a historic district.

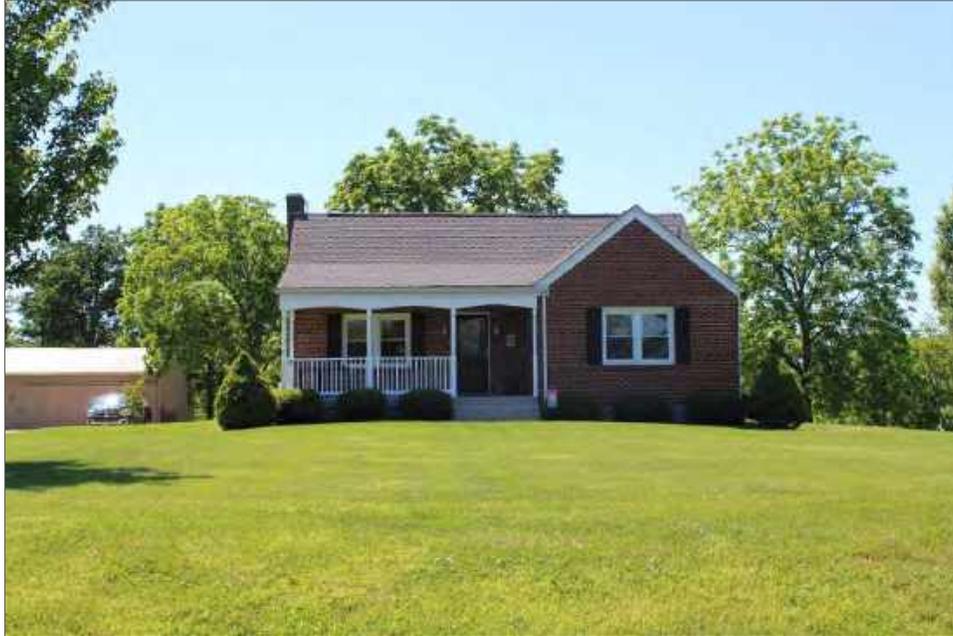
VDHR# 034-5326
House, 1162 Hites Road

This single dwelling was built in 1956 according to local records and exhibits a Minimal Traditional style. The one-story building has a mostly rectangular form with an offset front cross gable. The masonry structural system is clad with brick laid in a stretcher bond and rests on a continuous foundation. The main entrance is on the east façade and is protected by a partial-width one-story porch. The roof of the porch is supported by turned posts. Fenestration consists of paired one-over-one double-hung sash windows with faux shutters and brick lintels. A side-gable roof, with asphalt shingles, covers the house. A brick, exterior end chimney pierces the slope of the roof.

The property is set on the west side of Hites Road on a small rural lot. The home sits back from the road on an open grassy yard. A gravel driveway extends from the road, along the south side of the dwelling to a parking area and a garage at its rear. The grass lawn is landscaped with foundation plantings and trees. There is a large open grass yard to the side and rear of the house.

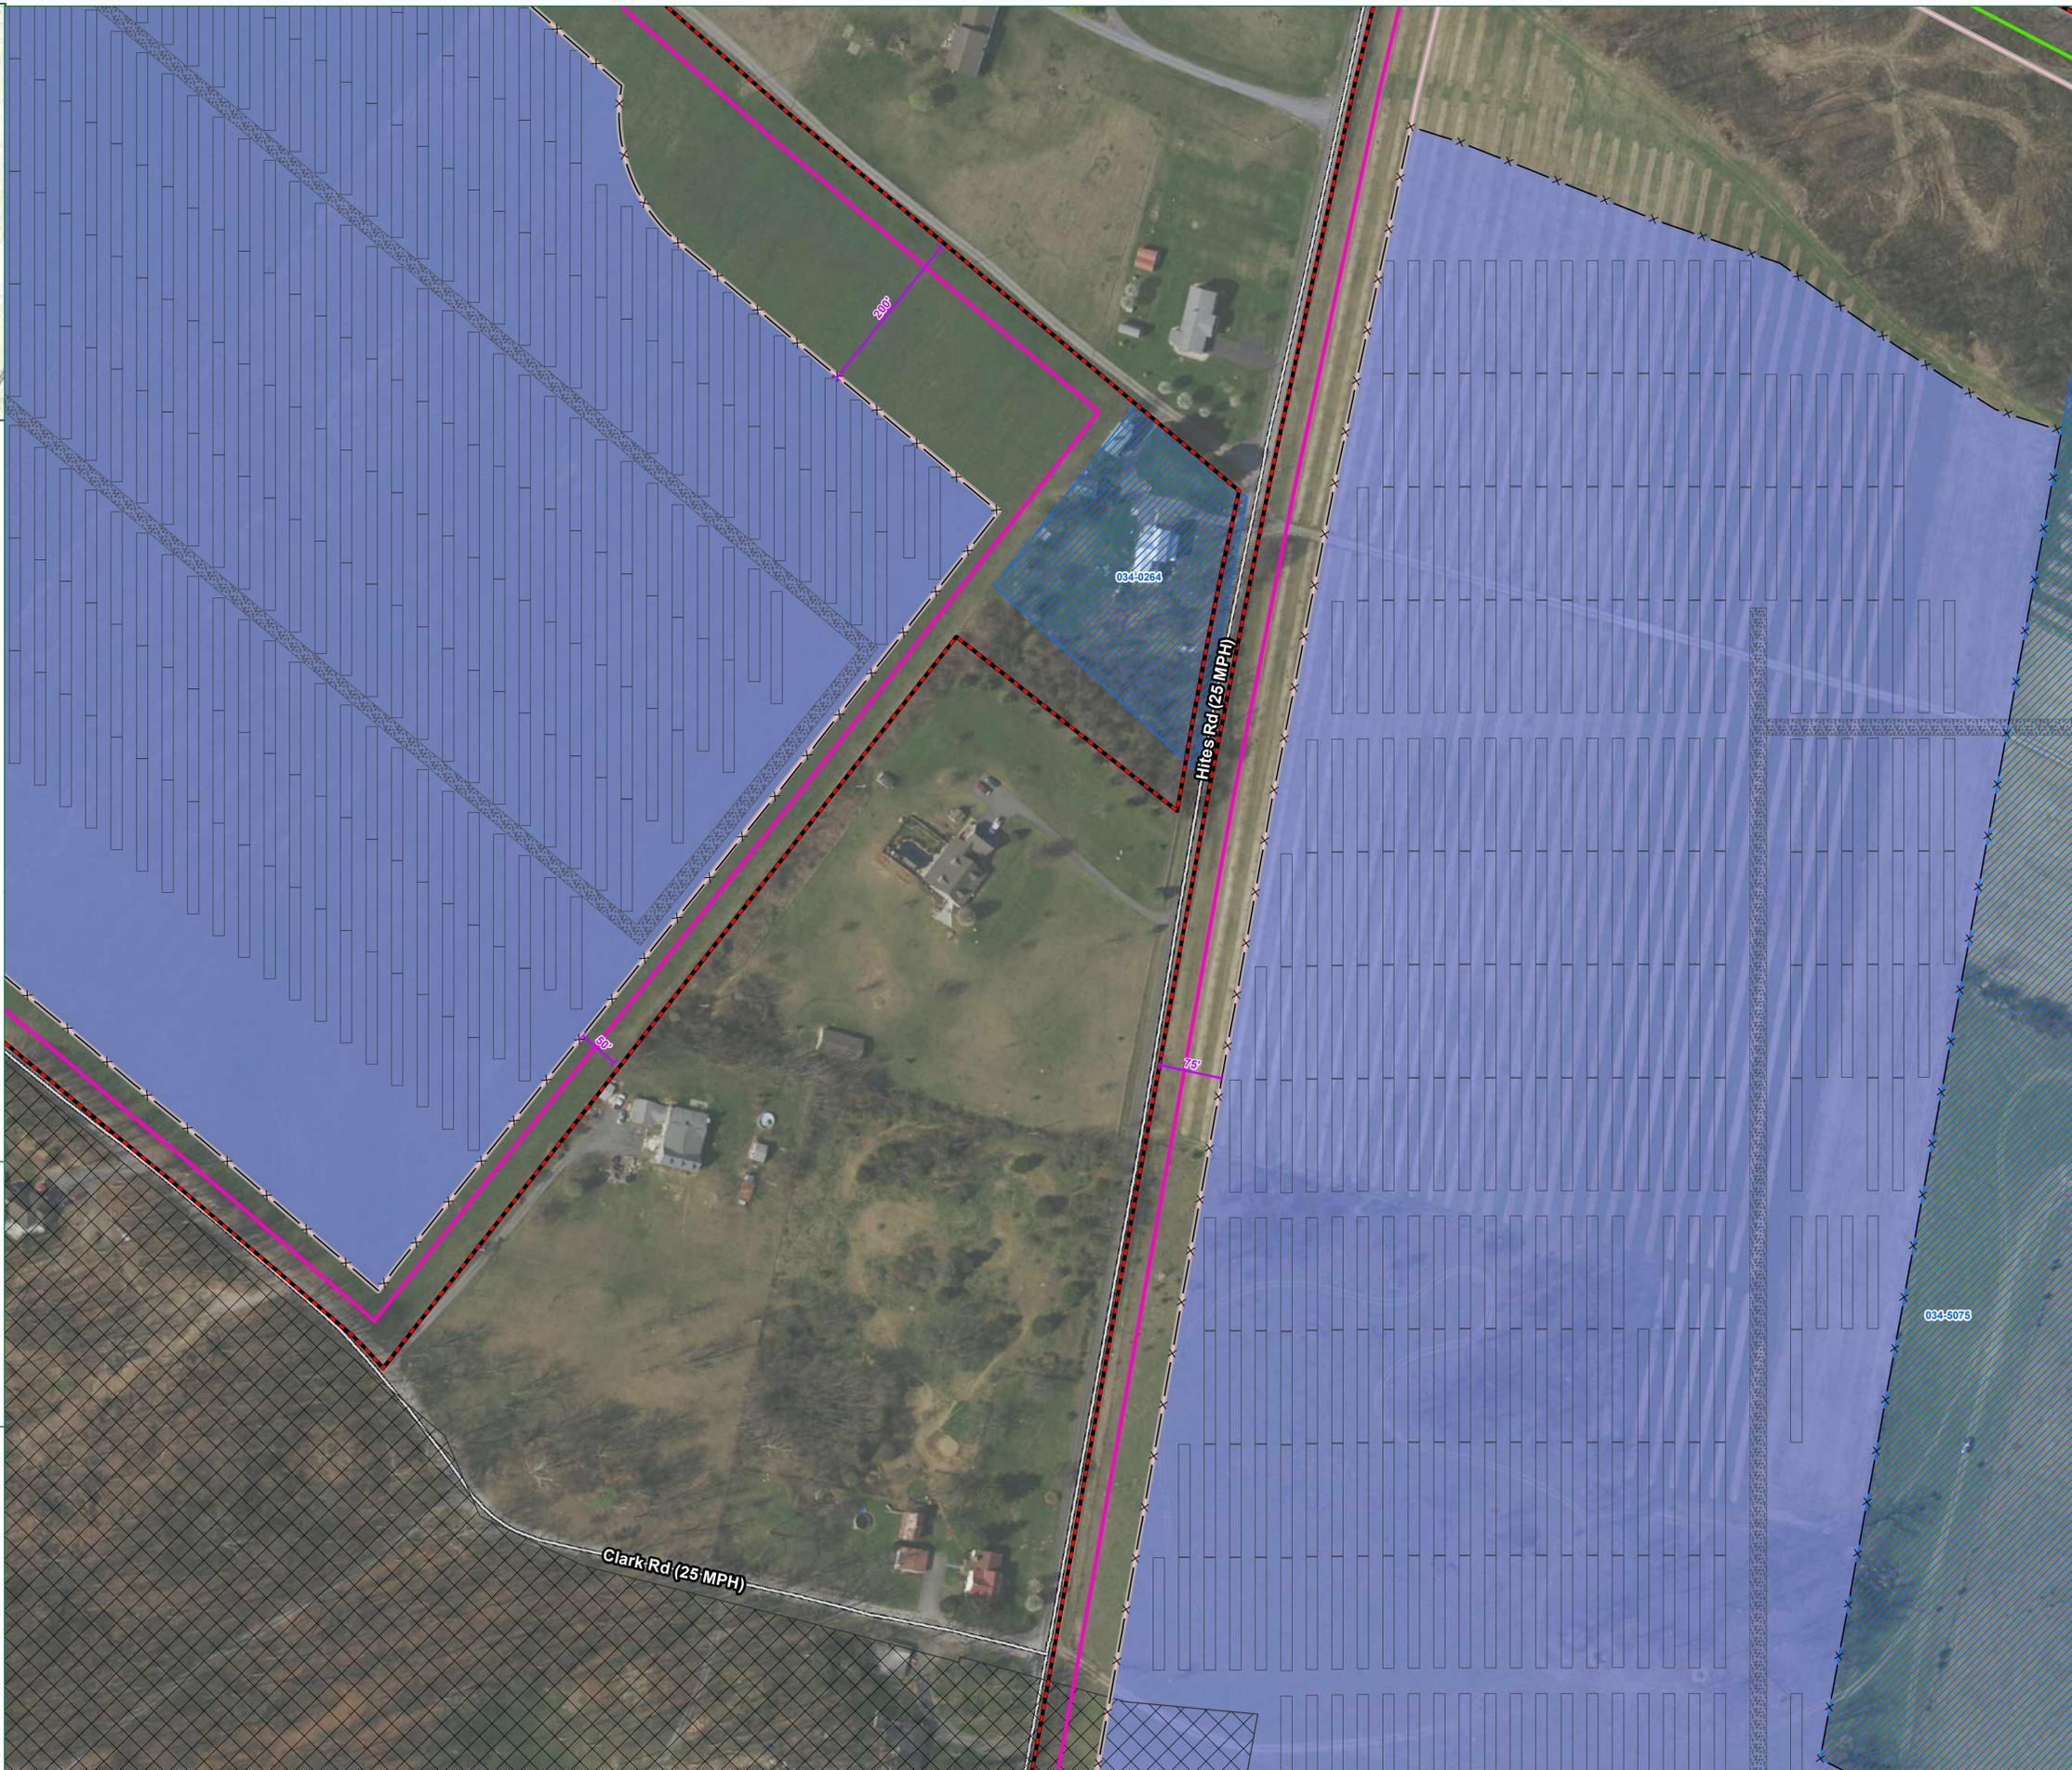
- PROJECT AREA HAS BEEN ALTA SURVEYED.
- SETBACK LINES ARE 60 FEET FROM ADJACENT RIGHT OF WAYS, 50 FEET FROM ADJACENT PROPERTY OWNERS WITH PARCELS LESS THAN 6 ACRES, 75 FEET FROM A PORTION OF HITES ROAD, 100 FEET FROM ADJACENT PROPERTY OWNERS WITH PARCELS GREATER THAN 6 ACRES, AND 200 FEET FROM ADJACENT AGRICULTURAL AND FOREST DISTRICT PARCELS GREATER THAN 6 ACRES.
- LANDSCAPING IS 10 FEET WIDE ALL AROUND EXCEPT WHERE 50 FEET OF MATURE WOODLAND IN WIDTH IS EXISTING.
- EXISTING WOODLANDS WITHIN THE SETBACK WILL BE RETAINED.
- CULTURAL RESOURCES HAVE BEEN FIELD DELINEATED BY DUTTON ASSOCIATES.
