Re: **In the Matter of: Tentative Cleanup and Abatement Order No. R9-2011-0001  
Submissions by BAE Systems San Diego Ship Repair, Inc. to the Administrative  
Record**

Pursuant to the Third Amended Order of Proceedings in this matter, BAE Systems San Diego Ship Repair, Inc. is enclosing copies of the below list of documents as supplements to the Administrative Record in the above-referenced proceedings.

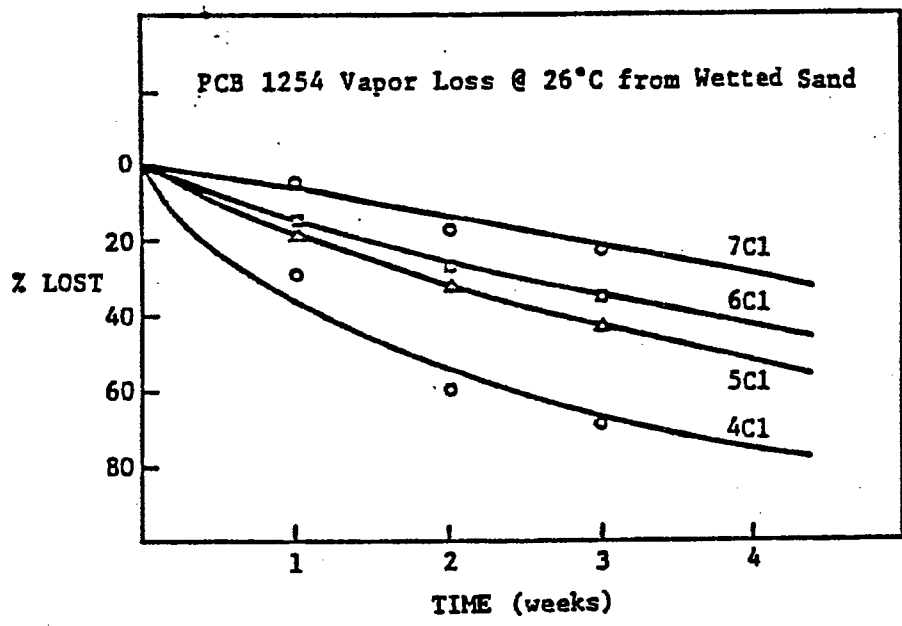
Figures 5 and 6. Volatilization of PCB isomers from Ottawa Sand contaminated with Aroclor 1254.<sup>75</sup>

Temperature also plays an important role in the amount of PCB evaporated from a spill because of the increase in vapor pressure that occurs with increasing temperature.<sup>75</sup> Figure 7 shows the variation in volatilization rates for temperatures of 26°C (79°F) and 60°C (140°F).

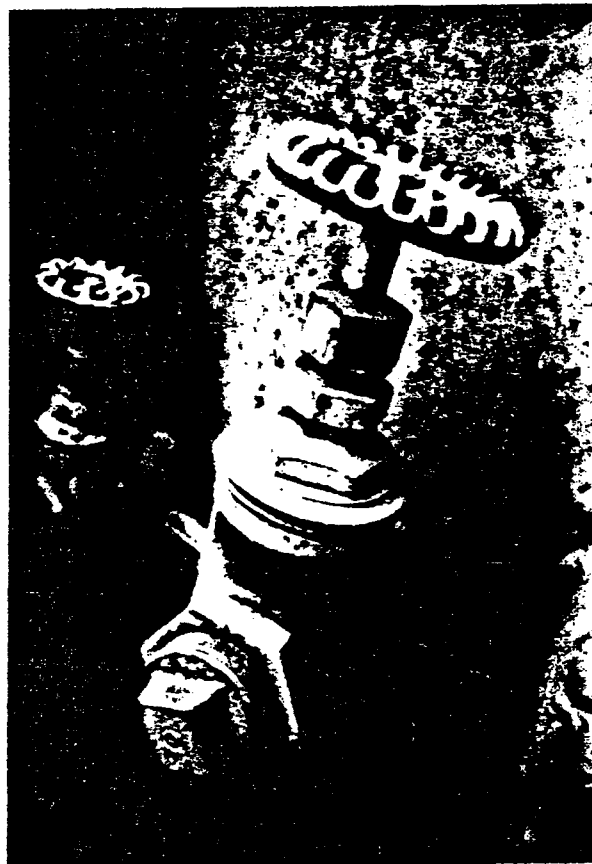
DESCRIPTION: View of main and secondary drain tap/valves on South Load transformer. Note leaks at threads and on stem of secondary valve, and dark oily material in can beneath valve. Also note leaked material on main valve stem at weld to transformer body.

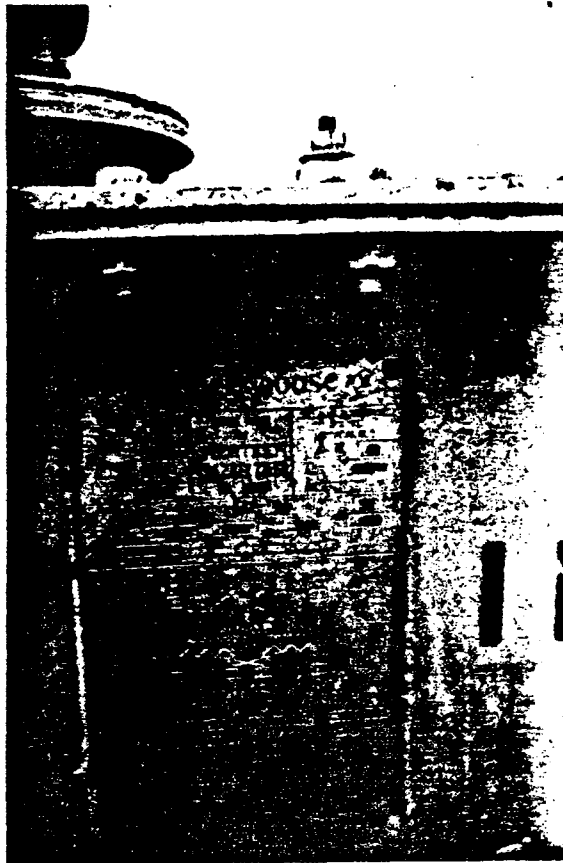
PHOTO NUMBER: 10

DESCRIPTION: Leaks from main drain tap/valve on North Lighting transformer. Note second leak from stem onto base of transformer behind valve.
