INSTALLATION RESTORATION PROGRAM

PHASE I—RECORDS SEARCH, HAZARDOUS MATERIALS DISPOSAL SITES

EGLIN AFB, FLORIDA

October, 1981

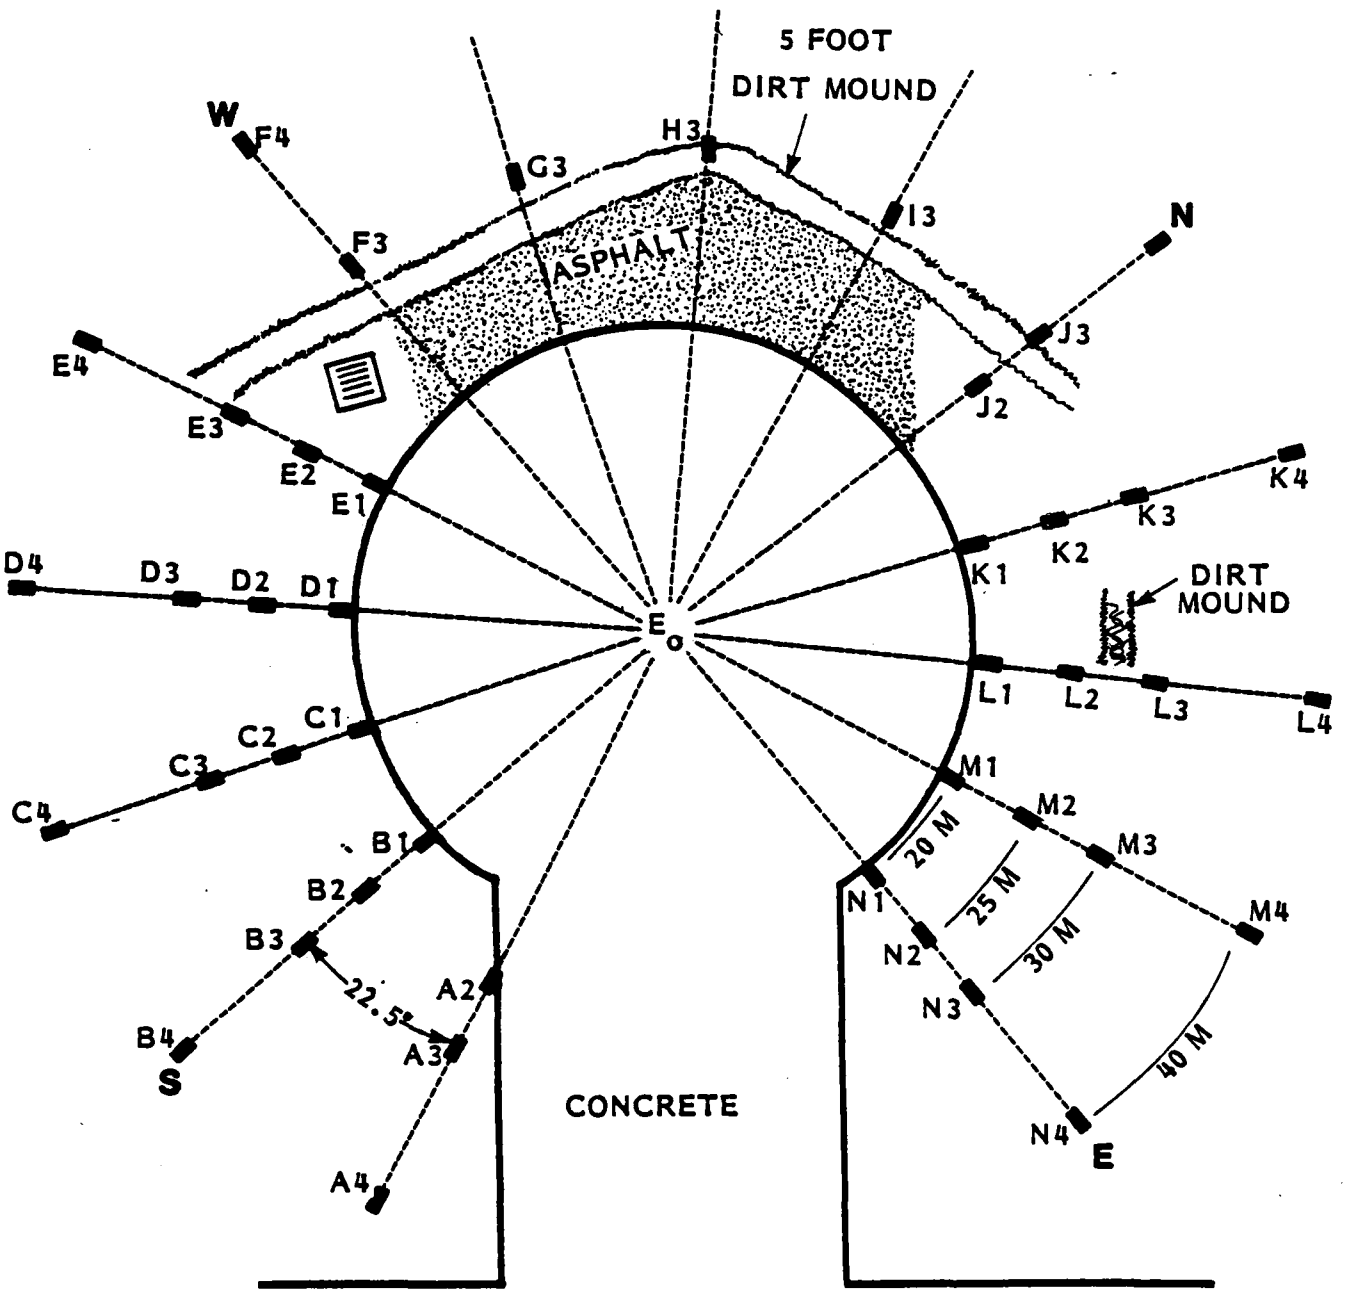
HARDSTAND 7 SOIL SAMPLE GRID

Arsenic contamination from Herbicide Blue loading operations have been identified on Hardstand 7. Figure 4.3 and Table 4.5 illustrate the levels of arsenic contamination which have been documented. Figure 4.3 is the soil sample grid key. Soil samples were collected at the various point at depths of 0-10 cm, 20-30 cm, 55-70 cm and 95-110 cm. Table 4.5
