BULLETIN NO. 31

Engineering Experiment Station

THE THEORY OF LOADS ON PIPES IN DITCHES,
AND
TESTS OF CEMENT AND CLAY DRAIN TILE
AND SEWER PIPE

A. Marston and A. O. Anderson

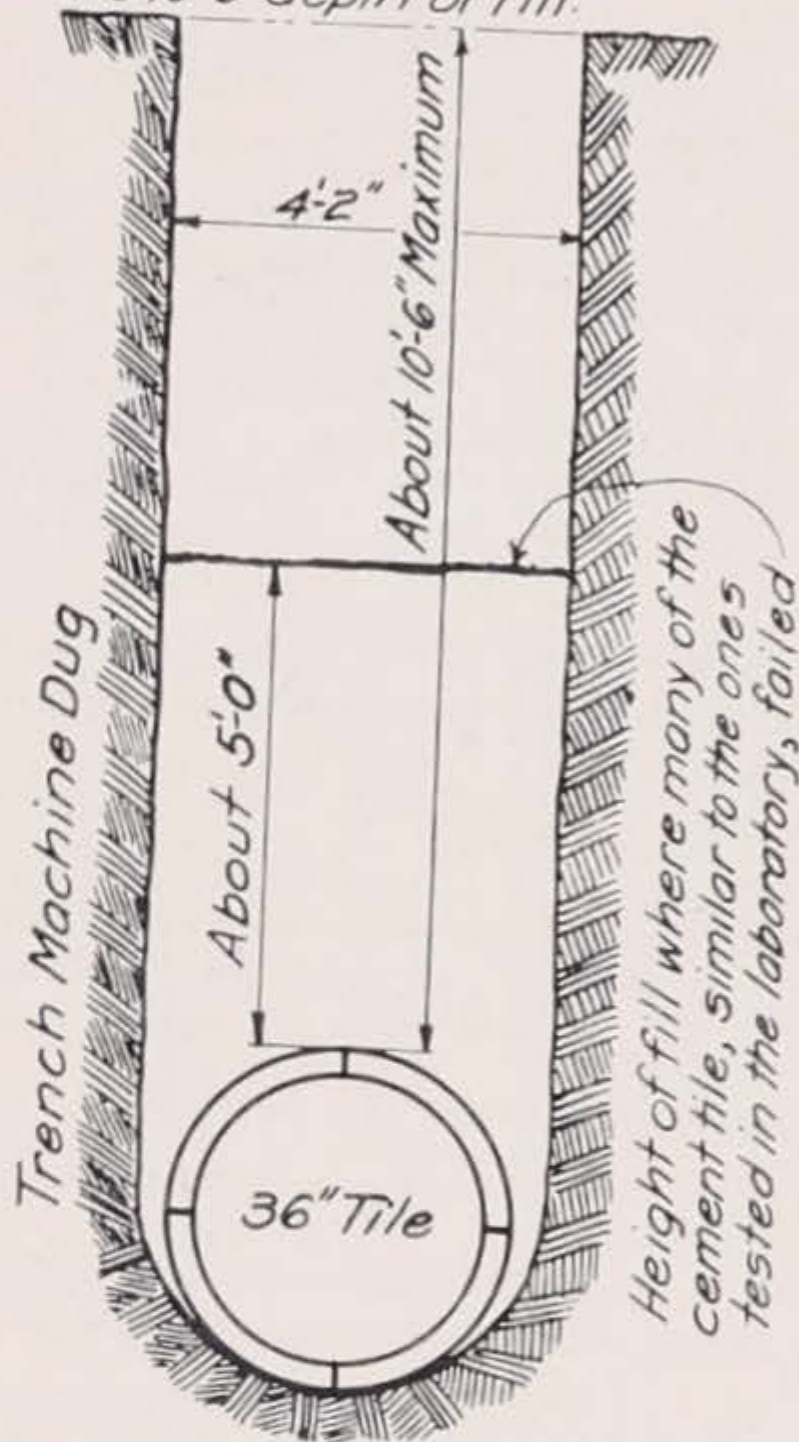
Fig. 4 shows the conditions in the noted case of failure of 36 inch diameter tile in Drainage District No. 29, Sac County, Iowa.

Some of the vitrified clay tile have cracked under the 10'-6" depth of fill.

Height of fill where many of the cement tile, similar to the ones tested in the laboratory, failed

Fig. 4. Cracking of 36 Inch Cement and Vitrified Clay Drain Tile during Construction, in Drainage District No. 29, Sac County, Iowa.

In this case the cement tile at first supplied were abandoned and the drain was completed with heavy, vitrified clay pipe, imported from without the state. Only seven lengths of these cracked during the course of construction, but after the lapse of a year it is reported that 31 lengths out of 200 examined have been found to be cracked under the full depth of fill.

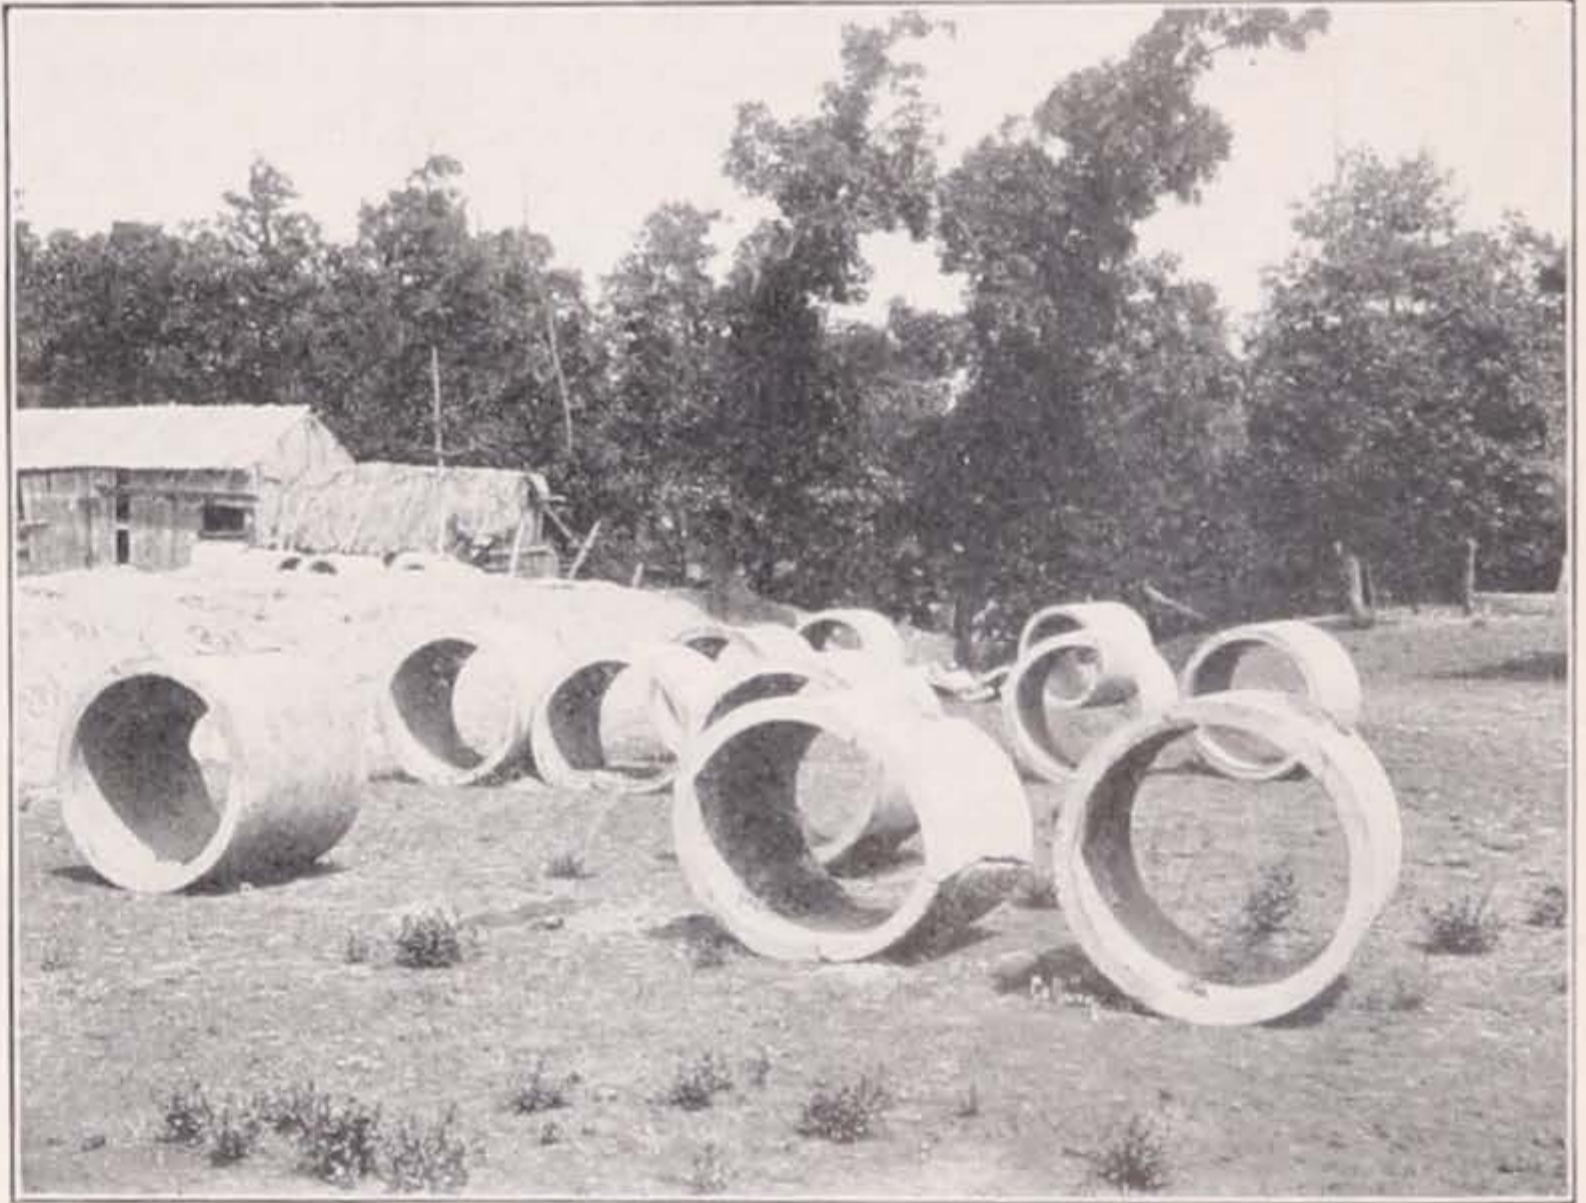
Fig. 5. View of Cracked 36 Inch Drain Tile from Ditch in Drainage District No. 48, Boone County, Iowa.

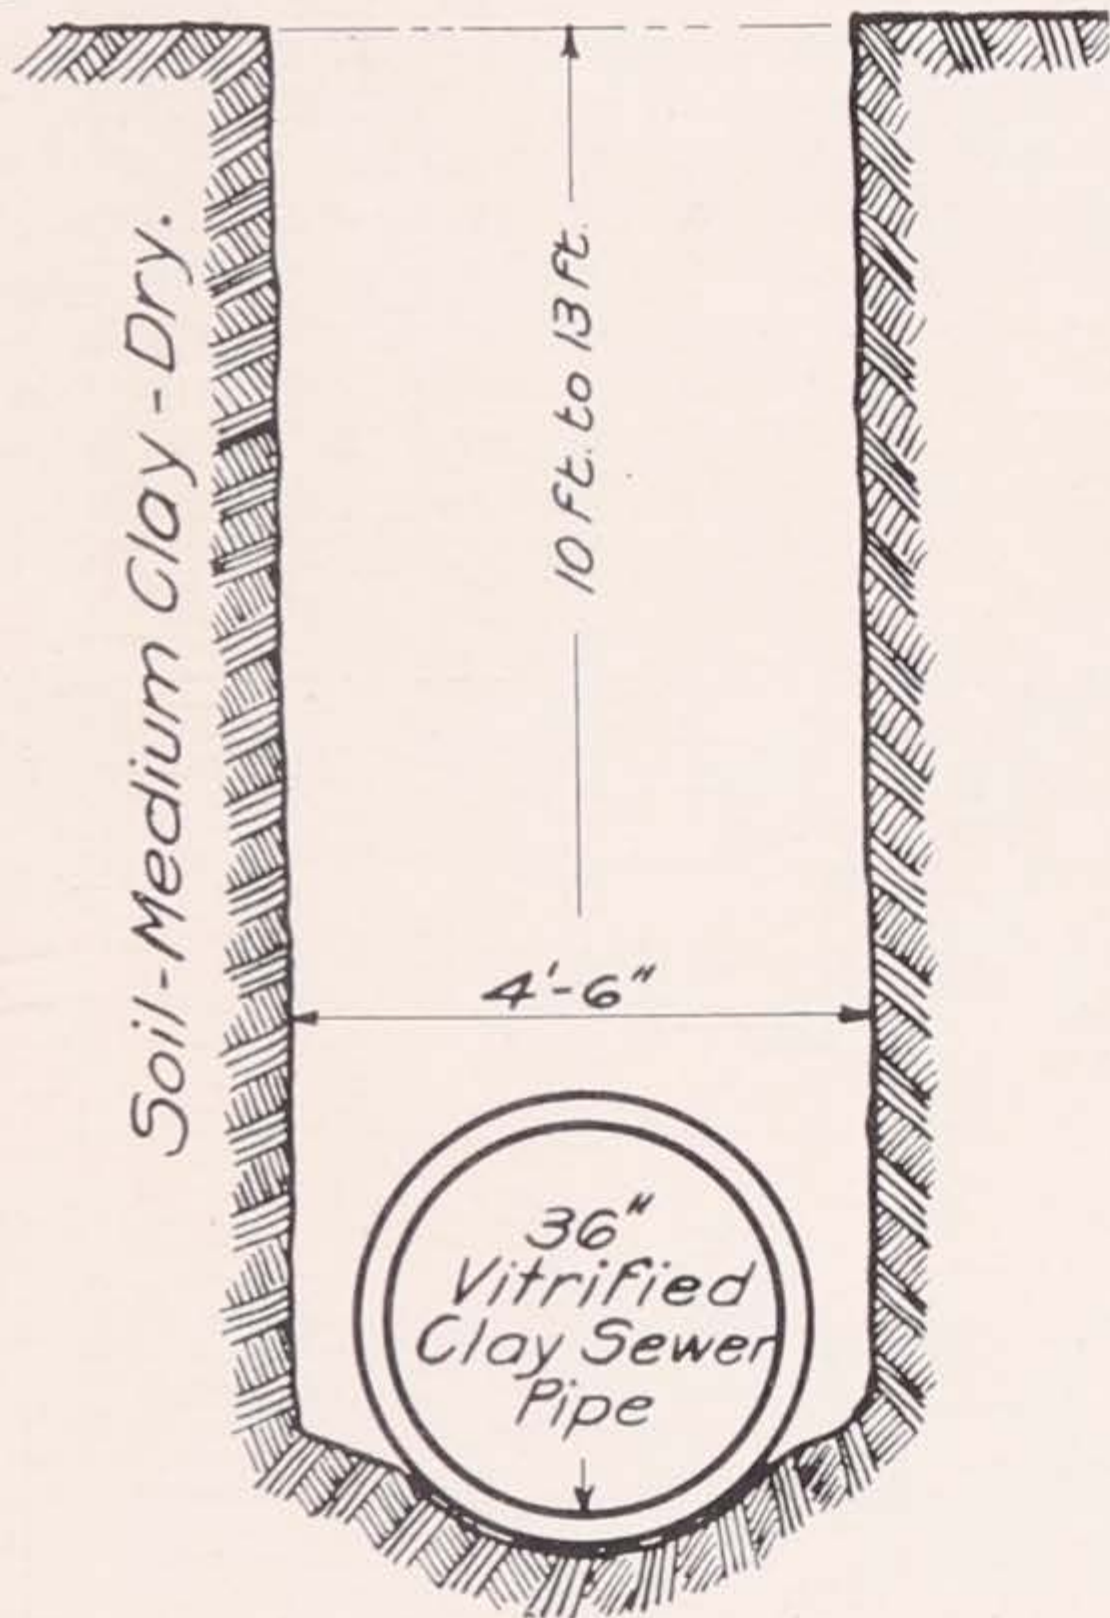
Fig. 6 shows the conditions of a very typical case, reported in March, 1912, by Mr. Chas. P. Chase, Consulting Engineer, of Clinton, Iowa. Mr. Chase says:

cracked. Cracks extended 25 to 60 feet at a stretch in continuous lines, as if it was one pipe. Conditions were favorable, and all pipe would be called good.''

Fig. 6. Cracking of 36 Inch Vitrified Clay Sewer Pipe in Ash Street Sewer, Clinton, Iowa.

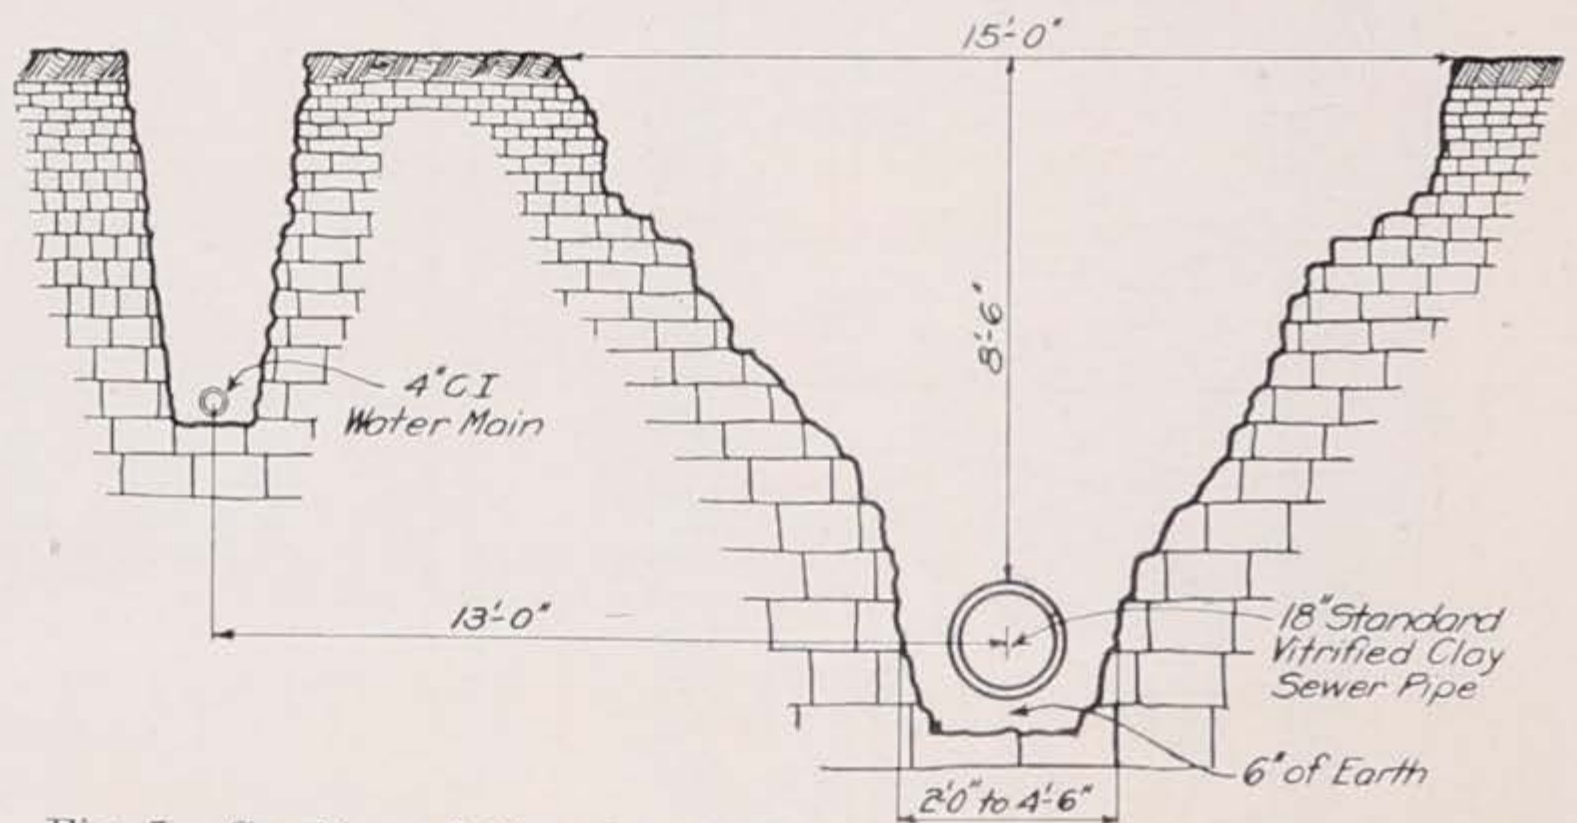
Fig. 7 shows another interesting though not as typical case of cracking of sewer pipe, reported in April, 1911, by Mr. R. P. Pooley, City Engineer, Charles City, Iowa. The sewer was built in 1901, and removed in 1911 to lower the grade, the water pipe having been laid in the meantime. Dynamite was used in blasting out the trenches for both the sewer and water pipe. About 6 inches of earth were placed under the sewer pipe before laying. Considerable blasted rock, supposed to have been shoveled back by the pipe layer, was found resting on the pipe. The 20 inch pipe was double strength, and about 50% was found to be cracked. The 18 inch pipe was single strength, and most of it was found cracked.

The width of the ditch at the level of the pipe varied from 2 to 4½ ft. An extremely interesting fact observed was that *all* of the pipe were found cracked where the width was 3 to 4½ ft., but *only part* were cracked where the width was only 2 to 2½ ft. The filling at the sides of the pipe was found to be in a comparatively loose condition. This illustrates again the fact, also observed in Drainage District No. 29, Sac County, Iowa (see page 17) that a pipe of given diameter is subjected to very much heavier pressure in a wide than in a narrow ditch.

Fig. 7. Cracking of 18 and 20 Inch Vitrified Sewer Pipe at Charles City, Iowa.

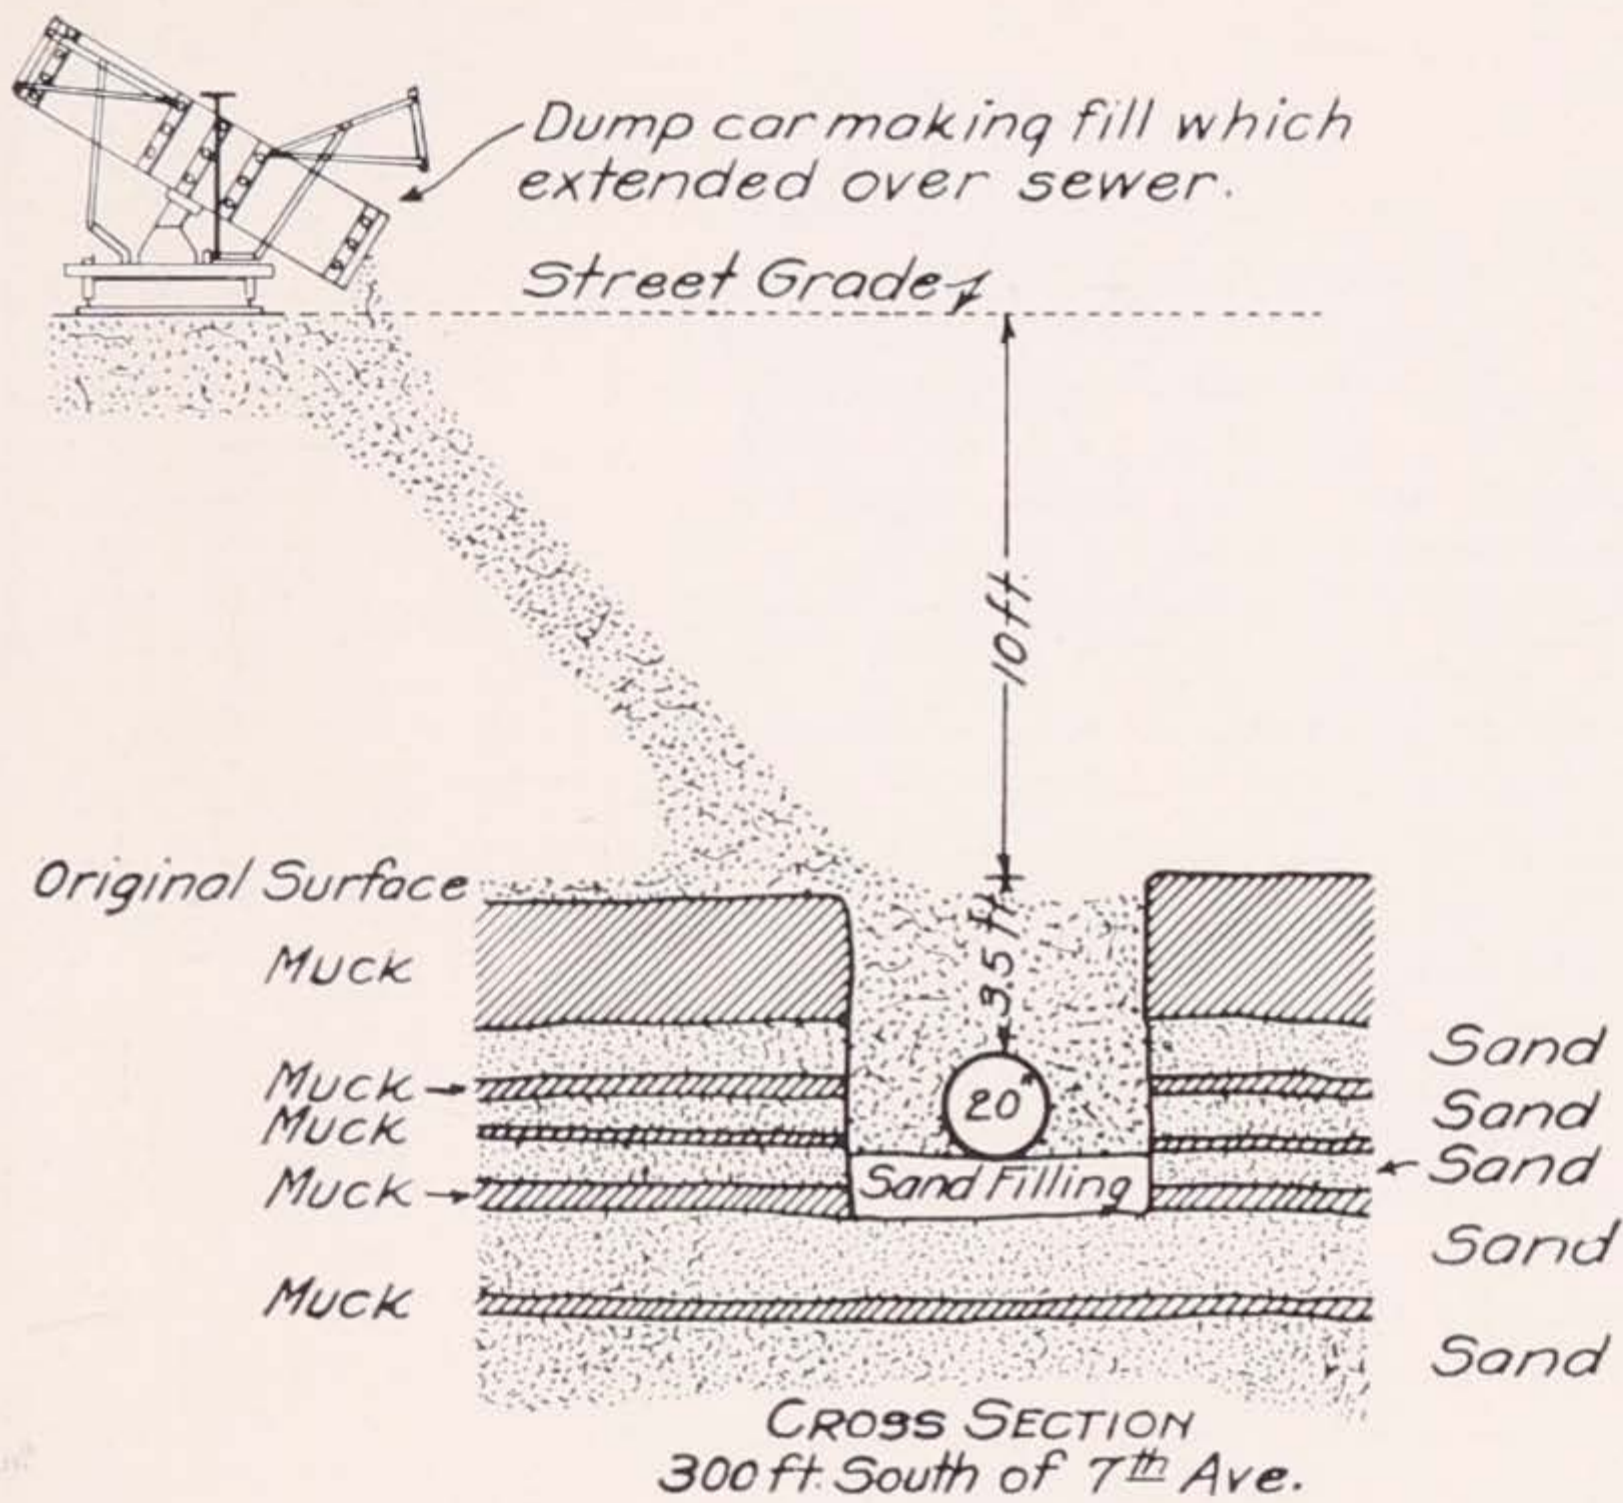
Fig. 8 shows the conditions under which a very instructive

failure occurred at Gary, Ind., in 1908. All the data of this failure were furnished by Alvord & Burdick, Sanitary and Hydraulic Engineers, Chicago, Ill. The sewer was constructed in May and June, 1907, of a good quality of 20 inch vitrified sewer pipe. The work was done under much difficulty, owing to the poor foundations, and the presence of water in large volumes, but care was taken to secure good results, and about 12 inches of muck under the sewer was excavated and replaced with sand. When the sewer was completed, the depth of filling was only about 3 ft. above the top of the pipe. Immediately afterwards, however, the Gary Sand Co. filled 10 ft. more over the entire sewer and vicinity, discharging the material from side dump cars on a track which paralleled the sewer on the east.

In the spring of 1908 exceptional floods subjected the entire sewer to a bursting pressure estimated by the engineers at 3 to 4 pounds per sq. in. (7 to 9 ft. head of water). In March, 1908, the sewer collapsed in several places, and filled with sand, so that eventually its entire reconstruction became necessary in May and June, 1908.

Fig. 8. Conditions under which 20 Inch Vitrified Sewer Pipe Cracked in Alley 8, Gary Ind., 1908.

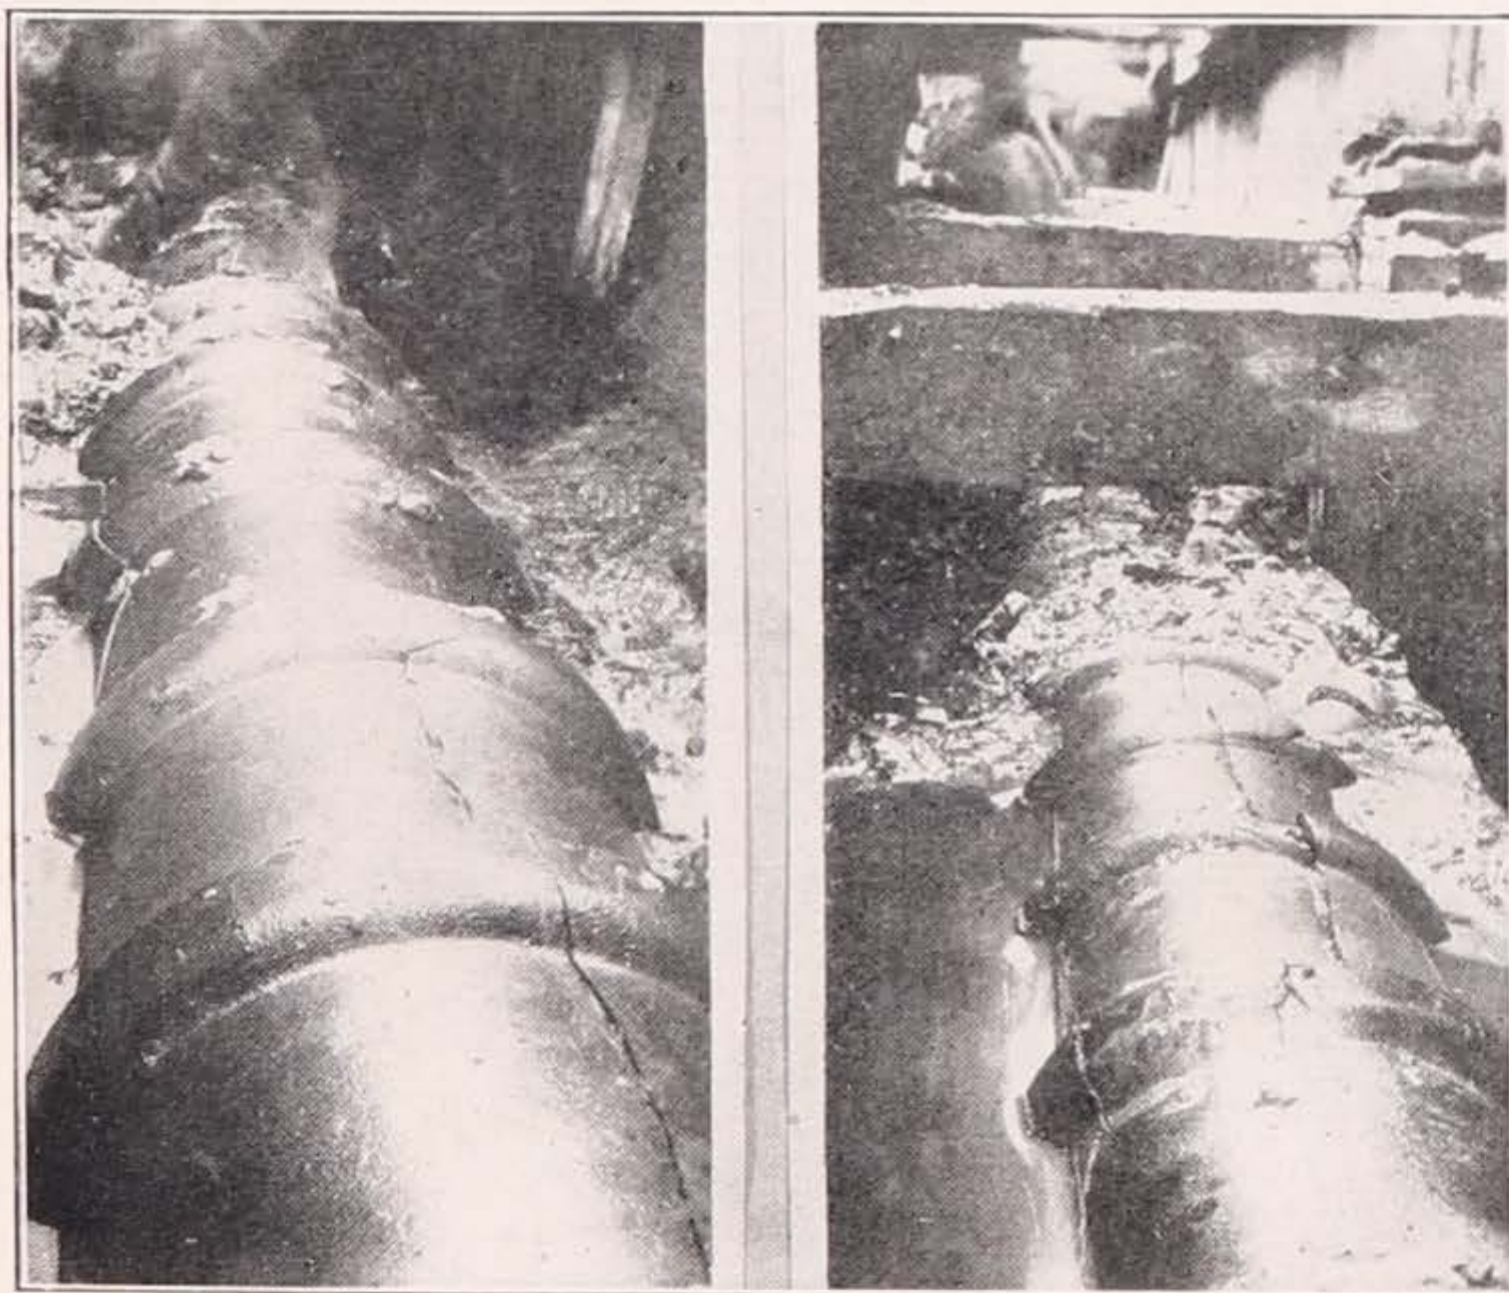
Fig. 9. Two Views of Cracked 20 Inch Vitrified Sewer Pipe in Alley 8, Gary, Ind., 1908.

It was the opinion of Messrs. Alvord & Burdick that the sewer pipe were cracked by the inclined pressure due to the side fill soon after the sewer was completed, and

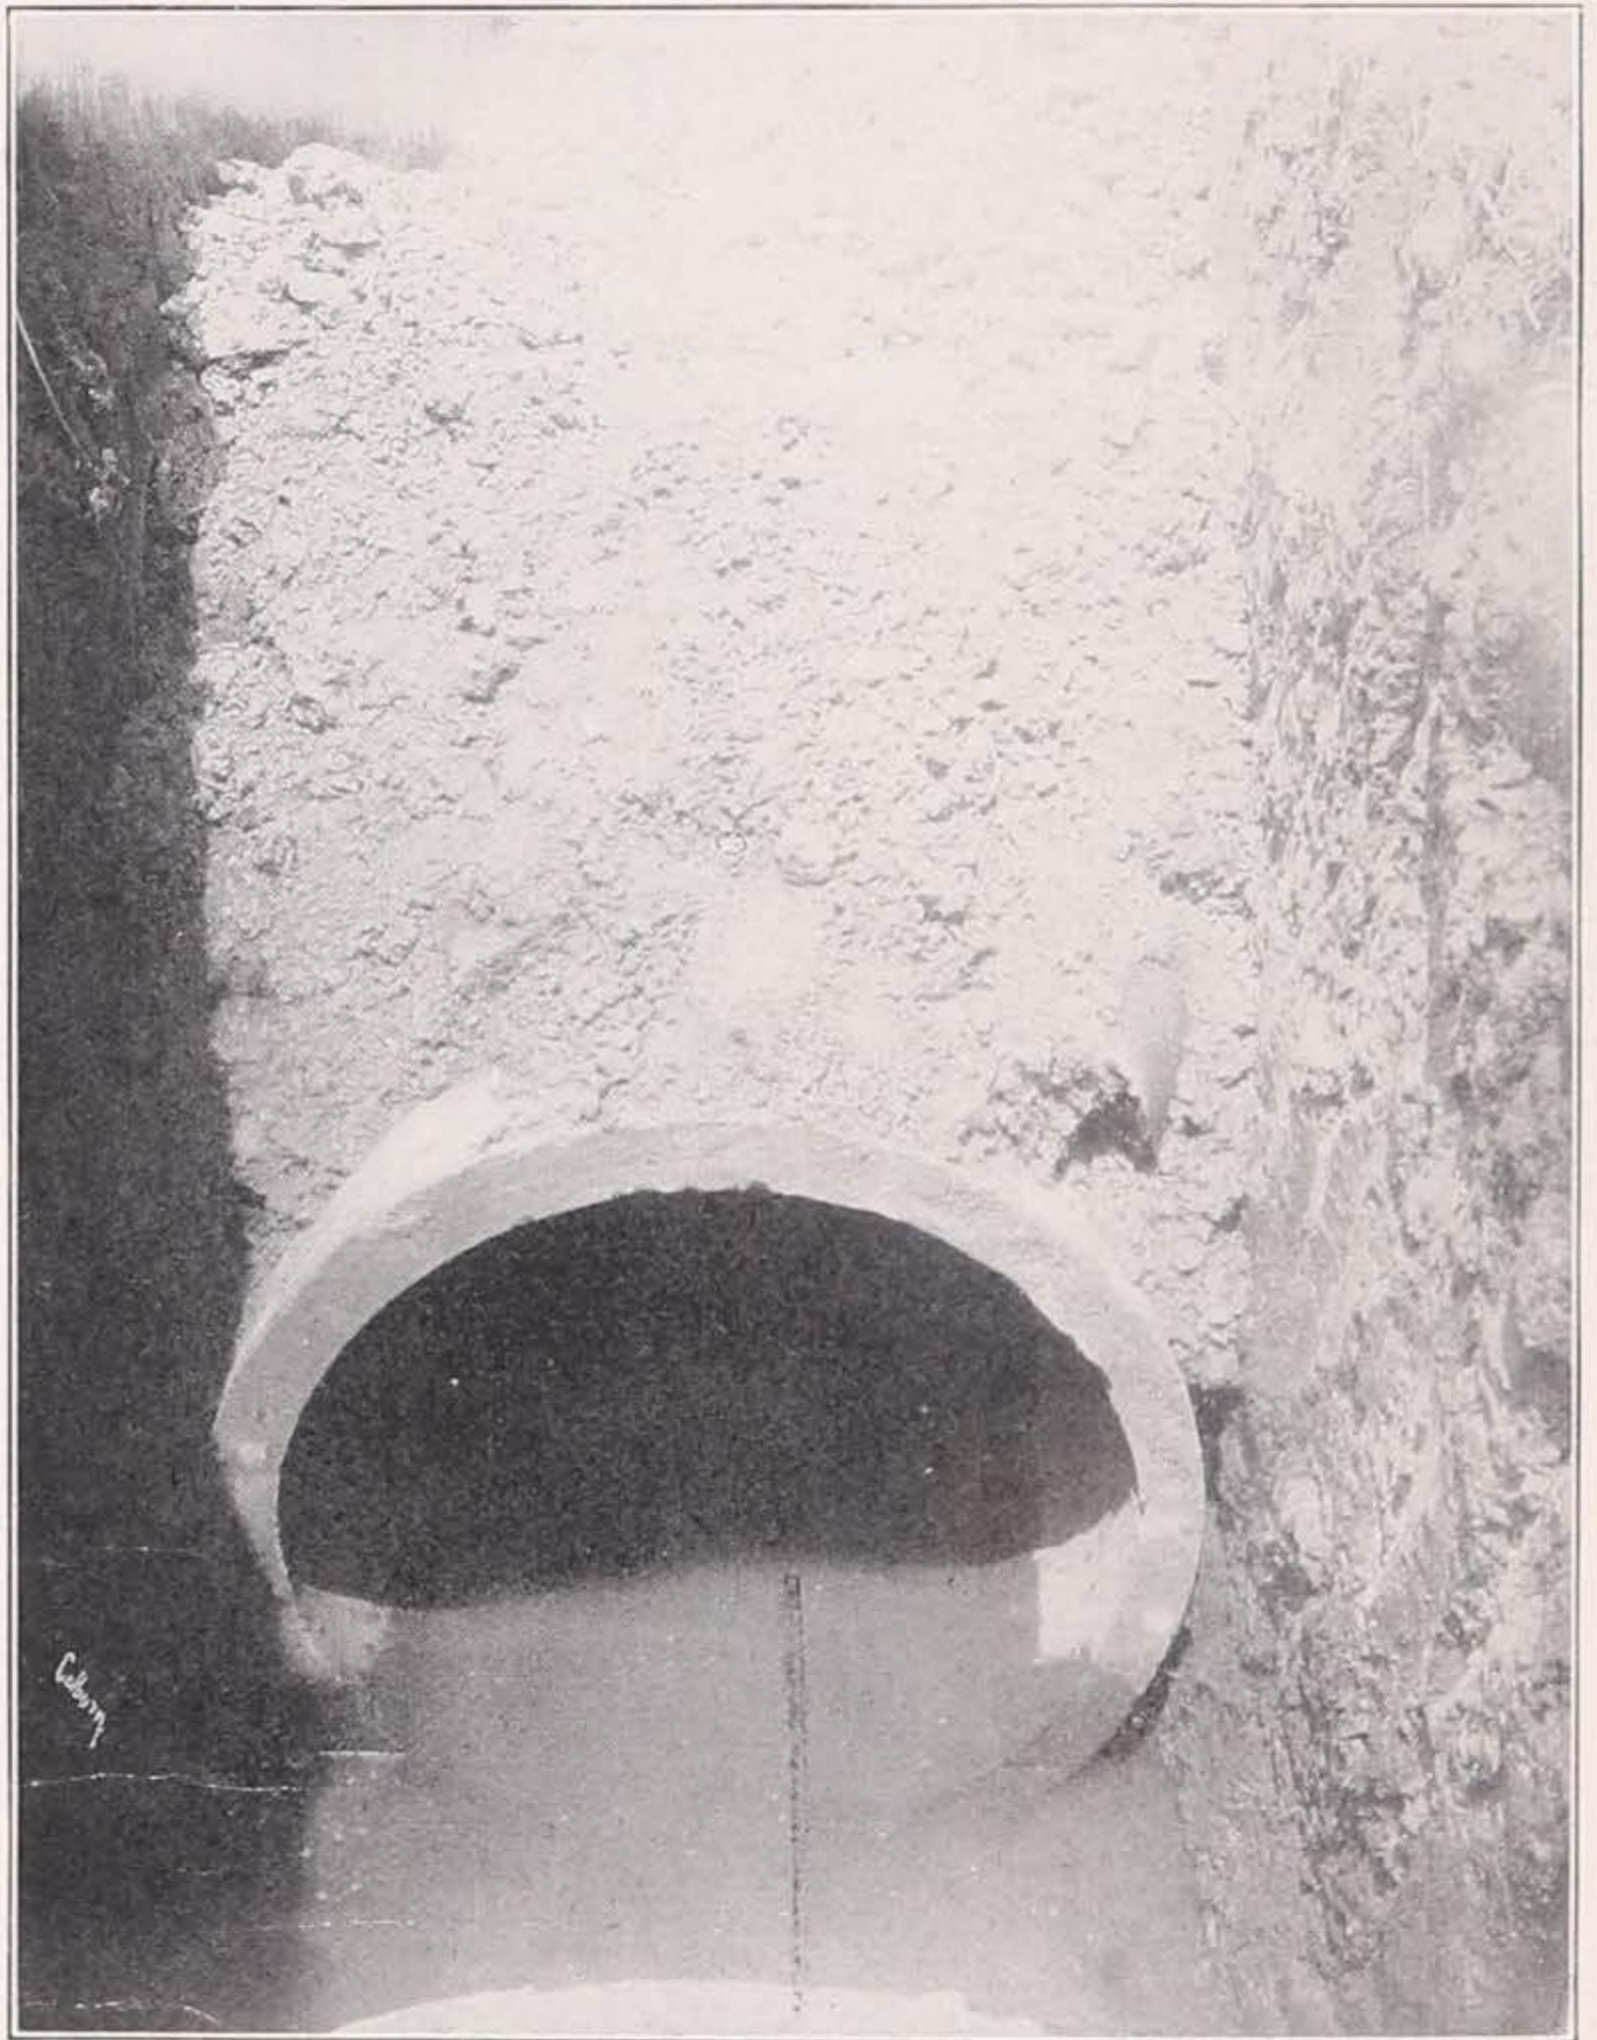
Fig. 10. Photograph Showing Typical Conditions of Bedding of Drain Tile in Ditches. The pipe are bedded on the bottom for about 90 degrees of the circumference, and receive practically no side support.

While careful ramming of the side ditch filling helps to prevent complete collapse of the pipe, yet ramming of the filling over the pipe may be too heavy, and may help cause cracking. This is evidenced by the fact, reported by Messrs. J. N. Hazle-

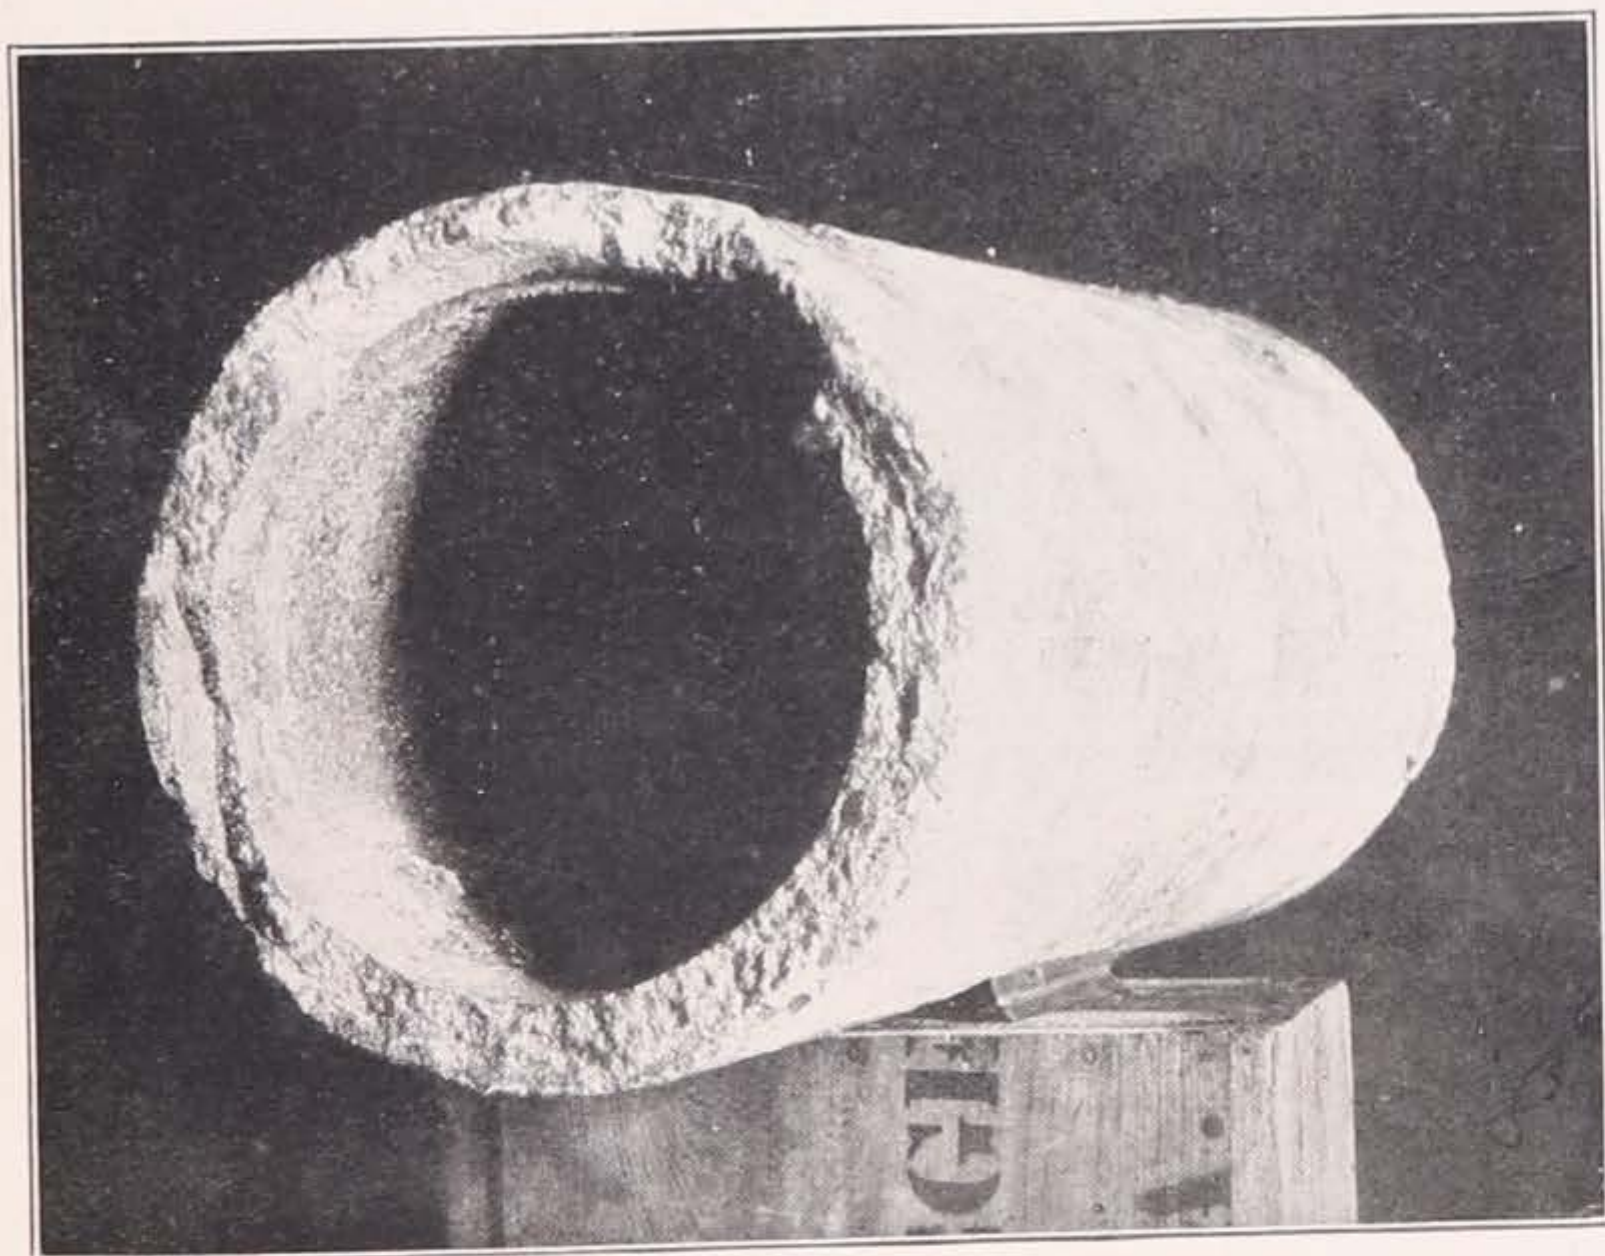
Fig. 26. An Eight Inch Cement Drain Tile, Taken Up for Tests after Used in Ground for Thirty-one Years.

range of ages. In fact, we secured some 8 in. and 10 in. cement pipe, which had been in actual use in the ground, in a drain and in a sewer respectively, for thirty-one years.
