CITY OF KEOKUK, IOWA TRAFFIC SAFETY STUDY

TRAFFIC SAFETY STUDY

KEOKUK, IOWA

Prepared by: KIRKHAM, MICHAEL AND ASSOCIATES
Architects - Engineers
Omaha - Minneapolis

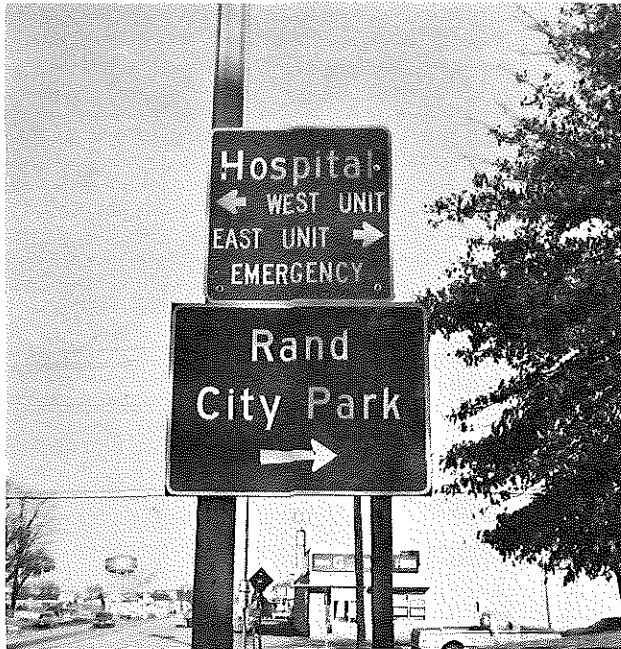
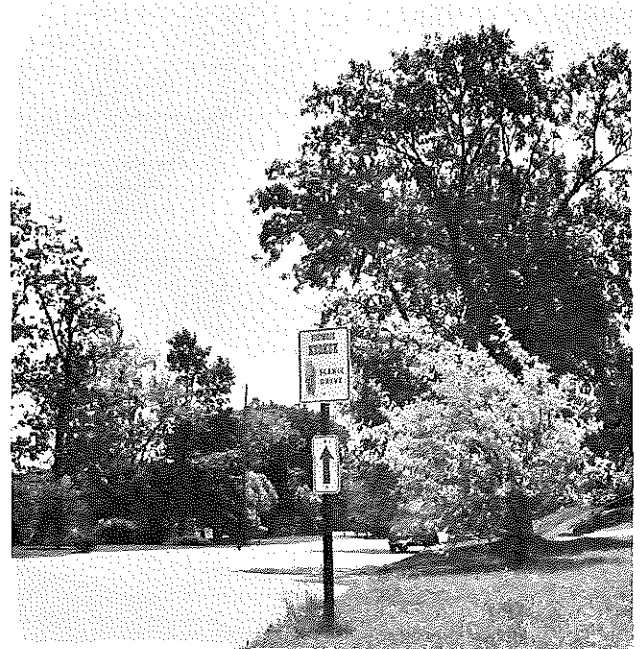
The signs shown above are helpful to the visitor and are a definite asset to the City's sign system.

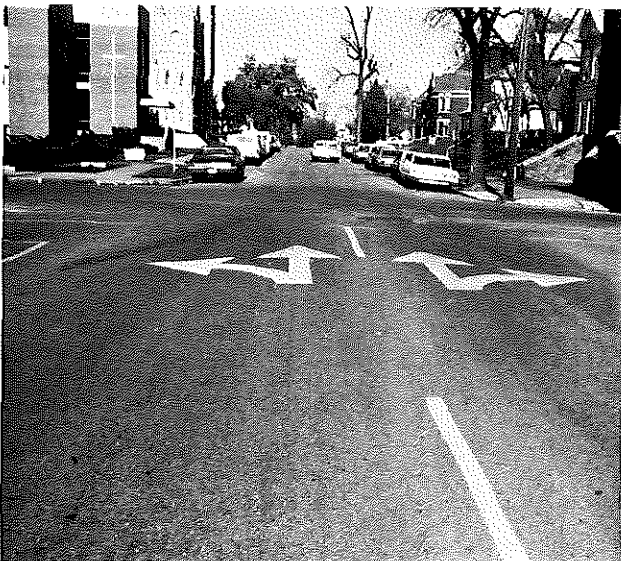
The adjacent photo is a typical example of the City's pavement marking methods.

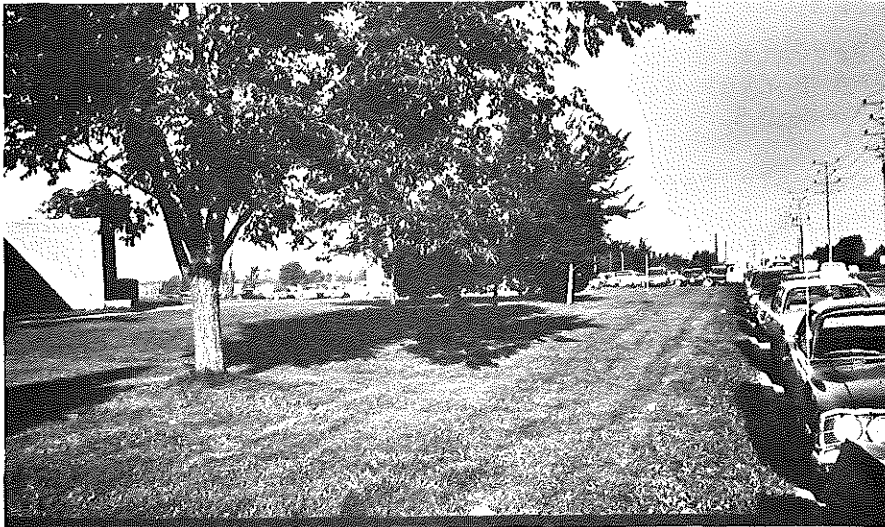
Municipal
Pool Area

these owners. There are also several areas of City owned property mainly in park areas that are in immediate need of sidewalk construction as there are pedestrians now using the streets, creating potentially dangerous situations. (See Photo below) In conjunction with the sidewalk replacement program, it would be advisable to initiate construction on the city owned areas as well. A tentative priority list is included in this section. These were areas that were observed during a period of data gathering and field review during the course of this study. Other areas may also have high priority as determined by city engineering department personnel through citizen complaints and long term observation over the past years.

The photos above emphasize the need for sidewalks. Both areas have high volumes of pedestrian traffic.

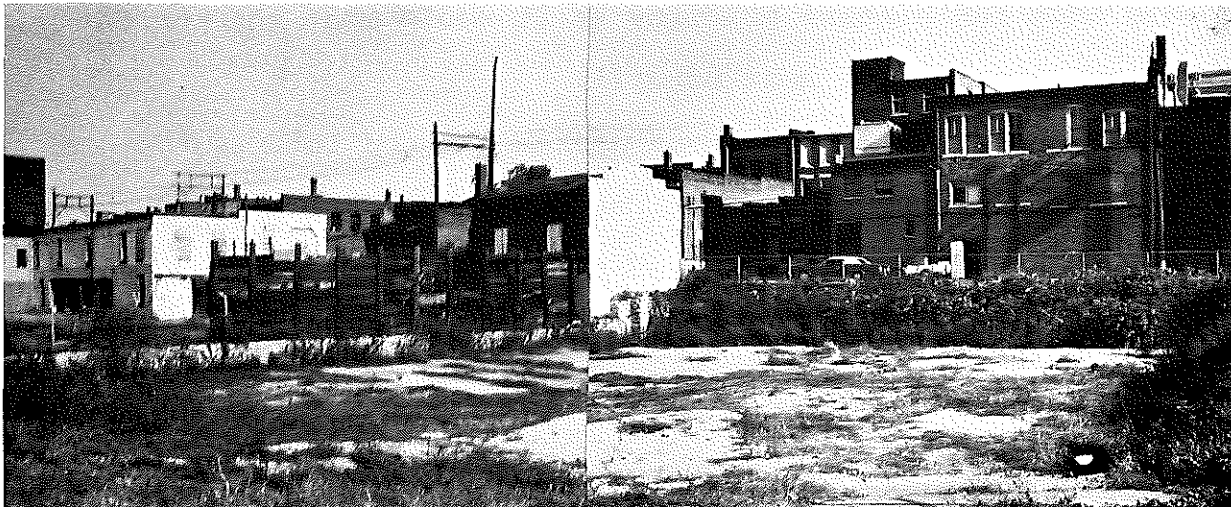
site lies in a 6 to 10 foot deep depression just behind the Main Street business buildings between 6th and 7th Streets (see Plate 5). Both Johnson Street on the west and the alley to the east lie higher than the proposed site. There will be construction expense as the area will have to be filled and paved. Provisions for drainage and building removal will also be required. The main advantages of this site is the convenient location to the core retail area. There have been some excellent proposals to develop this parking area in conjunction with a walk thru mall included in the "New Faces for Old Places" program now being supported by the Chamber of Commerce. Another advantage of the site is its adequate size for worth while development. There is room for more than 150 parking spaces on the site almost doubling the existing off-street public parking area. As one can see in the series picture below, the Johnson Street site as presently maintained, has a weed control problem and is on the verge of becoming a blighted area. The development of converting this area into a landscaped functional parking area would be a major asset to the City.

Site of proposed municipal parking lot between 6th and 7th Streets adjacent to Johnson Street.

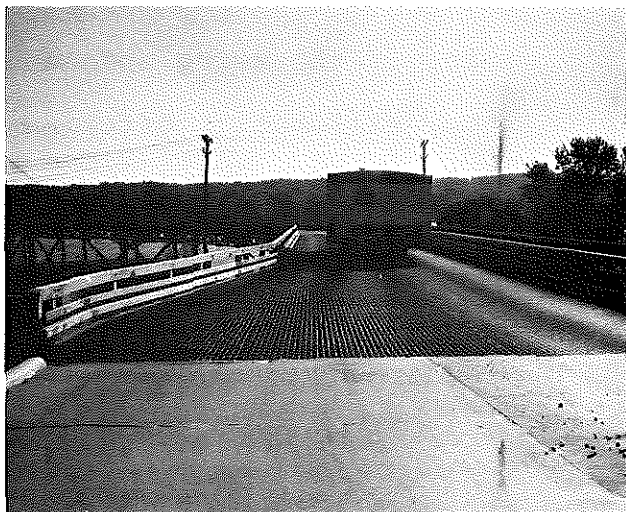
Besides the swing span opening operation which stops all traffic there are other inherent problems with the bridge which adversely affect vehicle capacity. The bridge is barely wide enough for two lane opposing traffic and has a reverse curve alignment which inhibits traffic flow at the west end. The photo, Plate 25 shows the crossing of a wide vehicle during which traffic in the opposite direction had to be stopped for several minutes. Two-way radios were utilized for this crossing. The open grate deck is difficult to drive on and drivers not use to this type of deck have a hard time maintaining the 20 mile speed limit. There is also an uneasiness that the sirens which announce the opening of the swing span and the gates which block the traffic may malfunction offering no protection against driving off the edge of the fixed portion of the bridge into the river. Of course this is not likely to happen as the operator checks the swing span making sure all vehicles are clear before the span opening operation begins. These factors do

Wide vehicle crossing the Municipal Bridge. **PLATE 25**

The ultimate solution to the Municipal Bridge problem is, of course, bridge replacement with a high clearance structure that meets navigation clearance requirements and would not have to be opened for river traffic. The approach terrain on both sides of the river is very suitable for a high clearance bridge. There are bluffs on each side of the river and traffic has to descend to the present bridge.

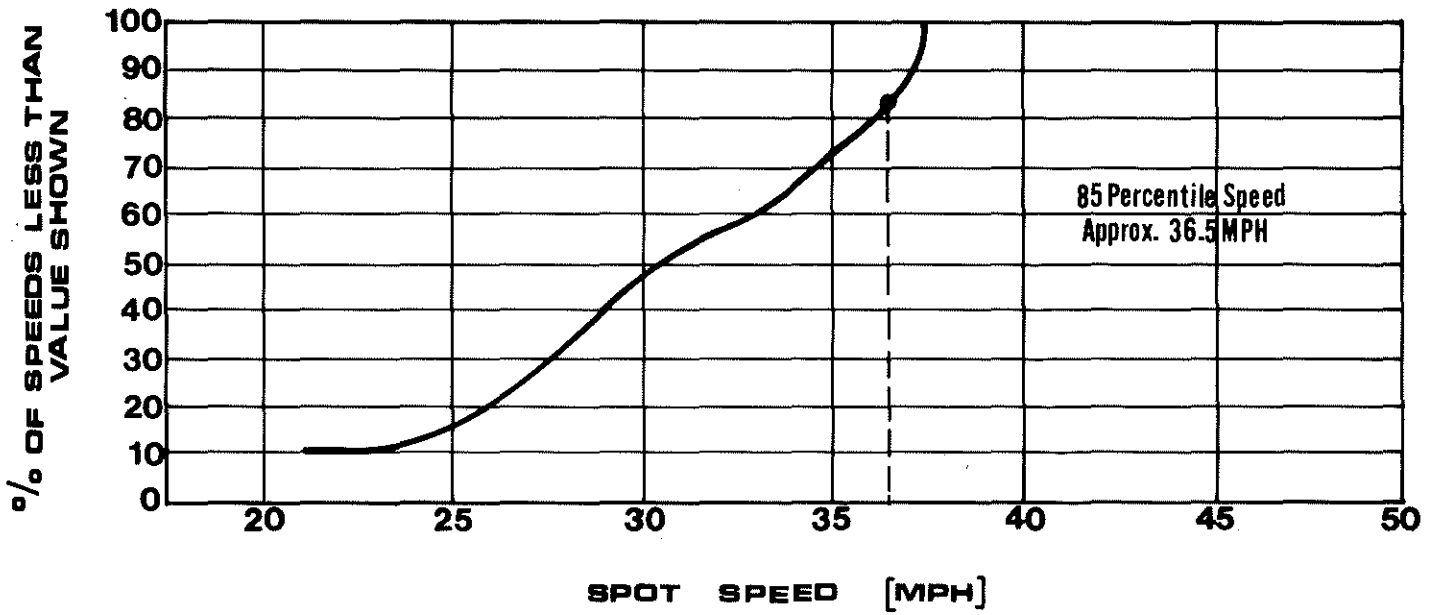
CUMULATIVE SPEED DISTRIBUTION
MESSENGER ROAD NEAR THE COMMUNITY COLLEGE

So far the road has had a low rate of accidents and the physical characteristics consist of long vertical curves and no horizontal curves. There are a considerable number of driveways and these are expected to increase. Weighing these factors it is recommended that the speed limit on Messenger Road be lowered to 35 miles per hour from U.S. 218 to the Middle Road Junction.

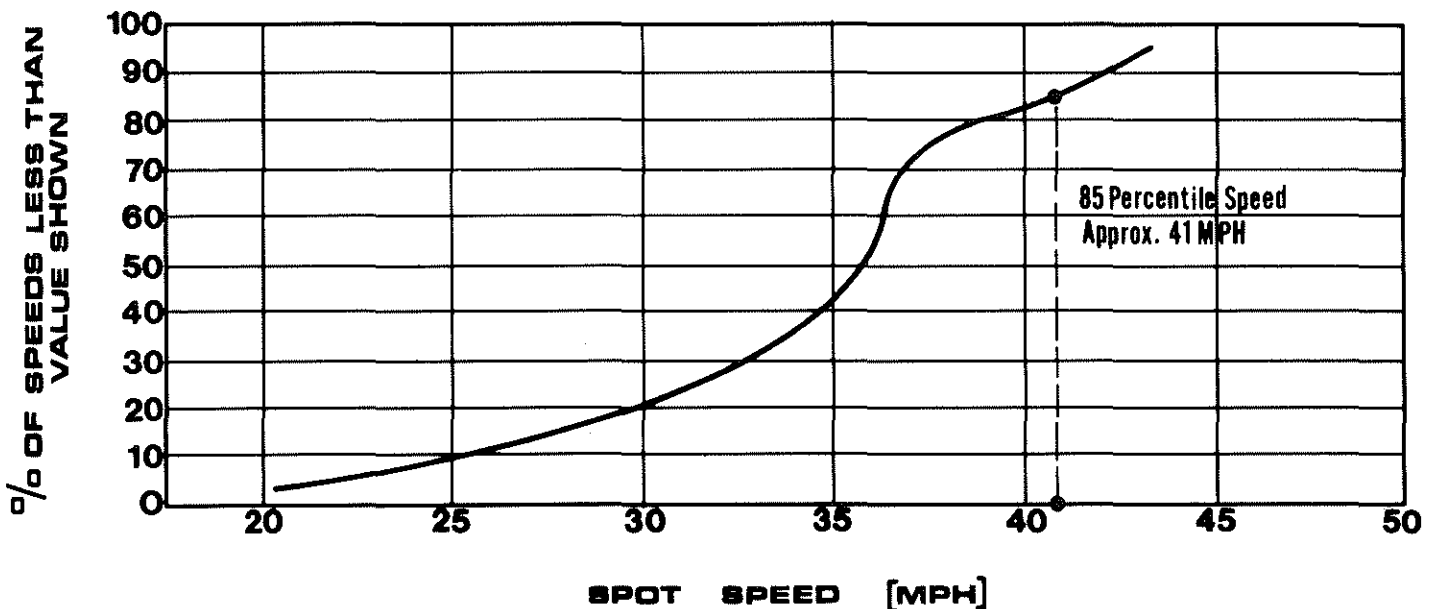
CUMULATIVE SPEED DISTRIBUTION
 MAIN STREET ROAD AT 22nd STREET

2. Main Street Road north of 16th Street
 This sector of Main Street Road carries a high volume of traffic (7000 to 12,000 vehicles per day in 1970) and is practically 100 percent developed from 16th street to Messenger Road. Access is virtually unrestricted and several businesses are the type that generate a lot of drive-in - drive-out traffic. The speed limit changes from 25 mph to 35 mph at 16th Street. The prevailing speed at 22nd and Main was measured on a weekday afternoon and was found to be 36.4 miles per hour. The Keokuk Police also measured the speed rates and found them to average approximately 35 miles per hour. Spot speeds of several individual vehicles were plotted and the 85 percentile speed taken from the graph shown below is 41 mph. There are no horizontal curves and sight distance appears to be adequate. Because of other characteristics of the roadway such as the expanding commercial development and the high rate of accidents at the shopping center entrance at 23rd and Main it is recommended at this time that the speed on this sector of Main Street be retained at 35 miles per hour. In the future, however, as development continues to grow and if accident rates continue to increase a re-evaluation of the sector between 16th and 23rd Streets on Main should be made.
