MERRIMACK RIVER BASIN
BRADFORD, NEW HAMPSHIRE

TODD LAKE DAM

NH 00288

PHASE I INSPECTION REPORT
NATIONAL DAM INSPECTION PROGRAM

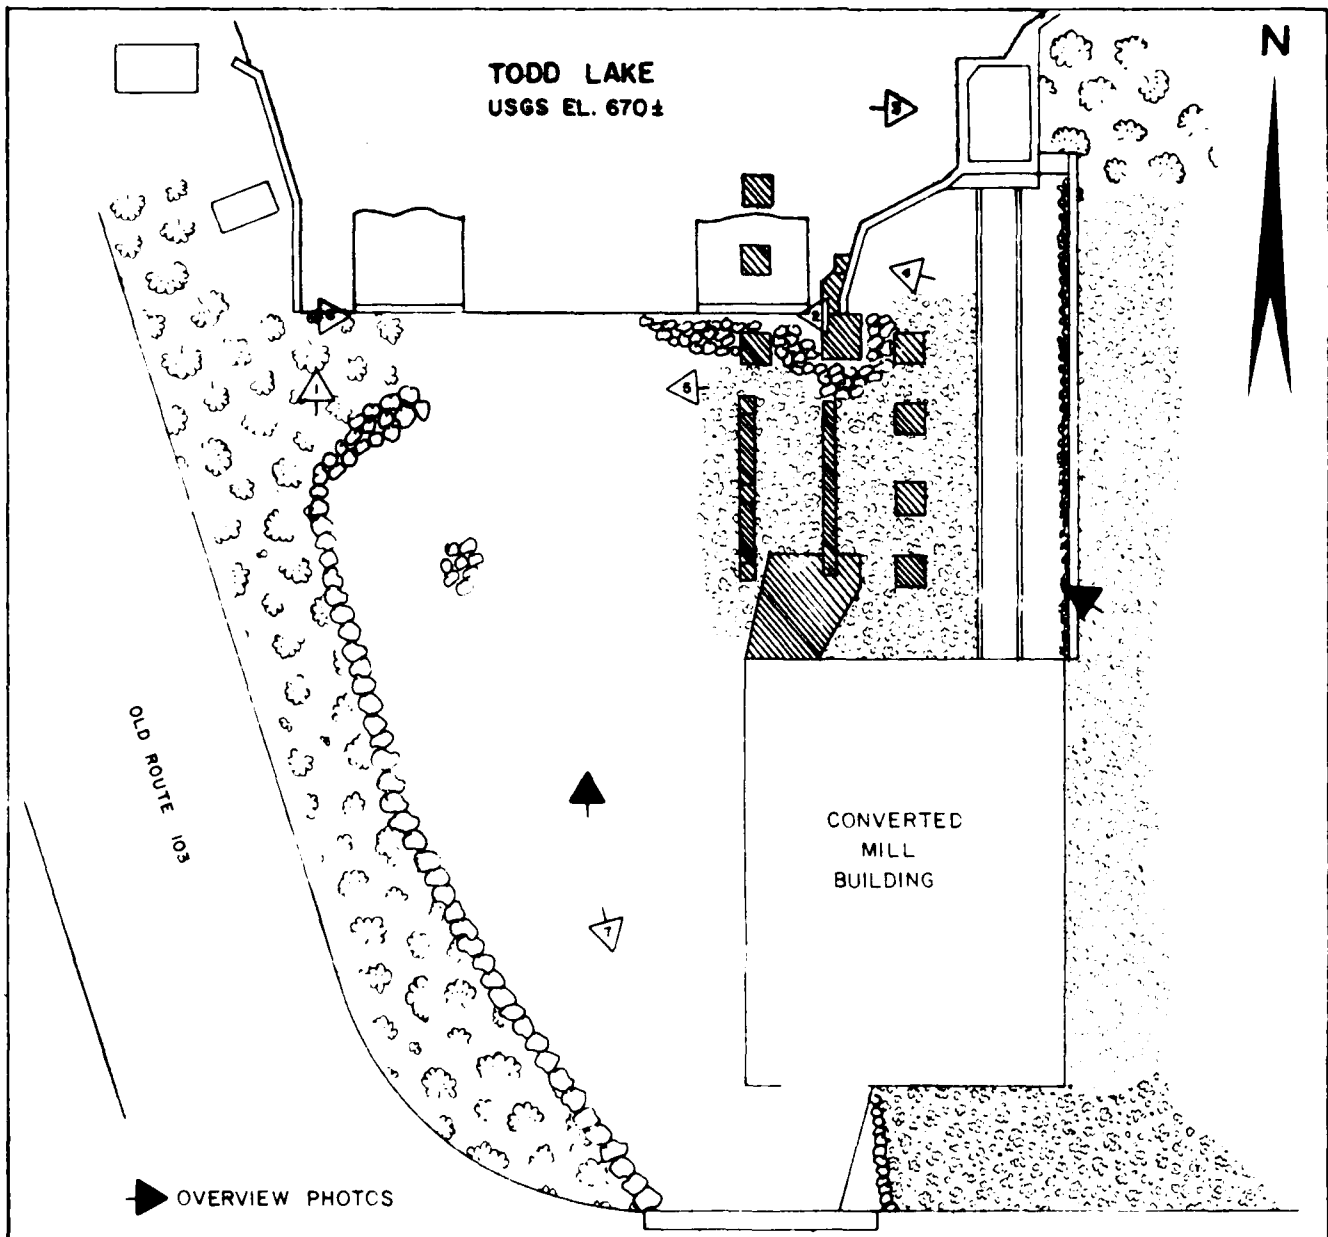
HOUSE	HOUSE
GOLDBERG, ZOINO, DUNNICLIFF & ASSOC., INC. GEOTECHNICAL CONSULTANTS NEWTON UPPER FALLS, MASS.	U.S. ARMY ENGINEER DIV NEW ENGLAND CORPS OF ENGINEERS WALTHAM, MASS.
NATIONAL PROGRAM OF INSPECTION OF NON-FED DAMS	
LOCATION AND ORIENTATION OF PHOTOS	
TODD LAKE	NEW HAMPSHIRE
SCALE 1" = 20'	DATE JULY 1978

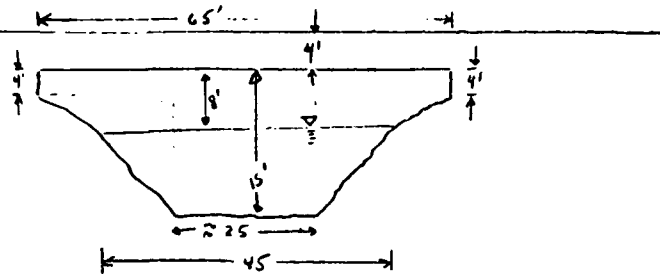
SOME CONSIDERATION MUST BE GIVEN TO WHETHER OR NOT THE NEW ROUTE 103 HIGHWAY EMBANKMENT WHICH FOLLOWS THE ALIGNMENT OF THE OLD RAILROAD WILL SERVE AS A DAM AND THIS BECAUSE THE PEAK FLOW THAT REACHES THE TODD LAKE DAM A CROSS SECTION AT THE HIGHWAY BRIDGE WAS TAKEN ON 7/12/78.

GIVEN THE LARGE OPENING $\approx 750 \text{ FT}^2$ AND THE LIMITED FREEBOARD OVER THE BRIDGE GOT TO PRESSURE FLOW, IT IS UNLIKELY THAT A SIGNIFICANT REDUCTION IN FLOW WOULD RESULT FROM THE BRIDGE.
