Osborne Tire Reef Benthic Survey Report

Florida Department of Environmental Protection

25 June 2019

DOCUMENT NO. CSA-OLSEN-FL-19-81070-3424-04-REP-01-FIN-REV01

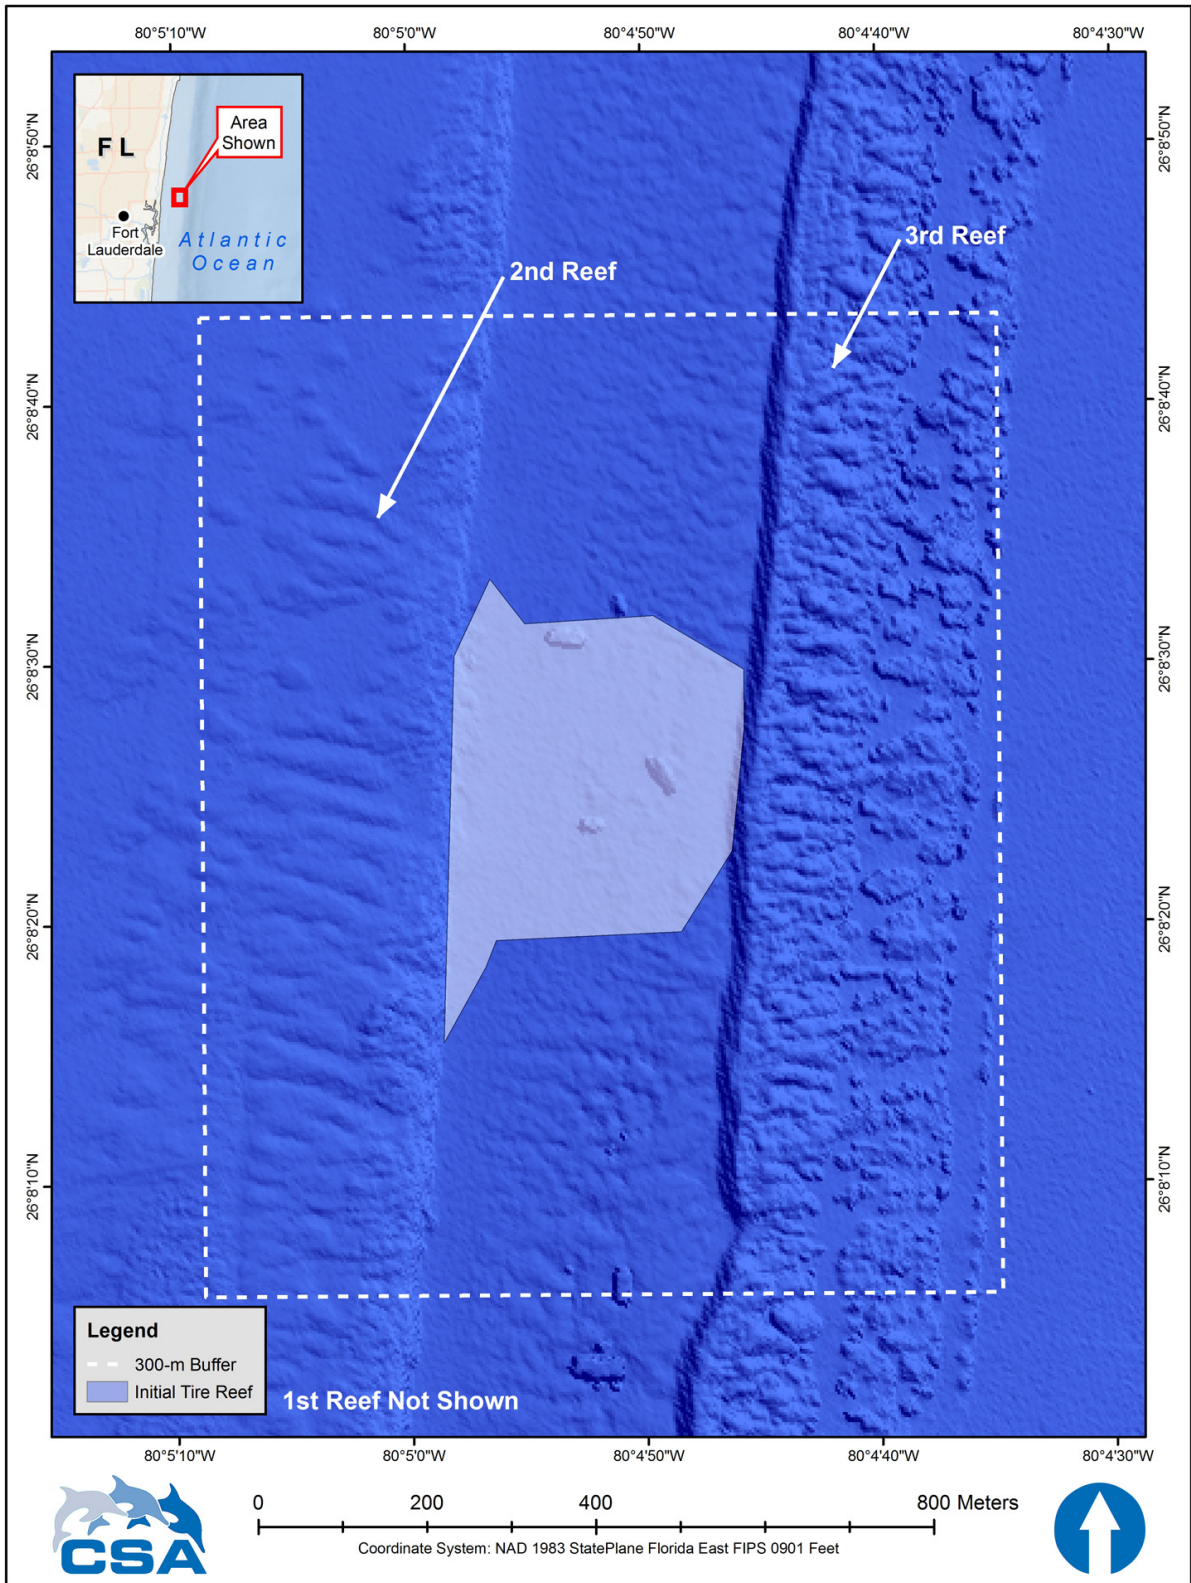
Figure 1. Osborne Tire Reef outline (initial Tire Reef) and the 300-m buffer rectangle. Background source: NOAA NOS Hydrographic Survey H12117, Year: 2008.

Towed video and diver video and observations indicated tires occurred in the OTR area as well as north, east, and south of the OTR area. Large concentrations of tires were visible and exposed along the eastern margin of the second reef (see **Figure 1** for reef locations), extending several hundred meters north of the defined OTR boundary (**Photo C-25**). Large accumulations of tires were also observed in the offshore (eastern) portions of sand channels across the third reef (**Photos C-26 and C-27**) as well as in adjacent sandy low relief areas east of the third reef and the OTR boundary. These tires were nearly totally exposed and covered wide expanses of the sand and rubble flats between reef structures (**Photos C-28 and C-29**). Despite the high abundance of tires east of the third reef, very few tires were observed on elevated reef areas, and where present they were generally in sand-filled depressions (**Photos C-30 and C-31**). Diver and towed video observations also confirmed that very few tires were present on elevated sections of the second and third reefs.

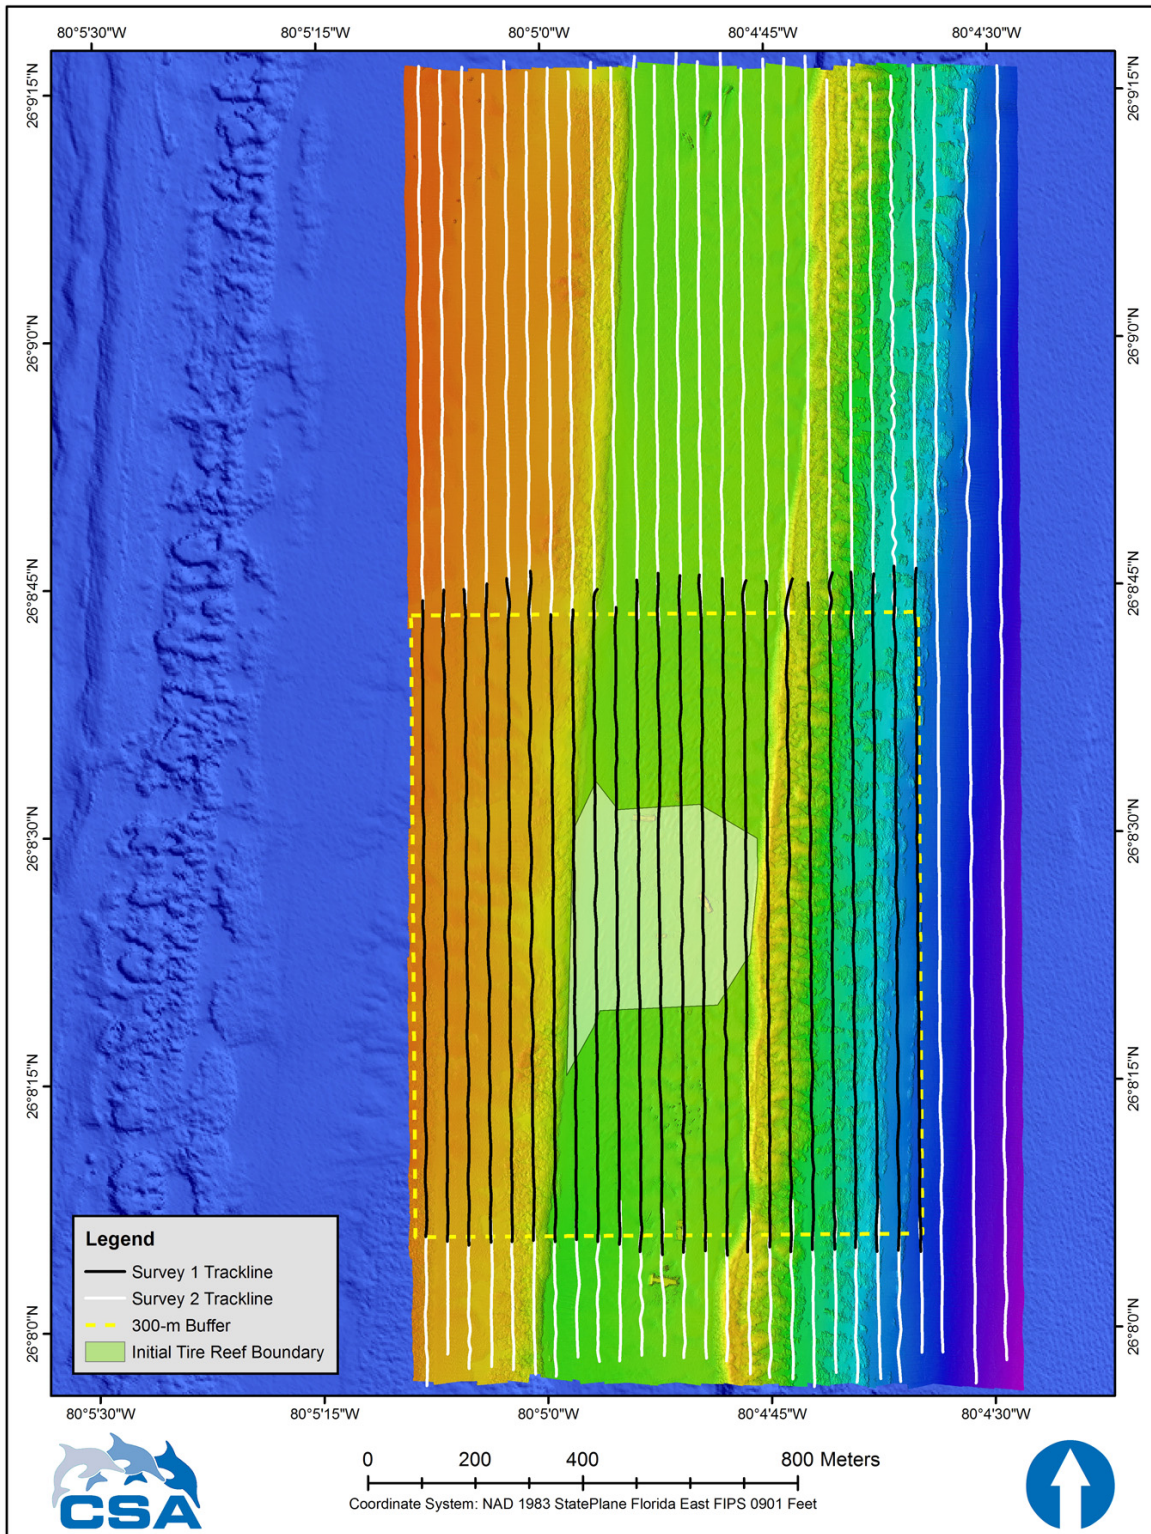
Figure 4. Side-scan sonar and multibeam survey transect plots including the expanded survey area (Survey 2) north, east and south of the original Osborne Tire Reef project area within the 300-m buffer (Survey 1). Background source: NOAA NOS Hydrographic Survey H12117, Year: 2008.

During this survey (Survey 1, that of the original OTR), it was observed that tires occurred beyond the 300 m buffer rectangle, substantially so to the north and to a lesser extent to the east and south. Olsen communicated these findings to FDEP, which resulted in additional side-scan sonar and multibeam survey efforts (Survey 2) to determine the extent of tire debris accumulations being authorized by FDEP. Survey 2 extended beyond the 300 m buffer rectangle 1,000 m to the north, 500 m to the east, and 500 m to the south. The survey was conducted with the same personnel, vessel, and equipment as the initial survey.

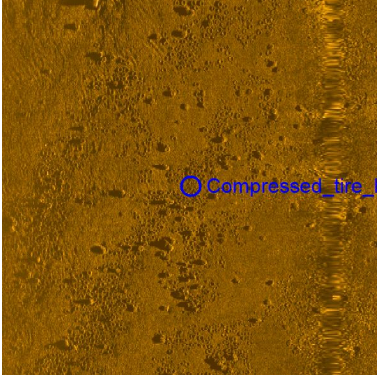
<p>Compressed tire bundles</p> <ul style="list-style-type: none"> • Sonar Time at Target: 4/27/2019 8:02:54 AM • Click Position 26.1389285772 -80.0810498269 (WGS84) (X) 957648.11 (Y) 657250.56 (Projected Coordinates) • Map Projection: FL83-EF • Acoustic Source File: I:\3425_Olsen_Tire_Reef_SS_Data\Olsen190427075800.xtf • Ping Number: 73671 • Range to target: 61.70 US ft • Fish Height: 21.22 US ft • Heading: 178.560 Degrees • Event Number: (-1) • Line Name: Olsen190427075800 • Water Depth: 0.00 US ft 	<p>Dimensions and attributes</p> <ul style="list-style-type: none"> • Target Width: 0.00 US ft • Target Height: 0.00 US ft • Target Length: 0.00 US ft • Target Shadow: 0.00 US ft • Classification1: • Classification2: • Area: • Block: • Description:

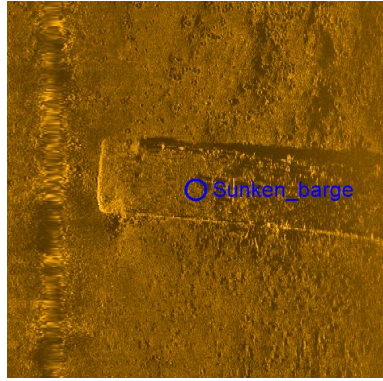
<p>Sunken barge</p> <ul style="list-style-type: none"> • Sonar Time at Target: 4/27/2019 8:00:48 AM • Click Position 26.1419383649 -80.0814287984 (WGS84) (X) 957516.04 (Y) 658343.72 (Projected Coordinates) • Map Projection: FL83-EF • Acoustic Source File: I:\3425_Olsen_Tire_Reef_SS_Data\Olsen190427075800.xtf • Ping Number: 71807 • Range to target: 62.46 US ft • Fish Height: 20.27 US ft • Heading: 181.210 Degrees • Event Number: (-1) • Line Name: Olsen190427075800 • Water Depth: 0.00 US ft 	<p>Dimensions and attributes</p> <ul style="list-style-type: none"> • Target Width: 31.59 US ft • Target Height: 0.00 US ft • Target Length: 126.71 US ft • Target Shadow: 0.00 US ft • Classification1: • Classification2: • Area: • Block: • Description:

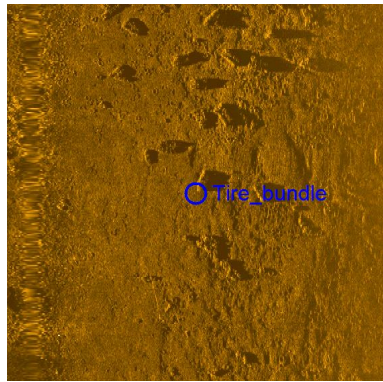
<p>Tire bundle</p> <ul style="list-style-type: none"> • Sonar Time at Target: 4/27/2019 8:01:26 AM • Click Position 26.1410206194 -80.0814556804 (WGS84) (X) 957509.58 (Y) 658010.06 (Projected Coordinates) • Map Projection: FL83-EF • Acoustic Source File: I:\3425_Olsen_Tire_Reef_SS_Data\Olsen190427075800.xtf • Ping Number: 72370 • Range to target: 71.49 US ft • Fish Height: 20.02 US ft • Heading: 179.820 Degrees • Event Number: (-1) • Line Name: Olsen190427075800 • Water Depth: 0.00 US ft 	<p>Dimensions and attributes</p> <ul style="list-style-type: none"> • Target Width: 0.00 US ft • Target Height: 0.00 US ft • Target Length: 9.44 US ft • Target Shadow: 0.00 US ft • Classification1: • Classification2: • Area: • Block: • Description:

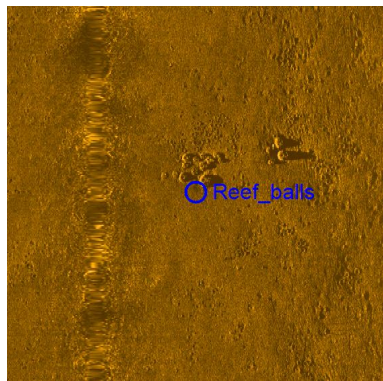
<p>Reef balls</p> <ul style="list-style-type: none"> • Sonar Time at Target: 4/27/2019 8:00:16 AM • Click Position 26.1427058979 -80.0813693663 (WGS84) (X) 957533.57 (Y) 658622.85 (Projected Coordinates) • Map Projection: FL83-EF • Acoustic Source File: I:\3425_Olsen_Tire_Reef_SS_Data\Olsen190427075800.xtf • Ping Number: 71338 • Range to target: 43.64 US ft • Fish Height: 18.98 US ft • Heading: 180.150 Degrees • Event Number: (-1) • Line Name: Olsen190427075800 • Water Depth: 0.00 US ft 	<p>Dimensions and attributes</p> <ul style="list-style-type: none"> • Target Width: 4.11 US ft • Target Height: 2.08 US ft • Target Length: 4.69 US ft • Target Shadow: 5.86 US ft • Classification1: • Classification2: • Area: • Block: • Description:

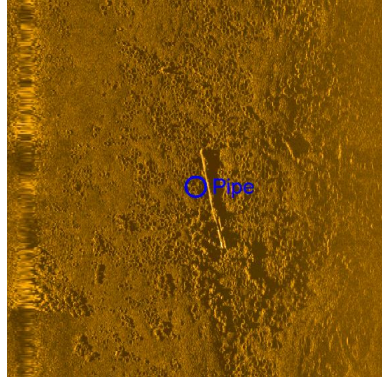
<p>Pipe</p> <ul style="list-style-type: none"> • Sonar Time at Target: 4/27/2019 8:24:44 AM • Click Position 26.1414634526 -80.0806366821 (WGS84) (X) 957777.14 (Y) 658172.93 (Projected Coordinates) • Map Projection: FL83-EF • Acoustic Source File: I:\3425_Olsen_Tire_Reef_SS_Data\Olsen190427082200.xtf • Ping Number: 93035 • Range to target: 74.12 US ft • Fish Height: 15.66 US ft • Heading: 179.480 Degrees • Event Number: (-1) • Line Name: Olsen190427082200 • Water Depth: 0.00 US ft 	<p>Dimensions and attributes</p> <ul style="list-style-type: none"> • Target Width: 1.74 US ft • Target Height: 0.85 US ft • Target Length: 44.57 US ft • Target Shadow: 4.35 US ft • Classification1: • Classification2: • Area: • Block: • Description:
---	---	---
