National Transportation Safety Board

Aircraft Accident Investigative Update

On January 26, 2020, at 0945 Pacific standard time (PST), a Sikorsky SK76B helicopter, N72EX, collided with hilly terrain near the city of Calabasas, California. The pilot and eight passengers were fatally injured, and the helicopter was destroyed by impact forces and fire. The helicopter was operated by Island Express Helicopters Inc. under Title 14 Code of Federal Regulations (CFR) Part 135 as an on-demand passenger visual flight rules (VFR) flight from John Wayne-Orange County Airport, (KSNA), Santa Ana, California, to Camarillo Airport, (KCMA), Camarillo, California.

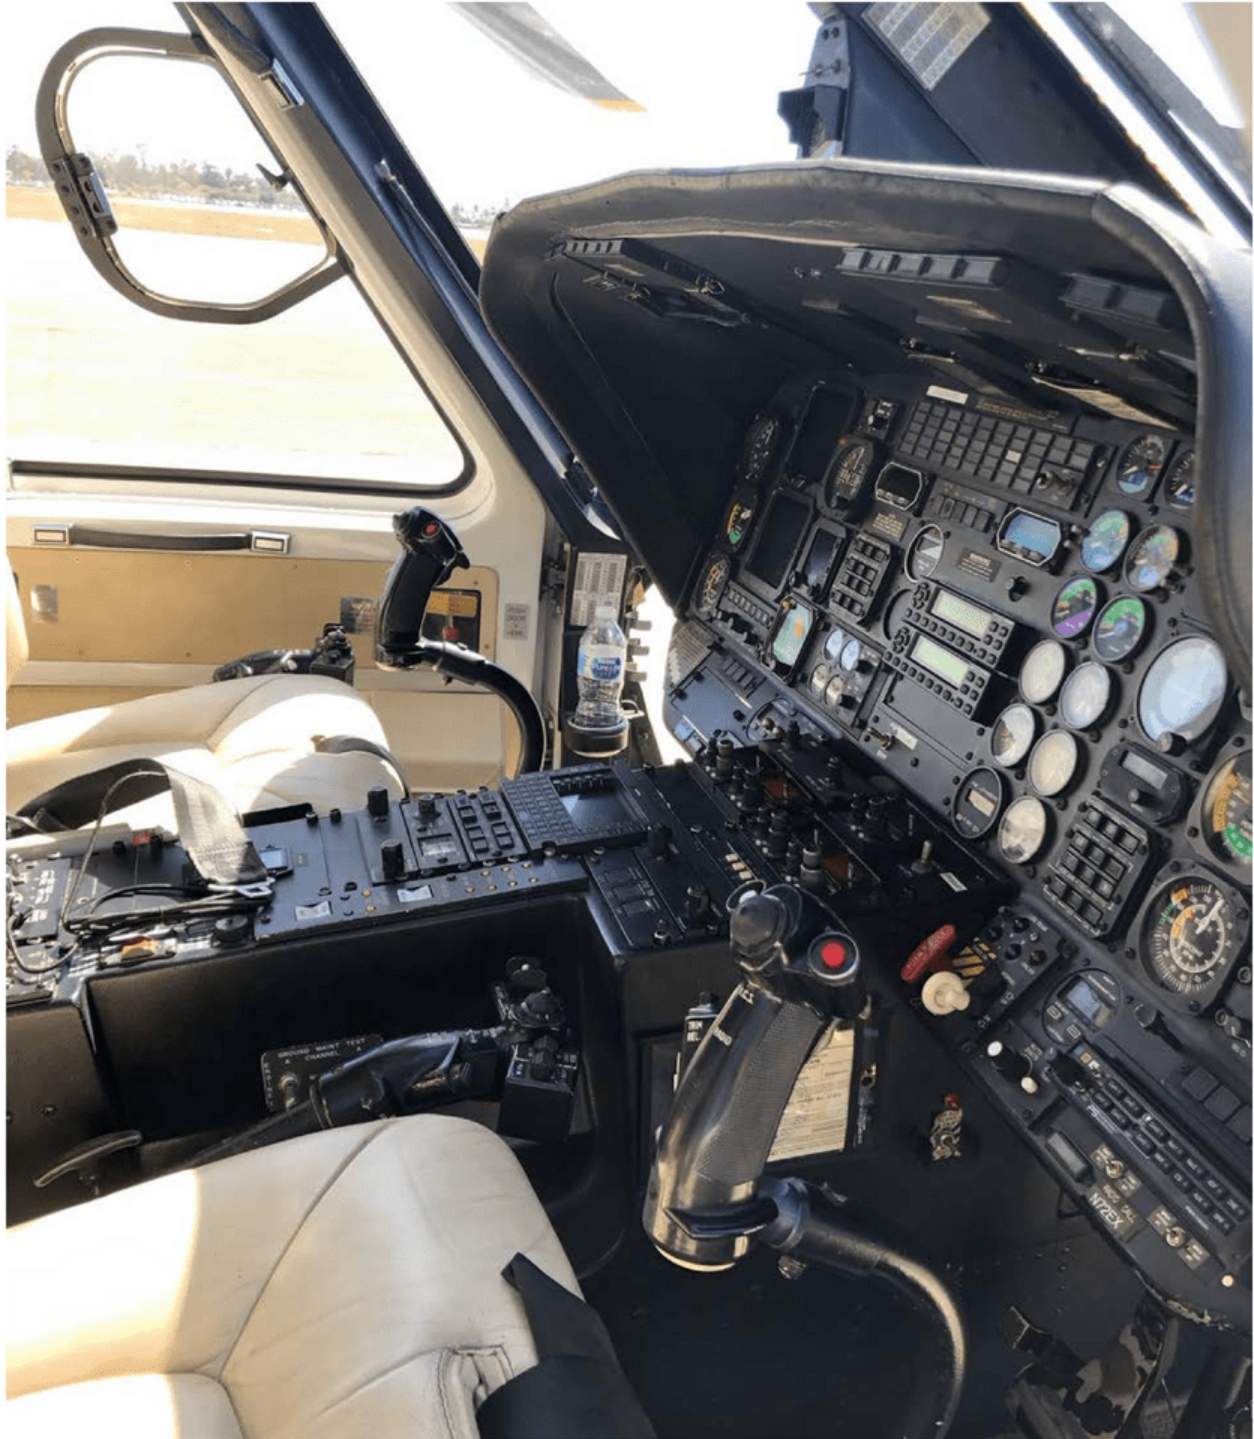
Figure 8. Photo of N72EX cockpit

The helicopter was not equipped with a flight data recorder or cockpit voice recorder (CVR) nor was it required to be for the accident flight. The helicopter was equipped with a four-axis automatic flight control system, electronic flight instrument system, radio altimeter, and ADS-B transponder. It was also equipped with a flight management system (FMS). The airworthiness group retained the FMS computer to examine it for any available recorded data stored in memory, and also retained two flight control computers, four gyros, and the standby attitude indicator for further examination. A number of personal electronic devices were recovered from the wreckage and will be examined for any relevant data.
