Problem:

- Thermal event originating in the headlamp/bucket area of vehicle

P4 Halogen Headlamp

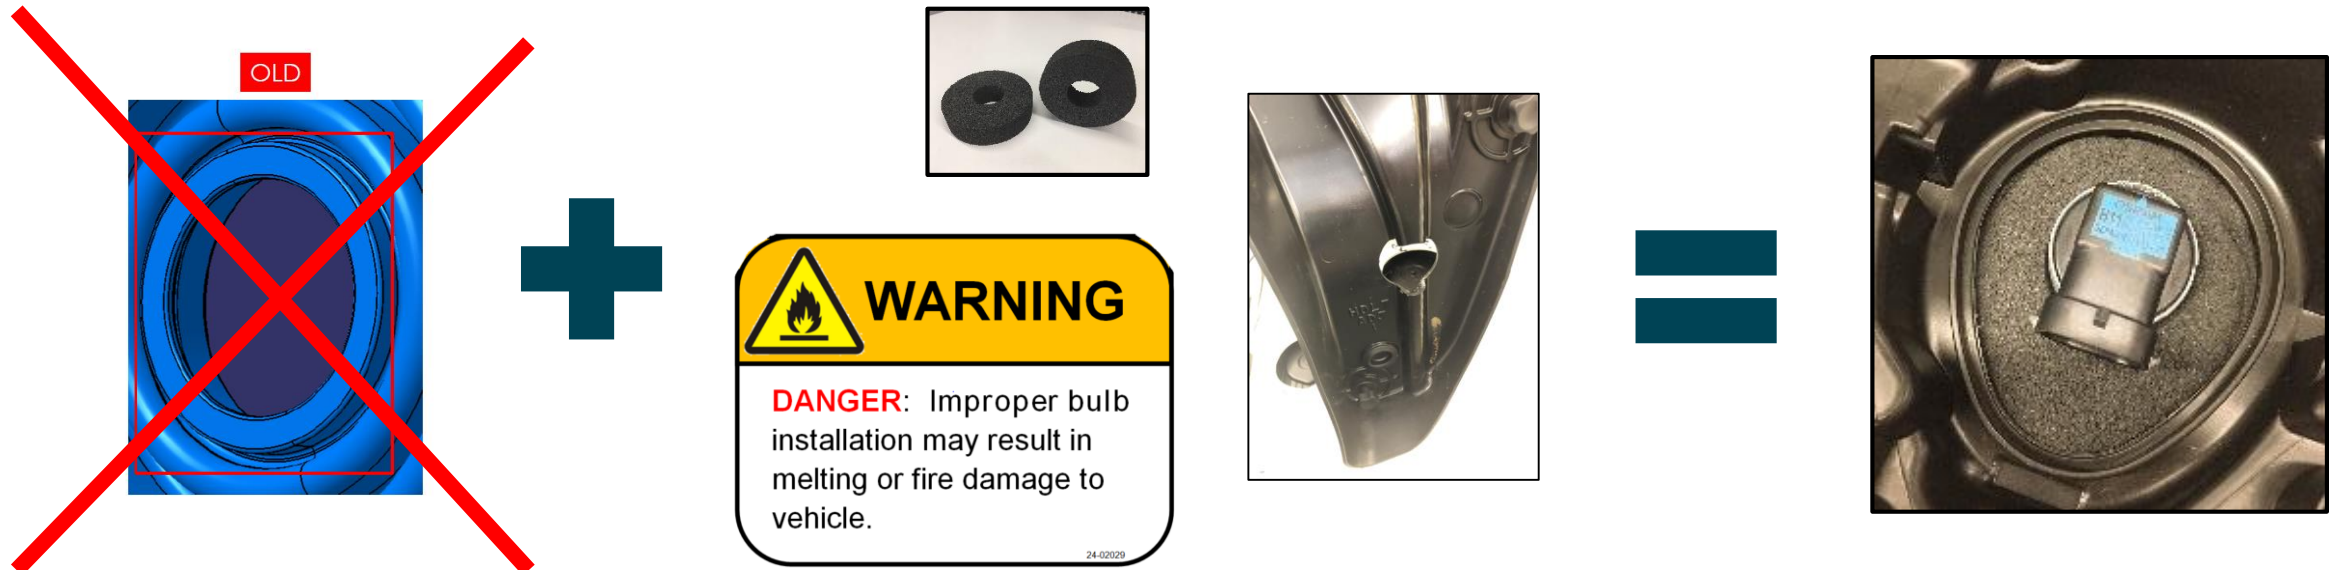
- Thermal event originating in the headlamp/bucket area of vehicle

- Bulb installed incorrectly & may disengage from reflector/headlamp

- All TMPs modifying headlamps (remove boot - installed grommet) as of 12/10/19
 - CLE started 12/5/19
- ZKW implementation of grommet with parts to DTNA C/O - 3/23/2020
- Warning label implemented
- Splash shield P59939+01 implemented 3/23/2020
