Salem Nuclear Generating Station, Unit No. 1 and Unit No. 2
Facility Operating License Nos. DPR-70 and DPR-75
NRC Docket Nos. 50-272 and 50-311

Subject: Response to NRC Request for Additional Information dated April 15, 2010, Related to Structures and Structures-Related Aging Management Programs for the Salem Nuclear Generating Station, Units 1 and 2 License Renewal Application

Enclosures: A. Responses to Request for Additional Information
B. Updates to LRA Appendix A and Appendix B
C. Updates to License Renewal Commitment List
D. MPR Associates Report MPR-2613, Revision 3

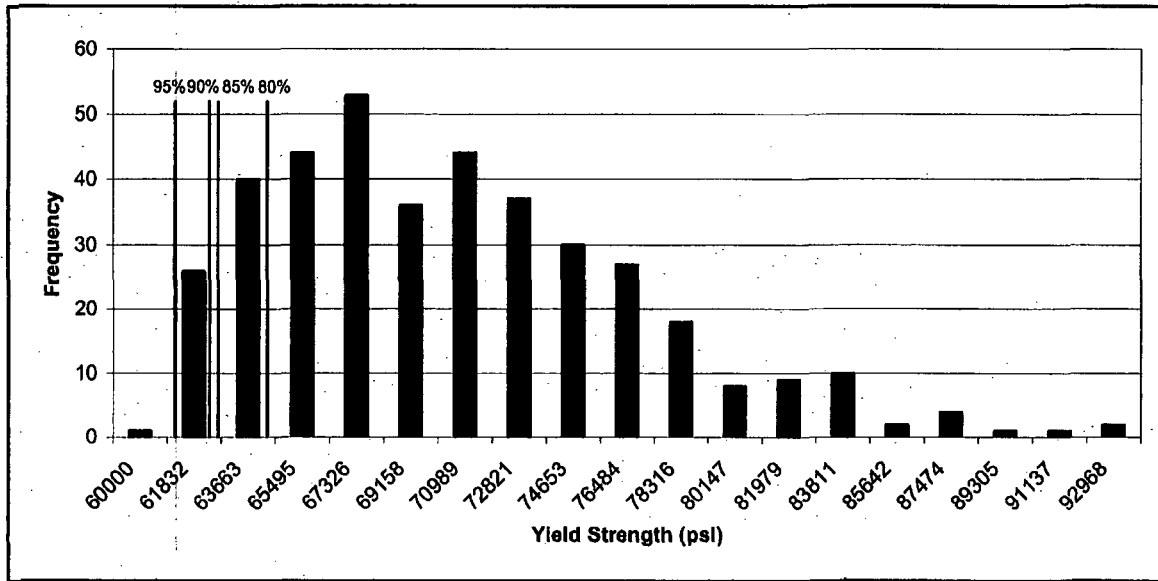
Figure 4-1. FHB Reinforcing Steel Yield Strength Distribution of Population Sampled

The above table and figure show that the actual yield strengths of the reinforcing steel in the Salem FHB are larger than the minimum specified 60 ksi. Based on the total population evaluated, the mean yield strength is almost 70 ksi and the 95% lower bound is 61.3 ksi (i.e., 95% of the data are greater than 61.3 ksi).

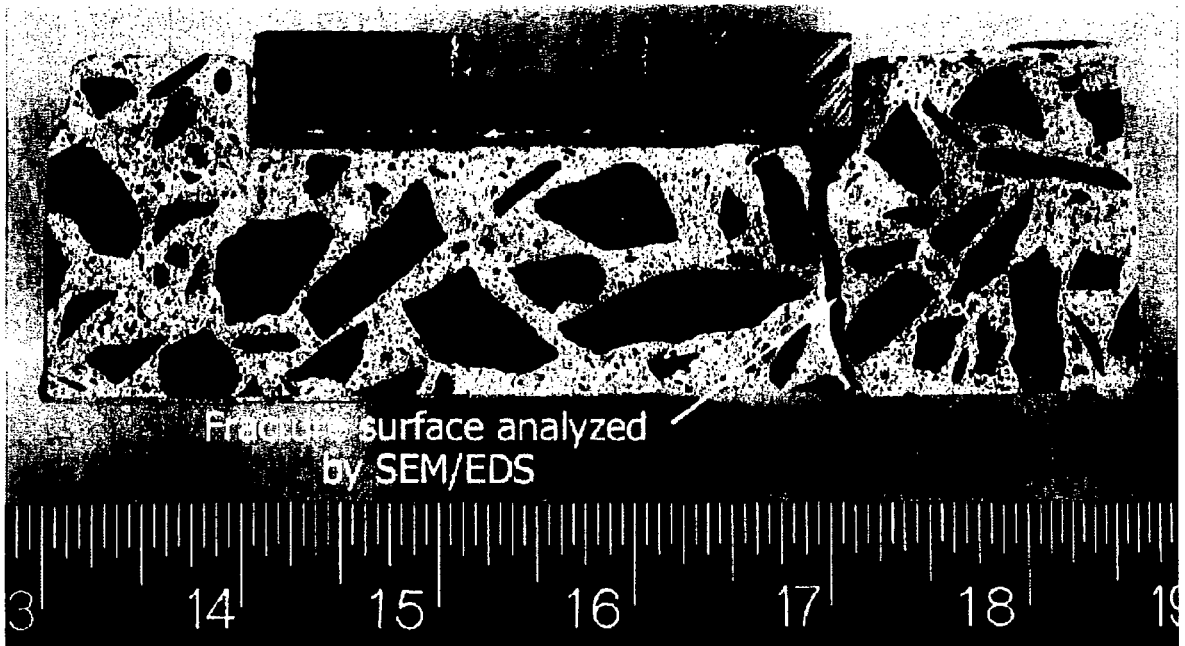
Figure 8. Cross-section view of Core 122, Section 1 (lapped surface).

The lapped section of the core is shown in Figure 8. As can be seen in the photograph the stainless steel channel debonded from the concrete.

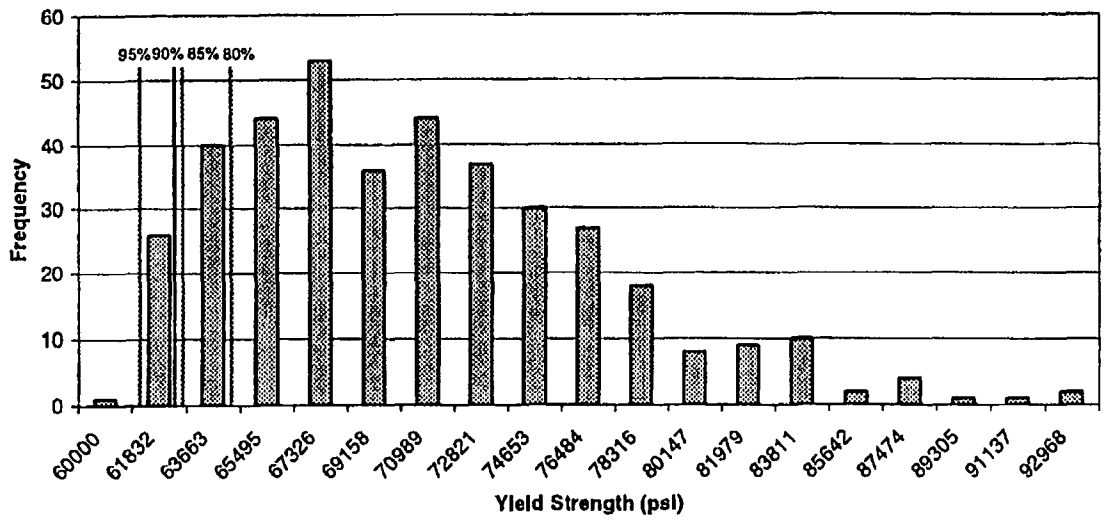
Figure 3-1. Yield Strength Distribution

The four vertical lines on the two figures above demark the values for which a given percentage of the data has at least that yield or tensile strength. These values are given in Tables 2-1 and 2-2. Given the yield strength distribution, 85% of the rebar specimens had yield strengths equal to or greater than 63,300 psi, and 90% equal to or above 62,200 psi. Looking at Figure 3-2, 85% of

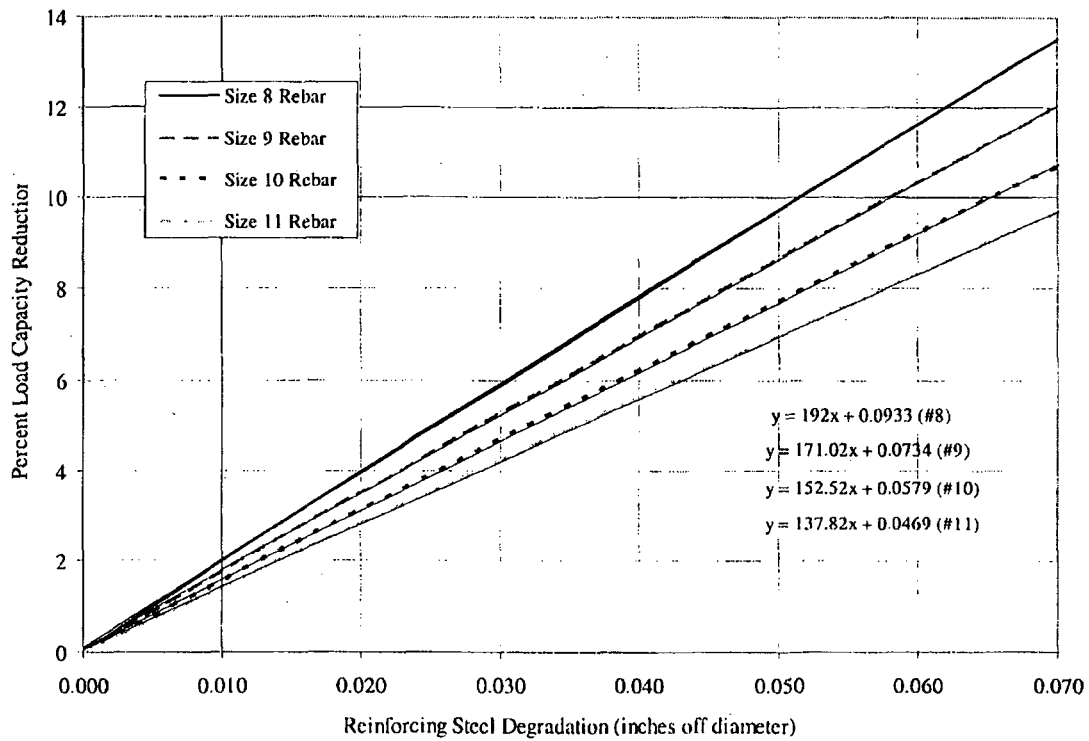
**Figure 3-1. Reductions in Reinforcing Steel Load Capacities
at Various Diameter Degradation Levels**

Figure 3-1 shows a plot of the percent reduction in reinforcing steel load capacities versus degradation for the various reinforcing steel sizes present in the spent fuel pool. Included on the plot are equations relating the percent load capacity reduction of each reinforcing steel size to the degradation level.
