NONCONFORMANCE - REPORT LOG & STATUS BOOK

1. PROJECT NO. 7220

MIDLAND PLANT UNIT #2  
 CONSUMERS POWER CO.  
 EG # 7220-M-115-KC

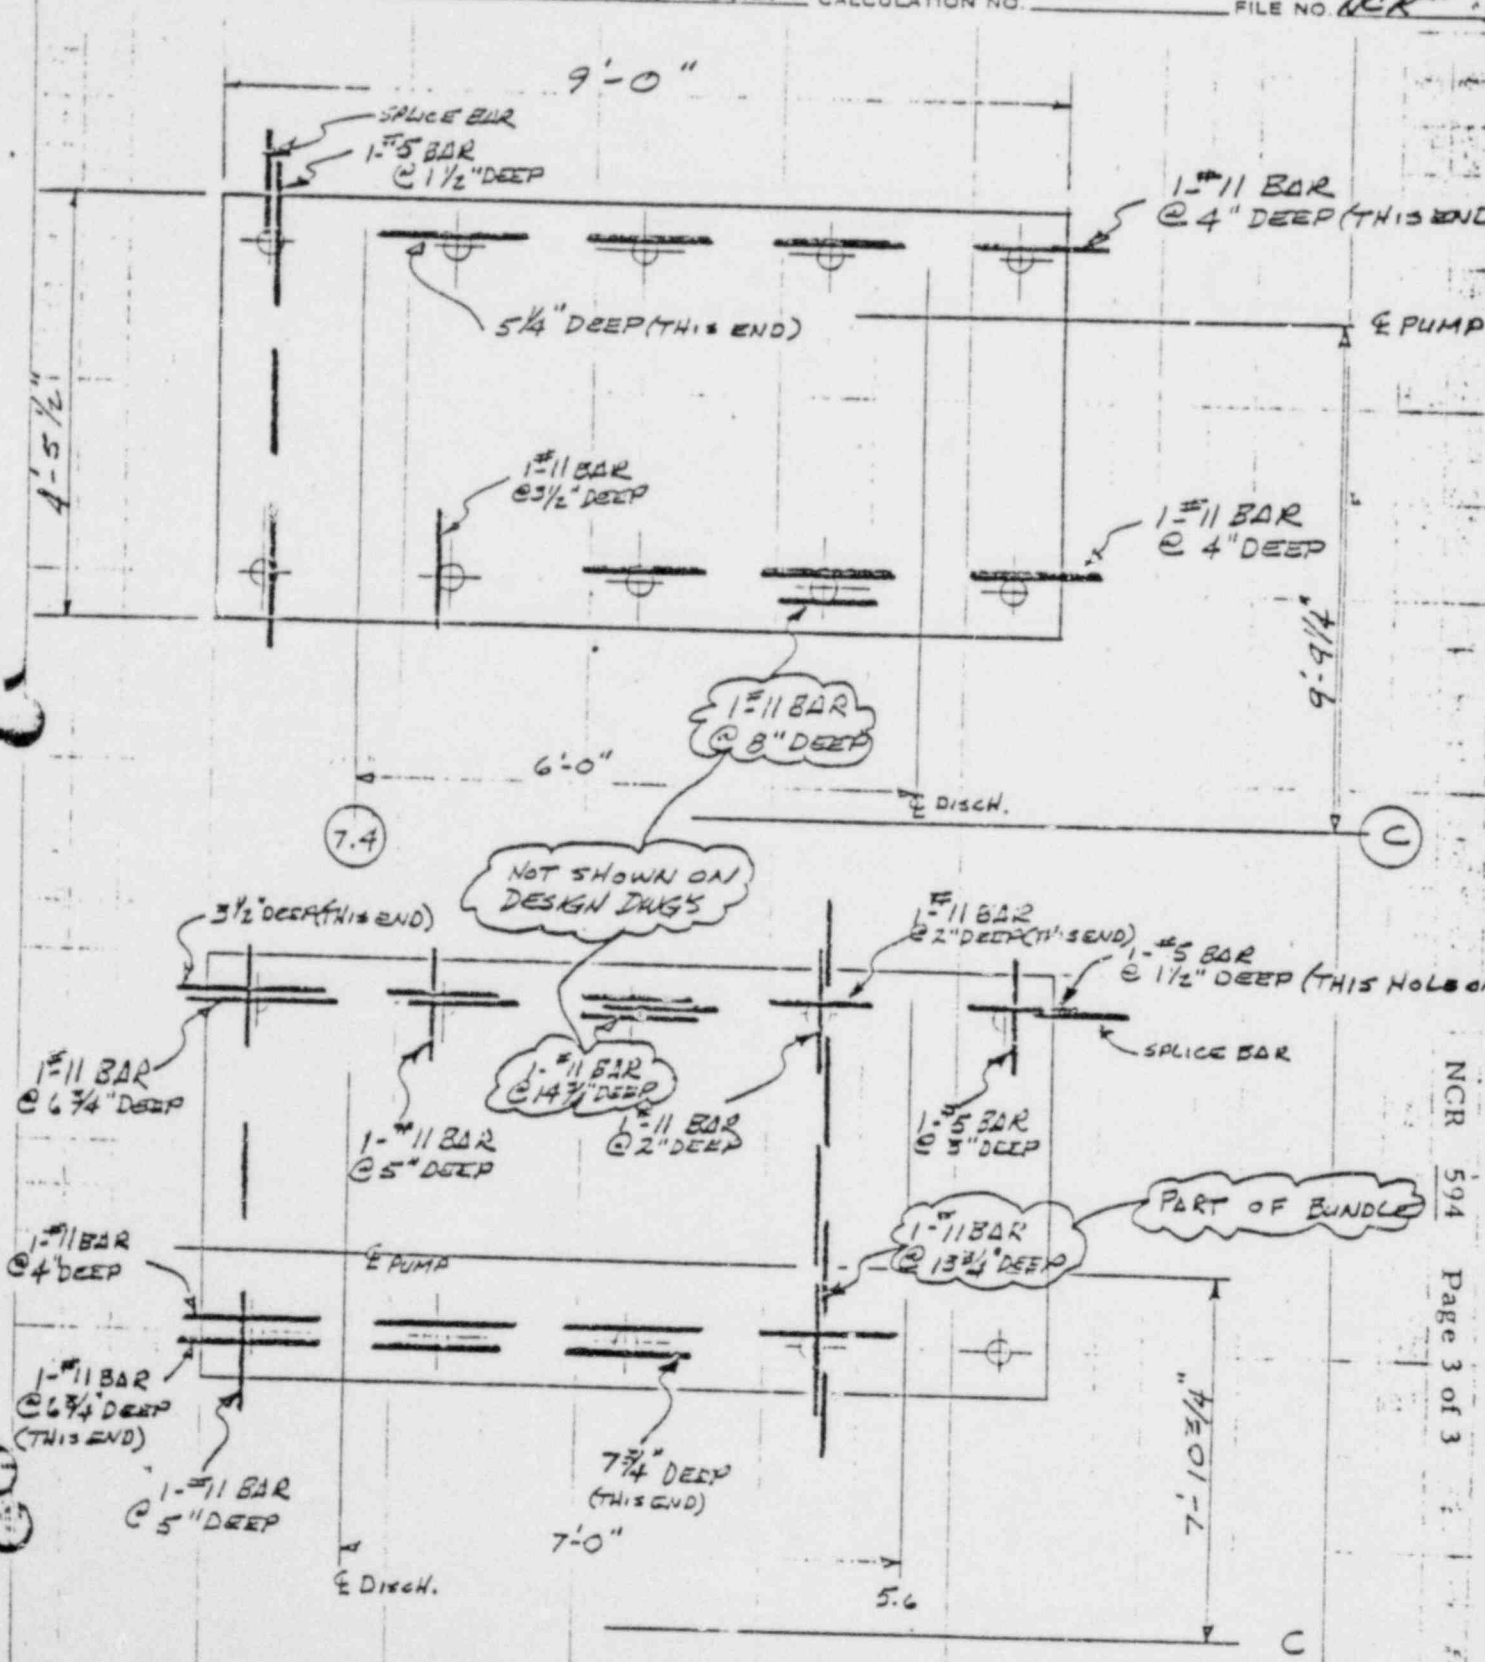
NCR 594 Page 3 of 3

1. Project Name Midland Units 1 & 2		Job No. 7220		19. No. 594	20. Page 1 of 3
2. Units) Common	3. Drawing/Part No. C-195 (Q)	Rev 4	4. Item Description CCW Pump Foundation	5. Item Location Aux. Bldg. 'C' Line at 5.6 & 7.4.

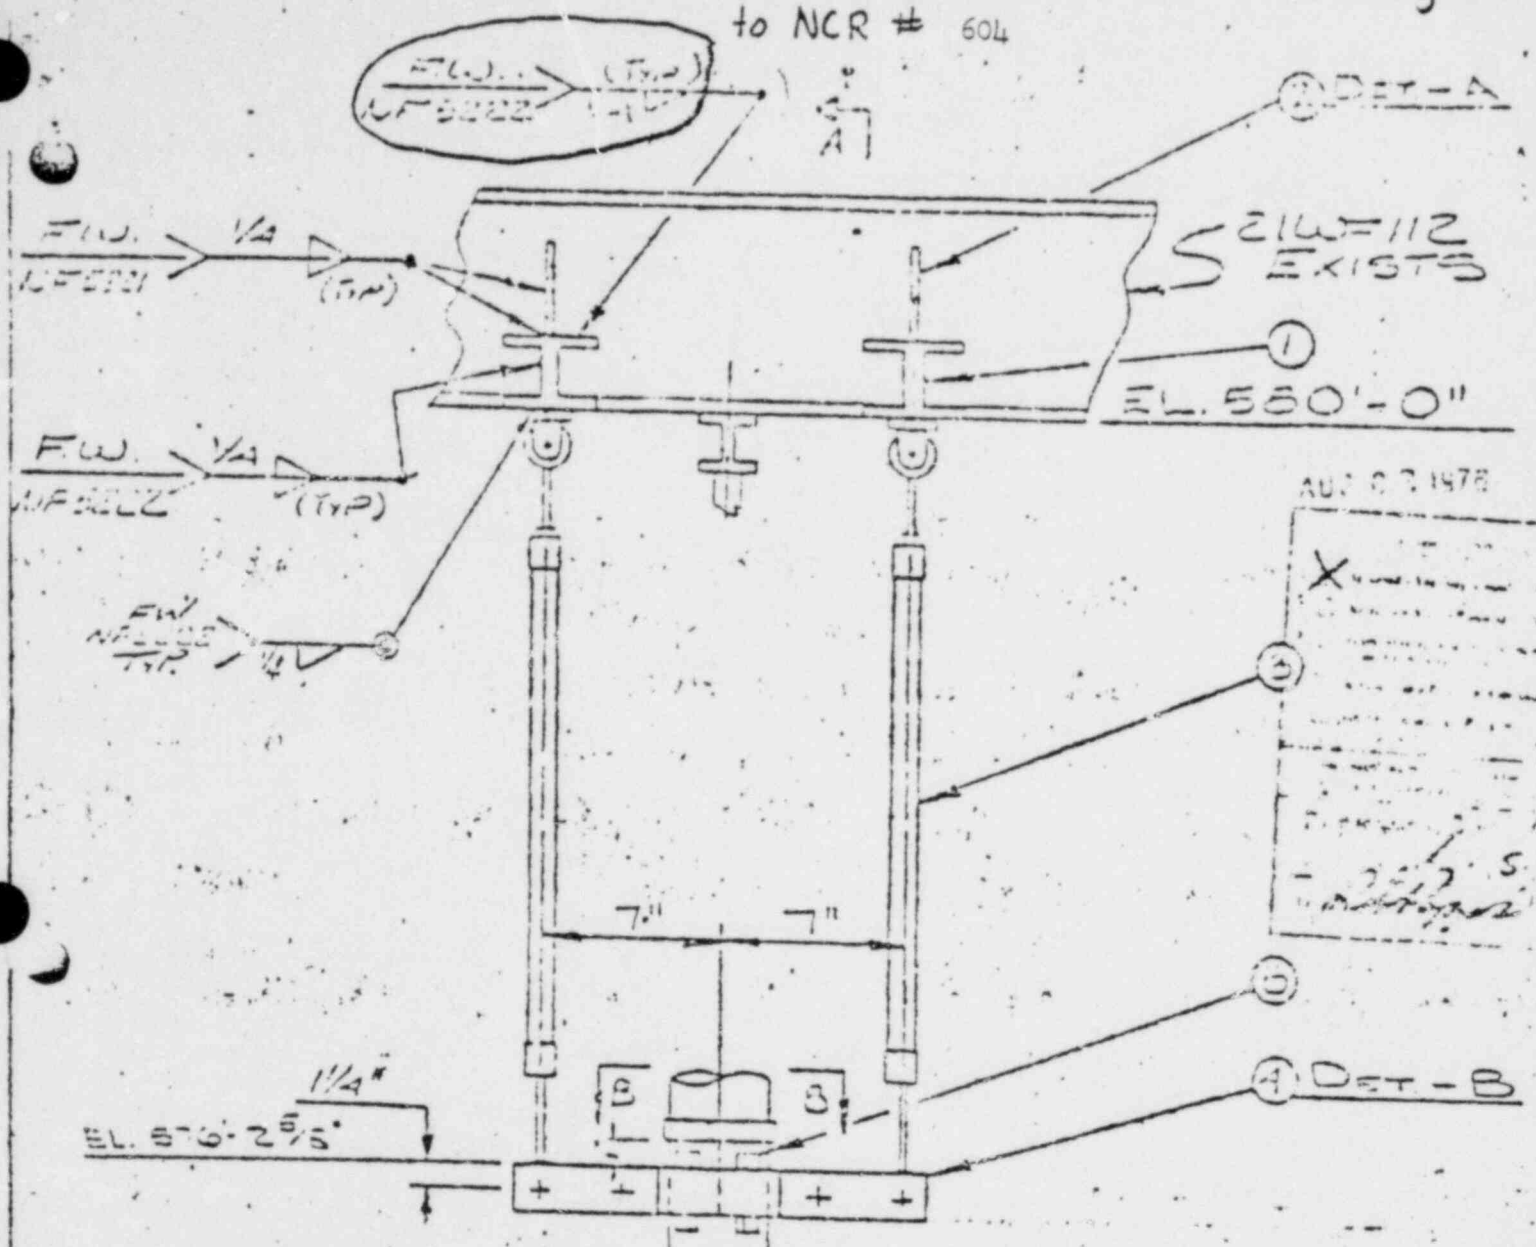
1. Project Name Midland		Job No. 07220		19. No. 604	20. Page 1 of 2								
2. Unit(s) 2	3. Drawing/Part No. Grinnell 2-613-4-24		Rev 3	4. Item Description Grinnell Pipe Hanger # 4-2HCB-21-HI									
6. P.O. Or Spec No. N/A		7. Serial No. N/A	8. Replacement Part P/N N/A REV N/A		10. Contractor/Supplier Construction N/A								
11. Inspection Criteria <input checked="" type="checkbox"/> DWG <input type="checkbox"/> SPEC <input type="checkbox"/> OTHER		IR NO. M326-148W NO. 2-613-4-24	12. ASME AUTHORIZED INSPECTION REQ'D <input type="checkbox"/> YES <input checked="" type="checkbox"/> NO		13. SKETCH ATTACHED <input checked="" type="checkbox"/> YES <input type="checkbox"/> NO								
16. Nonconforming Condition:		24. Disposition Concurrence			15. Equip Furnished By								
<p>Grinnell drawing 2-613-4-24 details a <math>\frac{1}{2}</math>" fillet weld connecting item #1 to existing 21 WF112 beam. (Ref. Sketch Attachment #1)</p> <p>Contrary to the above, hanger 4-2HCB-21-HI has been installed omitting the weld across the top flange of Item 1. Q.C. final visual inspection has been accepted on this item.</p> <p>"Q" No. 4.131 1 Hold Tag Applied</p> <p>Hold for disposition</p>		<table border="1" style="width: 100%; border-collapse: collapse;"> <tr> <th>REWORK</th> <th>REJECT</th> <th>REPAIR</th> <th>USE AS IS</th> </tr> <tr> <td style="text-align: center;"><input checked="" type="checkbox"/></td> <td style="text-align: center;"><input type="checkbox"/></td> <td style="text-align: center;"><input type="checkbox"/></td> <td style="text-align: center;"><input type="checkbox"/></td> </tr> </table>			REWORK	REJECT	REPAIR	USE AS IS	<input checked="" type="checkbox"/>	<input type="checkbox"/>	<input type="checkbox"/>	<input type="checkbox"/>	<p>PROJECT FIELD ENGINEER <i>T.C. Valomyans</i> 11/17/76</p> <p>PROJECT ENGINEER <i>[Signature]</i> 11-18-76</p> <p>PROJECT CONSTR QC ENGINEER <i>[Signature]</i></p> <p>AUTHORIZED INSPECTOR <i>[Signature]</i></p>
		REWORK	REJECT	REPAIR	USE AS IS								
		<input checked="" type="checkbox"/>	<input type="checkbox"/>	<input type="checkbox"/>	<input type="checkbox"/>								
		17. Reported By <i>Kenneth O. Anderson</i> 11-15-76			18. Validated By <i>[Signature]</i> 11-16-76								
		21. Routing <input checked="" type="checkbox"/> TO FIELD ENGINEERING <input type="checkbox"/> TO OTHER'S (SPECIFY)		25. Disposition Results									
22. <input checked="" type="checkbox"/> Field Engineering Disposition <input type="checkbox"/> FIELD ENGINEERING RECOMMENDED DISPOSITION TO PROJECT ENGINEERING		<p>Rework in accordance with Grinnell Drawing 2-613-4-24.</p> <p><i>D. R. Bales</i> 11-15-76 <i>D. Williams</i> 11-17-76</p>											
23. Project Engineering Disposition		26. QC Acceptance											
		<p>QC ENGINEER _____ DATE _____</p> <p>AUTHORIZED INSPECTOR _____ DATE _____</p>

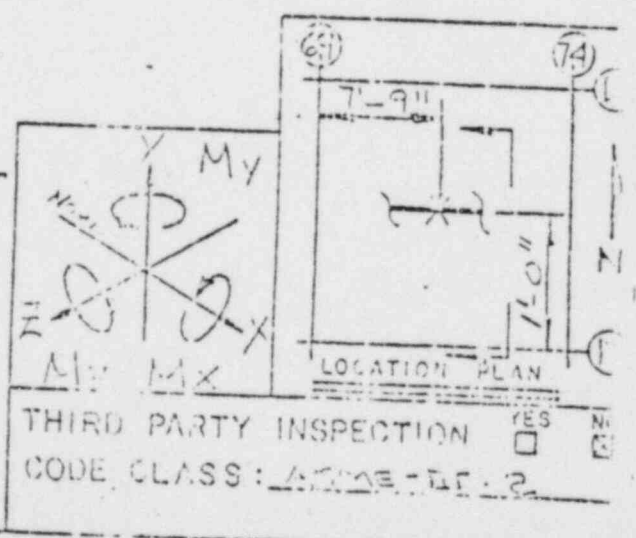
DESIGN SK 2-11-4-34 REV 1  
 VENDOR DRAWING REVIEW APPROVAL  
 LEVEL 1  
 S. AMP 82476  
 CLAMPS USED ARE MODIFIED 3" DIA  
 FIG. 295 WITH FLAT BAR LINERS  
 SKETCH INDICATES 3" DIA FIG 295  
 FOR USE ON BILL OF MATERIALS  
 ITEM 3, FIG. 211. 1 SWAY STRUT

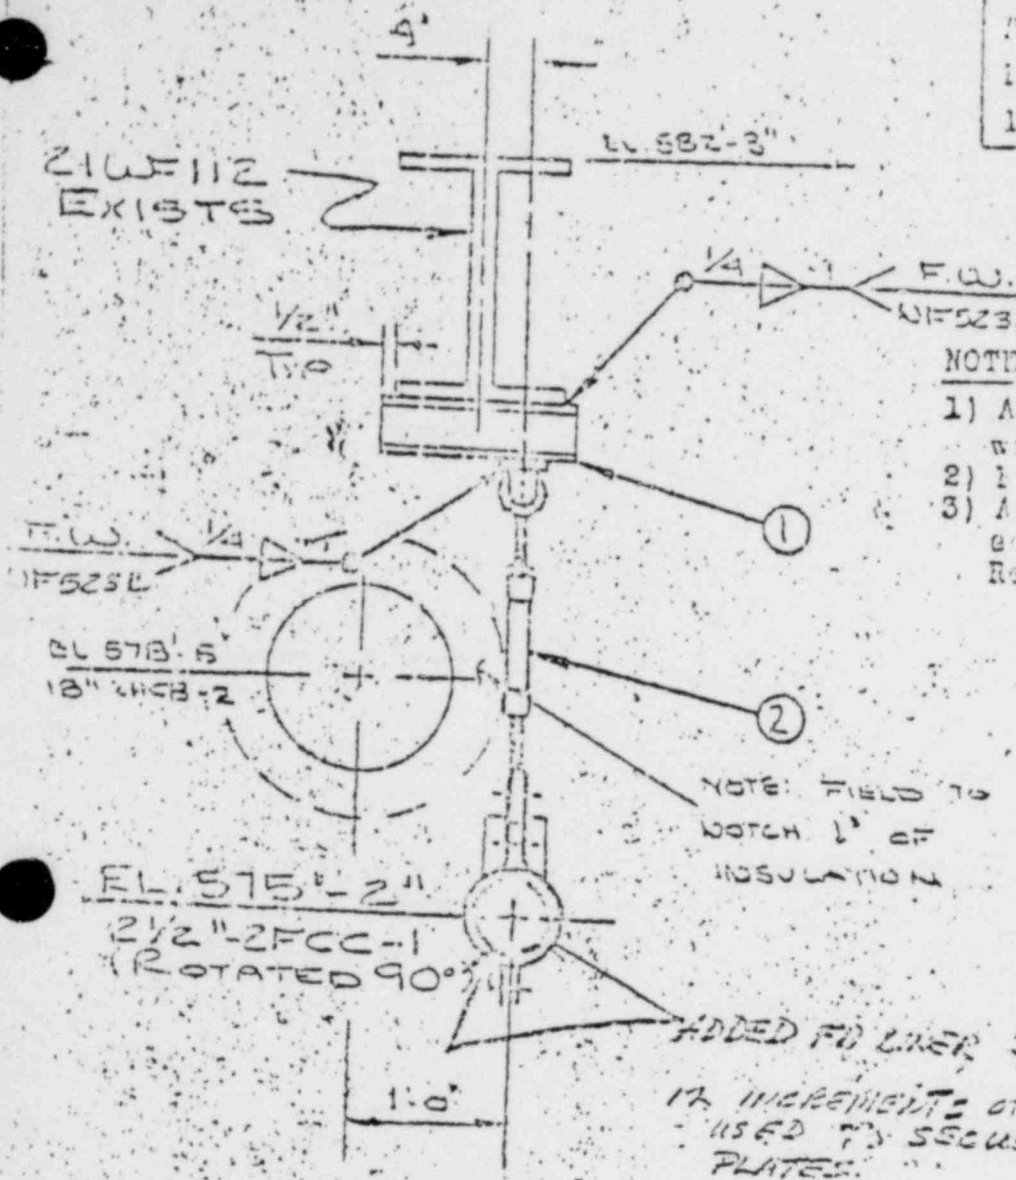
CLAMPS USED ARE MODIFIED 3" DIA  
 FIG 295 WITH FLAT BAR LINERS

SKETCH INDICATES 2 1/2" DIA  
 FOR USE ON  
 BILL OF MATERIALS ITEM 2  
 FIGURE 211 #1 SWAY STRUT

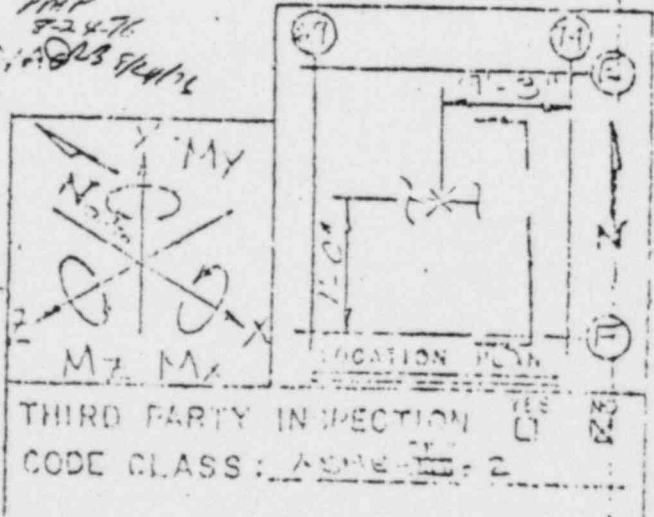
CLAMPS USED ARE MODIFIED 5" <sup>PMP 82476</sup> <sub>3/8" DIA</sub> <sup>3/8" DIA</sup> <sub>3/8" DIA</sub>  
FIG 295 WITH FLAT BAR LINERS.

SKETCH INDICATES 3" DIA FIG 295  
FOR USE WITH BILL OF MATERIALS  
ITEM 3, FIG 211 #1 SWAY STRUT

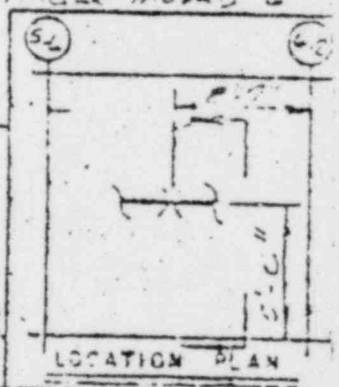
3-1FCB-28-H6  
 DESIGN SK 1-11-4-34 REV. 1  
 VENDOR DRAWING APPROVAL LEVEL 1  
 CLAMPS USED ARE MODIFIED 5" DIA. FIG 295 WITH FLAT BAR LINERS  
 SKETCH INDICATES 3" DIAMETER  
 FIG 295 FOR USE ON BILL OF MATERIALS ITEM 3 FIG 211 #1 SWAY STRUT
