OAKLAND COMMUNITY COLLEGE
A VISION OF EXCELLENCE IN THE 21st CENTURY

FIVE YEAR CAPITAL OUTLAY MASTER PLAN

Facility & Utility Condition
Assessments

R1-2016-175 | December, 2016 | Condition Appraisal Report

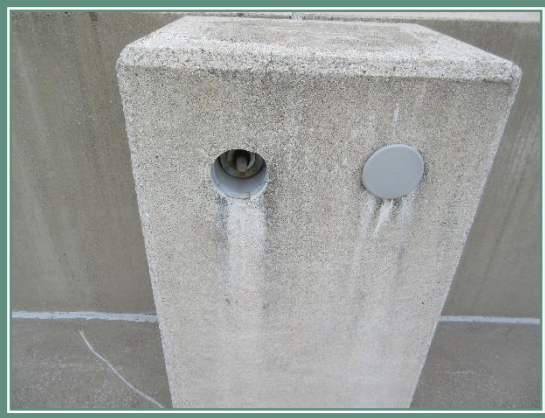
Overall the exterior sealant of Parking Structure No. 2 is in poor condition. Both the horizontal and vertical exterior sealants have failed and need to be replaced.
