## IN-SERVICE PERFORMANCE OF STRUCTURAL DETAILS

FINAL TECHNICAL REPORT  
on  
Project SR-1232  
"Structural Details Failure Survey"

IN-SERVICE PERFORMANCE OF STRUCTURAL DETAILS

NEWPORT NEWS SHIPBUILDING

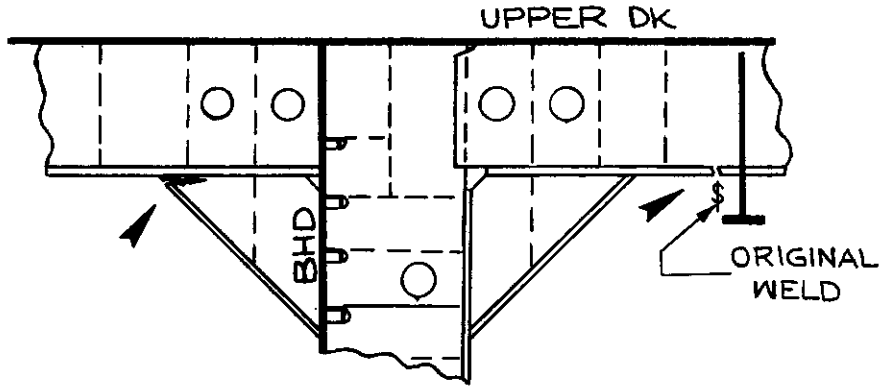
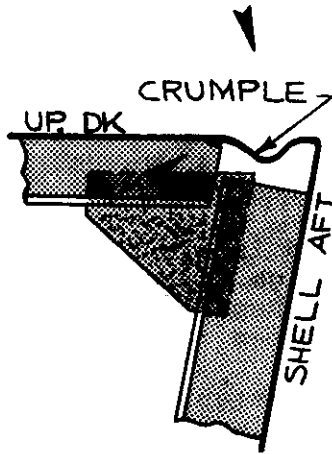
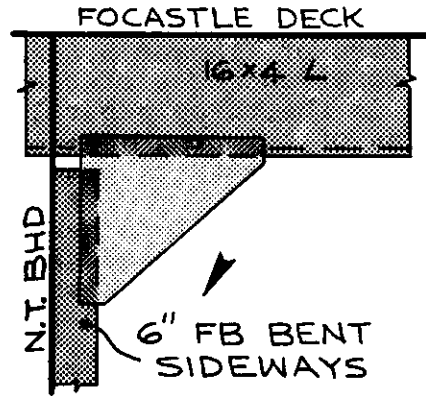
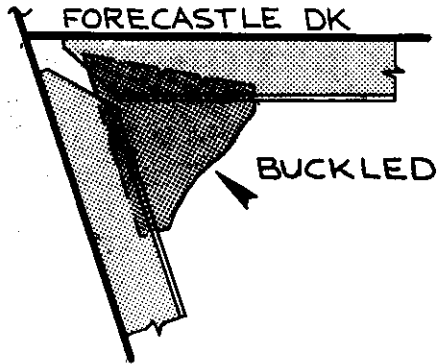
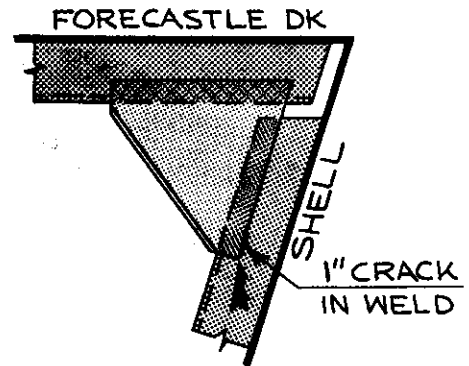
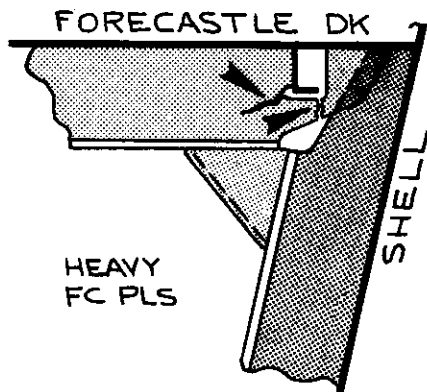
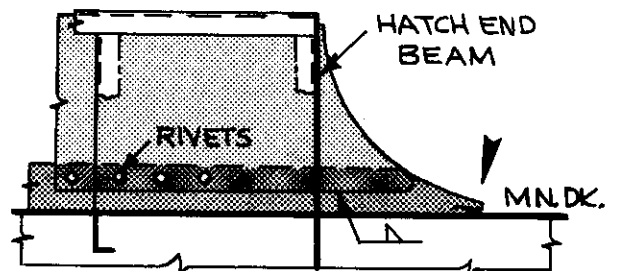
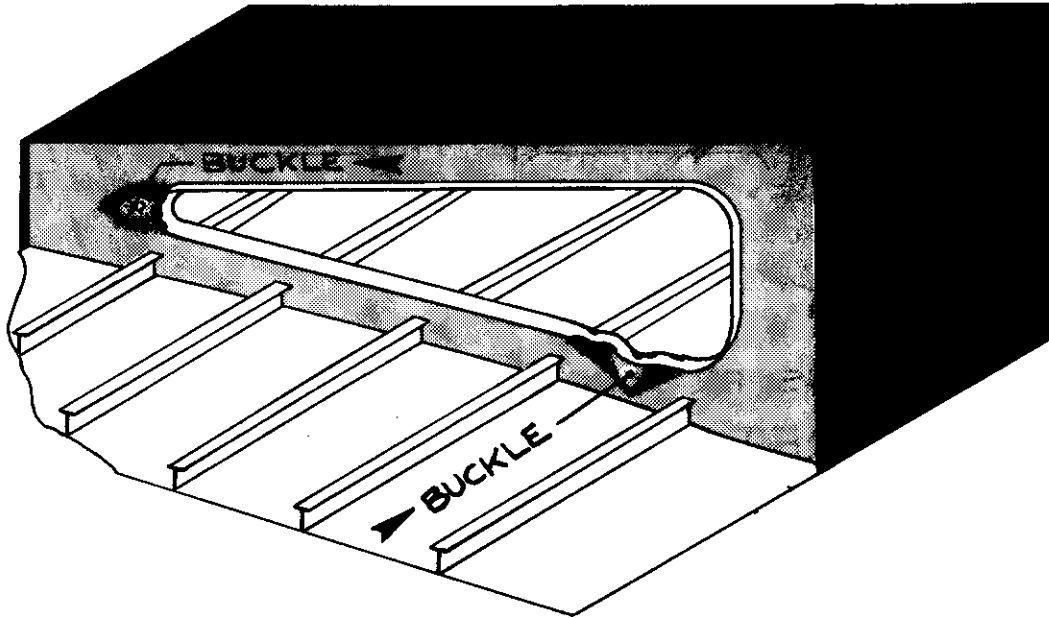
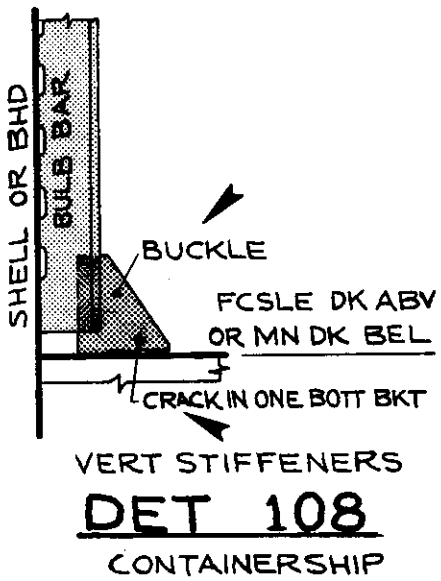
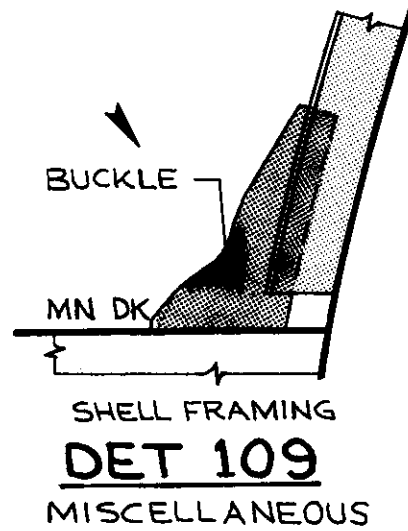
SAMPLE BEAM BRACKET FAILURE MODES

Sample failure modes in beam brackets are presented in Figure 5 which shows several conditions as they existed on the ships. Cracks are shown occurring in ends of face plates, welds, abrupt member endings, cutouts and in a relatively soft end of a hatch coaming. Buckles are shown as they existed in deck plating, flat bars reinforced by a bracket, flat plate corner bracket, curved face plate brackets and a straight flanged bracket. Three of the sample details have both cracks and buckles in which one type of failure perpetrated the appearance of the other such as in detail 112 where the failure of the bulb bar added to the bending moment in the flanged plate bracket and released the lateral supportive forces at the bracket top.

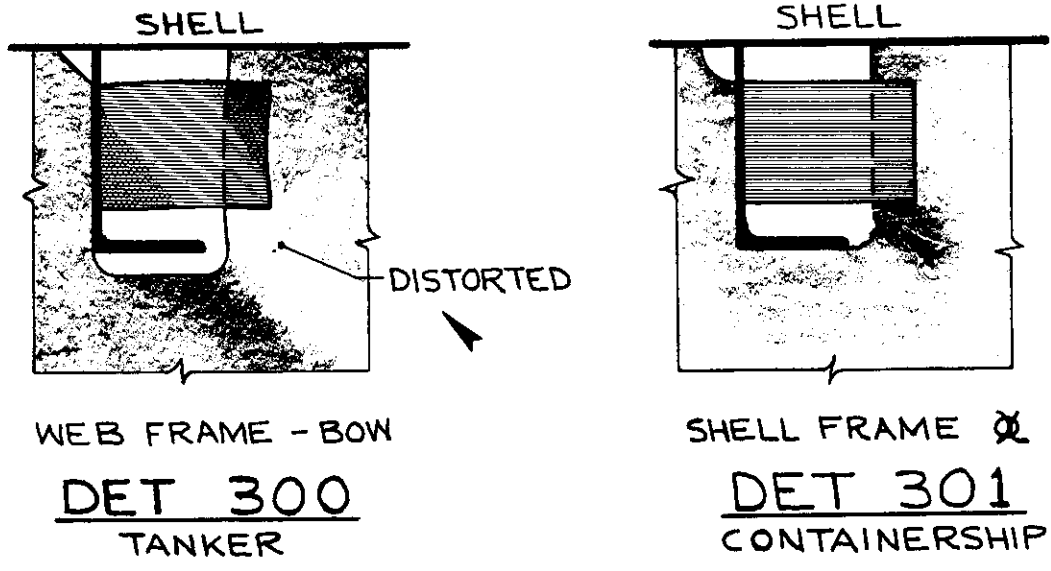
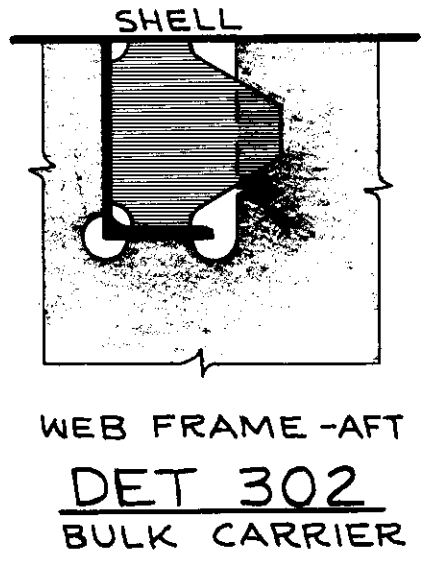
SAMPLE NON-TIGHT COLLAR FAILURES

A very high percent (99.9%) of the details were sound. The remaining .1% is an estimated thirty-three failures as presented in Table 7 which gives the distribution according to ship types, location within the ships, and reasons for the failure of the details. They were in three different forms as shown in Figure 15 where cracks existed at the intersection of the collar clips and the cutouts in two cases and where distortions were present in the web plating and collar clip in the other case. Detail 300 could reasonably be considered a failure of the web frame plating rather than the collar.

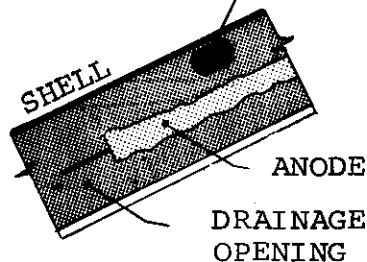
INADEQUATE DRAINAGE ON A BULK CARRIER

Drain holes were also susceptible to corrosion in locations of poor access and neglect. Failure causes also include location in high stress regions, jagged edge cuts during construction or on board repairs, heavy sea areas in the bow, and collision. Holes in many ballast tanks, machinery spaces and shaft alleys were inadequate to properly drain water, oil, and mud from horizontal stiffeners as shown in Figure 23. A close examination of the photo in the figure shows a thick layer of mud near a drain hole in a horizontal longitudinal that has a flange extending above the web.

The layers of mud is on the web of an upturned flanged shell longitudinal in the forepeak tank. The mud coated anode almost obscures the 3" x 6" drainage opening located behind the anode near the shell and in the 16" longitudinal. The mud is caked to within four inches of the drainage hole.

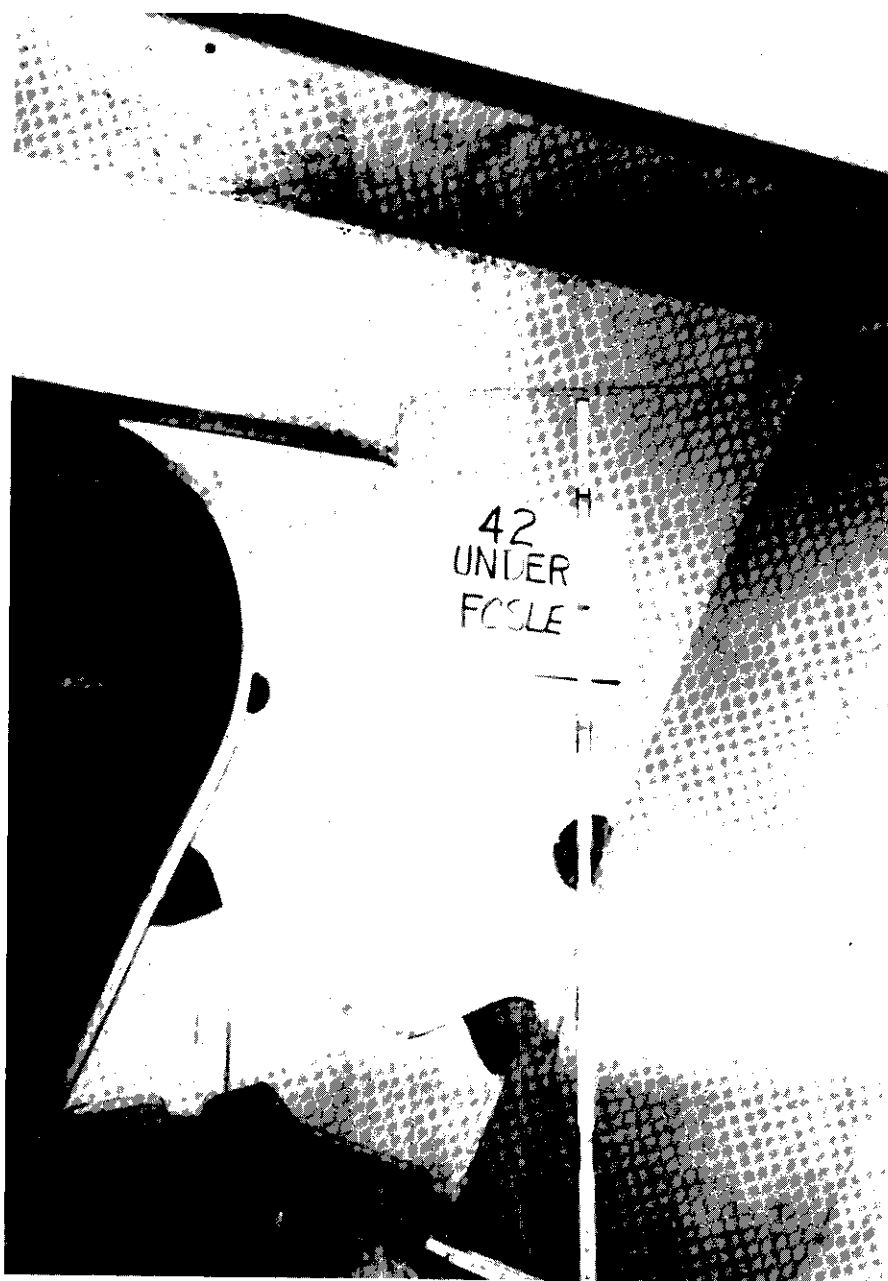
LAPPED WEB CUTOUTS AND OTHER  
STRUCTURAL DETAILS IN A BULK CARRIER

This picture is of the upper portion of a web frame supporting the side shell and forecastle deck.

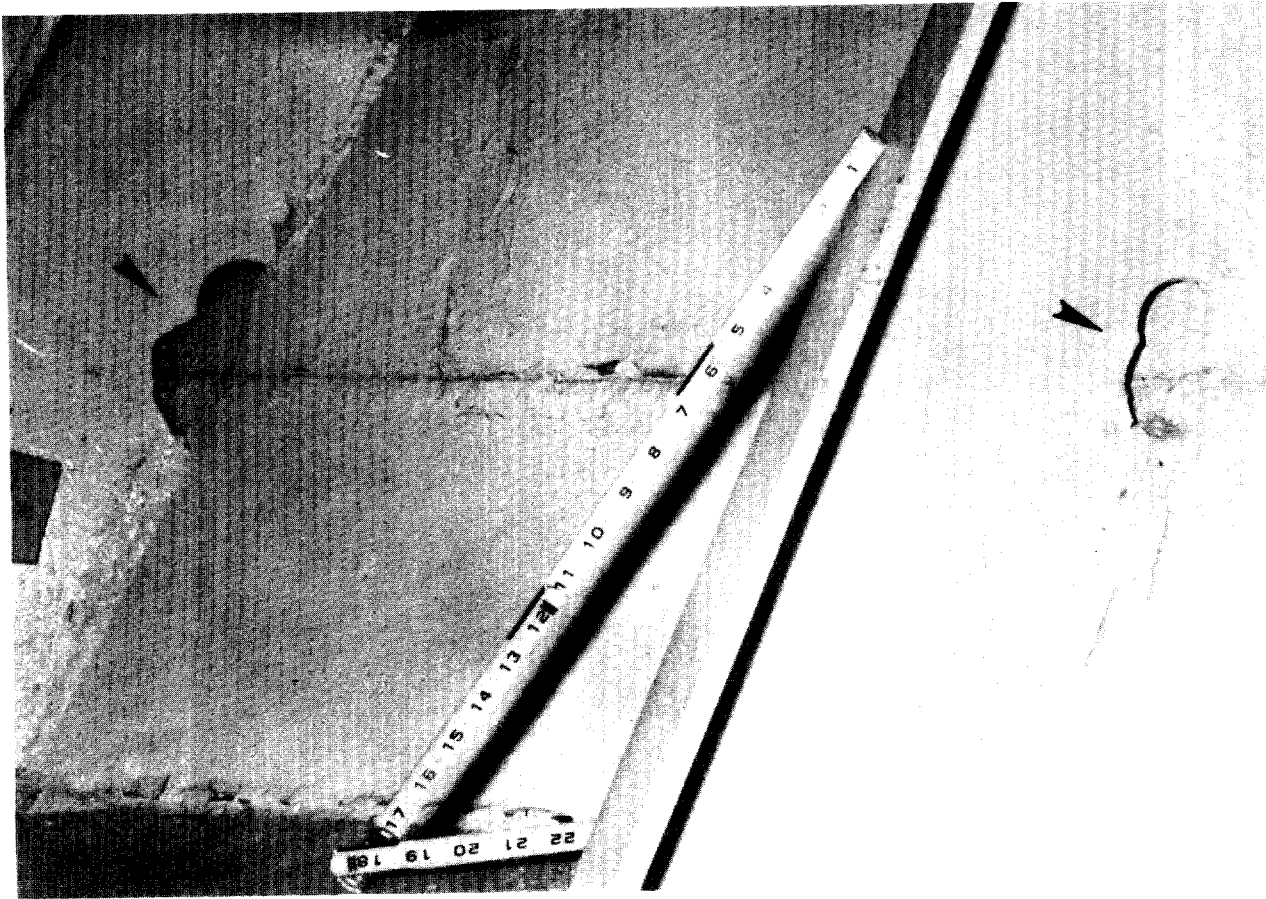
FIGURE 26

Figures 26 and 27 are pictures of sound and failed weld clearances. The jagged part of the sound weld clearance in Figure 26 was cut by a hand held torch during fabrication of the tanker. The cracks in Figure 27 are through the welds on a containership.

SOUND WELD CLEARANCES ON A TANKER

The photograph shows two weld clearance cuts that were obviously elongated with a hand torch during fabrication to suit the shell seam location. These cuts were in side shell frames between forecandle and upper deck.

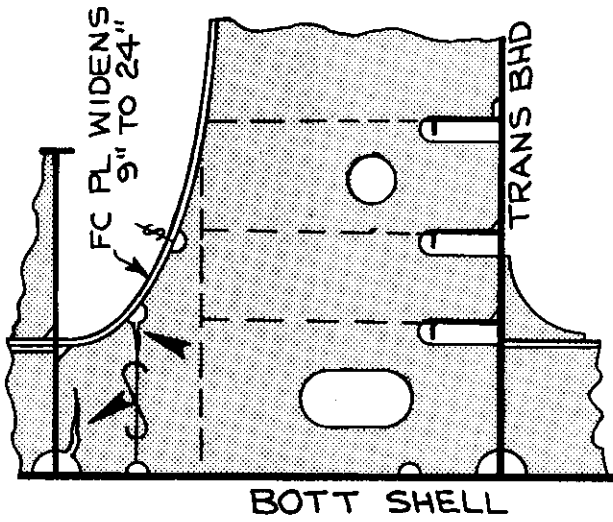
O.T. BHD WEB  
DET MC 100  
TANKER

SAMPLE MISCELLANEOUS CUTOUT FAILURES

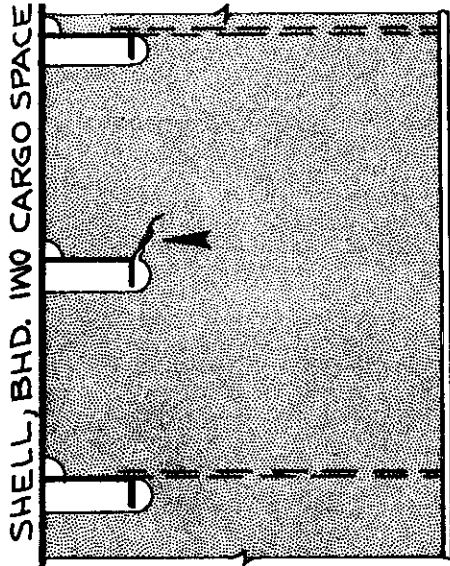
TRANS WEBS  
DET CC 100  
COMBINATION CARRIER,  
TANKER

SAMPLE CLEARANCE CUT FAILURES

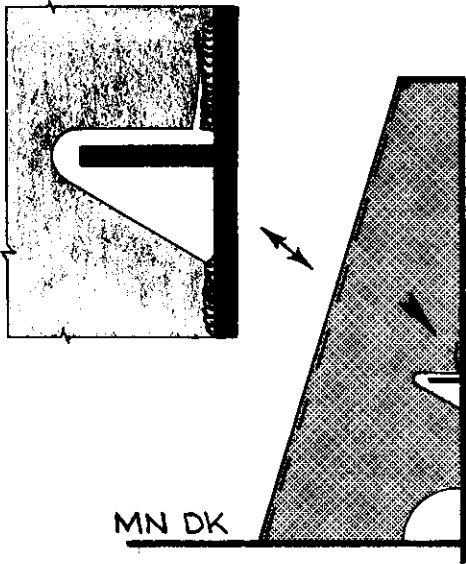
BULWARK  
AT MIDSHIP DKHSE  
DET CC 102  
GENRL CARGO

Group "A" details were generally limited to cutouts in brackets supporting bulwarks with failures occurring as cracks at the welded corners of the cutouts. The reduction in shear area is the apparent cause of these failures.

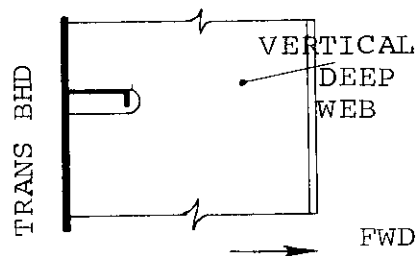
FIGURE 33

Group "D" experienced the highest number of observed failures. It also included the largest number of observed repairs. Failure cracks were prone to be at the angle heel corner of the cutout and were considered to be primarily due to high notch factors. Figures 32 and 33 are illustrations of the failure mode. Both figures show a short crack that has started at an angle heel. Rewelding the crack does not appear to be the best repair technique as verified by the picture in Figure 34 which is of a clearance cutout in a web frame. The cutout permits passage of a side shell longitudinal. Two almost parallel weld beads originated from a corner of the cutout and reveals a history of cracks. Beads of welds where cracks had possibly occurred were relatively common on a few ships. At times, something extra, such as a pad or a flat bar stiffener similar to the one on the web frame, had been added in an effort to prevent future cracks.

FAILURE MODE FOR GROUP "D" CLEARANCE  
CUTOUTS ON A TANKER

The view is of a detail 8-D-6 cutout around a horizontal stiffener piercing a vertical web on the transverse oil tight bulkhead. The expected failure mode is a crack in the plating at the stiffener heel.

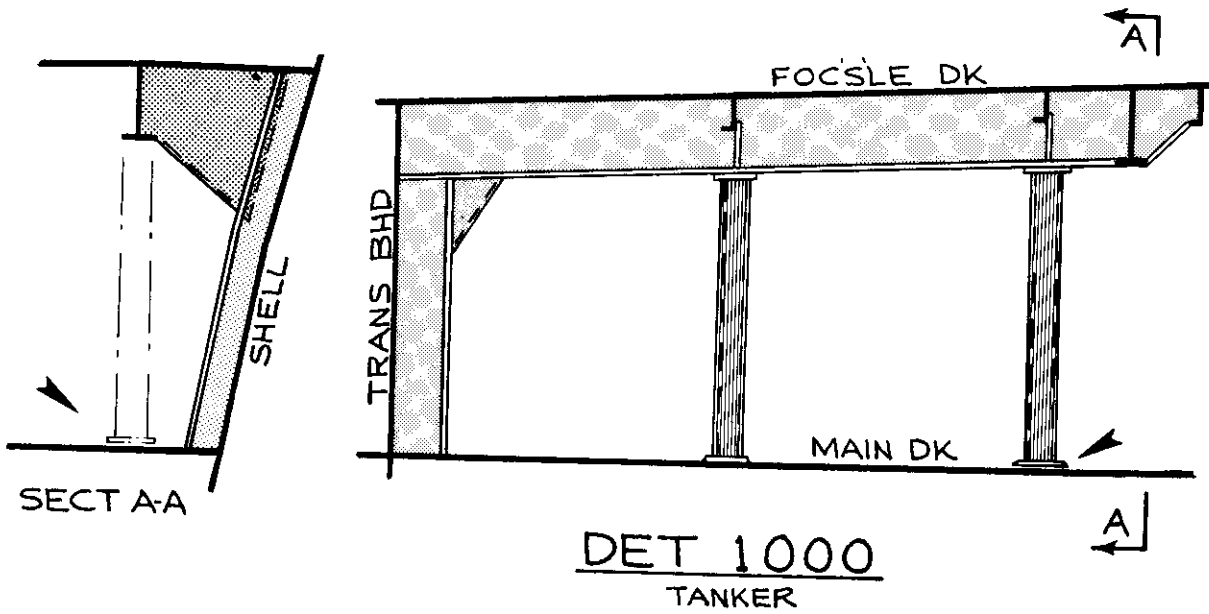
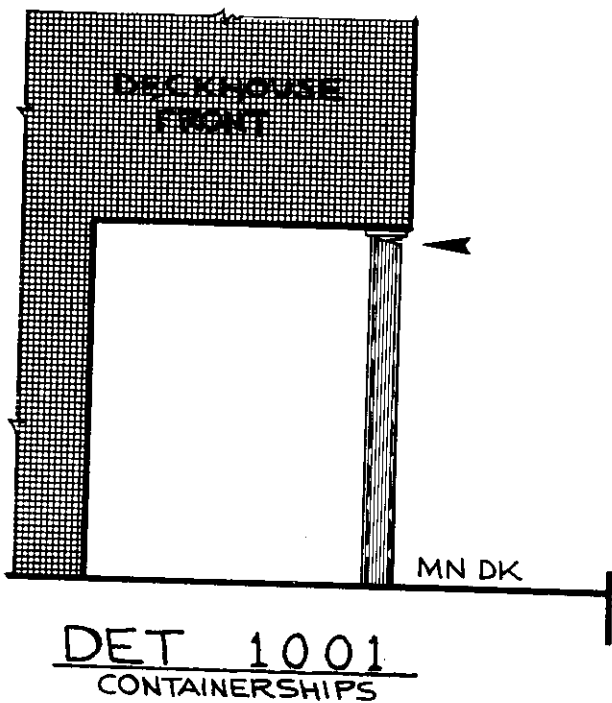
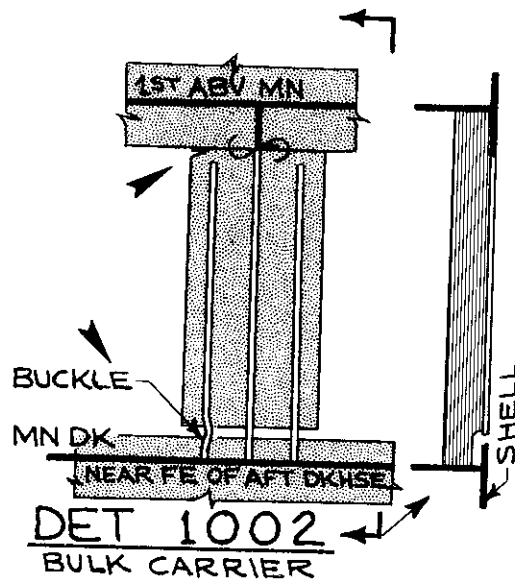
FIGURE 43

Sample failure modes, depicted in Figures 43, 44, and 45, show tension failure due to an unusual design combined with a heavy side shell load, and cracks and buckles due to relative motions between main deck-houses and the side shell. Figure 44 contains a photograph of the crack problem noted above for detail 10-B-9. Figure 45 is a distorted stanchion on a general cargo ship.

SAMPLE STANCHION END FAILURES

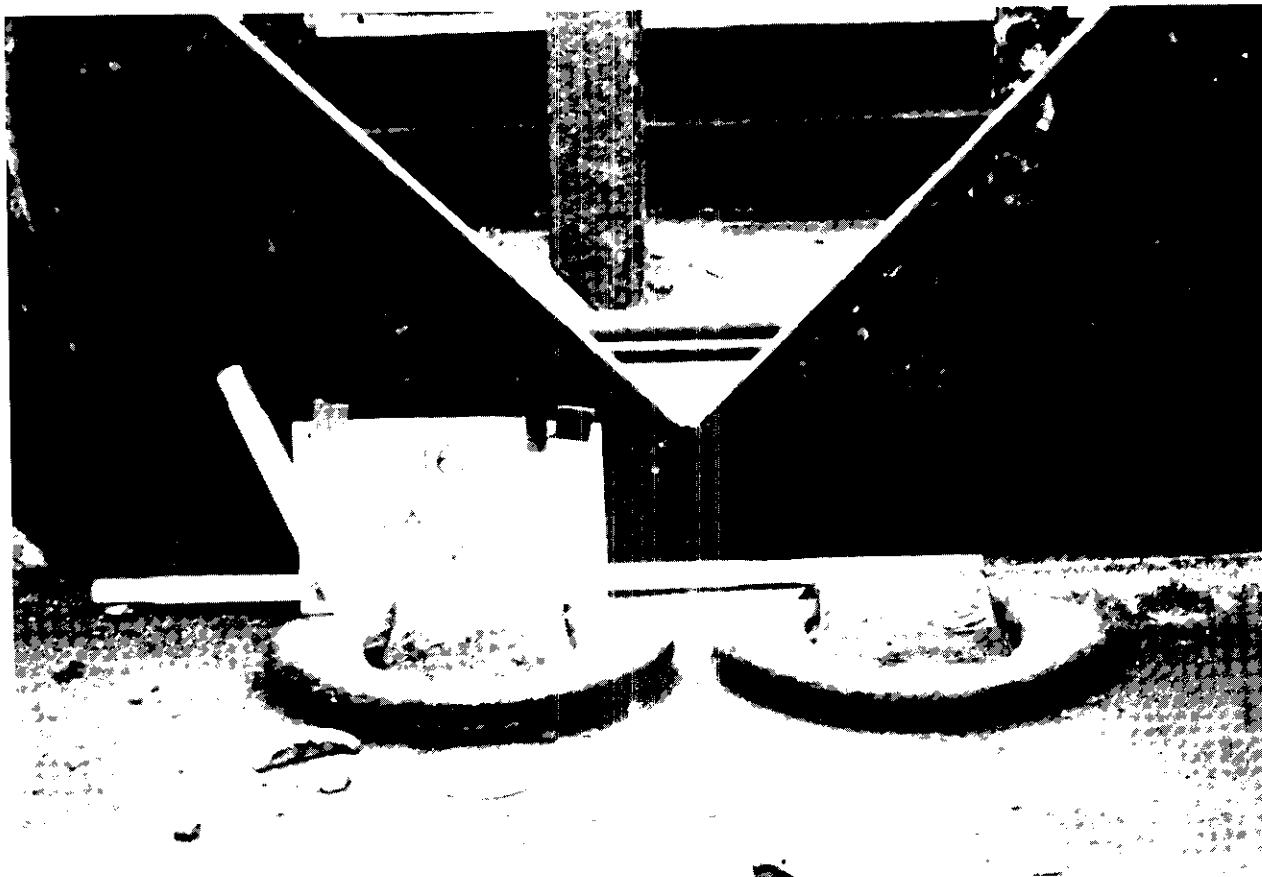
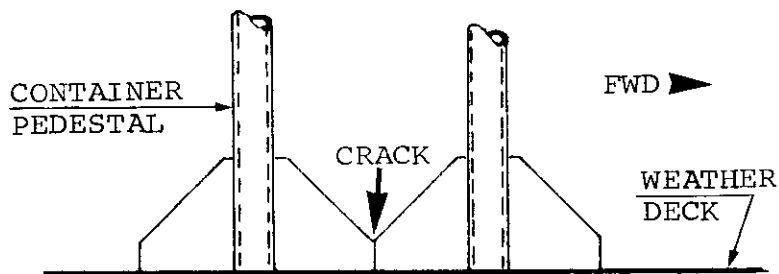
FIGURE 44

FAILED STANCHION END BRACKET  
CONNECTION ON A COMBINATION CARRIER

View on weather deck looking outboard at the intersection of two container stand brackets, similar to detail 10-B-9. The crack originated at the vee notch and continued through the weld to the deck plating.

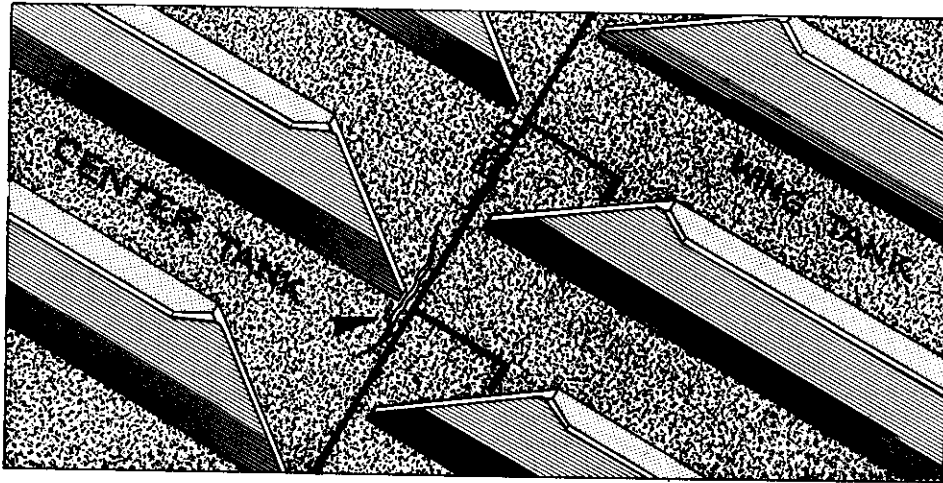
TRANS. O.T. BHD.  
DET 1101  
TANKER

SAMPLE STIFFENER END FAILURES

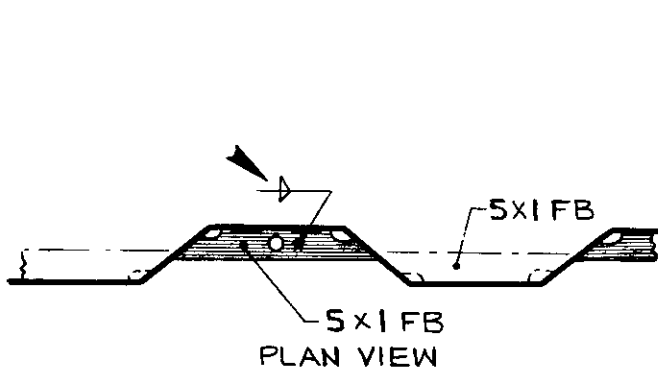
FBS. 0 CORRUGATED L.B.H.D  
CARGO HOLD AMIDSHIP  
DET 1200  
COMBINATION CARRIER

SAMPLE PANEL STIFFENER FAILURES

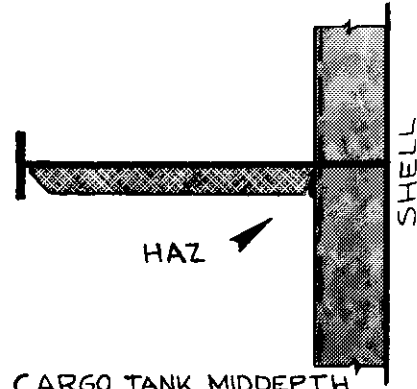
LONGL AT WEB FR  
DET 1201  
TANKER

The photograph in Figure 52 shows a crack similar to detail 1201 in Figure 51. These cracks occurred on the bottom of cargo tanks as well as at mid depth. Figure 53 shows a buckled flat bar stiffener which has been subject to an unusual and local horizontal load on a miscellaneous bulkhead. Figure 54 contains a photograph of a reinforced panel stiffener on a transverse hatch coamway.

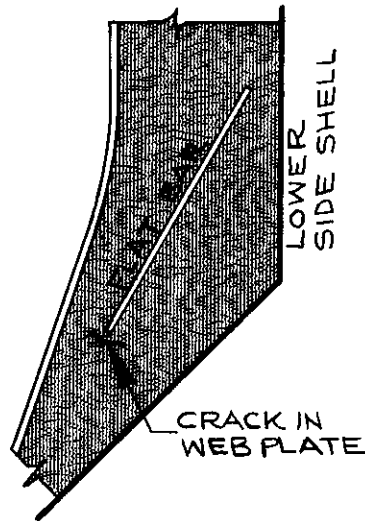
CARGO HOLD OUTBD  
SHELL FRAME  
DET 1202  
BULK CARRIER

Of the 40,480 details observed in this family there were only 261 (0.6%) failures. Individually, however, group "D" had the most observed failed details (100) and the highest percentage of failures (7.3%). The large number of failures in this group is attributed to collisions or impact from large objects which resulted in loadings not anticipated in the design stage. Unnecessary fabrication notches also contributed to some of the failures. Failure modes associated with panel stiffeners are shown in Figure 51 which includes a crack in the attaching welds, in a stiffener end, and in plating at a stiffener end. Weld cracks in detail 1200 were due to inadequate welding and possibly elongation of the longitudinal corrugated bulkhead while the ship was in a seaway. In detail 1201, the crack resulted from the interaction of the shell longitudinal and panel stiffener at a cutout in the web frame in conjunction with the possible concurrent swashing loads from oil in the tank. Cracks in detail 1202 resulted from lateral distortion of the shell frame during a collision.

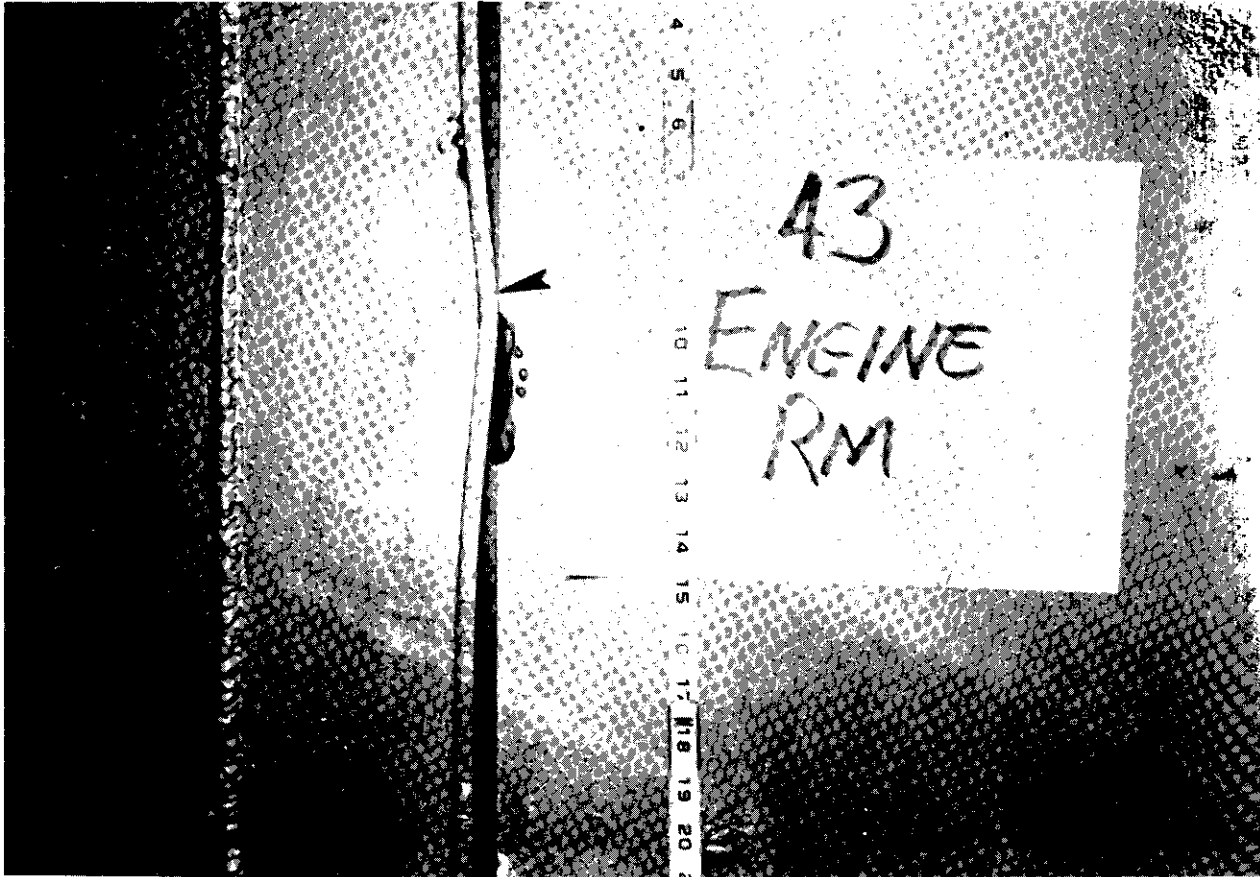
FIGURE 53

BUCKLED PANEL STIFFENER ON A GENERAL CARGO SHIP

The photograph shows the buckled position of a detail 12-C-5 flat bar panel stiffener on a girder web. The 26" x 4" girder was laterally displaced resulting in the buckled panel stiffener.
