NEWTOWN DAM, BUCKS COUNTY  
PENNSYLVANIA

6 National Dam Inspection Program - Newtown Dam  
(NDS I.D. ~~PA 01964~~ PA 01964, NUMBER  
DER I.D. No. 9-178, NUMBER  
SCS PA 621) NUMBER  
Delaware River Basin, Newtown Creek,  
Bucks County, Pennsylvania.  
PHASE I INSPECTION REPORT,  
NATIONAL DAM INSPECTION PROGRAM

WOODWARD-CLYDE CONSULTANTS  
5120 Butler Pike  
Plymouth Meeting, Pennsylvania 19462

DEPARTMENT OF THE ARMY  
Baltimore District, Corps of Engineers  
Baltimore, Maryland 21203

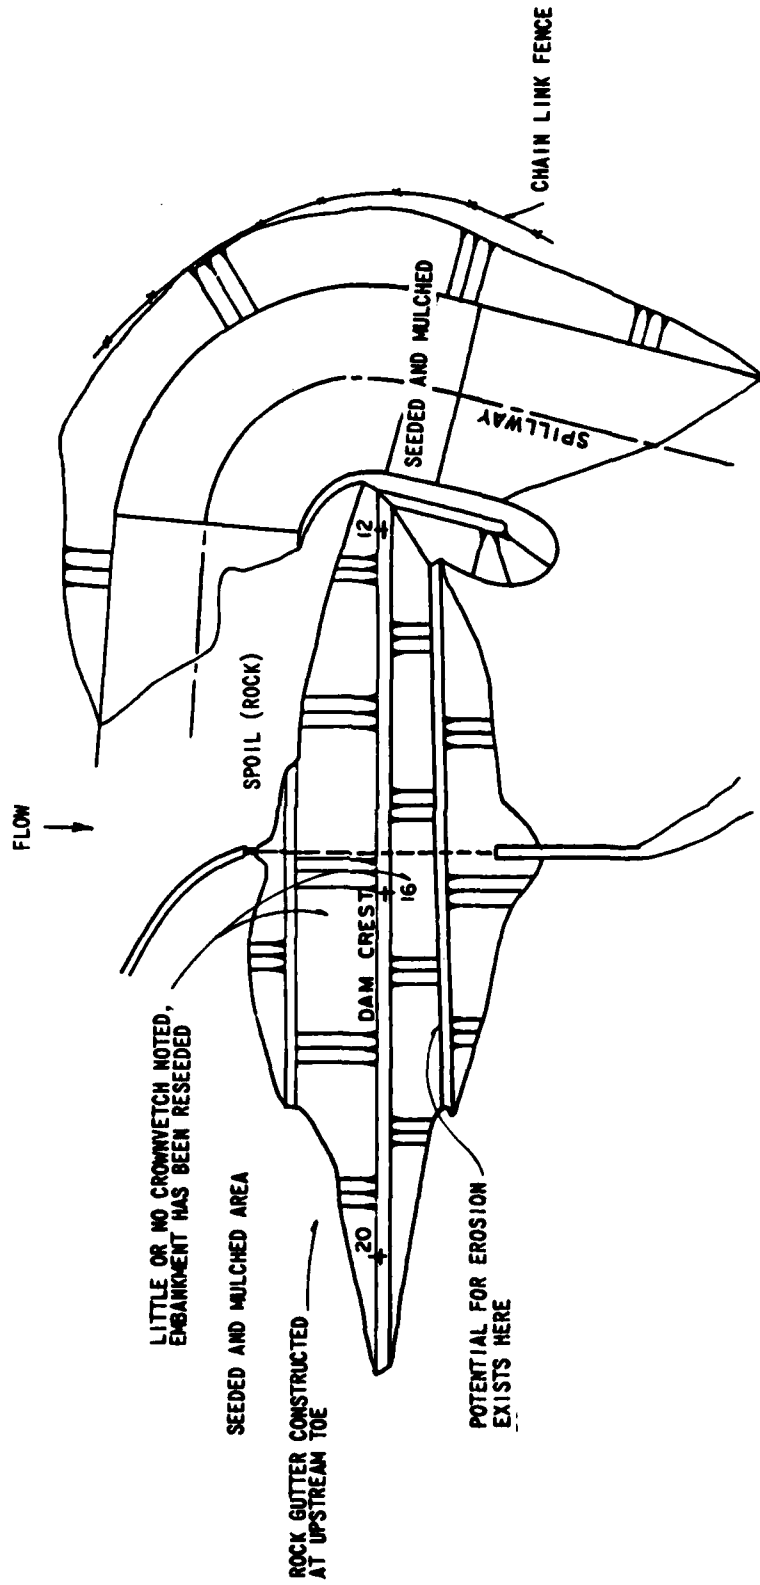
FIELD OBSERVATION PLAN  
 SCS PA 621  
 SHEET 5A OF 11

*Embankment drains outletting through impact basin walls were dry.*

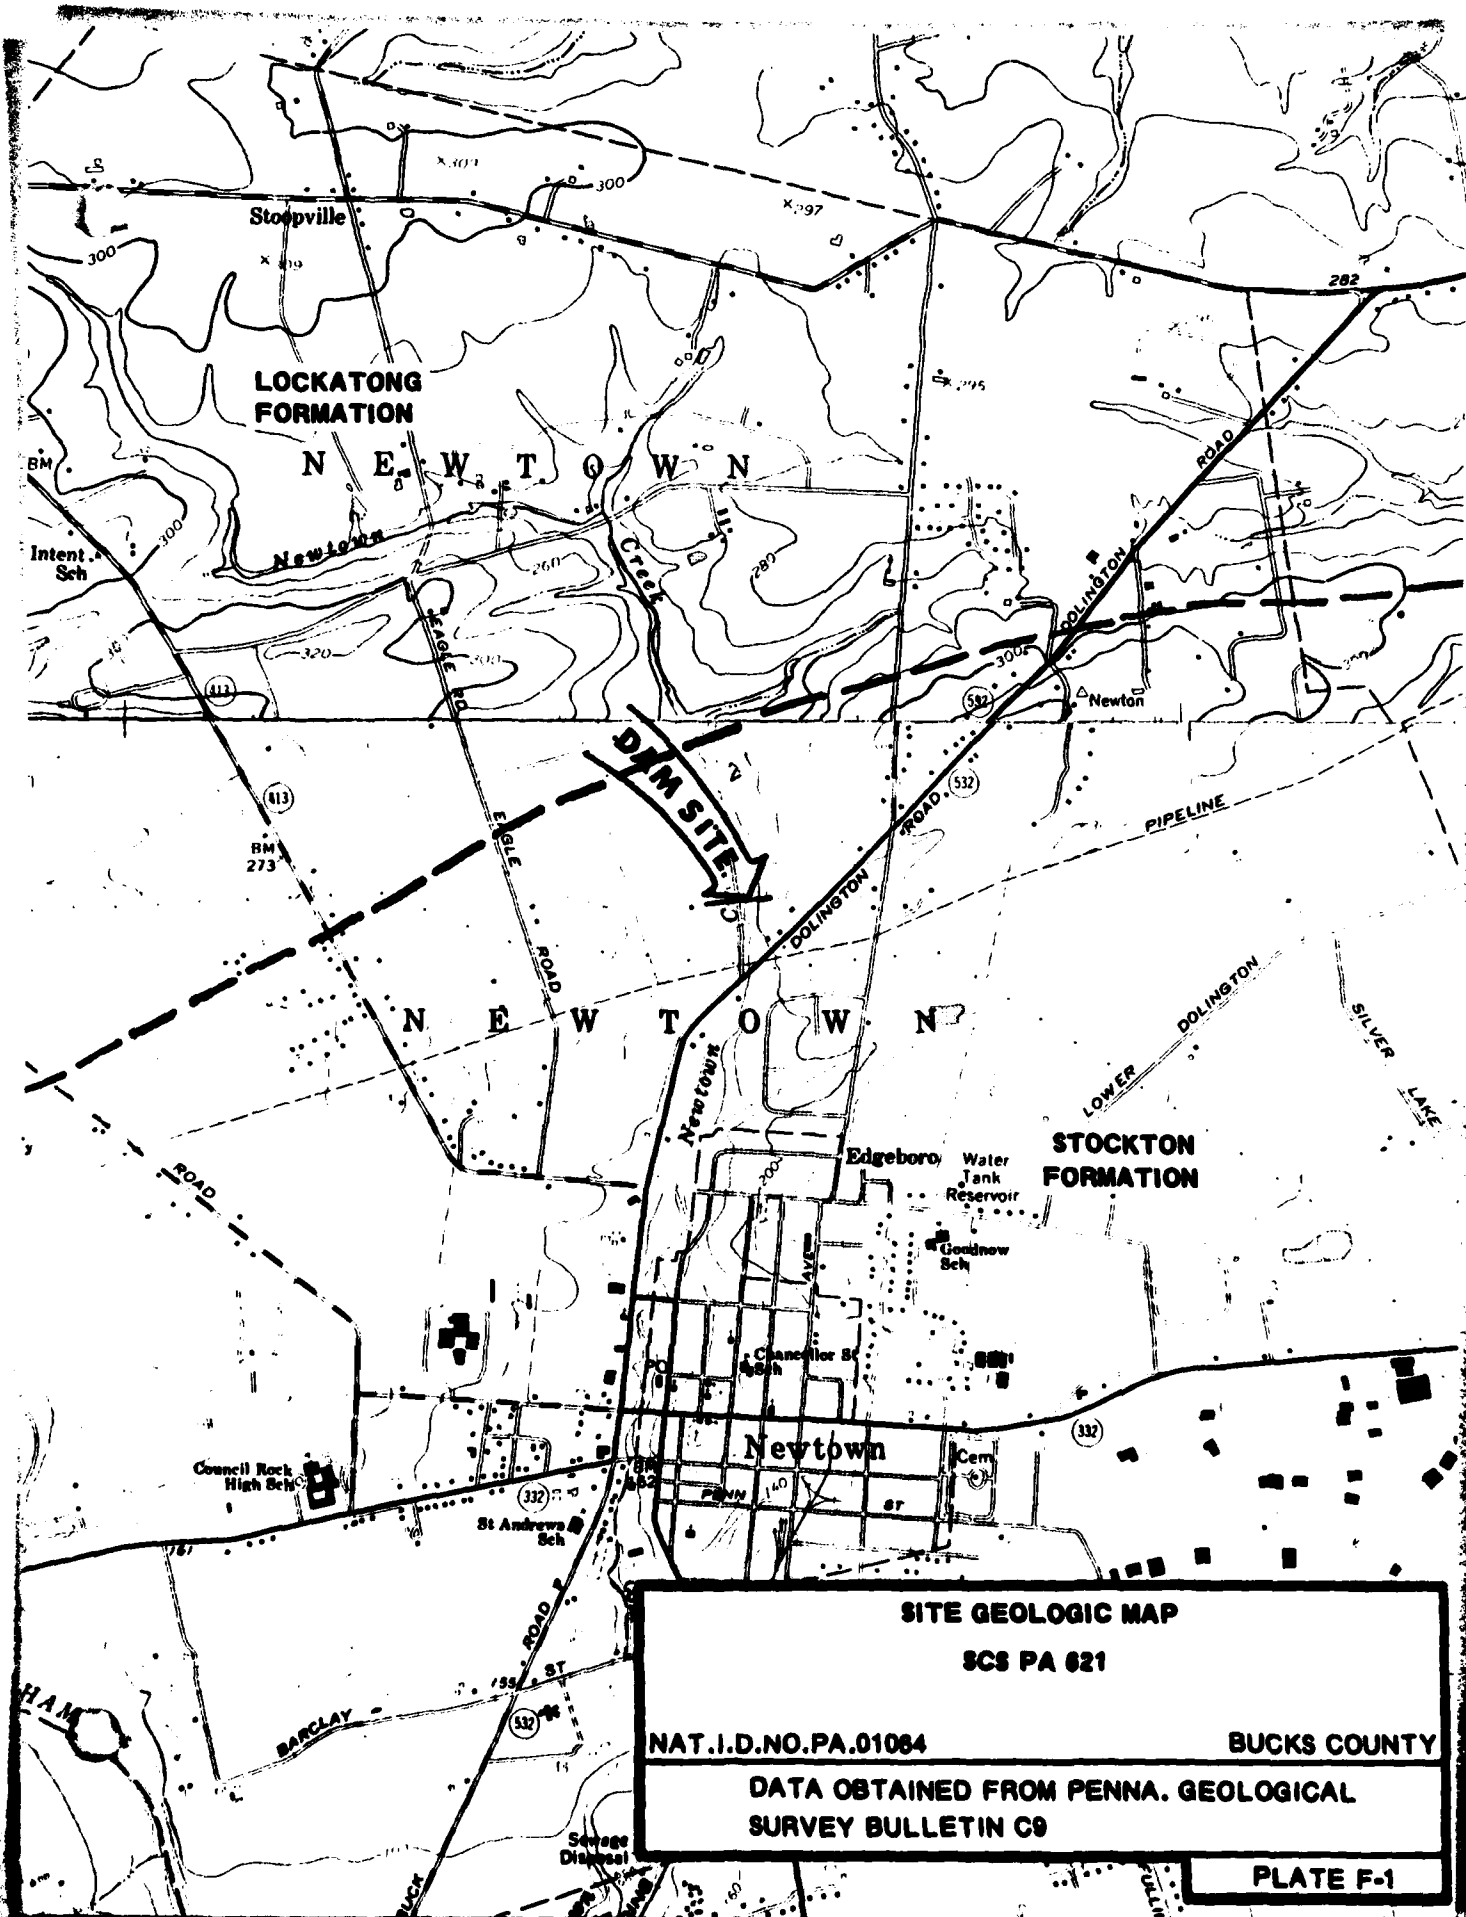
**SITE GEOLOGIC MAP**  
**SCS PA 621**

SCS PA 621 Dam is located in the Triassic Lowland Section of the Piedmont Physiographic Province. As shown in Plate F-1, the site is underlain by the Stockton Formation of Triassic age. Information contained in the state files describes the bedrock as silty shale and shaly and sandy siltstone that strikes east-west and dips 10 to 20 degrees to the north. This is consistent with the observed N70°E strike and 11 degree north dip (upstream) of bedrock exposed on the left side of the emergency spillway. High angle rock jointing strikes near east-west (parallel to dam centerline) and north-south (perpendicular to dam centerline). A potential for seepage under the dam exists due to the jointed and blocky character of the bedrock.
