*Lab*  
NRL Report No. R-2225  
BuShips Prob. S347T-C  
(X-108C)

Report on  
TESTS OF MODEL SC-2 RADAR EQUIPMENT

Contractor:  
General Electric Company  
NAVAL RESEARCH LABORATORY  
ANACOSTIA STATION  
WASHINGTON, D. C.

5 January 1943 to 15 April 1943

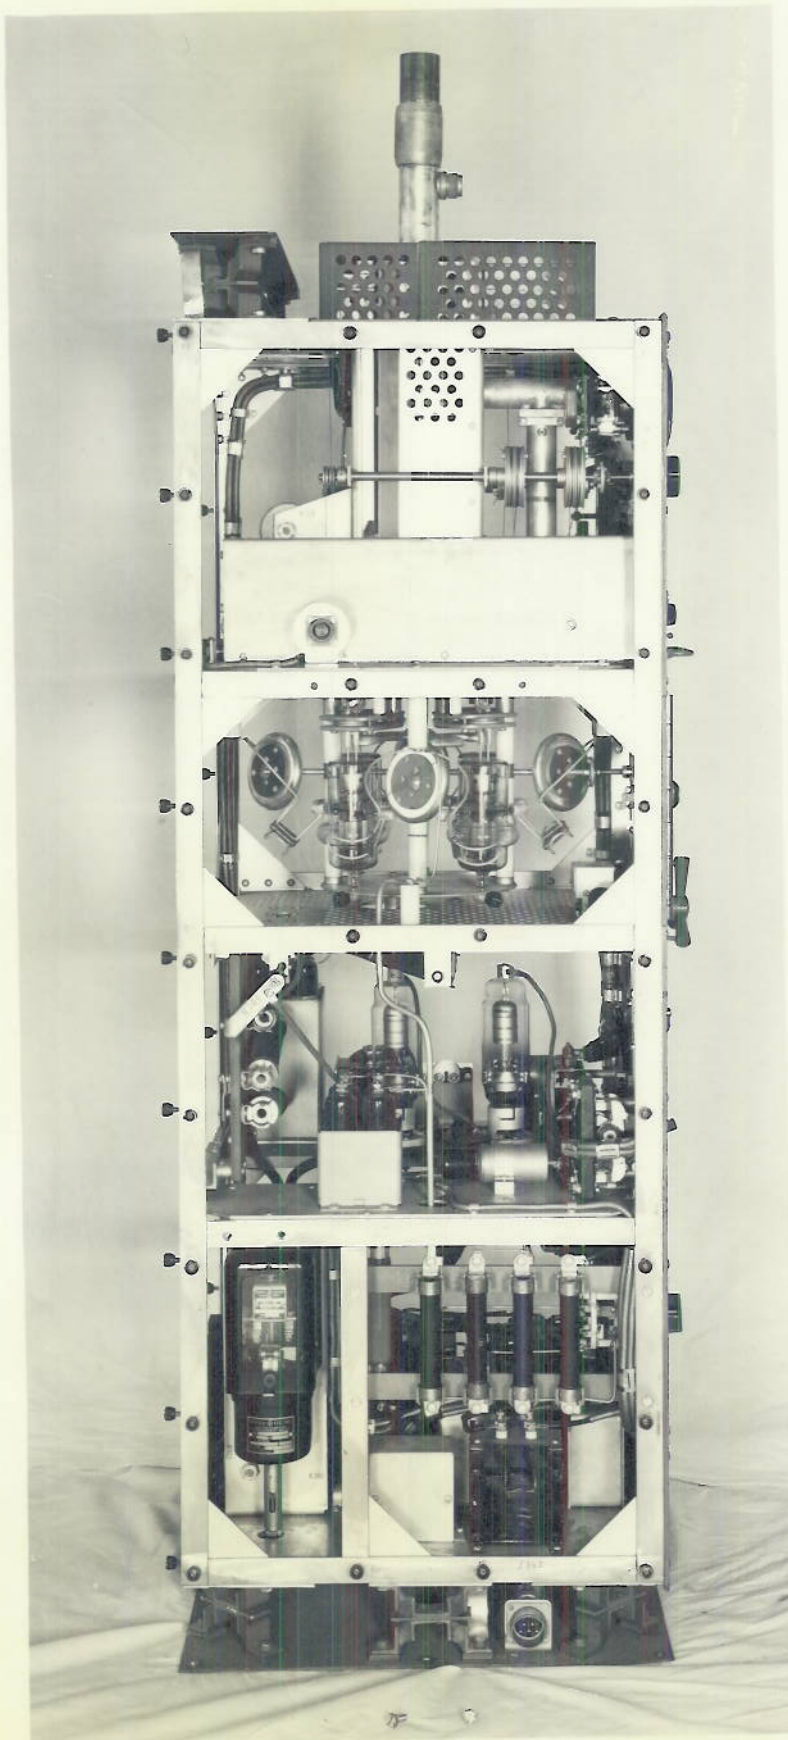
**PLATE 4 SEC.2**

- (b) The coupling jack J303A at the bottom left side of the transmitter (visible on Plate 4) became loose in its mounting as a result of vibration. This permitted the jack to oscillate so that the plug P303A which fits into it struck against the deck on which the transmitter was mounted. It is recommended that this jack be secured in a manner that will prevent it from being loosened by shock or vibration.

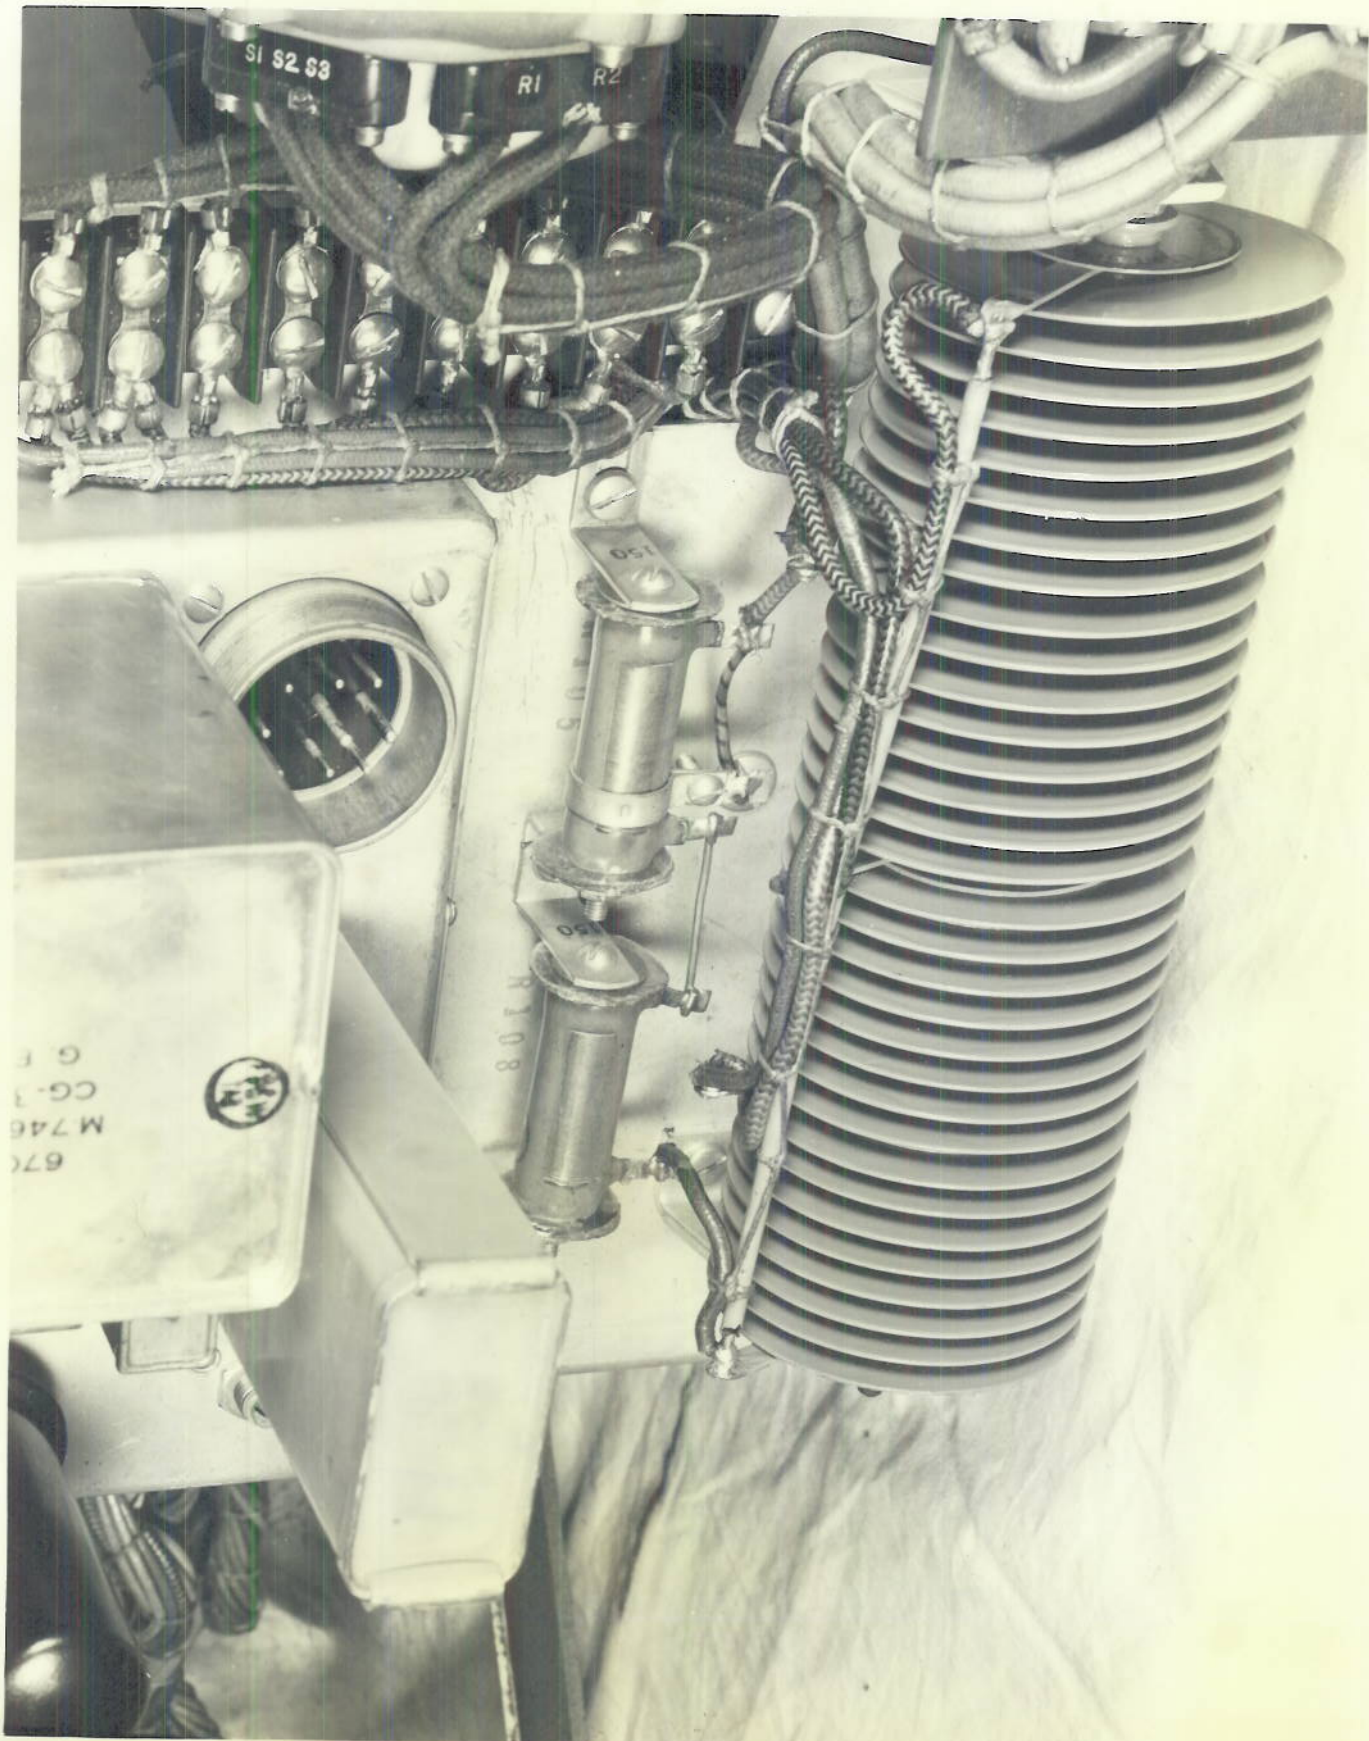
**PLATE 12 SEC. 2**

- (a) Resistors R102C, R105, and R108 (Plate 12) in the control unit are of the wire wound type with a vitreous enamel covering. A portion of the resistance wire has been left exposed to permit the use of a clamp band around the resistor as a variable tap. The terminals on these resistors are in the form of tabs. Paragraph 3-2-3A of reference (b) requires the use of ferrule type wire wound resistors in Naval radio equipment and states that these resistors shall meet the requirements of reference (c). Paragraph 7-1 of reference (c) requires that the coating completely cover the exterior of the resistor. It is recommended therefore that the present resistors be replaced by ferrule type resistors having a completely coated surface. The instruction book lists CAO-63639F as the Navy type number of the resistors R-105, R-108. The suffix "F" indicates that these are grade 1 class 1 resistors. It is considered highly improbable that a resistor having a portion of its wire exposed in the manner described would successfully withstand the Navy tests required for classification as grade 1 class 1. It is, therefore, recommended that the Bureau of Ships require the Contractor to justify the use of this type number.

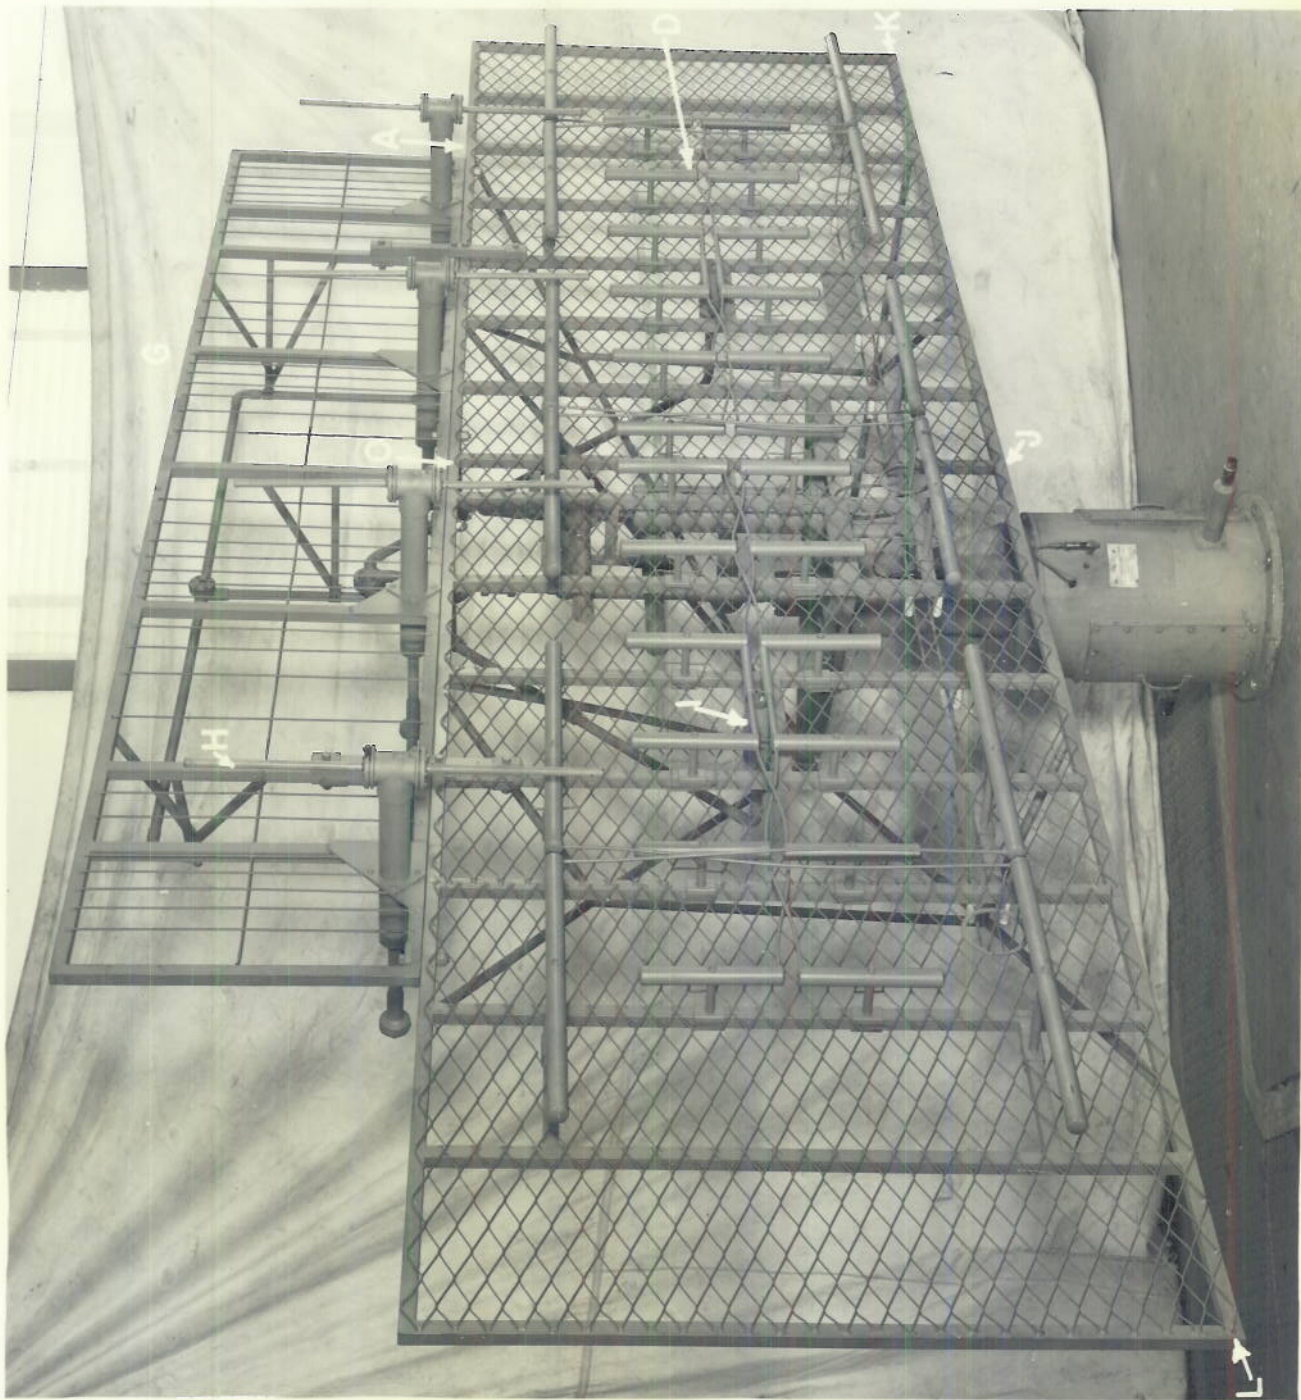
PLATE 18 SEC. 2

- (a) A number of points on the antenna resonated at certain of the applied vibration frequencies and developed considerable amplitudes of motion. The maximum amplitudes obtained were measured and are listed in Table 4. Reference to Plates 18 and 19 will reveal the location of the various points.
- (b) The excessive amplitude of motion induced in the structure caused a number of the antenna components to become disrupted, namely:

The frame at point A on Plates 18 and 21;  
The clamp bolt at point B on Plates 19 and 22;  
The weld between two struts at point C on Plates 19 and 23;  
The weld securing one of the feeder lines to the end of a radiator as shown at point D on Plates 18 and 24;

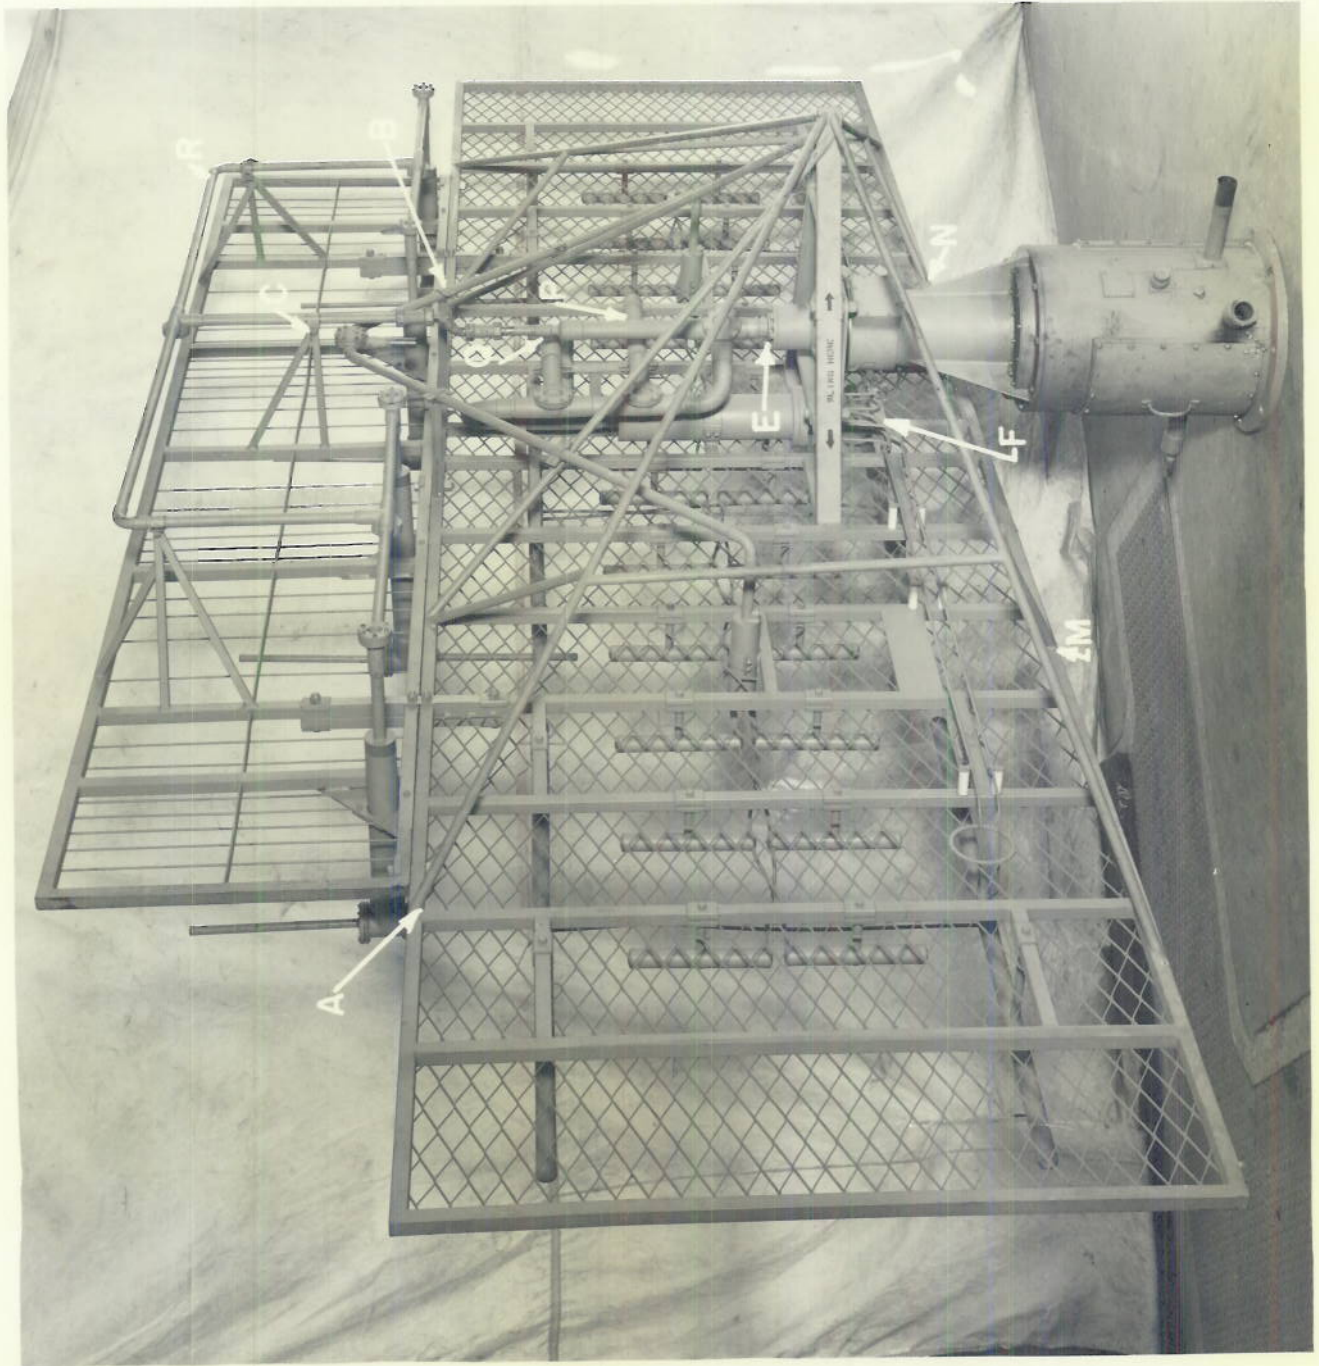
PLATE 19 SEC. 2

The outer conductor of the main concentric line at the point at which it connects to the rotating joint as shown at E on Plates 19 and 25;

The threads on the studs at the bottom of one of the matching sections. These threads became stripped. The loss of the threads caused the sleeves which thread on these studs to loosen at F on Plates 19 and 26.

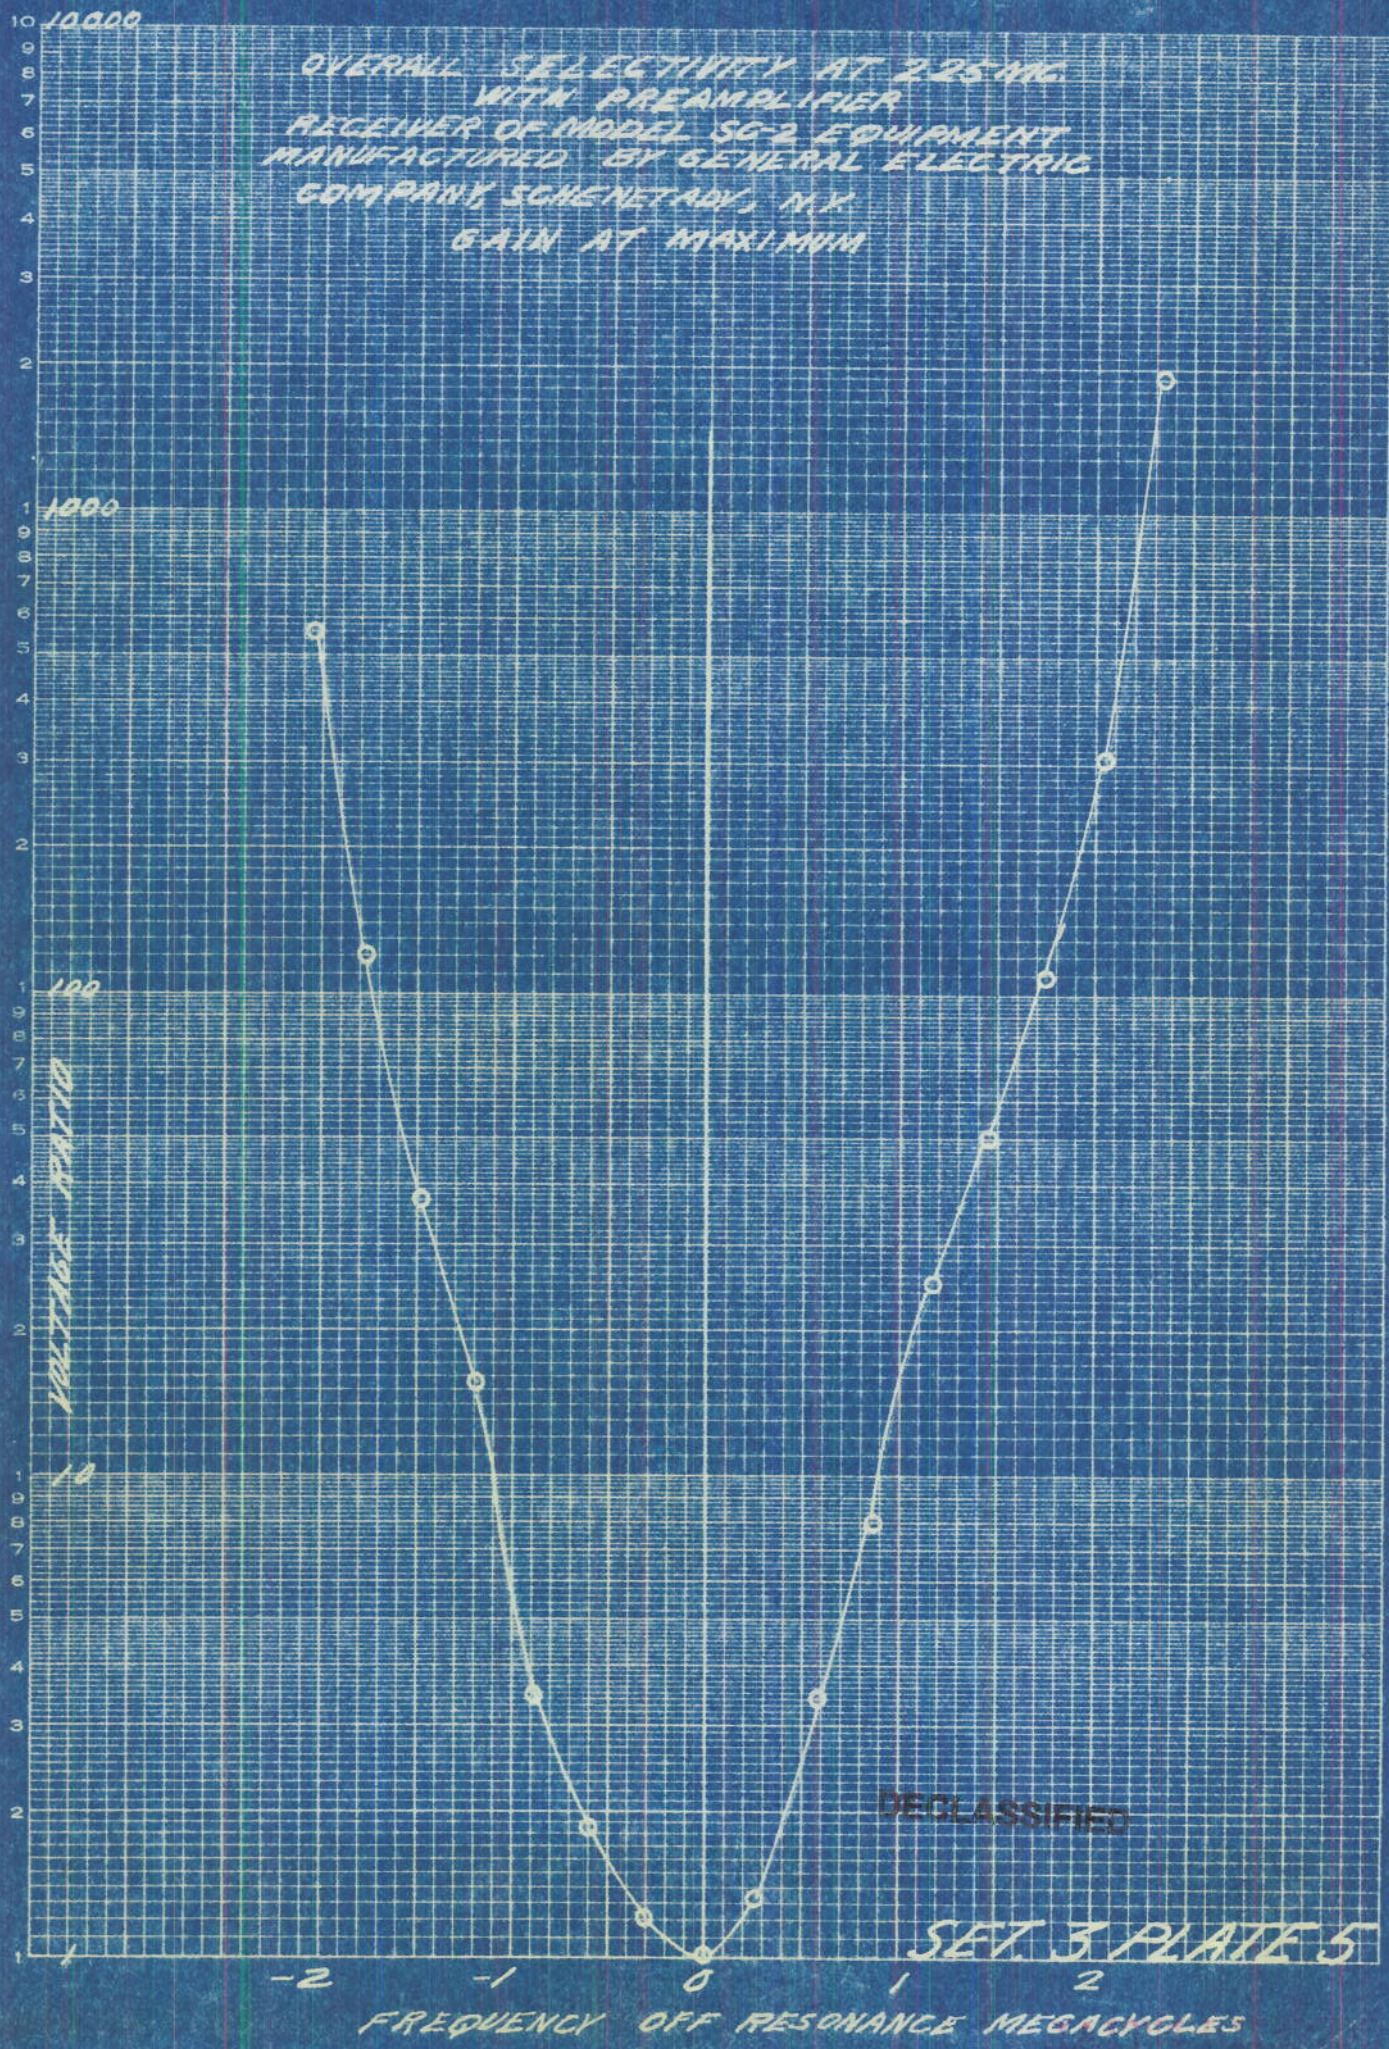
OVERALL SELECTIVITY AT 2.25 MC  
 WITH PREAMPLIFIER  
 RECEIVER OF MODEL SG-2 EQUIPMENT  
 MANUFACTURED BY GENERAL ELECTRIC  
 COMPANY, SCHENECTADY, N.Y.  
 GAIN AT MAXIMUM
