Product and Service Issues and Answers

Today's program has 6 parts:

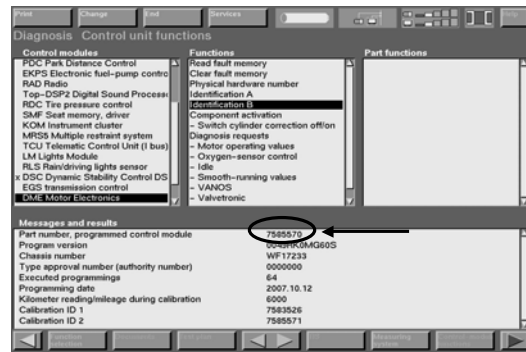
- Loss of power at idle, or when slowing to a stop, in vehicles equipped with an automatic transmission
- All of these situations would not cause a fault code to be set in the DME

- Update the DME software using only Progman V27.01.01, programmed number 7585570, or higher
- Important: the EGS (if equipped) must also be at the latest software level
