EUROPEAN ORGANIZATION FOR NUCLEAR RESEARCH
European Laboratory for Particles Physics

Task Force Report

Safety of Personnel in LHC underground areas following the accident of 19th September 2008

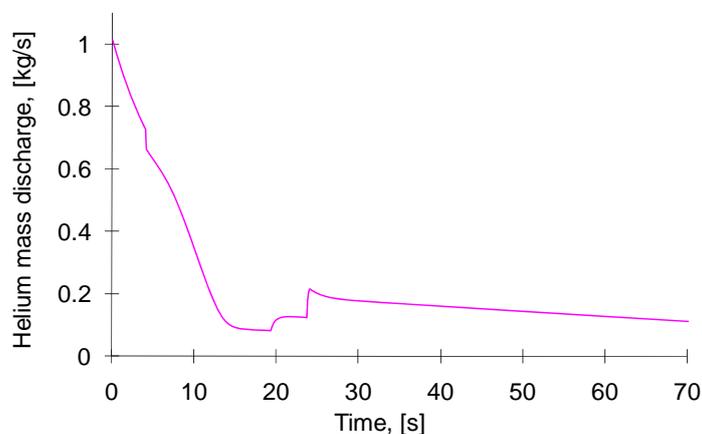
Fig. B2: Helium discharge during the QRL test-cell experiment

The maximum credible incident (MCI) was defined in 1999 in the preliminary risk analysis of the cryogenic system [1]. At the time, in case of electrical arcs, the maximum flow which could be discharged from the magnet cold mass into the insulation vacuum enclosure of the readout cryostats was assessed to be 2 kg/s. This value was based on a maximum breach cross-section of 5 cm². It also corresponds to the average flow discharge through a quench valve having a larger section passage (~12 cm²), as measured after a magnet resistive transition [2] (see Fig.B1). This figure shows at the very beginning a mass-flow peak exceeding 2 kg/s, whereas in case of helium release, the insulation vacuum acts as a buffer volume. This volume of about 80 m³ is able to buffer about 60 kg of helium at 60 K. An experiment was also performed on a 107 m test-cell of the cryogenic distribution line (QRL) [3], equipped with a bursting disk of 5 cm² cross-section on header C, to stimulate a helium discharge via the vacuum enclosure into a simulated tunnel. During this experiment, a maximum flow of 1 kg/s was deduced (see Fig. B2), validating the hypothesis.
