2005 Annual Inspection of the Monticello Mill Tailings (USDOE) and Monticello Radioactively Contaminated Properties Sites

December 2005

U.S. Department
of Energy

Office of Legacy Management

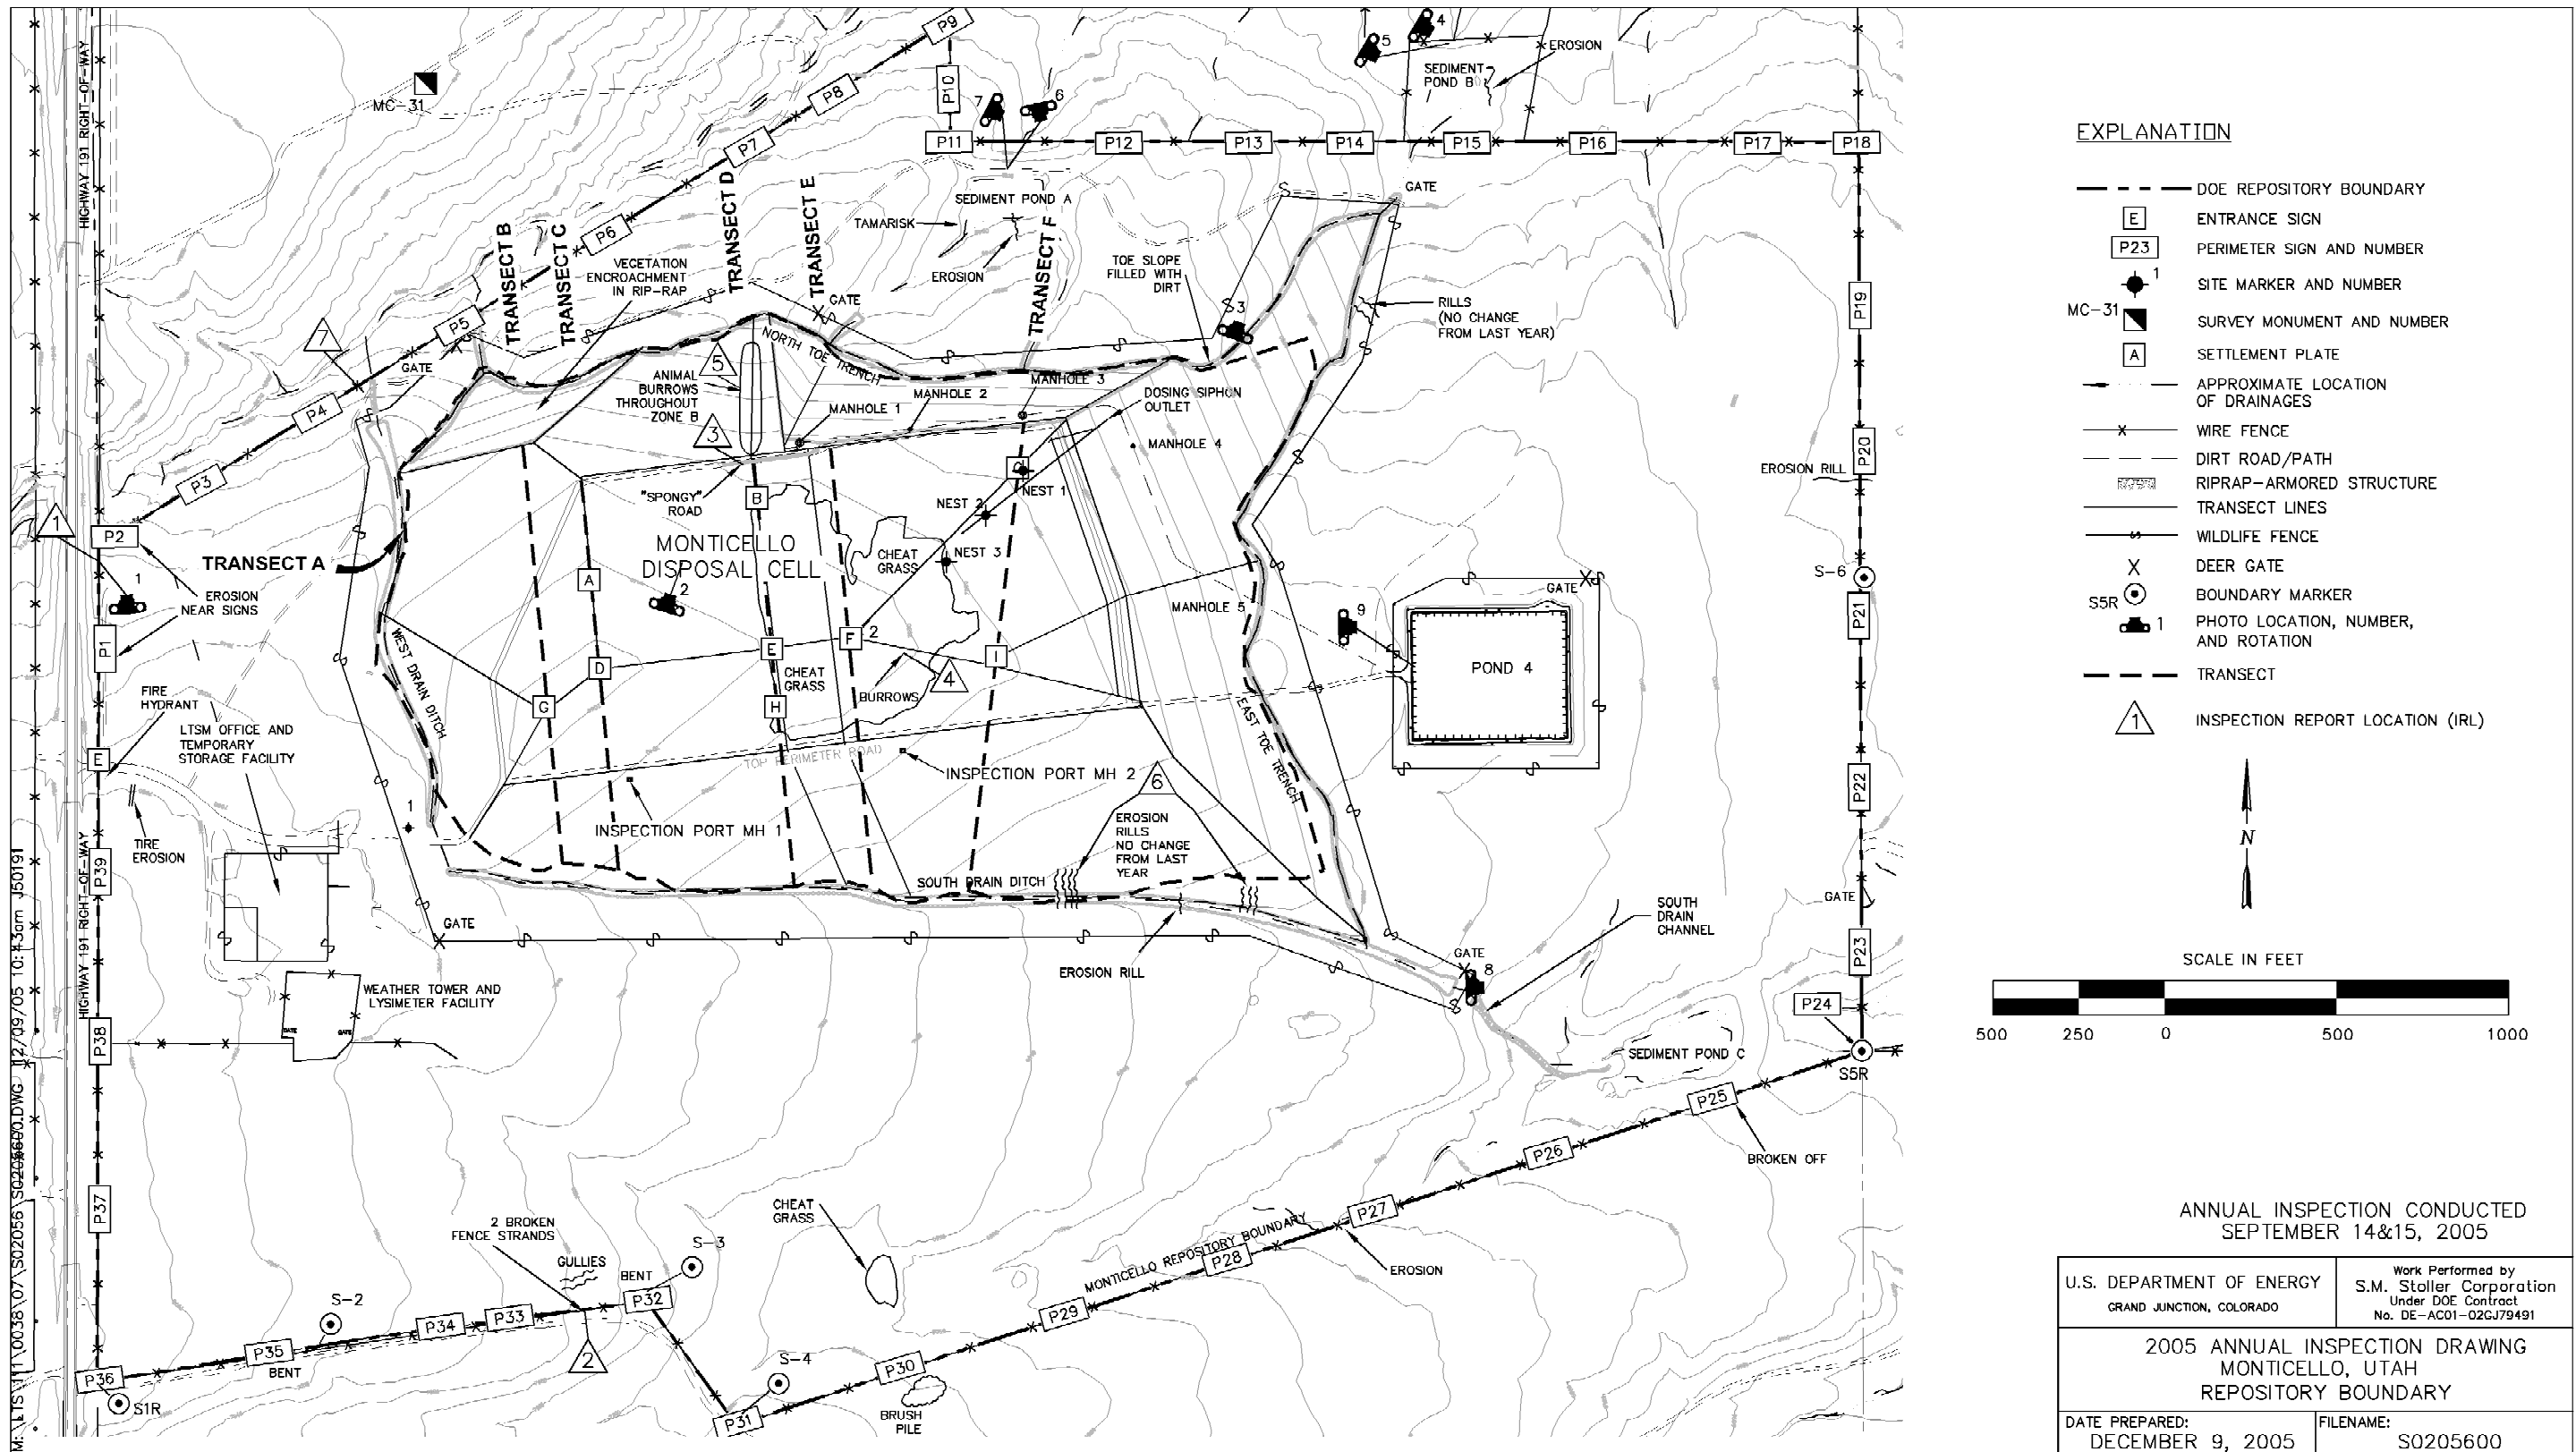
Figure 2. Monticello, Utah, Repository Boundary

The perimeter fence delineating DOE-owned property is a conventional barbed wire stock fence. Fences along the north and east boundaries are in excellent condition. Fences along the west and south boundaries are older and in need of maintenance but remain in fair condition. An erosion gully (PL-1) (see [Figure 2](#), Inspection Report Location [IRL] 1) has formed along one section of the west fence near perimeter sign P1. The cause of the erosion was determined to be runoff from Highway 191. DOE, EPA, and UDEQ agreed that erosion control measures were not warranted and that the fence should be maintained as a physical barrier to humans. If the fence becomes

irreparable, it will be relocated a few feet to the east on DOE property. One section of fence near perimeter signs P32 and P33 (see Figure 2, IRL 2) has two broken strands of wire and will be repaired. Tumbleweed accumulations noted in the 2004 annual inspection report had been removed. Tumbleweeds do not appear to be a significant problem this year. With the exception of the gate at the site entrance at Highway 191, field gates in the perimeter fence do not have locks. Access through these gates does not result in access to the repository or the Temporary Storage Facility (TSF). Interior fences restrict access and secure the repository and TSF.

The inspector located survey marker S2 between perimeter signs P34 and P35 and noted that it was not listed on the inspection drawing. The location of S2 has since been placed on the inspection drawing. Survey marker S6 was not located.

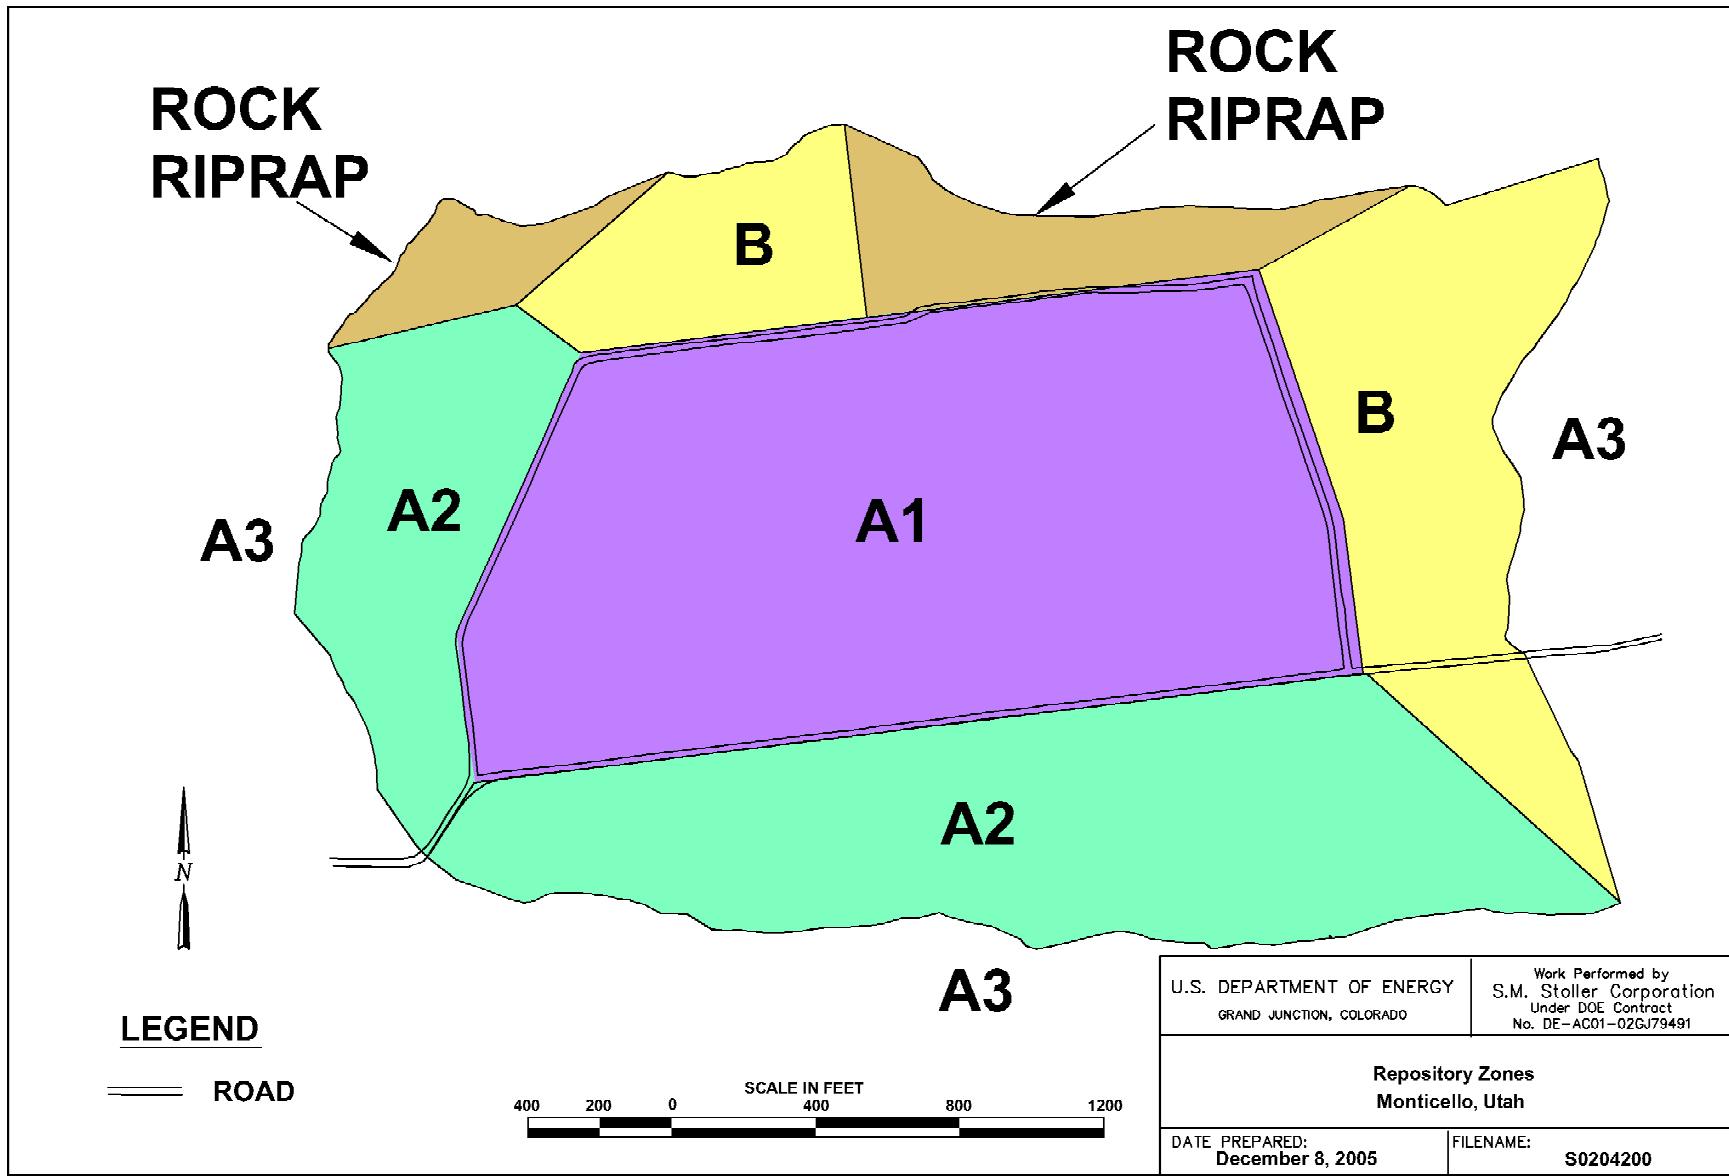
Figure 4. Repository Zones

The top of the disposal cell was seeded with native grasses, forbs, and shrubs, and planted with sagebrush seedlings in late April/early May 2000. From 2001 to 2003, the vegetative cover was dominated by weedy species. By 2004 and 2005, plant cover and diversity had improved. However, several concerns continue to exist: (1) the cover continues to be dominated by cheatgrass (*Bromus tectorum*), an annual weedy species, in many areas; (2) the density of shrubby vegetation is less than 10 percent of the success criterion for Zone A1 and only 25 percent of the success criterion for Zone B; and (3) the relative cover of forbs in Zones A1 and A2 do not meet success criteria and do not appear to be increasing over time.

Given the progress of revegetation since 2000, reclamation specialists believe that many of the vegetative cover requirements, particularly shrub density, are not likely to be met soon. In 2004, EPA's soil scientist recommended that no action involving mechanical disturbance of the soil be taken for a minimum of 1 to 2 years. However, he agreed broadcasting appropriate seed that could compete with cheatgrass might be beneficial. He also believed that annual weed cover would diminish and shrub density would increase over time. In response to the specialists' concerns about shrub density and cheatgrass cover, DOE over-seeded a native seed mix in April and July 2005 in Zone A1 and in the east portion of Zone B. The seed mix was composed of one
