**Number:** 777-78A0094  
Original Issue: July 29, 2014  
ATA System: 7830

**SUBJECT:** EXHAUST (Trent 800 Engines) - Thrust Reverser System - Thrust Reverser Inner Wall Replacement

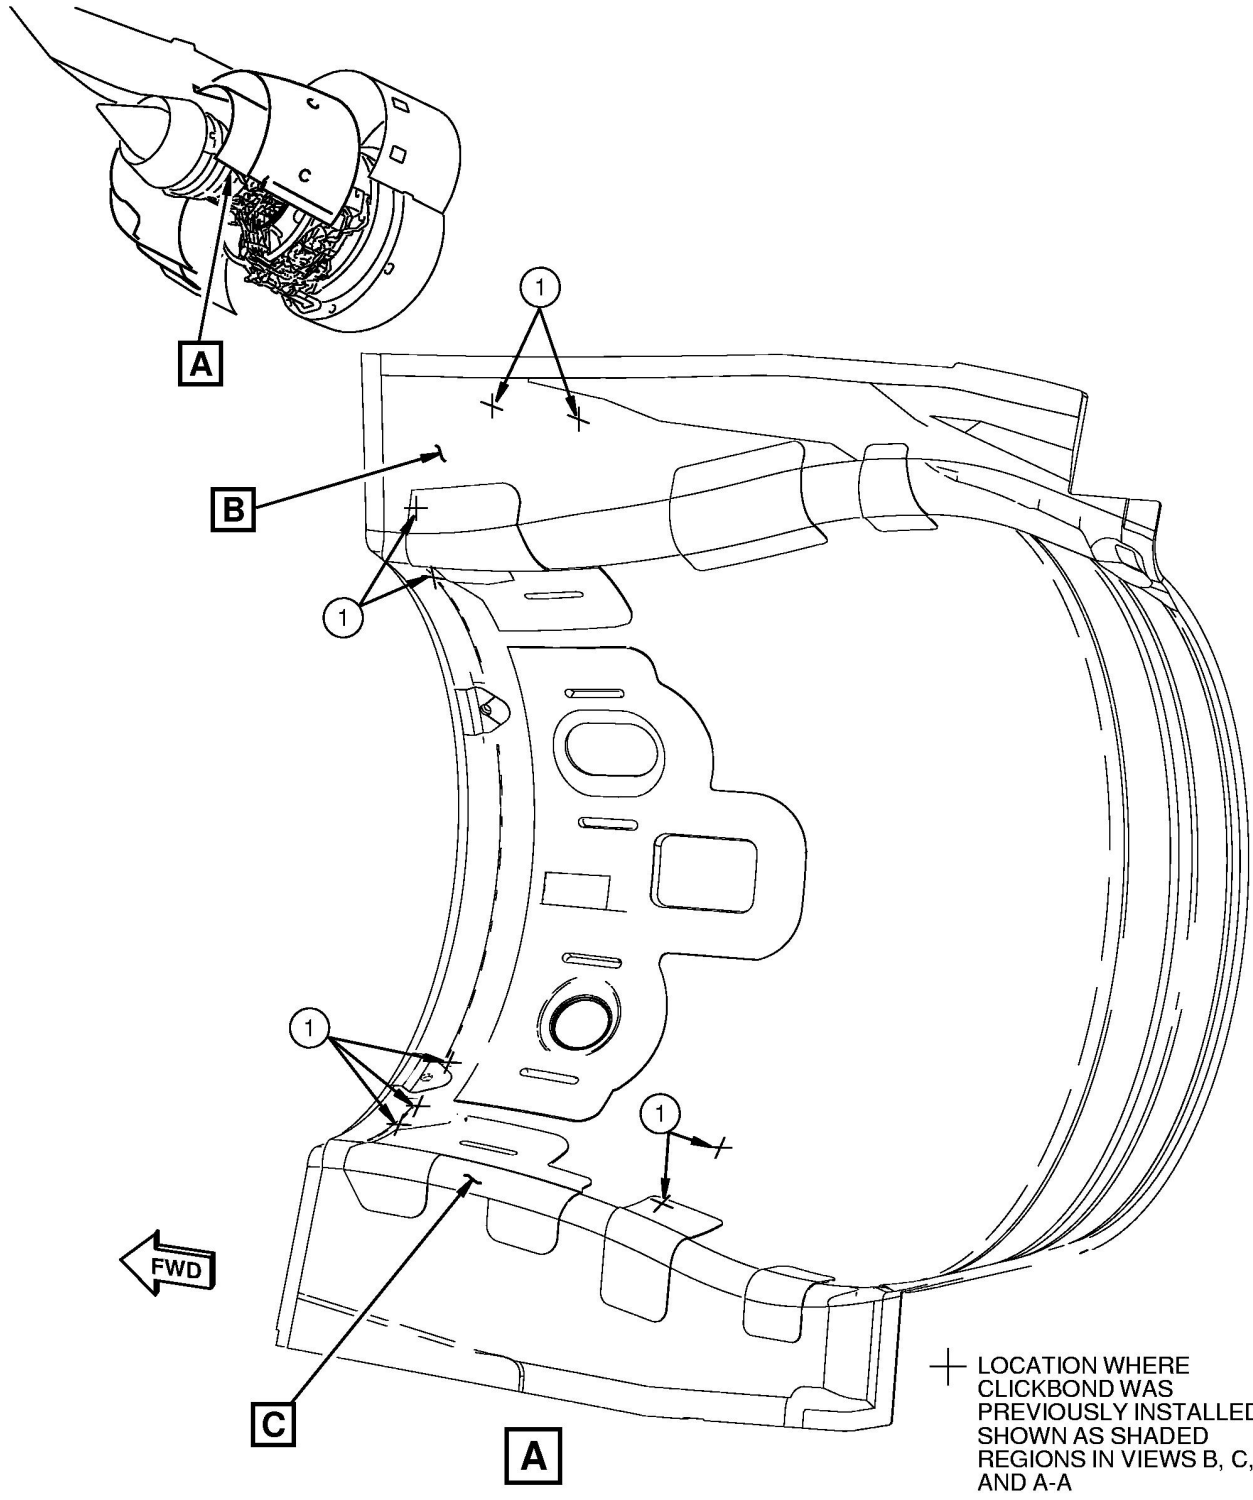
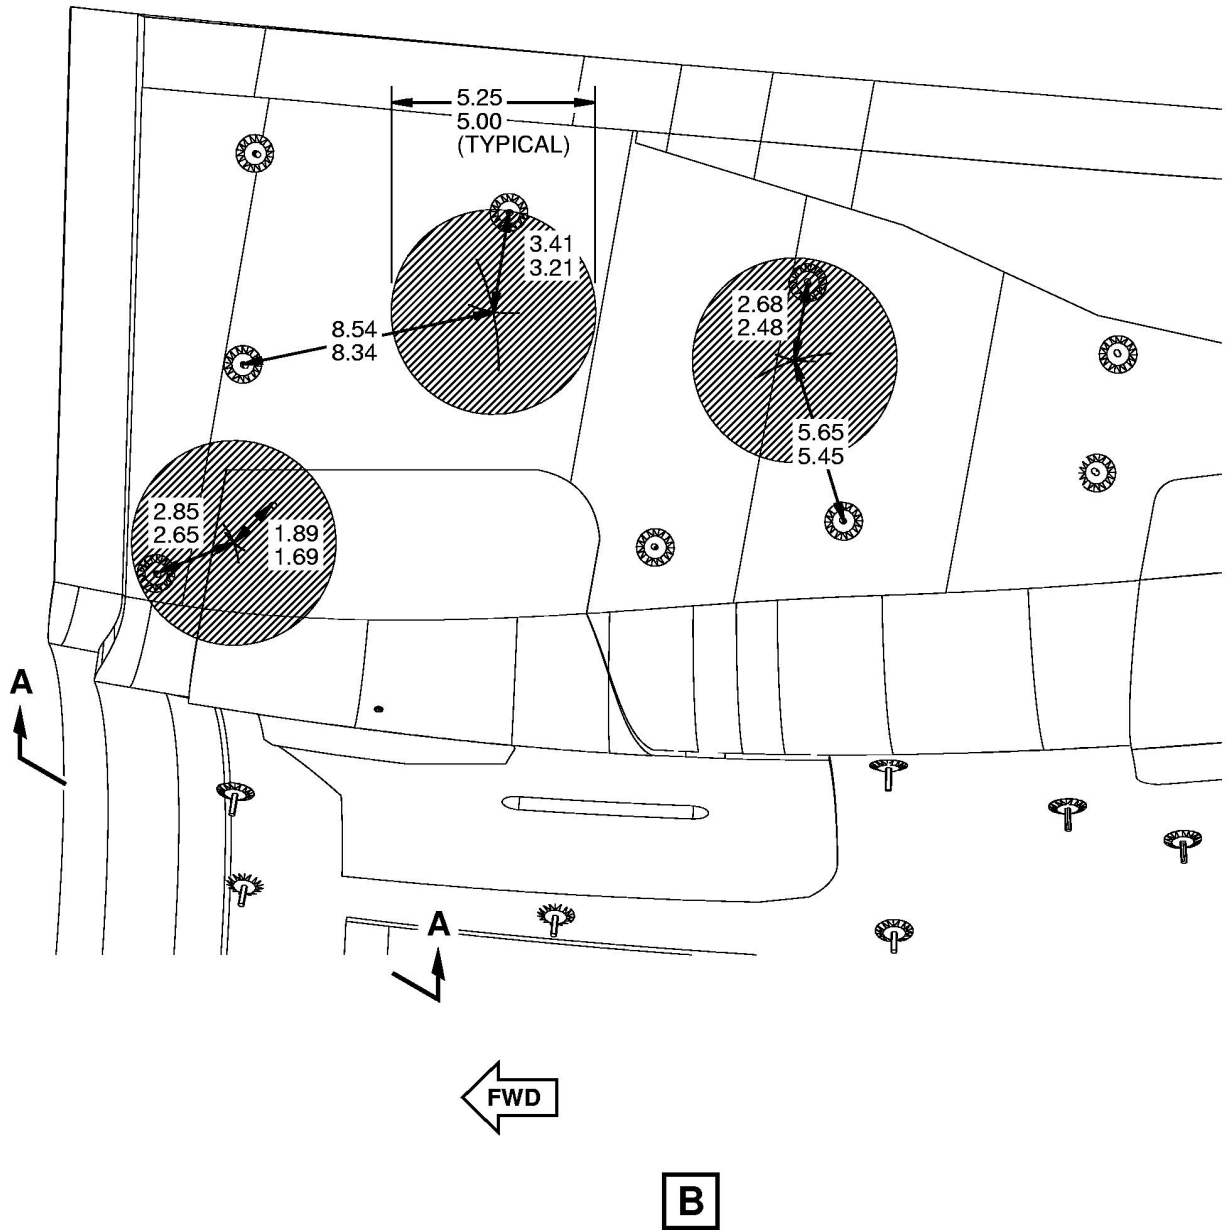
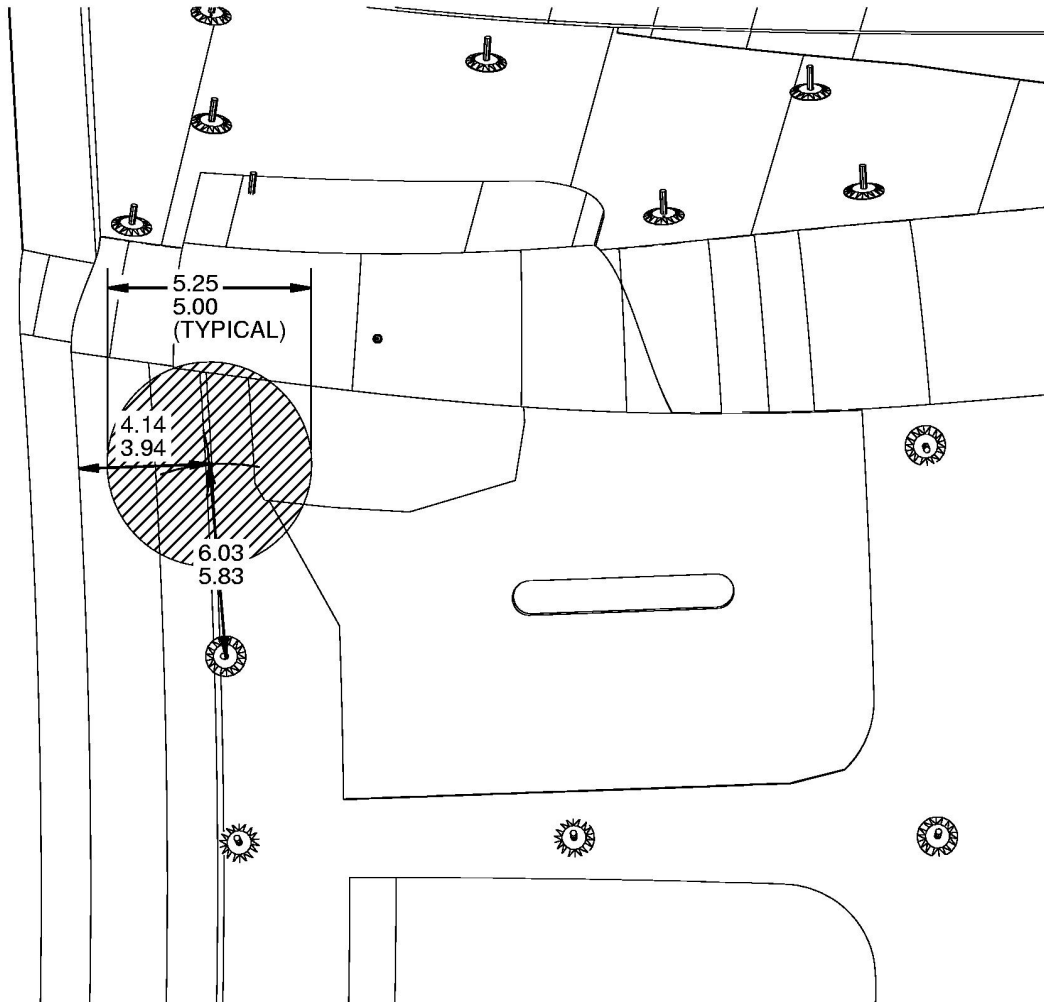
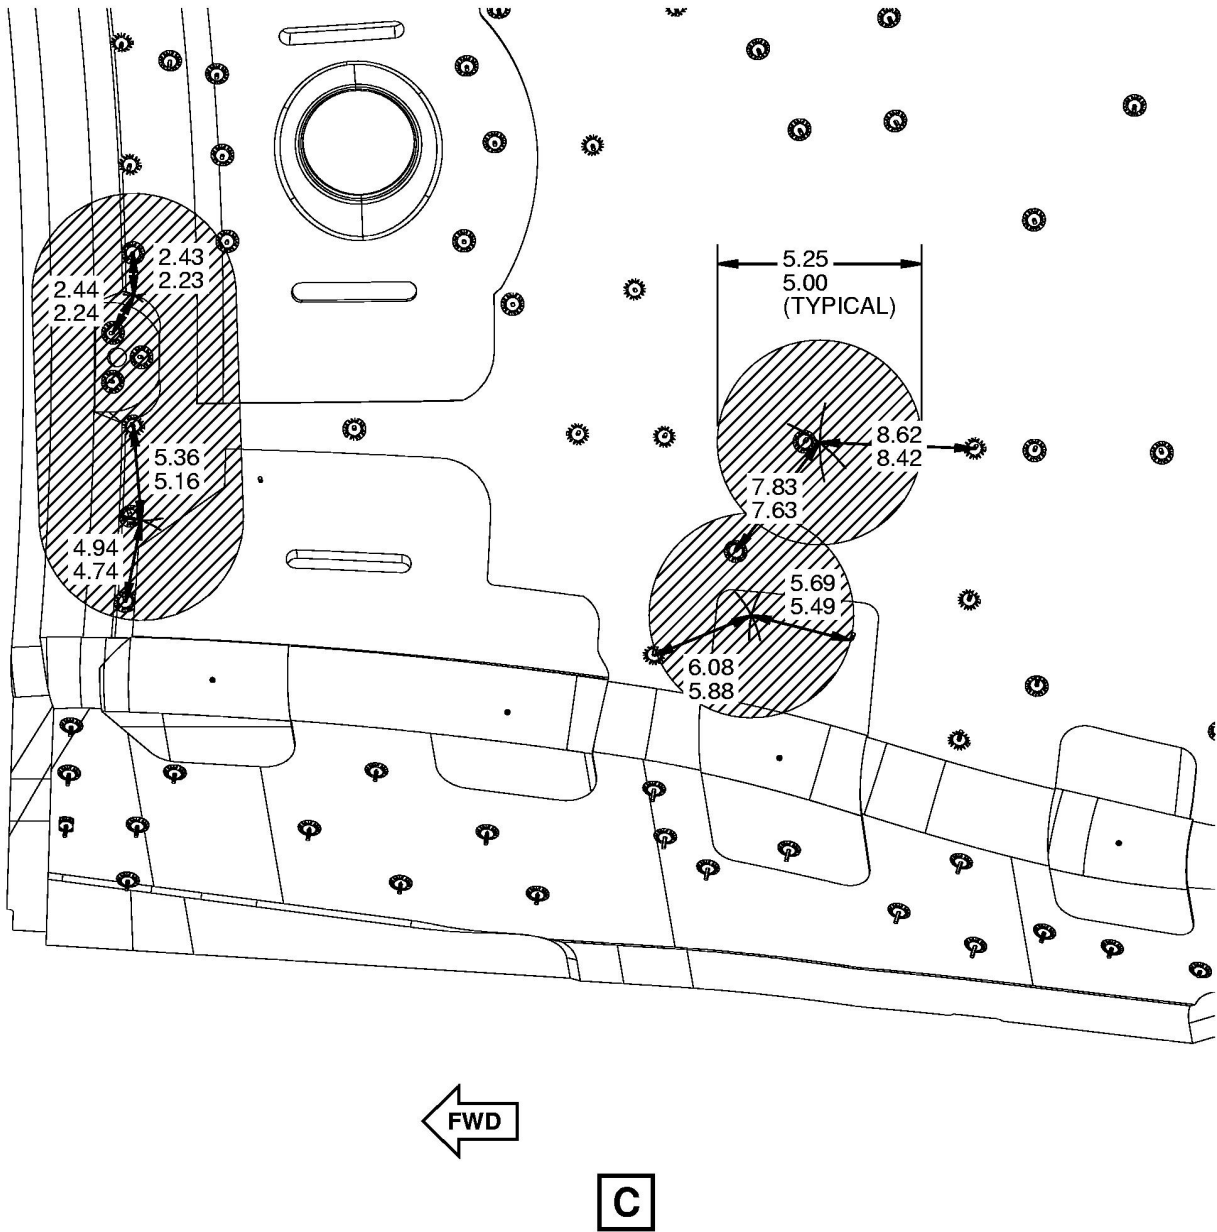
FIGURE 10: RIGHT SIDE INNER WALL CHANGED CLICK BOND LOCATIONS (SHEET 1 OF 5)

2. Do PART 7: NDT OF TR HALF INNER WALL at re-worked click bond areas. Refer to FIGURE 10 for location of re-worked click bonds
  - a. CONDITION 41: ANY DISBOND OR DELAMINATION FOUND ON RIGHT TR HALF INNER WALL

- (1) ACTION 1: Go to Step 2 - Do PART 7: NDT OF TR HALF INNER WALL at re-worked click bond areas. Refer to FIGURE 10 for location of re-worked click bonds

- (1) ACTION 1: Go to Step 3 - Do a detailed inspection of the clickbond areas for previous repairs.
3. Do a detailed inspection of the re-worked clickbond areas for previous repairs. Refer to FIGURE 10 for the location of the re-worked click bonds.

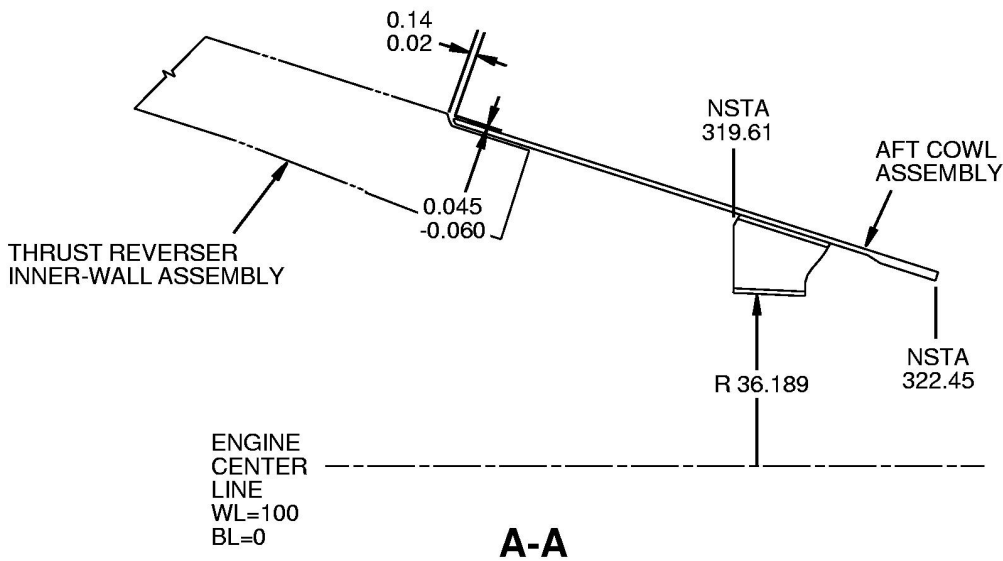
2258783

REFERENCE FOR CHECKING AFT COWL, NOT REQUIRED FOR INNER-WALL REPLACEMENT. HAS BEEN USED TO DETERMINE OUT OF TOLERANCE DETAIL PARTS. CLEARANCE OF 0.13 TO ENGINE NOMINALLY
