Condition Assessment and Rehabilitation Plan Hangar One

for NASA Headquarters and
Ames Research Center, California

Volume 1
Condition Assessment

Hangar One – Ames Research Center, Moffett Field, CA

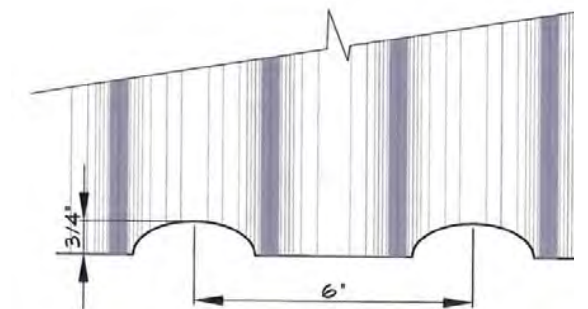
Figure 2.4

The upper portion of metal wall panel (or the area historically referred to as the Mansard Siding) has a different profile than the V-Beam shape with convex ribs. These Mansard Siding panels are currently covered with a black, fluid-applied bituminous coating but were originally a silver colored panel to match the V-Beam panels below. The black coating was added to help create a higher surface temperature which in

turn works to reduce the potential for condensation to develop on the interior of the hangar roof surfaces.

A black fluid-applied bitumen coating was added to the Mansard Siding visually giving the hangar a larger “roof” area. This is the black portion on the existing hangar exterior. This is not the original design intent of the building and is not intended to be replaced as part of the Rehabilitation Plan. The black coating was added after the original construction of the hangar in the 1950s in an effort to address some of the environmental and moisture problems that were being encountered in the hangar. By providing this black coating on the roof of the building the upper portion carries a higher surface temperature which in turn reduces the potential for moisture to develop on the inside of the hangar. When the hangar is re-sided with a non-black portion of roof at the Mansard Siding, care must be taken to alleviate this same potential problem but with a solution that maintains the original appearance of the metallic, aluminum-colored siding.

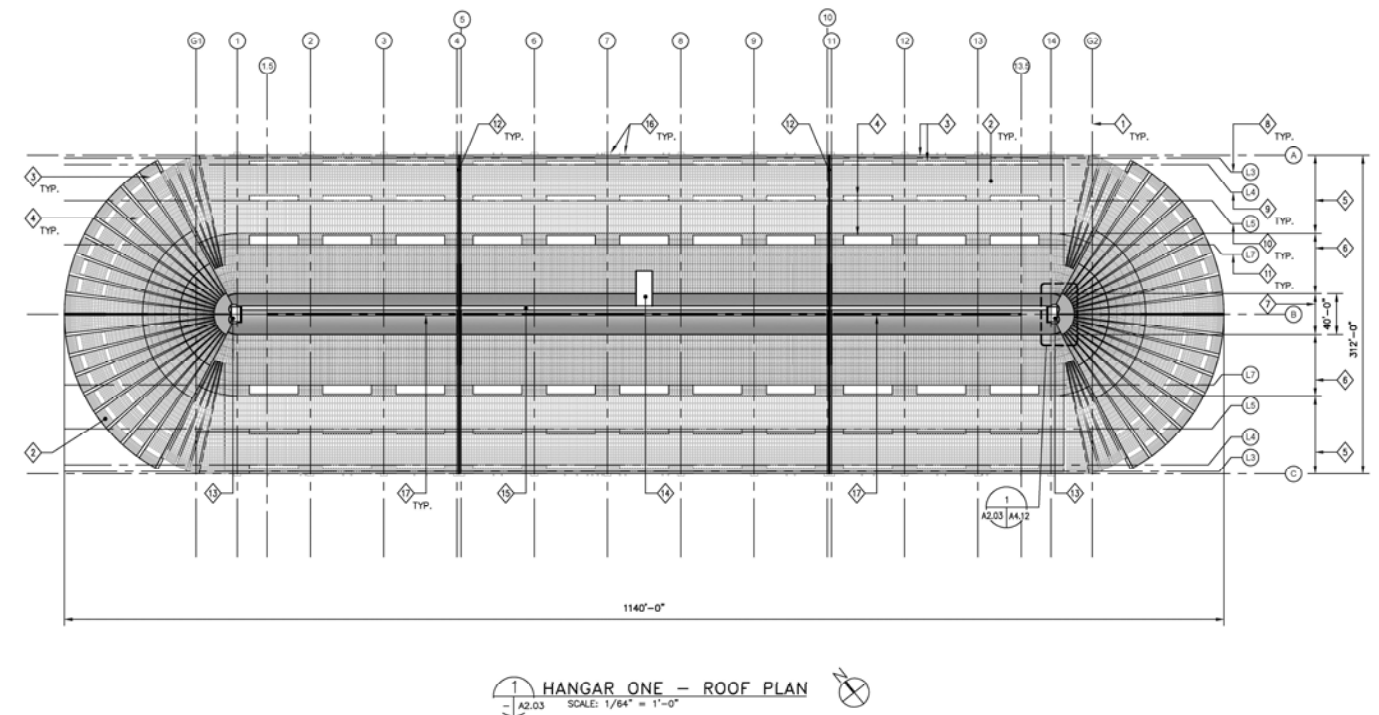
Figure 2. 8

There are also two dog houses located at the north and south ends of the roof for access to the hangar door pivots and a central access platform where access to the walkway is provided. The current railing configuration on the walkway does not meet OSHA requirements for guardrail height. The existing wood decking of the exterior roof walkway and contaminated wood on the internal catwalks will be removed with the ongoing Navy removal action. The railings and steel structure will remain.

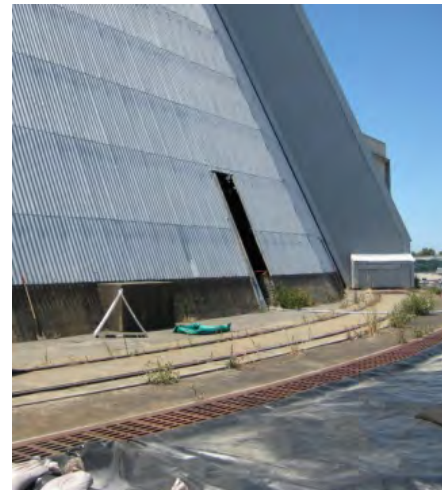
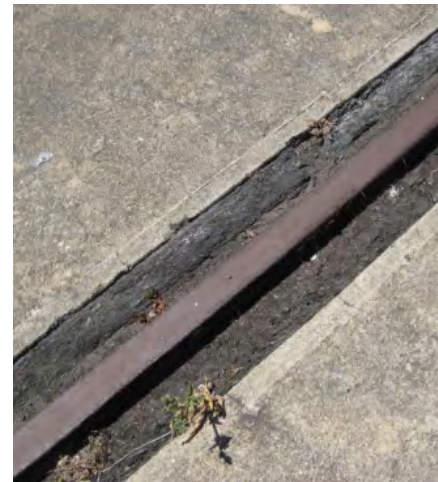
Figure 2. 14

The hangar door tracks consist of standard gauge railroad tracks that are attached directly to the concrete below with steel brackets. Composite material filler members have been installed around the tracks (see figures 2.14 and 2.15) as a safety precaution to fill the leftover large gaps and to allow for carts or other objects to be rolled over the tracks. It has recently been identified that these composite

filler members contain asbestos and will be removed as part of the ongoing Navy removal action. The steel rails will be left in place. Although not considered historic these filler members may need to be replaced for future use as a safety precaution.

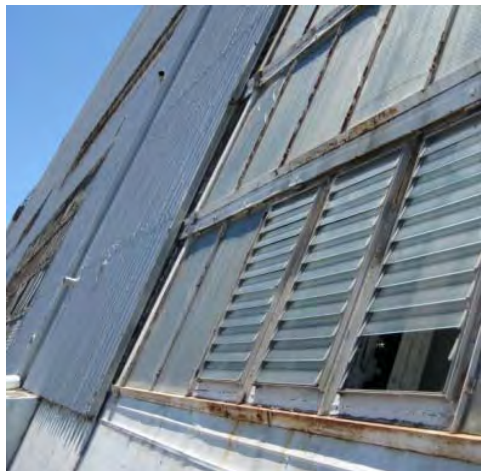
Figure 2.18

The existing windows are mostly intact but are in fairly poor condition. Many of the lowest sets of windows are damaged and have been broken over time. The corrugated glass is also cracked and broken in many places. It was the original intent to salvage and re-install the windows as part of the rehabilitation of the hangar. However, the full extent of window damage is too great to support salvage and repair of the existing window systems (frames and glazing). Therefore, the Rehabilitation Plan calls for all windows and frames to be replaced as part of the rehabilitation process.

The flat glass profile occurs at the lower two sets of horizontally oriented windows on the east and west facades of the hangar and on the lower set of windows at the hangar doors. Some of the windows in the lowest set on the east and west facades are louvered and or hinged for operability (see figures 2.18 and 2.19).

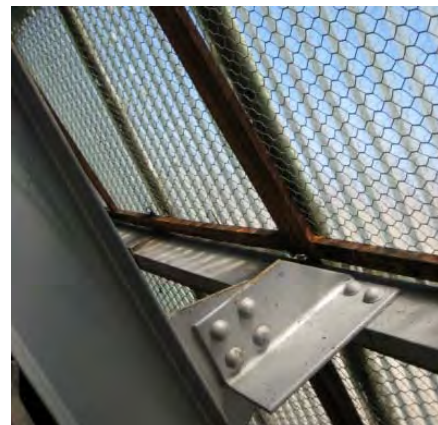
Figure 2.21

The corrugated windows represent one of the important features contributing to the historic value of the exterior of the hangar. Chicken wire panels with wooden frames have been installed at the interior of the windows (see figure 2.21) in isolated locations in order to minimize the potential for broken pieces of the glass to fall to the hangar floor below.

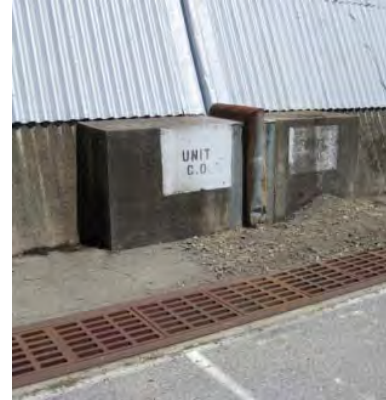
Figure 2.28

occur while keeping moisture from getting inside the hangar. The expansion joints continue across the concrete foundation walls at the base of the hangar exterior (see figure 2.28). The expansion joints augment the thermal expansion capabilities of the metal panel bolt/clip system, which were designed to flex with the movement of the panels.

The expansion joints are in relatively good condition. At the metal siding areas the joint covers have received minor denting. These joint covers have received the various coatings over time and do not have any visible corrosion or deterioration. The metal covers at the concrete base have received more damage over time and are dented and rusted. They will require replacement as part of any future rehabilitation of the hangar exterior.

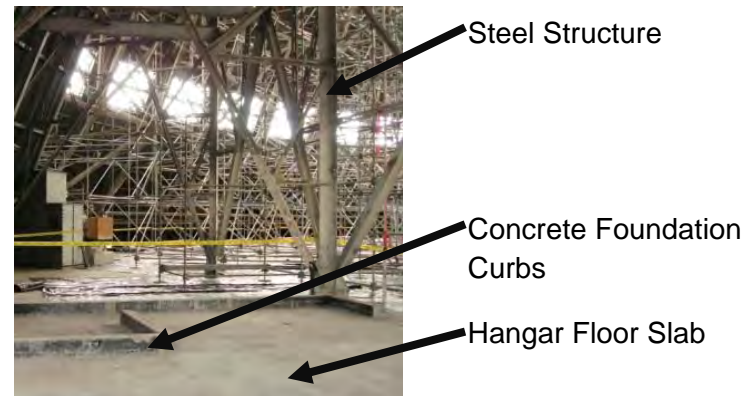
Figure 2.32

Based on interior construction and structures that were added for the various occupants of the hangar there are concrete foundation curbs at various locations in the hangar (see figure 2.32). The removal of these curbs is not presently part of the Navy removal action but the curbs would have to be removed as part of any future improvements. Refer also to the structural condition assessment for additional concrete slab information. Two locations of concrete slab within the hangar have been noted during the Navy removal action where the concrete is deteriorating. One location existed prior to the removal action. A third area within the hangar was identified as a potential void space beneath the concrete slab that may have been created during a water main break. The water main break was repaired by NASA and occurred prior to the removal action.

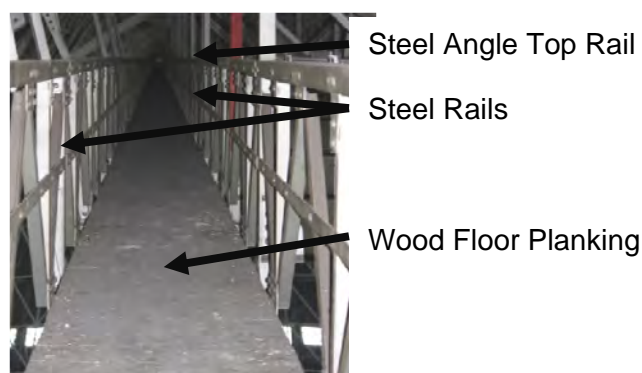
Figure 2.33

A series of stairs, ladders and catwalks provides access between the hangar ground floor and the upper portion of the hangar interior, including access to the outer portions of the roof. The current configuration of railings, specifically the height and/or shape of railings does not comply with OSHA requirements. The stair railings are

As part of the ongoing Navy removal action the wood floor planking of the catwalks is being removed as it has absorbed contaminants. The steel components will be left in place and future use will dictate the replacement requirements.

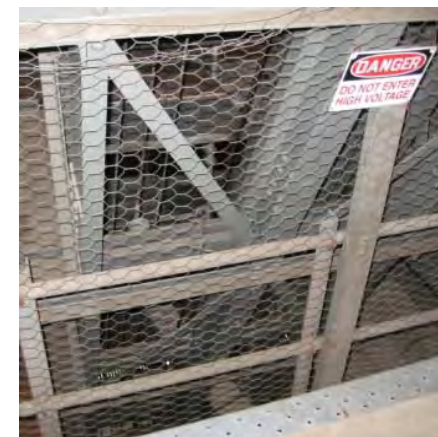
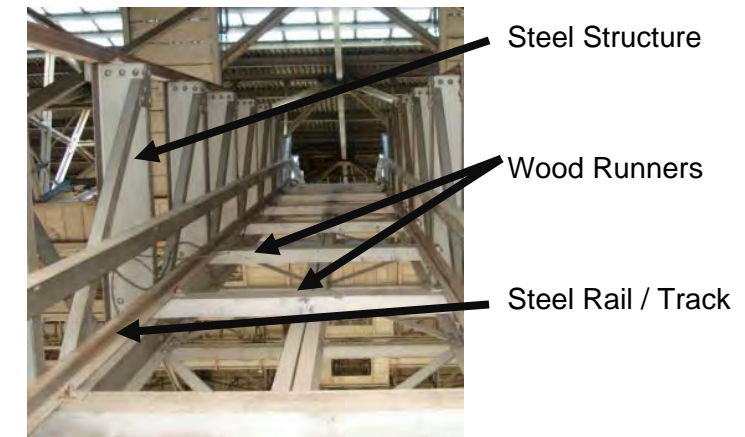
The steel elevator rails are welded to steel angles which are in turn welded to the steel hangar superstructure. There are wood runners spaced periodically (see figures 2.34 and 2.35) that have similar contaminants as the metal panels. These wood runners are being removed as a part of the ongoing Navy removal action. An engineering analysis by Will Design in April 2011 has verified that removal of these wood runners would not adversely impact the steel rail connection to the hangar structure from a vertical load standpoint.

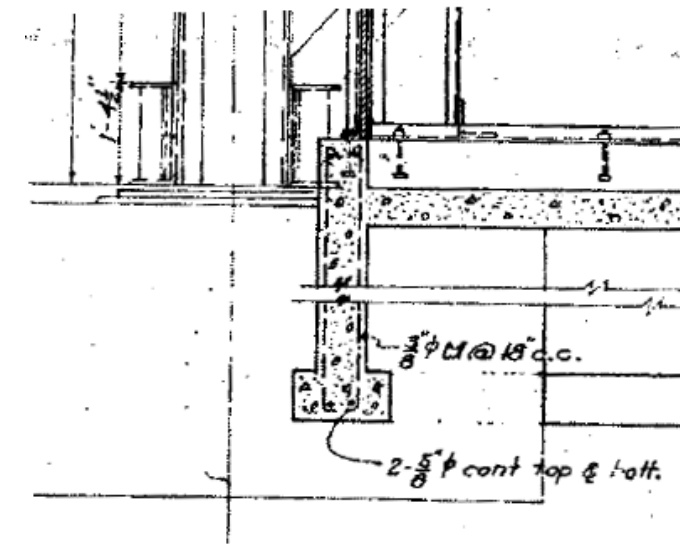
Figure 3-19: Original Interior Room Foundation: Reference Drawing M4-0001-S58

There were multiple structures that were added to the interior of the hangar throughout its life. The typical interior structure foundation is a cast in place concrete curb doweled into the slab on grade (see figure 3-19). The buildings have been removed as part of the Navy's removal action, but the concrete curbs remain in place. The removal of the buildings does not affect the hangar's structural integrity.

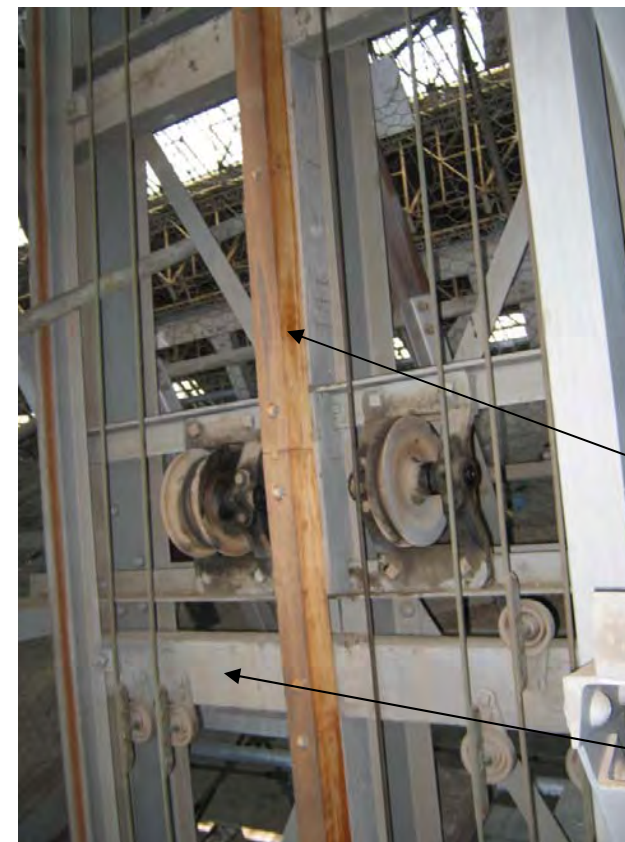
The elevator system uses redwood ties to support the rails and a redwood center rail that apparently guides the elevator cab. The wood members at the elevators would need to be replaced if the elevators are to be made functional again.

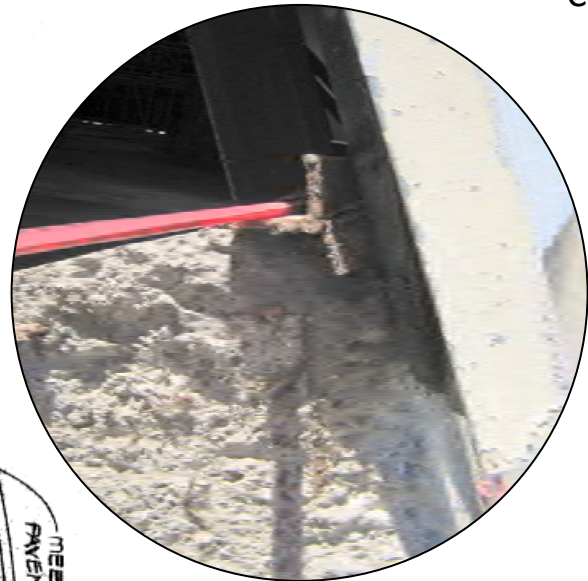
Figure 3-27: Saw Cut Concrete Wall at New Opening in Hangar

The concrete perimeter walls also appear to be in good condition. No concrete decay was noted during the site visit. The new doors in the hangar wall were saw cut through the concrete. The saw cut portion may need to be replaced for historical reasons.

The one tall new opening in the east side of the hangar will need to be repaired. At this location, a wind girt was completely severed to accommodate the new opening. That wind girt will need to be replaced with a modern steel member similar to the original member. The location of the girt is shown in Figure 3-27. The figure shows the steel member at the top of concrete wall which was cut and will need to be replaced. The girt is directly above the opening shown in the figure.

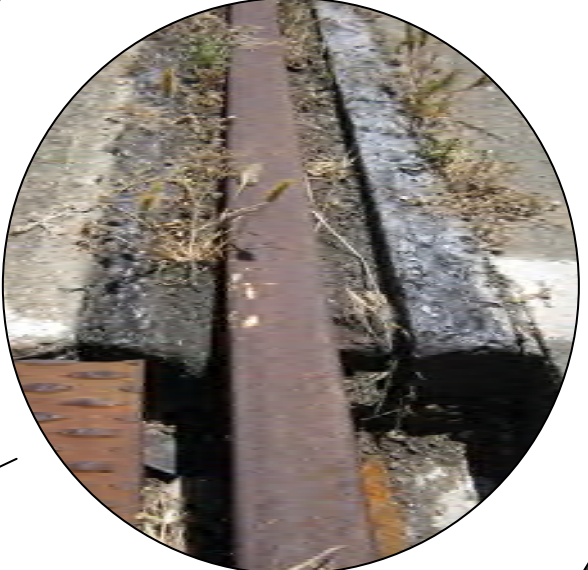
Figure 3-29: Railroad Tracks

There are railroad tracks down the center of the hangar as well as along the sides of the hangar and around the ends of the hangar doors. The railroad tracks at the hangar doors are surrounded by a contaminated material which will be removed as part of the Navy’s removal action. The railroad tracks at the center of the hangar are surrounded by an asphalt material which will be left in place.

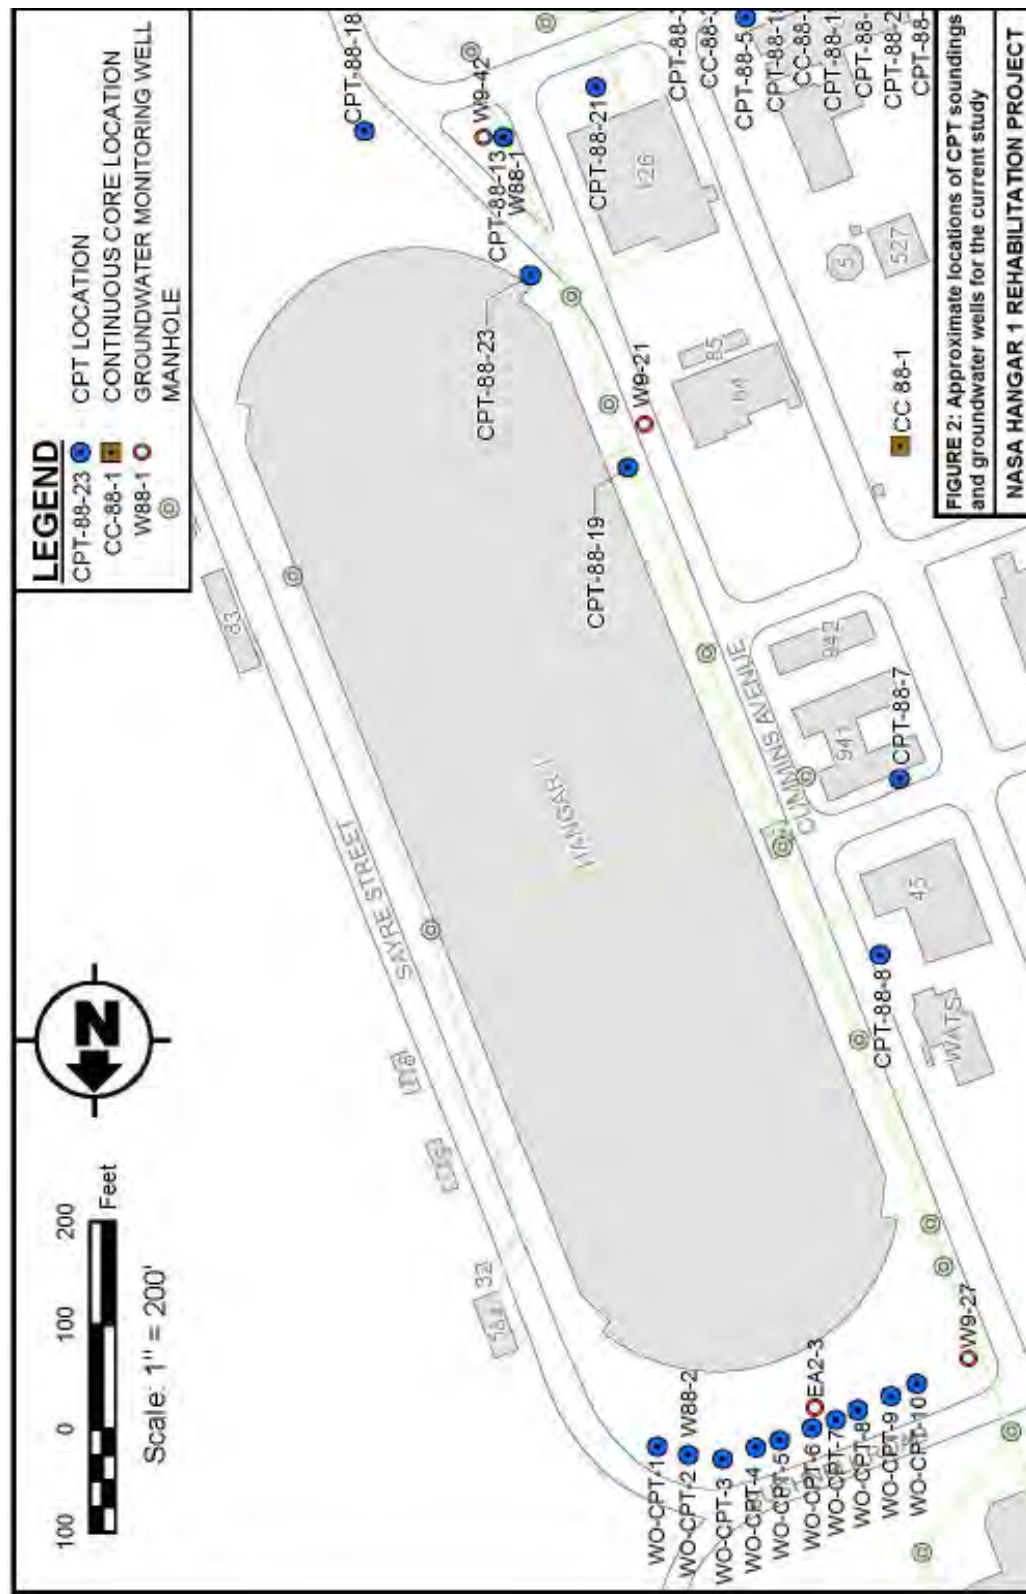
FIGURE 5-2 APPROXIMATE LOCATIONS OF CPT SOUNDINGS AND GROUNDWATER WELLS FOR THE CURRENT STUDY

The majority of the soil investigations was conducted using Cone Penetration Test (CPT) soundings that were pushed along the western and northern sides of the building. Several groundwater monitoring wells were also installed in these areas, as part of the groundwater contamination studies performed for the adjacent facilities. Figure 5-2 shows the approximate locations of some of these CPT soundings and wells, and Attachment A presents the logs.

No subsurface information was made available to us at the time of this study for areas inside and along the eastern side of the building. We assume that similar subsurface conditions are present throughout the building site. Because the soil and groundwater conditions were interpreted using limited data and only to the maximum depth explored, subsurface conditions between borings/soundings may differ significantly from those shown on the logs.

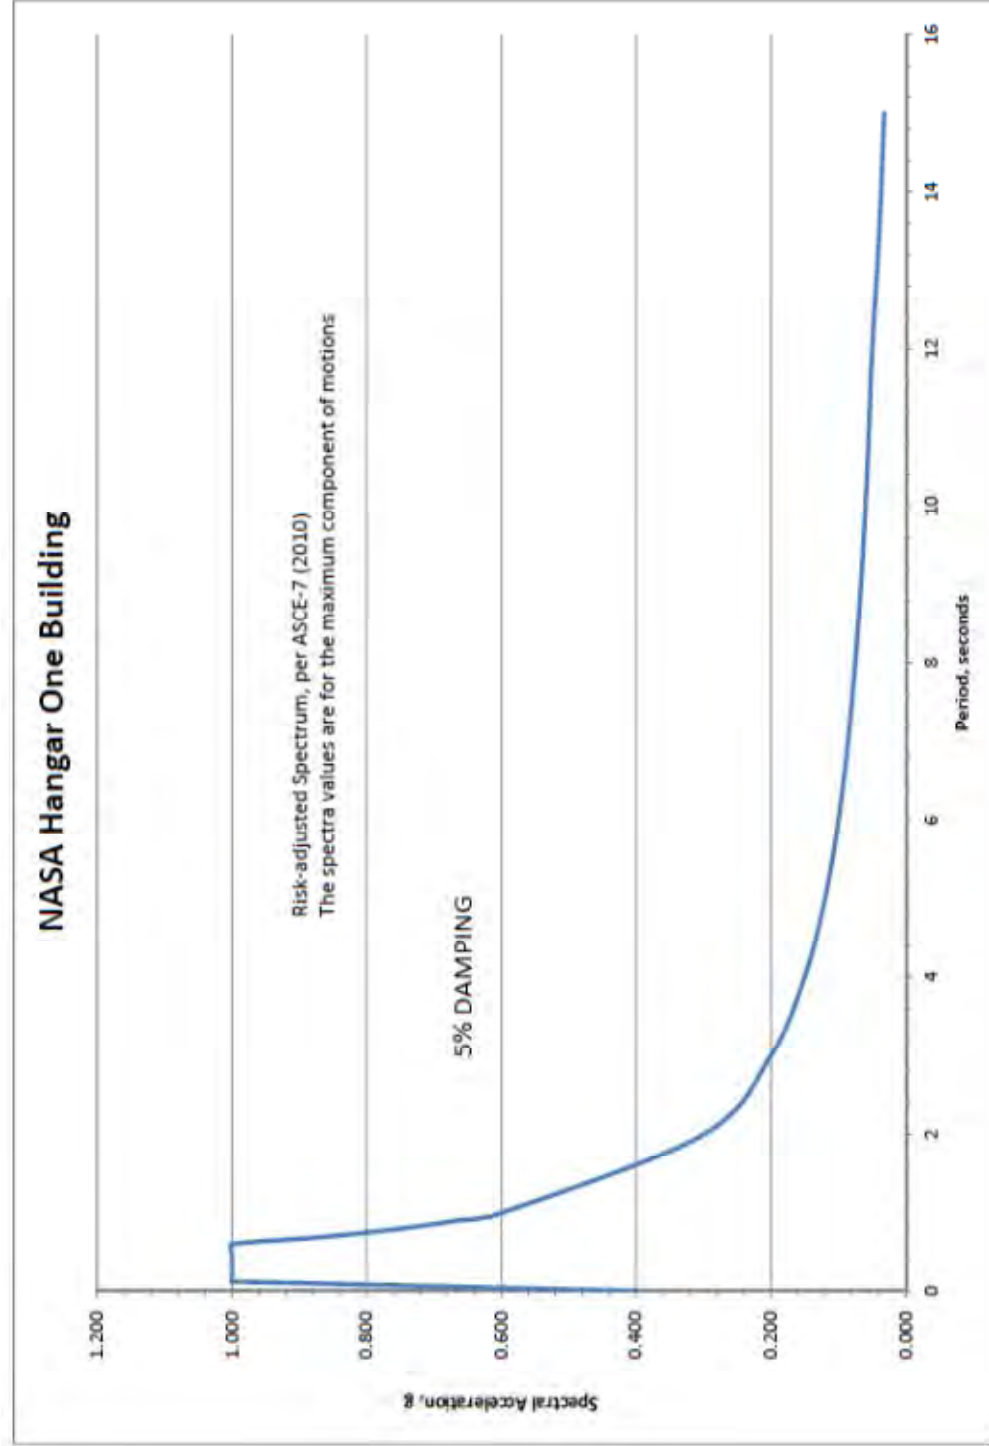
FIGURE 5-3
5%-damped Acceleration Response Spectrum (ASCE-7, 2010)

CH2M HILL reviewed these new standards, and estimated the design seismic parameters using their seismic requirements. Figures 5-3 and 5-4 show the 5%-damped ARS curves developed in accordance with the 2010 ASCE-7 and 2008 USGS seismic data. For the 2008 USGS data, ground motions associated with the following return periods were developed: 72 years, 224 years, 475 years and 2,475 years (corresponding to 50%, 20%, 10% and 2% probabilities of being exceeded in 50 years, respectively). Because the building is located at about 14.5 km from the San Andreas Fault, the near-fault effects on long-period motions (periods greater than 0.5 seconds) were included in the figures for considerations.

Note that the ARS curves and PGA values developed above are for a Seismic Site Class D (a stiff soil site), with an average shear-wave velocity in the upper 100 feet of the site soils of 275 m/sec (or 900 feet/sec). As discussed in Section 5D below, the cohesionless soil underlying the hangar site is susceptible to liquefaction under the design earthquakes. Per the building codes, a site with liquefiable soil should be classified as Seismic Site Class F for ground motion characterization. Furthermore, the codes

require that a site-specific response analysis be performed for Site Class F to evaluate the effects of liquefied soil on earthquake ground motion. However, if the liquefiable soil is mitigated, as recommended in Section 5D.4 below, the site can be classified as Seismic Site Class D; a Site Class for which the seismic design parameters presented herein have been developed for. Failure to mitigate soil liquefaction will result in different seismic design parameters than those presented in this section.

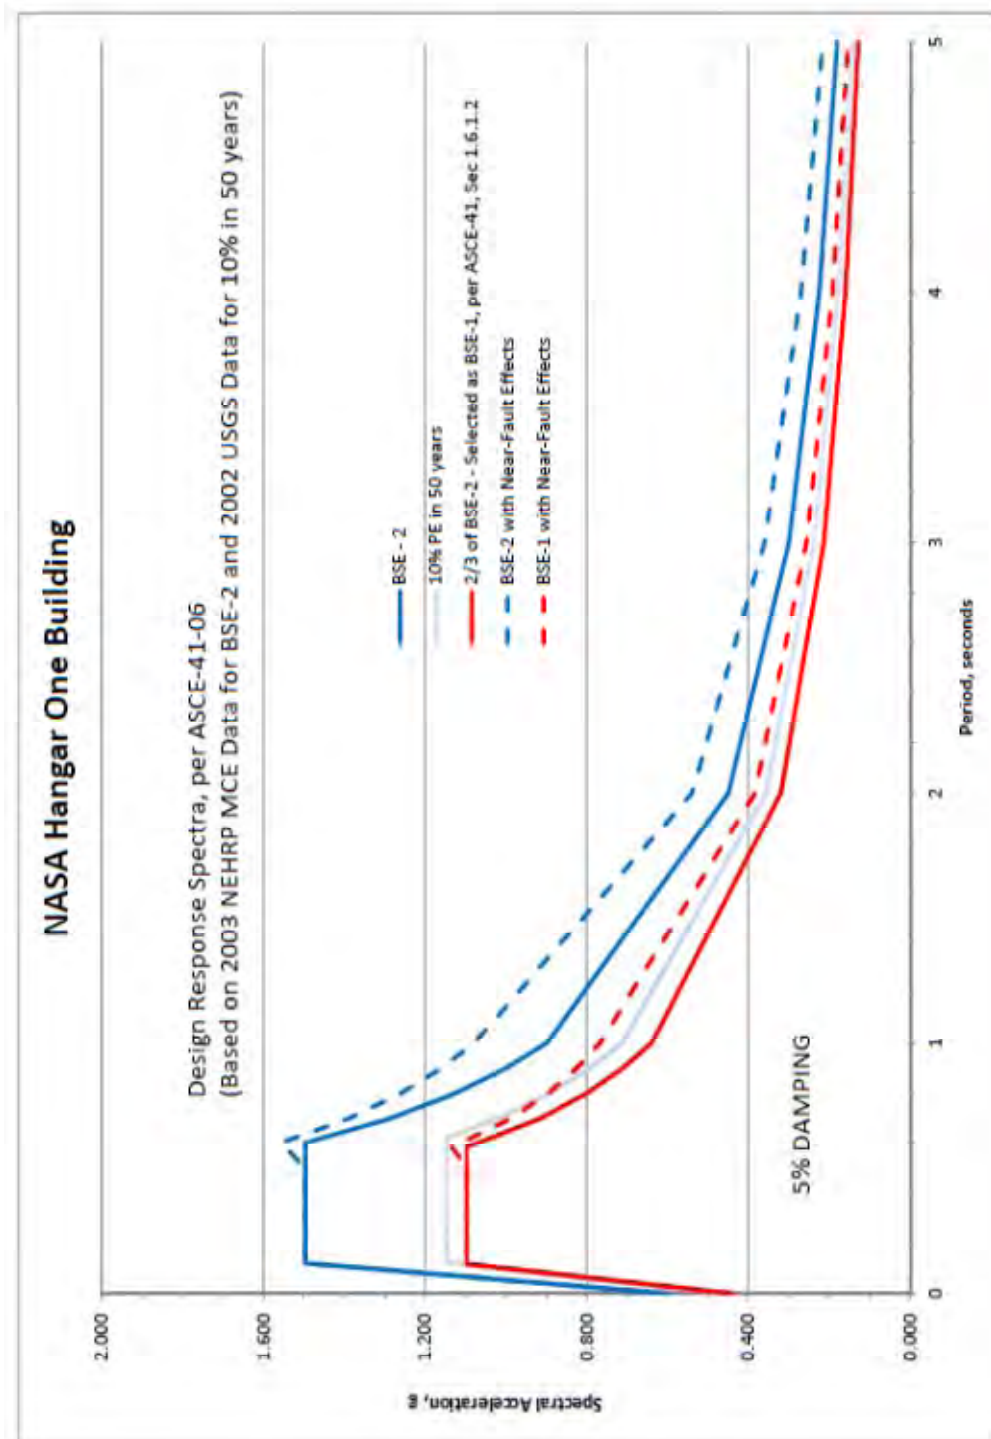
Figure 5-5
5%-damped Acceleration Response Spectrum (ASCE-41-06)

We understand that the current study also considers the ASCE-41 (2006) as the basis for the structural analysis. This standard considers two level design earthquakes (BSE-1 and BSE-2 earthquakes) for structural performance evaluation during earthquakes. Figure 5-5 presents the calculated 5%-damped BSE-1 and BSE-2ARS curves developed using the guidelines of ASCE-41 (2006).

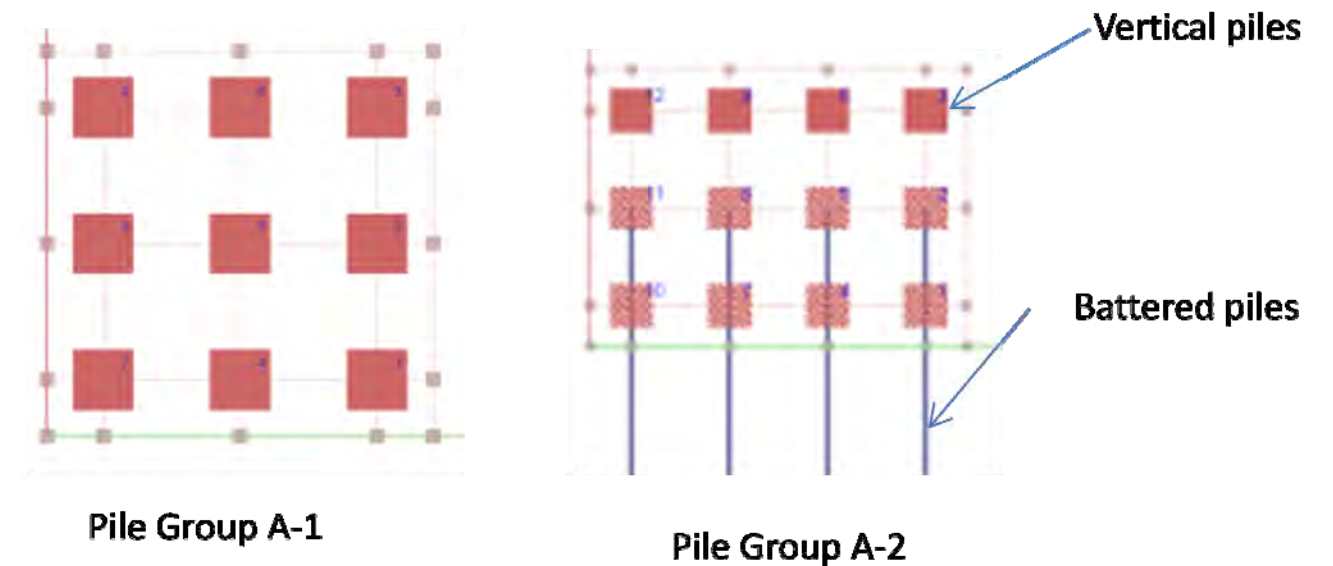
FIGURE 5-6 SCHEMATIC DRAWINGS OF PILE GROUPS A-1 AND A-2

For this study, we developed the relations for the two pile groups that support Arch #6: Pile Groups A-1 and A-2. Pile Group A-1 is an 8.5-feet by 8.5-feet, 4-foot thick, square pile cap supported by 9 vertical piles. Pile Group A-2 consists of an 8.5-feet by 11.5-ft, 4 feet thick, rectangular pile cap supported by 4 vertical piles and 8 battered piles. Figure 5-6 shows the schematic drawings of these two pile groups.

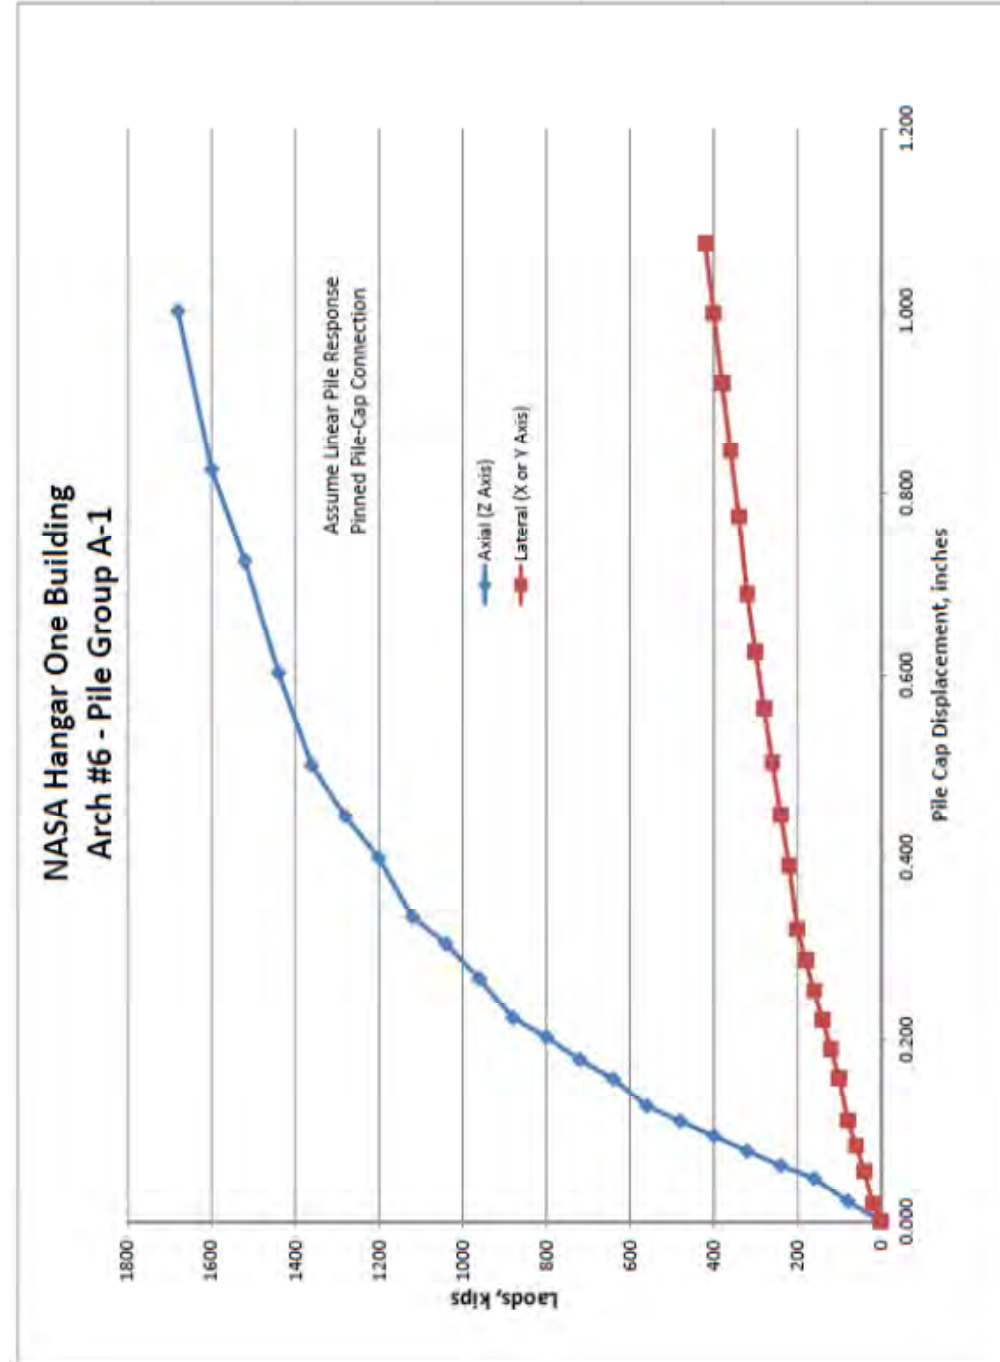
FIGURE 5-7
Load-Displacement Relationship for Pile Group A-1 (Axial and Lateral Axis)
(x-axis: building's transverse direction, y-axis: building's longitudinal direction)

We used the computer programs FB-Multiplier (version 4, Florida Bridge Software Institute, 2000) to calculate the load-displacement relationships of a pile group. In the analysis, the pile and pile cap elastic cross sectional properties were used, the loads were applied individually (separately) in each direction, and a pile-to-pile cap pinned connection was assumed. Figures 5-7 through 5-10 depict the calculated load-displacement relationships of these two pile groups.

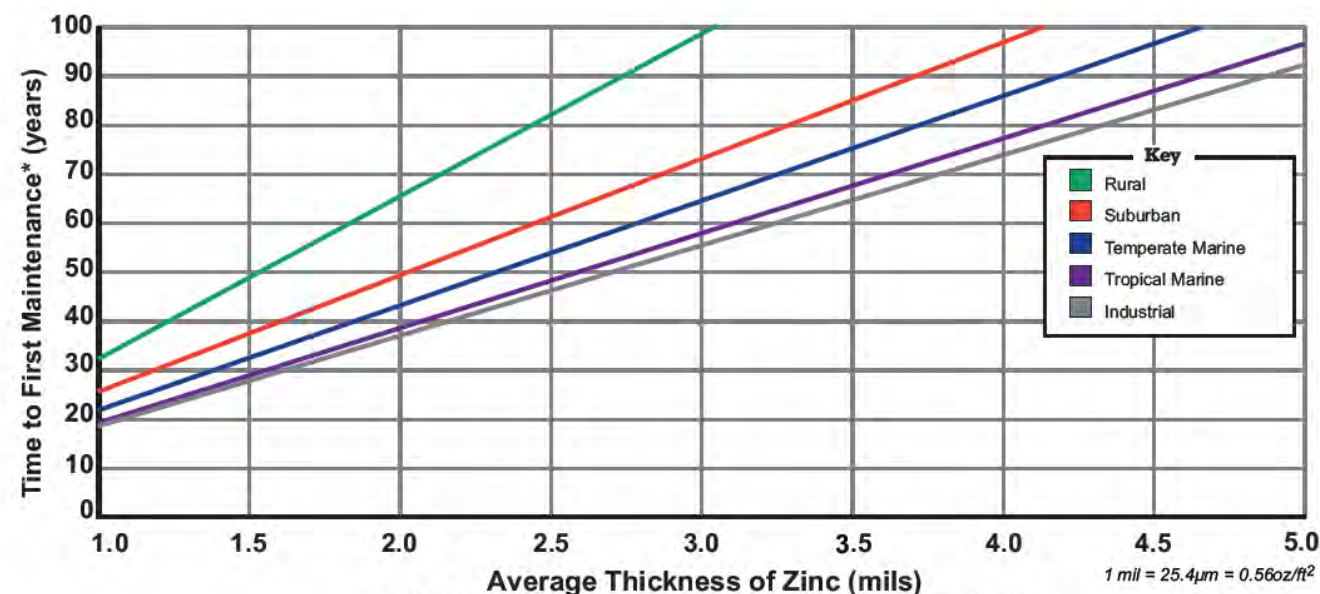
Figure 6.6

Attachment using the j-clip fasteners will allow for potential thermal expansion and contraction resulting in abrasion of the existing protective coating at the existing C channel sub-frame. Provide an appropriate material to either the j-clip or the channel similar to Teflon that will eliminate or minimize the potential from damage to the protective coating. This material will need to be included with the final design and engineering of the metal panel systems.

The corrugated metal panels should be galvanized with the thickest available galvanizing at the time. A survey of national steel suppliers shows a maximum available galvanizing thickness of G360 (3.24 mils thick), although the number of suppliers capable of such a thick coating is very limited. This has the potential to provide a maximum of 75 years without maintenance in a temperate marine environment such as Moffett Field (see the below figure from the American Galvanizers Association). Thinner galvanizing such as G235 (1.98 mils thick) is more readily available, but only has the potential to provide a maximum of 45 years without maintenance. Painting the steel after galvanizing may prolong the time until the steel rusts.

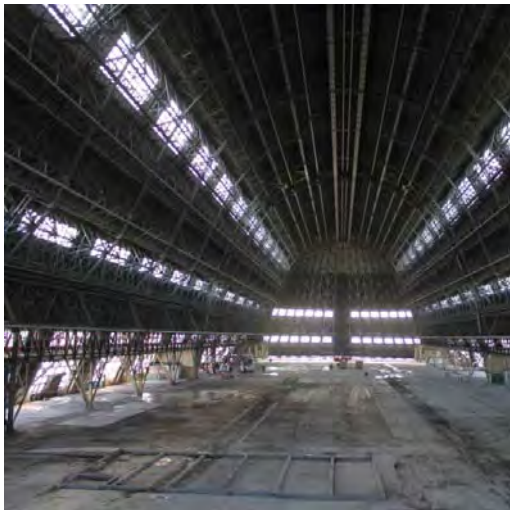
Figure 6.11

The existing hangar floor slab is less than ideally smooth. It is rough, and uneven in various locations that will make it an area of future modifications, depending on future tenants requirements. The floor slab also contains multiple locations of existing concrete curbs that served as foundations for previous interior construction that has since been removed from the facility as part of the Navy demolition contract. These curbs will require future removal to facilitate re-use of the interior of the hangar. There also are small areas of topping slabs that previously provided smooth floor slabs within various interior spaces. These topping slabs will likely need to be removed to meet future tenant needs. Additionally, the existing 8" deep hangar slab was originally designed for use with a 'lighter than air' aircraft. Because of this, the floor slab load capacity might not be suitable for heavy loading and traffic.

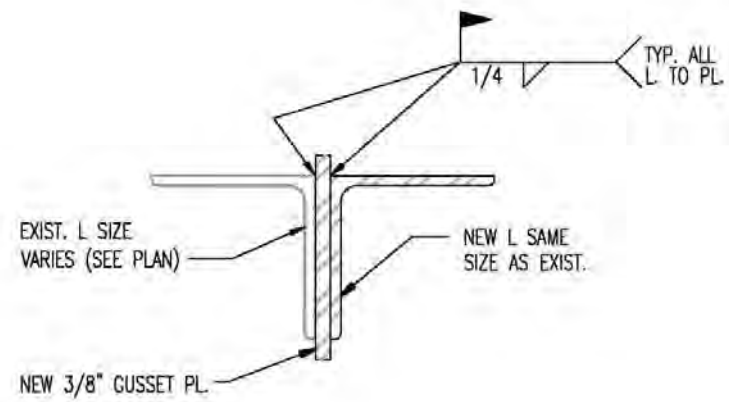
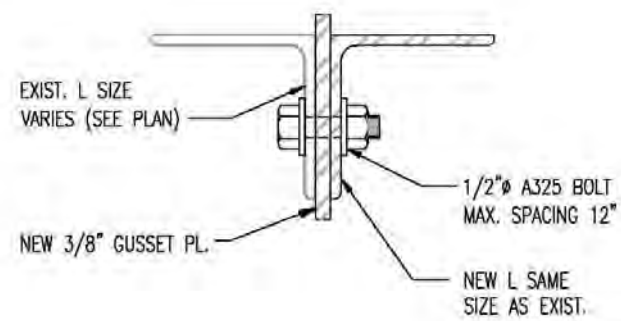
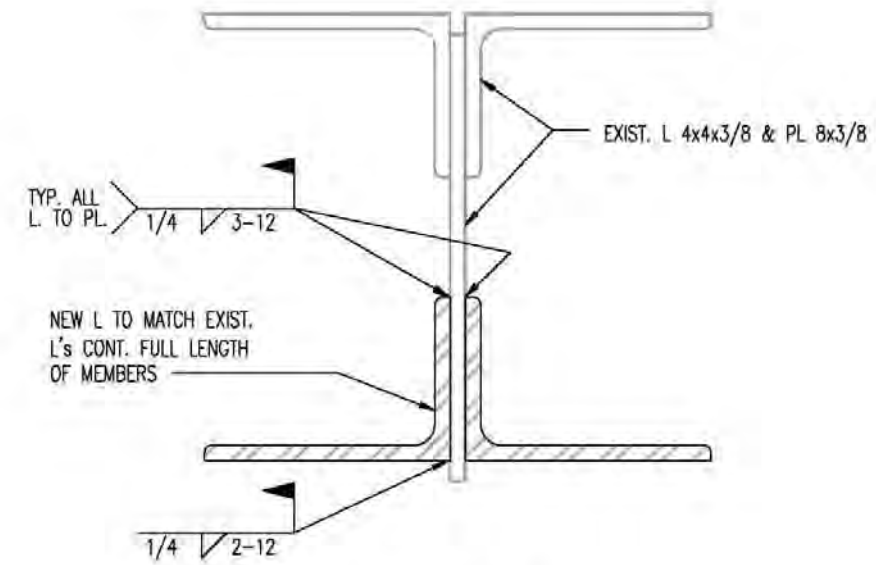
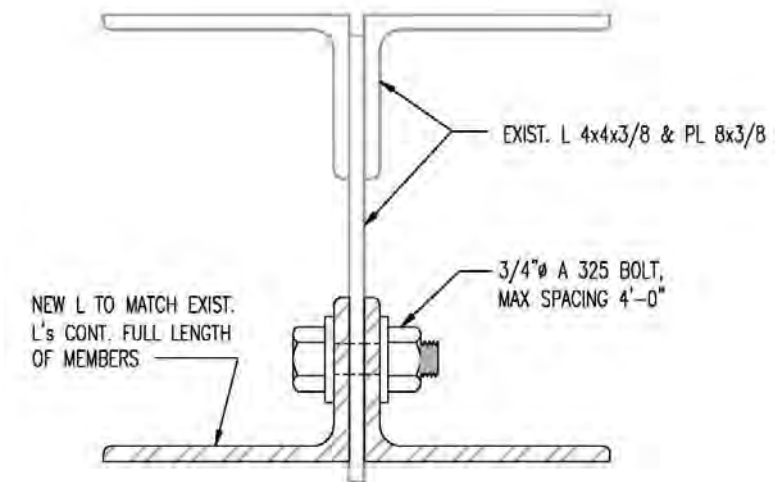
Figure 7-1 Retrofit Details

- In Type I retrofit (required mostly in bracing members), single angle members are proposed to be retrofitted by providing another angle of the same size angle and a gusset plate between the two angles as shown in Figure 7-1.
- Type II (Not Used)
- In Type III retrofits (required mostly in A frame members), two single angles in + configuration with a gusset plate between them are proposed to be supplemented with two more smaller single angles as shown in Figure 7-2.
- Type IV retrofit involves a double channel built-up section with an “I” beam in the middle. This section is mostly found in arch members. The section is proposed to be retrofitted by providing channel sections on each side of the “I” beam web and bolting them together as shown in Figure 7-2.

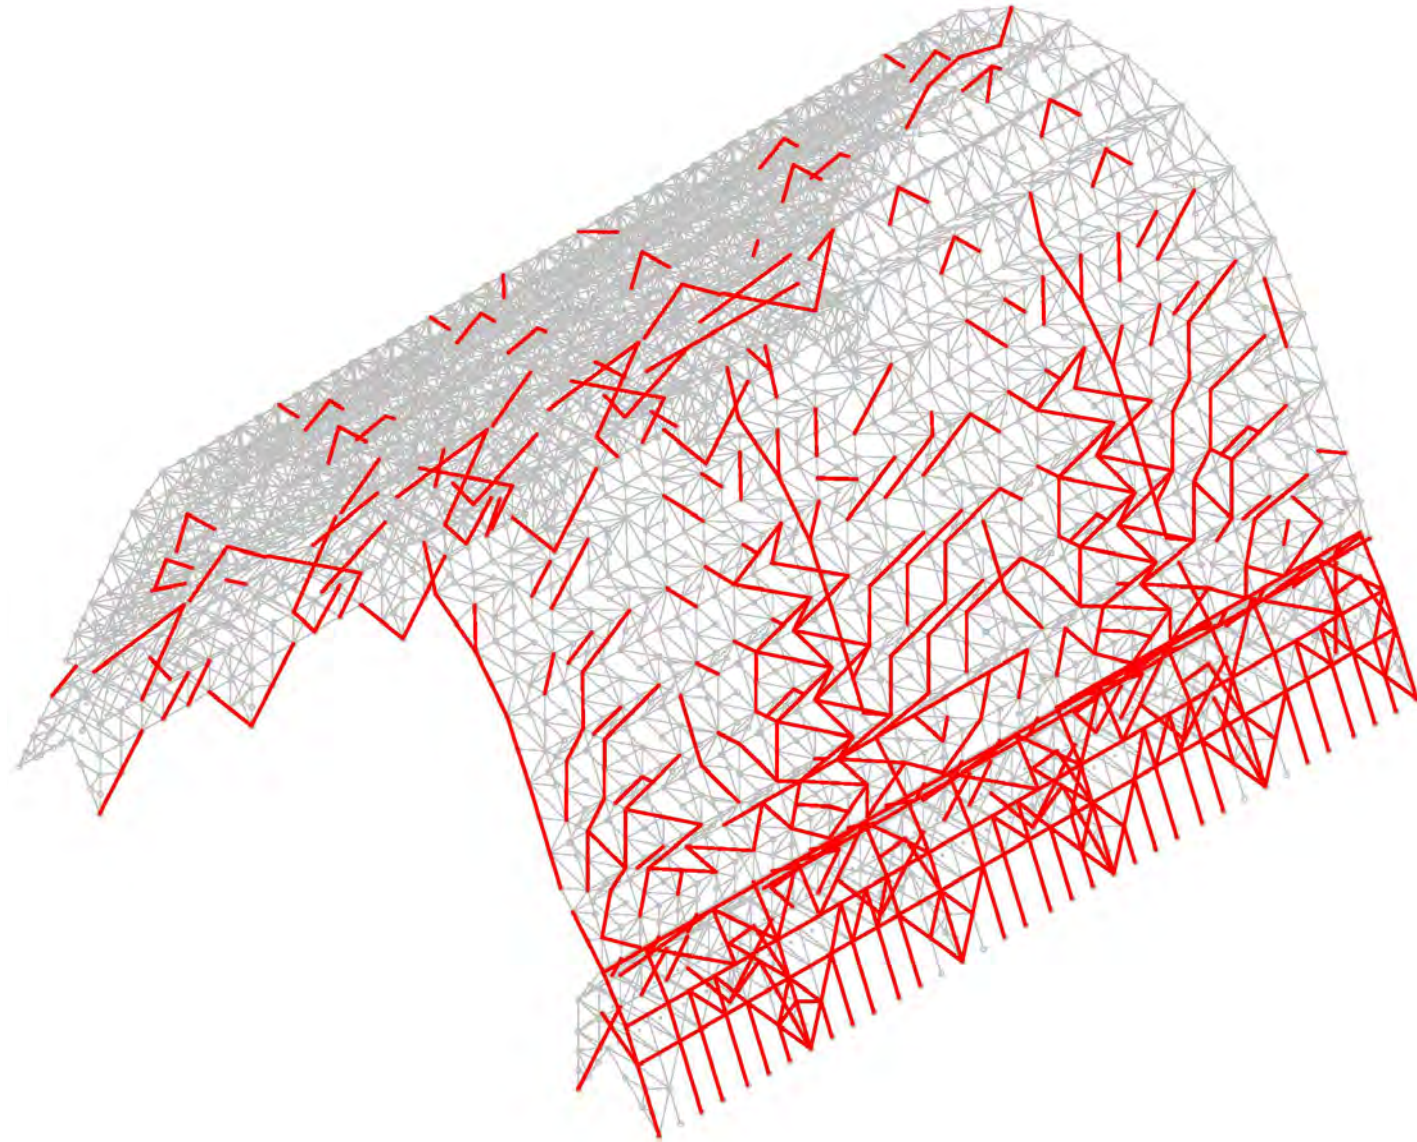
Figure 7-3

Overstressed members considering an assumed differential settlement. Note: The differential settlement is for comparison purposes only.

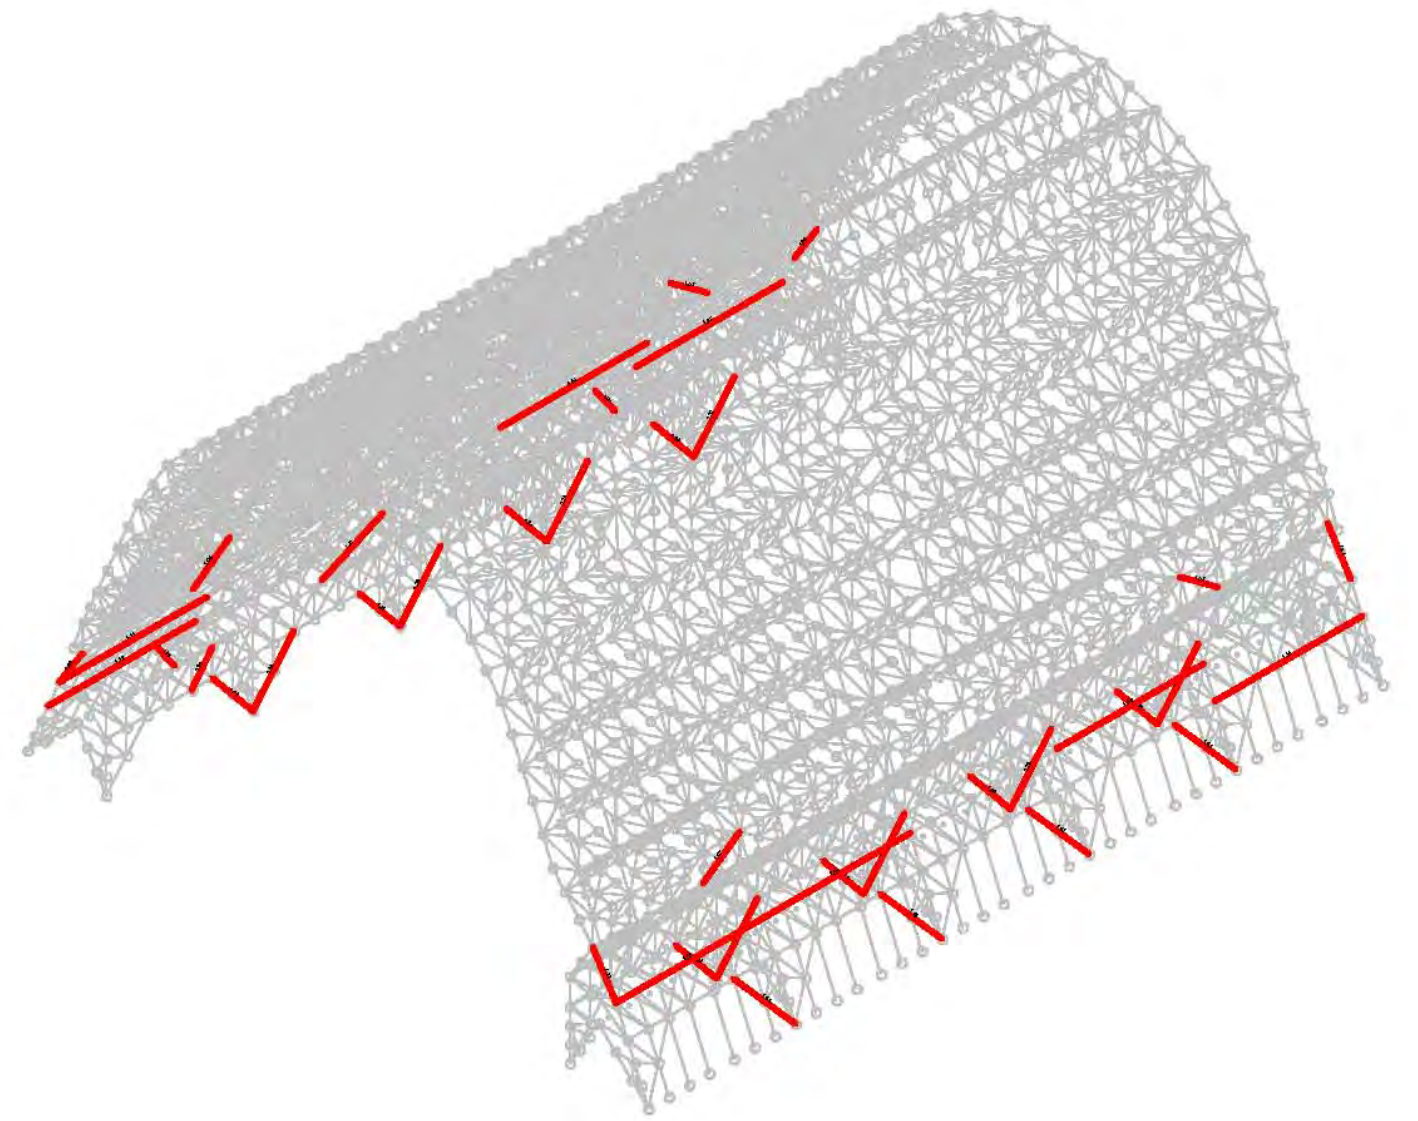
Overstressed members considering only lateral seismic forces without differential settlement.
