Condition Assessment and Rehabilitation Plan Hangar One

for NASA Headquarters and
Ames Research Center, California

Volume 1
Condition Assessment

Hangar One – Ames Research Center, Moffett Field, CA

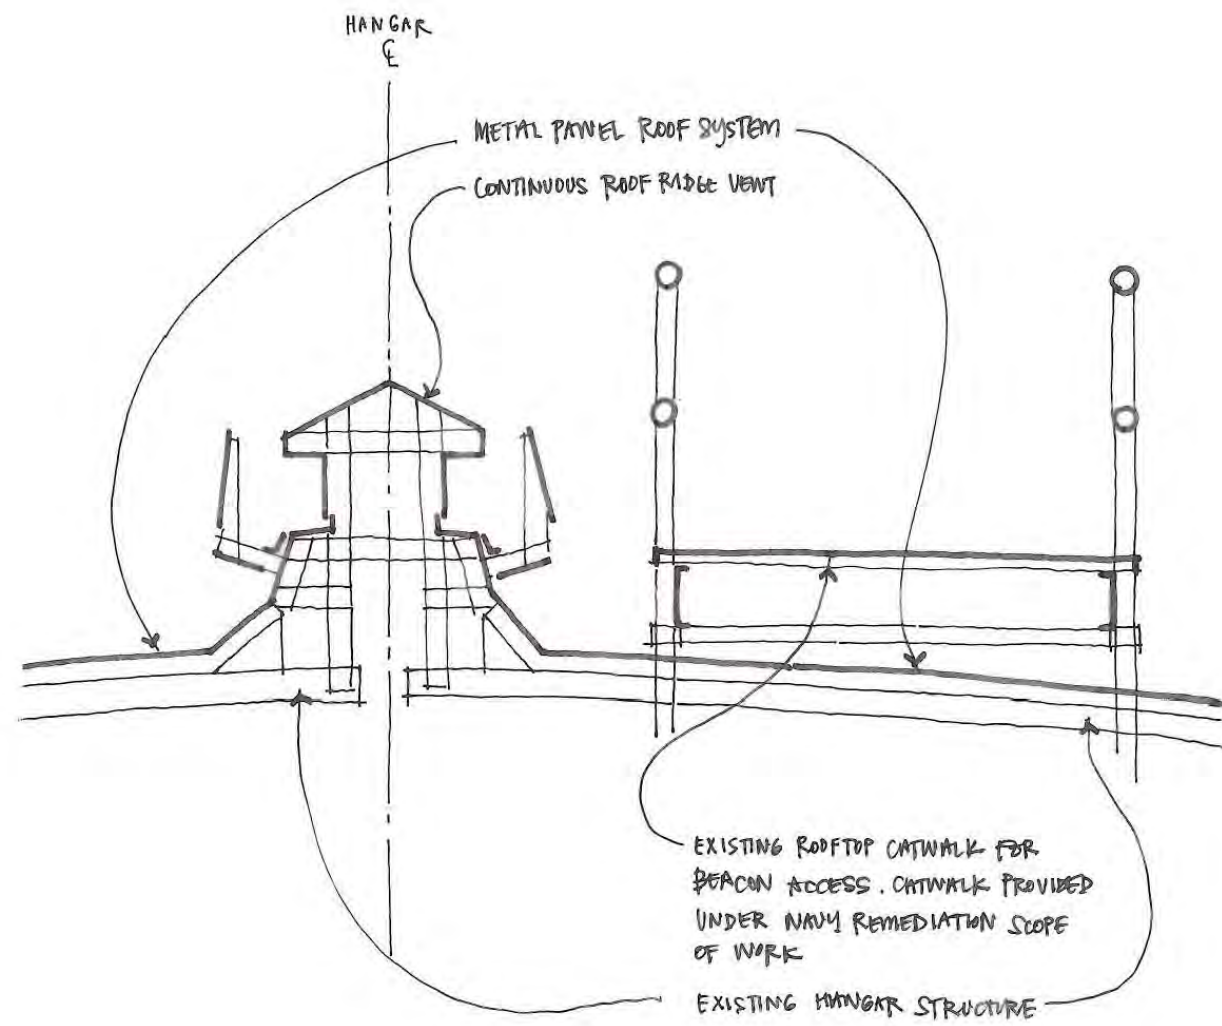
ROOF WALKWAY & RIDGE VENT
CONCEPTUAL DETAIL SKETCH

There is an existing continuous roof vent (refer to sheet 7.67 of the AECOM As-Built Drawings, included as Appendix K) and roof access catwalk that run the length of the hangar at the roof. The ridge vent shall be replaced completely to match the overall visual appearance of the original construction detailing with

mechanical modifications for ventilation as discussed in section 8.0 Mechanical and Plumbing Systems for more detailed requirements. Refer also to section 12.C Installation Diagrams and Conceptual Details for conceptual detail requirements. As originally designed and constructed the ridge vent was intended to help mitigate vapor condensation from occurring in the ceiling of the hangar. The roof access catwalk has been partially replaced and updated as part of the Navy's removal action scope of work. This catwalk provides access to the beacon obstruction lights on the hangar roof. An OSHA upgrade to the railing height has not been provided by the Navy.

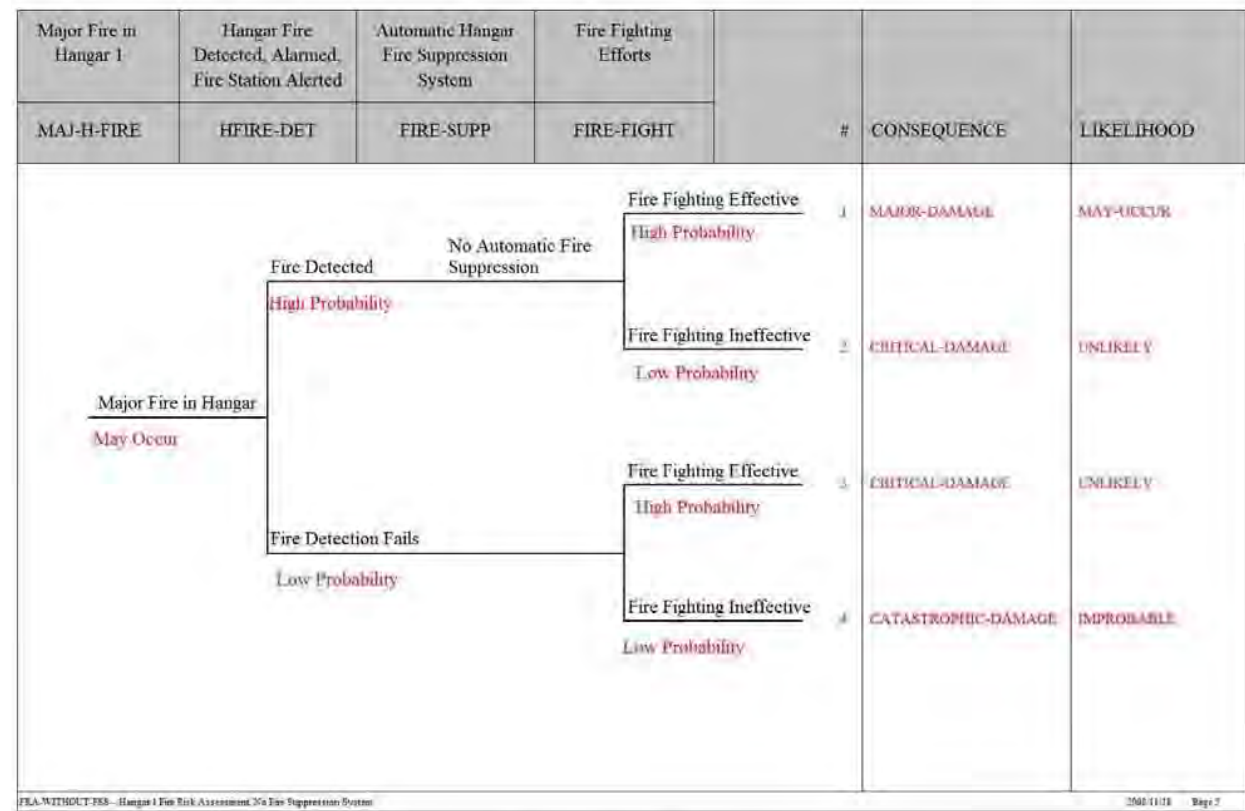
Figure 3: Event Tree for Fire Risk in Hangar 1 *without* any Special Hazard Fire Suppression System

The event tree in Figure 3 represents event sequences that could lead to fire damage in Hangar 1 and whose worst-case likelihood of occurrence has been judged to be as: “May Occur” in the life of the hangar.

The first event branch that then occurs is fire detection. It was judged that there is a high probability that a major fire in the hangar would be successfully detected by the new fire detection/alarm system, conversely it was judged that there is a low probability that fire detection would fail.

No branching occurs at the second branch since there is no Special Hazard Fire Suppression System.

At the third branch: if the fire is detected the alarm is set-off and the NASA/Ames Emergency Dispatch Center is notified. Since the NASA/Ames fire station is very close to Hangar 1, the response - *if* NASA/Ames Fire Department resources are in quarters and not assigned to another emergency incident - should be immediate and the team assessed that fire fighting should be effective (event sequence #1, Figure 3) with a high probability occurrence; and only with a low probability that fire fighting be ineffective (event sequence #2, Figure 3).

A major fire occurrence with effective firefighting (event sequence #1, Figure 3) was assessed to result in “Major damage” as a consequence with likelihood that it “May Occur” in the life of the hangar. A major fire with ineffective firefighting (event sequence #2, Figure 3) was assessed to result in “Critical Damage” as a consequence with a likelihood of “Unlikely” to occur in the life of the hangar. If the fire is not detected automatically, it eventually will get detected by personnel and the fire station notified. However, the notification is relatively late in this case (as compared to when the fire is automatically detected and the fire station is automatically notified). So in this case late effective firefighting results in “Critical Damage” (event sequence #3, Figure 3). Otherwise ineffective firefighting (event sequence #4, Figure 3) would result in “Catastrophic Damage” to hangar, which was judged to have an “Improbable” likelihood of occurrence in the life of the hangar.

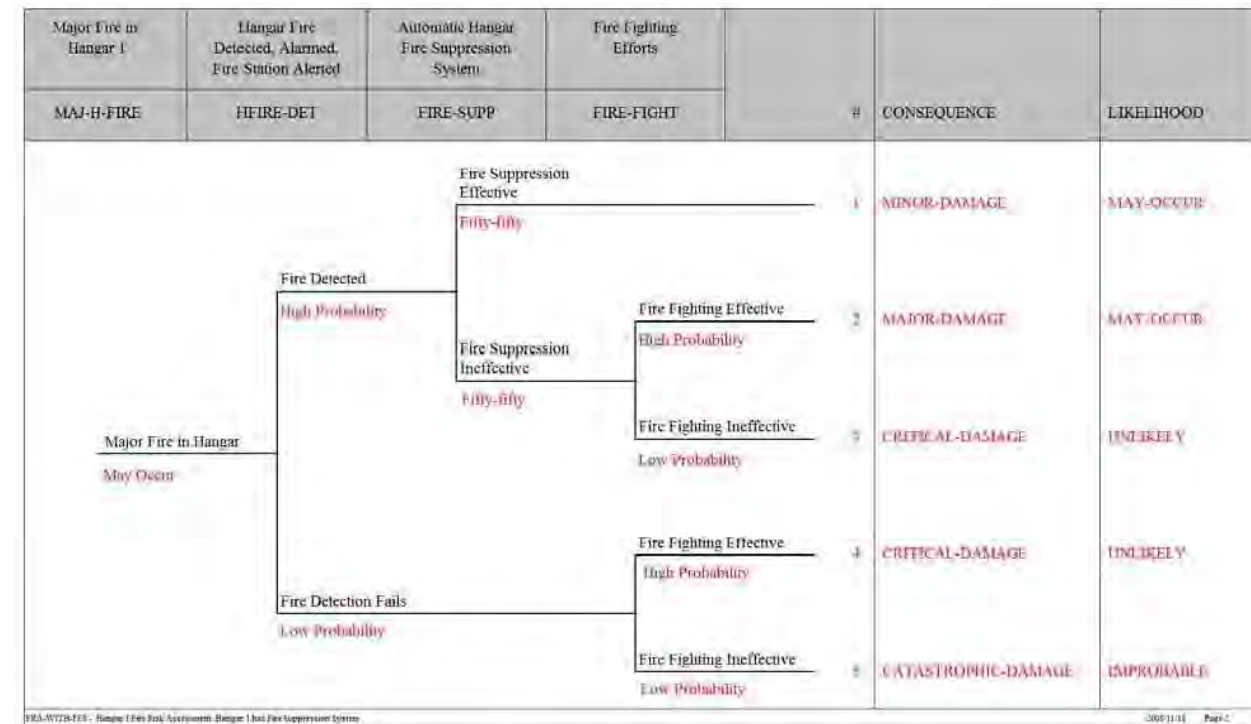
Figure 5: Event Tree for Fire Risk in Hangar 1 with a Special Hazard Fire Suppression System

The initiating event (a major fire in hangar) in this *-with* Special Hazard Fire Suppression System event tree (Figure 5) represents the same initiating event used in the previous *-without* Special Hazard Fire Suppression System event tree (Figure 3). For the initial sequence fault trees were developed for this initiating event where three basic events must occur to trigger the initiating event: the presence of flammable material, an ignition source, and local fire fighting to be ineffective) for a major fire in the hangar. Each of these basic events is either “Likely” or “Probable” to occur, but the combination of the three is assessed to have a likelihood of “May Occur”.

The first event branch that then occurs is fire detection. As in the previous event tree sequence, there is a high probability that a major fire will be detected by the detection/alarm system, and a low probability that the system will fail to detect a major fire.

The next event branch is different in the two event trees because of inclusion of the Special Hazard Fire Suppression System. In this event branch if the fire suppression system is effective (event sequence #1, Figure 5), it results in “Minor Damage” to the hangar with a “May Occur” likelihood of occurrence in the life of the hangar.

If the fire suppression system is not effective, firefighting efforts (event sequence #2, Figure 5) were judged to have a high probability of limiting the fire damage, since the NASA/Ames fire station is adjacent to Hangar 1 and can react immediately *if* NASA/Ames Fire Department resources are in quarters and not assigned to another emergency incident. Event sequences 2 and 3 are assessed to have “Major damage” and “Critical damage,” respectively — just like the previous event tree in Figure 3. These event sequences also occur with the same likelihood, the reason being that the probabilities are reduced by a factor of two but not by an order of magnitude. When fire is not detected automatically, the accident sequences are identical to earlier event tree for hangar fire risk *without* the Special Hazard Fire Suppression System in Figure 3.

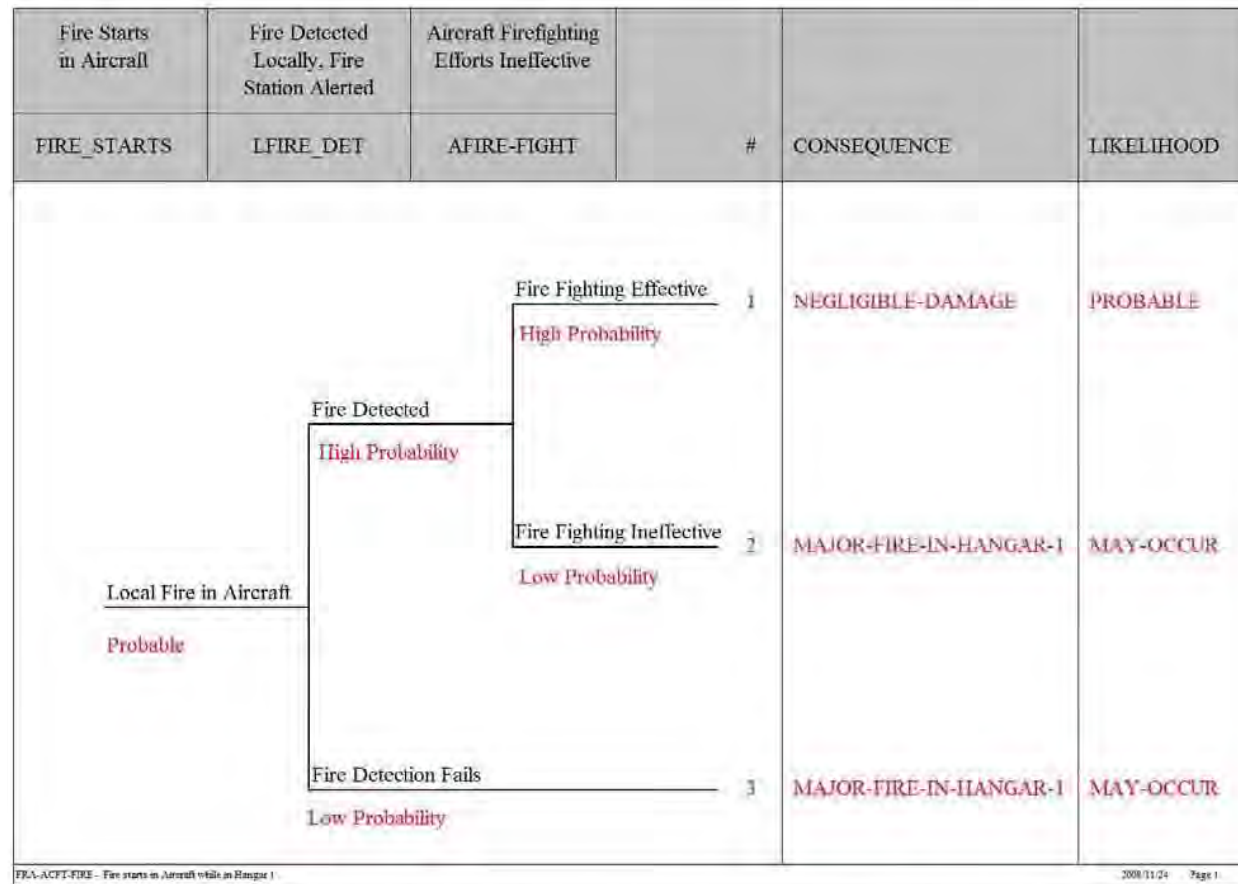
Figure 8: Event Tree for Aircraft Initiated New Hangar 1 Fire Risk

This section assesses the aircraft initiated risk of a “Major fire in Hangar 1.” The event tree is shown in Figure 8.

The initiating event is that a local fire starts in an aircraft that is stored in the hangar. This is assessed to be “Probable” in the life of the hangar. Local fire detection occurs with a high probability. When detected, the NASA/Ames Emergency Dispatch Center is alerted. If the local fire fighting is effective, it results in sequence #1 with a “Minor Damage” consequence and a “Probable” likelihood in the life of the hangar. Event sequence #1 occurs whether or not there is a Special Hazard Fire Suppression System and this risk is shown in the risk assessment matrix of Figure 1.

Event sequence #2 occurs if local fire fighting is ineffective and it results in a “Major fire in Hangar 1.” Event sequence #3 occurs if the fire is not detected in time so that it results in a “Major fire in Hangar 1.” These two event sequences shows that an aircraft related fire initiating event can spread and become a “Major fire in Hangar 1” with a “May Occur” likelihood in the life of hangar. These sequences feed the initiating event in event trees of Figures 3 and 5. These results partly justify the likelihood assessment of “May Occur” for the initiating event in “Fire Risk in Hangar 1 *without* any Special Hazard Fire Suppression System” (Figure 3) and “Fire Risk in Hangar 1 *with* a Special Hazard Fire Suppression System” (Figure 5).

Note that the event tree of Figure 8 does not include the NASA/Ames Fire Department's effectiveness in fighting the fire — they are included in the event trees of Figures 3 and 5.

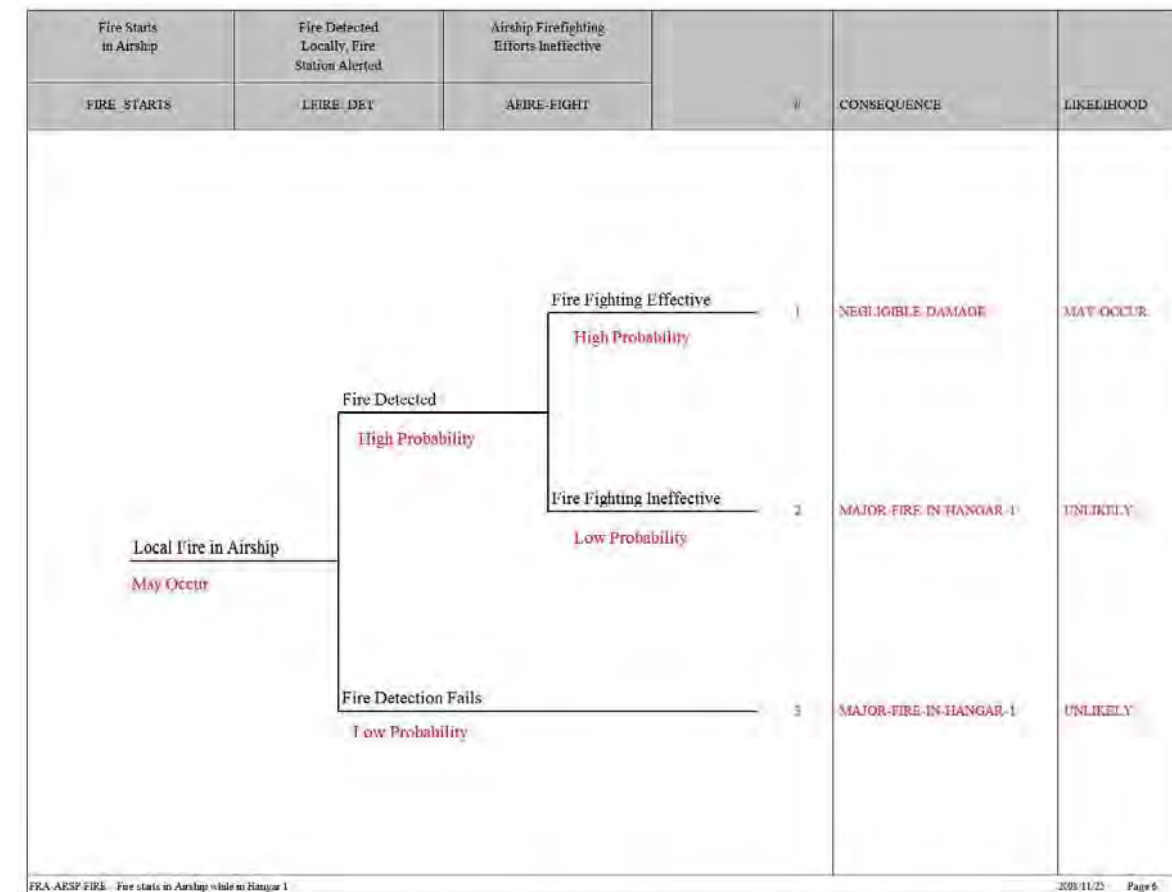
Figure 9: Event Tree for Airship Initiated New Hangar 1 Fire Risk

This section assesses an airship initiated risk of a “Major fire in Hangar 1.” The event tree is shown in Figure 9 and is similar to that of the event tree for the aircraft initiated fire (Figure 8).

The initiating event is that a local fire starts in an airship that is stored in the hangar. This is assessed to be “May Occur”. This is a lower likelihood than for the initiating event of a local fire starts in an aircraft (shown in Figure 8) which was assessed to be “Probable”. The lower likelihood is because of the smaller quantities of fuel and other flammable materials in an airship. The lower complexity of an airship is also assessed to have lower likelihood of an ignition source.

Local fire detection occurs with a high probability. When detected, the NASA/Ames Emergency Dispatch Center is alerted. If the local fire fighting is effective, it results in sequence #1 with a “Minor damage” consequence and a “May Occur” likelihood. Event sequence #1 occurs whether or not there is a Special Hazard Fire Suppression System. This risk is not shown in Figure 1 since it is lower than the similar risk from an aircraft (see Figure 8).

Event sequence #2 occurs if local fire fighting is ineffective and it results in a “Major fire in Hangar 1”. Event sequence #3 occurs if the fire is not detected in time so that it results in a “Major fire in Hangar 1”. These two event sequences show that an airship related fire initiating

event can spread and become a “Major fire in Hangar 1” with an “Unlikely” likelihood of occurrence. These sequences feed the initiating event in event trees of Figures 3 and 5. The “Unlikely” likelihood is much lower, and hence, a subset of the “May occur” likelihood for the initiating events of Figures 3 and 5. Recall from the previous section that the higher likelihood is driven by the aircraft initiated fire risk (so far).

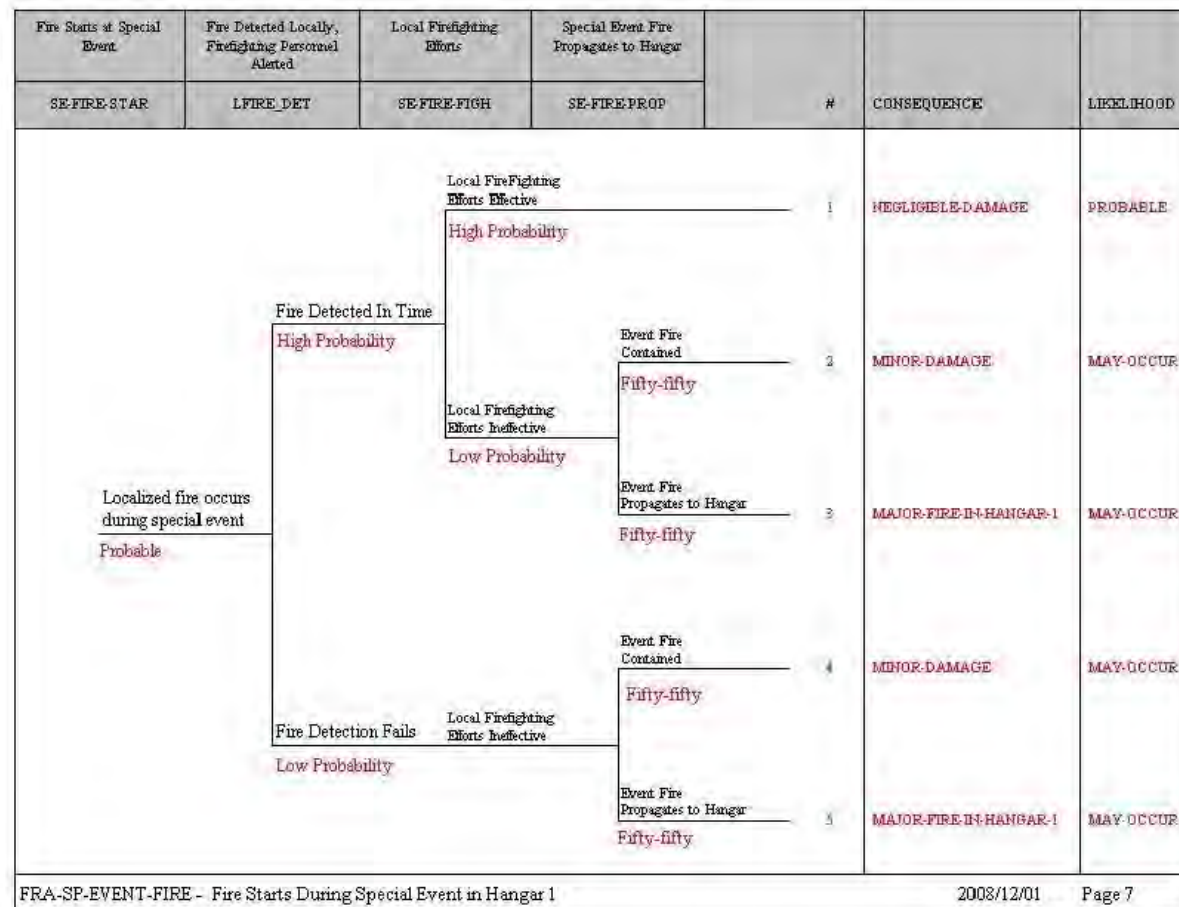
Figure 10: Event Tree for Special Event Initiated Hangar 1 Fire Risk

This section assesses the risk of a “Major fire in Hangar 1” due to special events such as public engagements. The event tree is shown in Figure 10. It is also assumed that the likelihood of fire during the construction of the Special Event infrastructure is no greater than the likelihood of a fire starting during the Special Event itself.

The initiating event of the Figure 10 event tree is that a localized small fire that occurs during the course of the special event. Due to the nature of special events, there can be multiple ignition

Local fire detection occurs with a high probability. When detected, the NASA/Ames Emergency Dispatch Center is alerted. In addition, the local personnel have access to and use the available fire suppression systems. If the local fire fighting is effective (sequence #1, Figure10), it was judged to result in a “Negligible Damage” consequence and a “Probable” likelihood in the life of the hangar.

If local firefighting is ineffective there is a chance (assessed as fifty-fifty) that the fire will not spread to the rest of the hangar (sequence #2, Figure 10). The fire may lack sufficient combustible materials, or have barriers or have separation. This scenario was judged to have a “Minor damage” consequence and a “May occur” likelihood in the life of the hangar. Conversely, if fire spreads to nearby to aircraft/airship/hangar combustible material it could result in a “Major fire in Hangar 1” (sequence #3, Figure 10). This risk of this scenario (sequence #3), could be reduced to a lower likelihood if there are sufficient firebreaks between the special event location and the aircraft/airship/hangar, but the fifty-fifty chance is a conservative assumption.

If the fire is not detected in time, (and event with low probability of occurrence), then there is no local fire fighting. The fire either spreads in Hangar 1 or is contained on a fifty-fifty chance. The former leads to a “Major fire in Hangar 1” with “May occur” likelihood in the life of the hangar (sequence #5, Figure 10); while the latter leads to “Minor damage” with “May occur” likelihood (sequence #4, Figure 10).

Event sequences #3 and #5 represent the worst-case and feed the initiating event in higher level event trees of Figures 3 and 5. These results show that the likelihood assessment of “May Occur” for the initiating event in “Fire Risk in Hangar 1 Without any Special Hazard Fire Suppression System” (Figure 3) and “Fire Risk in Hangar 1 With a Special Hazard Fire Suppression System” (Figure 5) are a result of aircraft initiated fires and special event fires.

Event sequences #1, 2, and 4 occur whether or not there is a Special Hazard Fire Suppression System. These risks are also shown in Figure 1.
