January 14, 2022

Version 2

Product Improvement: Multi-Model 3G OTA TCU Software Update**AFFECTED VEHICLES**

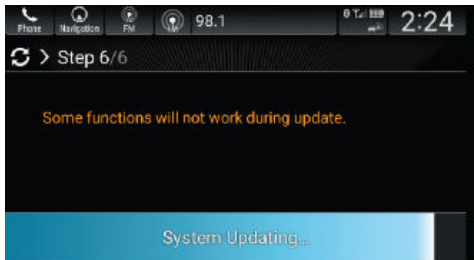
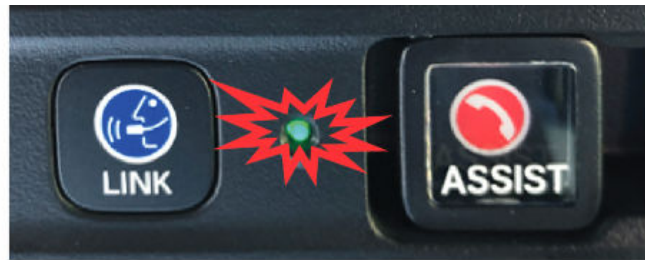
- If you see CODE: 57D or CODE: 5AC, the **Update Failed** due to **Poor cellular signal**.

- Move the vehicle to an open-air area to get **Optimal Cellular Signal** strength.
