**Seismic Vulnerability of Equipment in Critical Facilities:
Life-Safety and Operational Consequences**

November 24, 1993

Technical Report NCEER-93-0022

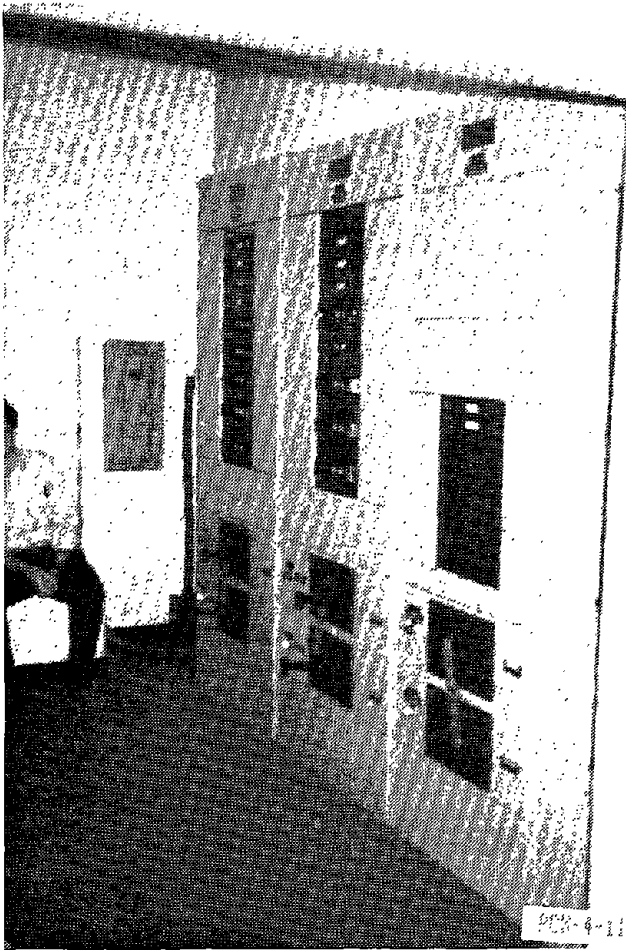
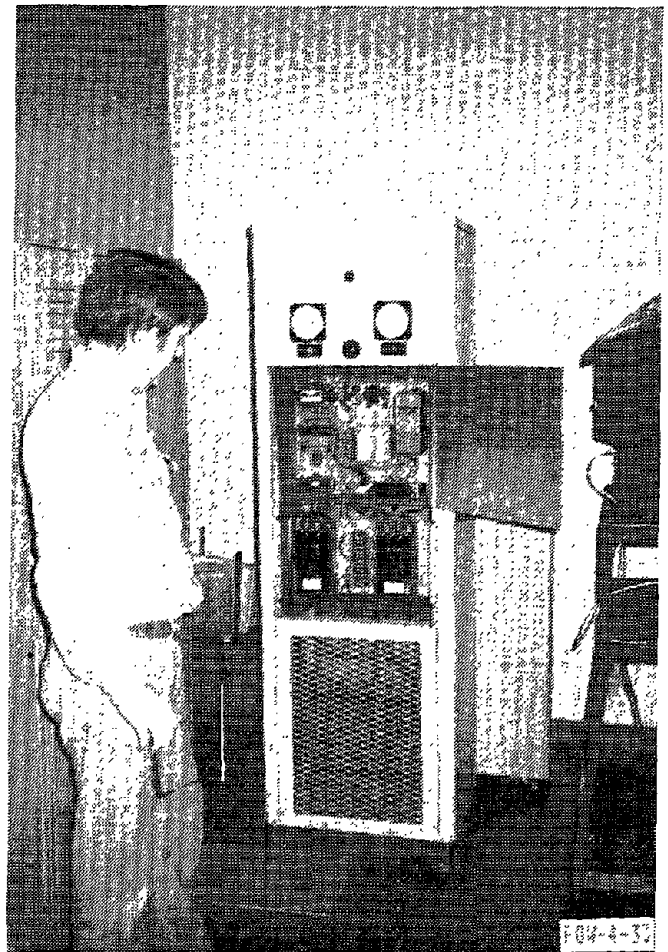
- During the 1987 Whittier Earthquake, at a substation which experienced an estimated PGA of 0.20g, a battery charger was tripped by the actuation of a molded case, branch circuit breaker in the associated distribution panel. The breaker actuation appears to be the result of impact of the panel with the wall (Figure 4-3).

Figure 4-3: At a substation affected by the 1987 Whittier Earthquake, the battery charger (lower photograph) was tripped by the actuation of a molded case circuit breaker in the associated distribution panel (upper photograph).

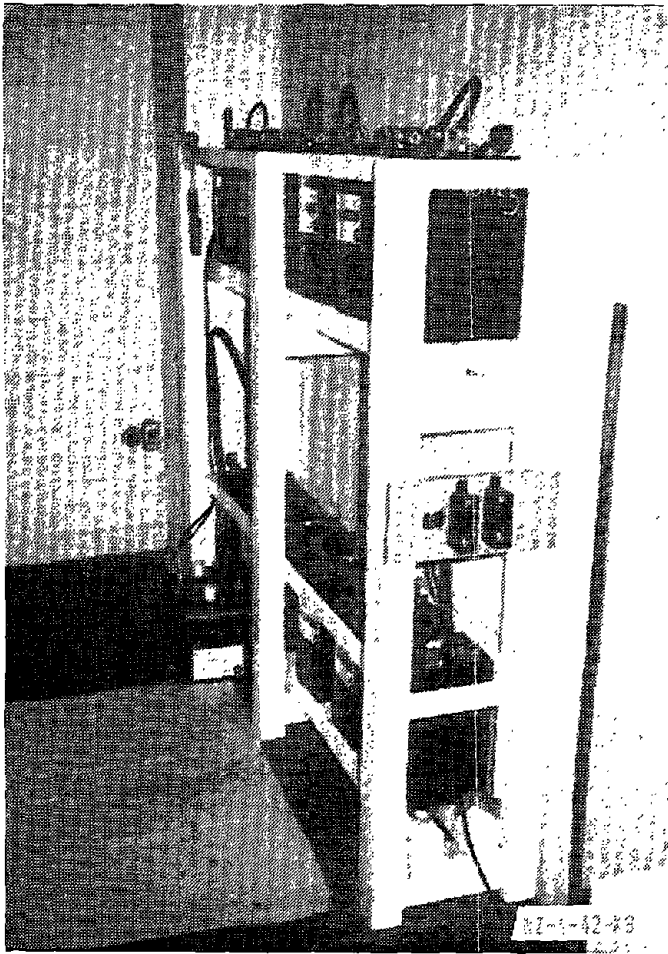
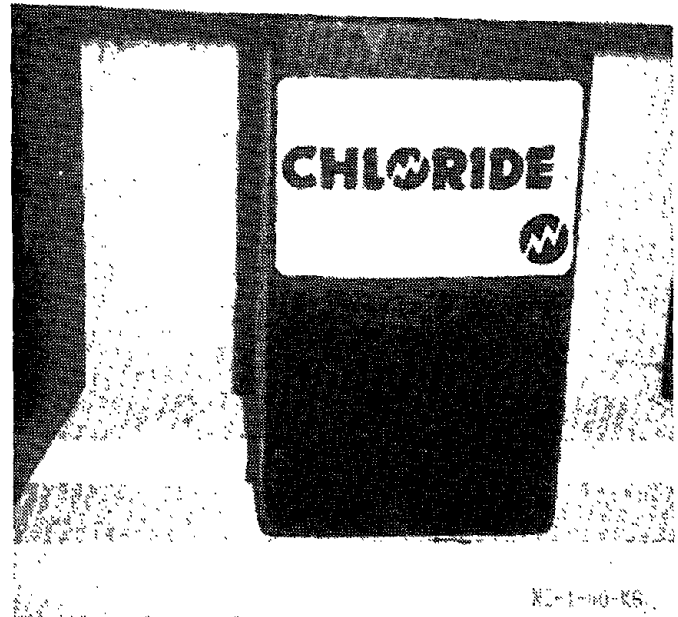
- Five cells on a substation two-tier battery rack would not operate following the 1987 New Zealand Earthquake. The cells were Chloride, flat plate batteries and weighed about 40 pounds each (Figure 4-4). Gaps between the individual cells allowed the cells to rock and pound during the earthquake. Loss of voltage was caused by the dislodging of the positive plates within the battery jars. It should be noted that the manufacturer attributed the damage to deterioration with age; the batteries were eight years old at the time of the earthquake.

Figure 4-4: Several of the lead selenium flat plate batteries in the upper shelf of the wooden two-tier rack suffered dislodged anode plates and loss of supply voltage due to banging of batteries during the 1987 New Zealand Earthquake.

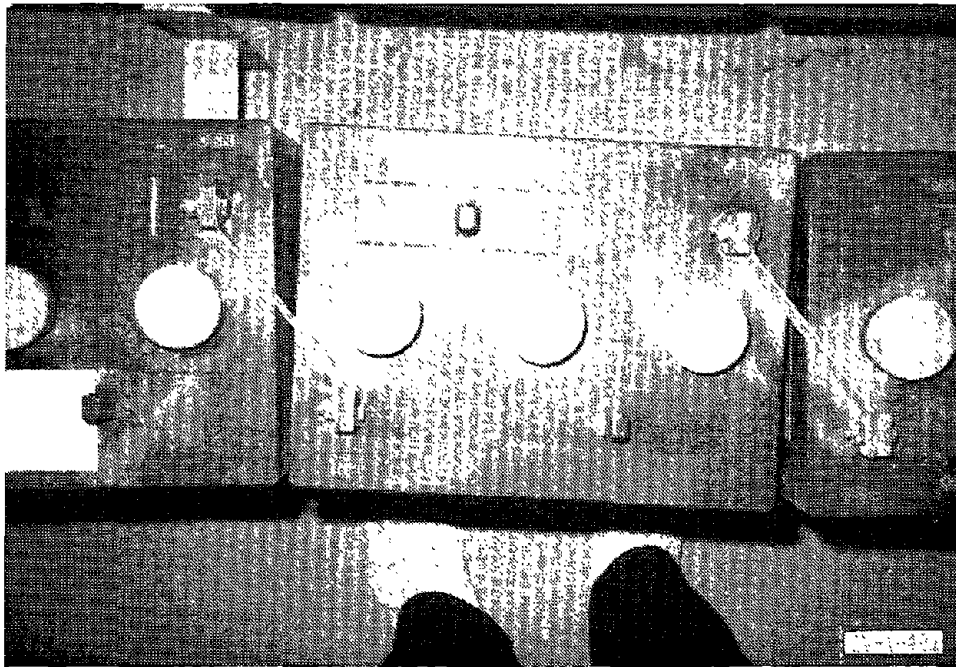
- At a privately owned hydroelectric plant affected by the 1986 Chalfant Valley Earthquake, unrestrained lead calcium cells shifted up to 1/2 inch in their rack (Figure 4-5). The battery rack had no spacers between the cells and no wraparound bracing to prevent movement of the battery cells. The owner/operator reported that the batteries were undamaged in spite of their movement.

Figure 4-5: Batteries from a hydroelectric plant, affected by the 1986 Chalfant Valley Earthquake shifted up to 1/2 inch in their rack but continued to function properly.

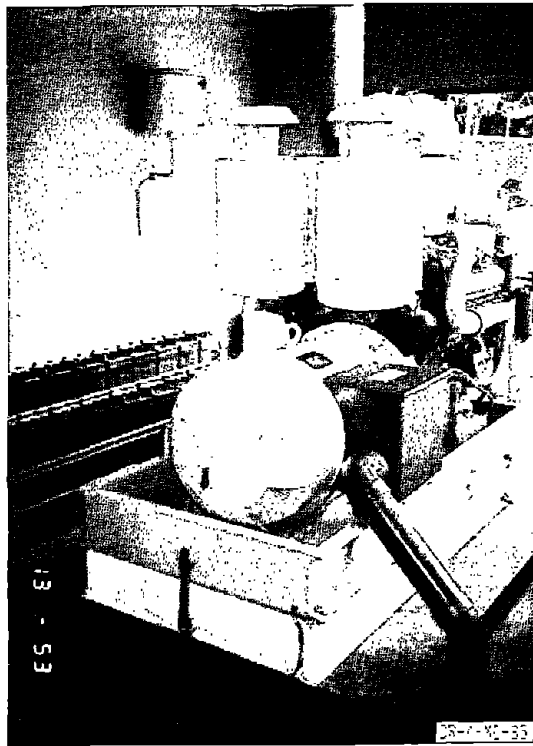
- A 200-kW General Motors diesel engine at a large power facility did not respond to a manual start following the earthquake. Inspection by a utility technician the day following the earthquake revealed a broken wire at the terminal connection serving the solenoid valve that controls oil flow to the Woodward governor (Figure 4-7). The technician described the wire connection as having "burned". This may have been a result of an overcurrent surge or a disconnect due to vibration.

Figure 4-7: The diesel generator at this site did not respond to a manual start following the 1991 Costa Rica Earthquake (measured PGA of 0.12g). Inspection by a utility technician the day following the earthquake revealed a broken wire at the terminal connection serving the solenoid valve (arrow, lower photograph) that controls oil flow to the Woodward governor.

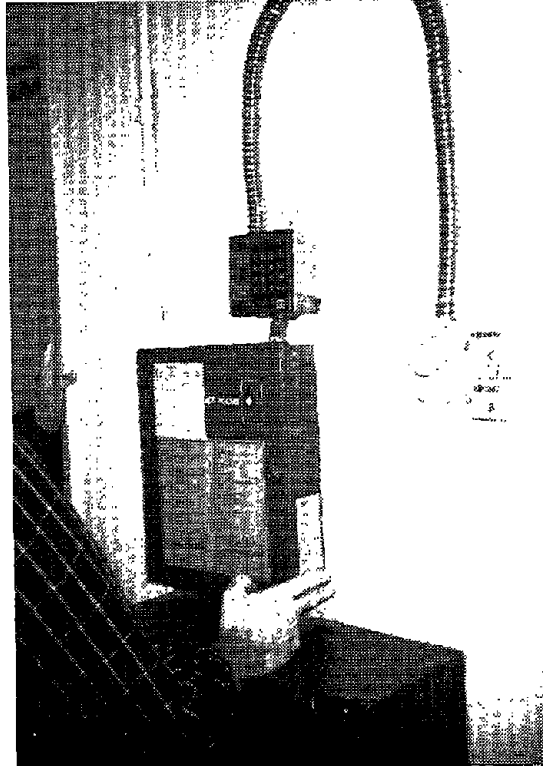
Figure 4-11: A fire control station at a small manufacturing facility. This control station experienced 0.35g during the 1989 Loma Prieta Earthquake and experienced no malfunction or damage.

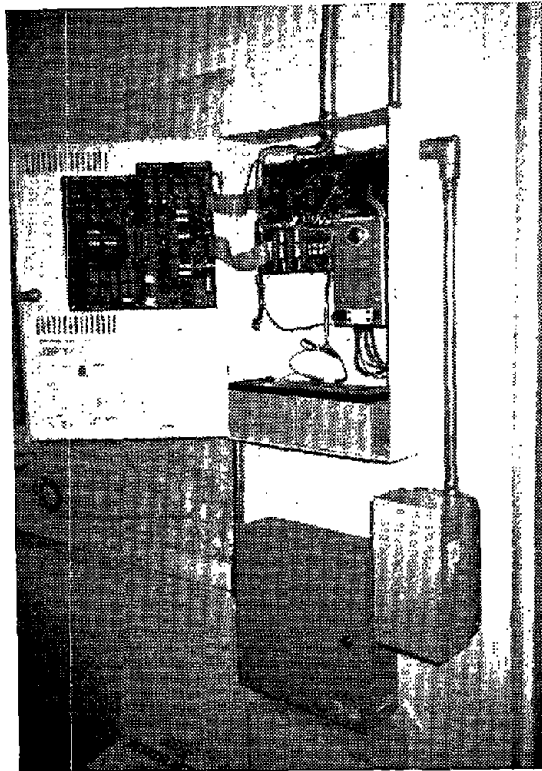
Figure 4-12: A fire control station mounted to an interior wall at a university which was affected by the 1989 Loma Prieta Earthquake. The control station functioned properly during the earthquake.

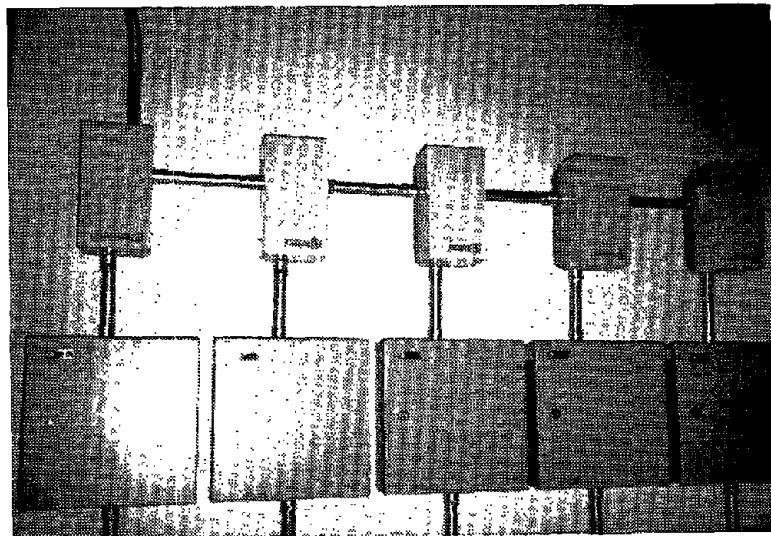
Figure 4-13: Fire communications panels at a university medical facility affected by the 1989 Loma Prieta Earthquake (0.25g). These communications panels relay data from the detectors to the fire department and were not affected by the earthquake.

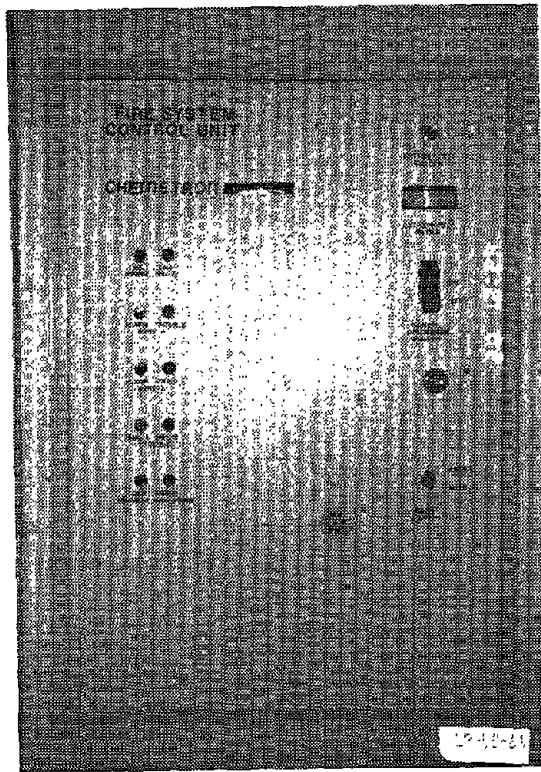
Figure 4-14: A wall mounted fire control unit at a large cement factory. This unit experienced the 1989 Loma Prieta Earthquake (0.25g) with no reported damage or equipment malfunction.

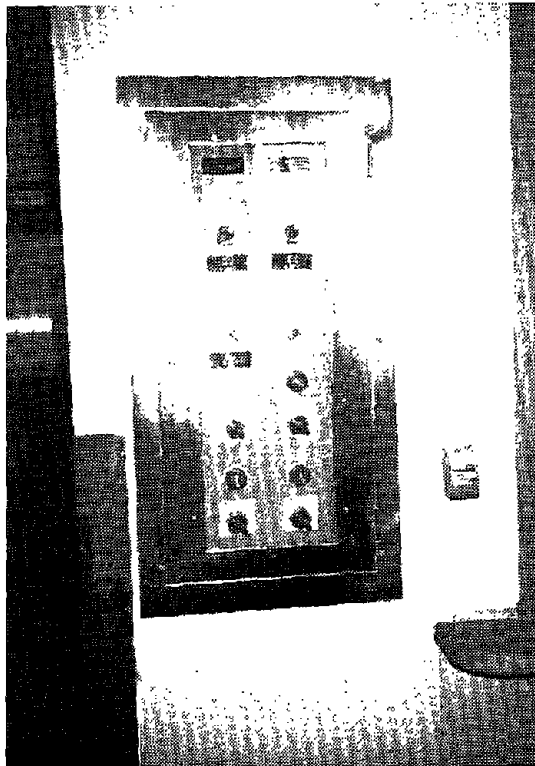
Figure 4-15: A wall mounted fire communications panel at a university medical facility. The panel was affected by the 1989 Loma Prieta Earthquake (0.25g) but was not damaged.

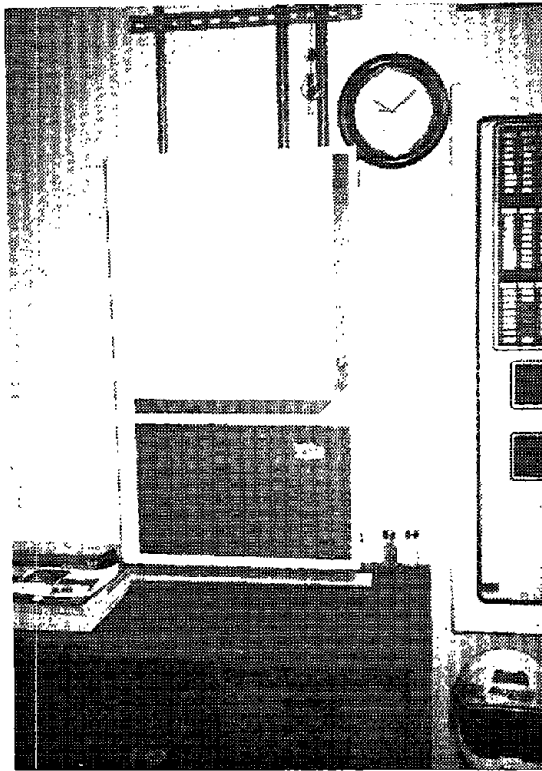
Figure 4-16: Wall mounted fire communications panel in the basement of a university medical facility affected by the 1989 Loma Prieta Earthquake (0.25g). The panel operated properly during the earthquake.

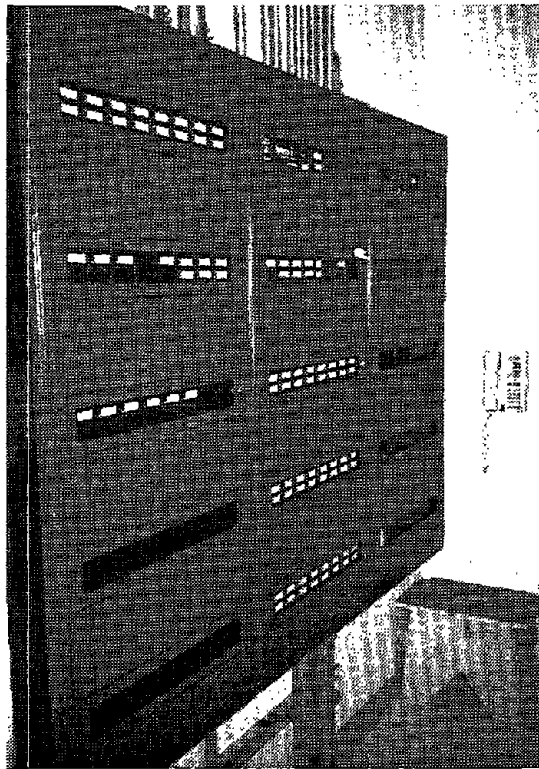
Figure 4-17: Fire alarm panel at a large university medical facility affected by the 1989 Loma Prieta Earthquake (0.25g). The alarm panel is mounted to an interior wall. There was no reported damage or equipment malfunction as a result of the earthquake.

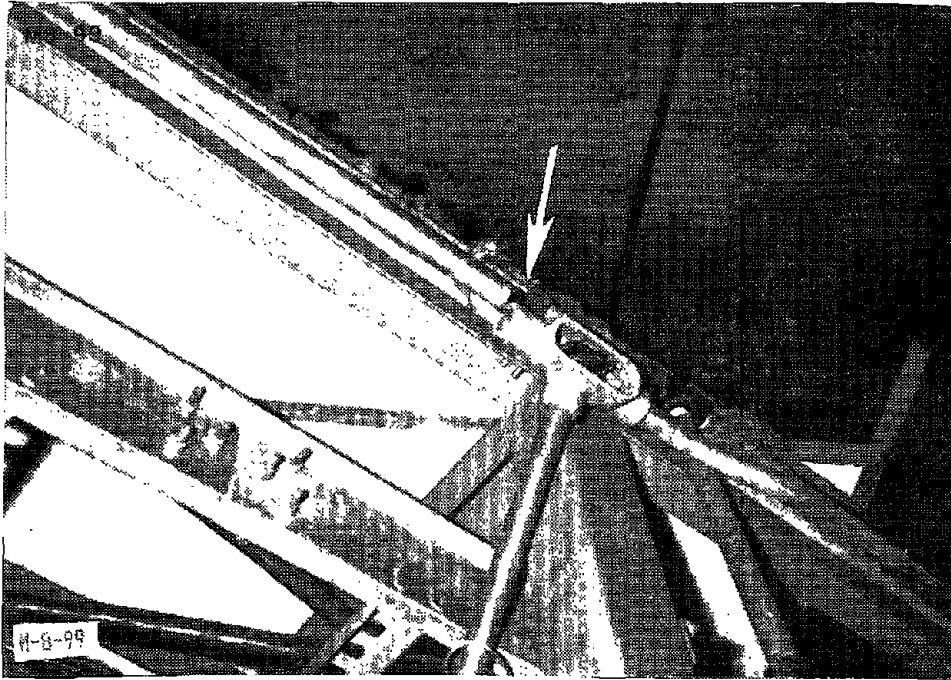
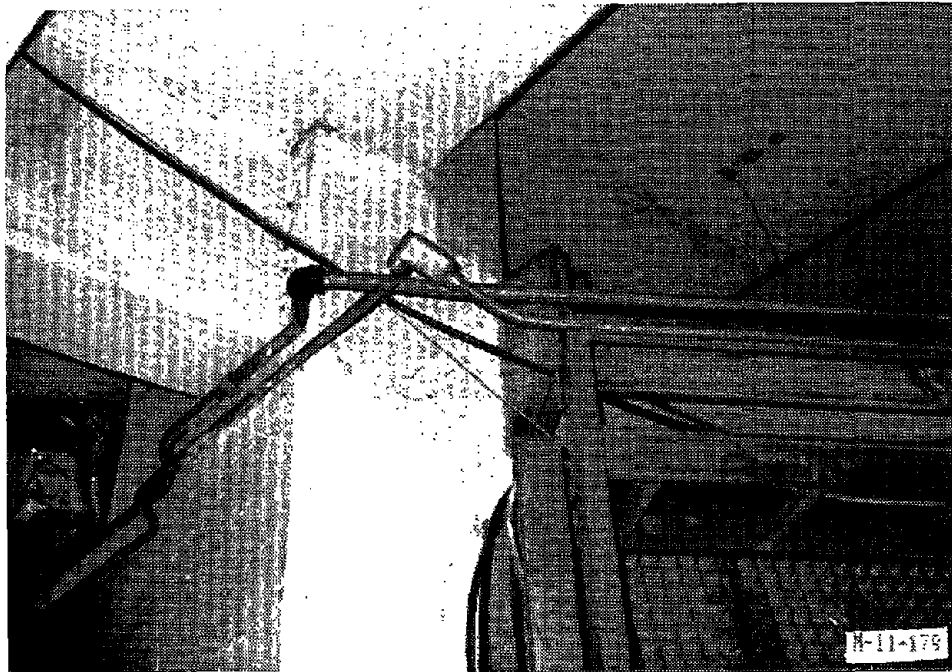
Figure 4-22: This conduit, located in a heavy industrial facility, pulled apart at couplings due to relative motion of two sections of the control panel (top photograph) and between the panel and the wall (bottom photograph).

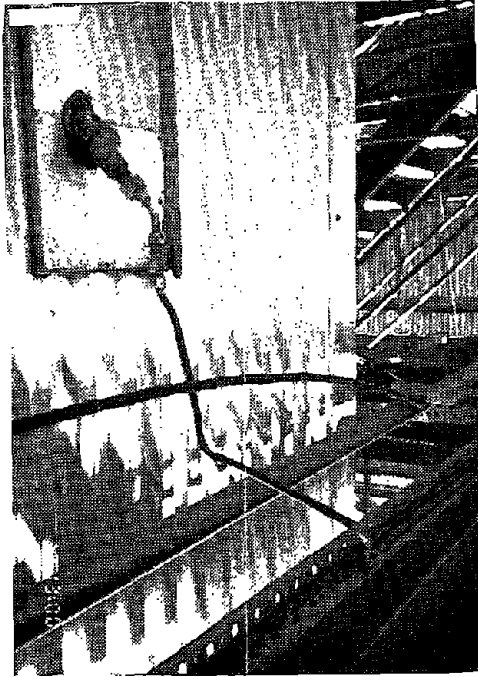
Figure 4-23: At a cogeneration plant affected by the 1992 Cape Mendocino Earthquake, tubes connected to a pressure top crimped when the suspended boiler swung, causing significant differential lateral displacement with the boiler support structure at this elevation

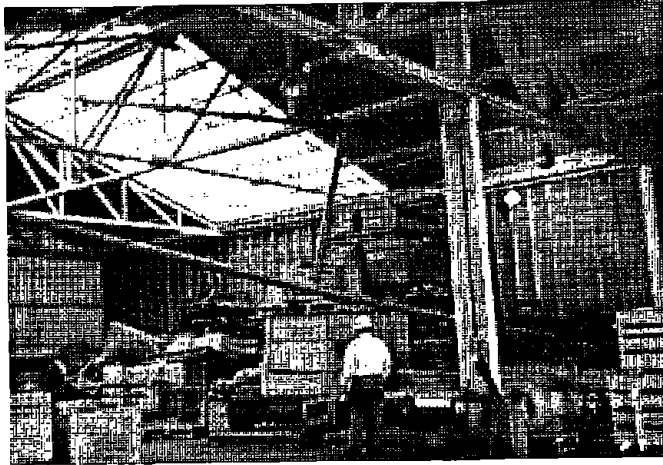
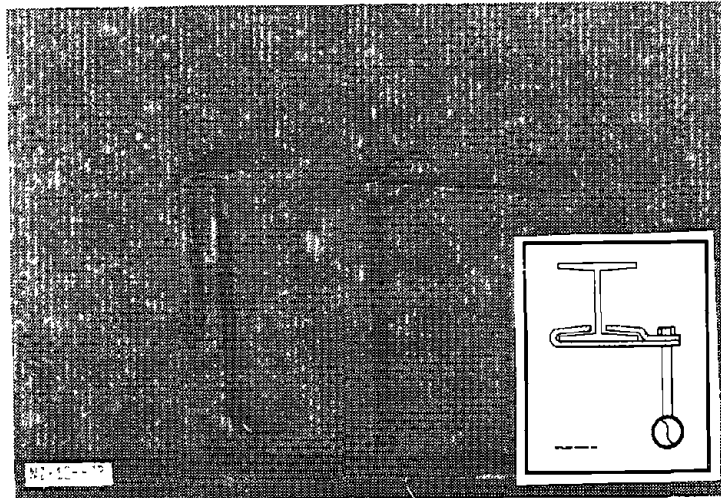
- At a paper mill affected by the 1987 New Zealand Earthquake, an entire section of sprinkler piping collapsed during the earthquake. All of the rod hanger supports for the piping were attached eccentrically to metal straps on the bottom flange of the ceiling beams (Figure 4-24). During the earthquake, the straps pried off of the beam flanges, losing the vertical support. Because the same detail was used throughout the system, each identical support failed, and the system unzipped, falling to the floor.

Figure 4-24: At a paper mill, affected by the 1987 New Zealand Earthquake, an entire section of the sprinkler piping system collapsed during the earthquake. The cause for the collapse appeared to be a poor support design in which rod hanger supports were eccentrically hung from straps on the bottom flange of a wide-flanged beam. They pried off of the beam flange.

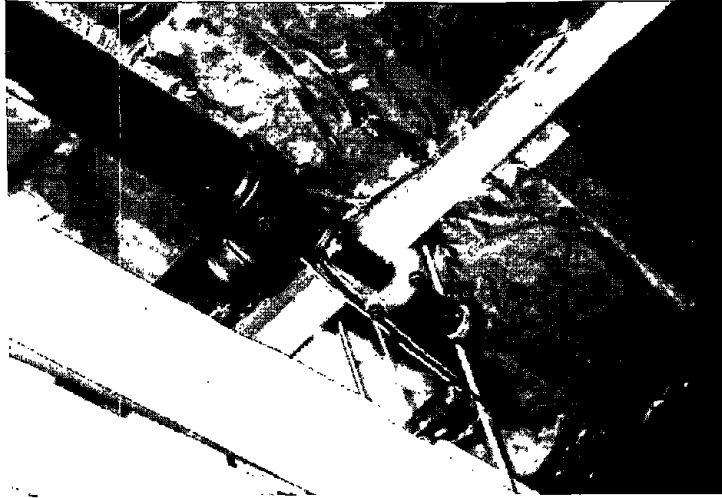
- At a small manufacturing plant, located in the epicentral area of the 1989 Loma Prieta Earthquake, threaded couplings in fire sprinkler lines cracked in two locations during the event (Figure 4-25). Cracking in the sprinkler line coupling may have been aggravated by impact from adjacent rod-hung piping and ducts in this very congested area of the ceiling.

Figure 4-25: At a small manufacturing plant, located in the epicentral area of the 1989 Loma Prieta Earthquake, threaded couplings in fire sprinkler lines cracked in two locations during the event.

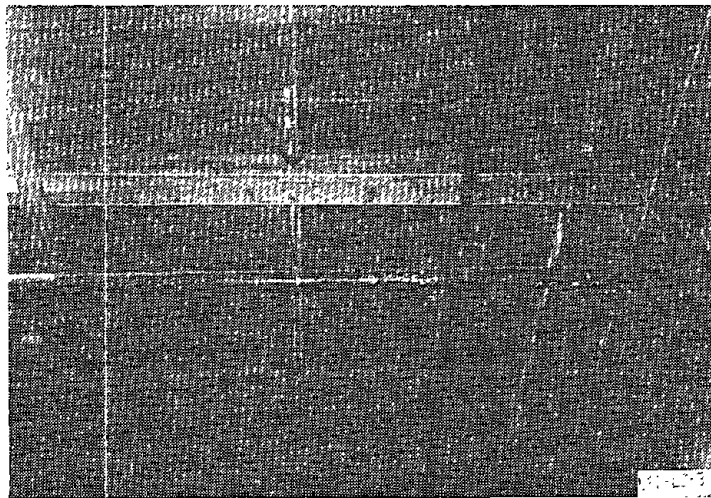
- At a food dehydration and packaging plant, affected by the 1989 Loma Prieta Earthquake, sprinkler lines cracked at threaded couplings at two locations. Cracked couplings occurred where a short vertical connection spanned between two long perpendicular pipe runs. It was apparent that the interconnecting pipe cracked while resisting differential movement between the two long runs of sprinkler piping (Figure 4-26).

Figure 4-26: At a food dehydration and packaging plant, affected by the 1989 Loma Prieta Earthquake, sprinkler lines cracked at threaded couplings at two locations. Cracked couplings occurred where a short vertical connection spanned between two long perpendicular pipe runs.

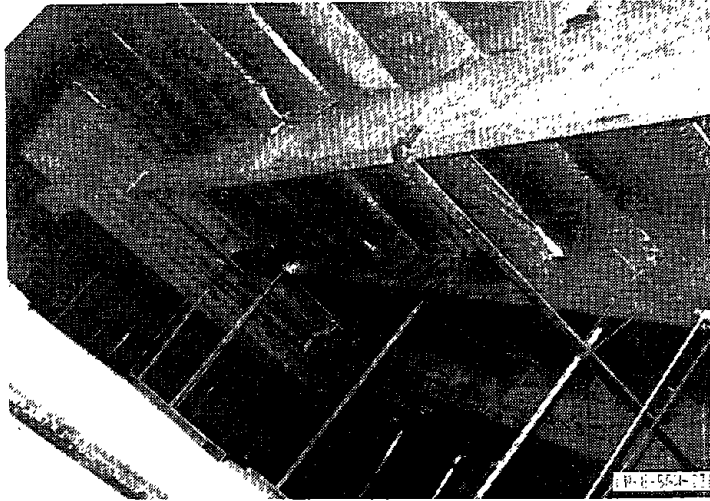
Figure 4-27: At a disk drive assembly plant, located in the epicentral area of the 1989 Loma Prieta Earthquake, seven sprinkler heads on flexible rod-hung pipe broke due to impact with adjacent wood ceiling beams.

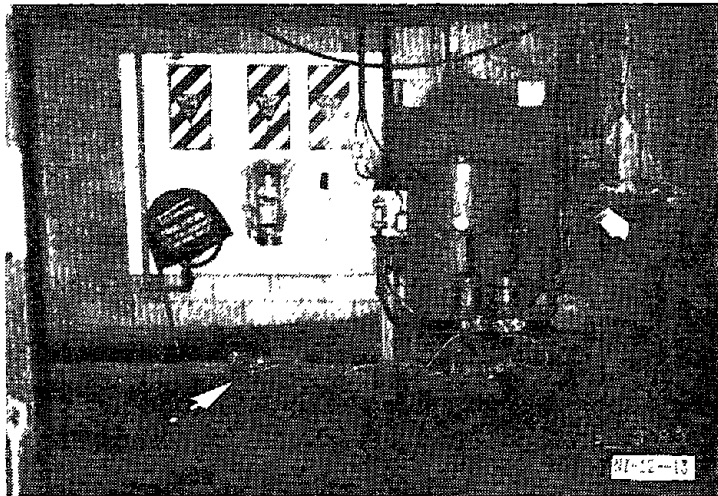
- There are several instances of fire extinguishers falling to the floor during earthquakes (Figure 4-28). It is not known whether any of these incidents resulted in damage to the extinguishers such that they would not operate.

Figure 4-28: Fallen fire extinguisher at a paper mill. Estimated PGA of 0.50g during the 1987 New Zealand Earthquake.

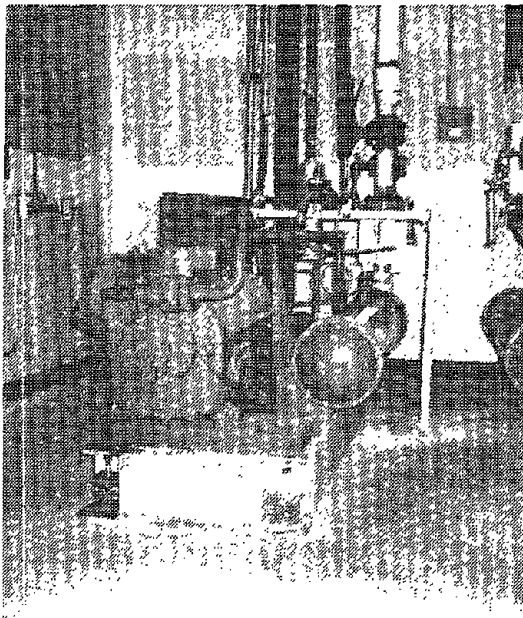
- At a large office complex, affected by the 1989 Loma Prieta Earthquake, eight pad-mounted refrigerant compressors rolled off their isolation mounts. The units were undamaged and operational once they were re-mounted. Attached piping had sufficient flexibility to accommodate the displacement (Figure 4-31).

Figure 4-31: One of eight pad-mounted refrigerant compressors located at a large office complex, affected by the 1989 Loma Prieta Earthquake, that rolled off its isolation mounts. The units were undamaged and operational once they were re-mounted. Attached piping had sufficient flexibility to accommodate the displacement.

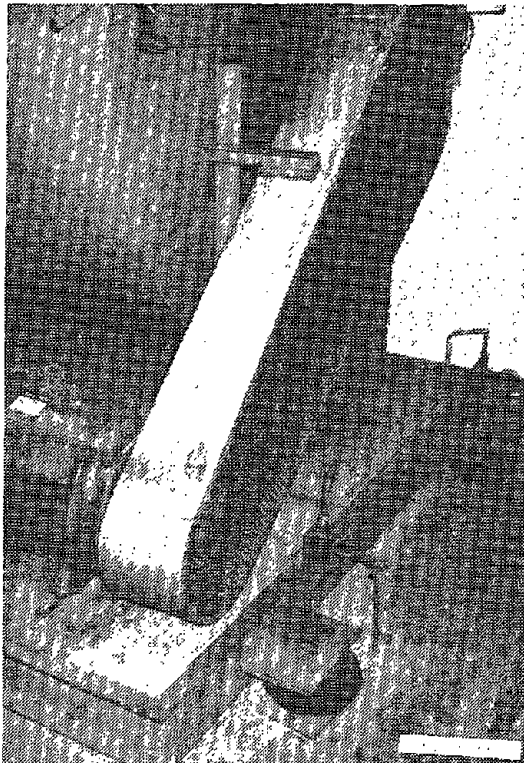
- At a large electrical substation, affected by the 1971 San Fernando Earthquake, a centrifugal fan located in the third floor HVAC room, broke its cast-iron isolation mounts. The isolation mounts were not designed to accommodate lateral loads. At the same facility one of six frame-mounted fans, in the basement, broke its spring isolator (Figure 4-43).
- At two data processing facilities, affected by the 1987 Whittier Earthquake, fans in the penthouses were knocked from their non-seismically designed vibration isolation mounts (Figure 4-44).
- At a large office complex, affected by the 1989 Loma Prieta Earthquake, a roof-mounted HVAC fan shifted on its rubber isolation

mounts. The fan was otherwise undamaged and operable (Figure 4-45).

Figure 4-45: This roof-mounted HVAC fan located at a large office complex, affected by the 1989 Loma Prieta Earthquake, shifted on its rubber isolation mounts. The fan was otherwise undamaged and operable.

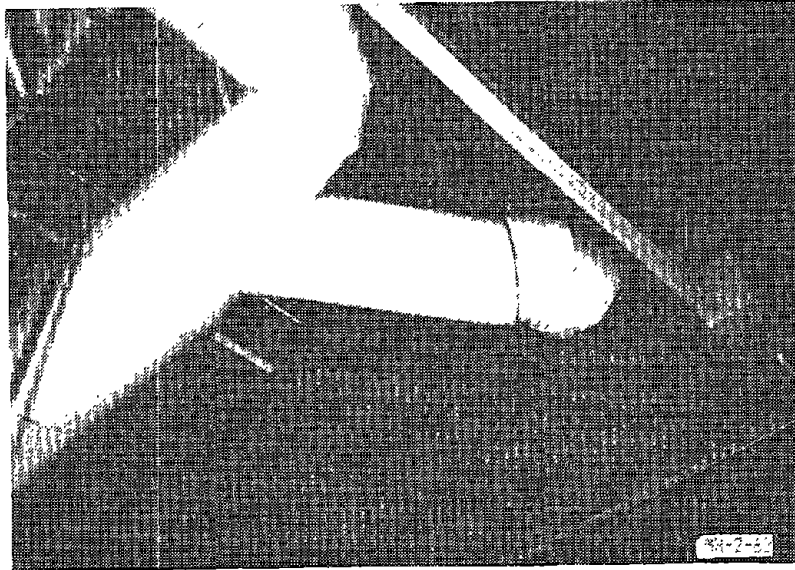
- At the same facility, another section of duct split a seam where a branch line entered a wall penetration (Figure 4-52). The damaged section was approximately ten inches in diameter, branching off an estimated twenty inch diameter header. The seam pulled apart near the wall, approximately four feet from the branch point. The branch apparently was not flexible enough to accommodate the header motion, and the seam was too weak to resist the imposed differential displacement.

Figure 4-52: At a small electronics manufacturing facility, affected by the 1984 Morgan Hill Earthquake, a branch line tore at a wall penetration due to flexible header motion.

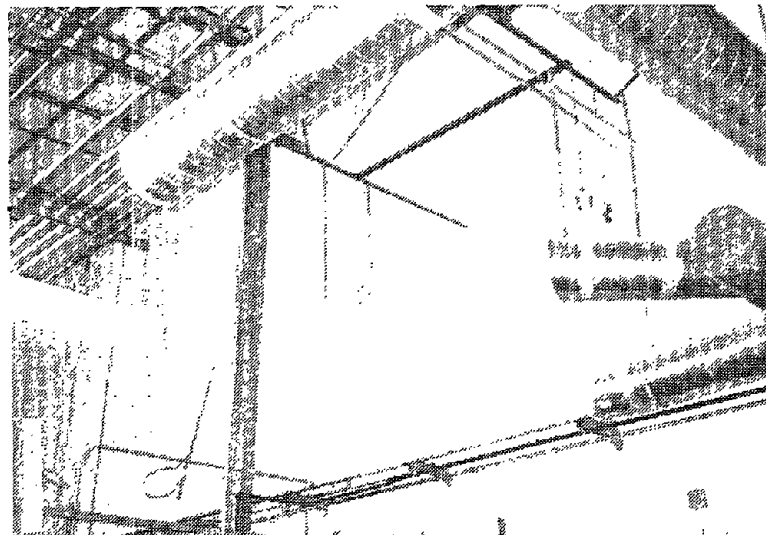
- At a small manufacturing facility, affected by the 1989 Loma Prieta Earthquake, a section of HVAC ducting broke and fell to the floor. The circular duct is lap jointed (without rivets or bolts) and hung from the ceiling with sheet metal straps. During the earthquake, a portion of the duct fell to the floor when a strap broke at the duct connection and the attached section pulled free of its joints (Figure 4-53).

Figure 4-53: At a small manufacturing facility affected by the 1989 Loma Prieta Earthquake, a section of HVAC ducting fell to the floor when a strap broke at the duct connection and the attached section pulled free of its joints. Joints are lap fit, with no rivets or bolts.

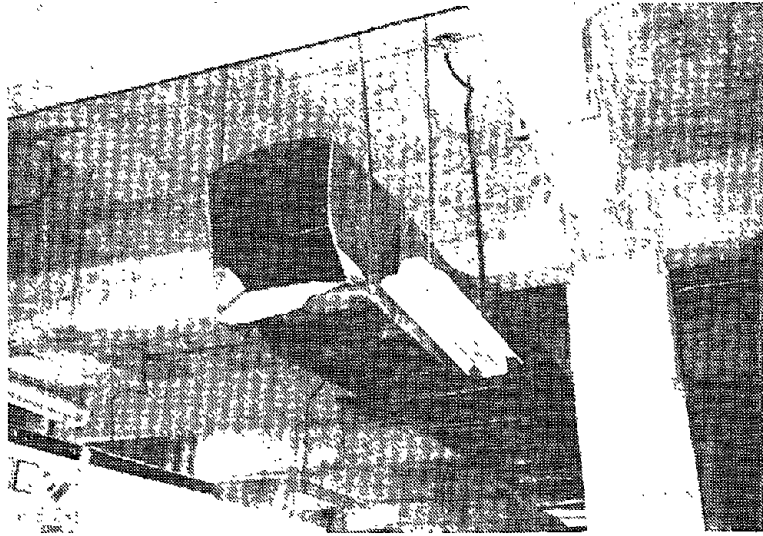
- At a chemical plant, affected by the 1985 Mexico Earthquake, a cantilevered duct section severed and fell. The duct was not positively attached to its rod-hung trapeze supports. Seismically induced uplift of the duct allowed the support to swing out from under the duct. The duct could not support the cantilevered weight and severed at a connection (Figure 4-54).

Figure 4-54: This a cantilevered duct section at a chemical plant severed and fell during the 1985 Mexico Earthquake. The duct was not positively attached to its rod-hung trapeze supports. Seismically induced uplift of the duct allowed the support to swing out from under the duct. The duct connections could not support the cantilevered weight and severed.

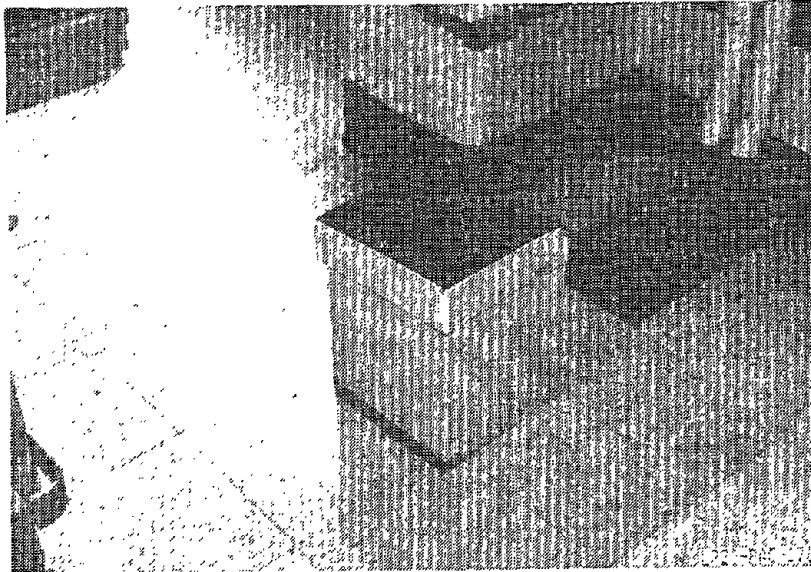
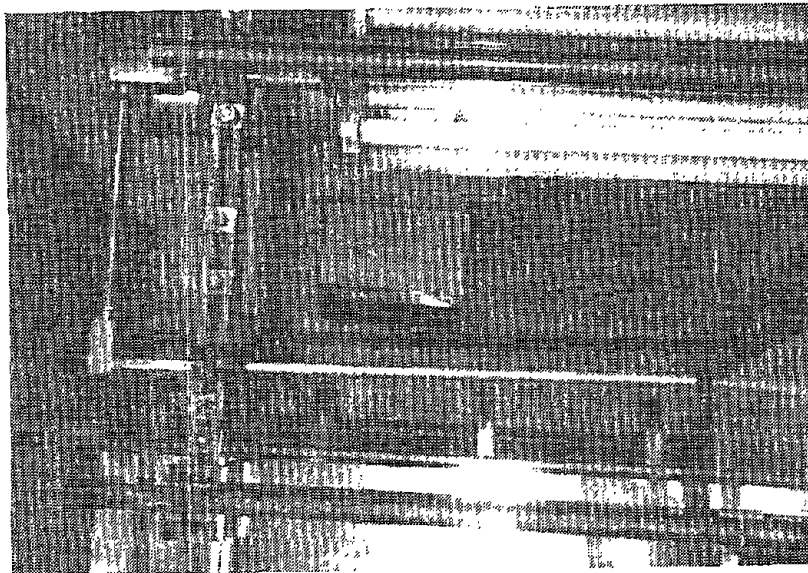
- At a communications building in Watsonville in the 1989 Loma Prieta Earthquake, a vertical cantilevered section of duct fell to the floor with its attached diffuser (Figure 4-56).

Figure 4-56: At a telecommunication building in the 1989 Loma Prieta Earthquake, a vertical cantilevered section of duct fell to the floor with its attached diffuser.

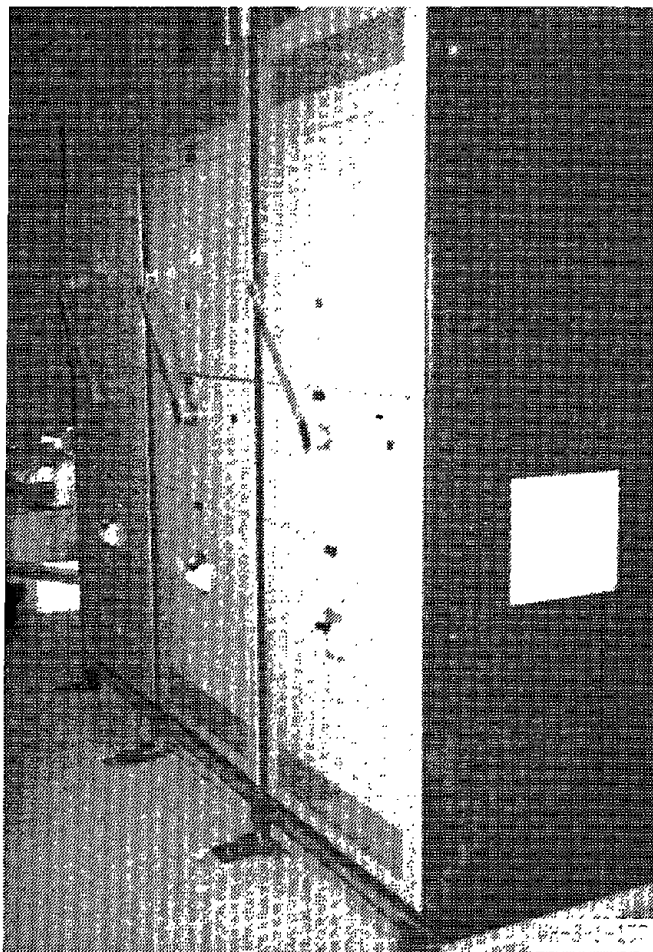
Figure 4-65: This three-section DC switchboard at a bank computer facility, which experienced an estimated peak ground acceleration (PGA) of 0.40g, during the 1987 Whittier Earthquake, broke its anchorage and shifted several inches.

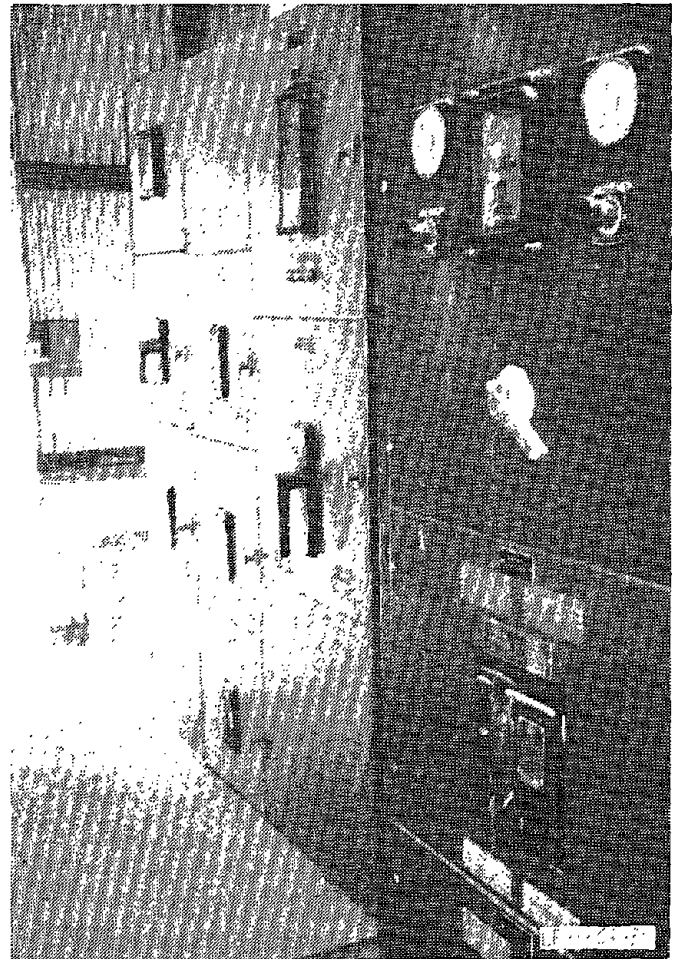
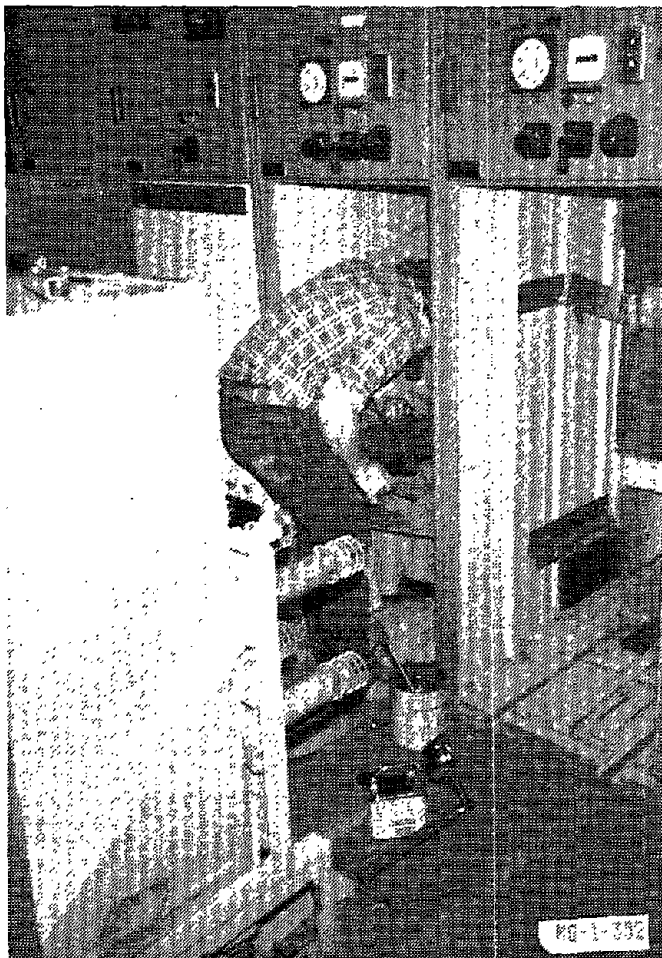
Figure 4.-67: This assembly of 4.16 kV switchgear, located in the control building of a pumping plant sheared its anchor bolts and slid during the 1983 Coalinga Earthquake.

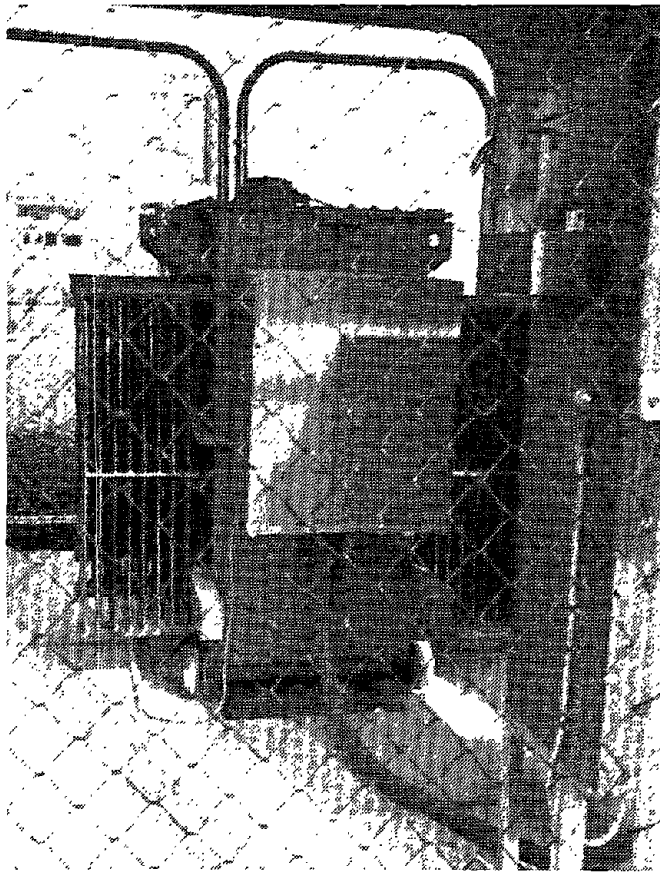
Figure 4-70: This unanchored oil-filled transformer at a paper mill, affected by the 1987 New Zealand Earthquake, slid several inches. The unit was reported as operable when power was restored.

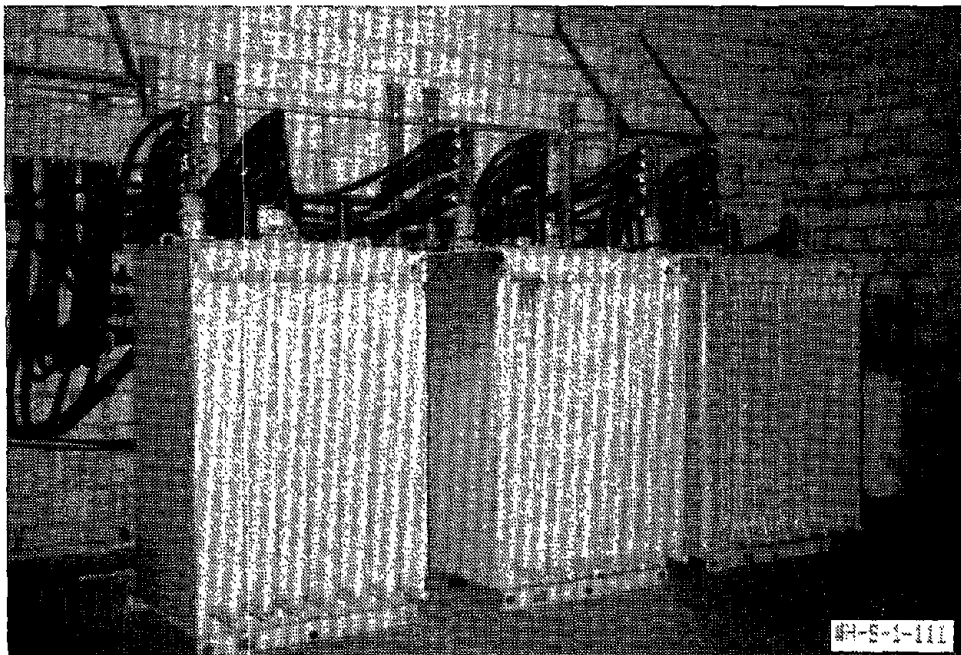
Figure 4-71: These three unanchored oil-filled transformers at a computer facility, affected by the 1987 Whittier Earthquake, shifted slightly. The units were undamaged when the facility reenergized about 24 hours after the main shock.

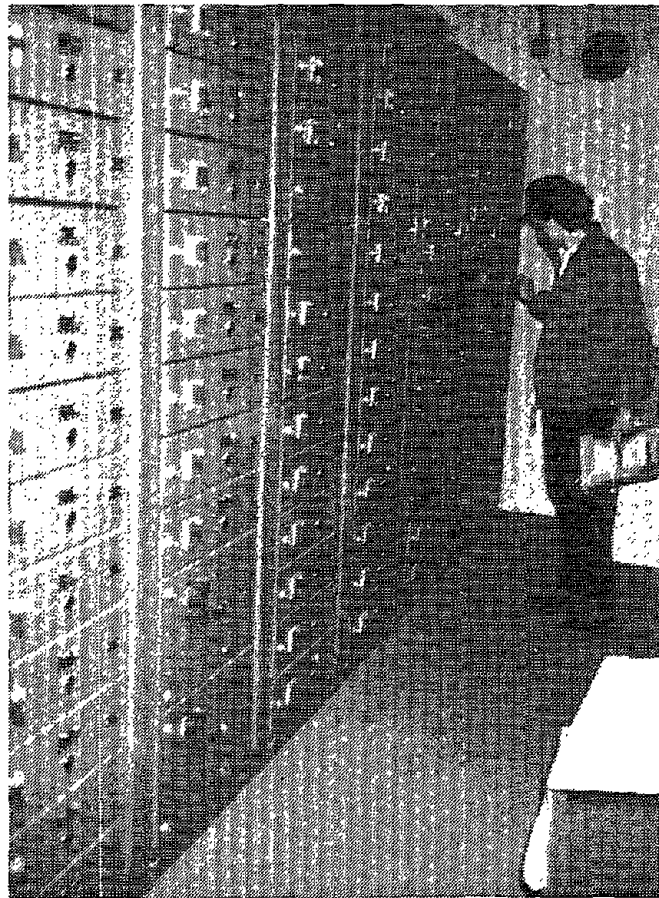
Figure 4-75: At a distillery, affected by the 1987 New Zealand Earthquake, there were some reports of earthquake-induced distortion to the MCC frame which resulted in difficulty in opening the controller doors and in removing the controllers.

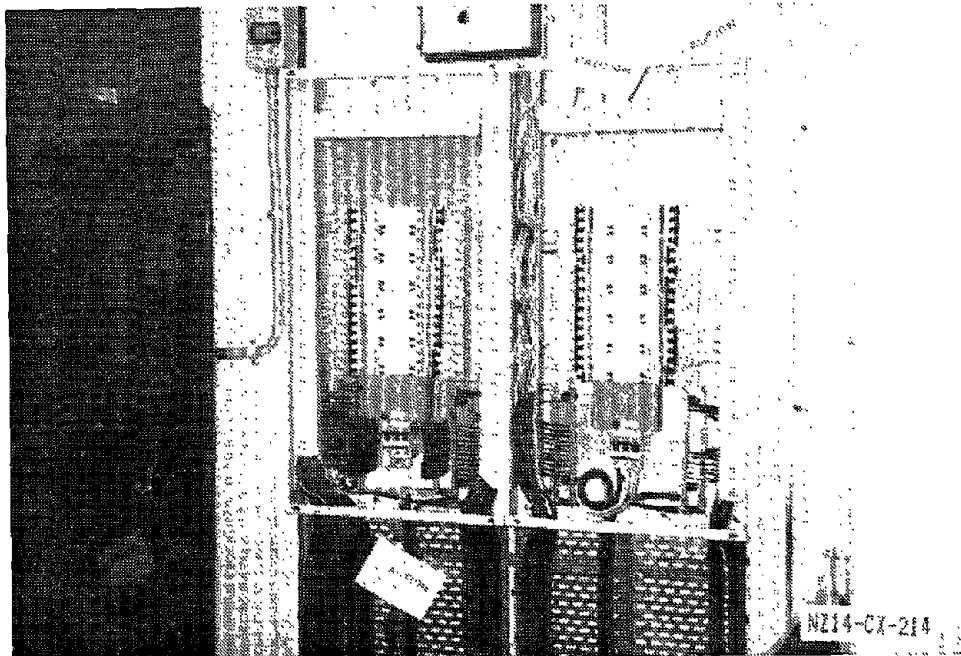
Figure 4-81: One of six distribution panels at a paper mill damaged by the 1987 New Zealand Earthquake. Apparently, the internal bus bars were not positively attached, such that the loose bus bars contacted and shorted the unit during the earthquake.

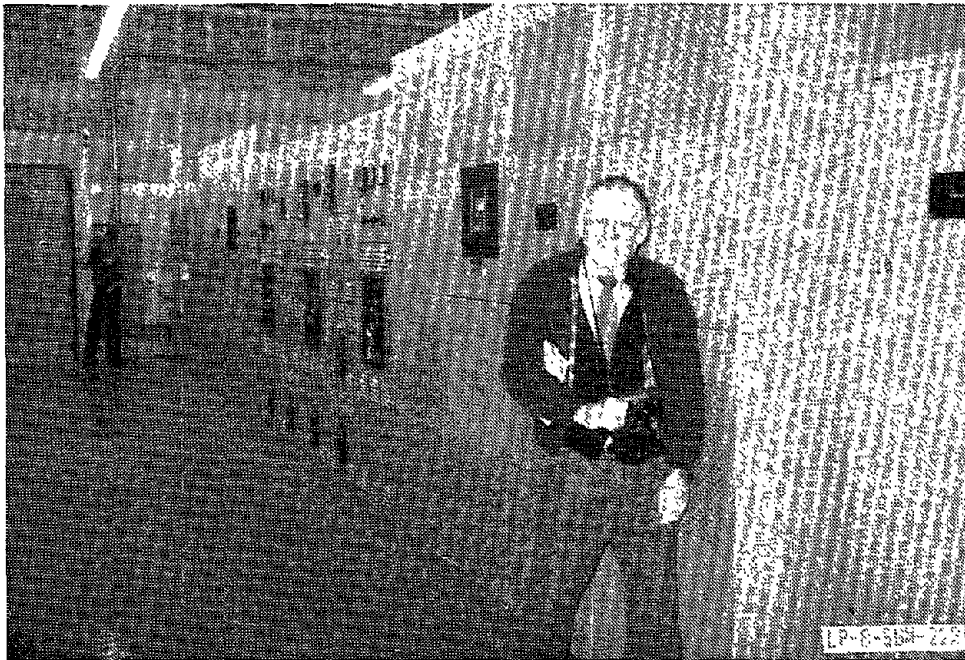
At a manufacturing plant, affected by the Loma Prieta Earthquake, two 480-volt substations were sprayed with water when an overhead sprinkler broke (Figure 4-85). Each substation included two transformers. Both unit substations were disassembled, dried out, and reassembled, prior to repowering three days after the earthquake.

Figure 4-85: One two 480-volt substations at a manufacturing plant, affected by the Loma Prieta Earthquake. These units were sprayed with water when an overhead sprinkler broke. Each substation included two transformers. Both unit substations were disassembled, dried out, and reassembled, prior to repowering three days after the earthquake.
