TWR-63941

**Flight 20 (STS-45)
Polysulfide Gas Path Investigation
Final Report**

July 1992

Thiokol CORPORATION
SPACE OPERATIONS

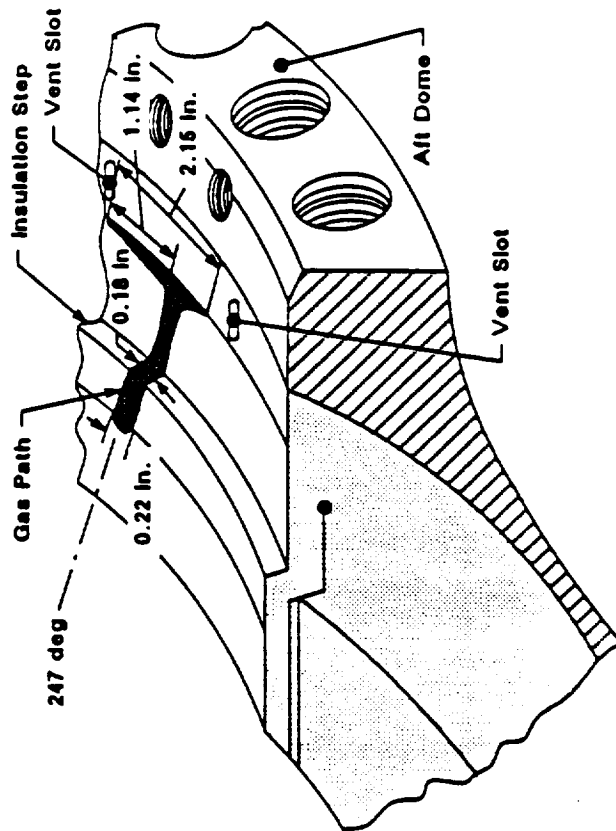
Gas Path at 247 Degrees
STS-42 (360T020) RH (B)

- a. The gas path within the nozzle-to-case joint polysulfide at 57.6 deg on the 20A, extending from the motor chamber to the wiper O-ring (see Figures 4-1 and 4-2).
- b. Evidence of combustion gas blow-by beyond the wiper O-ring with local heat damage to the wiper O-ring (see Figure 4-2).
- c. A gas path within the polysulfide at 247 deg on the 20B nozzle-to-case joint (see Figures 4-1 and 4-2).

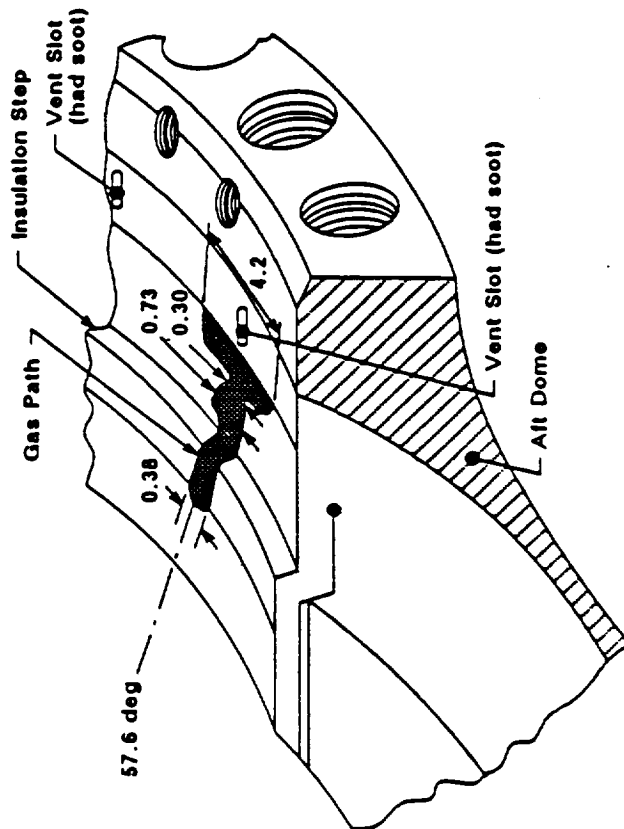
Gas Path at 57.6 Degrees
STS-42 (360T020) LH (A)

Figure 4-2. Gas Path on 20A and 20B

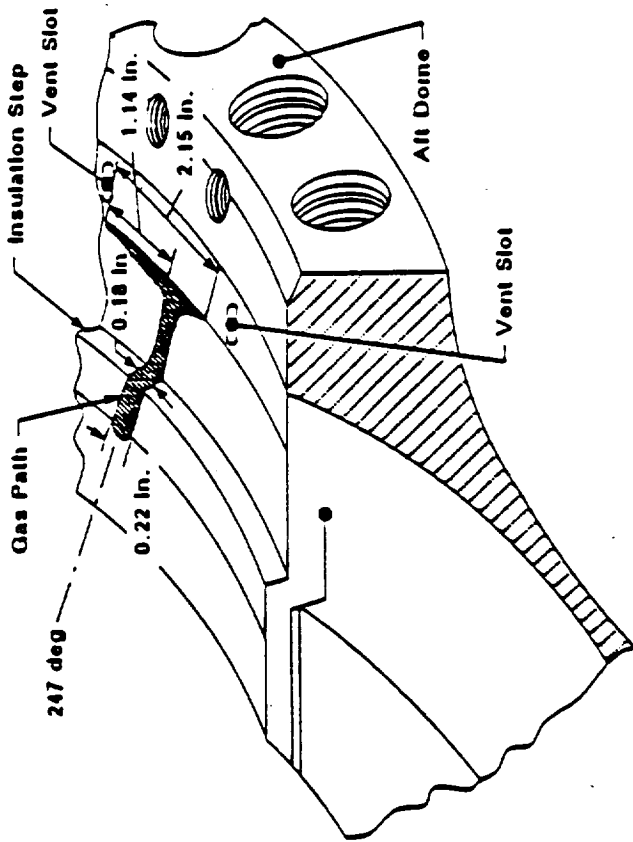
Figure B-3. Gas Path on RSRM-20B Aft Dome

Gas Path at 247 Degrees
STS-42 (360T020) RH (B)

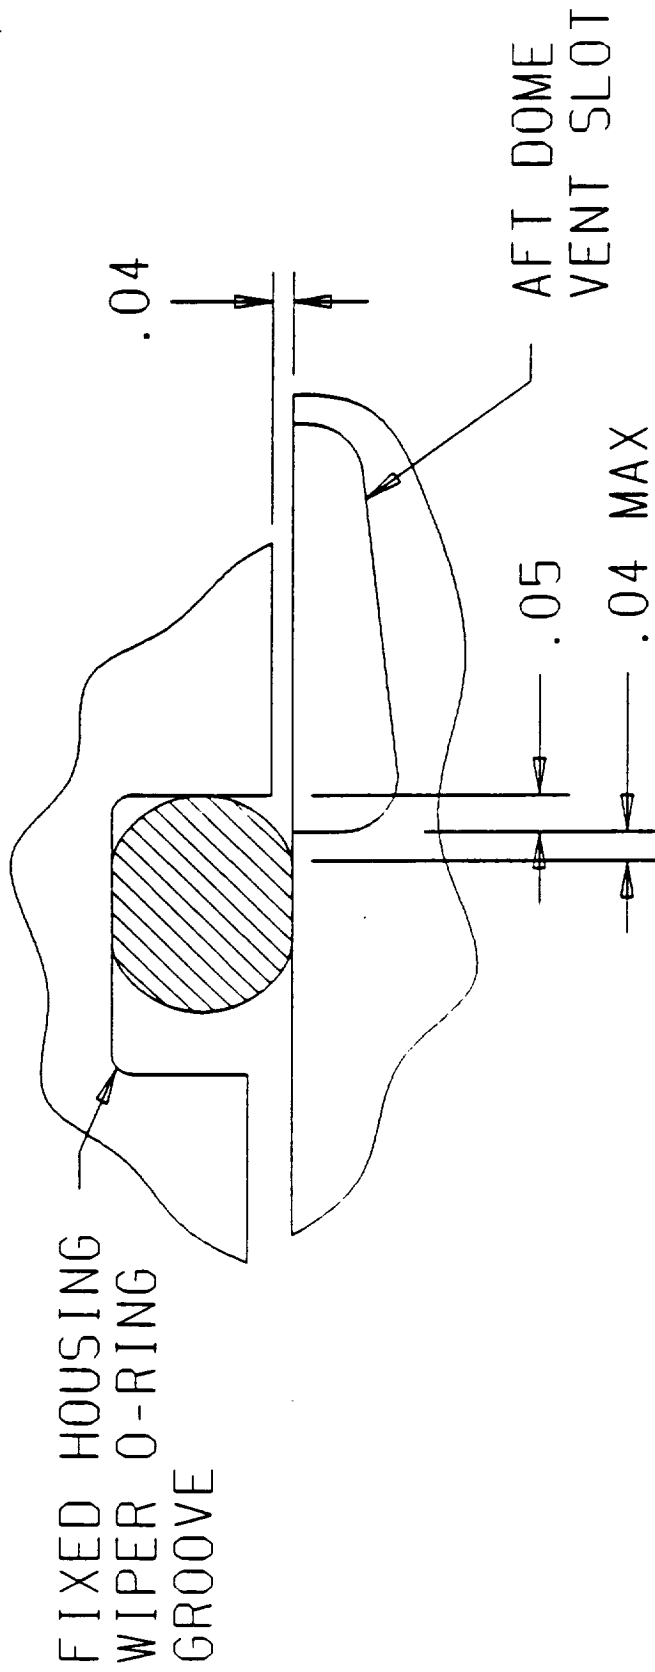
Figure B-18. Assembled Wiper O-Ring Configuration

RSRM 20A, ACTUAL WIPER O-RING CONFIGURATION AT 64.8° (

MAX O-RING GROOVE WIDTH: .380
 MAX O-RING GROOVE DEPTH, FROM F.H. METAL SURFACE: .201
 MIN O-RING DIAMETER: .2731
 O-RING DEFORMED LENGTH: .297 - .301
 O-RING FOOT PRINT: .115 - .120

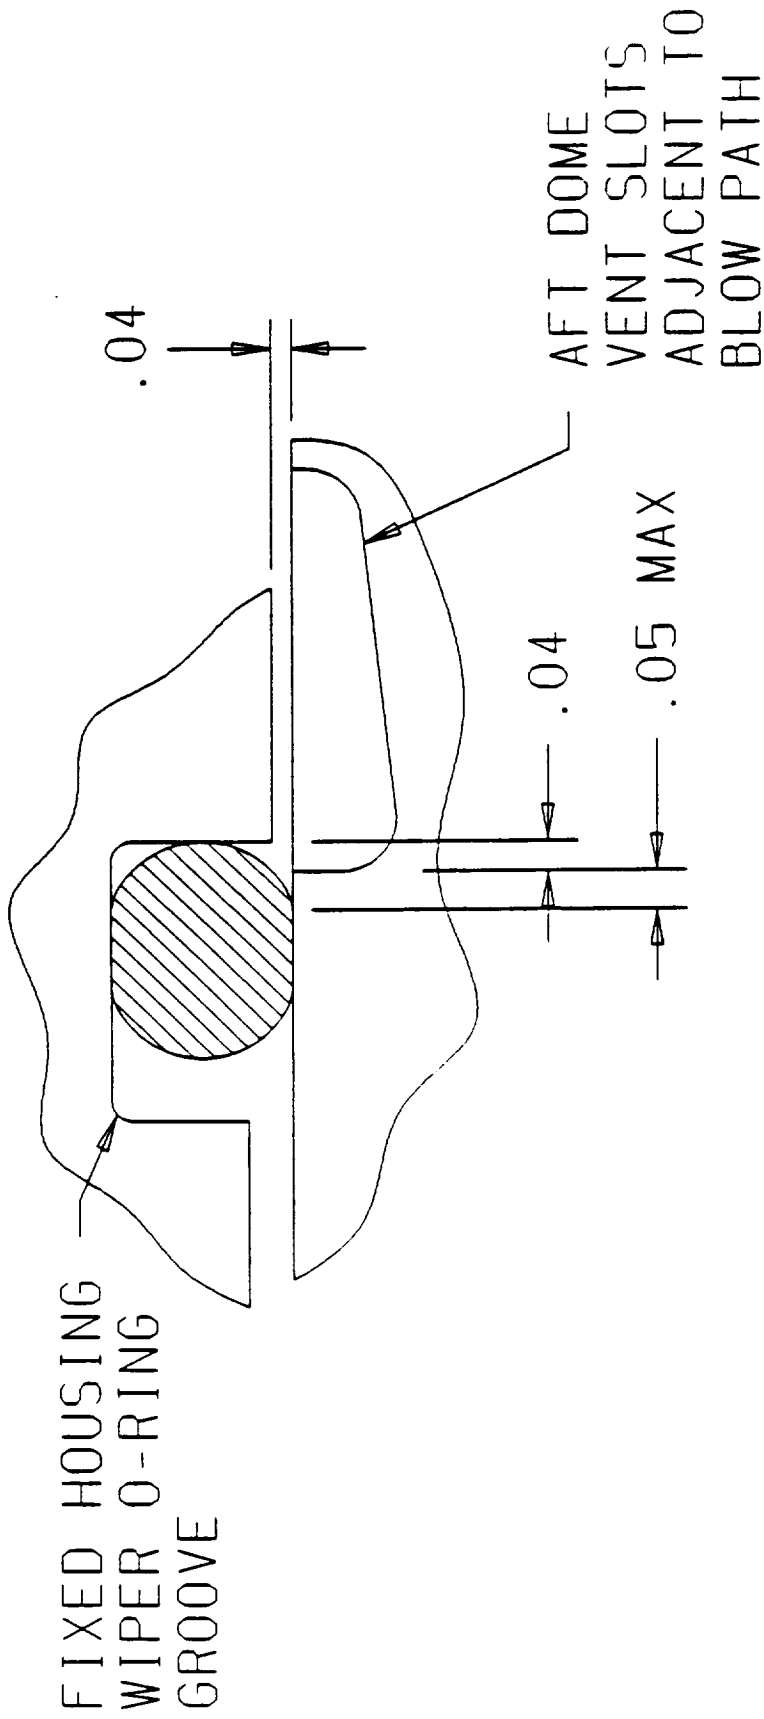
Figure B-19. Assembled Wiper O-Ring Configuration

RSRM 20B, ACTUAL WIPER O-RING CONFIGURATION AT 247.0°
 VENT SLOT DIMENSIONS ARE AVERAGED FROM ADJACENT VENT
 SLOTS AT 244.8° AND 252°.

MAX O-RING GROOVE WIDTH: .376
 MAX O-RING GROOVE DEPTH, FROM F.H. METAL SURFACE: .196
 MIN O-RING DIAMETER: .2721
 O-RING DEFORMED LENGTH: .297 - .301
 O-RING FOOTPRINT: .117 - .122

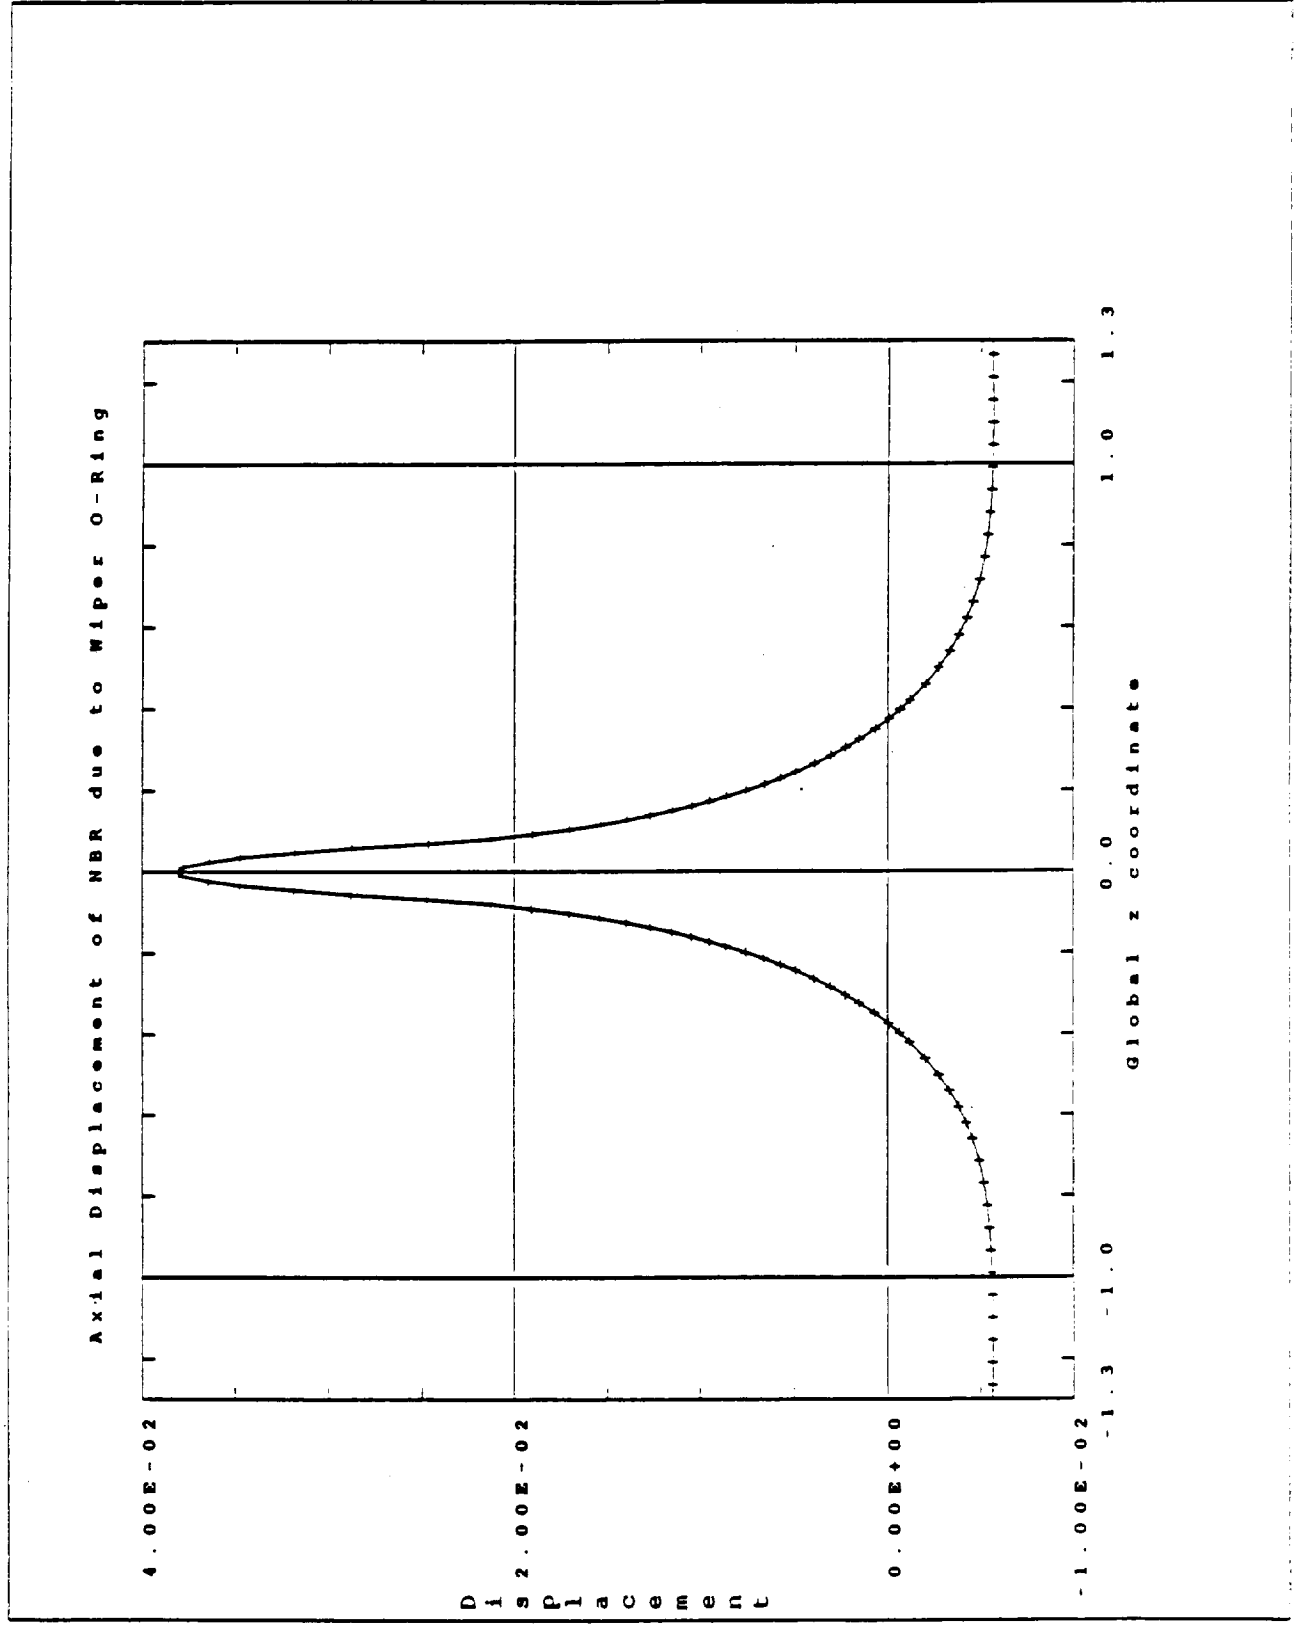
Figure 6-22. NBR Indentation

wiper O-ring during the postflight inspection, it has been determined that the wiper O-ring blowby that occurred in this joint was short lived, lasting on the order of 0.15 seconds before resealing. A probable scenario on why the O-ring leaked and then resealed is based on the indentation made in the NBR by the wiper O-ring. Due to the NBR indentation, the wiper O-ring did not have sufficient sealing capability when the joint rotated at ignition. The wiper O-ring would have been blown to the aft edge of the NBR indentation and wedged between the aft sides of the O-ring groove and the NBR indentation before resealing. The blowby would have occurred during time the O-ring was shifting.

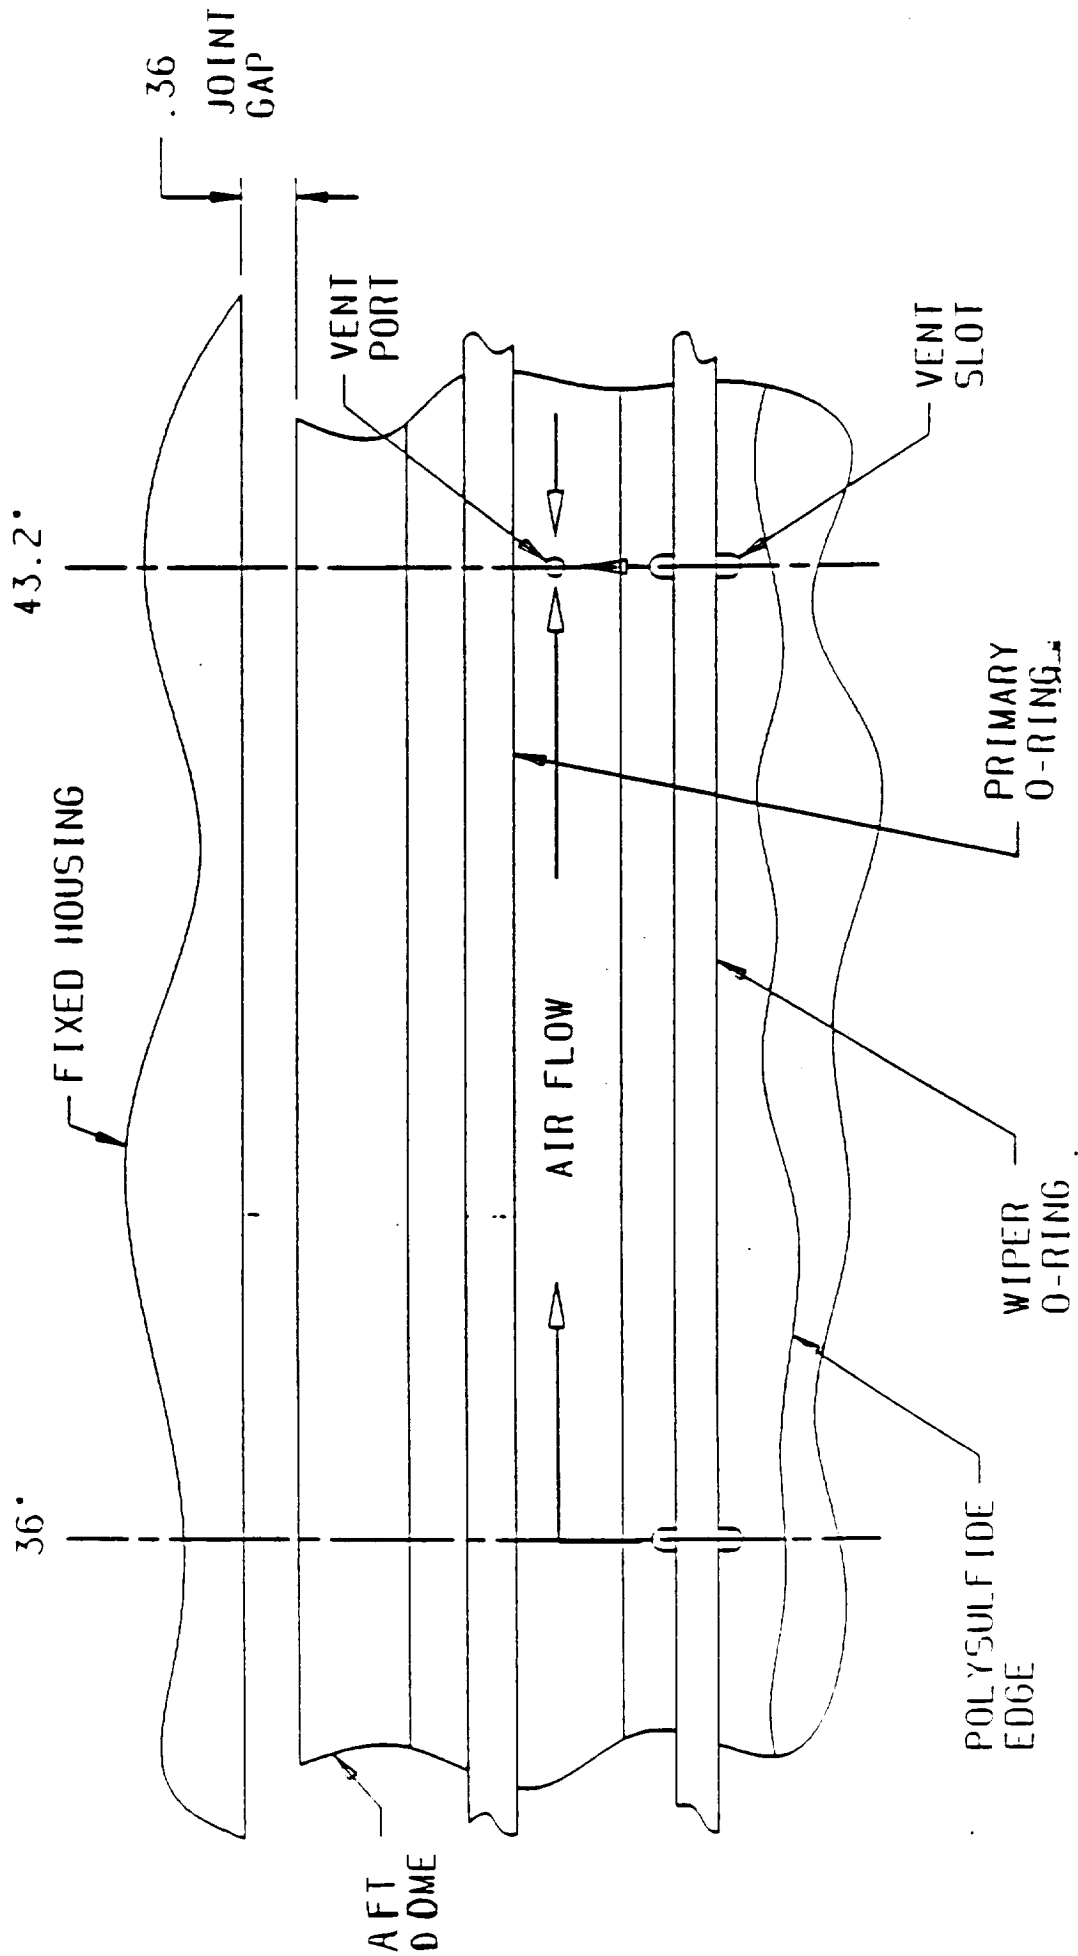
Figure B-32. Nozzle-to-Case Joint Assembly

Roundness measurements taken prior to NJAD and flight nozzle installations have shown that the aft dome has been out of round by as much as 0.208 inch on diameter (RSRM-24A). Fixed housing measurements are not taken prior to nozzle installations, but are assumed to be within 0.005 inch of round based on refurbished measurements. During the assembly, contact between the aft dome and fixed housing metal hardware and the O-rings act as rounding fixtures to force the two components to be concentric. Theoretically, there will be locations around the circumference where the gap between the hardware is at a maximum and locations where the gap is zero. The joint design could allow a condition where there is no standoff gap between the fixed housing GCP and the aft dome NBR, as well as the two metal components. With this condition the channel between the wiper and primary O-rings would not exist in localized areas, possibly isolating a large portion of the trapped air in the joint

from the vent port. This condition could result in the formation of large voids and gas paths in the polysulfide as the assembly progressed.

3.1.1 An investigation is recommended into concepts to improve the air venting capability of the nozzle-to-case joint during the assembly process, including: extending the vent slots aft to the case metal part, adding more vent ports to the fixed housing, and incorporating a bleed path around the circumference of the joint.

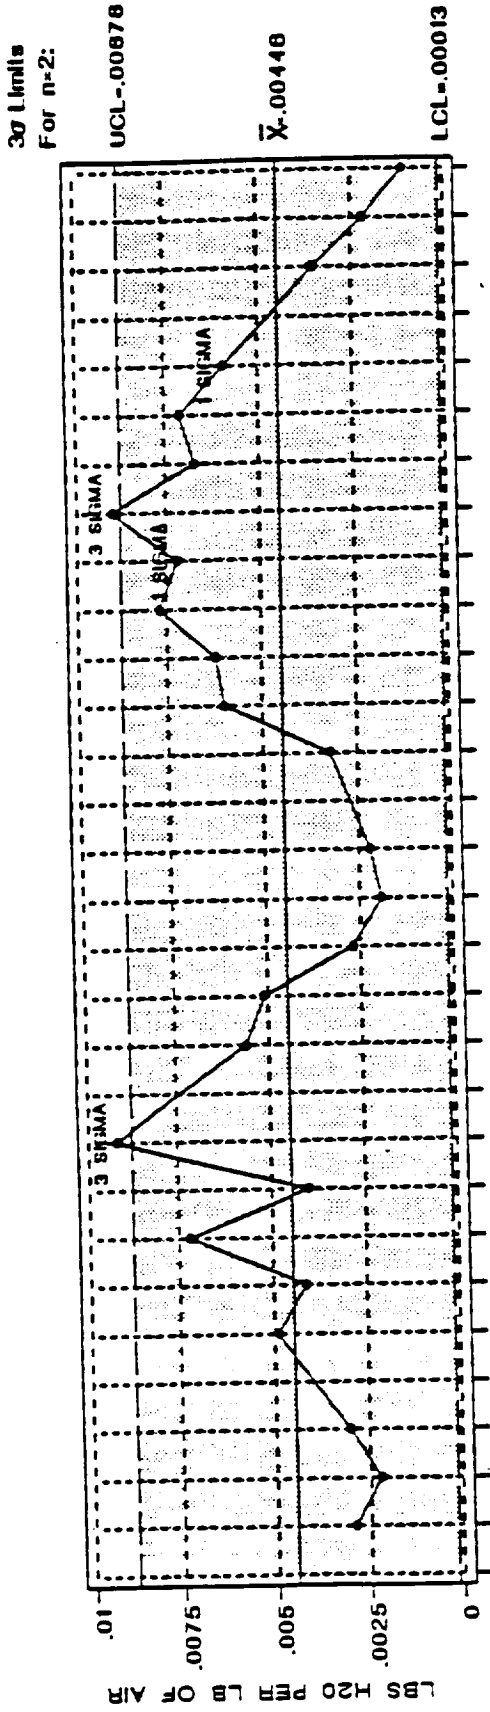
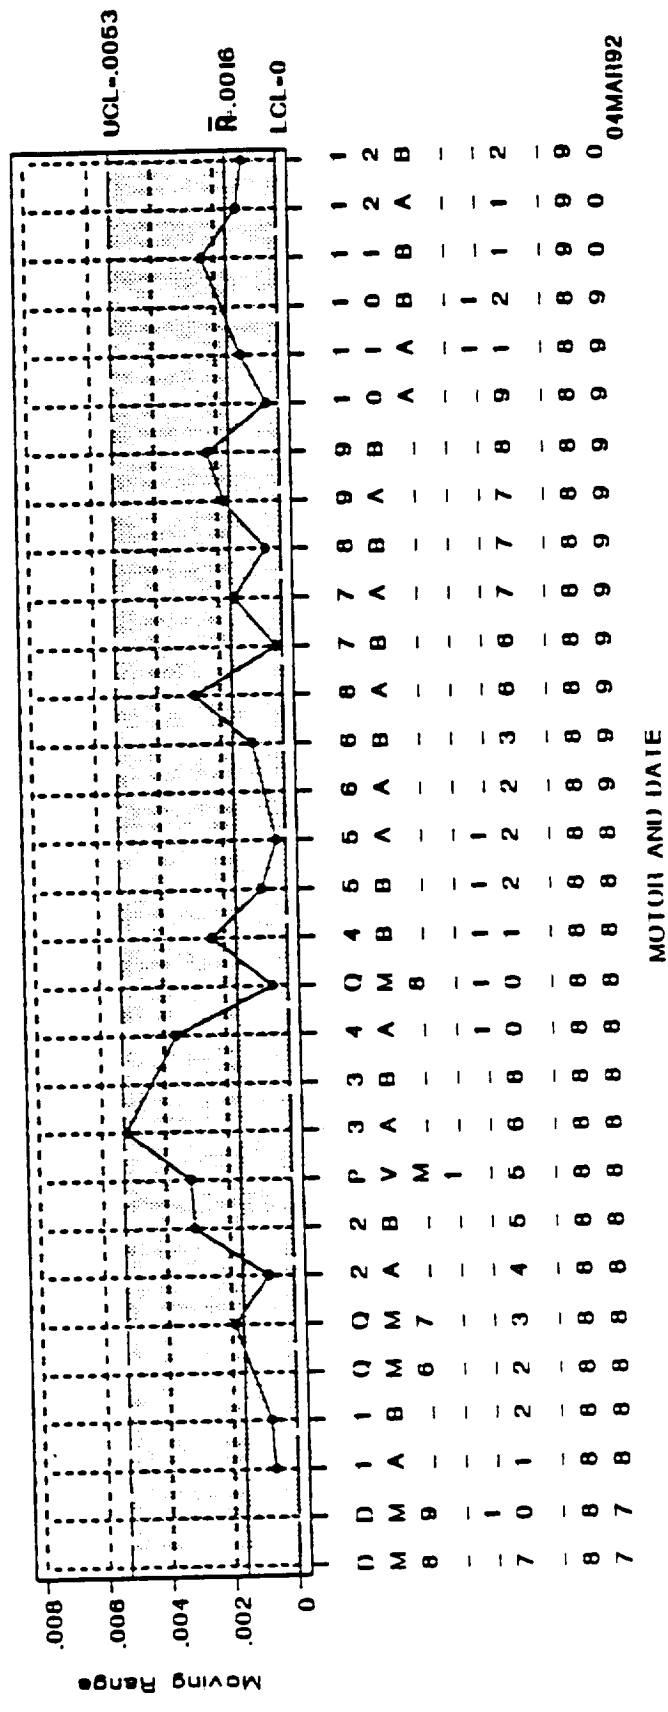
Figure 5-6. Absolute Humidity

The absolute humidity at the plant during the nozzle installation process was .0019 lbs of water per lb of dry air for the -20A segment and .0014 lbs of water per lb of dry air for the -20B segment. Both readings are below mean of .00446 lbs of water per lb of dry air, but within the historical data base (See Figure D-6). Lower absolute humidity has the potential for reduced polysulfide viscosity since moisture is a cure accelerator. The current polysulfide application specification does not have absolute humidity requirements, however, the new specification does.

- 3.5 The conditioning of the fixed housing and aft dome should be better controlled to improve uniformity of the component.
- 3.6 Limits should be established for the absolute humidity at time of polysulfide application.

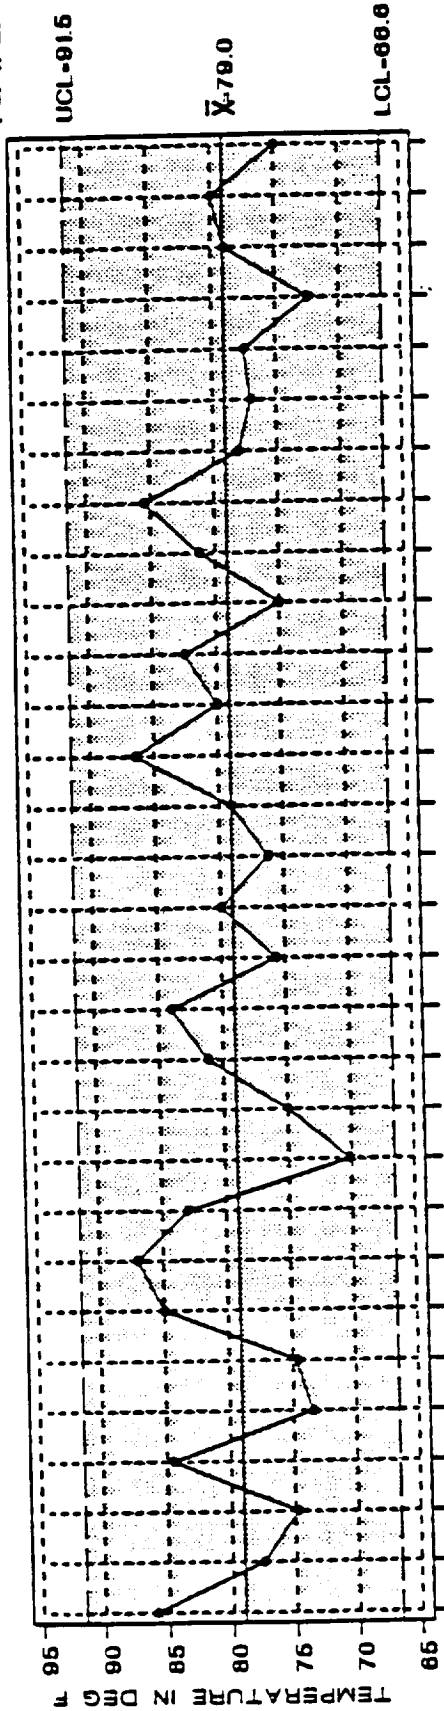
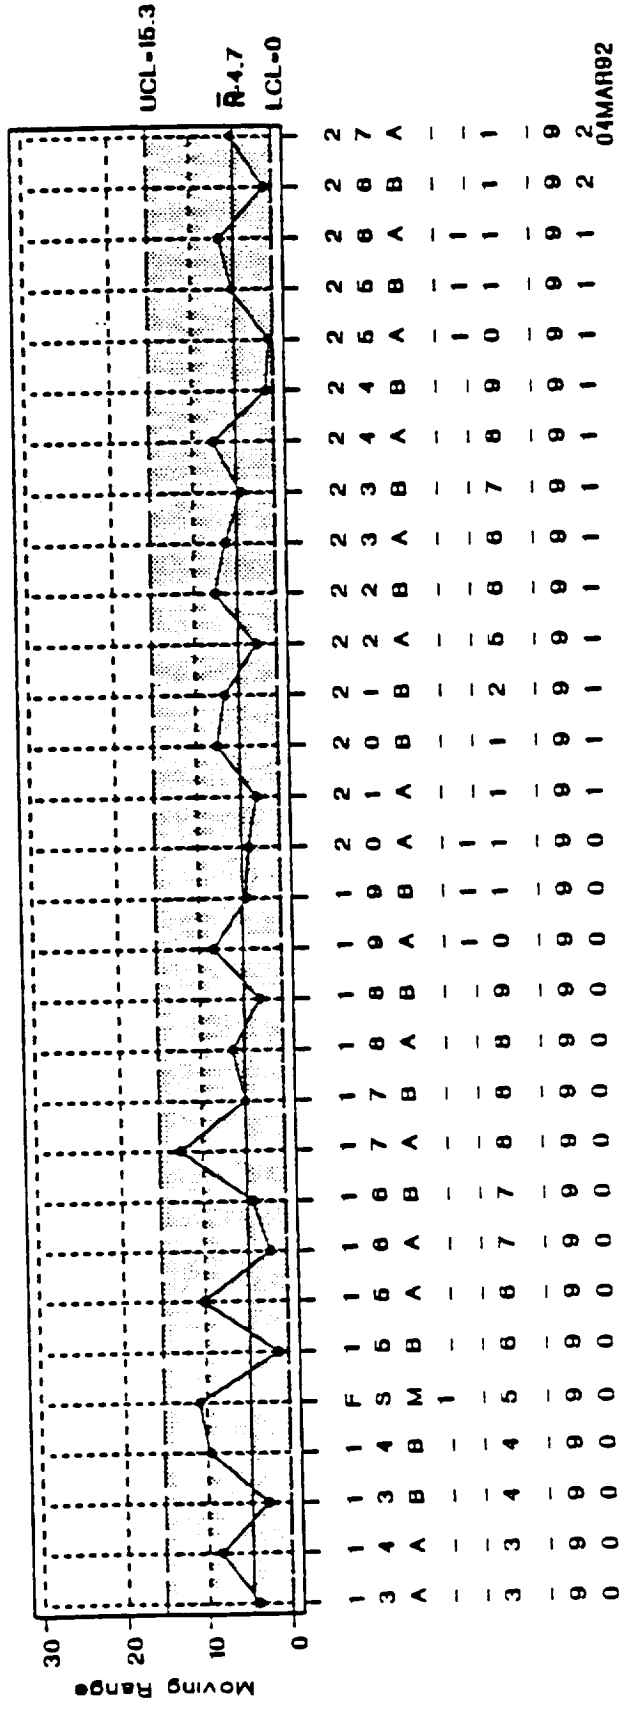
Figure B-7. Average Fixed housing Temperature (CONT)

The average of four fixed housing temperature measurements taken off the phenolic bonding surface prior to polysulfide application was 76°F for the -20A nozzle and 86.5°F. for the -20B nozzle. The -20A nozzle was slightly below the mean of 79.0°F. while the -20B nozzle was 7.5°F. above the mean. However, both are within the historical data base (See Figure D-7). The average temperature per the specification is 70 - 100° F. It should be noted that the temperature measurements are taken

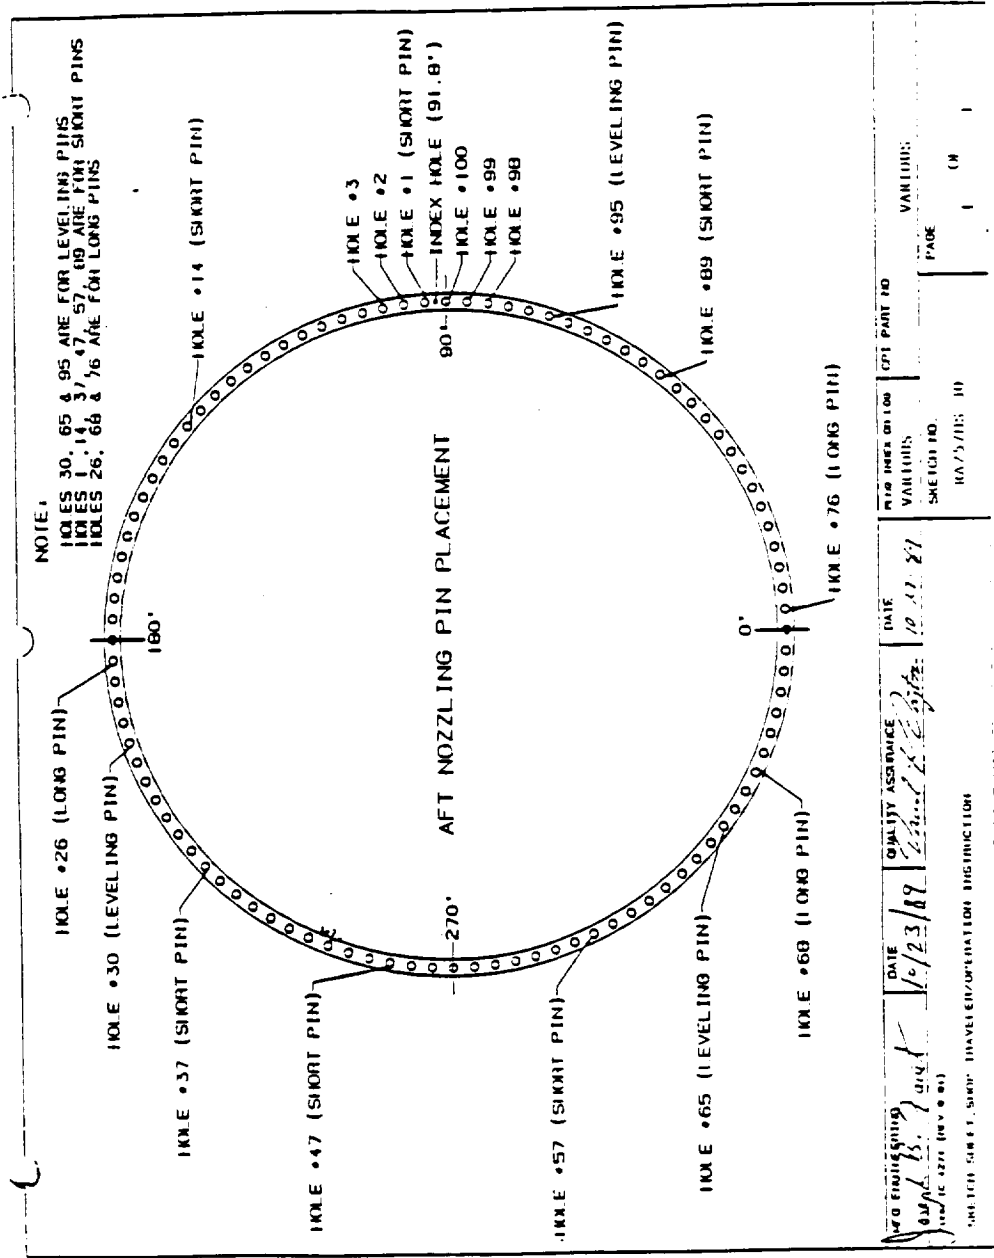
Figure D-15. Guide Pin Positions

The influence of out of round conditions on the assembly was evaluated. Concentricity is controlled during assembly by the use of three each long tapered guide pins (36-inches long) and six each short tapered guide pins (8.5-inches long) which are positioned in the axial bolt holes on the aft boss. The guide pins are installed at various locations to force the fixed housing and aft boss to conform to each others shape (see Figure D-15). The long guide pins begin the initial "rounding" with the final shape accomplished by both the long and short guide pins at 5-inches from seating. The clearance between the fixed housing through holes and the guide pins is .020 to .032 inches. The maximum condition of .032 inches is the controlling factor until approximately 3 inches from seating when the wiper O-ring on the fixed housing enters the aft boss. At this point, the guide pins are no longer controlling the assembly. The metal tolerances of the fixed housing and aft boss are tighter than the guide pin to fixed housing through holes and the components now control the assembly clearances. The long guide pins begin the "rounding" with the final shape accomplished by both the long and short guide pins at 5 inches from seating.

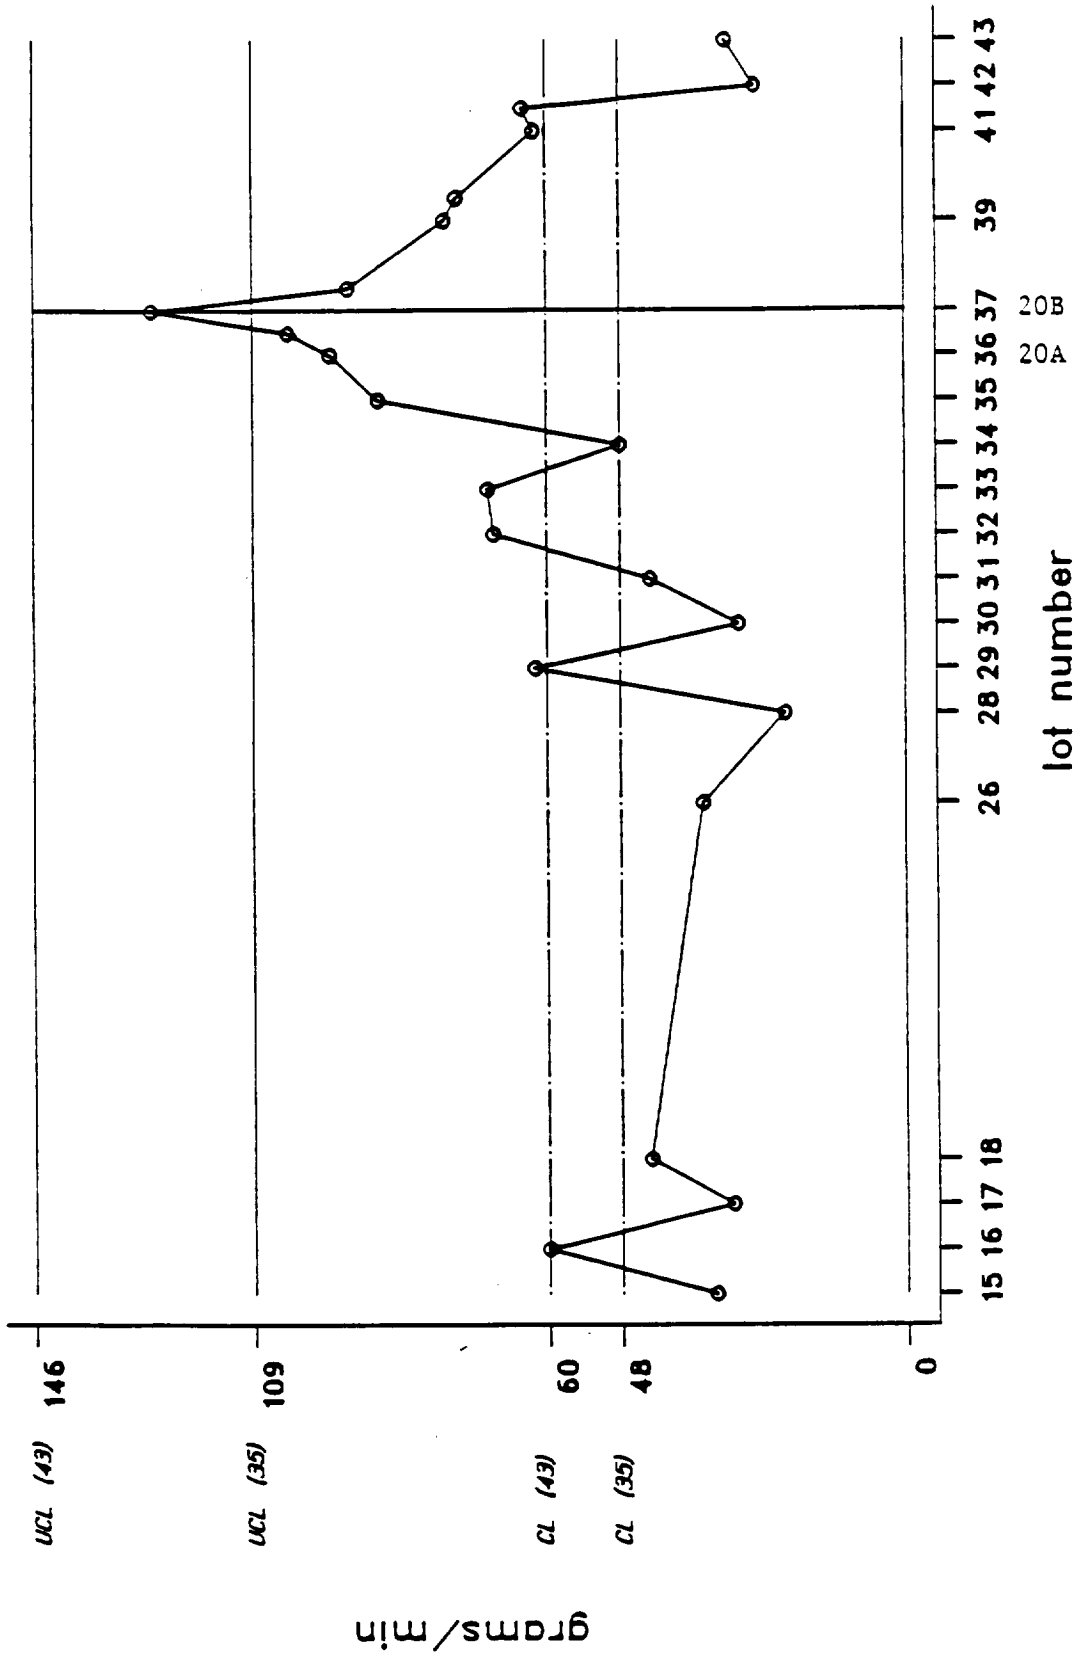
Figure E-1. Application Life (Extrusion) Acceptance History for 4907 Polysulfide

1. Lot 037 viscosity build is significantly slower than the other four lots tested
2. Lot 037 flow down a vertically-oriented, graduated aluminum bar was the lowest of the five lots tested
3. Lot 037 application life as measured by Semco tube extrusion was the highest of the lots tested (120 gms/min) and confirmed the original lot acceptance test results (127 gms/min)

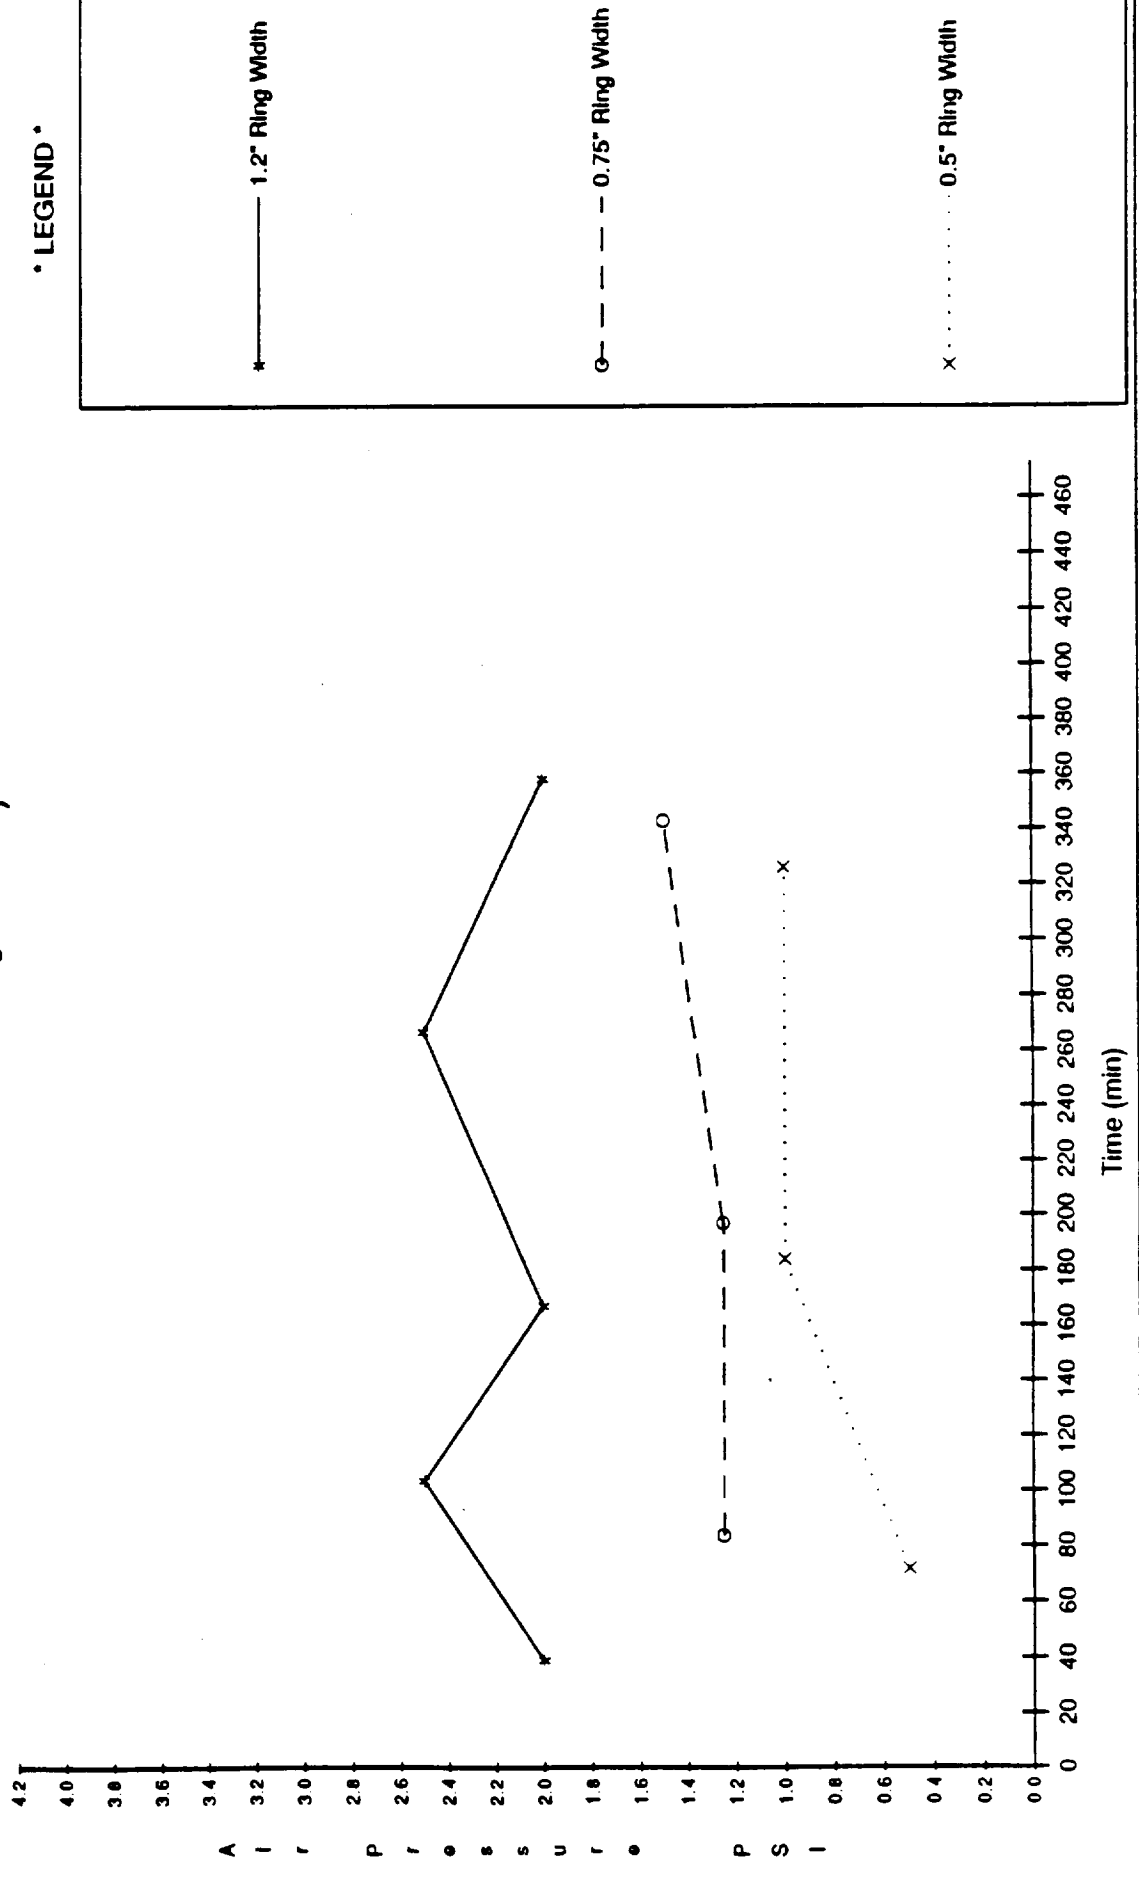
and E-12). All the testing was performed at 70-75°F with humidity under 10 percent RH except one data point was taken at 100°F.

Figure E-II. Screened Polysulfide Ring Width Effect on Required Air Pressure

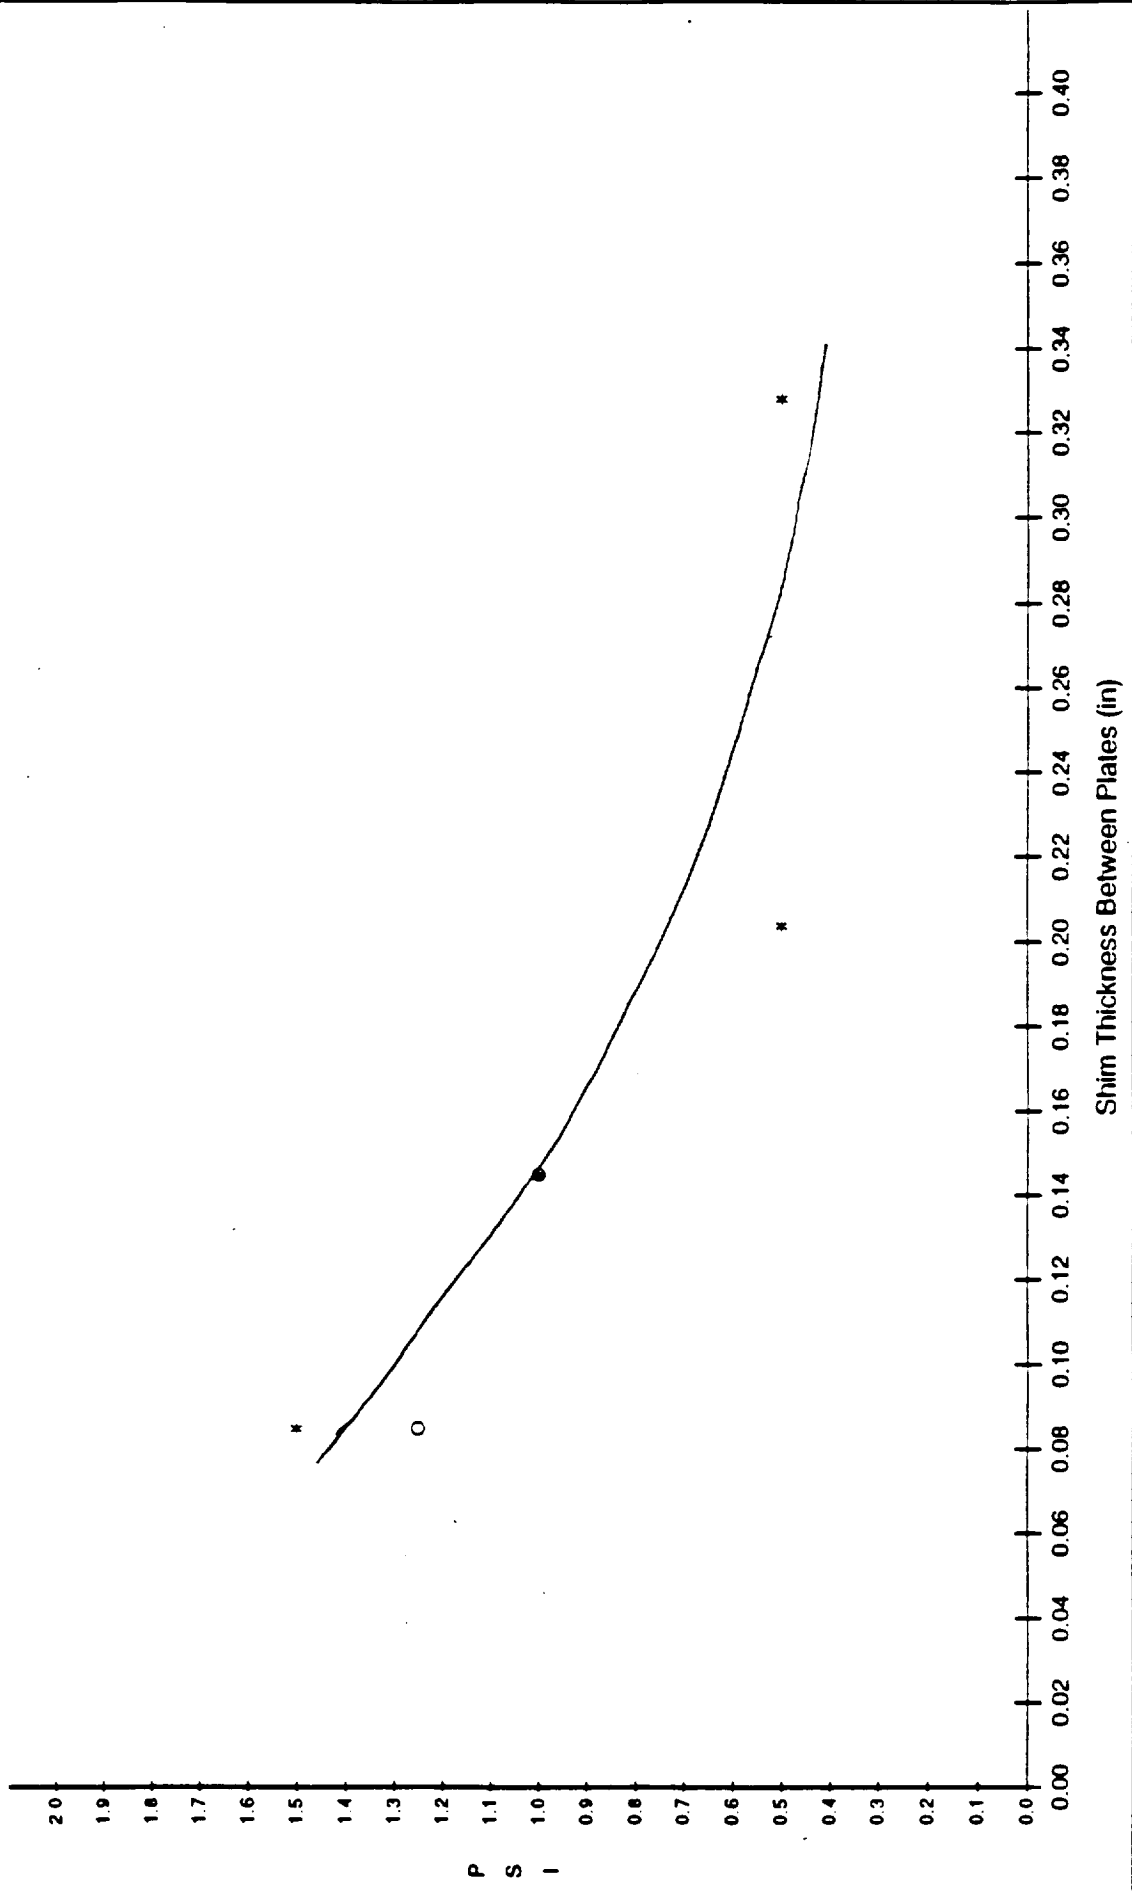
Figure E-12. Screened Polysulfide Ring Thickness Effect on Required Air Pressure
