TWR-63941

**Flight 20 (STS-45)
Polysulfide Gas Path Investigation
Final Report**

July 1992

Thiokol CORPORATION
SPACE OPERATIONS

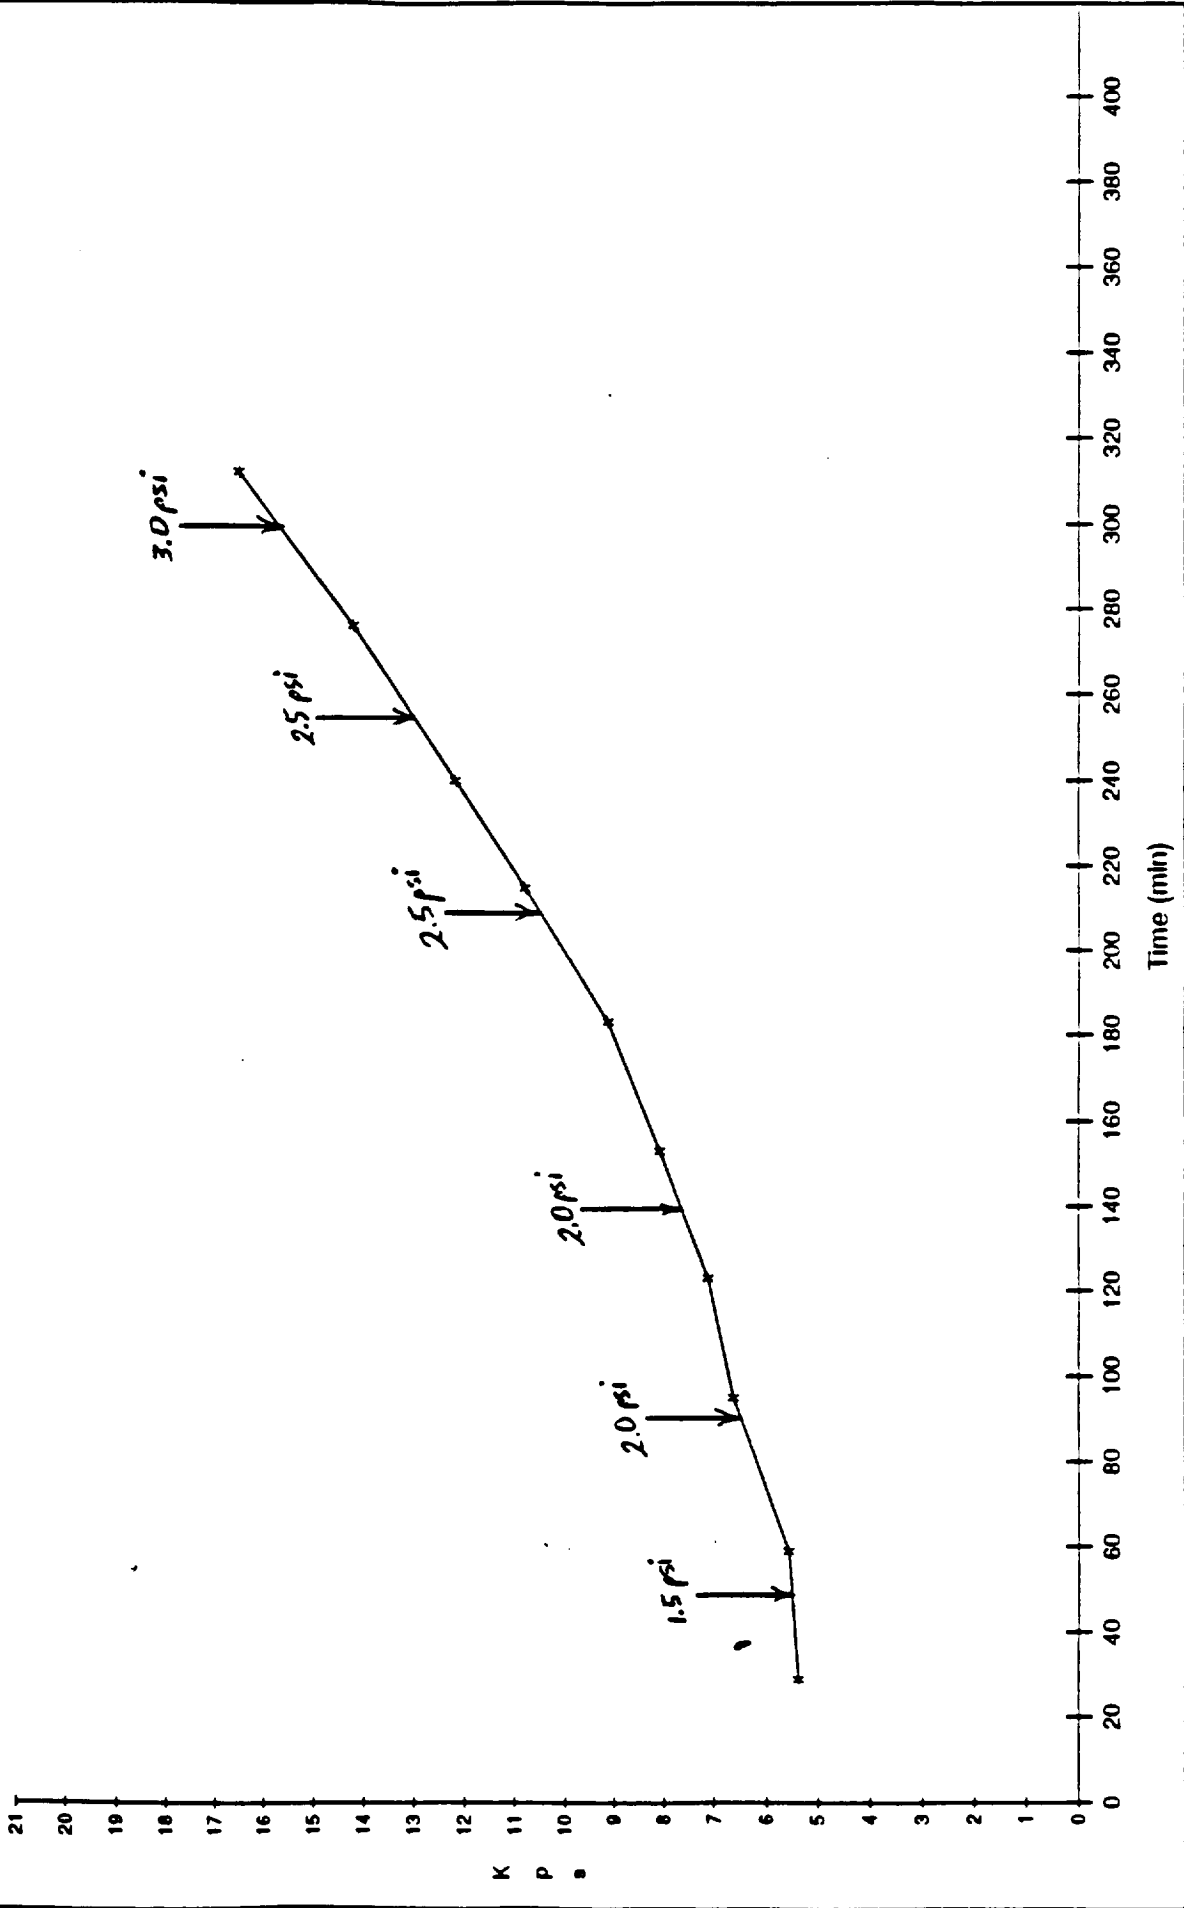
Figure E-13. Air Pressure Required to Form Gas Path During Viscosity Build of Lot-0043

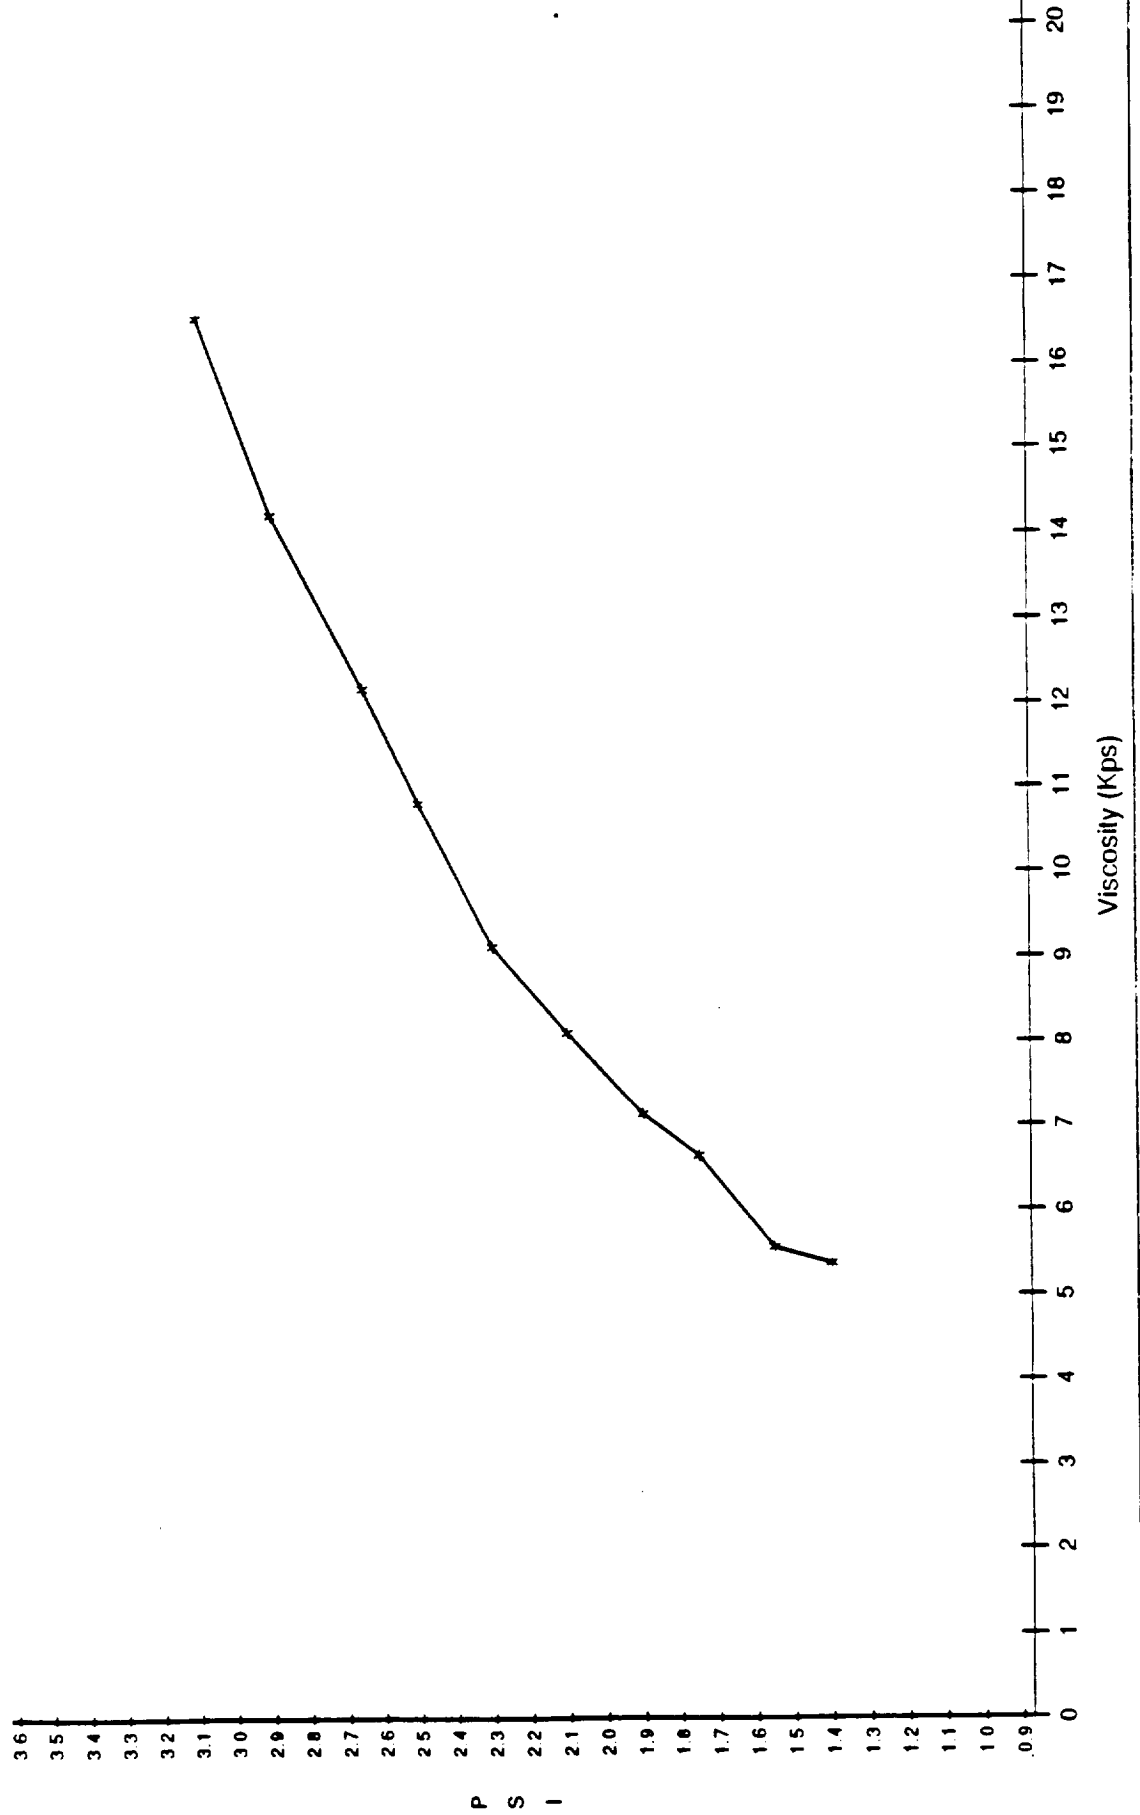
Figure E-14. Air Pressure Required to Form Gas Path During Viscosity Build of Lot-0043

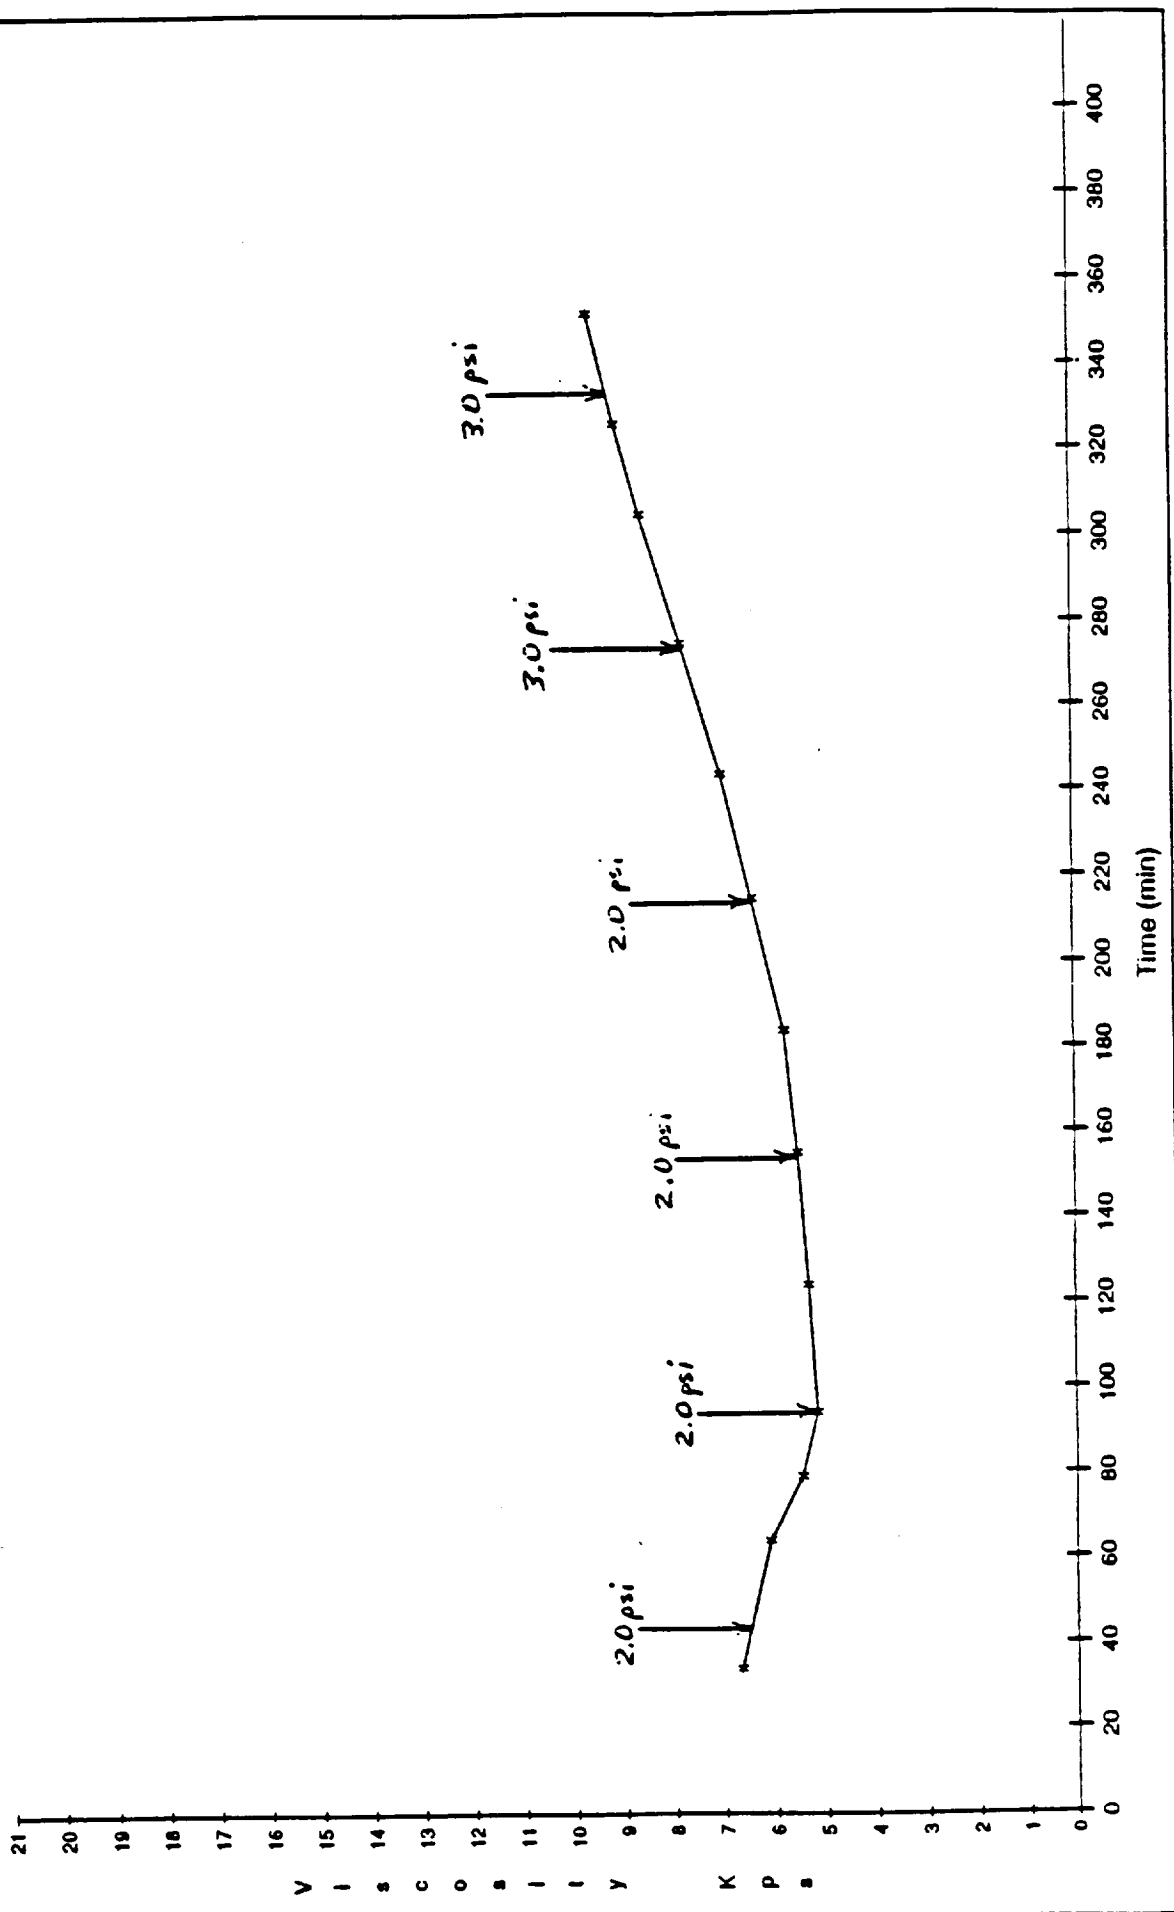
Figure E-15. Air Pressure Required to Form Gas Path During Viscosity Build of Lot-0041

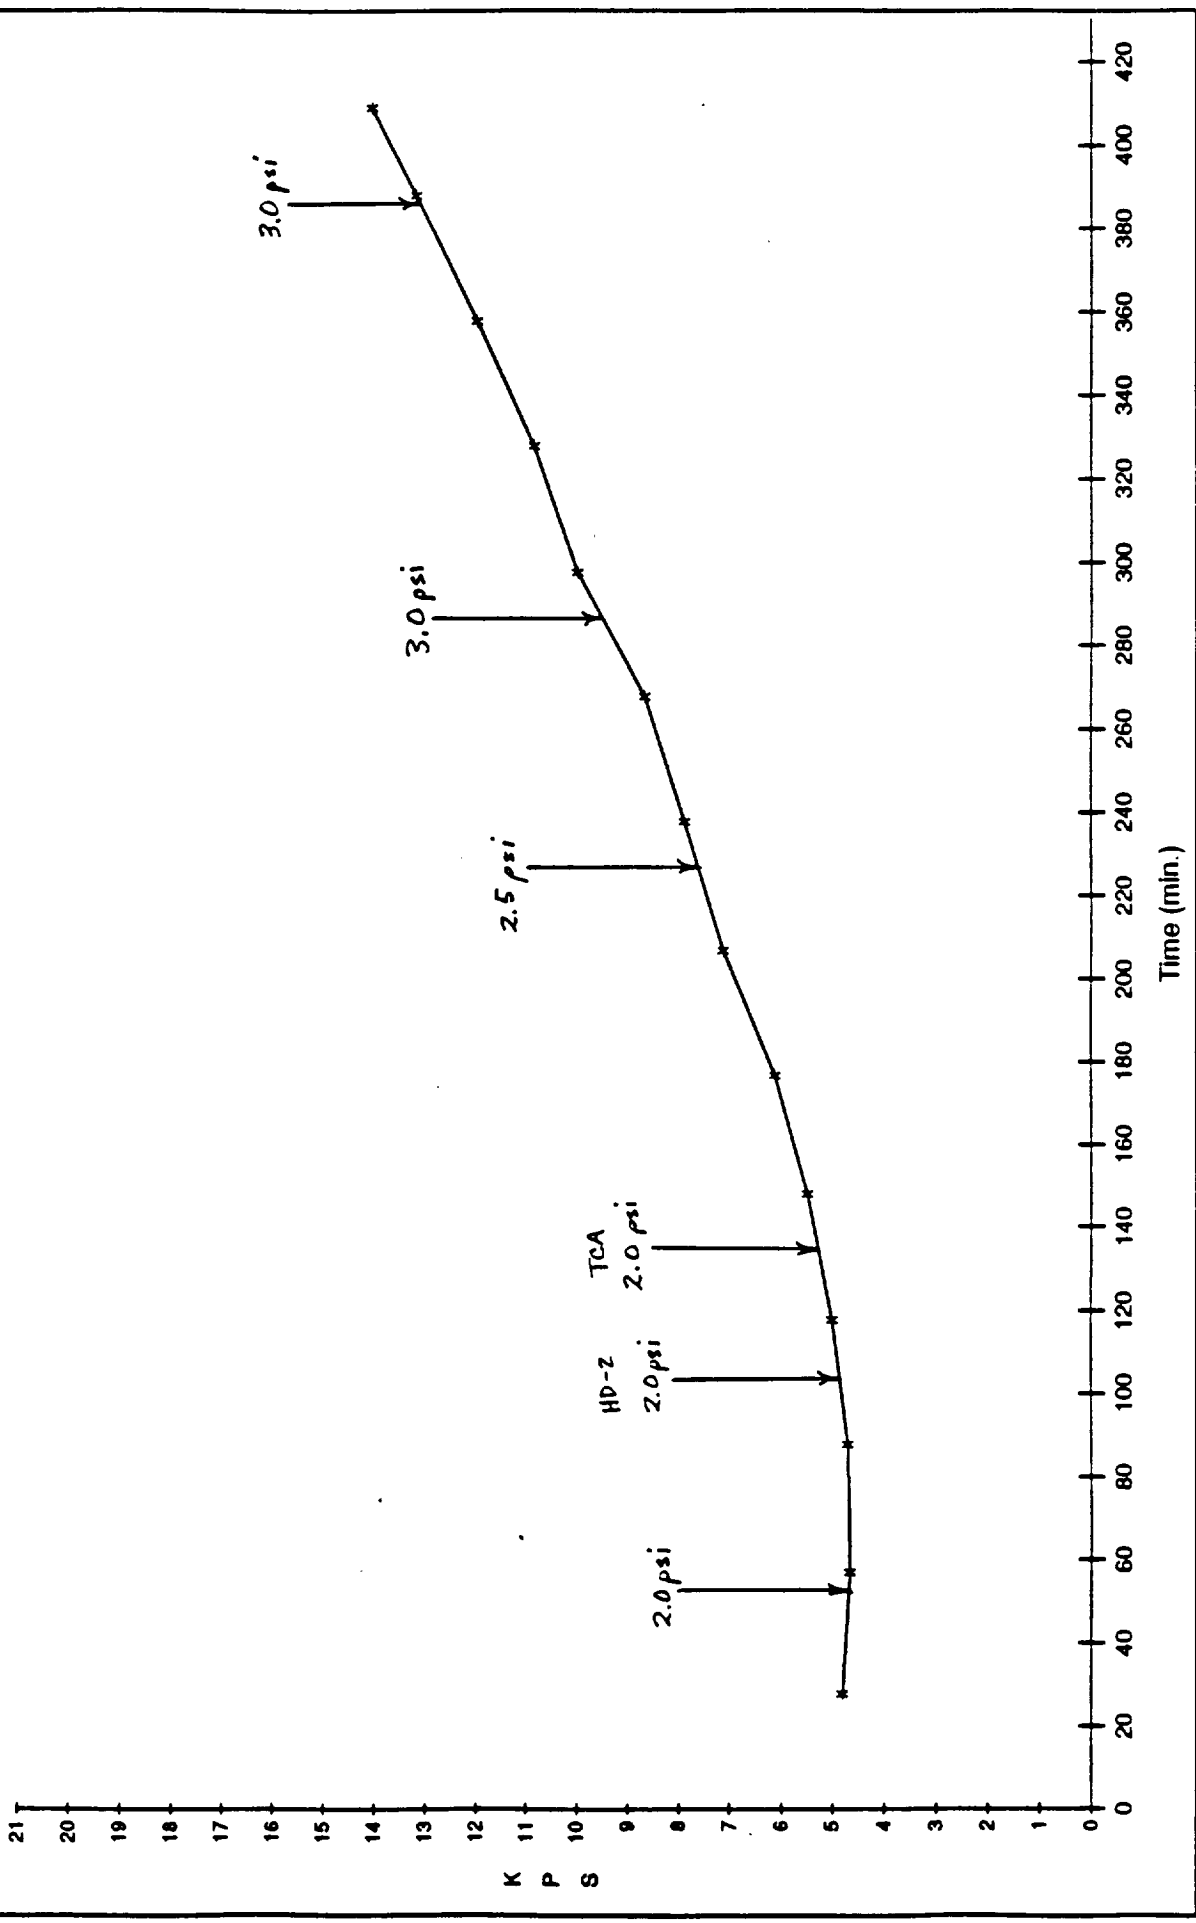
During testing of Lot 039 material, two contaminants were tested for their affect on gas path formation. The first contaminant tested was Conoco HD-2 grease. It was tested by smearing a half-inch wide grease path on one of the plexiglass plate halves to see if the contamination would facilitate a gas path through the polysulfide ring. The failure (gas path) did not occur at the greased location. The second contaminant tested was methylchloroform. A circle of polysulfide was screeded on the plexiglass model with methylchloroform liberally poured across a two-inch portion of the screeded ring. The failure (gas path) did not fail at the methylchloroform-treated portion of the screeded polysulfide ring. Figure E-16 shows the contamination test results. Plots of the other test results are shown in Figures E-13 through E-19 (Photo Negative #127384).

Figure E-16. Air Pressure Required to Form Gas Path During Viscosity Build of Lot-0039

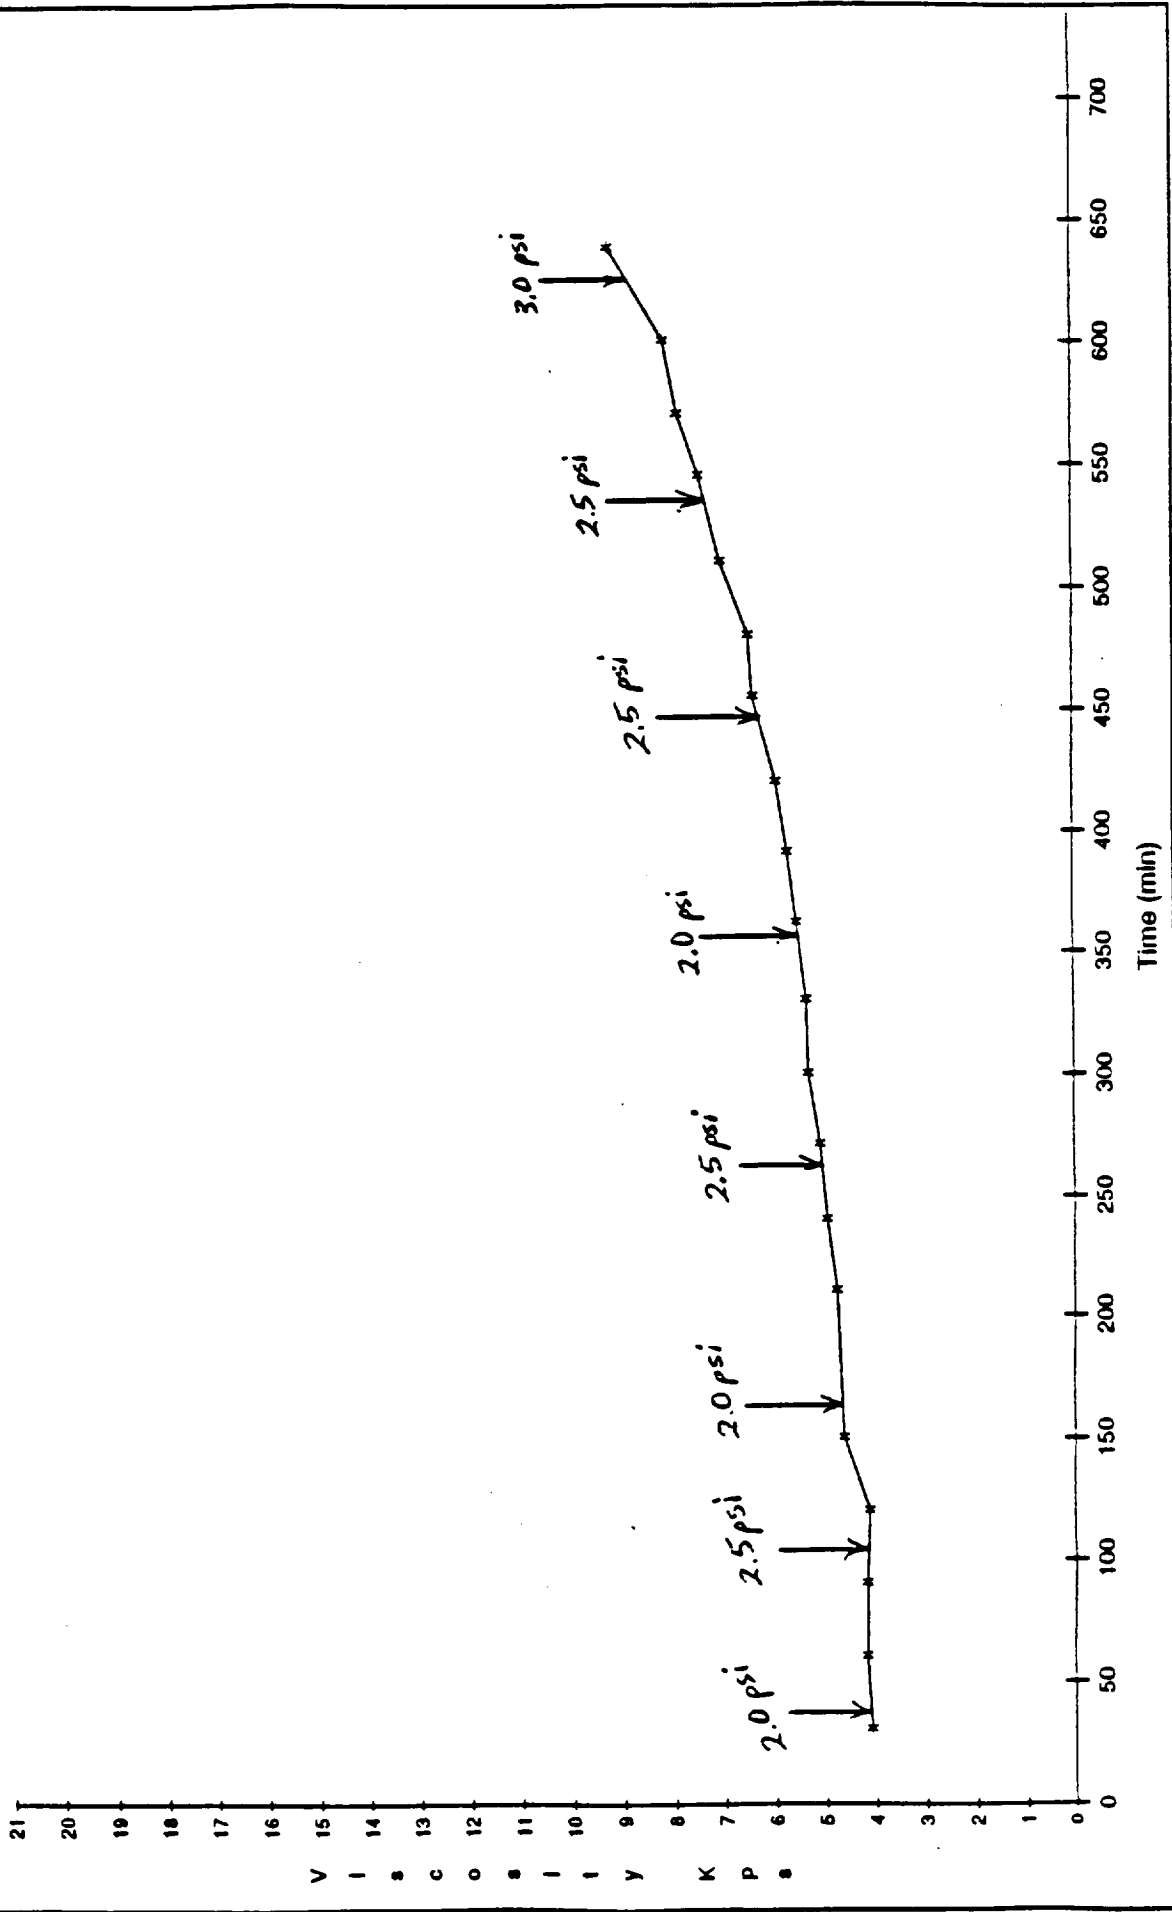
Figure E-17. Air Pressure Required to Form Gas Path During Viscosity Build of Lot-0037

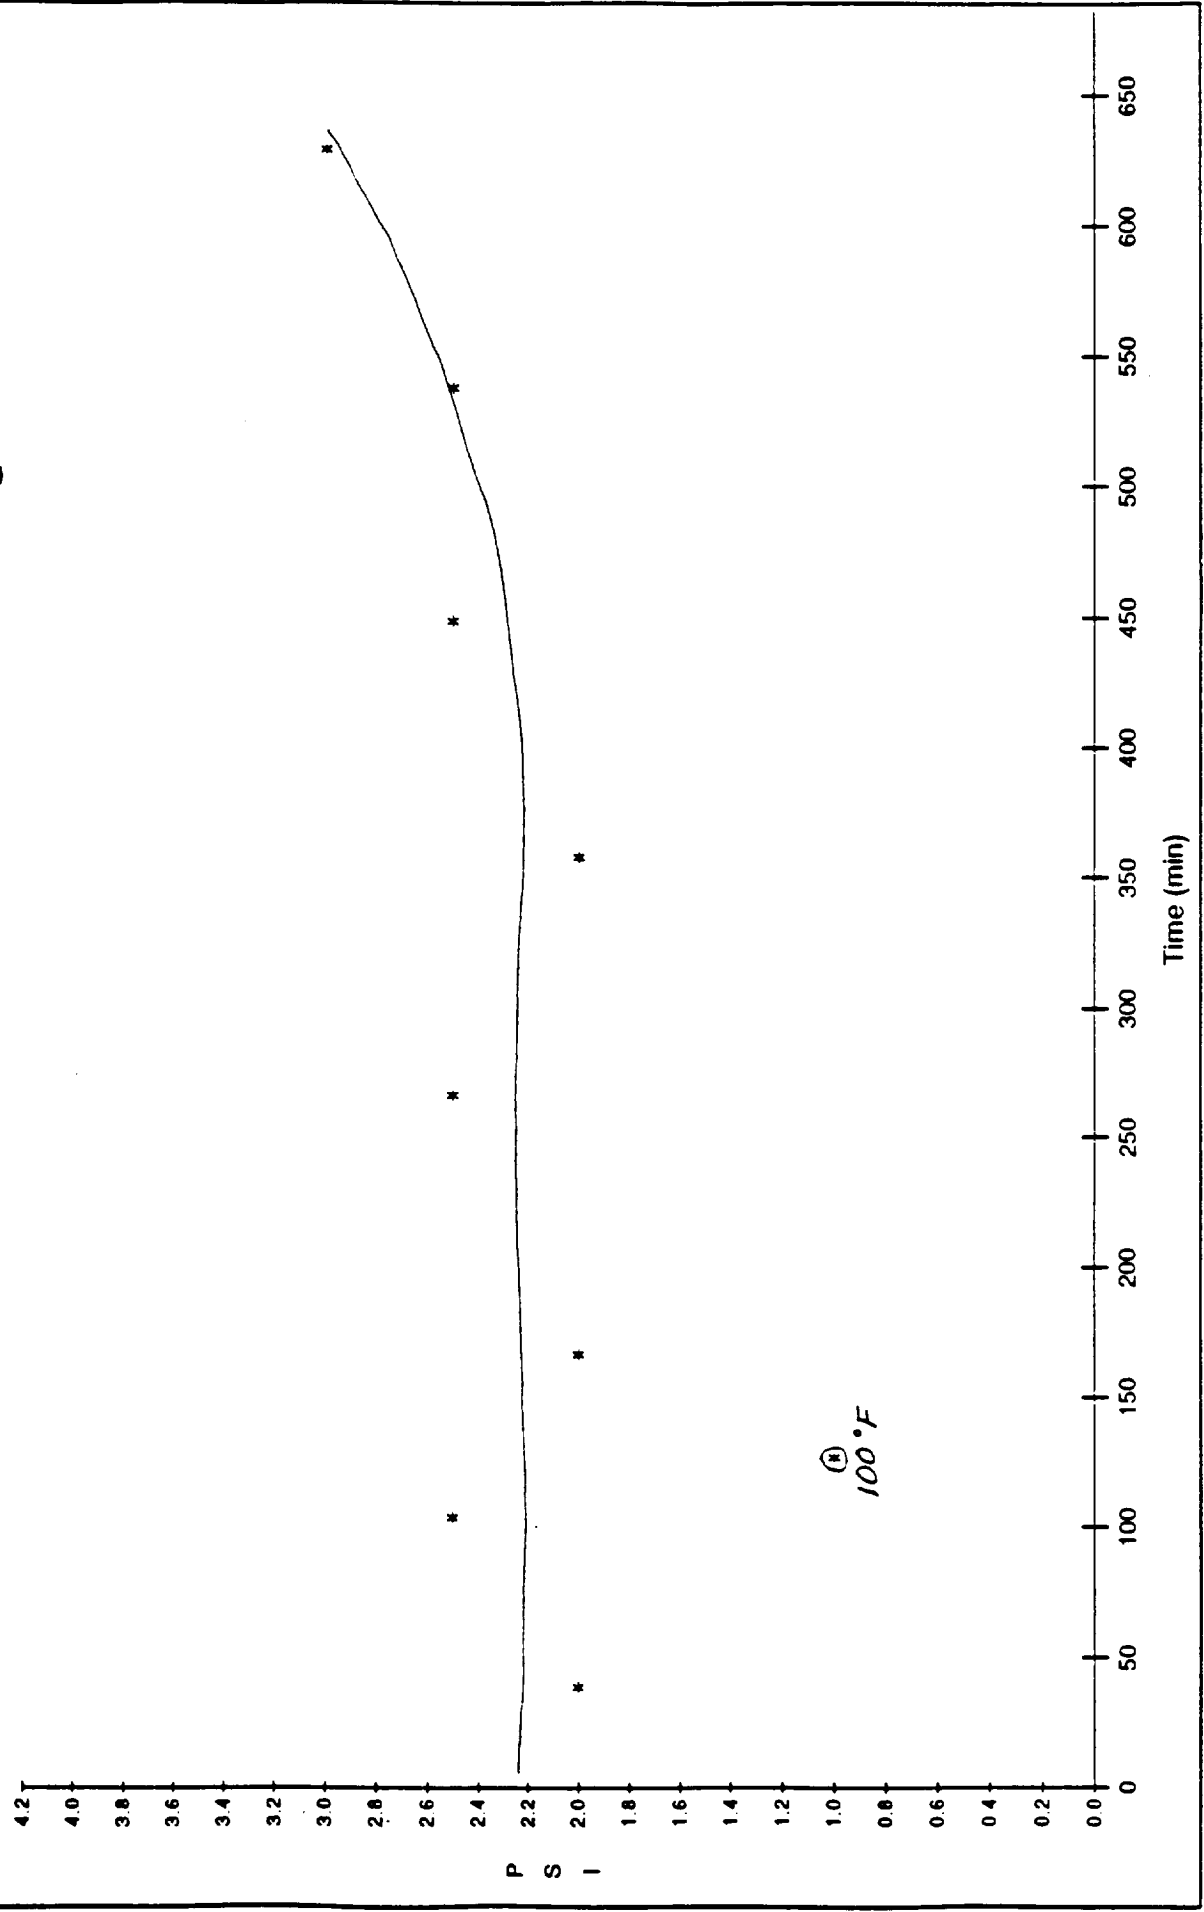
Figure E-18. Temperature Effect on Plexiglass Model Air Pressure

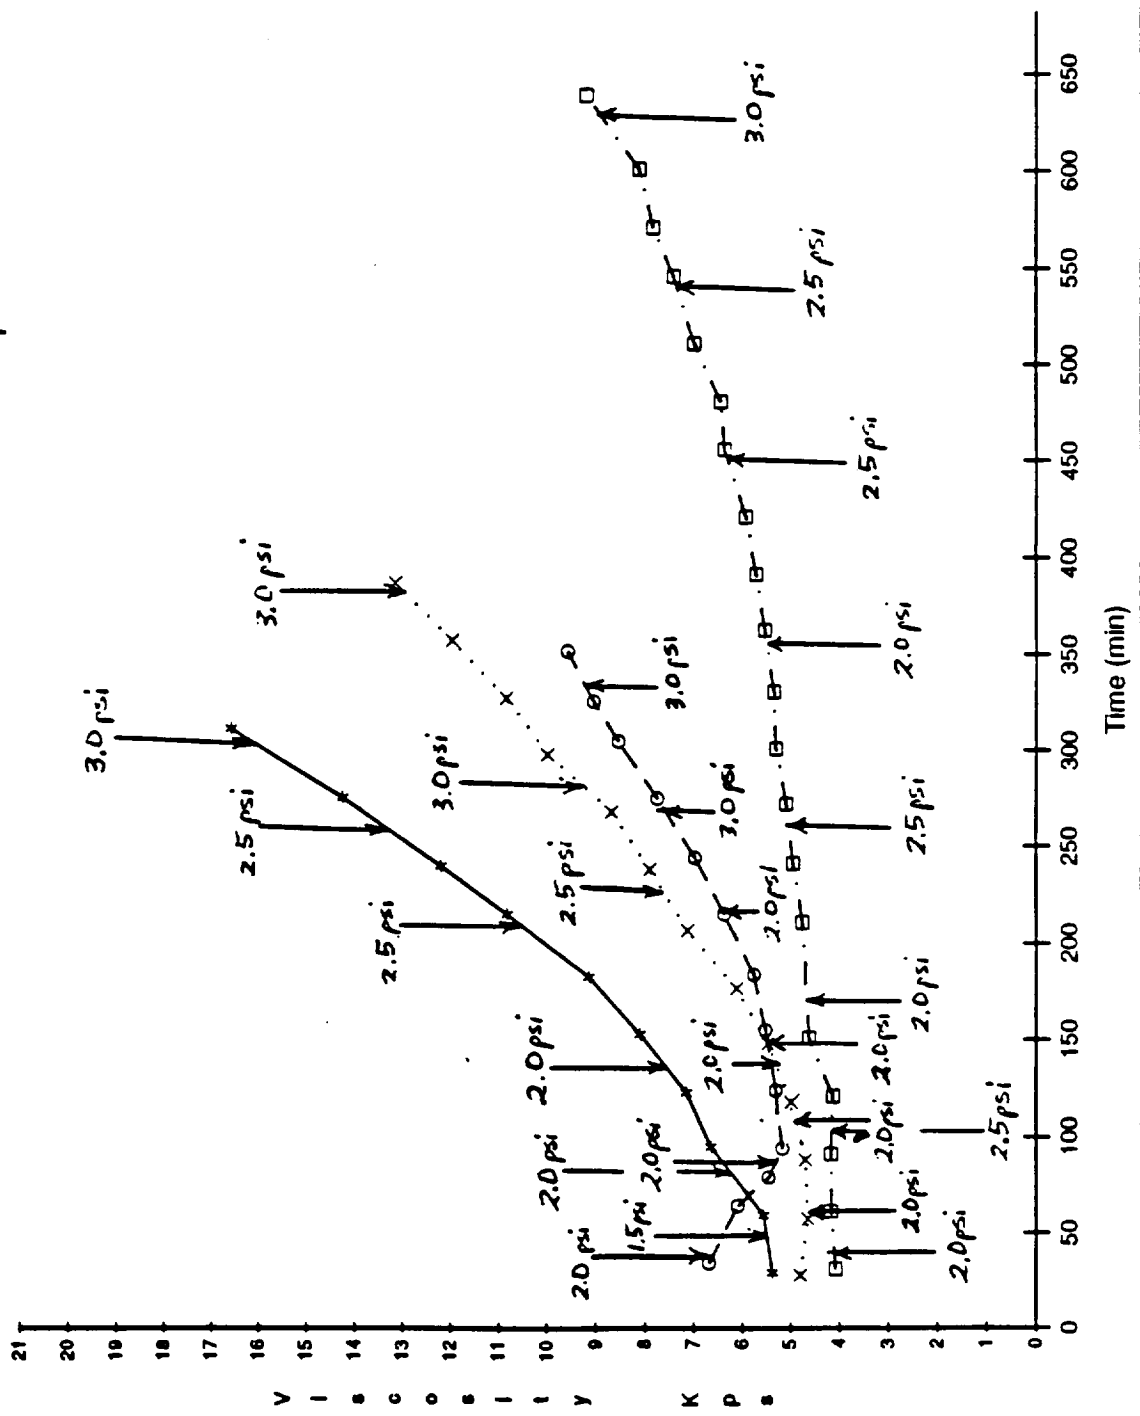
Figure E-19. Comparison of Plexiglass Model Air Pressure by Lots During Viscosity Build
