2016 BRIDGE INSPECTION REPORT
March 18, 2016

BRIDGE NO. CE0079001
BREWSTER BRIDGE ROAD
OVER
BIG ELK CREEK

SABRA, WANG & ASSOCIATES, INC.

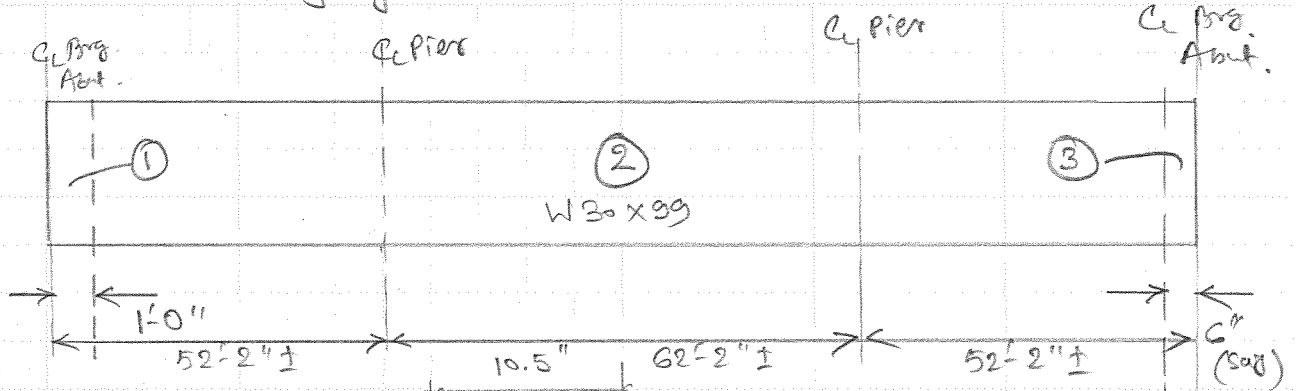
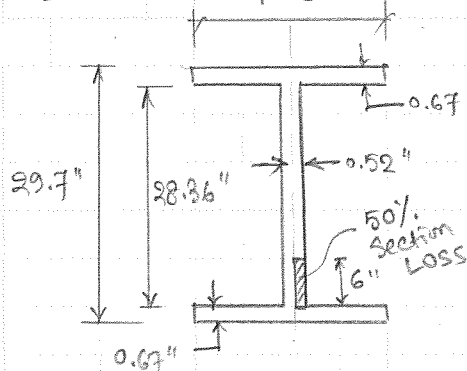
Section 1

At west abutment, beam web exhibits 1' long x 6" high area of heavy corrosion (prev. reported as 50% section loss). At east abutment, beam web exhibits a 4" wide x 6" high area of heavy corrosion. The section loss for the web appears to be up to 1/8" based on visual observation & judgement.

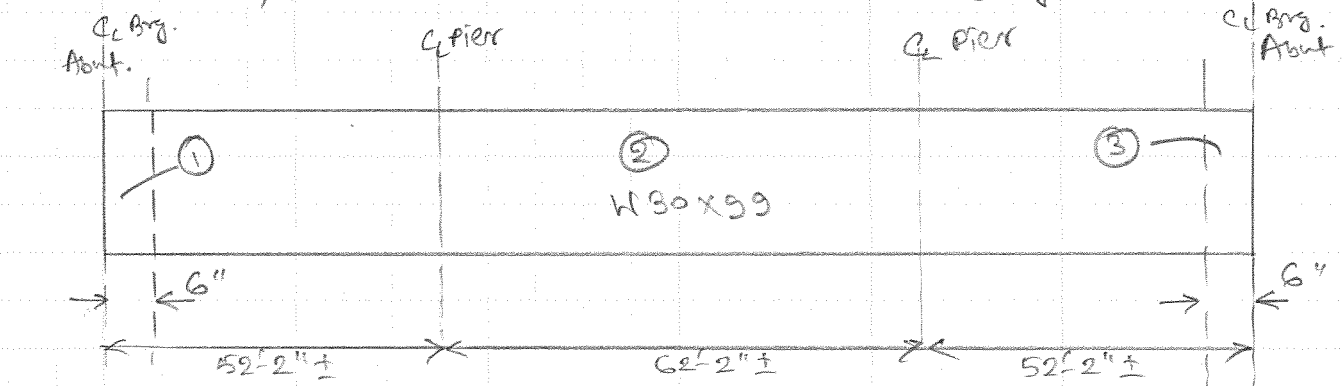
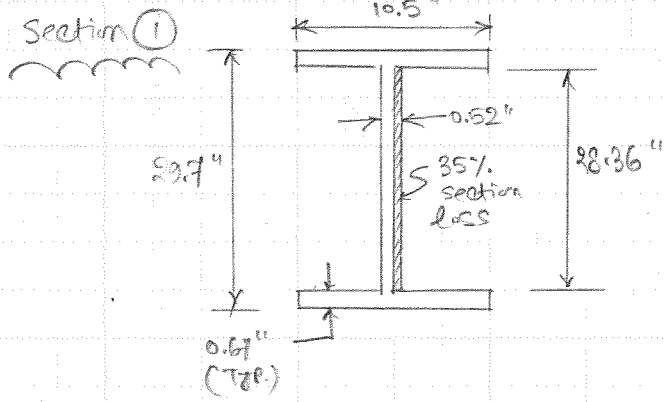
At west abutment, Beam 6 exhibits a 6" wide x full ht. area of heavy surface corrosion. The section loss appears significant (previously reported as 25%) and should be precisely measured. Assume 35% section loss for this analysis. At east abutment, Beam 6 web exhibits 6" wide x full ht. area of heavy corrosion. The section loss appears to be up to 1/8" based on visual observation & judgement.
