EA11-012

HONDA

4/20/2012

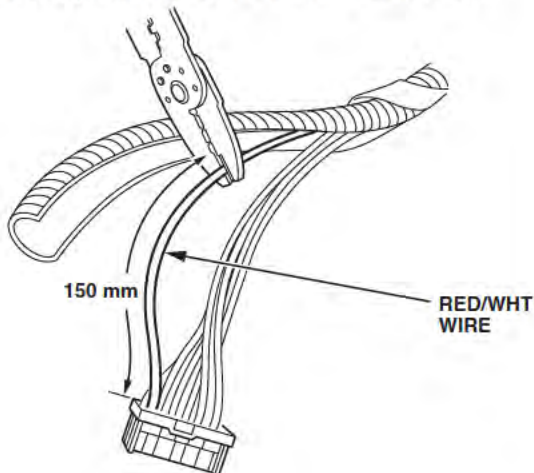
11. Inspect the 16P connector for heat damage or discoloration.
  - If the connector is OK, go to step 12.
  - If the connector is damaged or discolored, go to step 14.
12. Using the Secondary Lock Opener from the Terminal Maintenance Set (T/N 070AZ-S5A0100), carefully pry open the secondary lock on the RED/WHT wire side of the 16P connector.

10. Locate the RED/WHT wire in the 16P connector. Then measure 150 mm from the end of the connector, and cut the RED/WHT wire there.

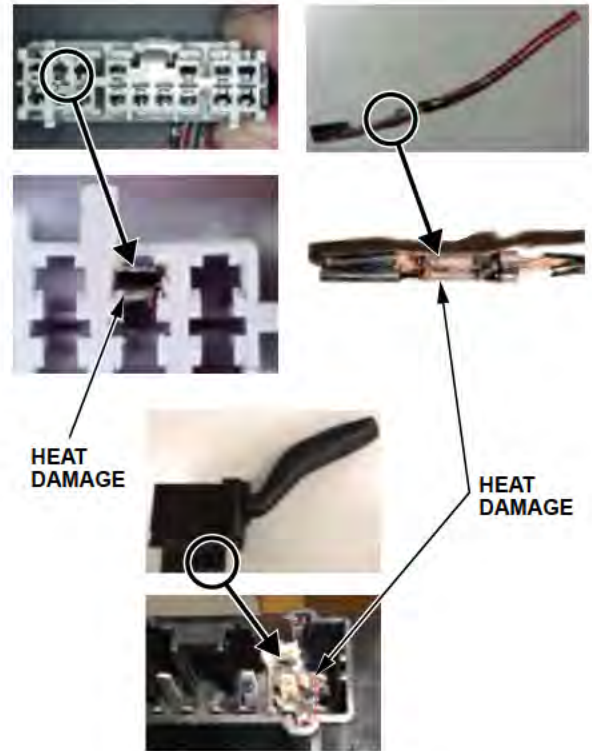
11. Using the photos below, check for signs of heat damage on the 16P connector, the terminal end of the RED/WHT wire, and the 16P terminals of the combination light switch.

- If you don't find any signs of heat damage, *retain the combination light switch* because you'll only be installing a Combination Light Switch Wire Kit. Go to step 14.
- If you do find signs of heat damage, *discard the combination light switch* because you'll be installing a Combination Light Switch Repair Kit. Go to step 12.

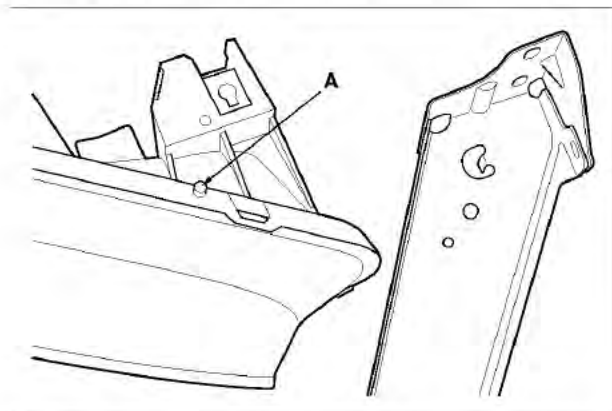
If the alignment pin (A) was broken in a collision and the headlight assembly itself was not damaged, the headlight assembly can be reused.

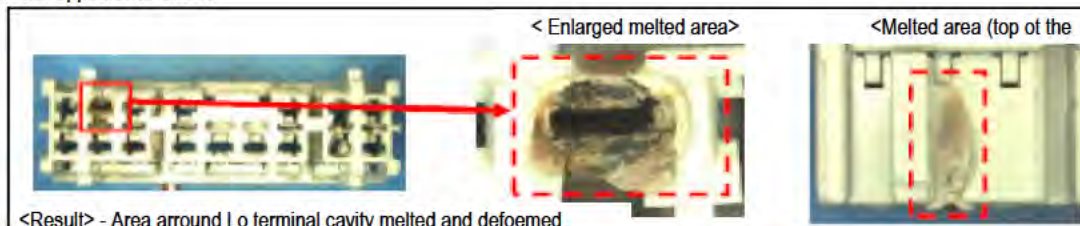
**1. Appearance check**  
 - Connector appearance check

<Result> - Area around Lo terminal cavity melted and deformed.

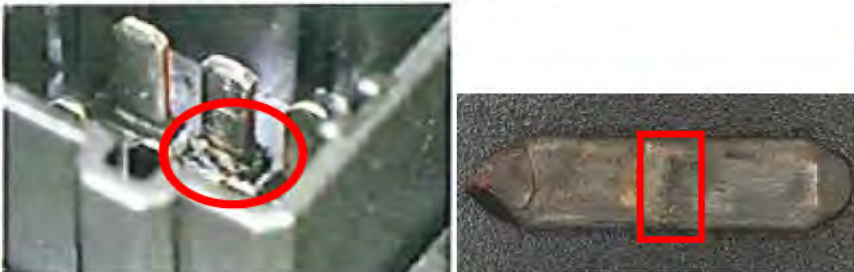
Male terminal in the lighting SW side	Female terminal in the harness side
<p data-bbox="174 391 750 438">Lo terminal is melting due to heat.</p>

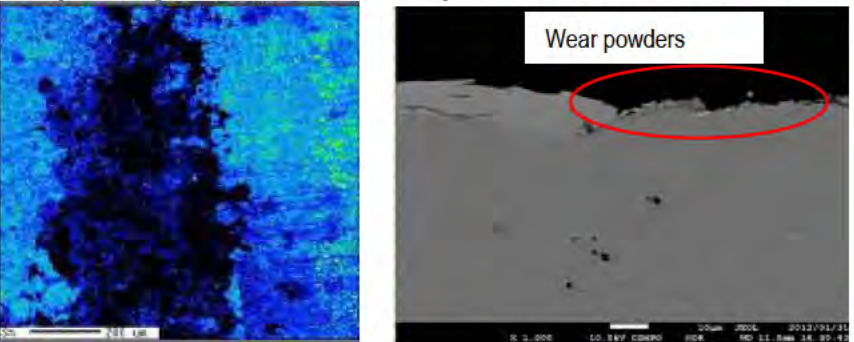
<p data-bbox="174 742 996 790">Sn plating wear, and wear powder accumulation</p>

SN plating wear, and accumulated wear powders indicate that the area had repeatedly been sliding.

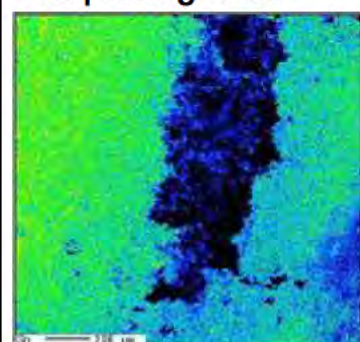
<p data-bbox="1086 742 1377 790">Sn plating wear</p>

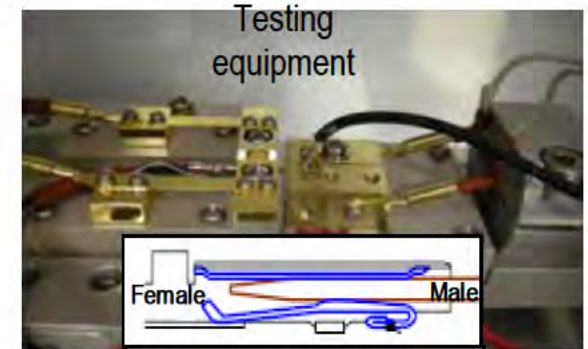
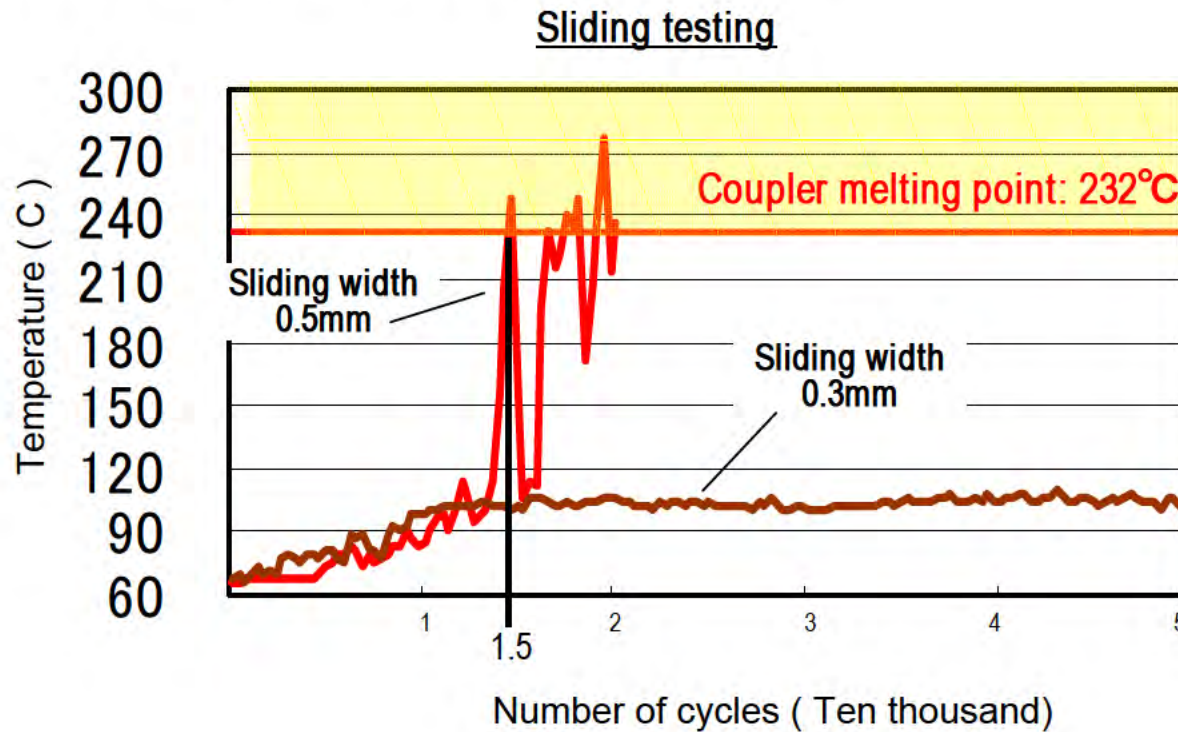
Recreation testing shows brass terminal (Sn plating) reaches the melting point after sliding of 150,000 cycles in 0.5 mm width. However, if it slides in 0.3mm width, or lower, this problem doesn't occur.

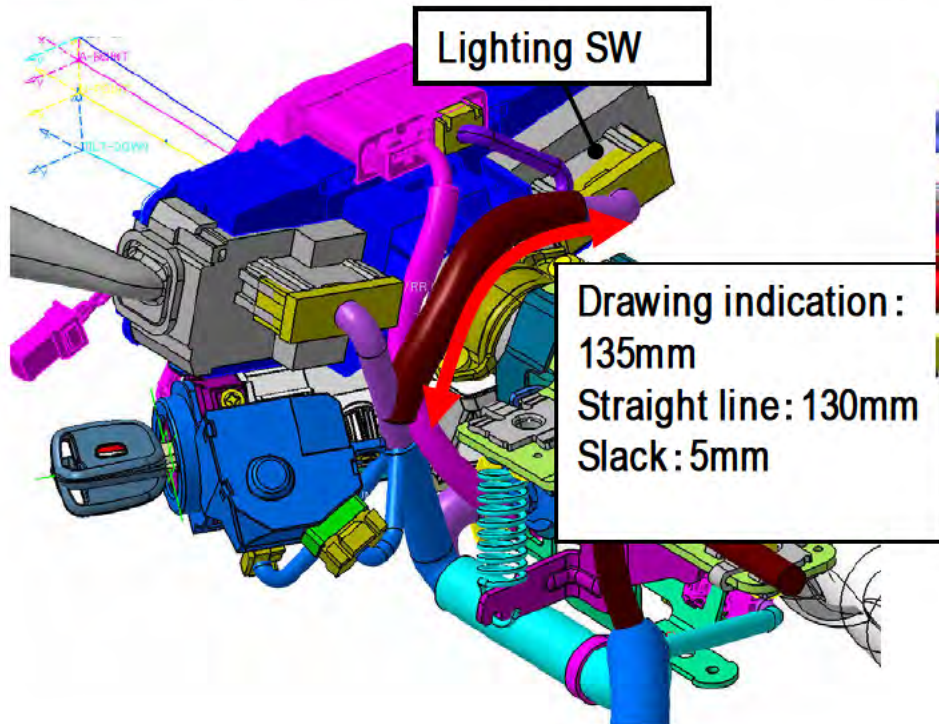
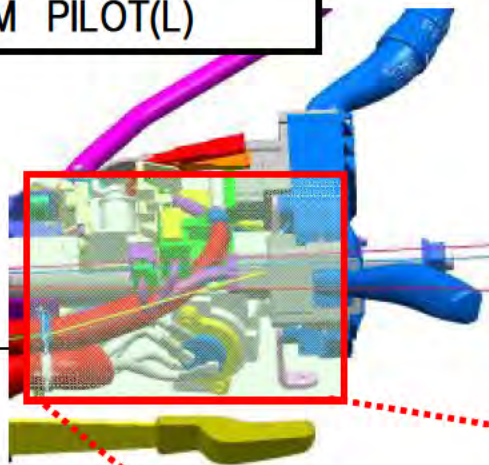
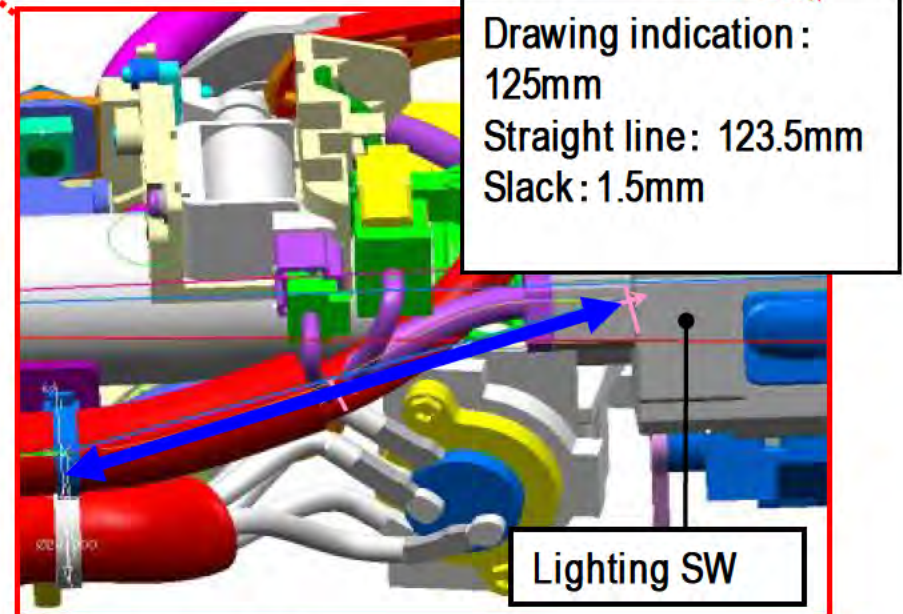
02 - 04M CR-V(L)

02 to 04M CR-V(L), and 03M PILOT(L) show a smaller amount of wire slack.

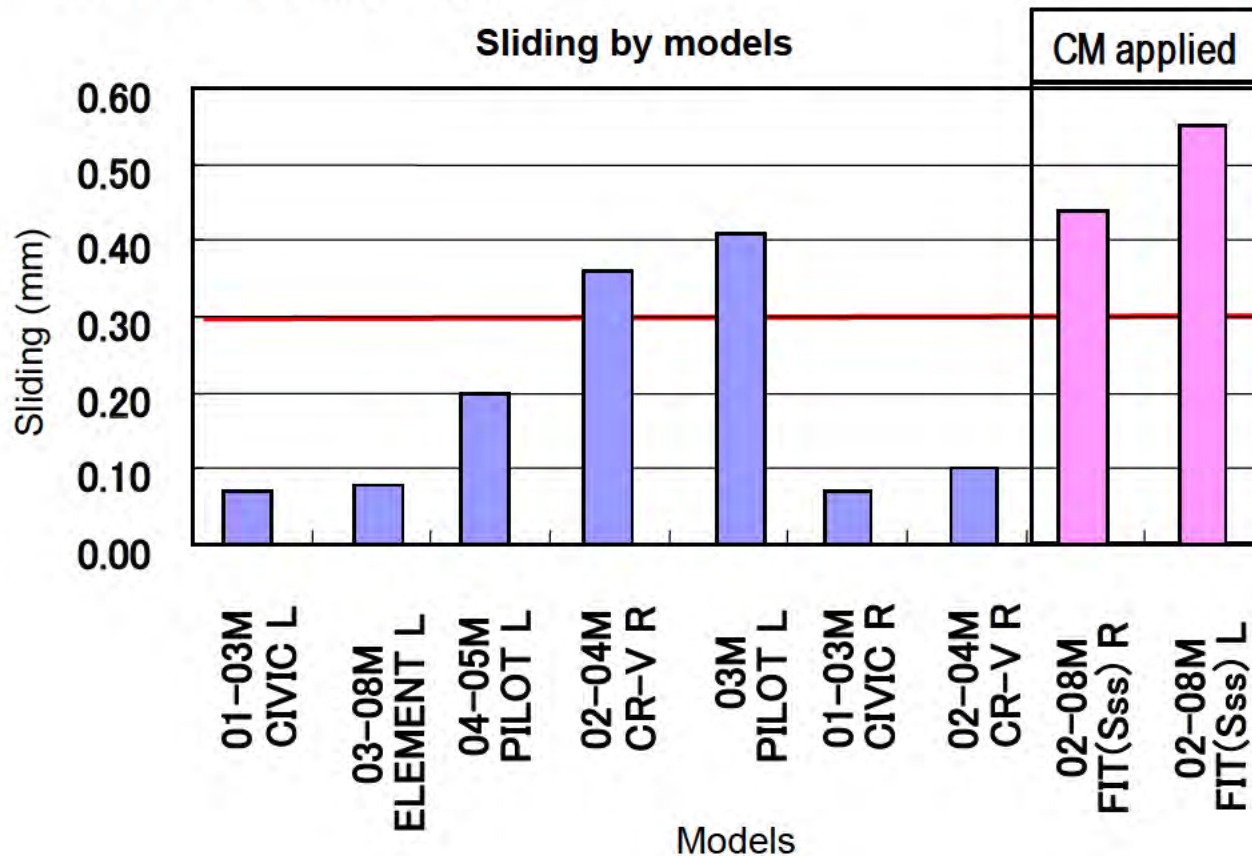
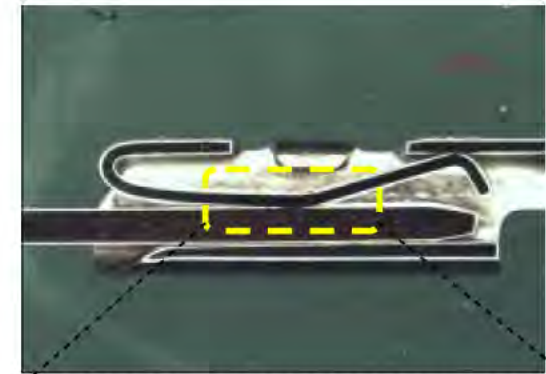
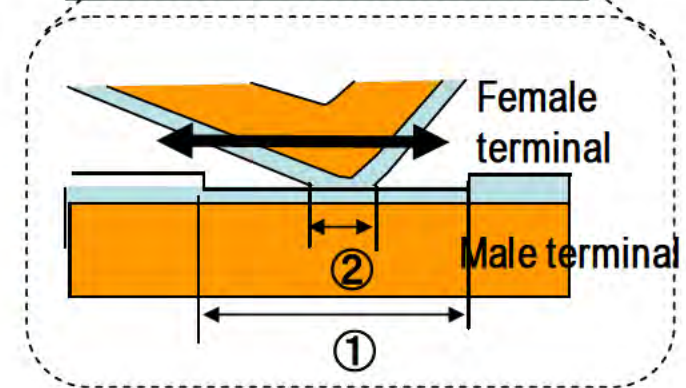
Sliding width exceeds 0.3mm in 02 - 04M CR-V(L), and 03M PILOT (L).

Sliding testing with 0.3mm width shows OK after 50,000 cycles by 8N.

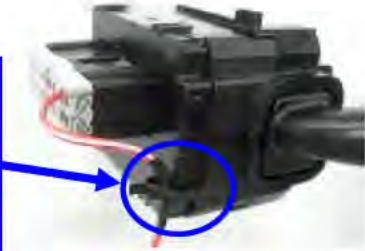
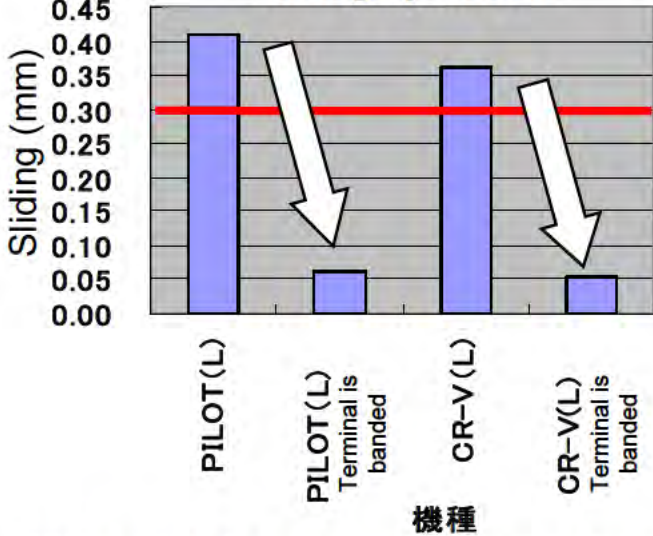
<table border="1" style="margin-left: auto; margin-right: auto;"> <caption>Sliding width data from chart</caption> <thead> <tr> <th>機種</th> <th>Sliding (mm)</th> </tr> </thead> <tbody> <tr> <td>PILOT(L)</td> <td>~0.41</td> </tr> <tr> <td>PILOT(L) Terminal is banded</td> <td>~0.06</td> </tr> <tr> <td>CR-V(L)</td> <td>~0.37</td> </tr> <tr> <td>CR-V(L) Terminal is banded</td> <td>~0.06</td> </tr> </tbody> </table> <p style="text-align: center;">機種</p> <p style="text-align: center;">Sliding width is reduced down to one-sixth.</p>	機種	Sliding (mm)	PILOT(L)	~0.41	PILOT(L) Terminal is banded	~0.06	CR-V(L)	~0.37	CR-V(L) Terminal is banded	~0.06

CM	Remarks																												
<p>▪ Sliding prevention by banding</p> <p>Harness for a female terminal is banded with a wire slack to lighting SW in order to make it follow the movement by SW manipulation, restricting the fitting area from sliding. (Harness need to be lengthen. )</p> <div data-bbox="226 730 629 935" style="border: 1px solid blue; padding: 5px; width: fit-content;"> <p>The harness for Lo terminal is banded with a band to lighting SW.</p> </div>

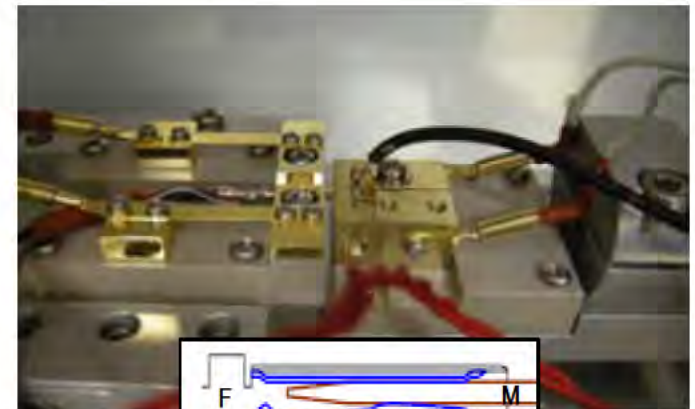
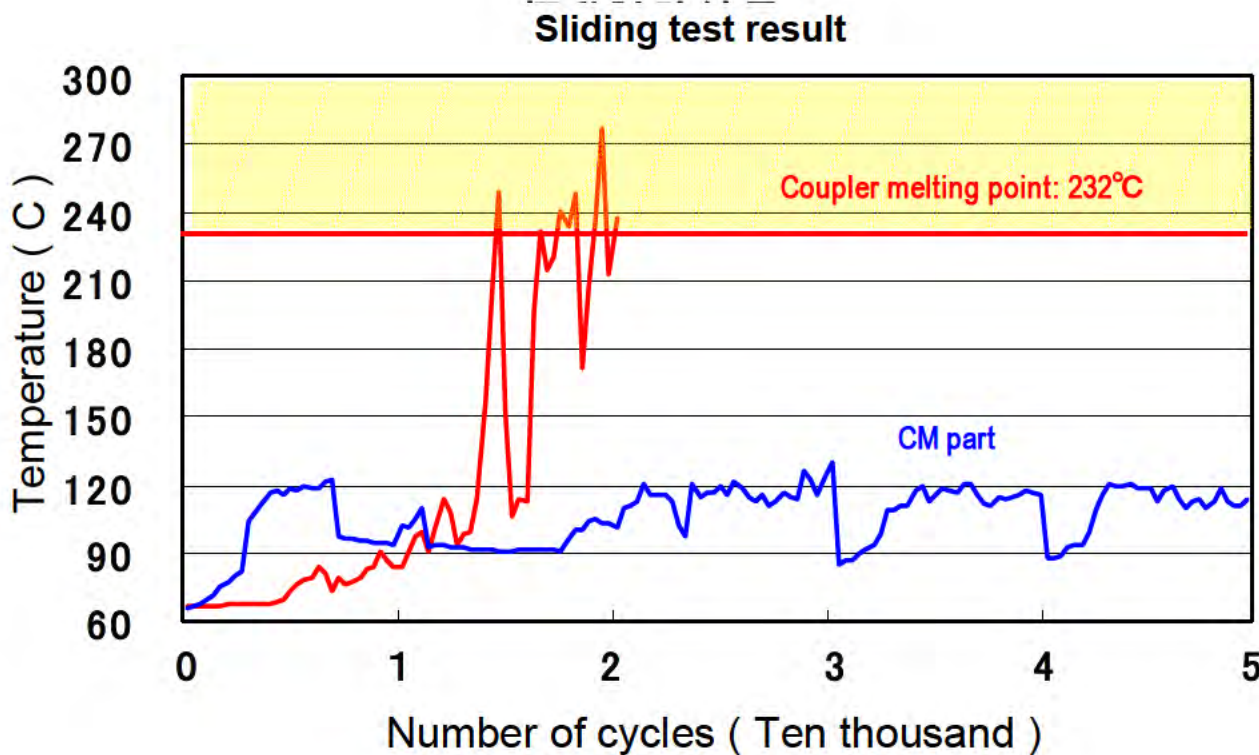
The sliding testing shows this failure won't occur in the market after the harness is banded together with a band, and the material of female terminal is changed to heat - resistant cooper alloy even if Sn plating on male terminal flakes due to wear.

CM parts doesn't melt after sliding of 50,000 cycles.

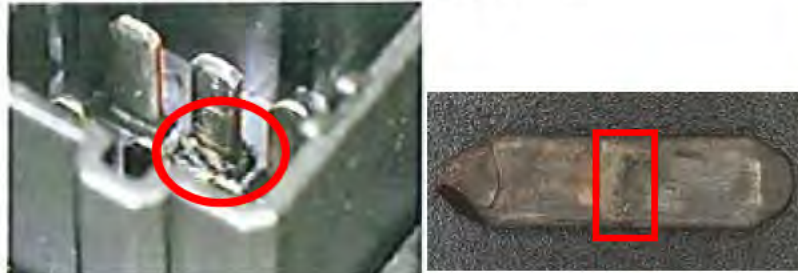
ライティングスイッチ側のオス端子

Lo端子が熱により、溶損している

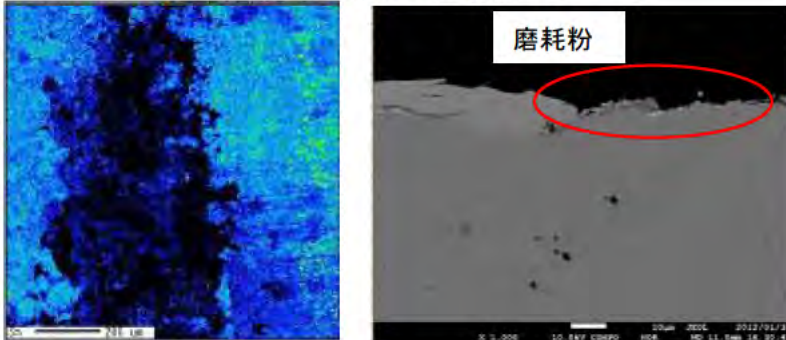
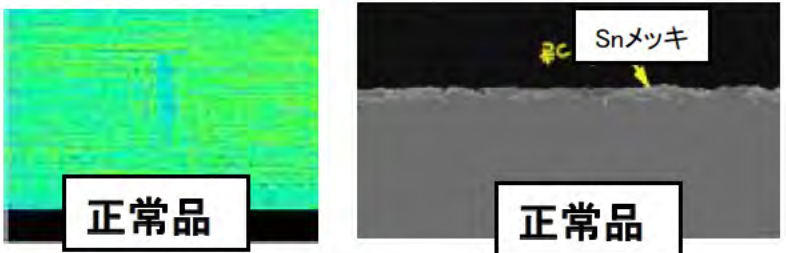
Snが磨耗し、磨耗分が堆積している

Snメッキが摩耗し、磨耗粉が堆積していることから、摺動の繰返しが発生している。

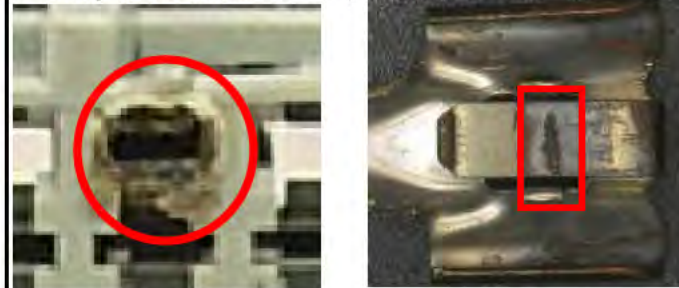
ハーネス側のメス端子

Lo端子が熱により、溶損している

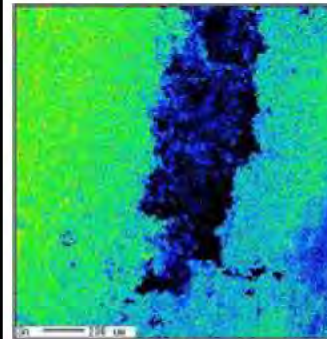
Snが磨耗している

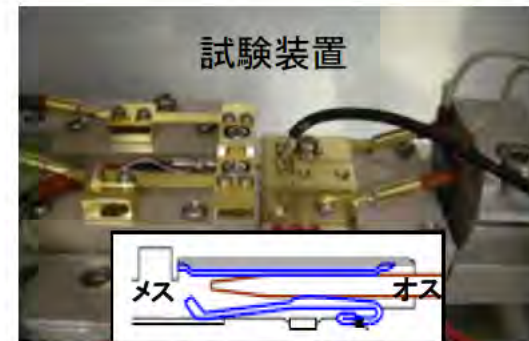
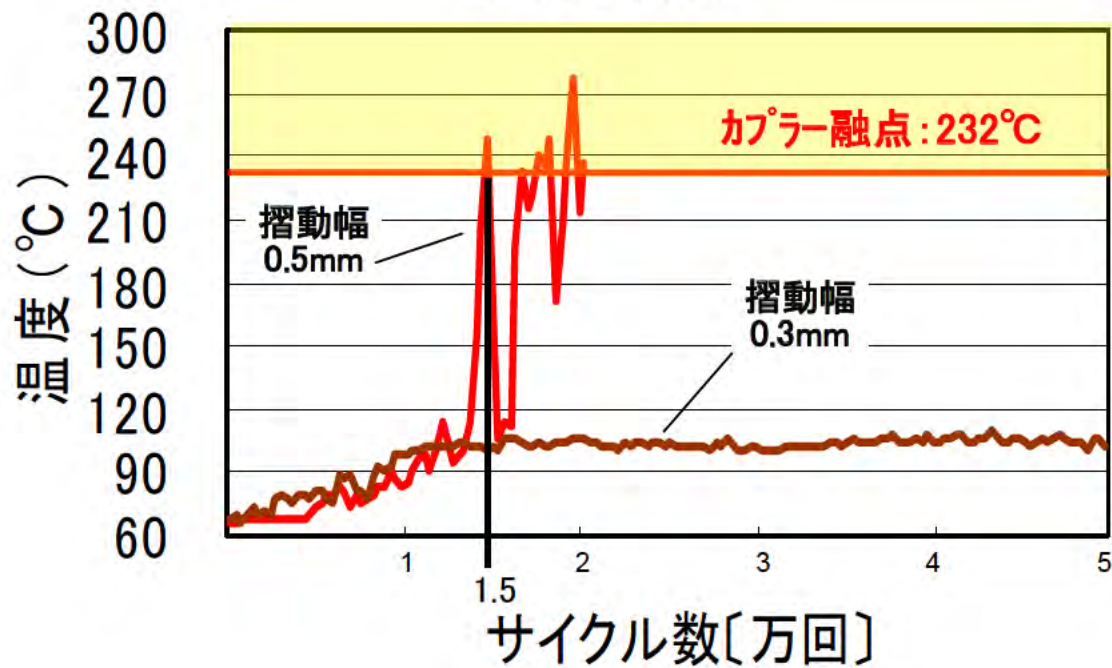
黄銅端子(Snメッキ品)は、摺動幅 0.5mm/約1.5万サイクルでコネクタ樹脂(PBT)の溶融温度に至ることが判明。また、0.3mm以下であれば問題なしと判明

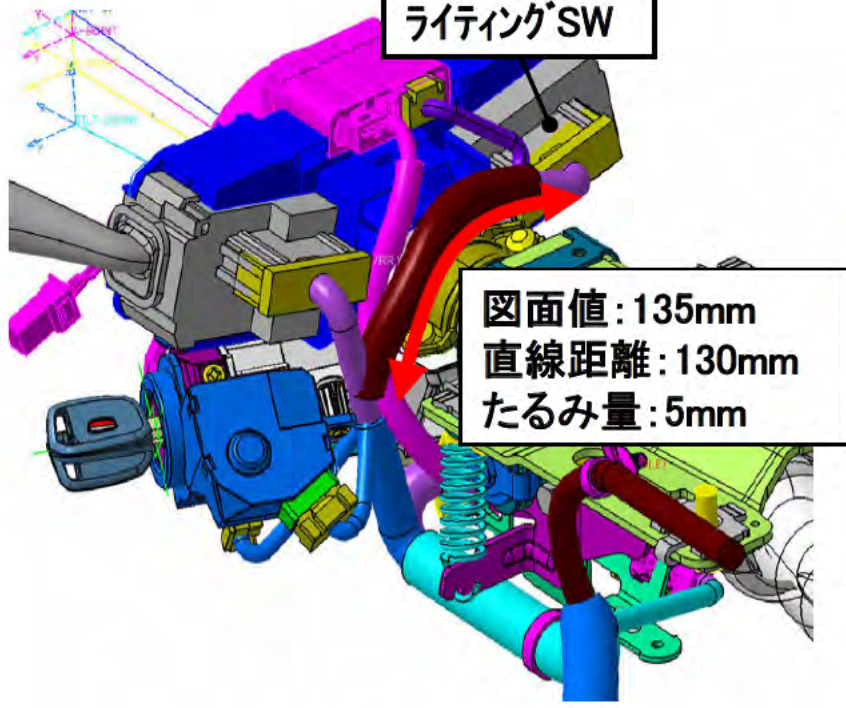
03M PILOT(L)

図面值: 135mm  
直線距離: 130mm  
たるみ量: 5mm

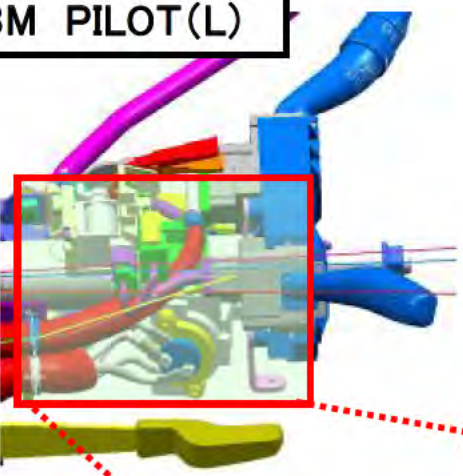
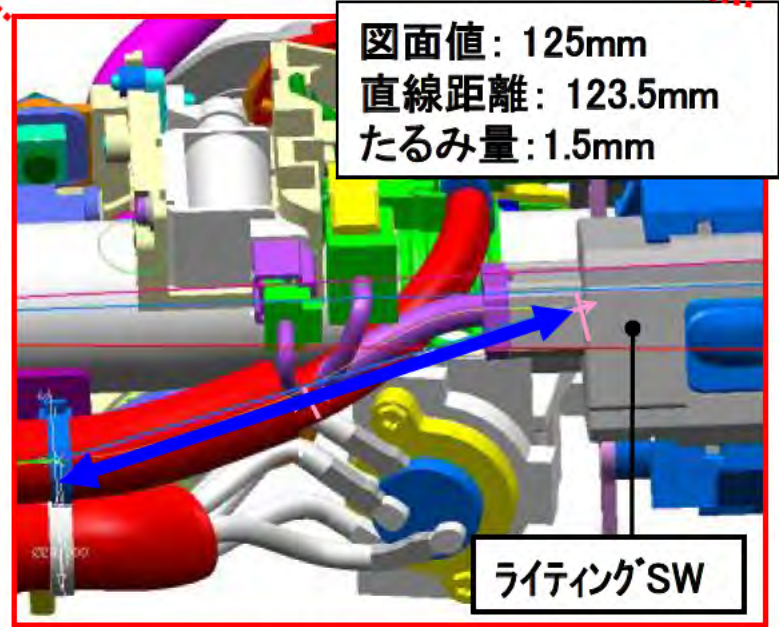
図面值: 125mm  
直線距離: 123.5mm  
たるみ量: 1.5mm

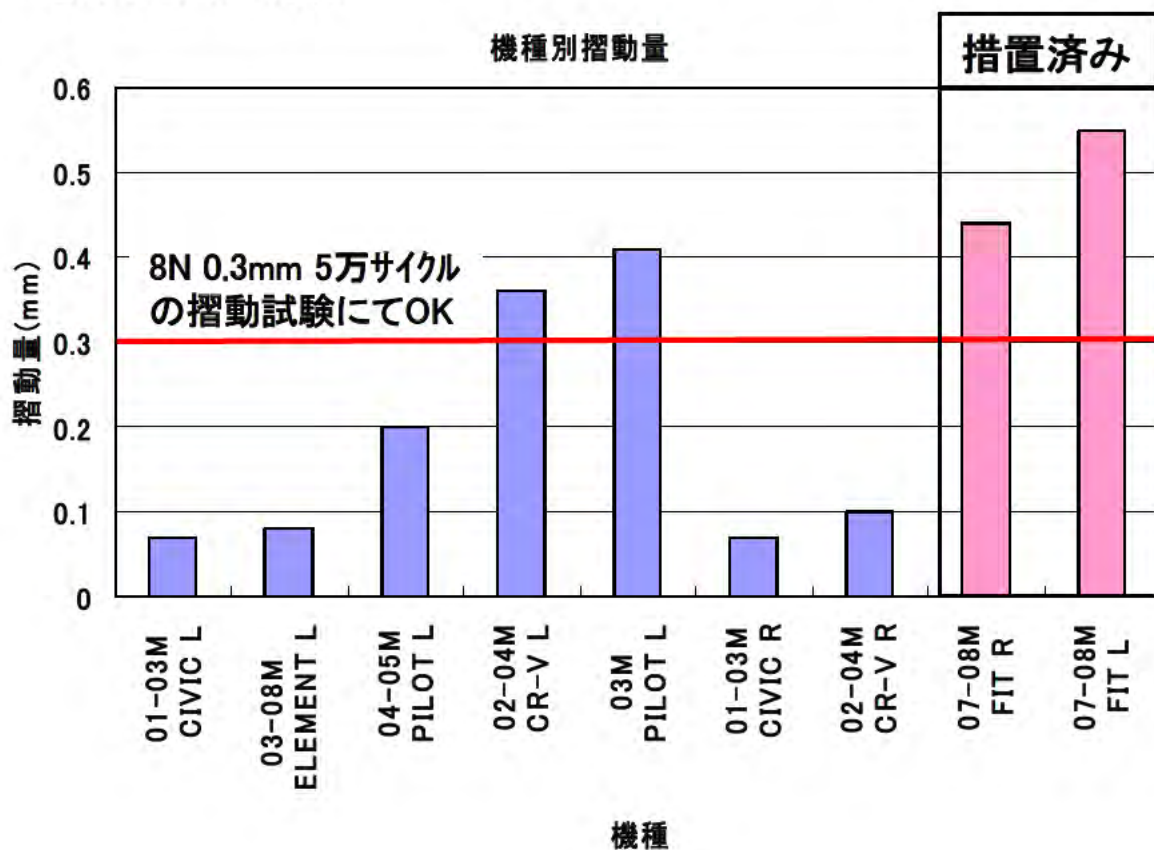
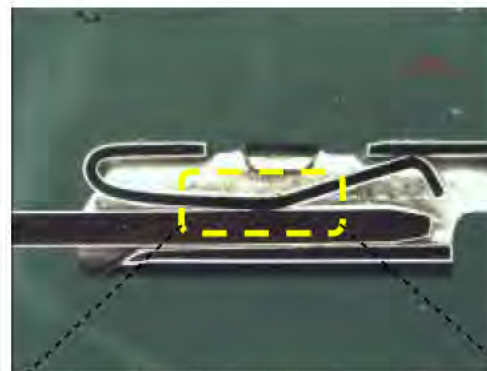
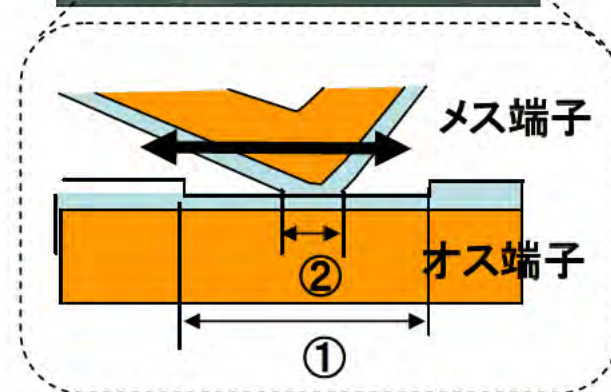
## 【測定結果】

02-04M CR-V(L) と 03M PILOT(L)が撓動量0.3mmを超えることが判明

撓動幅 = オス端子撓動幅①  
- メス端子撓動幅②

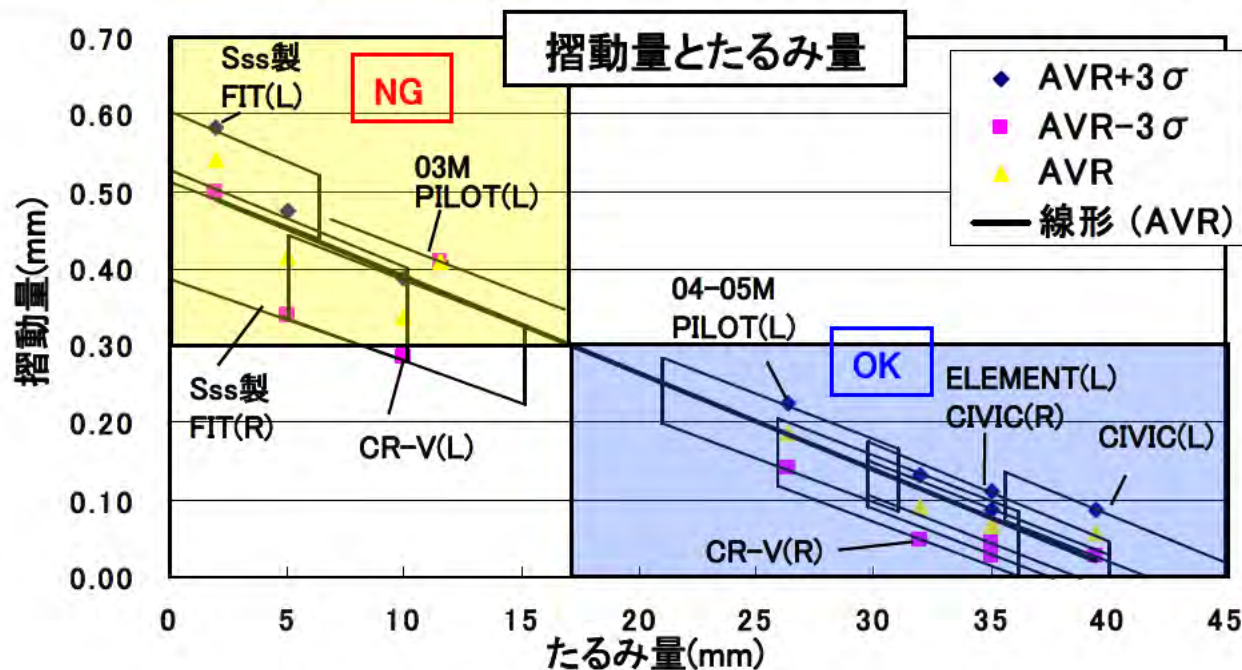
# 解析結果 図面及び実車検証と摺動量

02-04M CR-V(L)と  
03M PILOTが摺動量  
0.3mmを超えることが判明

CIVICについては、摺動量が  
最も小さく、摺動量の解析から  
は問題なしと判断する

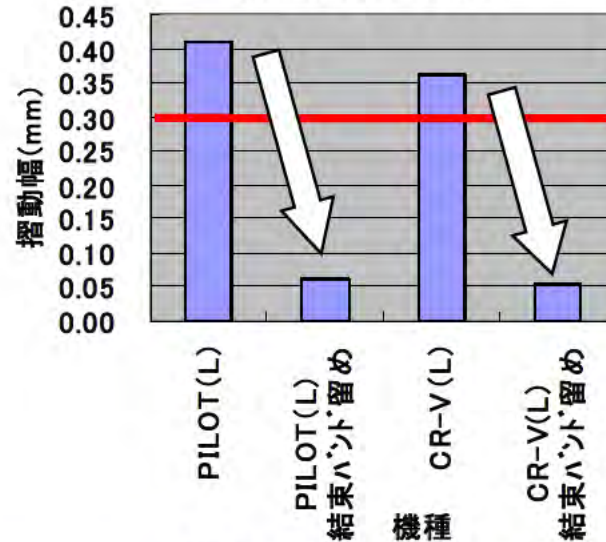
機種別の摺動幅

摺動量が約1/6に減少

- ・結束バンド留めによる摺動防止  
たるみを確保した状態でメス端子ハーネスをライティンスイッチに結束バンドで固定することにより、スイッチ操作時の動きに追従させ、端子嵌合部の摺動を抑制する（ハーネスを長くする必要あり）

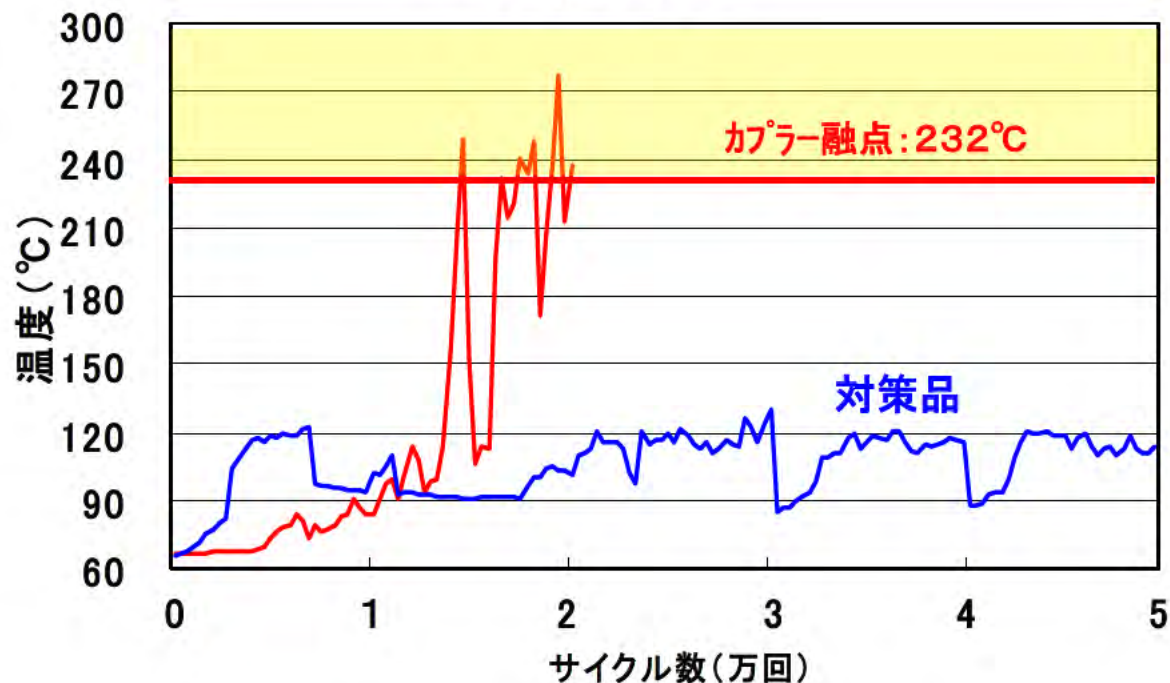
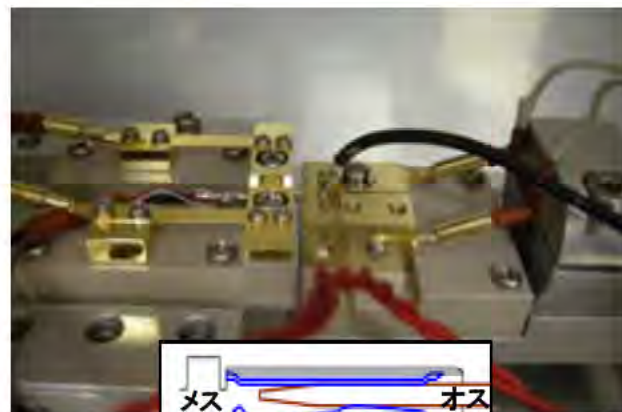
## 摺動試験結果

オス端子のSnメッキが磨耗により剥離したとしても、結束バンドによるハーネス固定とメス端子耐熱銅合金に変更すれば、今後の使用過程において不具合が発生しないことを確認した。

対策は5万サイクルでも溶損に至らない。

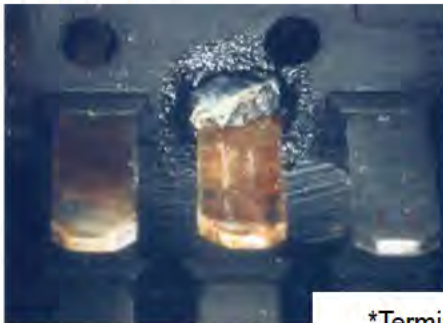
The terminal looks discolored due to heat, and the bottom made from resin is melting.

\*Terminal is melting.

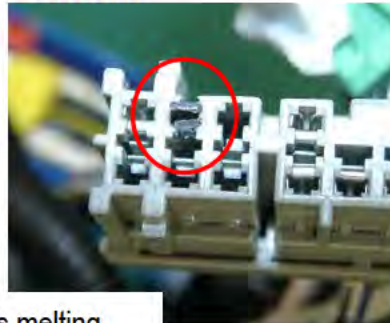
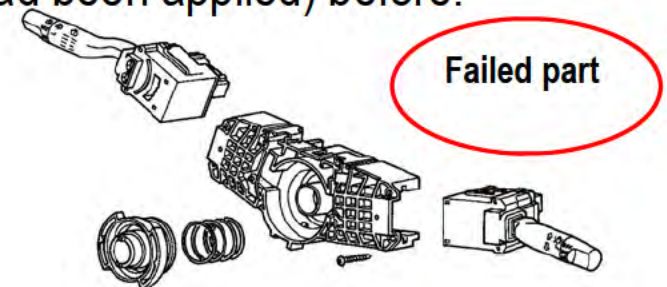
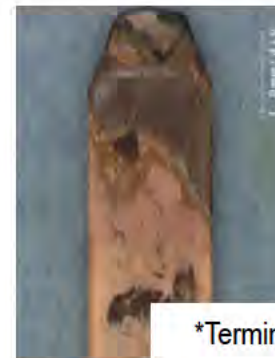
The housing is melting, and force of tongue plate is decreased at the bottom.

\*Terminal was heated.

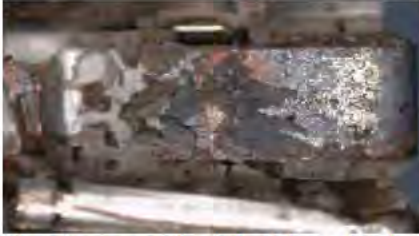
<p>A gap btw tab, and tongue plate is 0.50mm.</p>

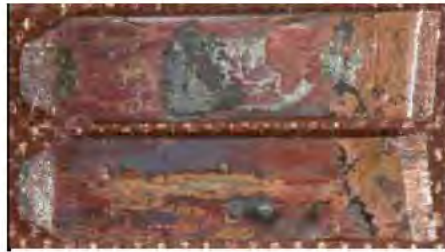
<p>Terminals of other circuit: Terminals of other circuit; 0.18~0.27mm</p> <p>The base material of terminal appears exposed since Sn came off.</p>
M terminal

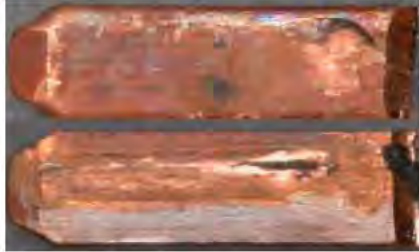
<p>A large amount of resin adheres due to heat.</p>

<p>Copper terminals are discolored.</p>

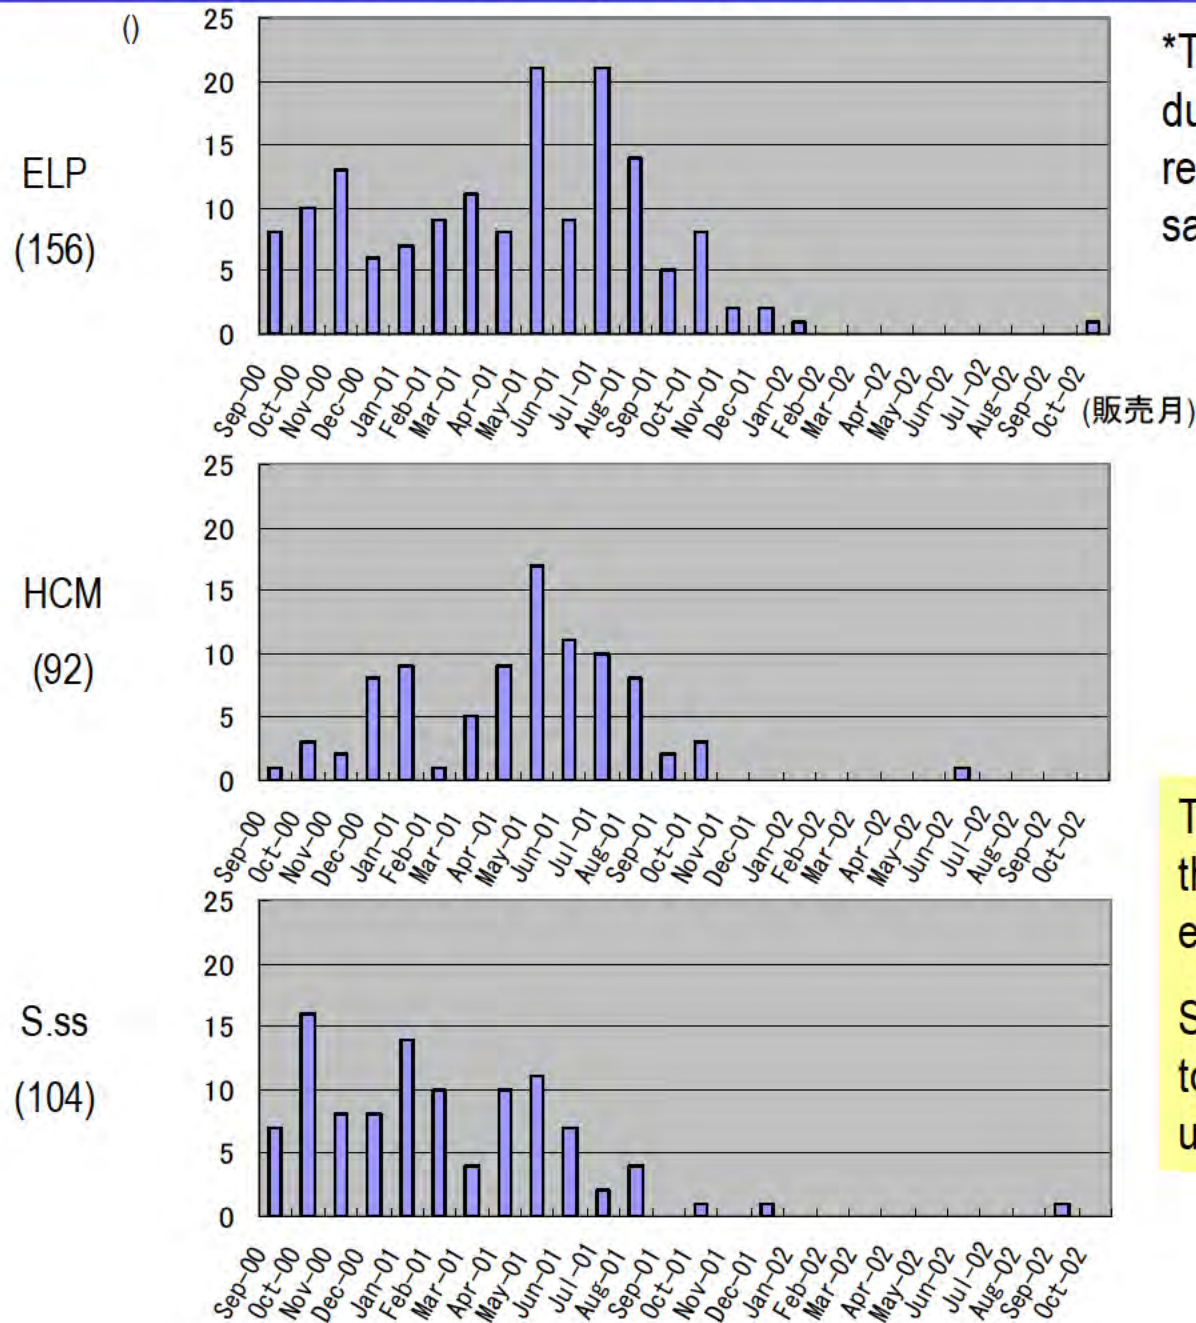
# Warranty claim analysis by AH(US/Civic due to melting)

\*Those three graphs show claims due to smoke, melting, and wire replacement related to head light by sale month, and factory.

This failure has increased from the units manufactured in the early stage of production.

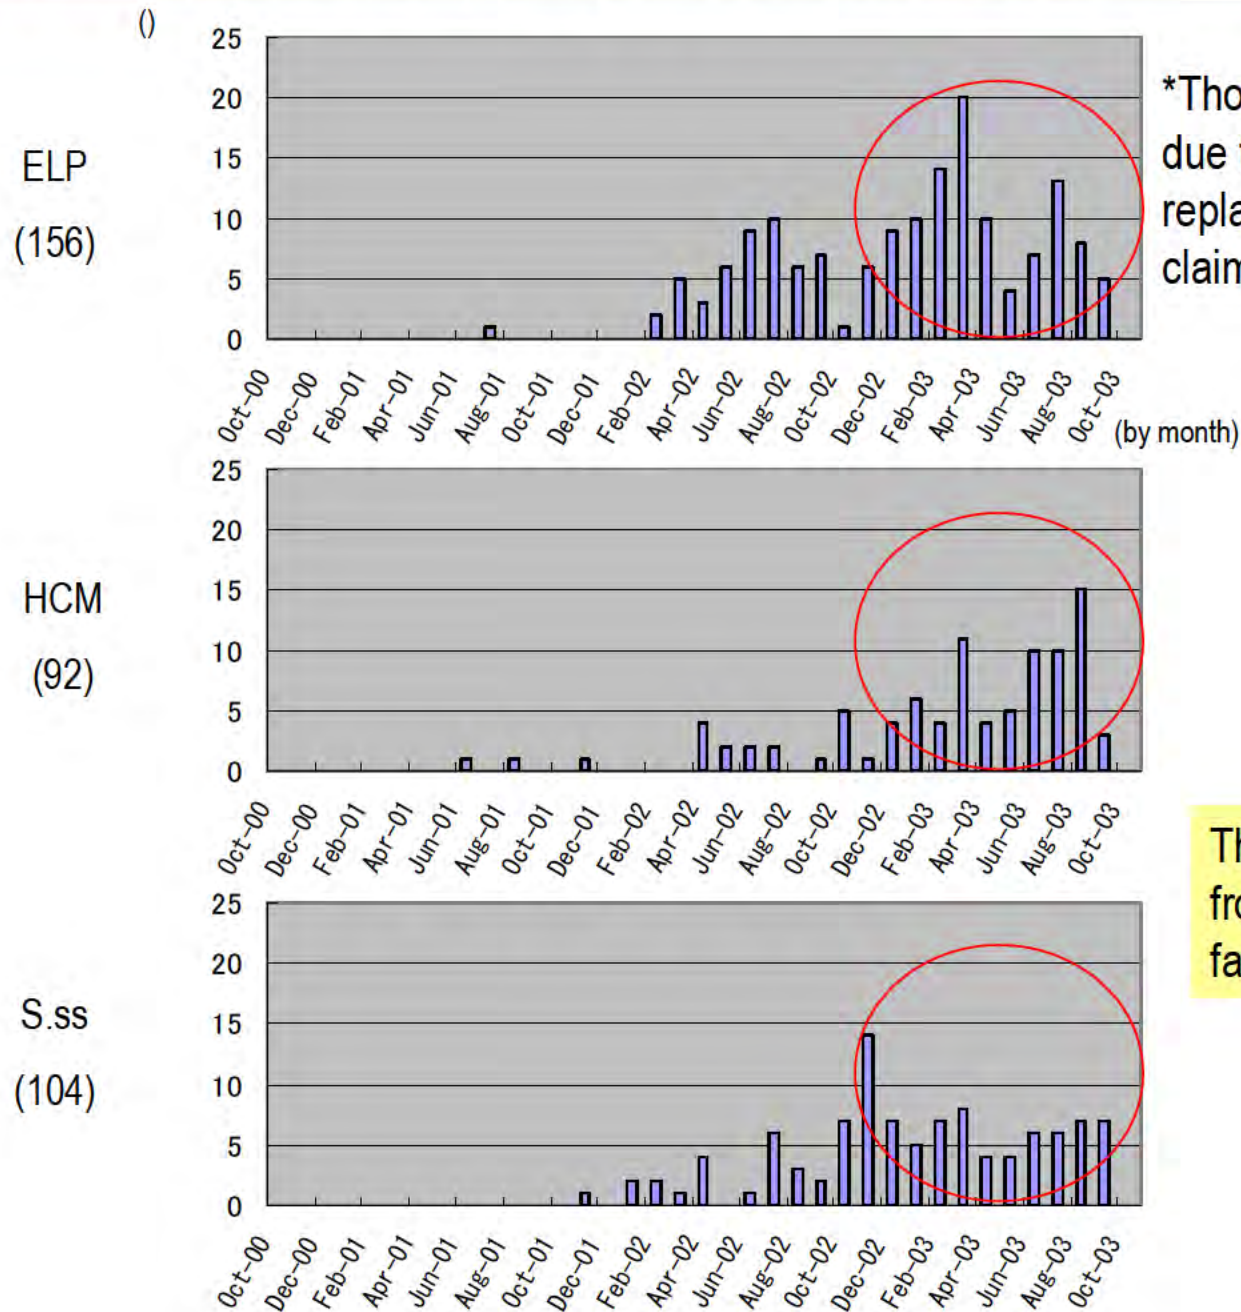
# Warranty claim analysis by AH(US/Civic due to melting)

\*Those three graphs show claims due to smoke, melting, and wire replacement related to head light by claim month, and factory.

This failure has recently increased from units produced by each factory.

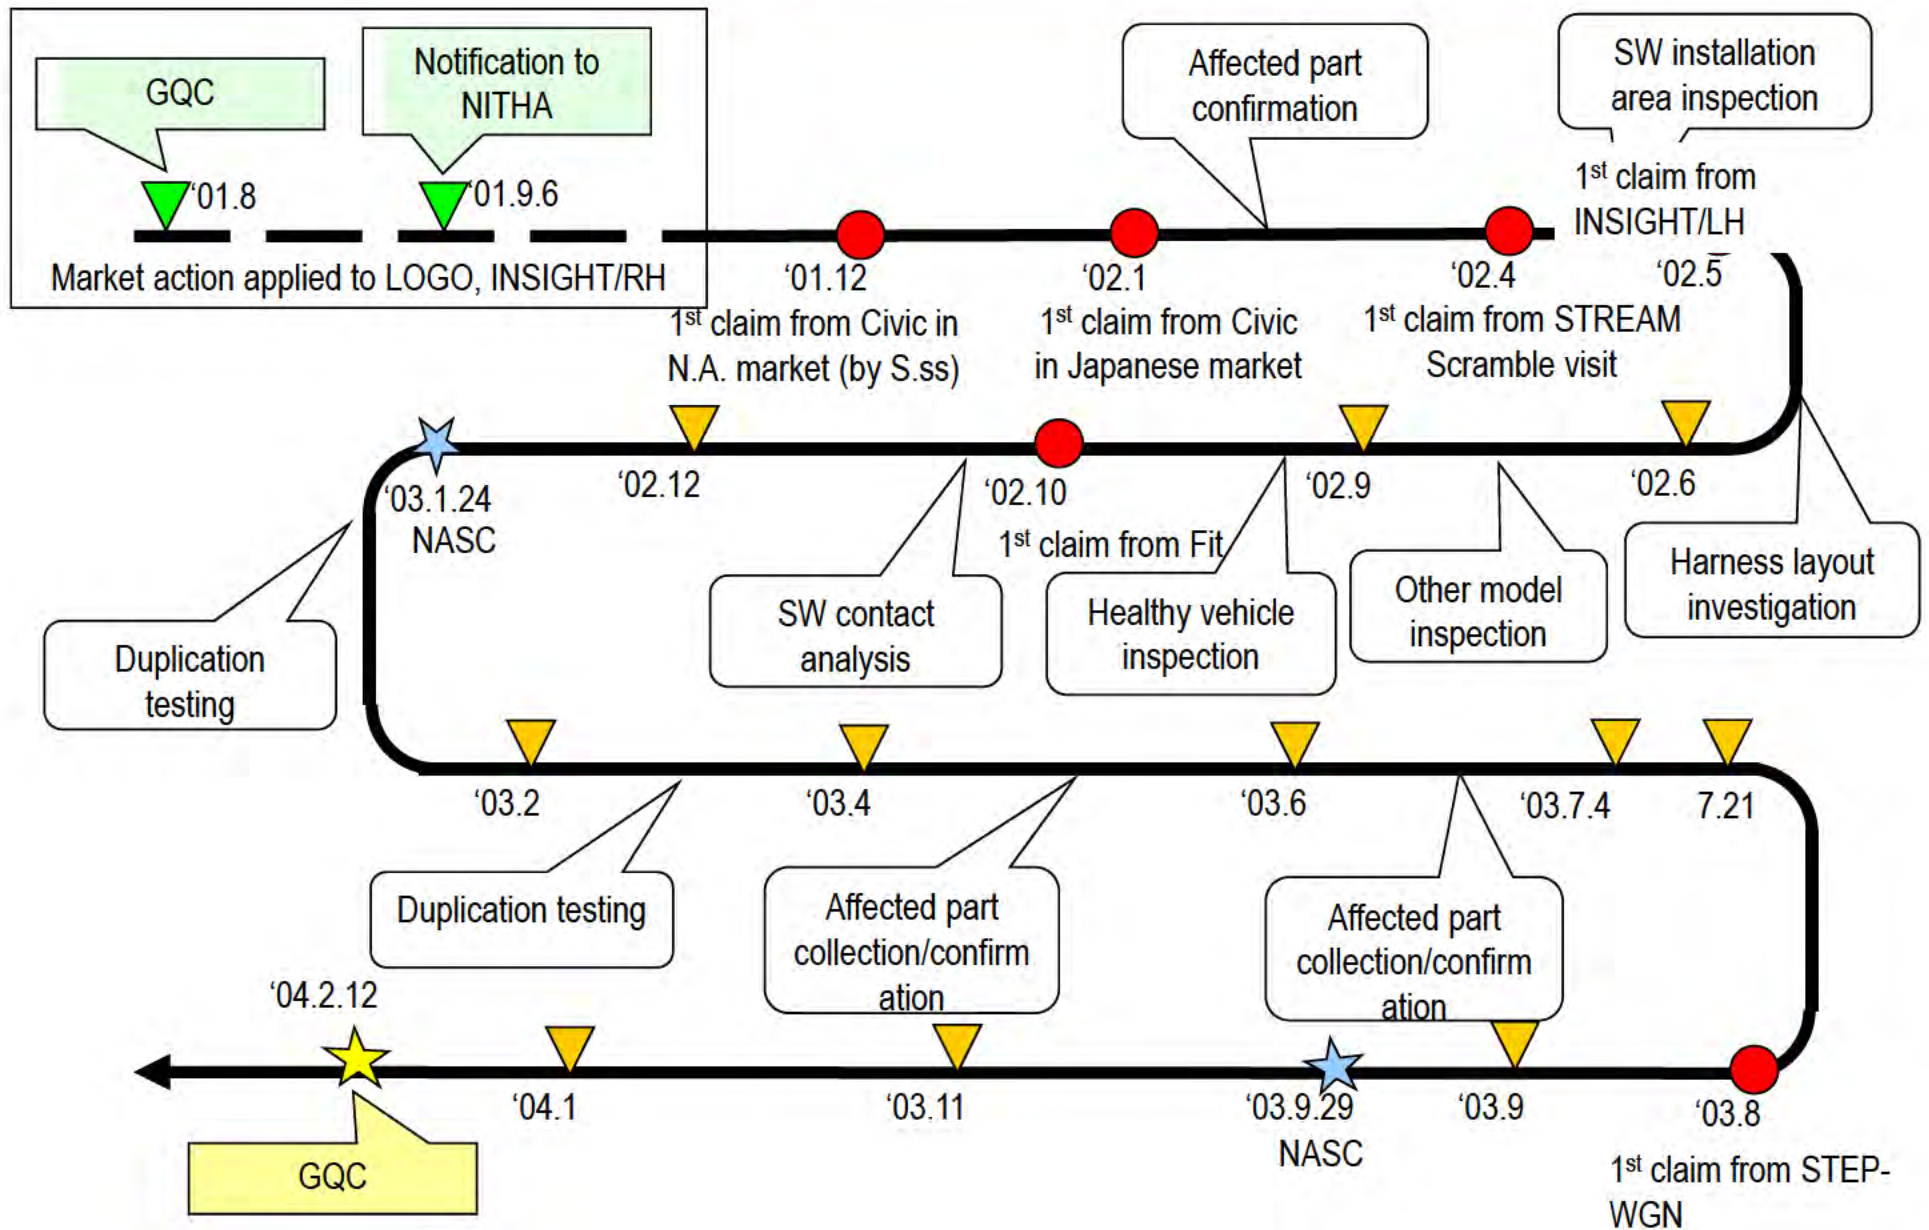
# Time line

▼ : Japan Steering Committee (JSC), 
 ● Information Exchange Meeting (IEM): 1<sup>st</sup> claim from each model

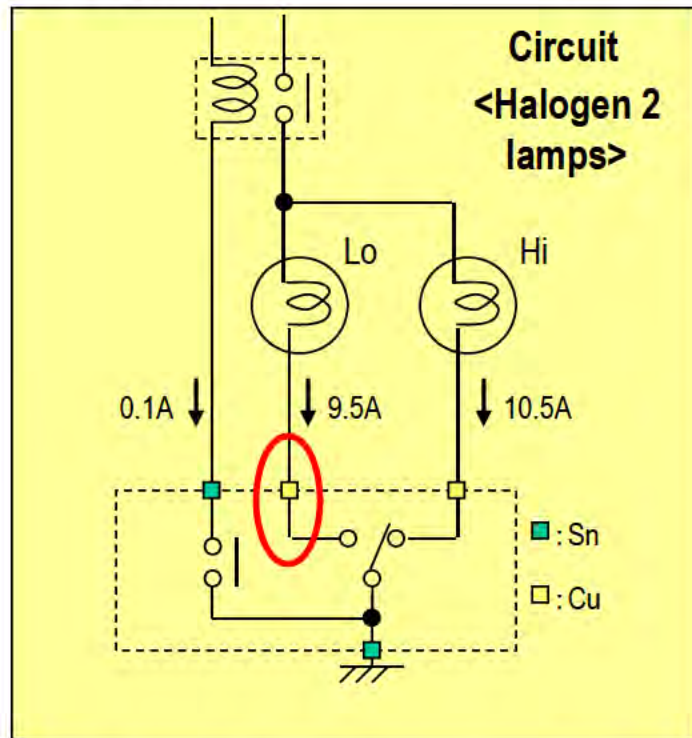
Current for low beam flows via SW.
