EA11-012

HONDA

4/20/2012

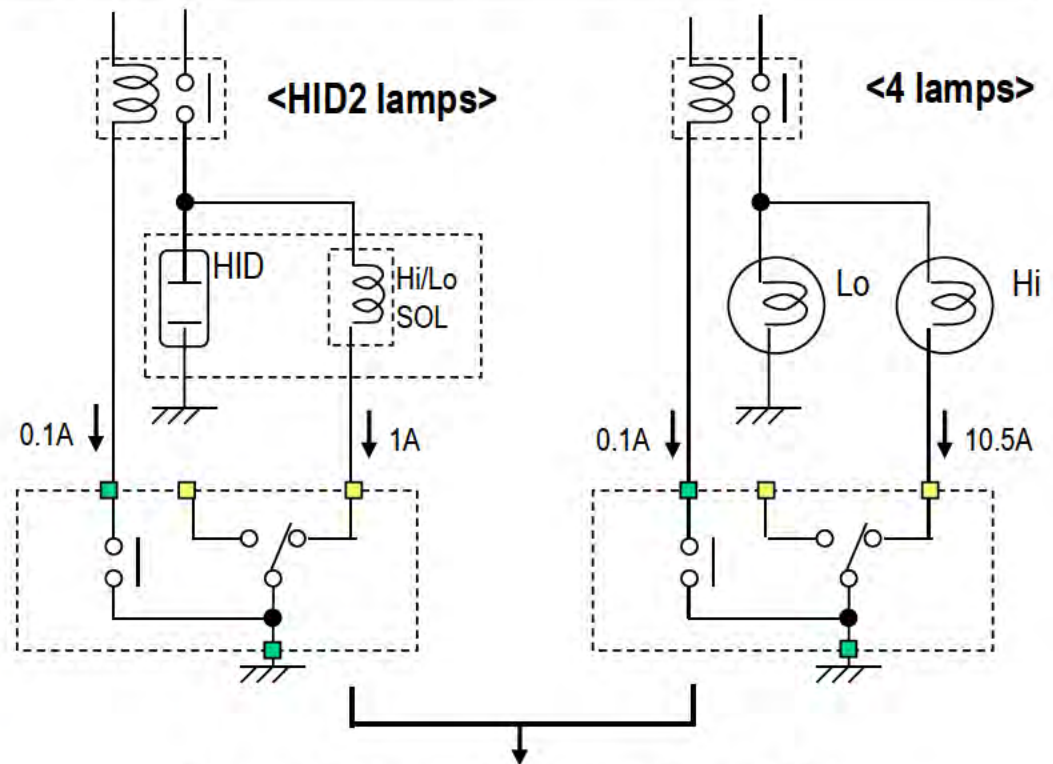
Current for low beam doesn't flow via SW.

The current is a reference value.

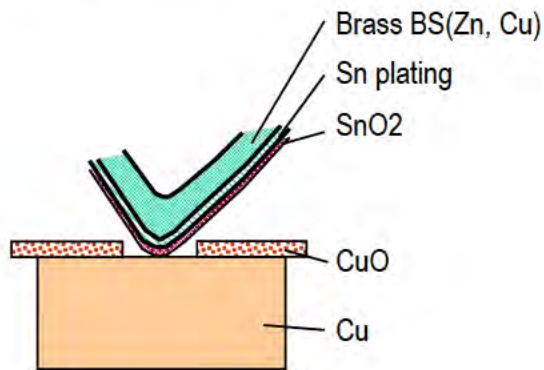
① When contact resistance is low

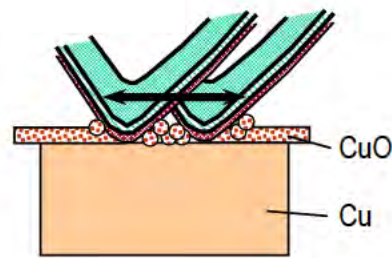
② Rubbing produces wear powders

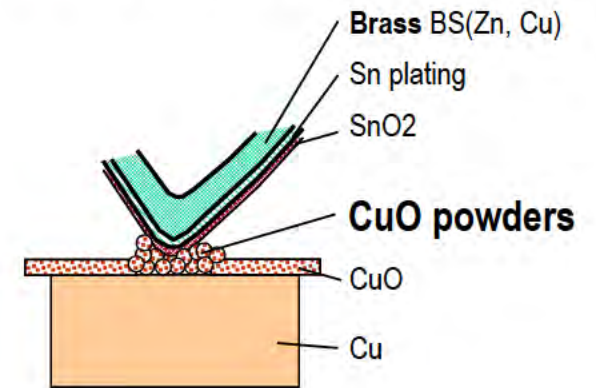
③ When contact resistance is high

**Terminal slides on oxidized copper (CuO), causing contact resistance to increase.**

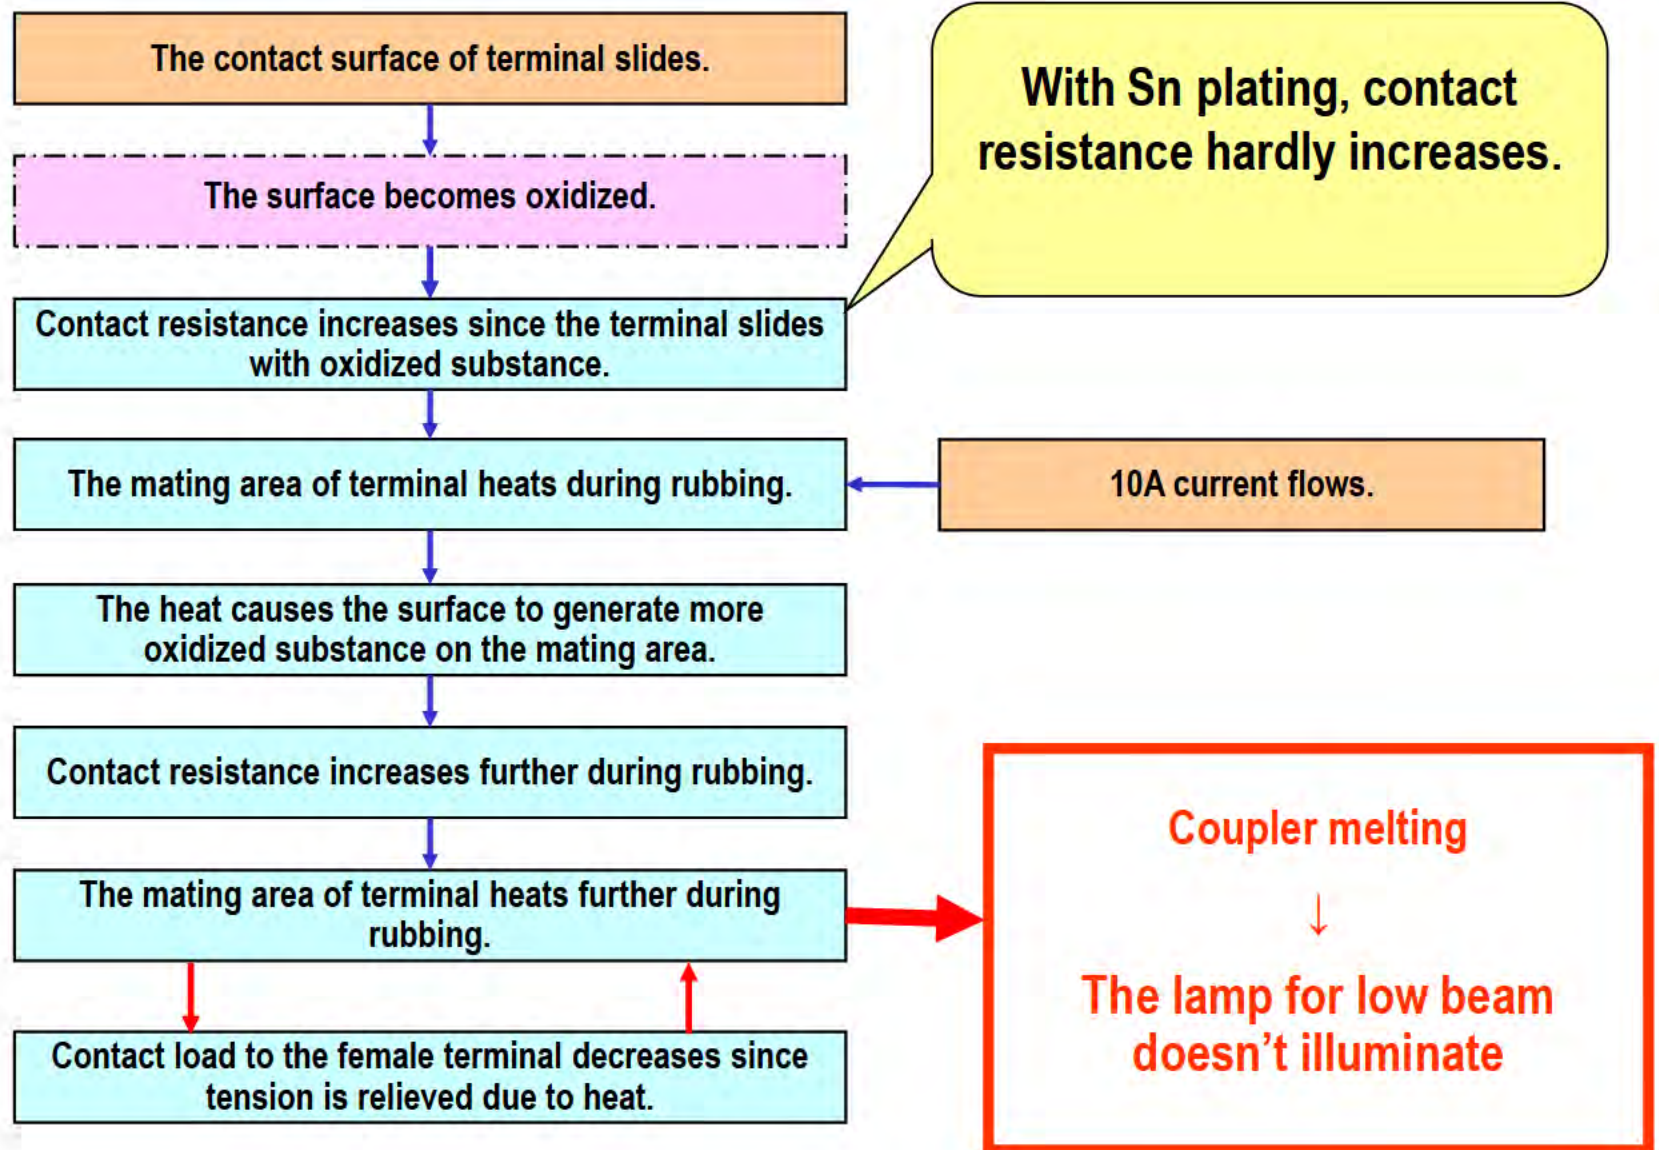
# Function for Sn plating

Plating is effective to prevent the contact surface from both wear, and resistance increase.

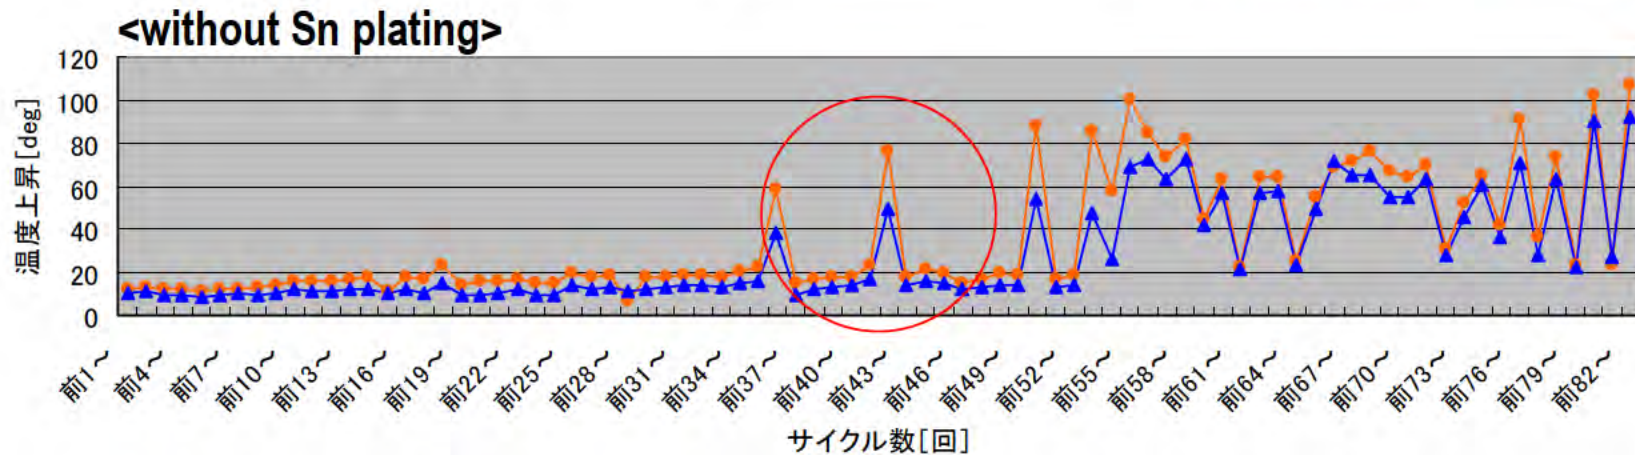
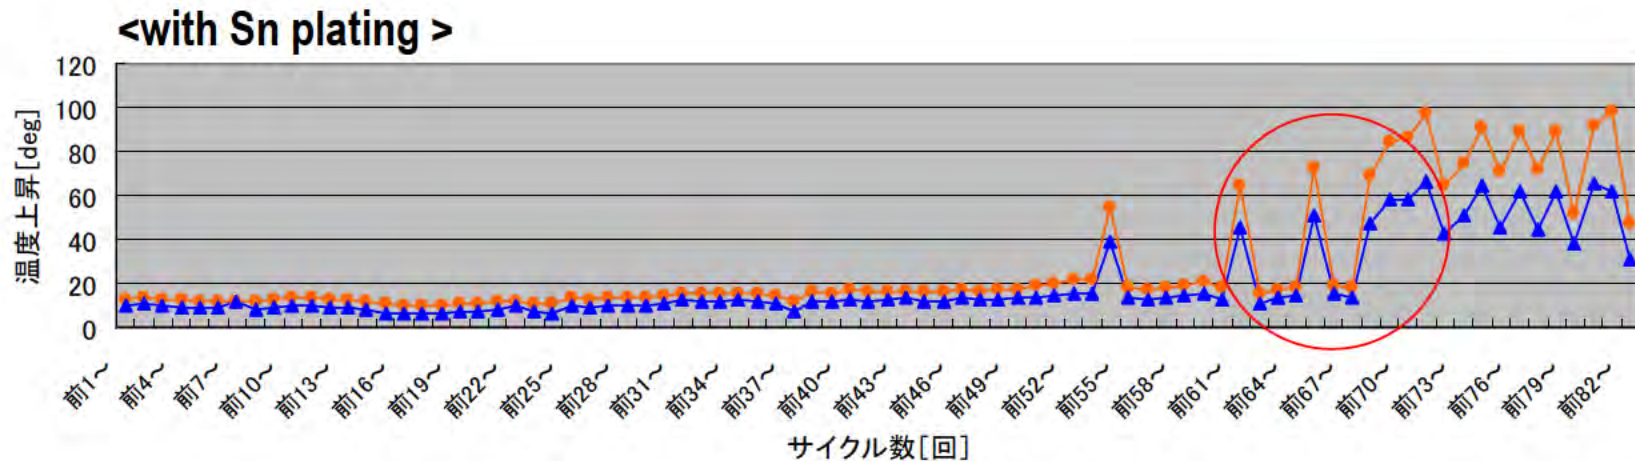
# Duplication testing result

- Temperature of LO terminal increases.
- Without Sn plating, temperature significantly rises at **45 cycles, or later.**
- With Sn plating, temperature significantly rises at **70 cycles, or later.**

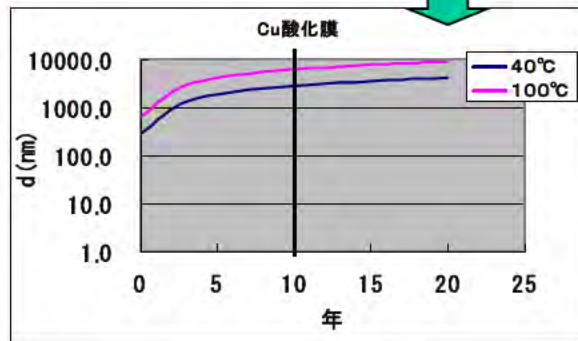
Predictable life time without Sn plating under 40 degrees.

$$45 \text{ cycles} \times 2.17 = 98 \text{ cycles}$$

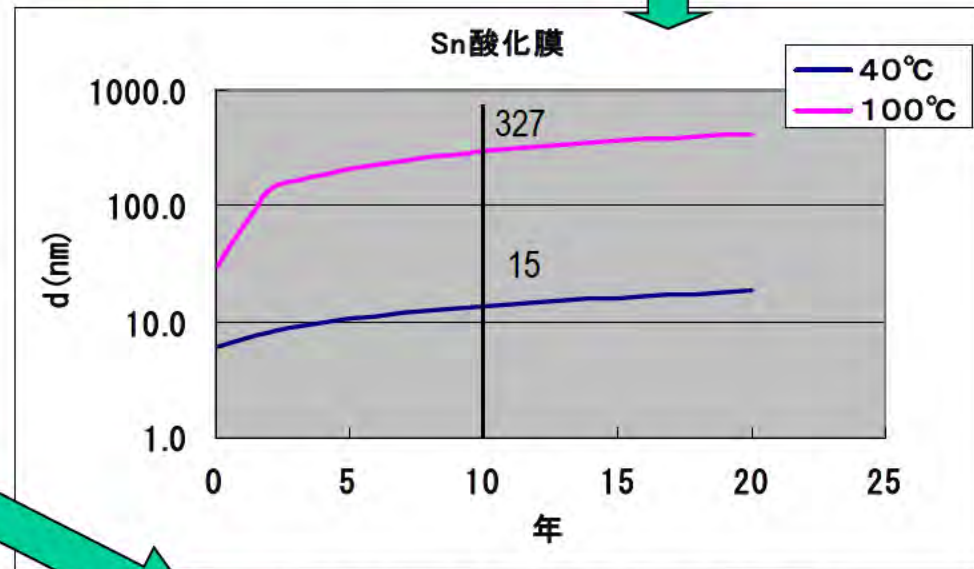
An oxidized film on Sn plating is susceptible to temperature.

• Predictable life time for parts with Sn plating under 40 degrees.  $70 \text{ cycles} \times 21.8 = 1526 \text{ cycles}$

**Predictable life time for Sn plating is 150,000km (The minimum mileage for failure occurrence)  $\times 15.6 = 234,000$  km**  
(HS part assurance: 220,000km in North America)

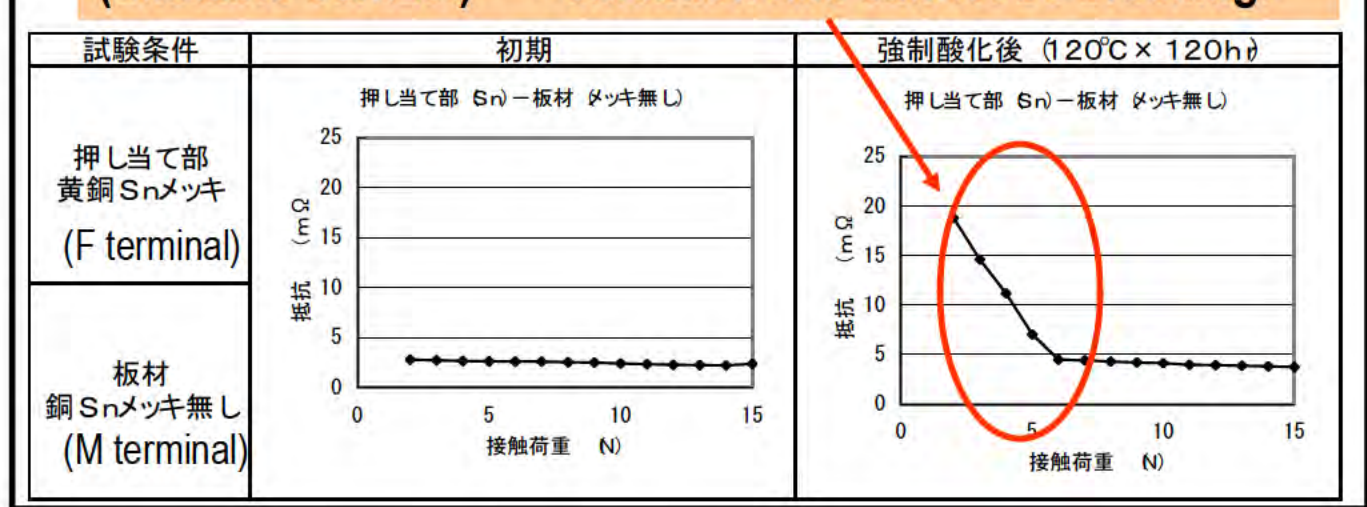
**Combination of Cu-Sn: higher resistance at 5N, or lower (unstable contact) → oxidation film cannot be breaking.**

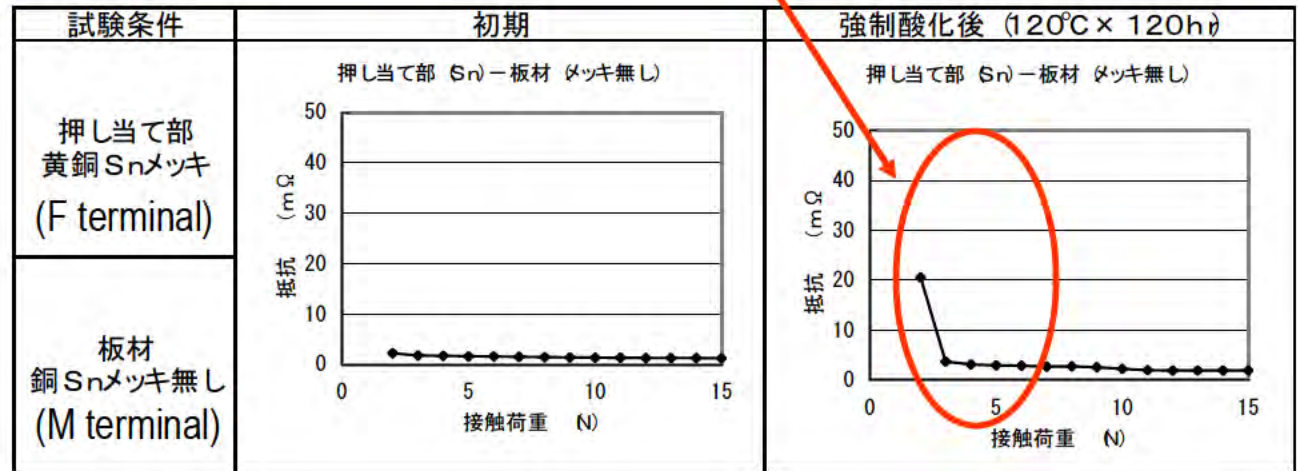
**Resistance continues to be stable at 3N, or lower with combination of Cu-Sn.**

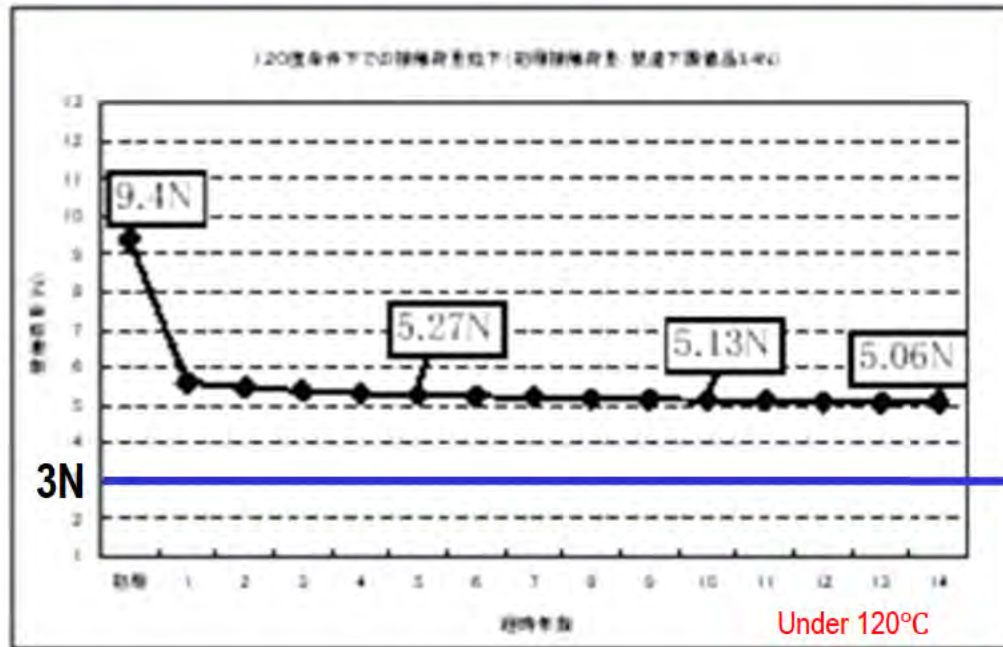
# Contact load aging change (Terminal HE090 for compact models)

Contact load for stable HE terminal

Contact load of MP parts is 9.4N, so it has enough room to 3N even if it ages.

Terminal HE090 has contact load high enough to remove oxidation film.  
(Oxidized cooper)

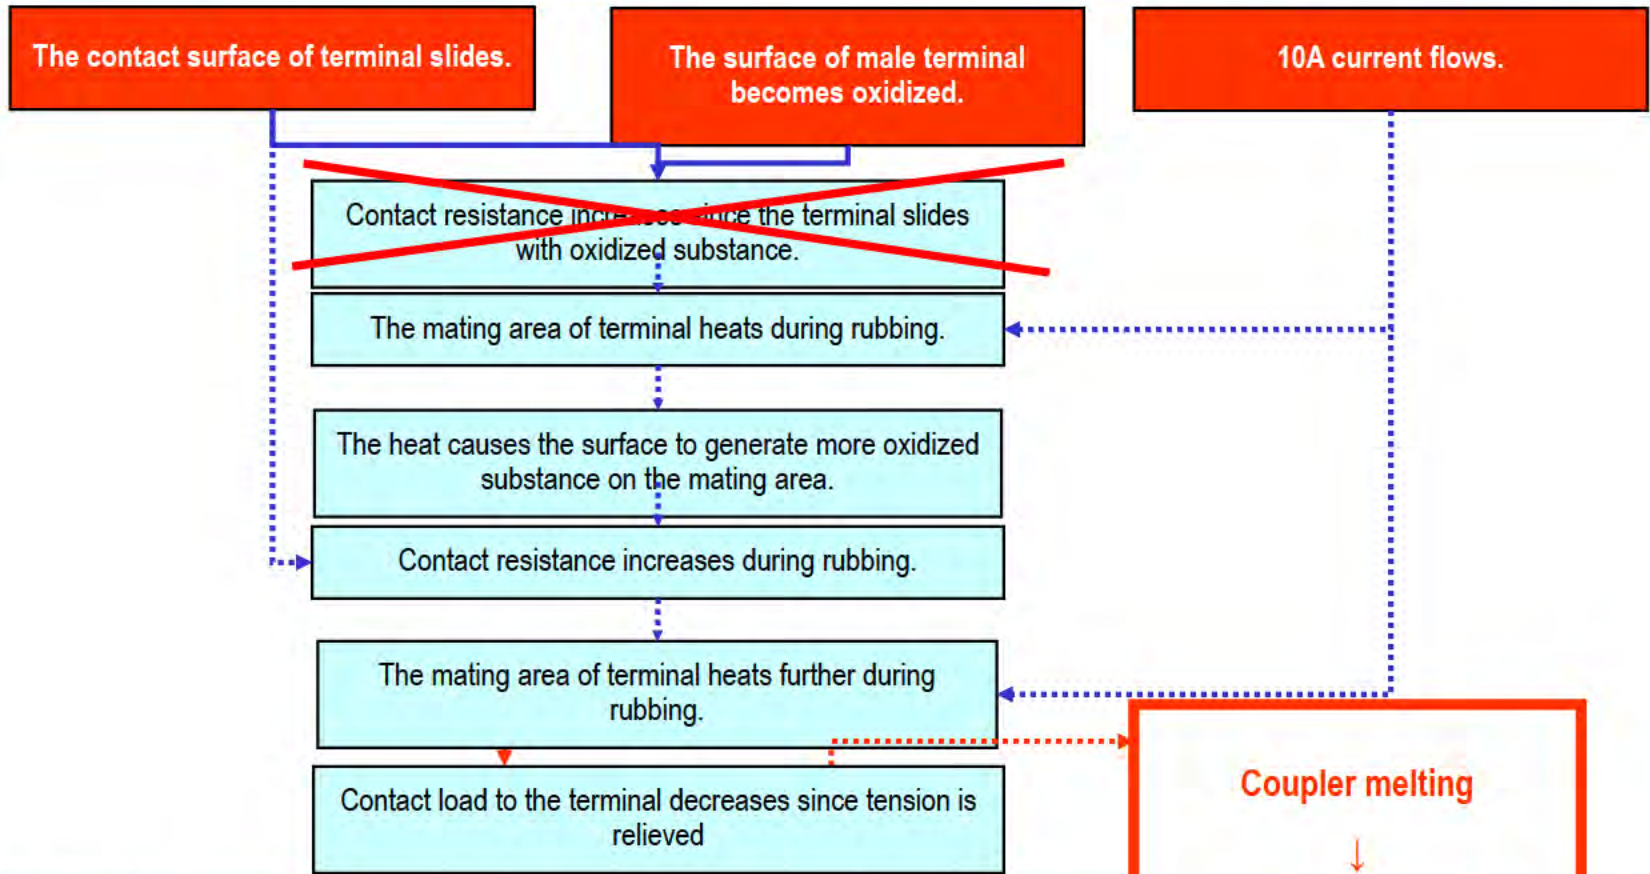
A flow of contact resistance increase is not established since terminal HE090 can retain contact load. So, failure “ lamp for low beam doesn’t illuminate” doesn’t occur.

Failure “lamp for low beam doesn’t illuminate” doesn’t occur from compact models.

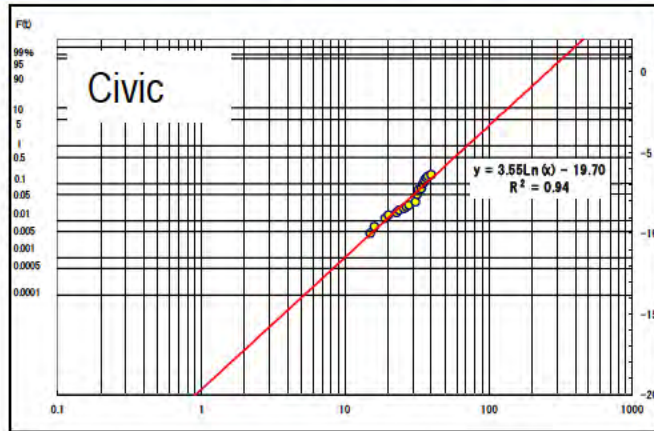
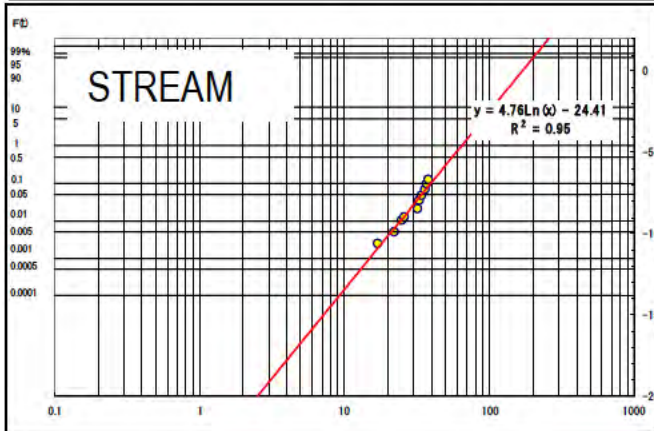
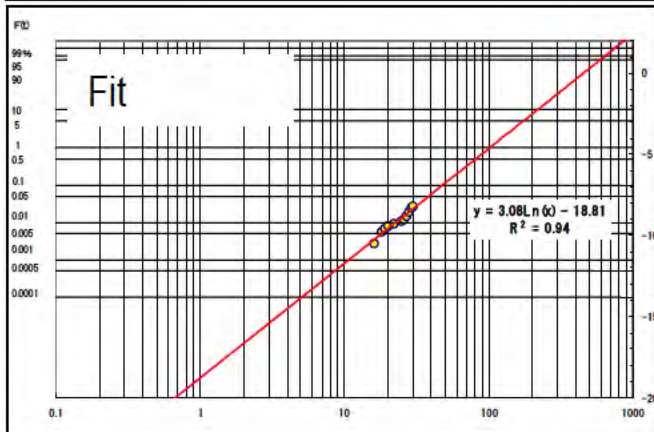
# Failure occurrence prediction for the Japanese market

Models \ Months to fail	Civic	STREAM	Fit
36	40 0.09 %	26 0.06 %	31 0.041 %
60	242 0.56 %	284 0.72 %	146 0.20 %
120	2741 6.39 %	6987 17.67 %	1219 1.66 %

Judging from warranty situation, and failure occurrence prediction by Weibull, this symptom will continue to occur.

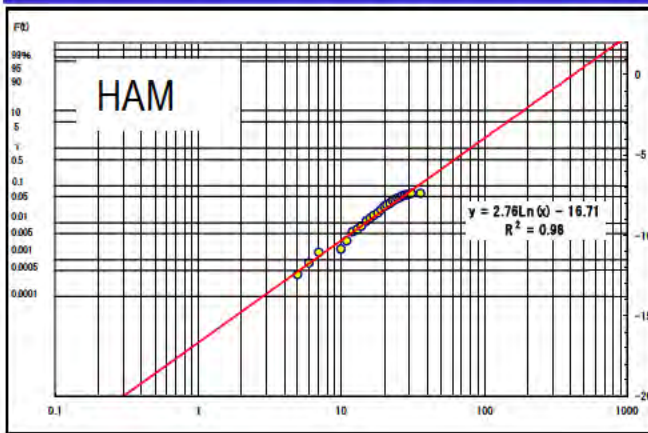
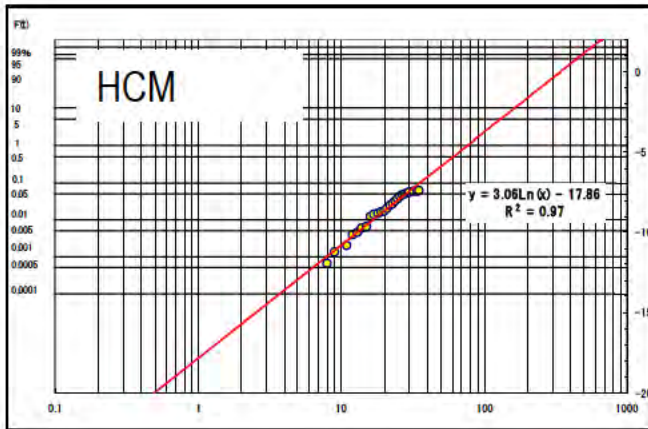
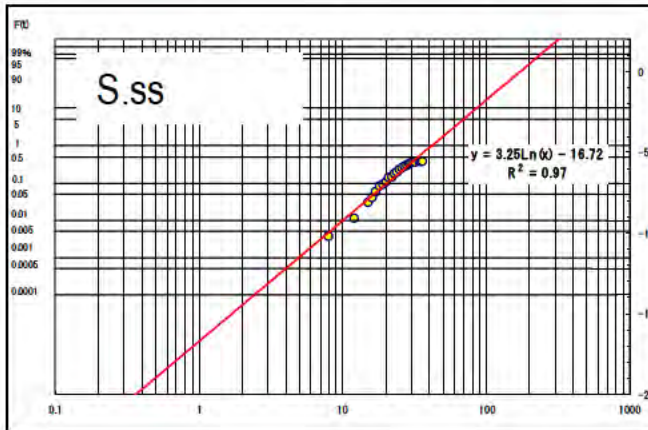
# AH Failure occurrence prediction (by HAM, HCM, and S.ss)

HAM	HCM	S.ss
Months to fail	Melting	Melting	Melting
36	282 0.111%	153 0.102%	163 0.618%
60	1154 0.453%	725 0.484%	841 3.204%
120	7732 3.034%	5943 3.968%	6983 26.614%

Judging from warranty situation, and failure occurrence prediction by Weibull, this symptom will continue to occur.

A proactive market action is proposed since this failure is predicted to increase in the future, and disturbs users when it occurs. (The head light suddenly goes off.) This is a flaw in safety.

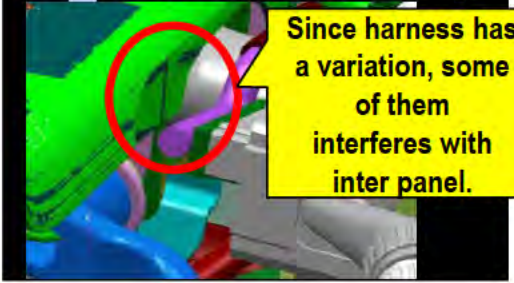
Since harness has a variation, some of them interferes with inter panel.

That harness varies in routing, and SW varies in assembly were not considered when terminal sliding amount was studied, resulting in wrong identification for target units. From the reason, those models were absent from the previous action target.

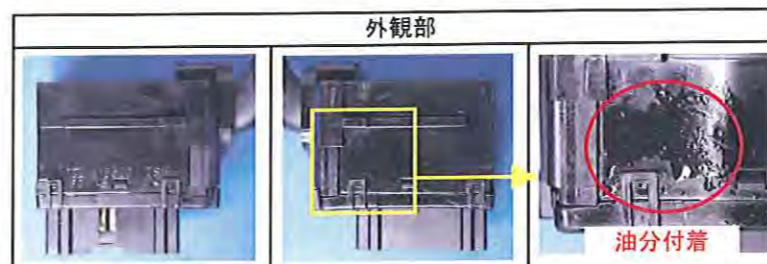
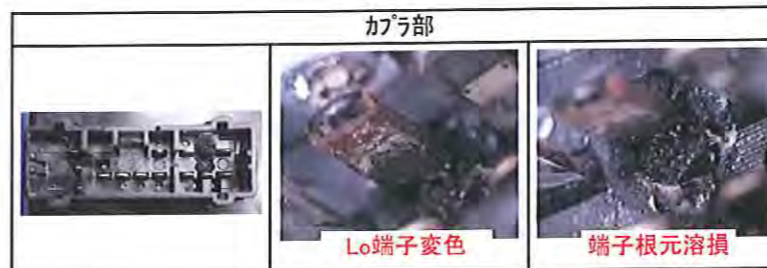
・各回路の導通確認(Lo回路は端子間を除く)を行ったところ、導通不良等の異常は見られなかった。

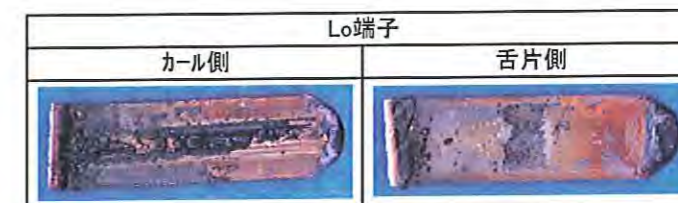
・Lo端子を切断し、この外観を確認したところ、カール側・舌片共に、端子全体が変色していることが確認できる。また、接触部及びその周辺に樹脂が付着していることも確認できる。

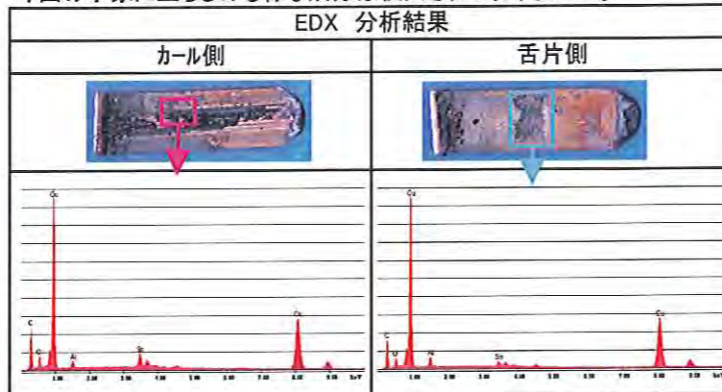
分析箇所	分析結果
Lo端子	SW端子成分の銅(Cu), 錫(Sn)が検出された。 上記成分の他には、SW樹脂成分の炭素(C)、酸素(O)、アルミニウム(Al)が検出された。

今回の事象に至らしめる様な成分は検出されていません。

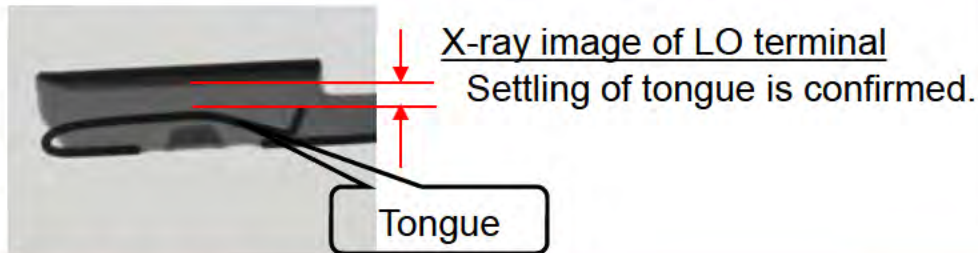
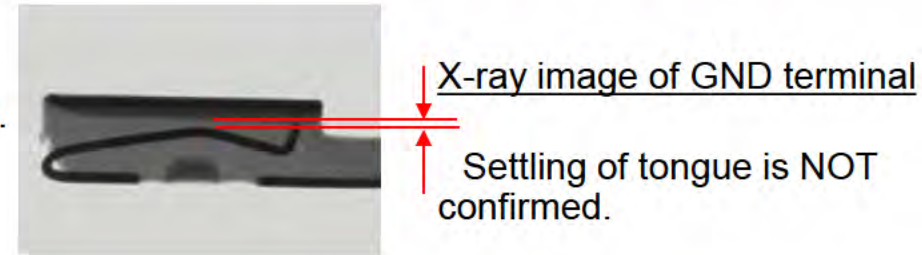
## Analysis results by X-ray (Harness side)

Heat discoloration is found on the returned lighting switches on LO circuit terminal and resin is melted at the root.

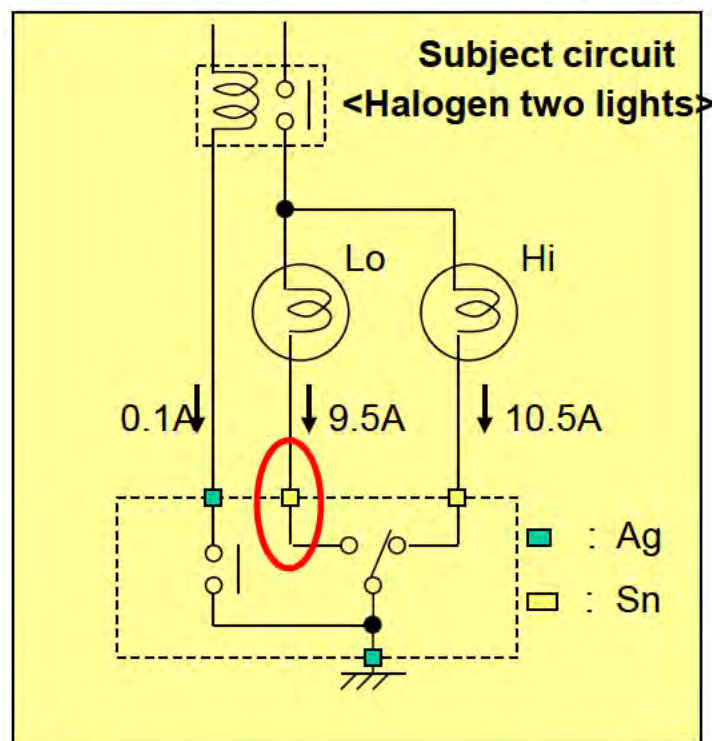
Low beam current passes through combination switch.

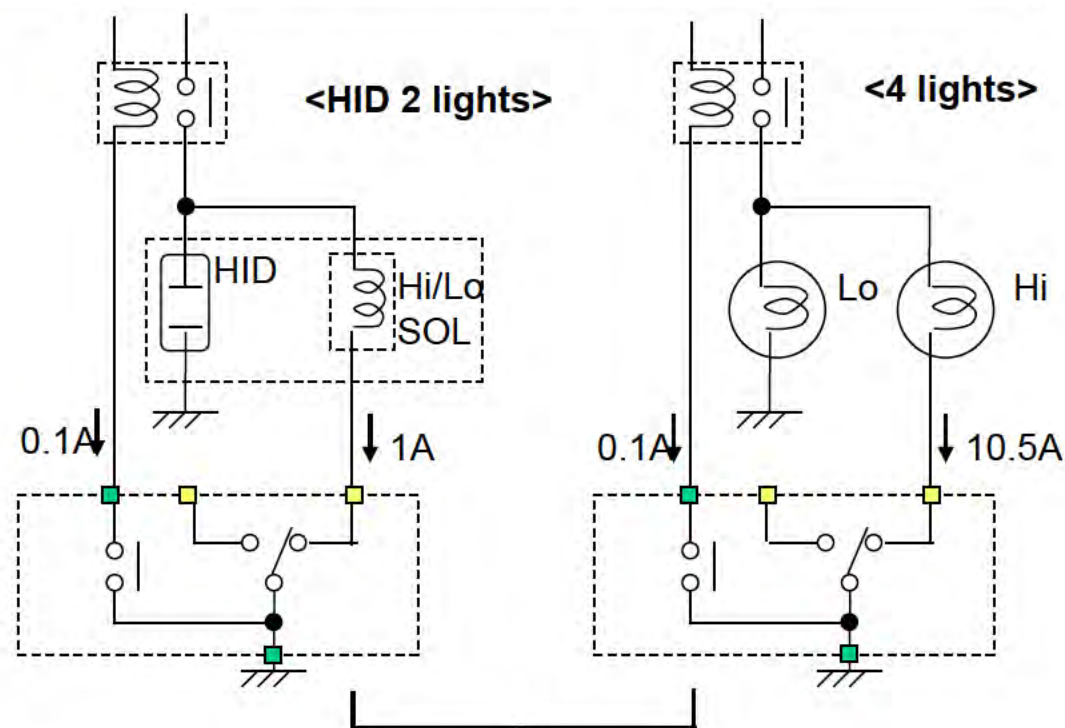
Low beam current does not pass through combination switch.

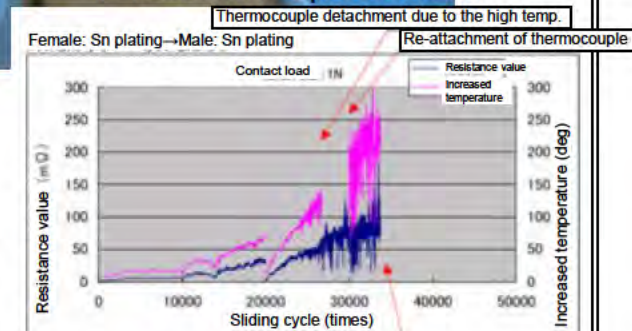
### <Part of contact pressure 1N>

- ◆ No abnormalities confirmed when contact pressure is within mass production control value (8N or more).
- ◆ GND (Ag-Sn) spec. has advantage so Ag plating is a factor to improve toughness of GND terminal. (Cu-Sn, Sn-Sn: 6N, Ag-Sn: 4N)
- ◆ Increased resistance is caused by exposed base material, copper.
- ◆ If contact load is high, resistance is stabilized from "oxide film is torn" that is a known effect and from "terminal sliding is reduced and plating wear is unlikely to be advanced" from the results of this time.  **$\Rightarrow$ It revealed that reduced contact load causes plating to wear, leading to heating and melt.**

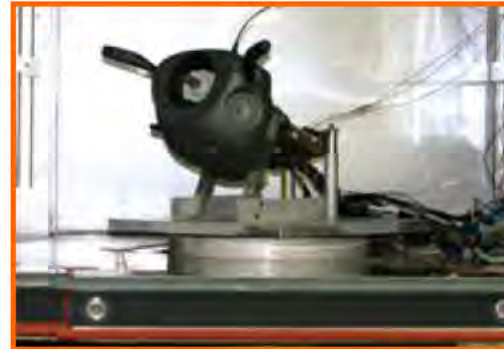
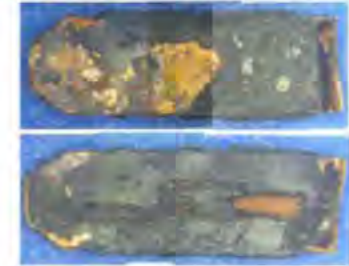
Melted terminal

The same appearance to market failed part

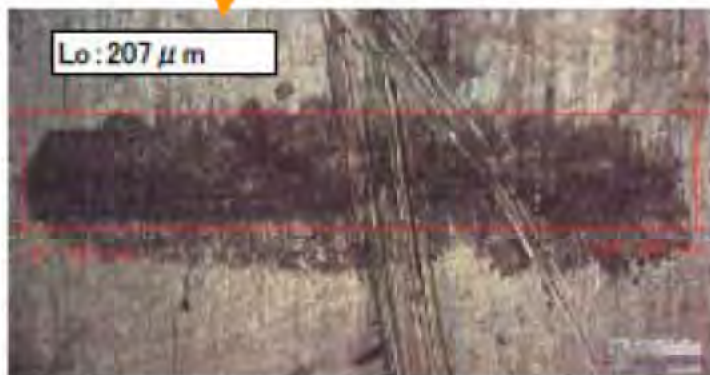
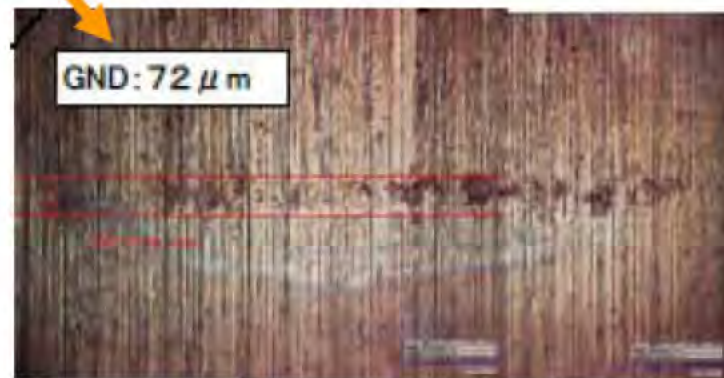
Market return parts indicate that terminals on the upper stage couplers are worn heavily

LT RELAY	LO	(AUTO OFF)	Locked area		Hi		R TURN	
146 $\mu\text{m}$	207 $\mu\text{m}$	—			202 $\mu\text{m}$		188 $\mu\text{m}$	
	FOG +	FOG -	SMALL RELAY	GND	L TURN	RELAY OUT		
	82 $\mu\text{m}$	110 $\mu\text{m}$	95 $\mu\text{m}$	72 $\mu\text{m}$	104 $\mu\text{m}$	103 $\mu\text{m}$

Small amount of wear = > Plating wear is not advanced and melt is unlikely to be led.

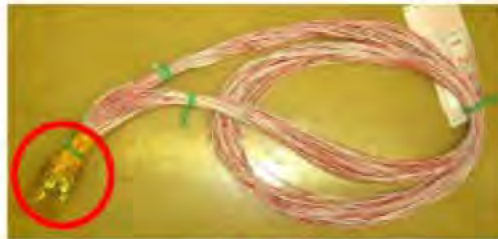
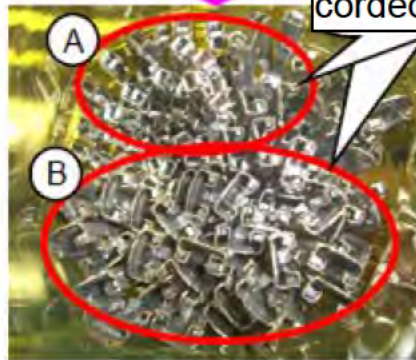
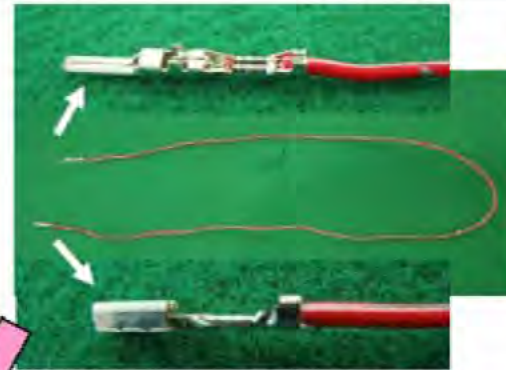
◆ Corded condition of work in process has a factor causing terminal deformation and improvement was instructed.

A and B are corded together.

Male terminal gets in female terminal and tongue may be deformed.

Terminals should be corded separately without fail.

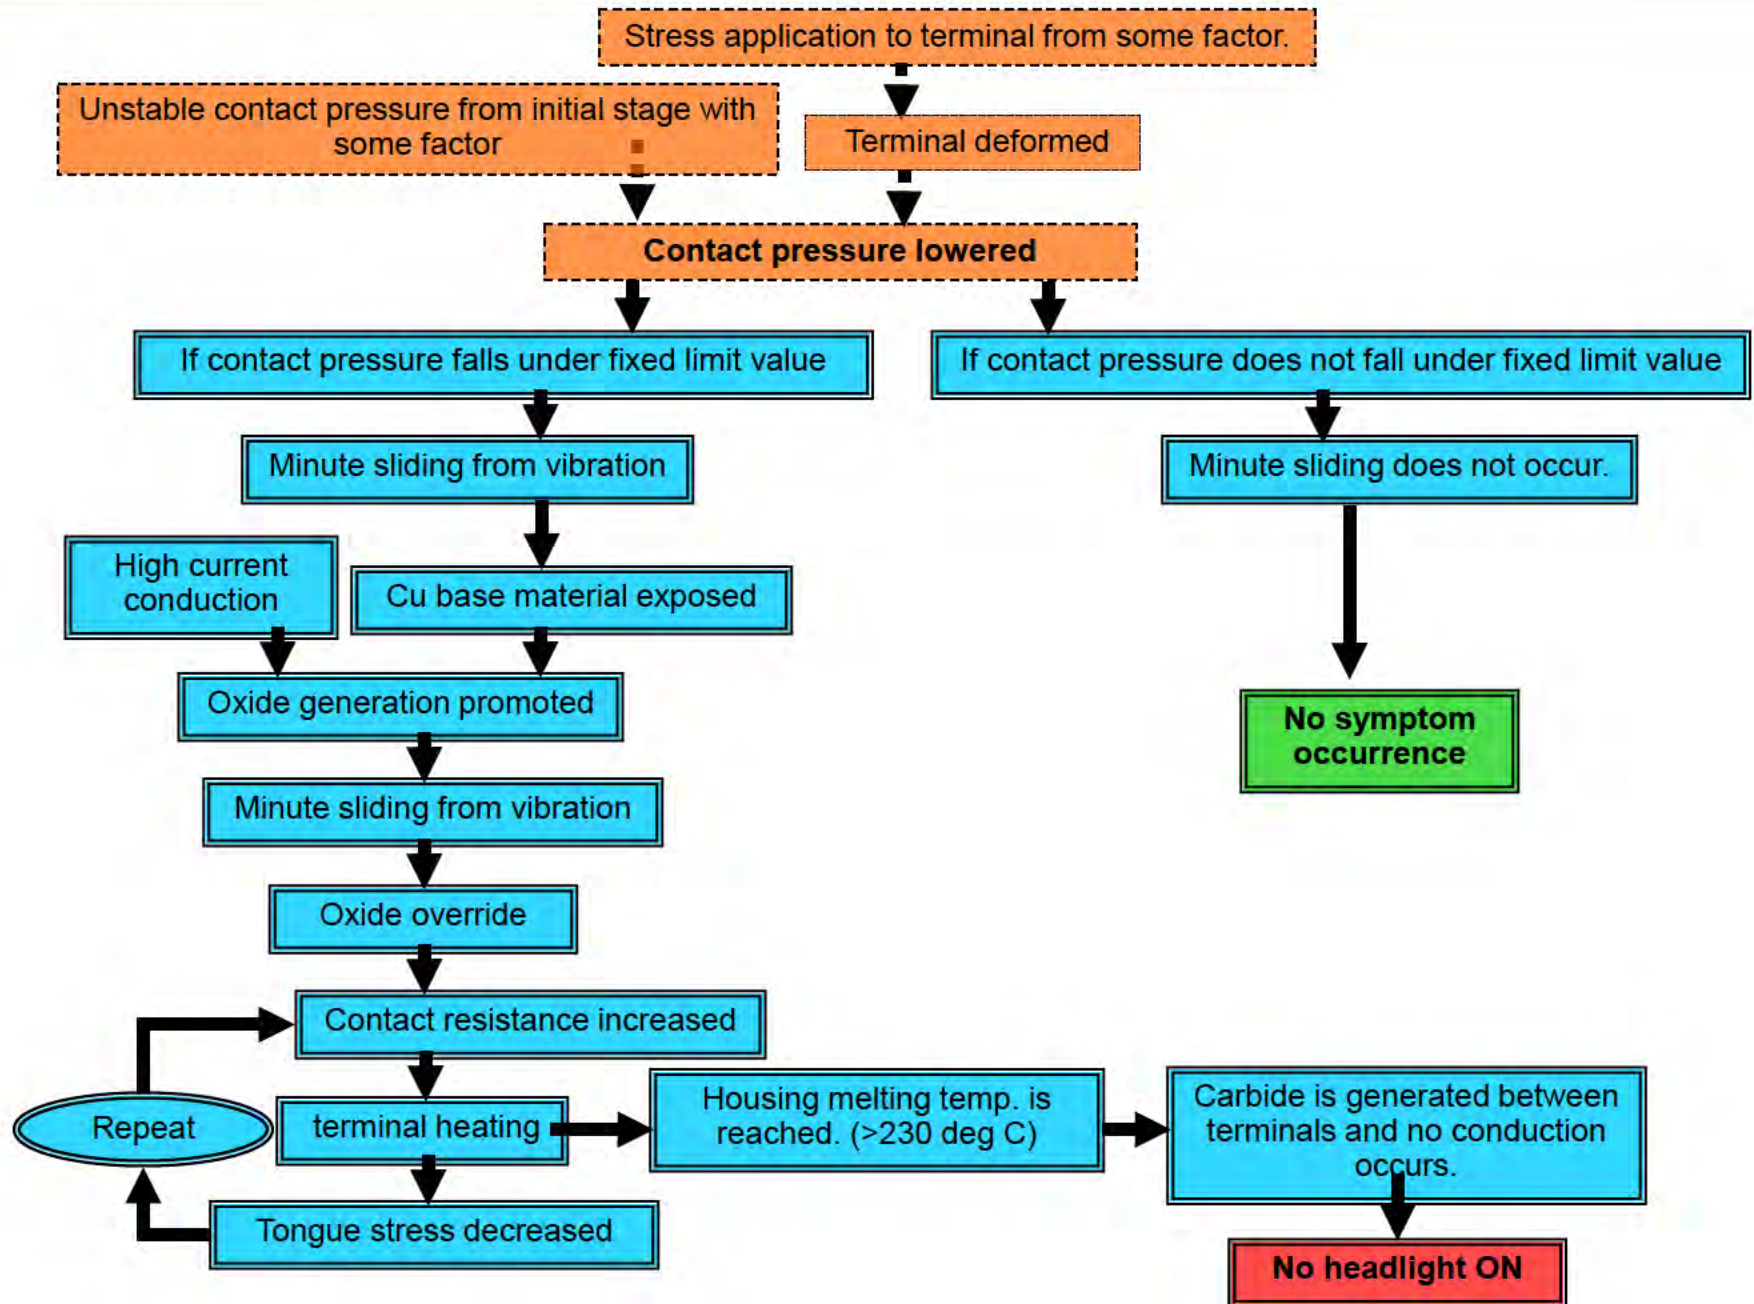
# Presumed occurrence mechanism

**Lowered contact pressure on terminal is considered to be the main factor but failure leading to the factor is not found in harness and vehicle manufacturing processes.**

**The reason why it occurs on Lo terminal only instead of Hi or GND terminals, is considered that Lo terminal is in a location minute sliding is likely to occur and use frequency of low beam is higher than low beam.**

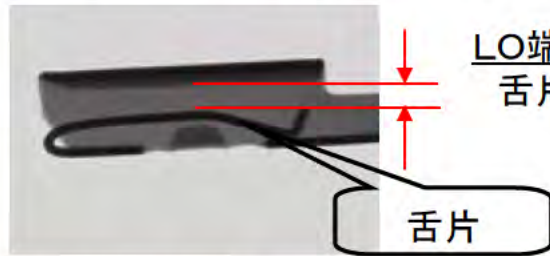
LO端子 X線画像  
舌片がへたっていることが分る。

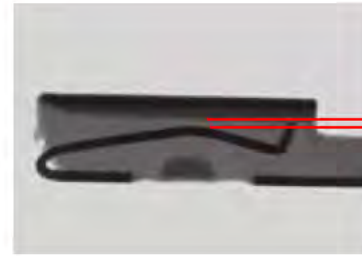
GND端子 X線画像  
舌片がへたっていない。

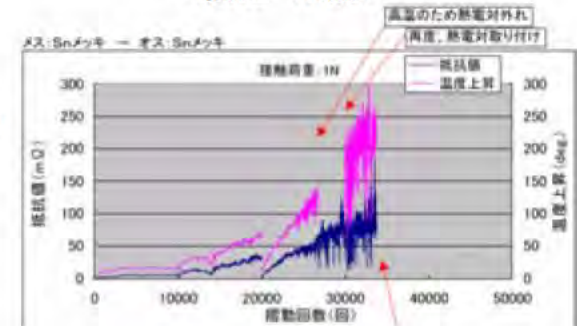
### <接圧 1N品>

- ◆ 接触圧 量産管理値内(8N以上)では異常が認められない。
- ◆ GND(Ag-Sn)の仕様に優位性が見られることから、AgメッキがGND端子のタフネスアップの一つの要因である。(Cu-Sn、Sn-Sn:6N、Ag-Sn:4N)
- ◆ 抵抗値上昇の原因は、母材である銅の露出である。
- ◆ 接触荷重が高いと  
従来より確認されていた効果「酸化膜を破る」ことと  
今回の結果より「端子の摺動が抑えられ、メッキの磨耗が進みにくい」ことで、抵抗値は安定する。

⇒接触荷重の低下がメッキの磨耗を招き、発熱・溶損に至ることがわかった。

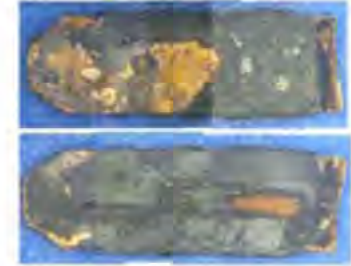
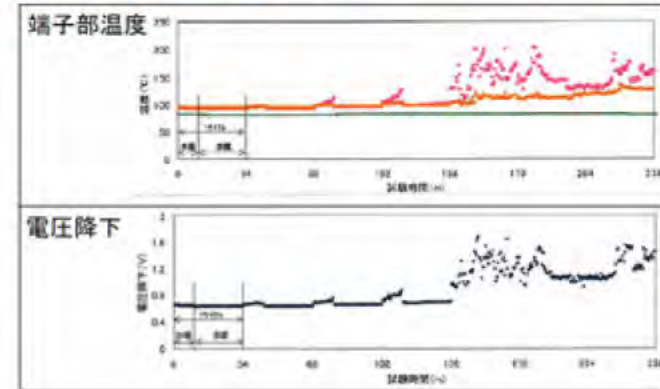
### 溶損端子

市場不具合品と同じ顔つき

- ◆接触圧、量産管理値内では異常が認められない。
- ◆接触圧1.5Nまで落とし、酸化を促進させるモードを加速要因として入れると、実車振動相当で事象再現した。
- ◆GND端子のみ接圧NG品を組み込み評価したが、若干の電圧降下が確認出来たのみで、溶損には至らなかった。(通常の倍のサイクル数実施)
- ◆メッキ材質を入れ替えたサンプルで評価したが、AgメッキのLo端子で溶損が再現。

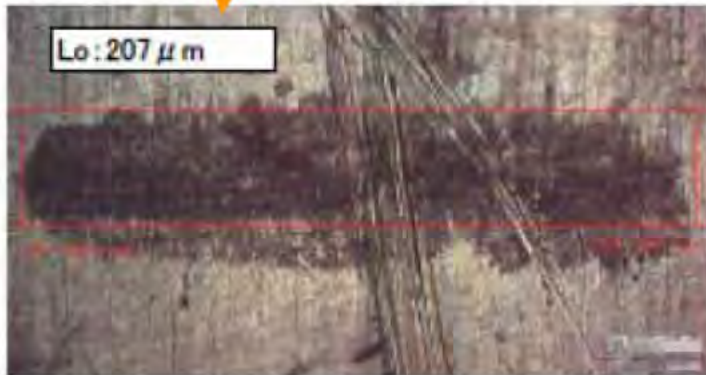
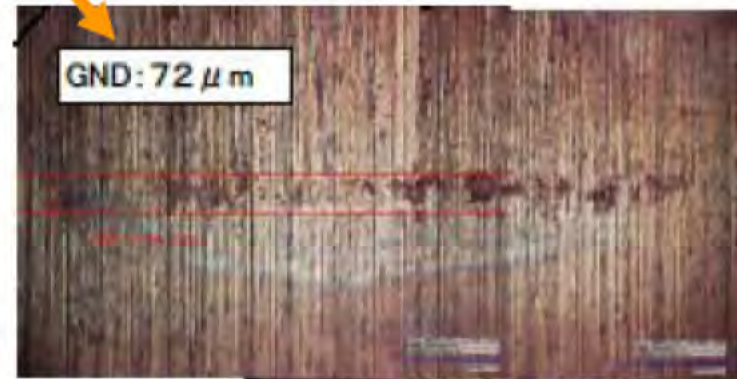
Fit 健康車 GD1-2000904 39,949km走行 オス端子表面摩耗量測定結果

LT RELAY	LO	(AUTO OFF)	ロック部		Hi		R TURN	
146 $\mu\text{m}$	207 $\mu\text{m}$	-			202 $\mu\text{m}$		188 $\mu\text{m}$	
	FOG +	FOG -	SMALL RELAY	GND	L TURN	RELAY OUT		
	82 $\mu\text{m}$	110 $\mu\text{m}$	95 $\mu\text{m}$	72 $\mu\text{m}$	104 $\mu\text{m}$	103 $\mu\text{m}$

摩耗量が小さい⇒メッキの摩耗が進まない為、溶損に至りにくい。

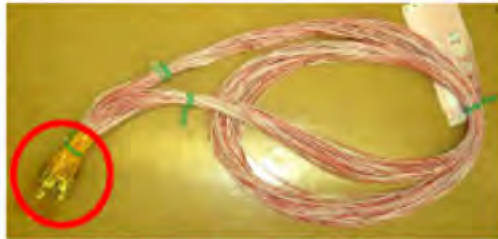
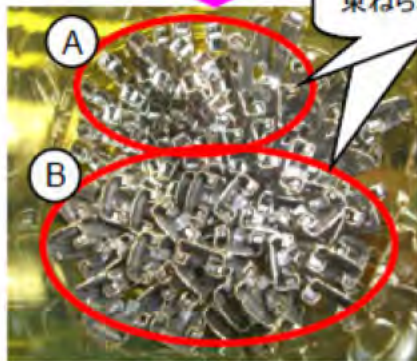
### 工程の現状

## ◆ 切圧品の結束状態に端子変形を起こす要因があり、改善を指示

AとBがまとまって束ねられている。

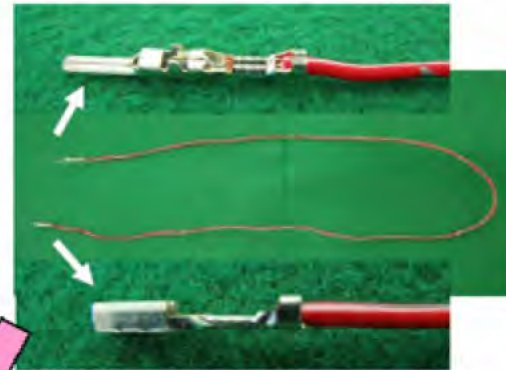
### FIT Lo回路の切圧品

オス端子がメス端子に入り込み舌片を変形させる恐れがある

<改善指示>  
端子は、必ず別々に束ねること

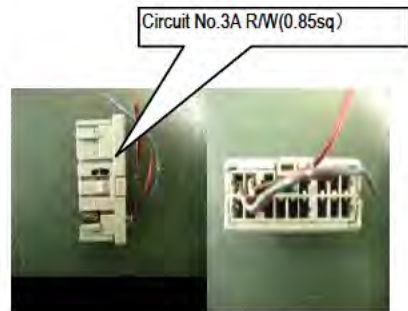
Terminal COMBI SW TURN & LT(1)

- Melting and discoloration of the wire coating were confirmed.
- Fitting mark due to contact pressure was confirmed.
- \* See appendix 2 for details.

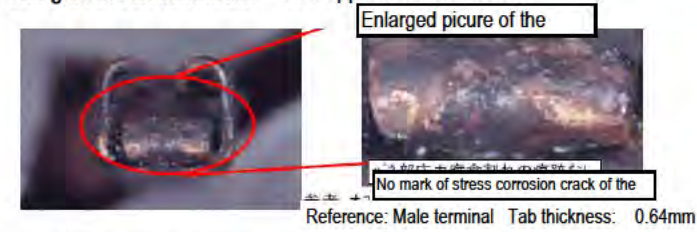
Since spring gap is over the male tab, contact load estimated is 0N.

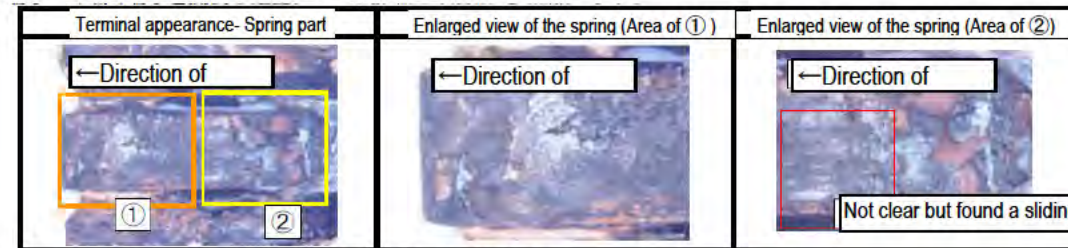
【Comment】: No cause which could lead to melting was found from the appearance observation.

Not clear but found a sliding mark. (Shown in red box)

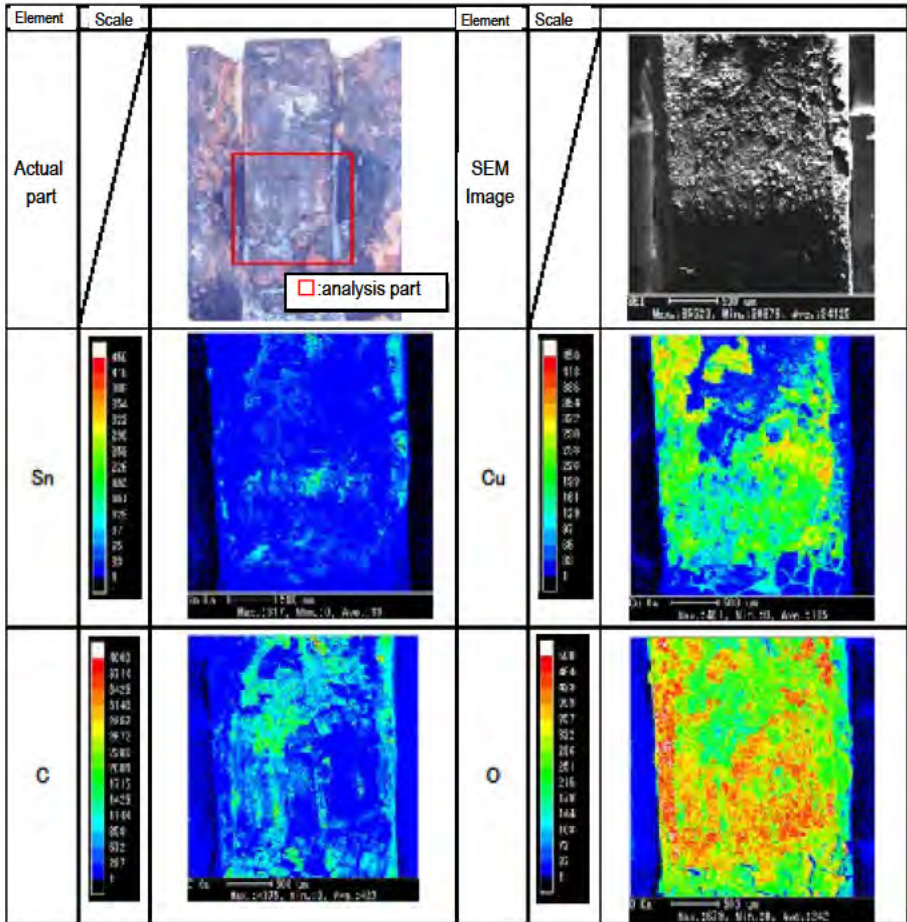
Surface analysis of Lo circuit terminal contact area (EPMA)

**[Comment]**  
 Melted badly and resin of the housing attached. Therefore, C and O are distributed widely. Also Cu diffusion has proceeded.

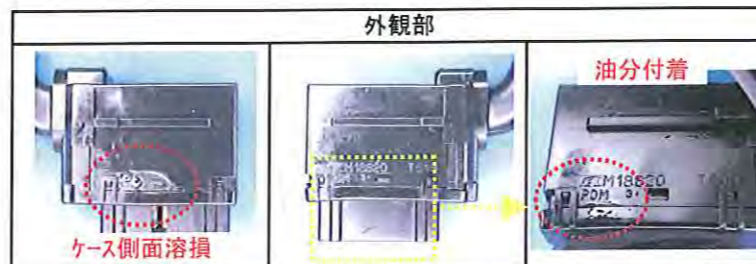
・各回路の導通確認(Lo回路は端子間を除く)を行ったところ、導通不良等の異常は見られなかった。  
2) 分解確認結果  
・Lo端子を切断し、この外観を確認したところ、カール側・舌片側共に端子全体が変色しており複数のアーク痕が確認できる。

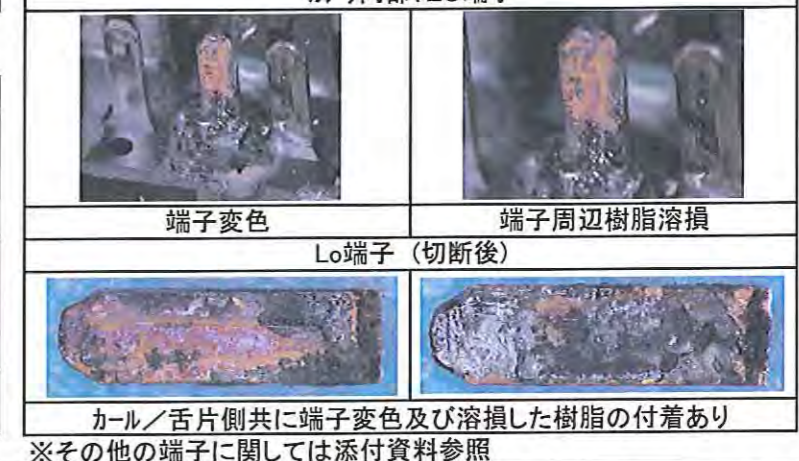
### カプラー内部: LO端子

3. まとめ  
以上の確認結果より、返却されたSWの内部回路に異常な箇所は確認されませんでした。ただし、Lo端子の溶損が確認できましたが、本SWにおいて発熱・溶損に至る要因は確認されませんでした。  
なお、発熱に至った要因として、何らかの接触不良が考えられますがその原因については相手側端子の詳細確認が必要と判断致します。
