EA11-012

HONDA

4/20/2012

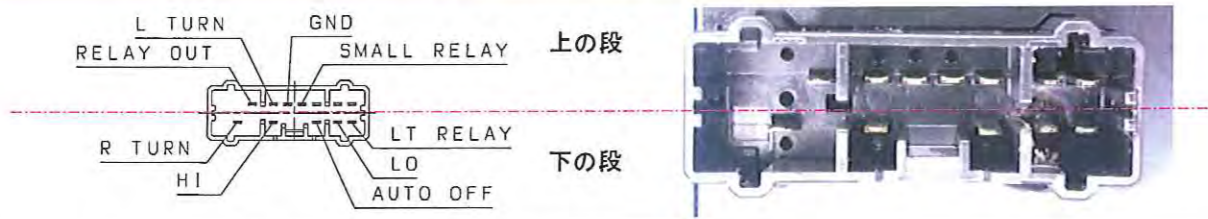
端子確認結果(LO端子以外)

端子名/メッキ仕様	RELAY OUT(Ag)		L TURN(Ag)		GND(Ag)		SMALL RELAY(Ag)	
	カール側	舌片側	カール側	舌片側	カール側	舌片側	カール側	舌片側
端子板厚【mm】	0.65		0.65		0.65		0.65	
端子メッキ厚【μm】	0.8	0.8	0.9	0.8	0.7	0.8	0.8	0.7
摺動幅【mm】	0.07		0.13		0.13		0.12	
端子写真	カール側							
	舌片側							
EDX分析								
分析結果	使用材料以外のピーク検出なく異常なし		使用材料以外のピーク検出なく異常なし		使用材料以外のピーク検出なく異常なし		使用材料以外のピーク検出なく異常なし

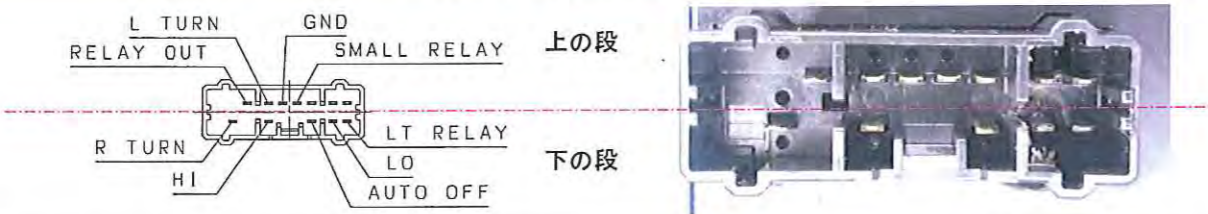
端子確認結果(LO端子以外)

端子名/メッキ仕様	R TURN(Ag)		HI(Sn)		AUTO OFF(Sn)		LT RELAY(Sn)	
	カール側	舌片側	カール側	舌片側	カール側	舌片側	カール側	舌片側
端子板厚【mm】	0.65		0.65		0.65		0.65	
端子メッキ厚【μm】	0.8	0.9	2.0	2.0	1.8	1.8	2.0	1.8
摺動幅【mm】	0.32		0.35		測定不可		0.55	
端子写真	カール側							
	舌片側							
EDX分析								
分析結果	使用材料以外のピーク検出なく異常なし		使用材料以外のピーク検出なく異常なし		使用材料以外のピーク検出なく異常なし		使用材料以外のピーク検出なく異常なし

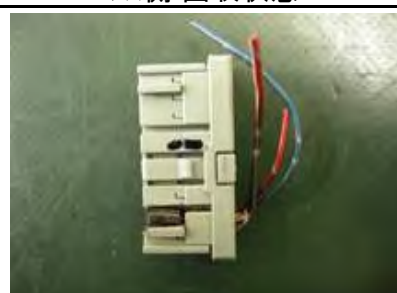
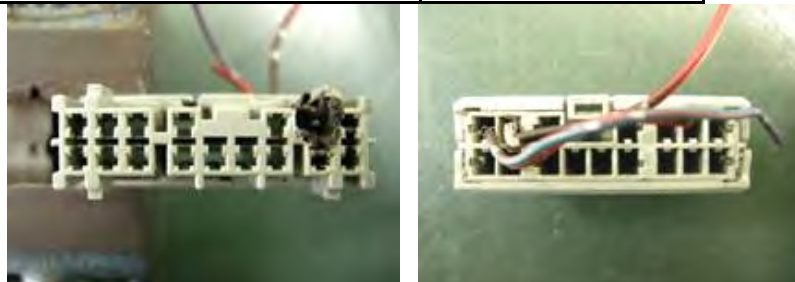
今回の調査の結果、Lo回路メス端子ハネ隙間が広く(0.70mm)、接触荷重が0(N)の状態であったと推測される(オス端子タブ厚:0.64mmより広い為)また、メス端子接点部に摺動痕が確認された為、当初は接触荷重が確保されていたと推測できる。その他、溶損が激しく、接点部にハウジングの樹脂が付着している。また、応力腐食による端子ハネ部の破損や、スパーク痕といった異常は確認できなかった。

<p>メスコネクタ 側面1</p>  	<p>メスコネクタ 側面2</p>  	
<p>メスコネクタ溶損部拡大</p>  	<p>メスコネクタ溶損部(間口)拡大</p>

所見: 溶損部付近以外に特に異常な傷、変形は見られない。

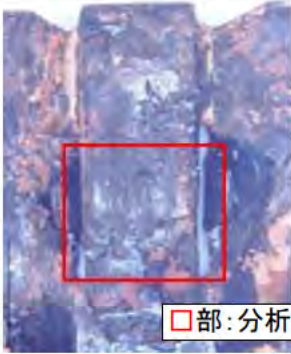
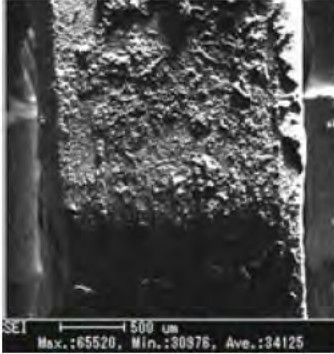
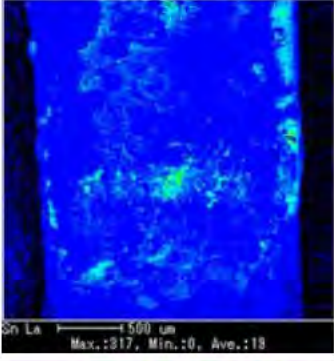
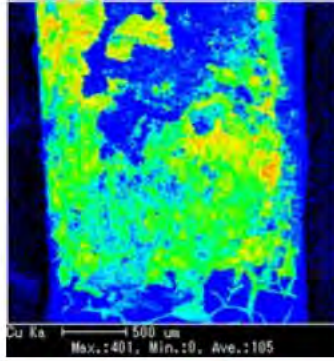
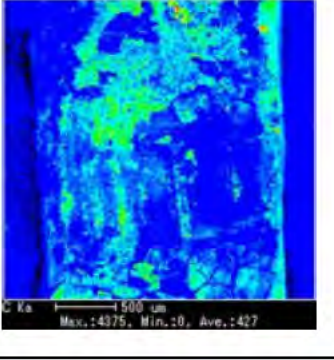
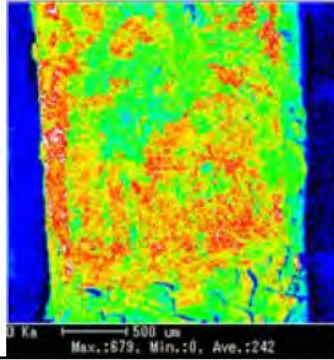
## ・Lo回路 端子接点部 表面分析(EPMA マッピング)

<p>所見:溶損が激しく、ハウジングの樹脂が付着している。その為、C、Oが広く分布している。 また、Cuの拡散が進んでいる。</p>

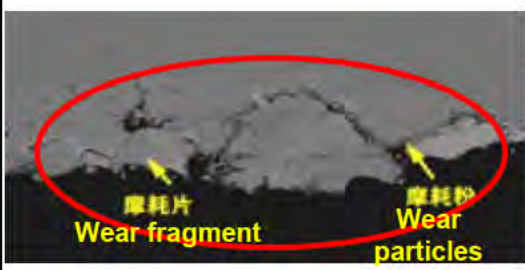
Female terminal at harness side			
Returned part

There is no Sn plating any more and wear particles of base material have accumulated.

Sn plating is worn and wear particles have accumulated. Repetitive sliding has occurred.

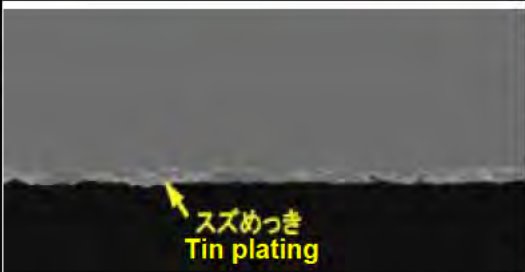
Sn plating is worn.
Non-defective part

Sn plating remains and no wear particles found.

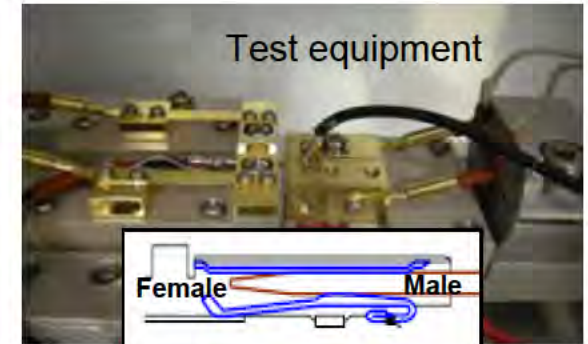
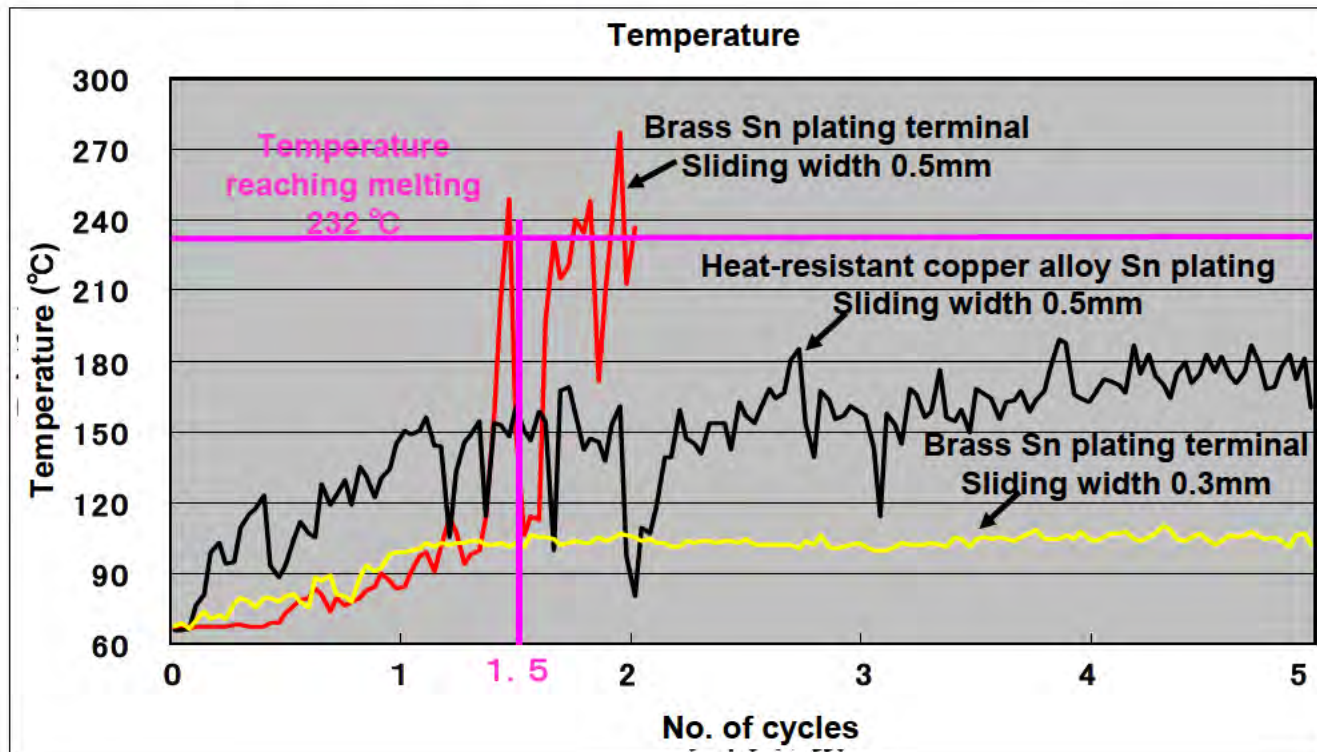
Brass terminal (Sn plating terminal) is confirmed to have achieved connector resin (PBT) melt temperature with sliding width 0.5mm/approx. 1.5 cycles.

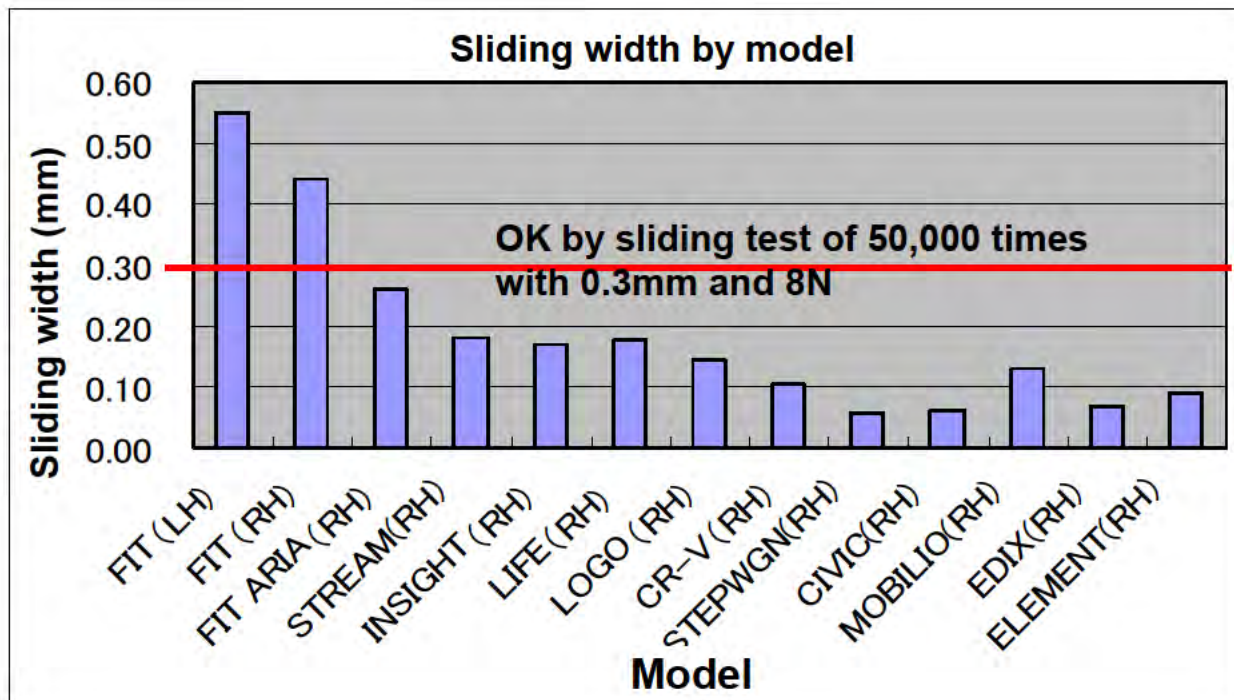
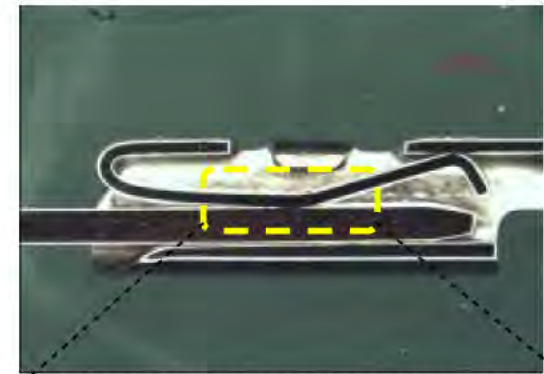
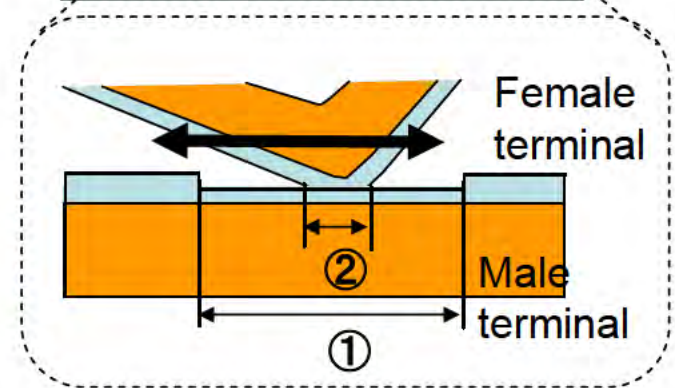
FIT/JAZZ has larger sliding width than other models.

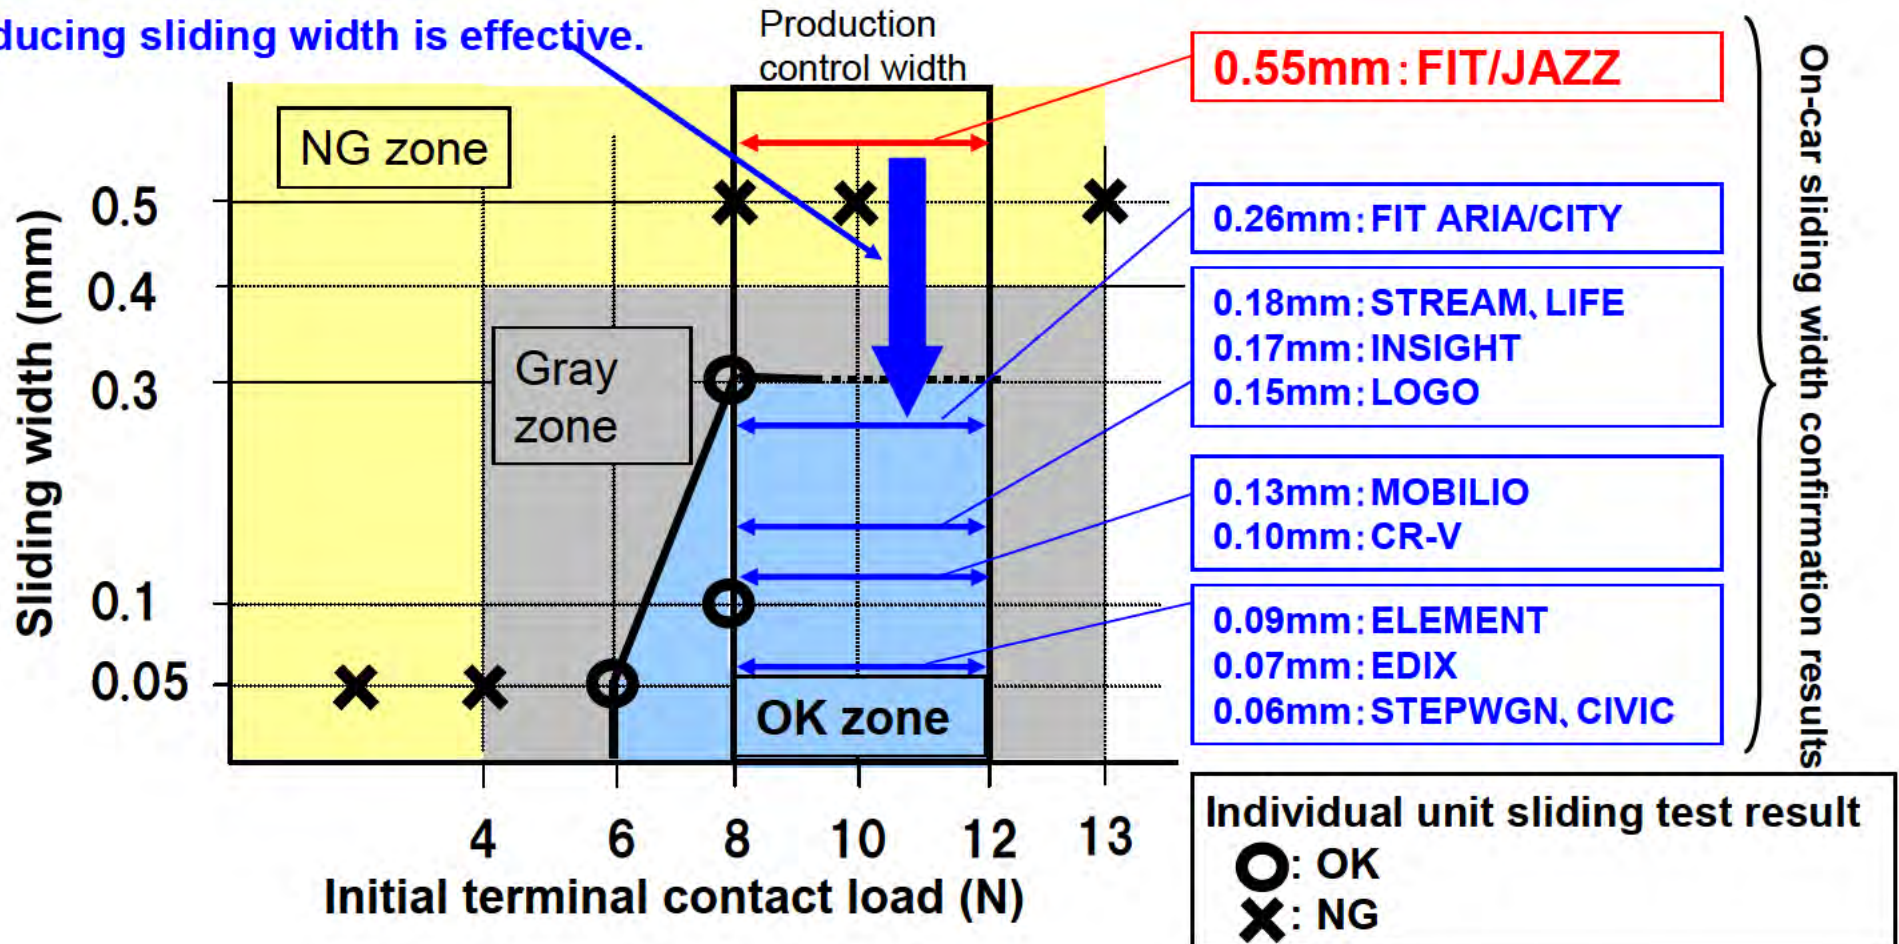
It is confirmed that only FIT/JAZZ is in NG zone where resistance increases. Reducing sliding width is the most effective countermeasure.

Reducing sliding width is effective.

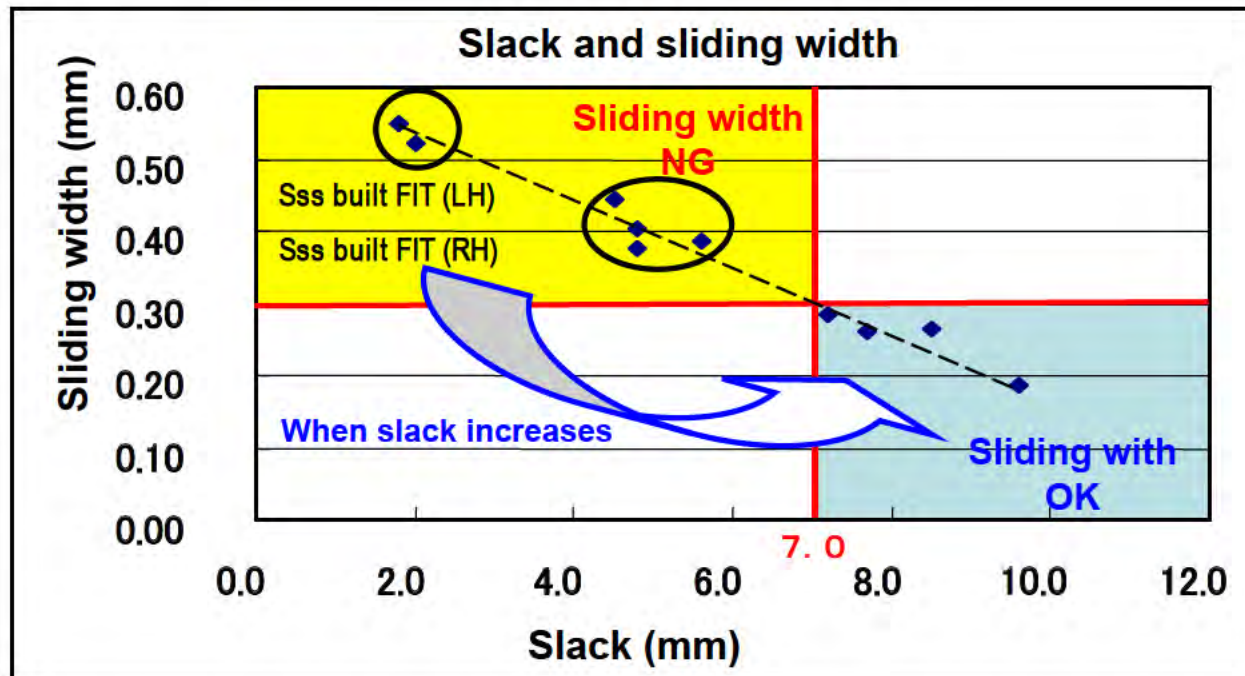
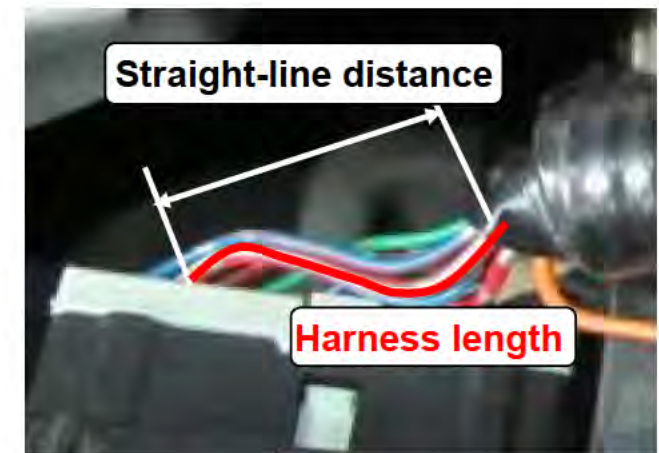
- Comparison between Sss built FIT and FIT built at other factories showed difference in slack, so correlation between slack and sliding width will be confirmed.

We found that sliding width decreases when slack increases.

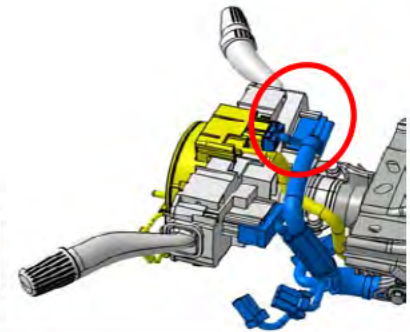
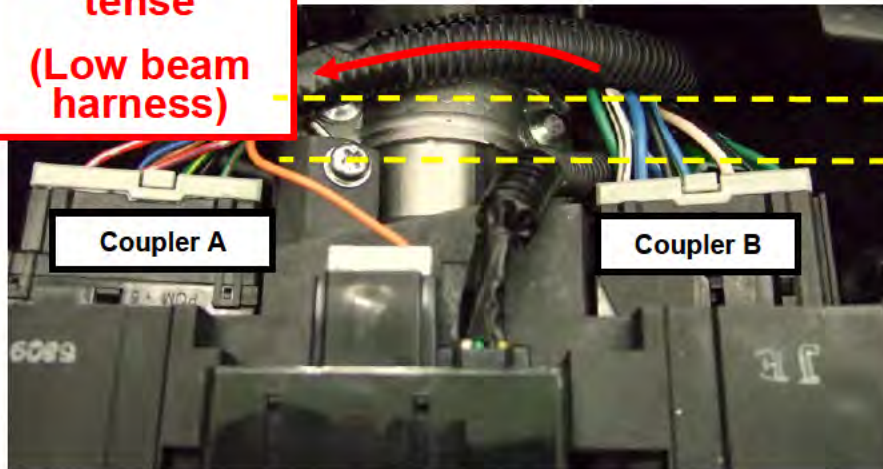
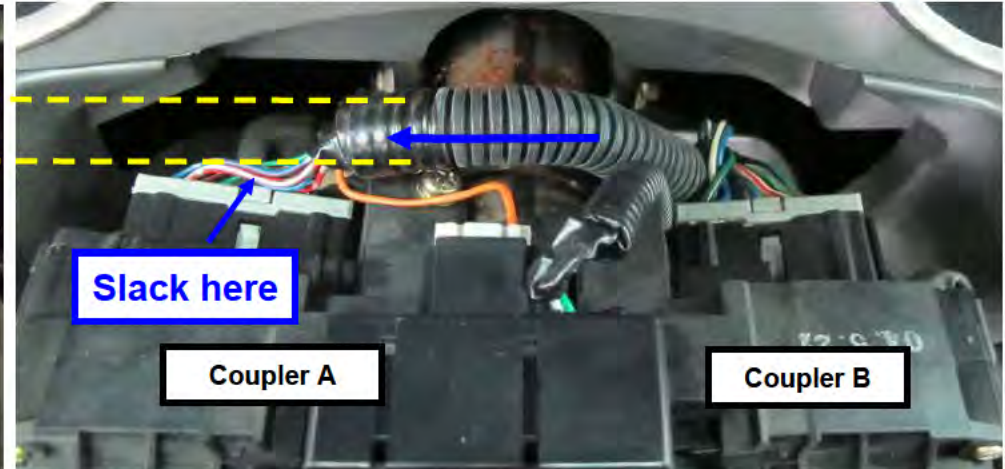
Harness is tense  
(Low beam harness)

When coupler B is set first, then coupler A is set on COMBI SW side, harness comes off from coupler, and low beam harness tends to be tense.

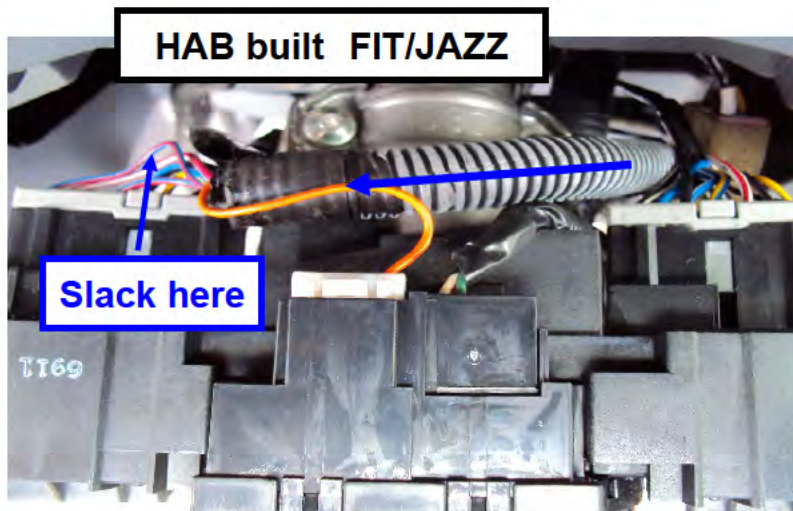
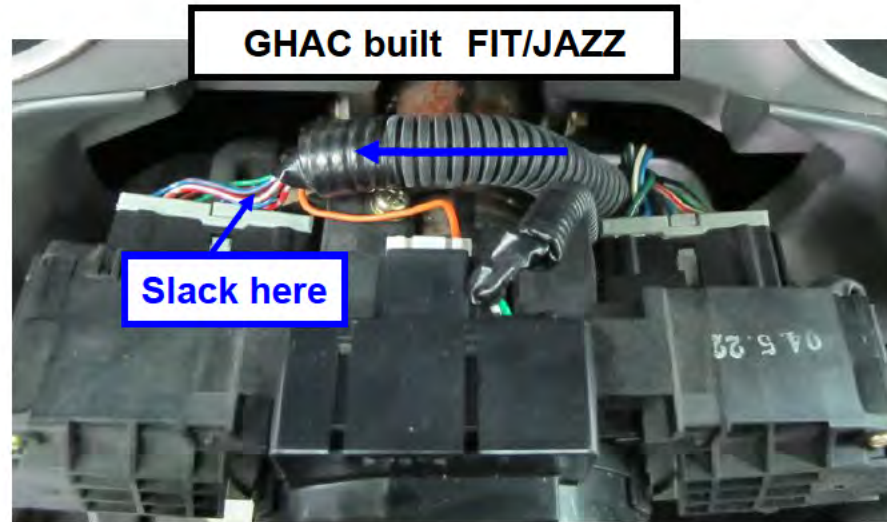
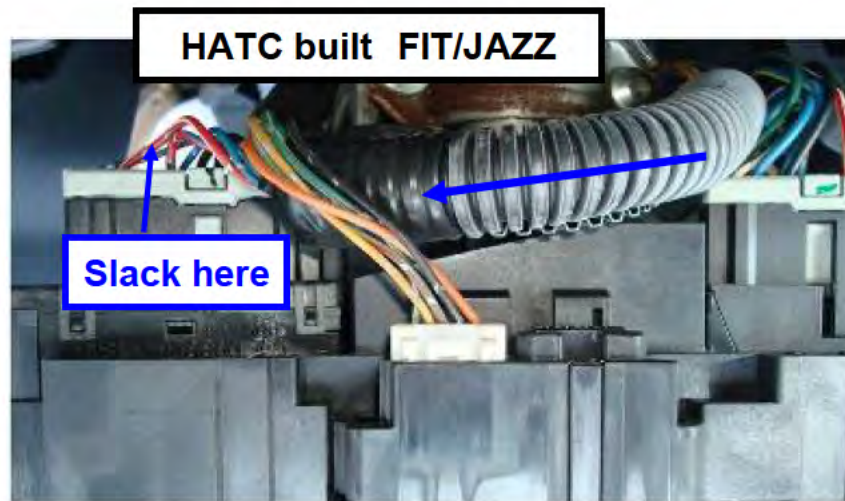
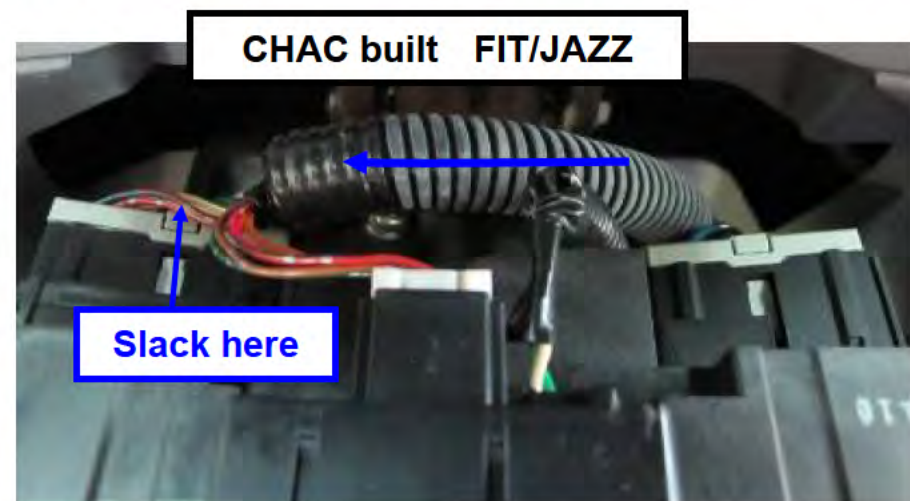
Low beam harness is tense for only Sss built FIT/JAZZ.

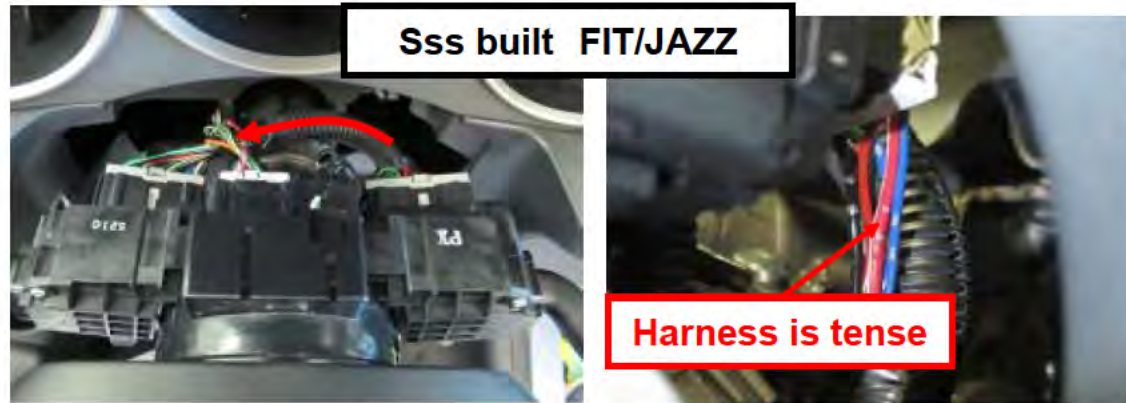
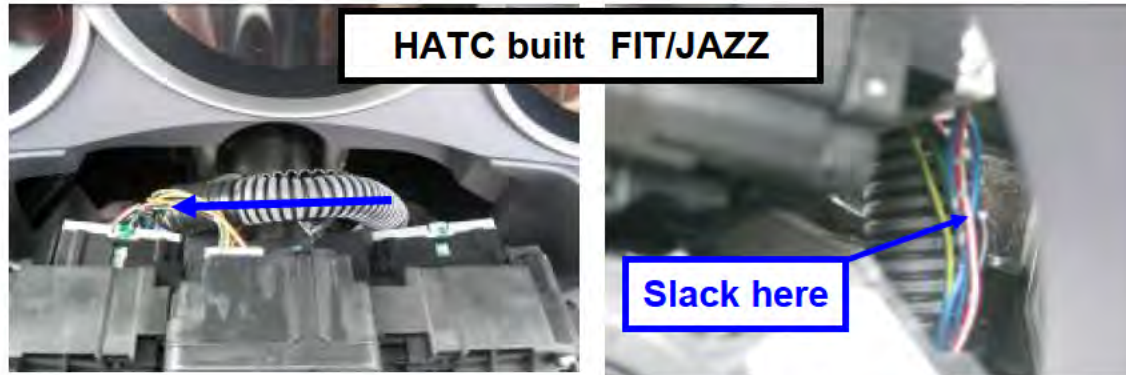
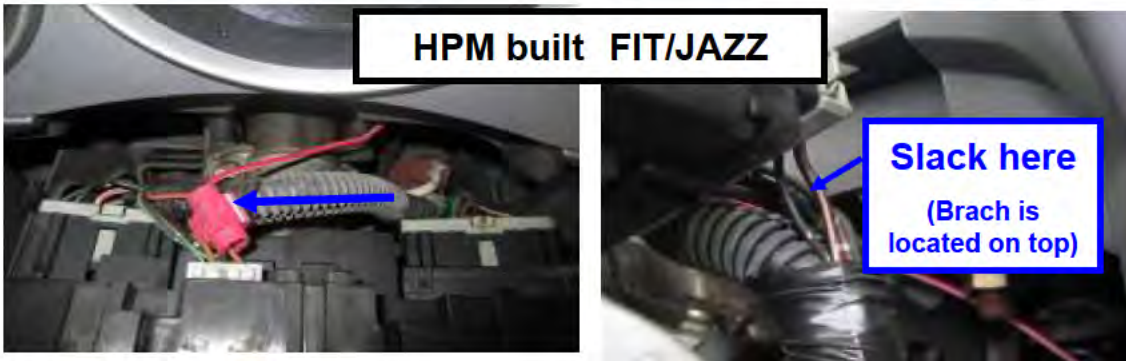
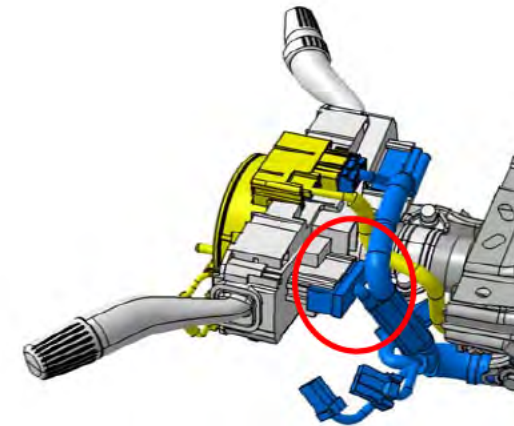
**Low beam harness is tense for only Sss built FIT/JAZZ.**

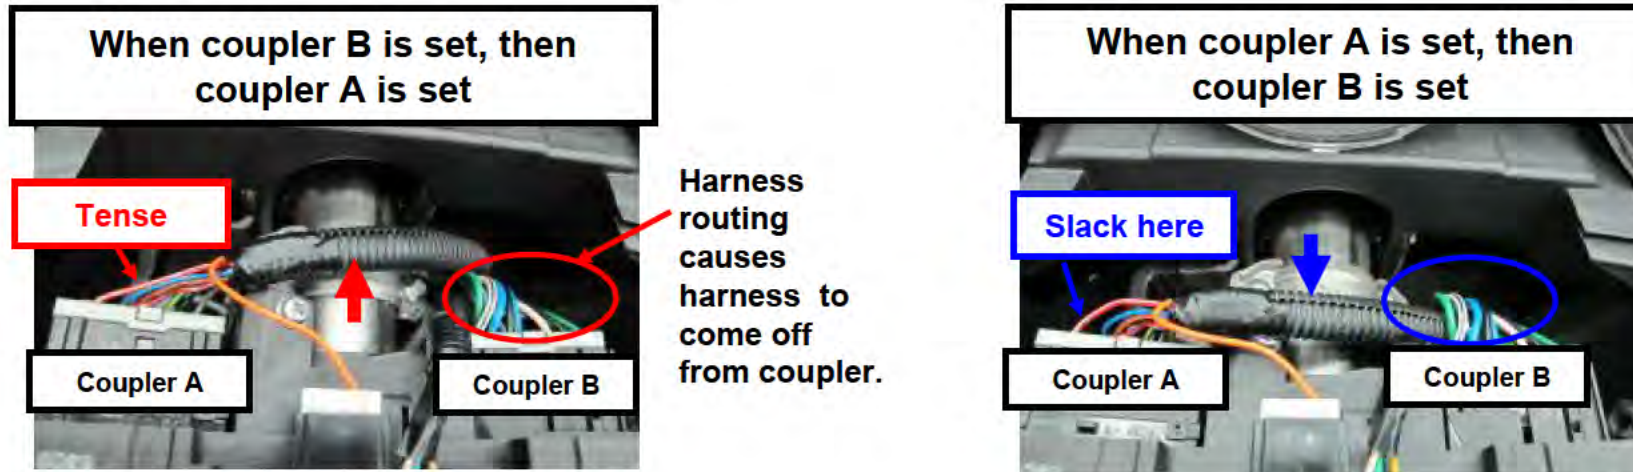
- ① When coupler B is set, then coupler A is set on COMBI SW side, harness comes off from coupler, and low beam harness tends to be tense.

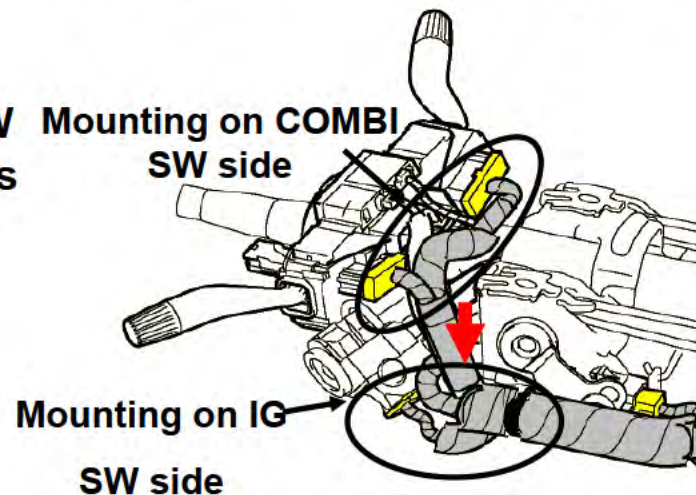
- ② When harness is mounted to COMBI SW, then mounted to IG SW, harness on COMBI SW side moves down, and low beam harness tends to be tense.

When coupler B is mounted, then coupler A is mounted on IG SW side per mounting order of Sss built FIT/JAZZ, low beam harness is tense.

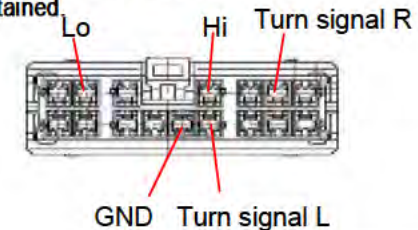
1. Current of terminals other than Lo / Hi / GND is 3.5A when turn signal is working, and less than 0.2A when turn signal is not working.
2. Hi / GND terminal is located on the center of the coupler, so slack is maintained.

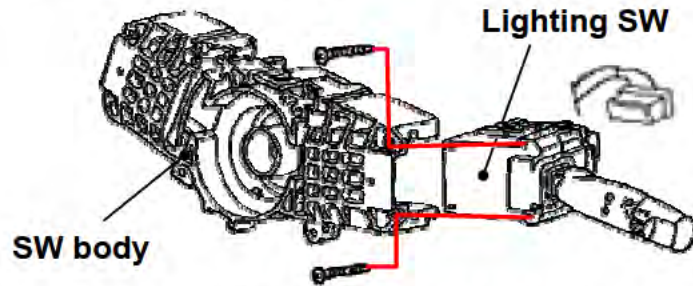
When lever is worked (Switching from Hi to Lo, turning lever while pulling the lever toward driver), with SW tightening screw as supporting point, the SW slightly moves.

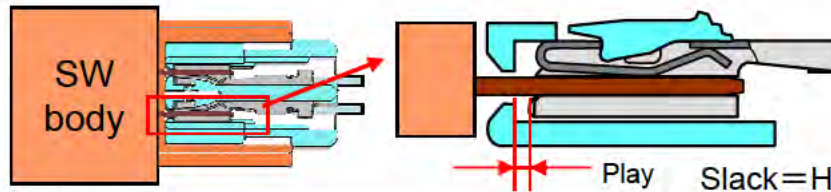
Play found between coupler and female terminal because of assembly and part tolerance.

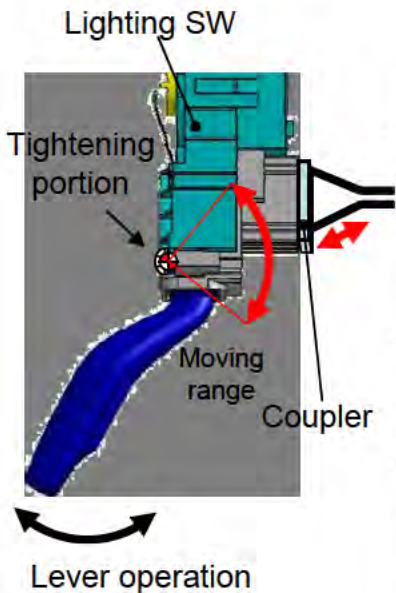
When harness is tense	When harness shows slack
Switching from Hi => Lo Passing Turning lever while pulling Operating direction Force (Return)	<p>Coupler, Female terminal, Male terminal, Headlight operating SW, (Reaction)</p>	<p>Harness slack absorbs dislocation</p>
Before / after operation		
Switching from Lo => Hi Turning lever while pushing Operating direction Force (Return)	<p>Slack does not easily occur</p>	<p>Harness slack absorbs dislocation</p>

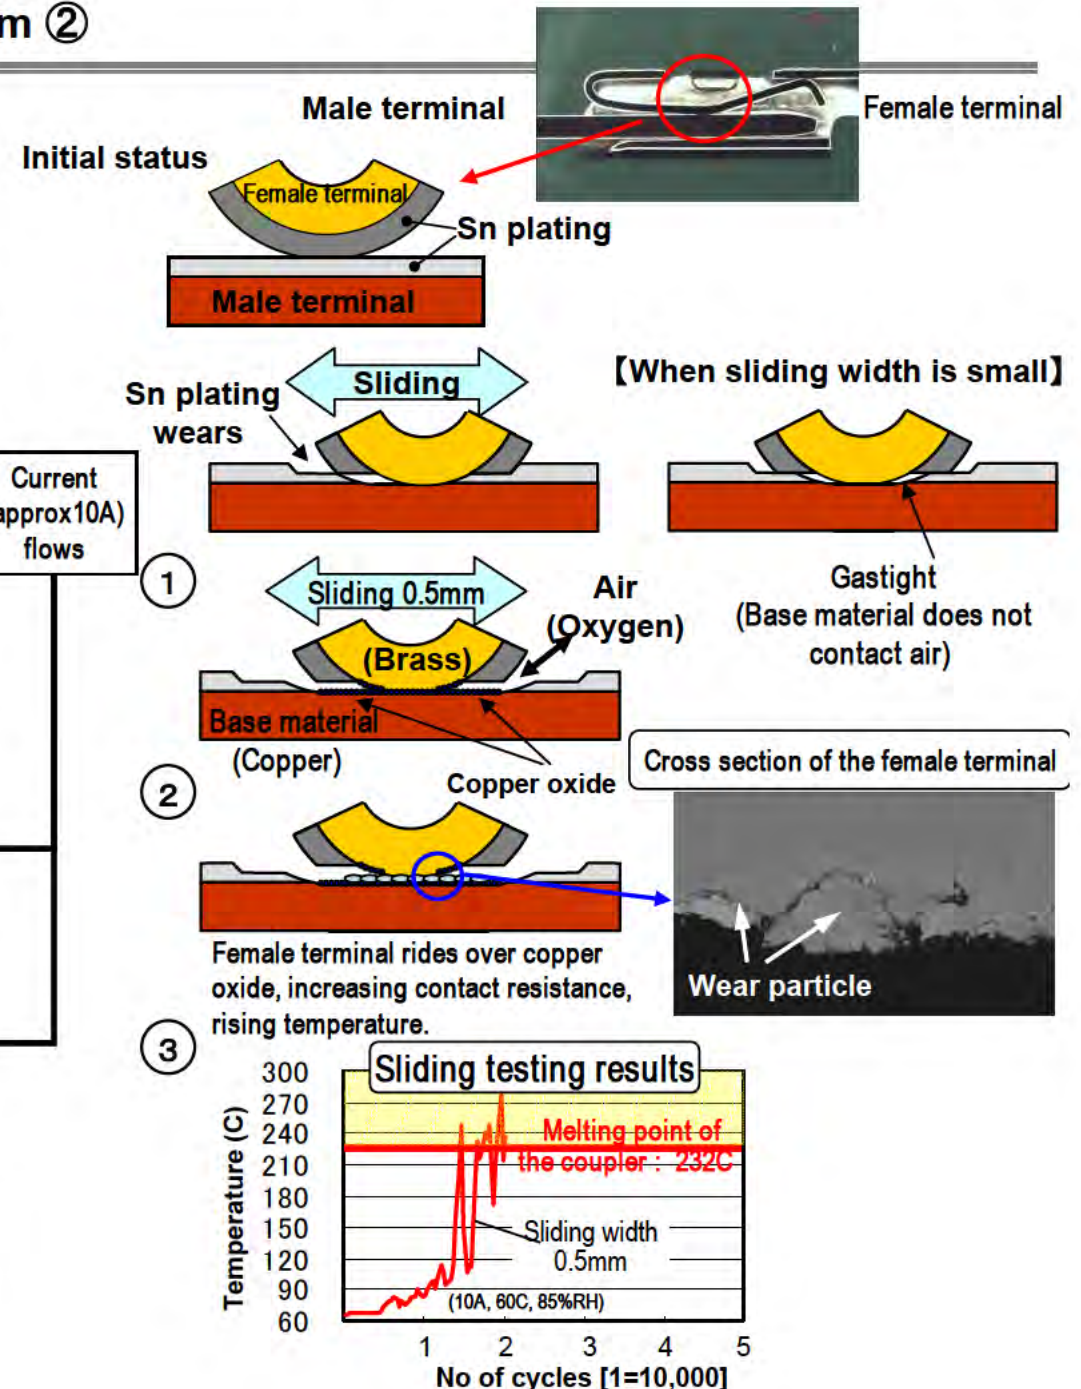
# Analysis results Occurrence mechanism ②

① Sn plating gradually wears from sliding of terminal connection area, base material is exposed, copper oxide generates on connection area between male and female terminal.  
When terminal repeatedly slides, copper oxide turns into wear particle, and wear particle builds up sliding portion.

② When terminal overrides wear particle from copper oxide, which built up when sliding, contact resistance increases, and connection area excessively heats up when headlight illuminates.

③ Less stress is applied to connection area of the terminal from heat, and contact pressure of the terminal drops.  
As a result, more wear particle enters between male and female terminal and the terminal further heats up.

If this condition continues, coupler plastic melts and flows into connection area, leading to no continuity, resulting in **no illumination of the low beam.**

\* No continuity occurs when coupler plastic melts and flows into connection area. Current does not flow, so fire does not spread.

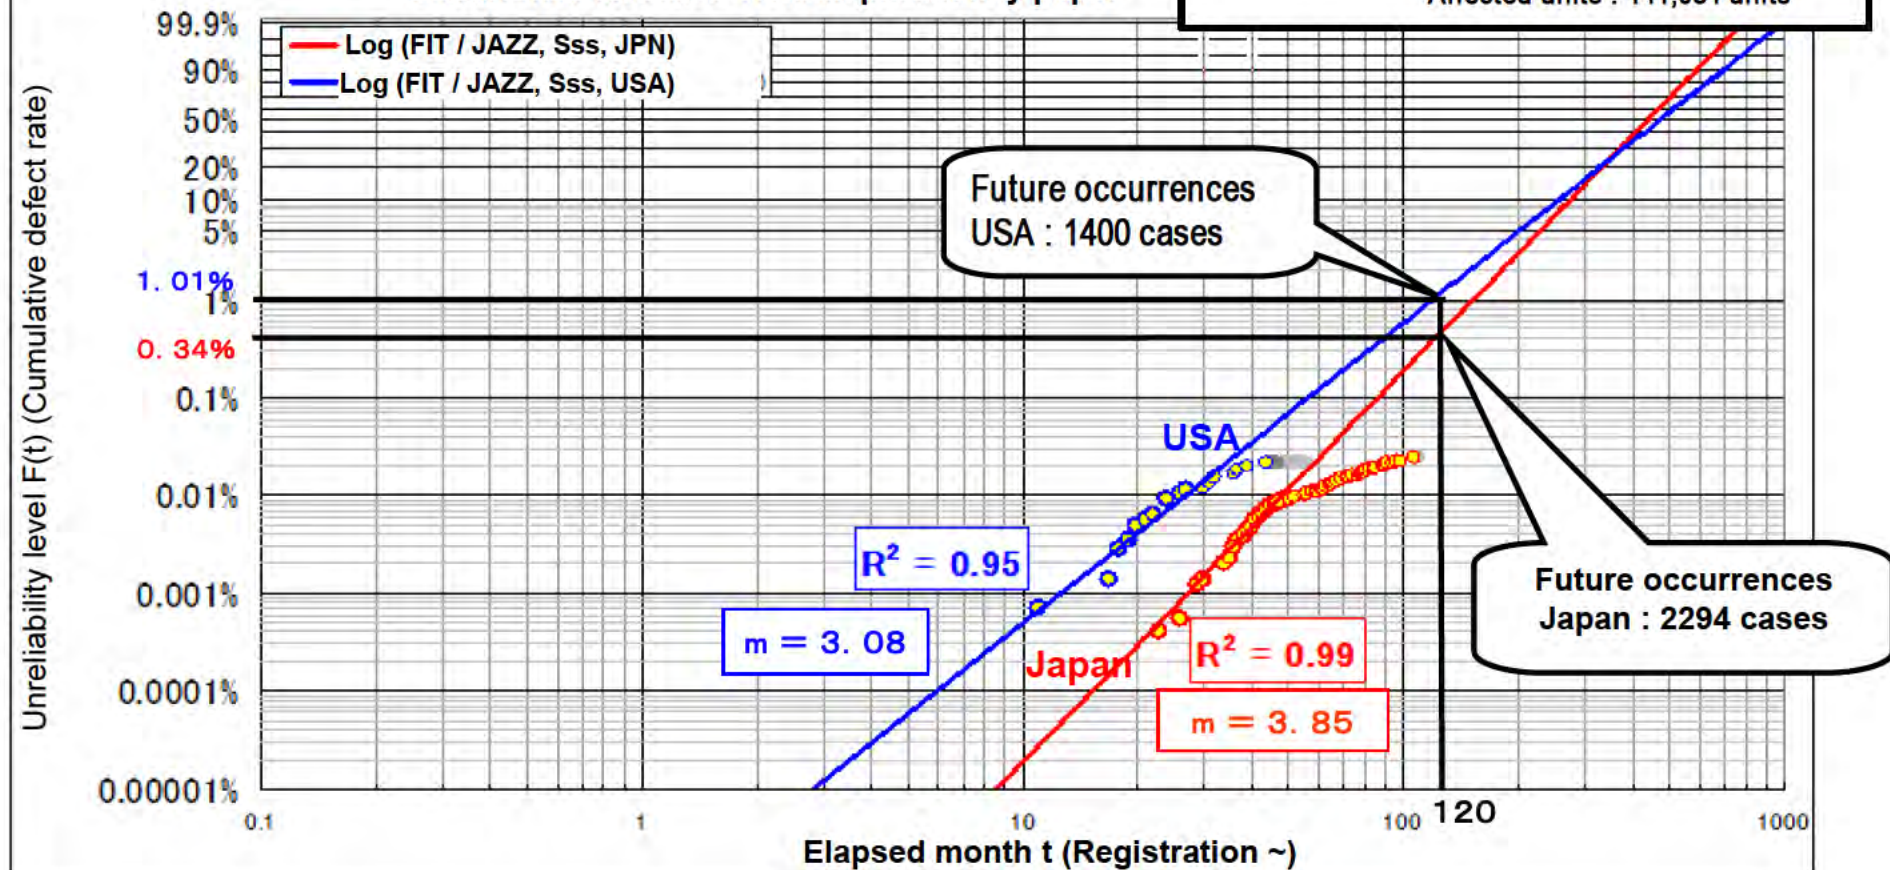
Occurrence forecast Weibull probability paper

Elapsed years	Current	In 10 years
Occurrences	25 cases	1425 cases
Occ rate	0.018%	1.01%
Affected units : 141,084 units

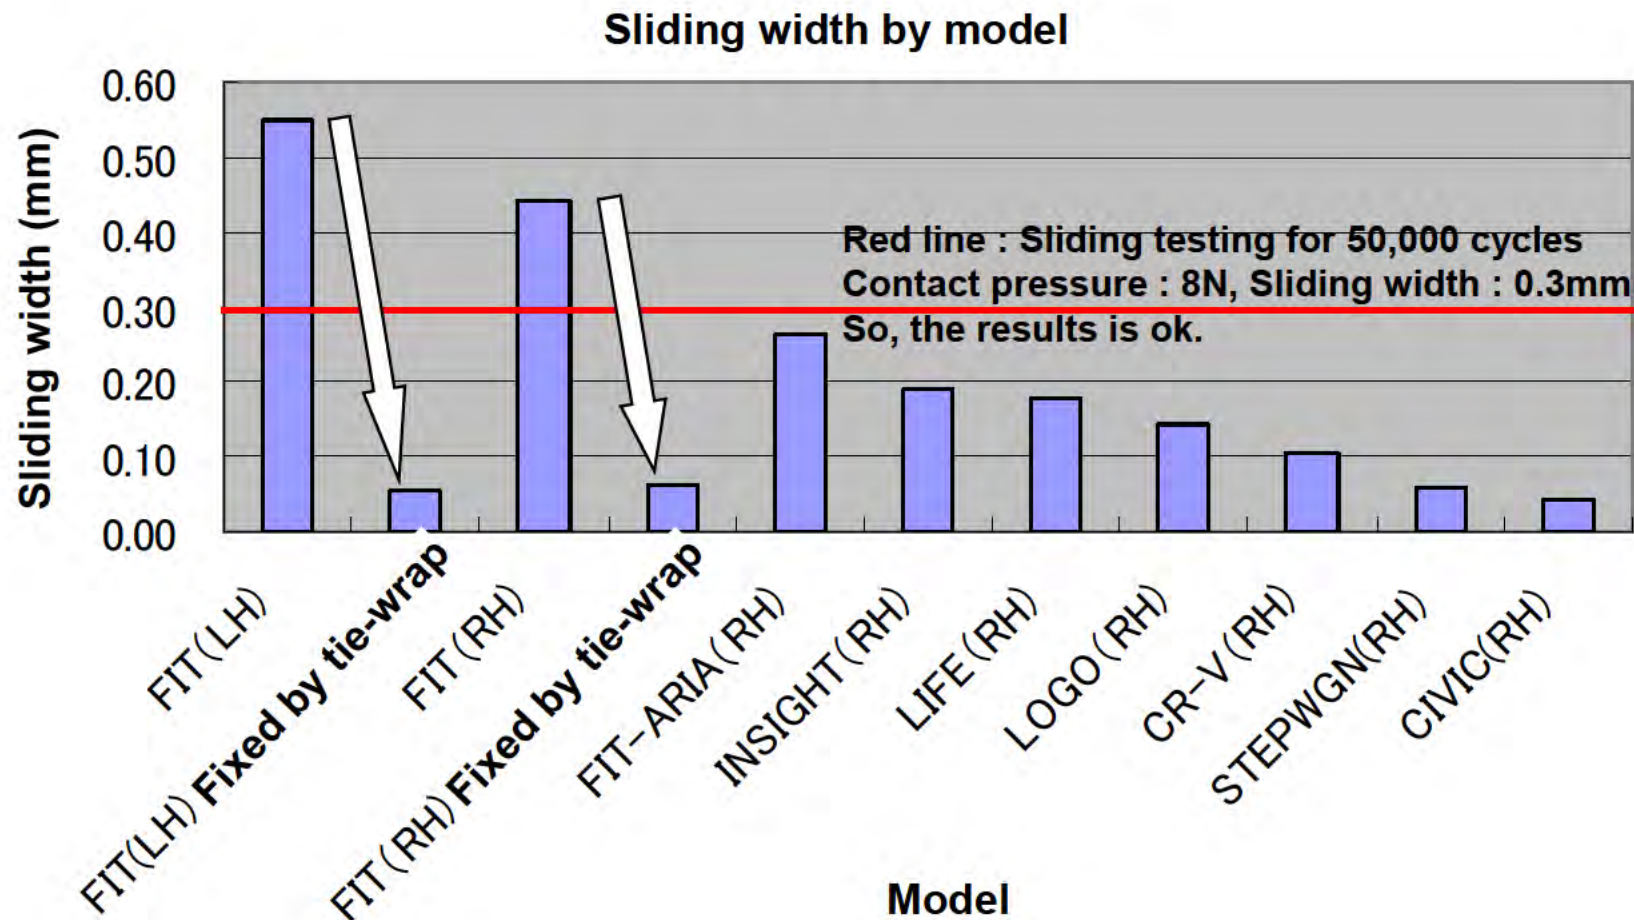
**Tie-wrap reduced sliding width to approx 1/10.**

- Confirm countermeasure effectiveness by operating lighting switch for 10,000 cycles on car. (1 cycle : Activate turn signal (Right) -> Neutral -> Activate turn signal (Left) -> Neutral -> Passing -> Neutral)

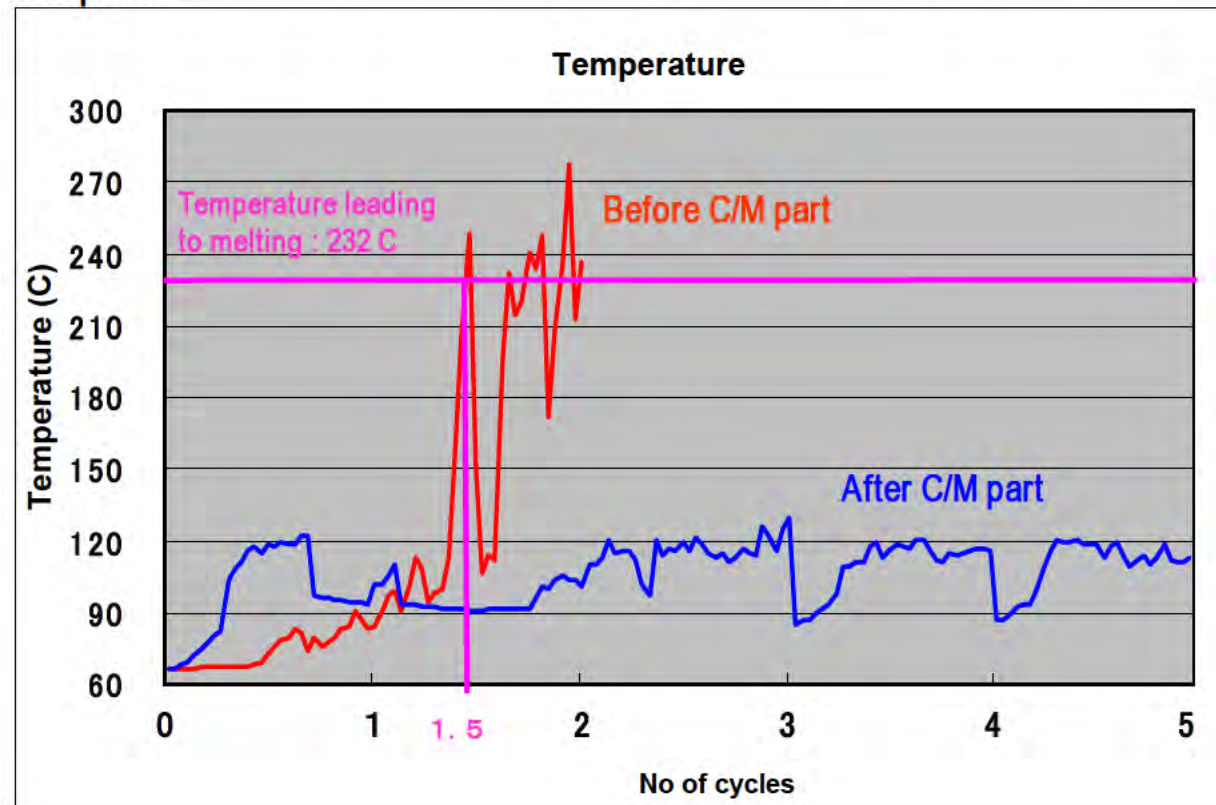
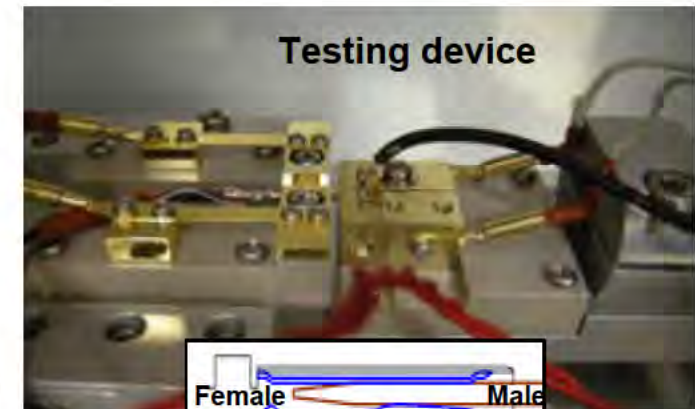
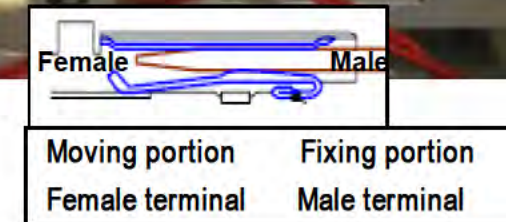
We found that the failure will not occur by fixing the harness by tie-wrap and changing material of the female terminal to heat resistance copper alloy, even if Sn plating of the male terminal separates from wear.

Before C/M part : Melting damage occurs in approx 1.5 cycles.

After C/M part : Melting damage does not occur in 5 cycles.

After C/M part shows at least more than 3 fold toughness than before C/M part.

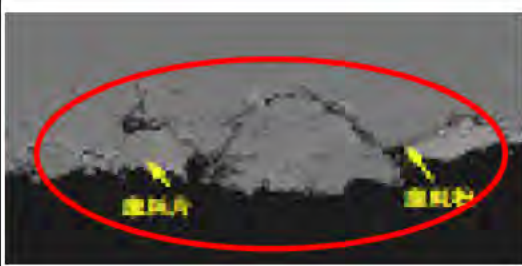
ハーネス側のメス端子			
返却品

Snメッキがなくなり、母材の磨耗粉が堆積している

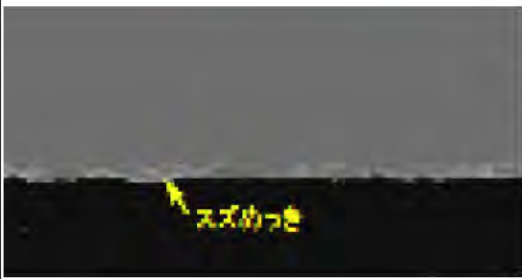
Snメッキが磨耗している
良品

Snメッキが残り、磨耗粉はなし

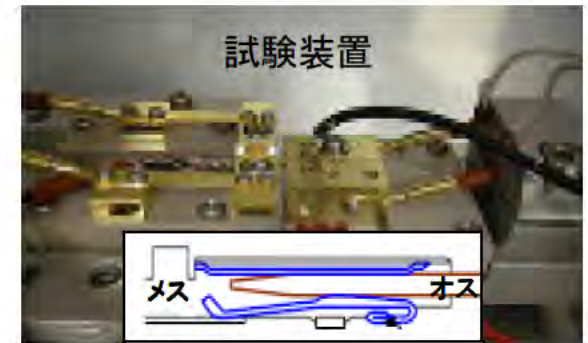
黄銅端子(Snメッキ品)は、摺動幅 0.5mm/約1.5サイクルでコネクタ樹脂(PBT)の熔融温度に至ることが判明

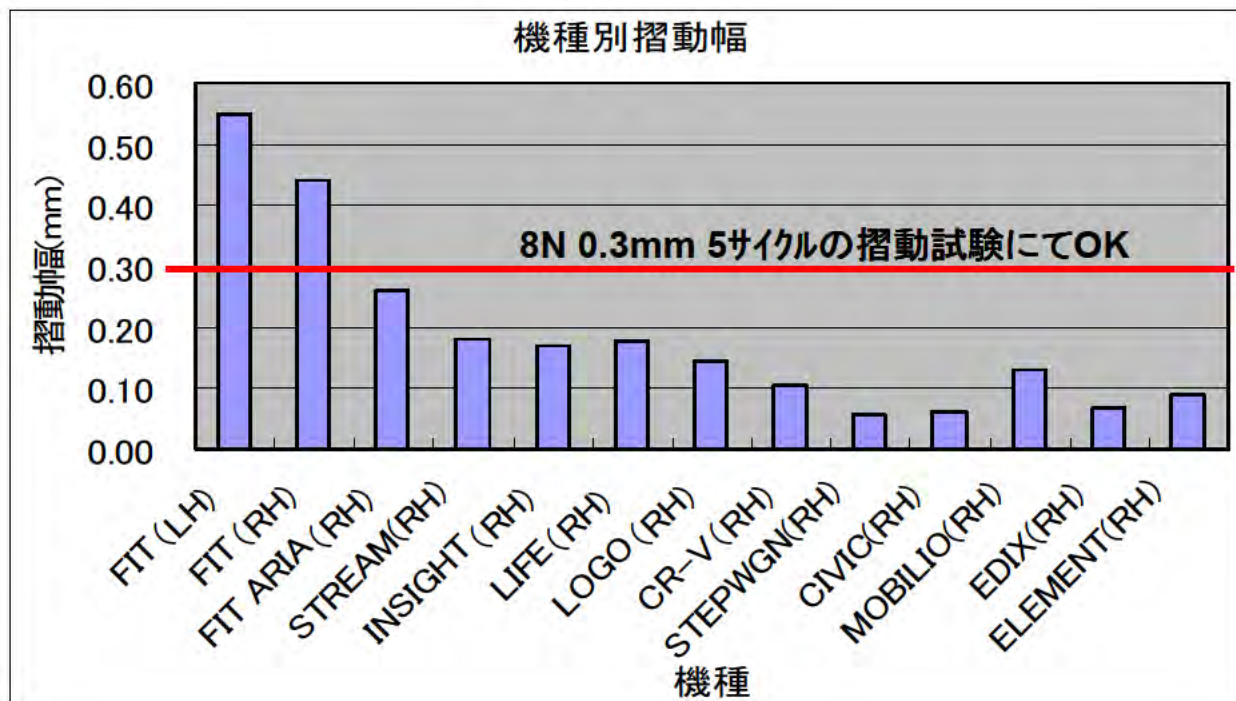
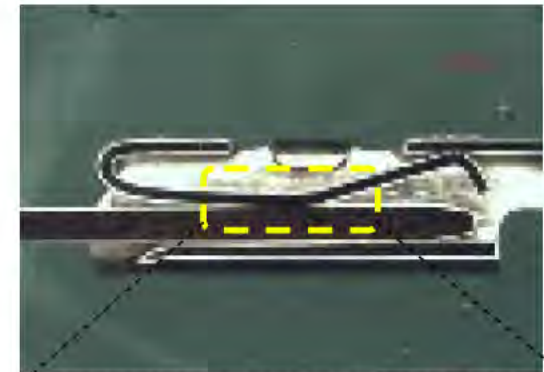
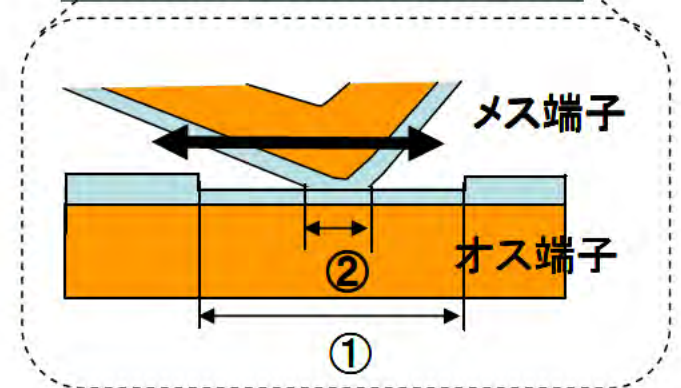
FIT/JAZZが他機種に比べ、摺動幅が大きいことが判明
