EA11-012

HONDA

4/20/2012

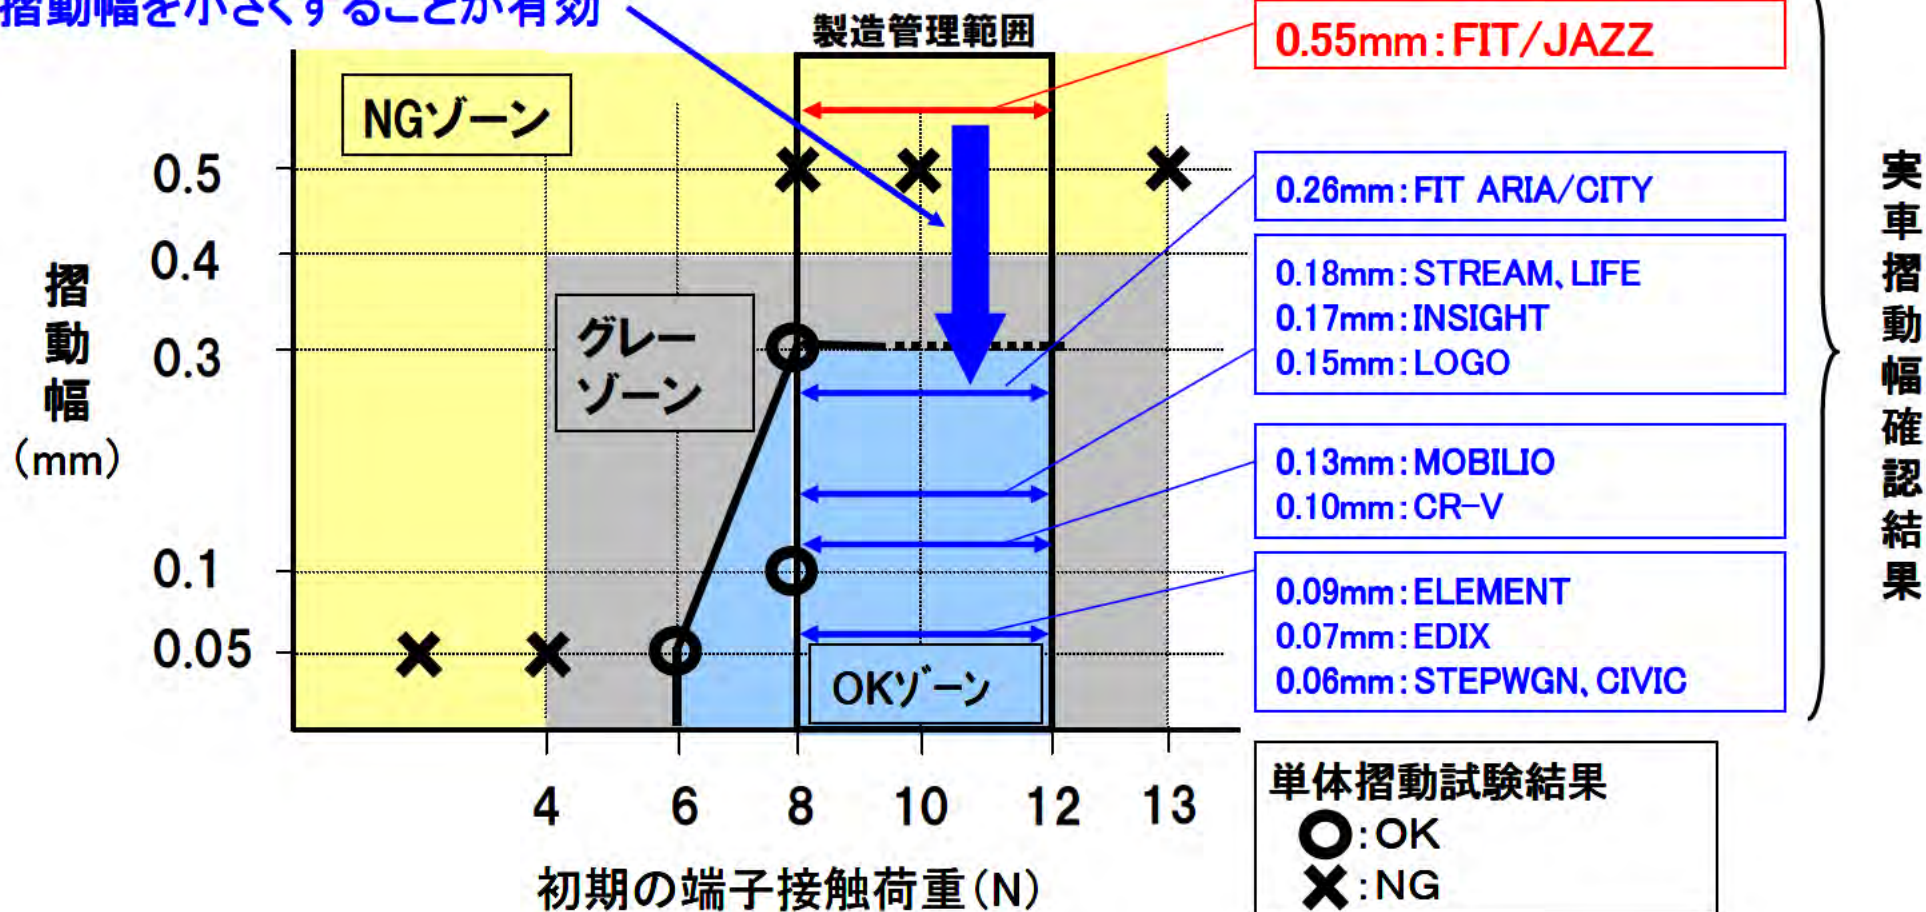
摺動幅を小さくすることが有効

FIT/JAZZの実車摺動幅のみが、抵抗値増大が認められるNGゾーンにいたることが判明  
また、摺動幅を抑えることが最も有効な対策である

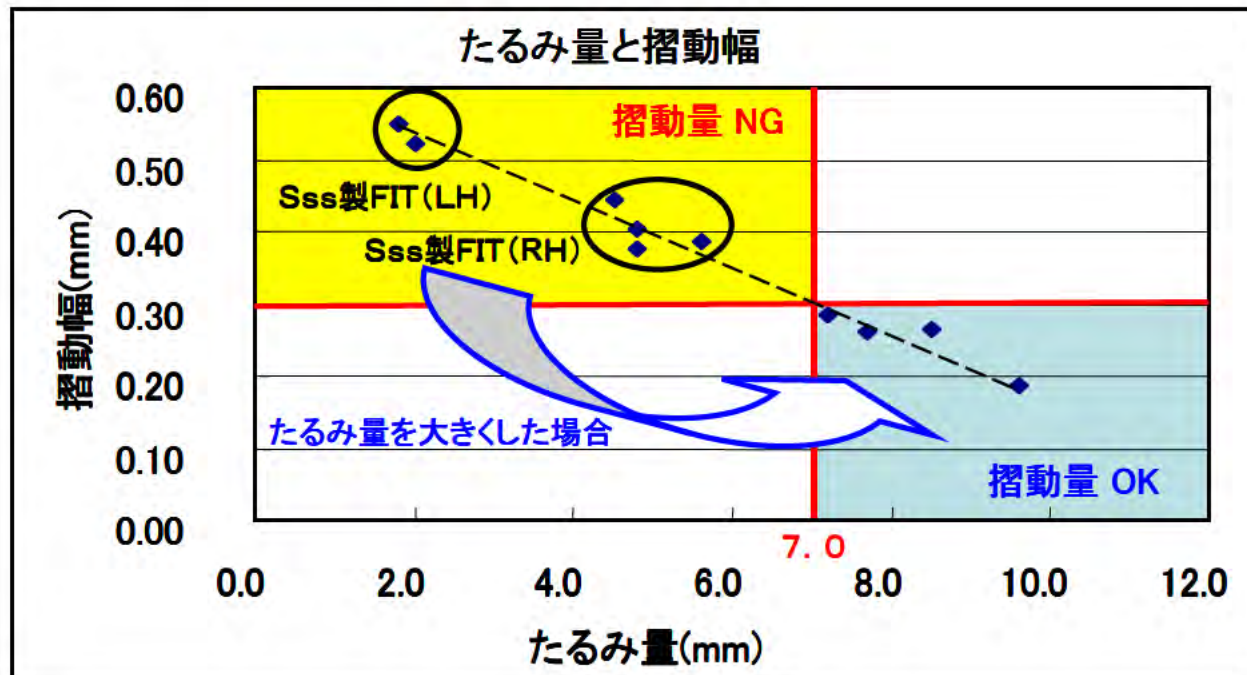
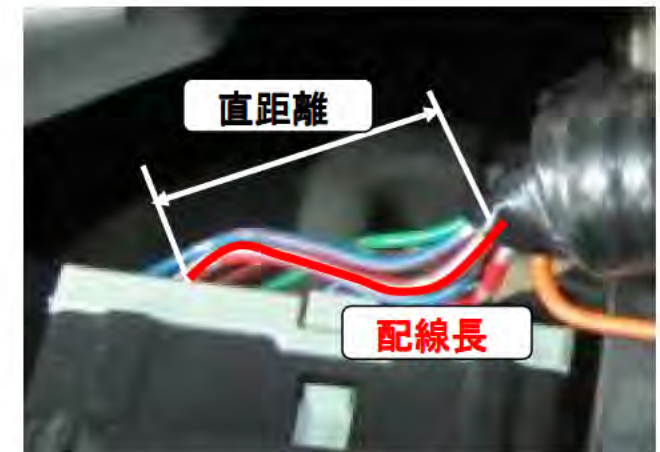
たるみ量が大きいと摺動幅も小さくなることを確認

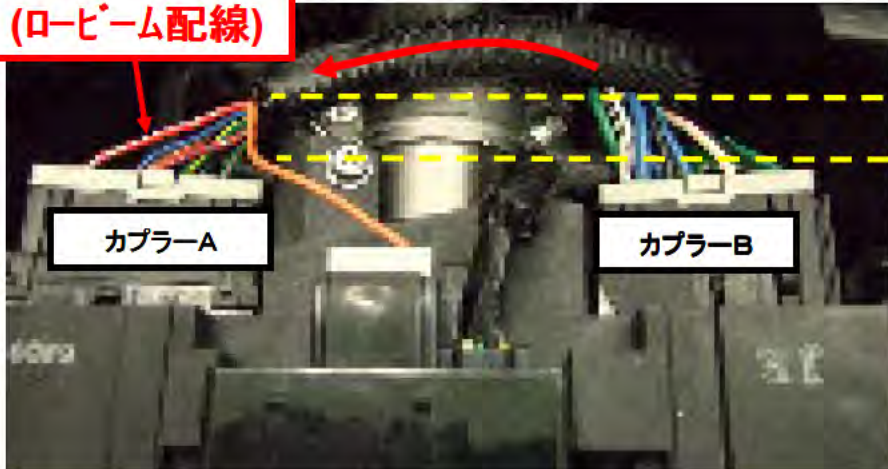
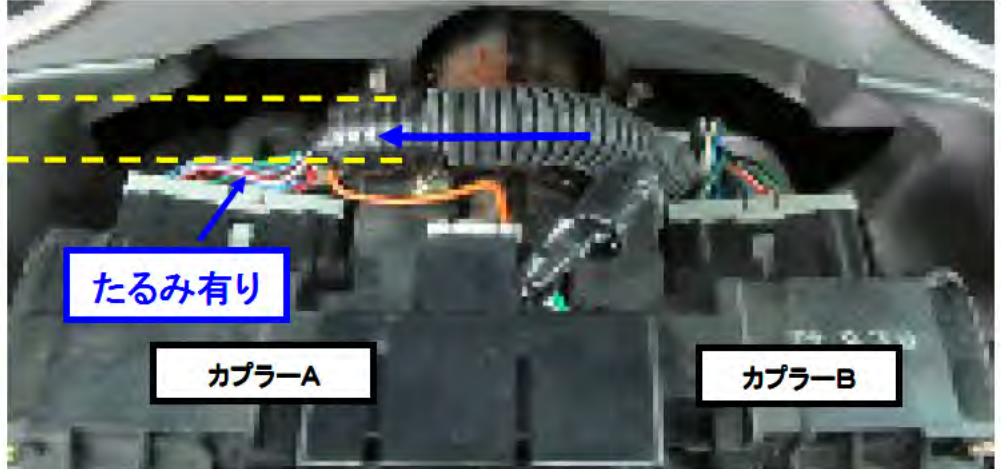
コンビSW側組付でカプラーB ⇒ カプラーAの順で組付を行うとハーネスがカプラーから離れ、ロービーム配線が張る傾向になる

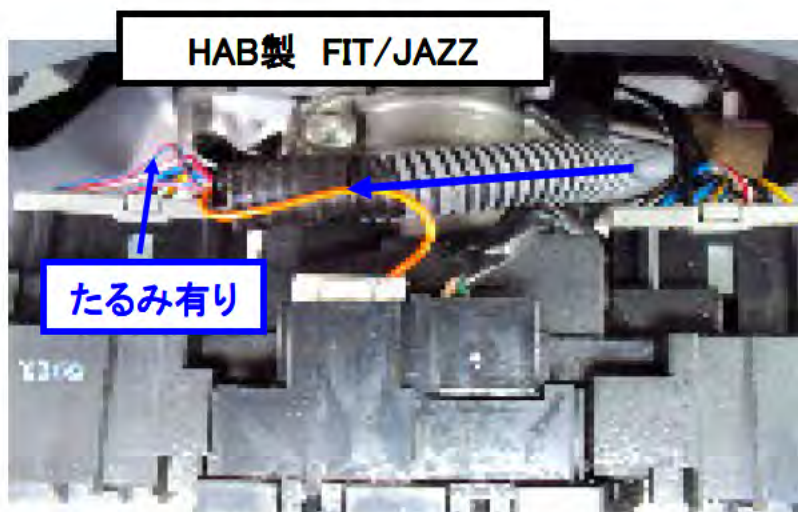
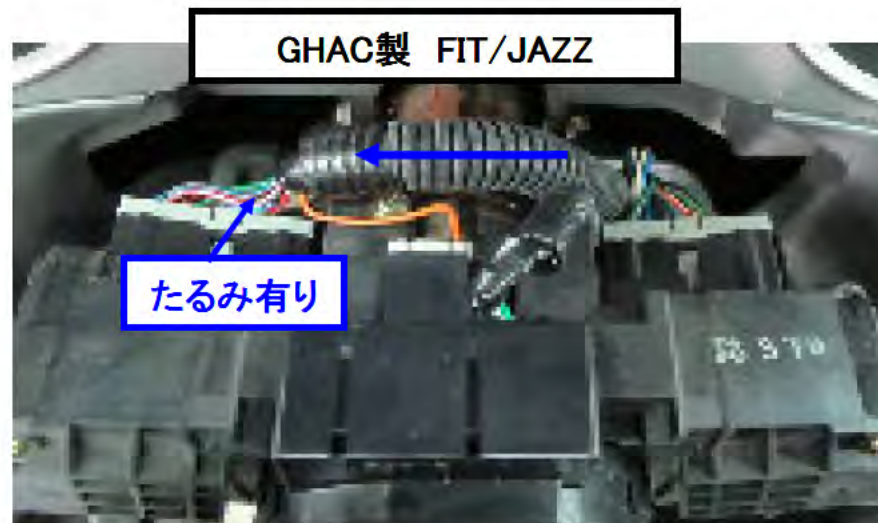
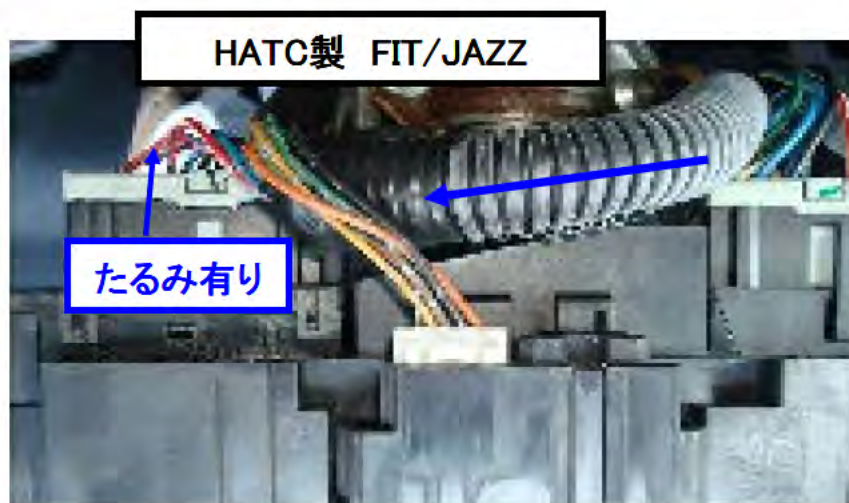
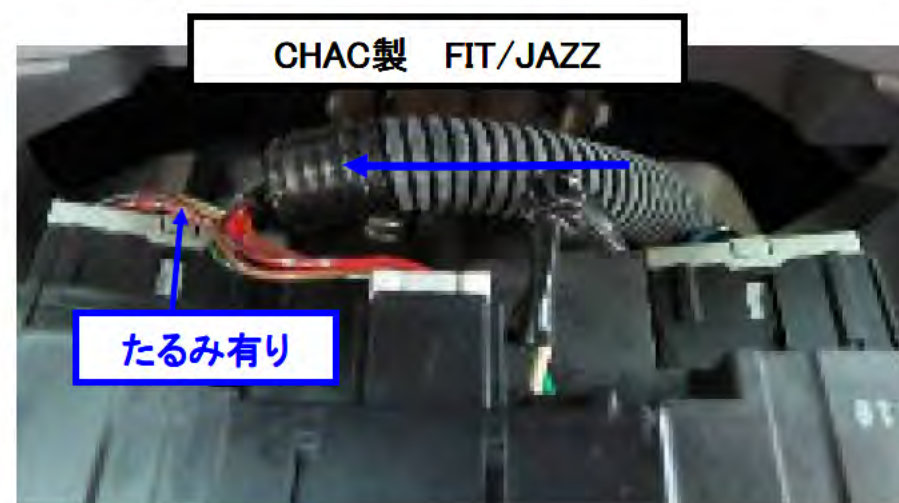
ロービーム配線が張った状態になる配索は、Sss製 FIT/JAZZのみである。

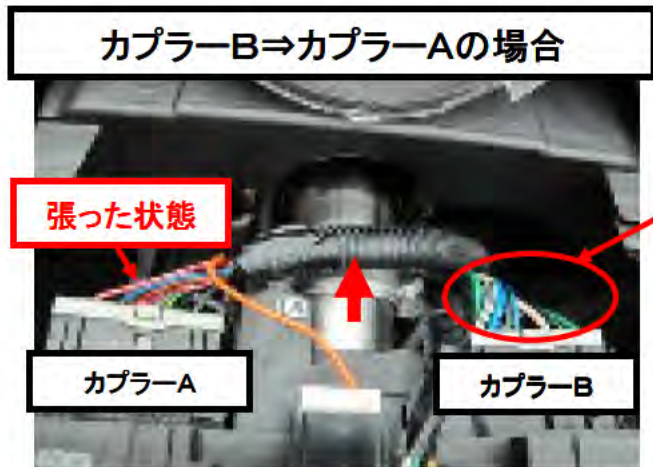
①コンビSW側組付でカプラーB ⇒ カプラーAの順で組付を行うとハーネスがカプラーから離れ、ロービーム配線が張る傾向になる

この部分の取り合いでカプラーから離れる

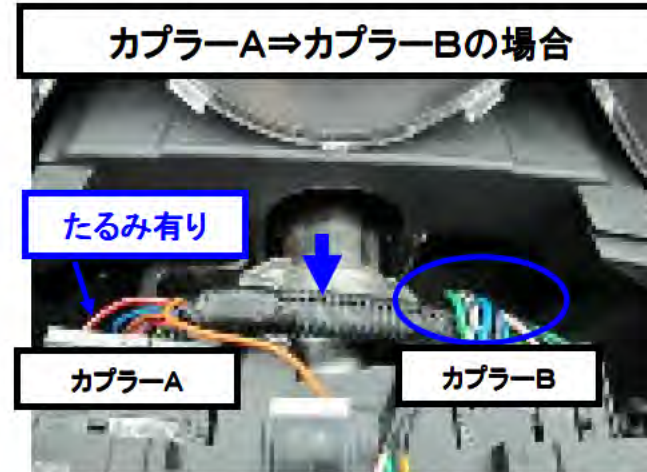
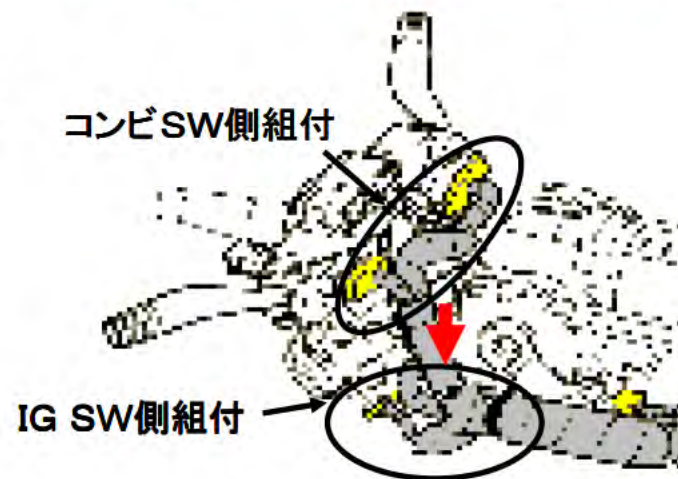
②コンビSW側組付 ⇒ IG SW側組付の順で行うとコンビSWの配線が引き下げられ、ロービーム配線が張る傾向になる

Sss製 FIT/JAZZの組付手順のカプラーB ⇒ カプラーA ⇒ IG SW側組付で行うとロービーム配線が張った状態になる。

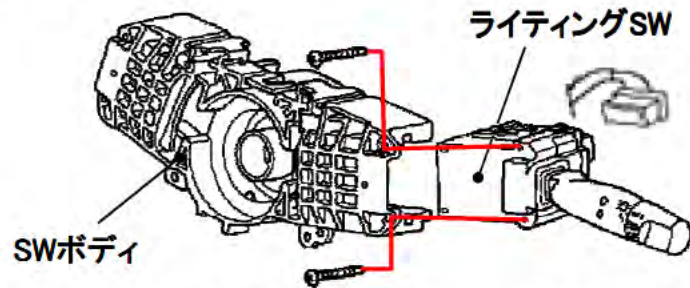
## ■ライティングSW構造

ライティングSWの締め付けネジを支点として、レバー操作(Hi-Lo切替や手前に引きながらのターン操作)を行うとSWが微かに動く

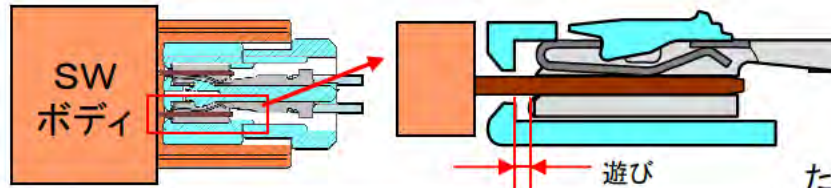
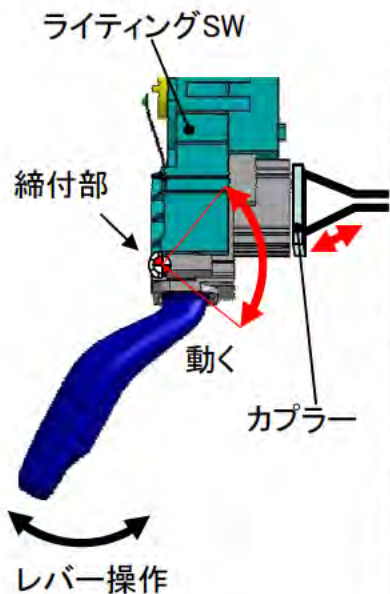
組立て性と部品の公差のためカプラーとメス端子に遊びがある

たるみ量 = 配線長(A) - レイアウト直距離(B)

配線が張っている場合	配線にたるみがある場合
<ul style="list-style-type: none"> <li>Hi⇒Lo切替</li> <li>パッシング</li> <li>引きながらターン</li> </ul> 操作方向 力		
操作前後		
<ul style="list-style-type: none"> <li>Lo⇒Hi切替</li> <li>押しながらターン</li> </ul> 操作方向 力

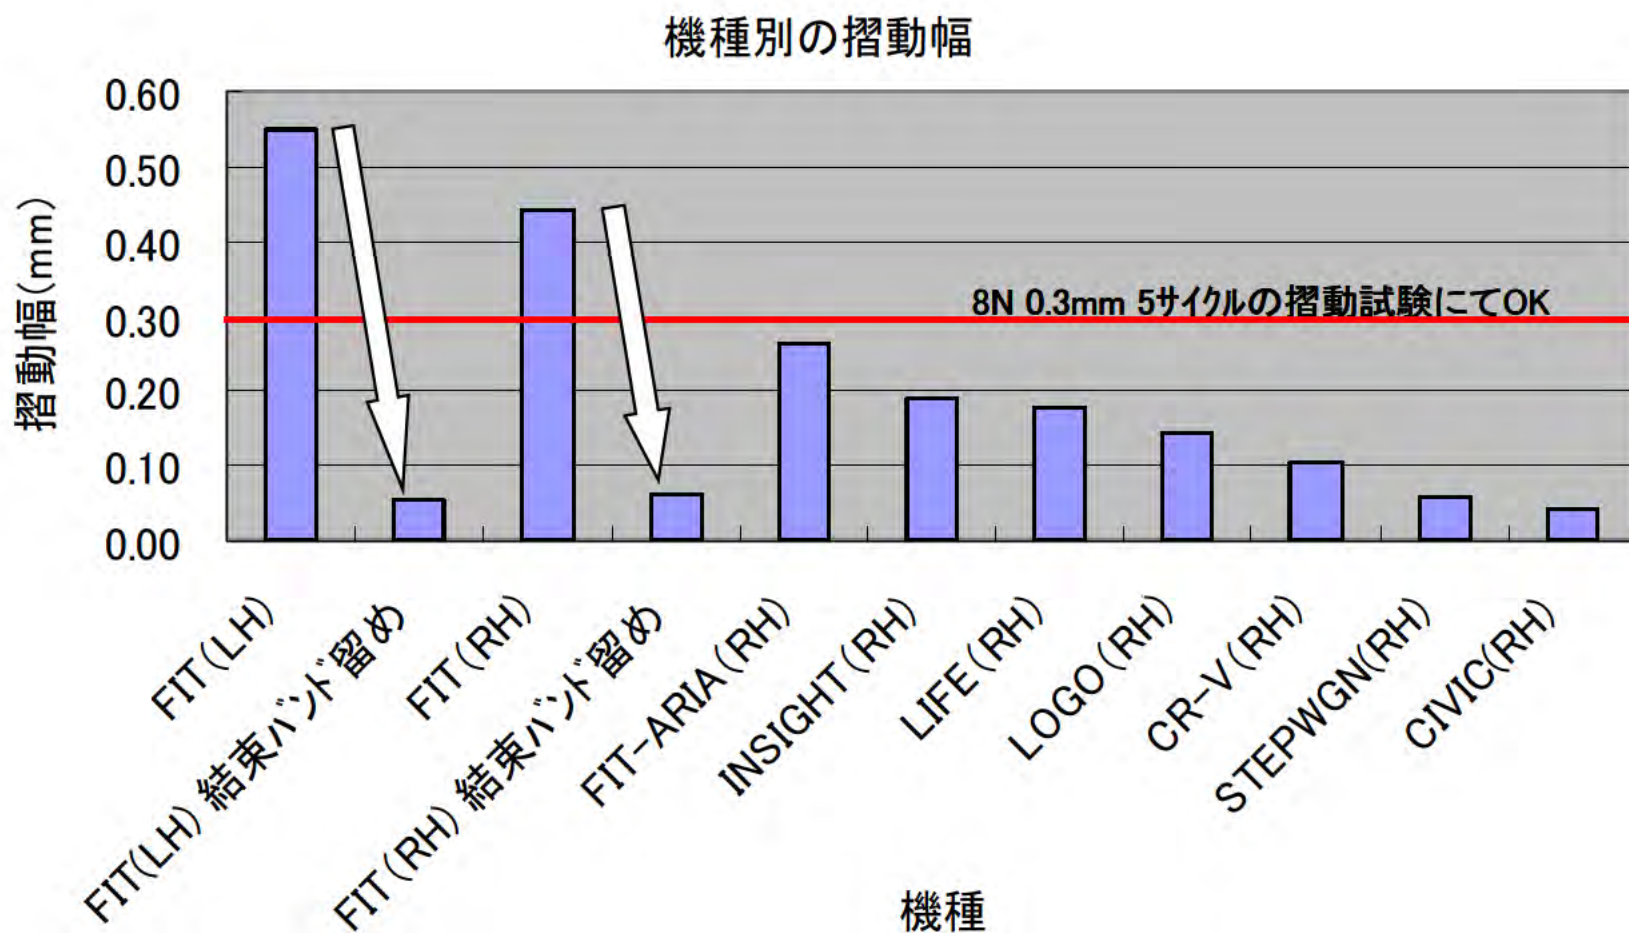
結束バンド留めによりで摺動幅が約1/10に減少

- ・実車にてライティングスイッチ操作1万サイクルによる対策効果を確認する  
 (1サイクル:Rターン→中立→Lターン→中立→パッシング→中立 のSW操作)

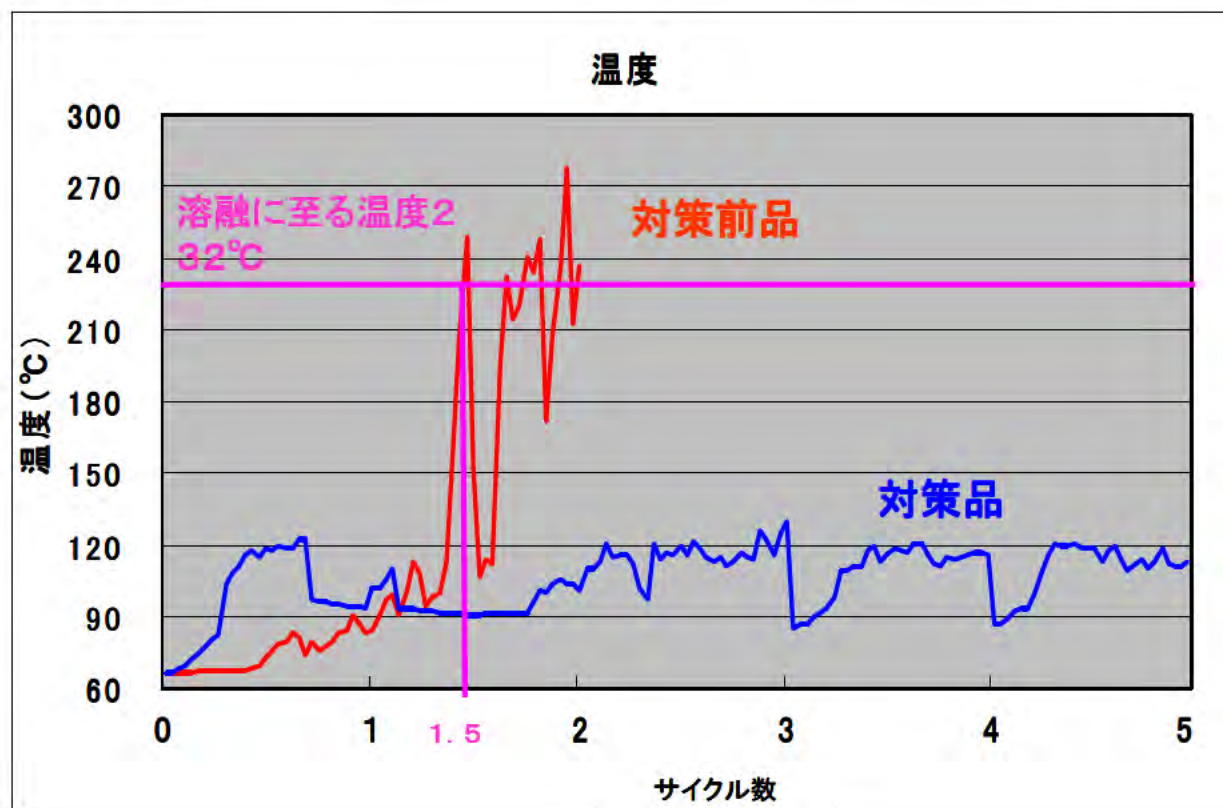
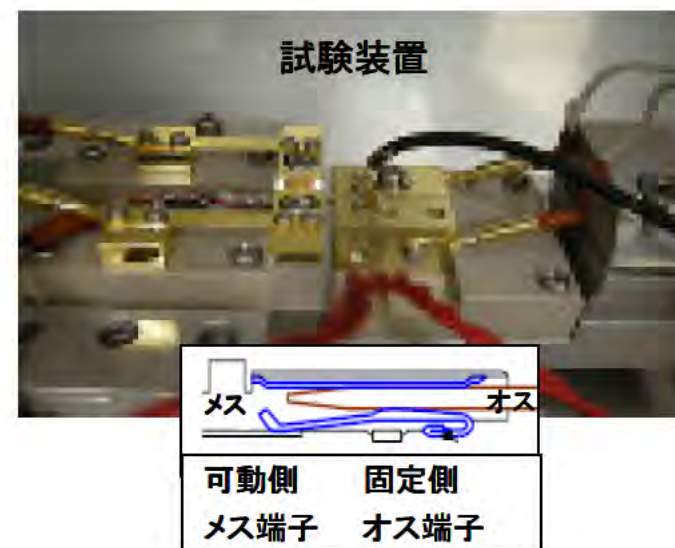
オス端子のSnメッキが磨耗により剥離したとしても、結束バンドによるハーネス固定とメス端子耐熱銅合金に変更すれば、今後の使用過程において不具合が発生しないことを確認した。

従来品が約1.5サイクルで溶損に至っているのに対して、対策は5サイクルでも溶損に至らない。従来より、最低でも約3倍以上のタフネスあり。

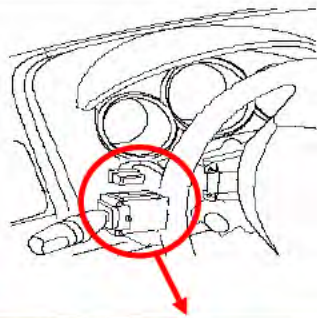
Due to inappropriate length setting for lighting SW wiring in instrument panel, lighting SW Lo terminal wiring is in pulled condition, from repeated large sliding in terminal joint area from turning operation or headlight switching operation etc. Sn plating on male terminal and female terminal is peeled, base material is worn and contact resistance increases from accumulated copper oxide, melted resin coupler flowed into contact surface and carbonized, leading to poor continuity.

No countermeasure applied due to discontinued model. To reduce sliding in terminal area in market, to fix Lo terminal harness to lighting switch by TY-RAP. And to change base material of female terminal from brass to heat resistant copper alloy.

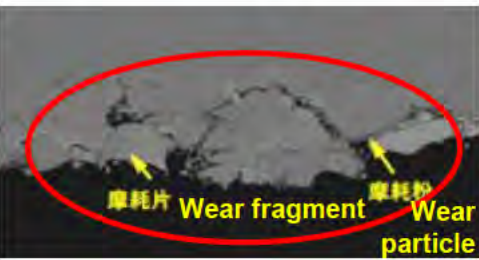
<p>There is no Sn plating any more and wear particle of base material has accumulated.</p>

<p>Sn plating is worn.</p>
Non-defective part

There is no Sn plating any more and wear particle has accumulated therefore it is caused by sliding.

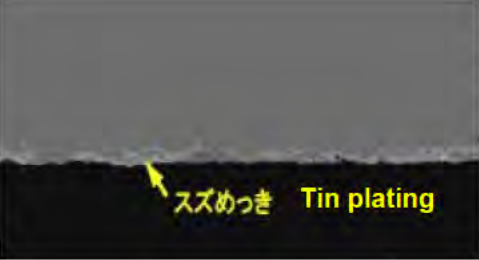
<p>Sn plating remains and no wear particle found.</p>

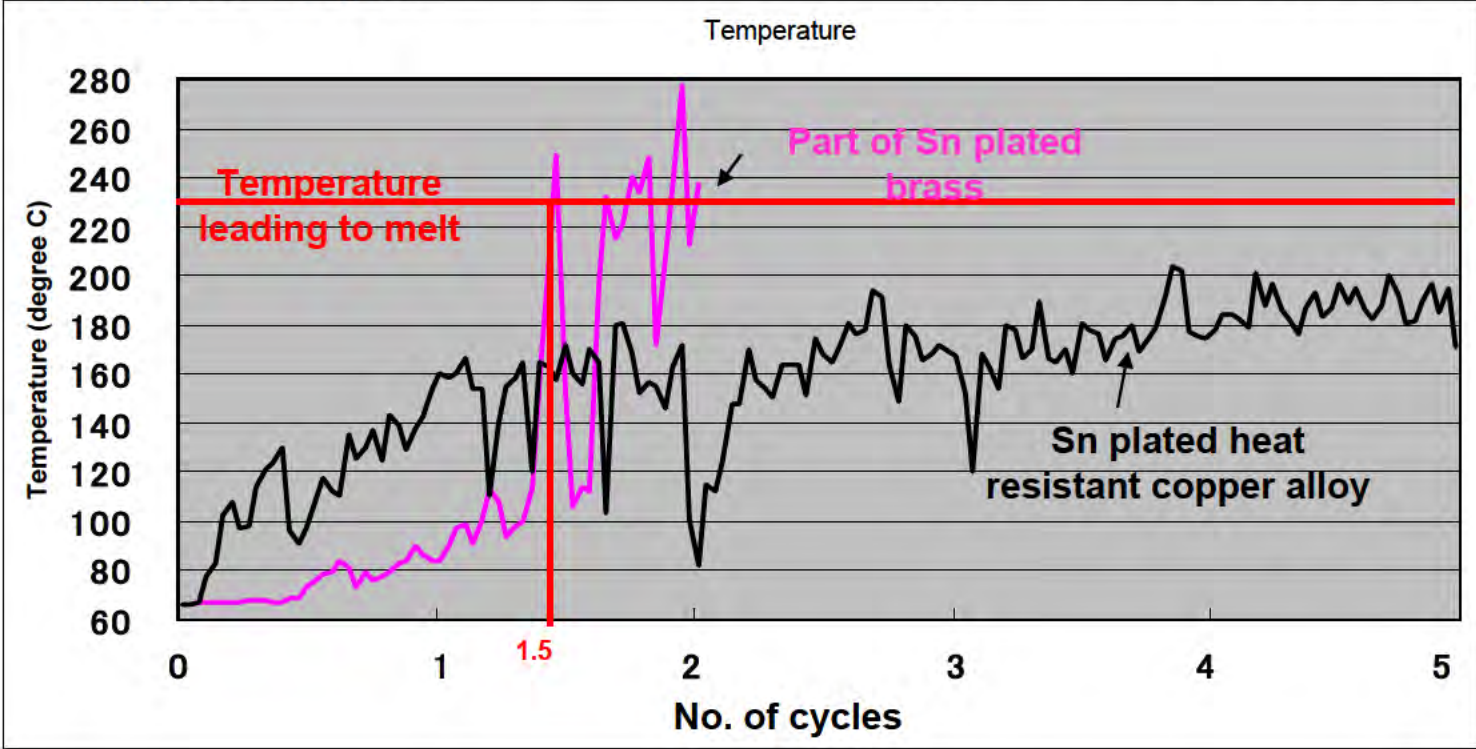
It revealed that connector melting temperature is reached by approx. 1.5 cycle.

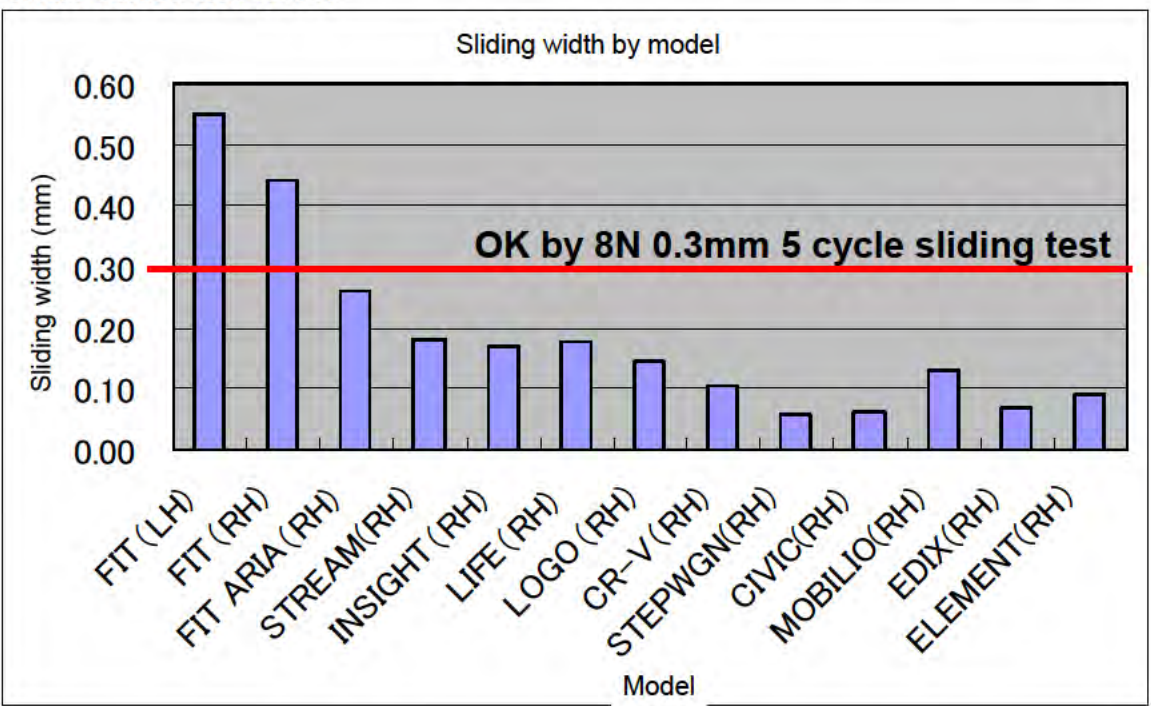
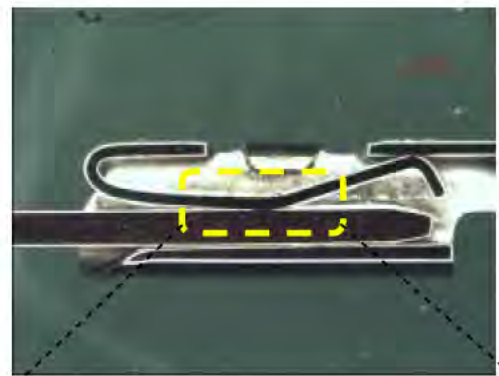
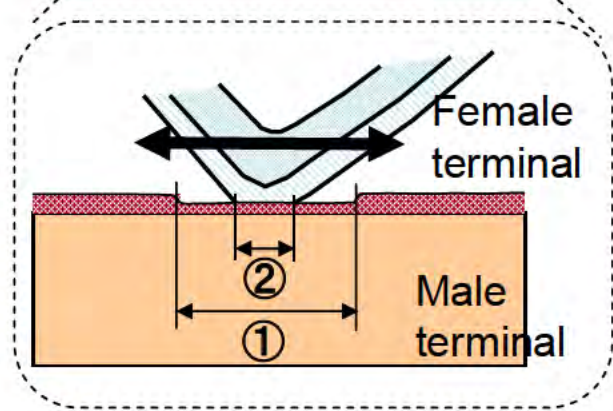
It revealed that FIT/JAZZ has large sliding width compared with other models.

Sliding width =  
 (Male terminal sliding width①)  
 - (Female terminal sliding width②)

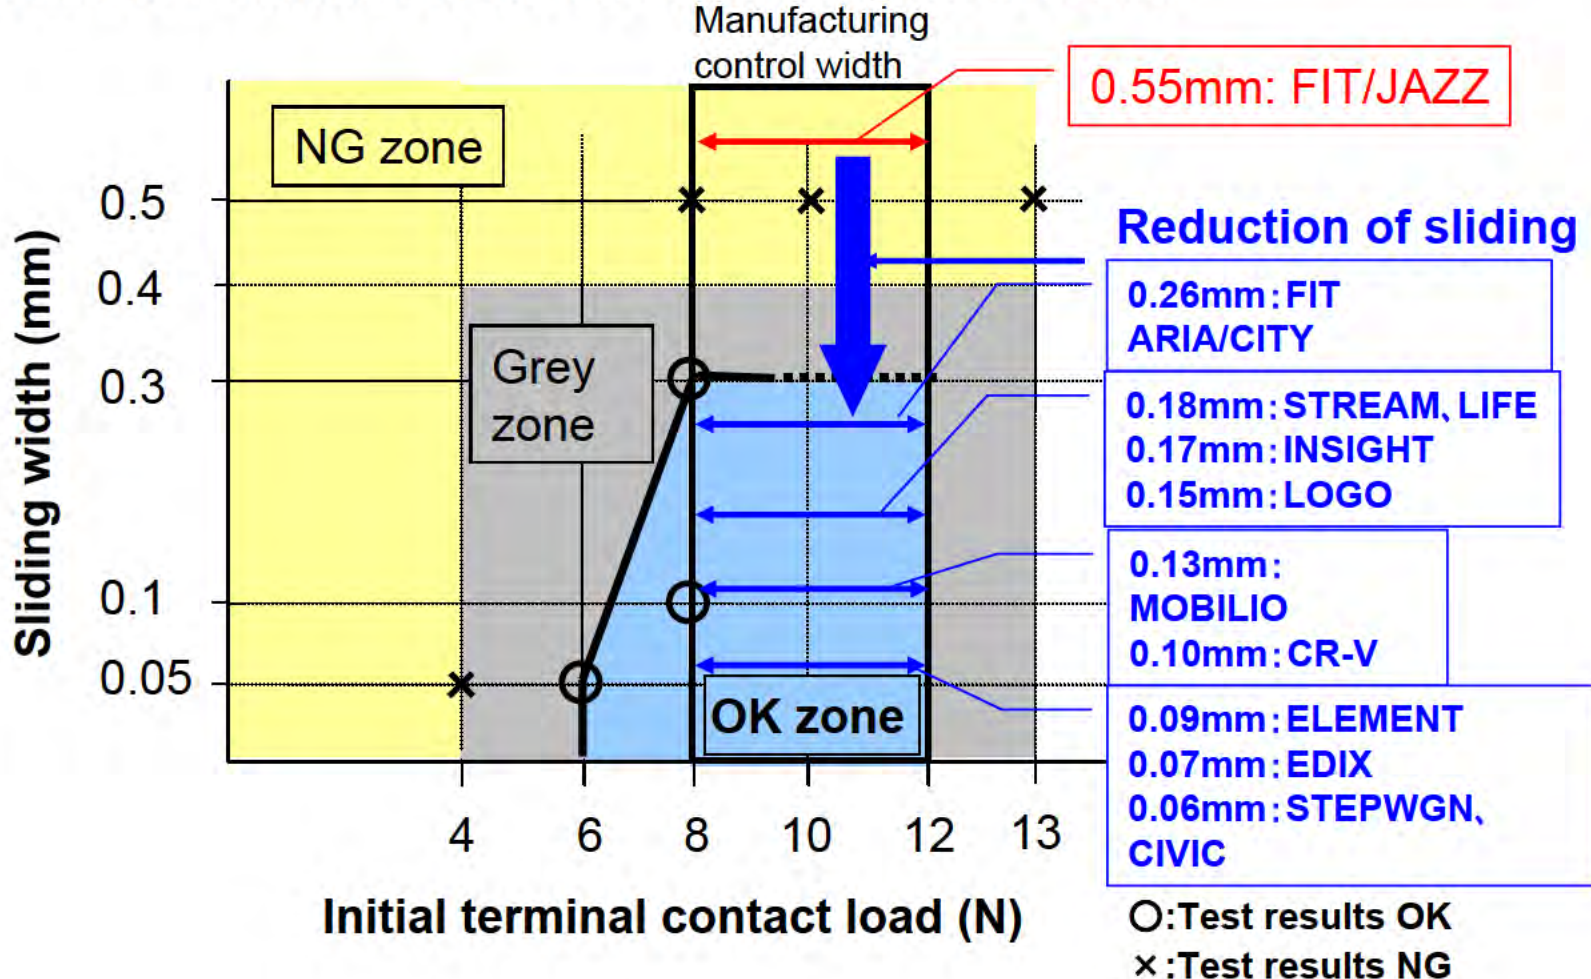
It revealed that sliding width on FIT/JAZZ is in NG zone where resistance increase is confirmed from the unit sliding test results.

It revealed that FIT/JAZZ only is in NG zone. Reduction of sliding width is the most effective countermeasure.

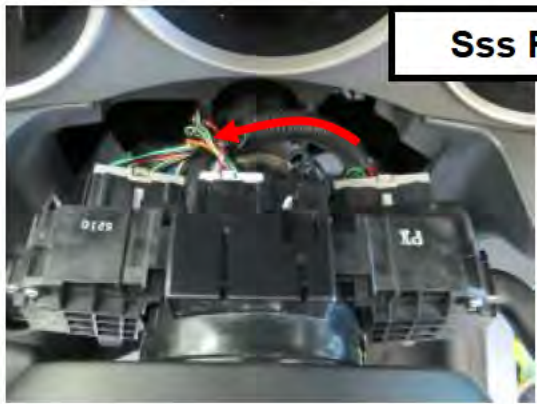
Only Sss FIT has a layout pulled condition of Lo terminal wiring occurs.

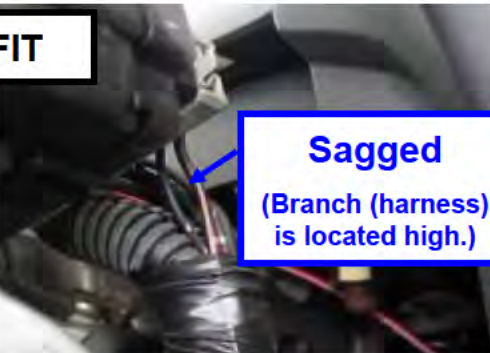
Sagged  
(Branch (harness) is located high.)

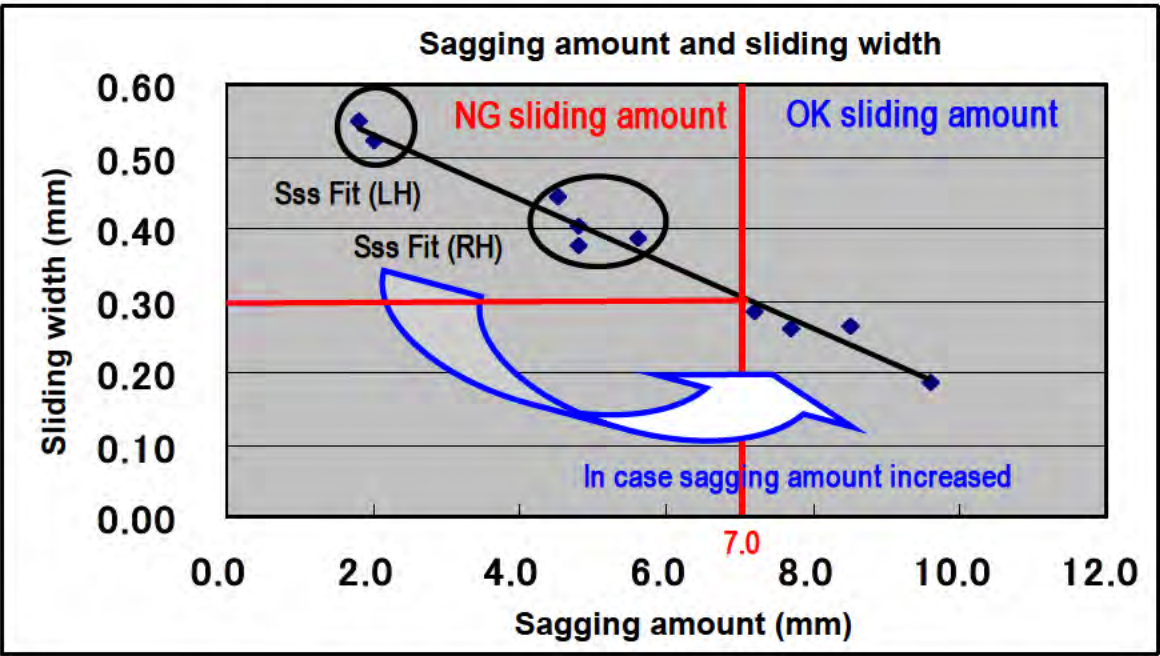
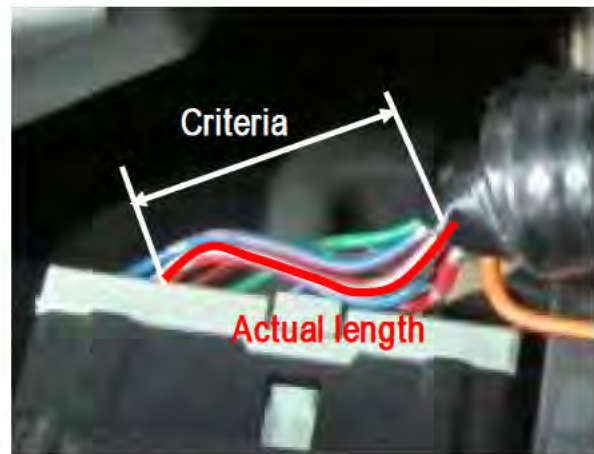
# 6. Analysis results 6-9 Investigation results on sliding width and harness sagging amount 20/31

Only Sss FIT has a layout pulled condition of Lo terminal wiring occurs.

Investigation results of correlation of sagging amount and sliding width as sagging amount of Sss FIT is different from FIT of other factories

Confirmed that if sagging amount is large, sliding amount becomes small.

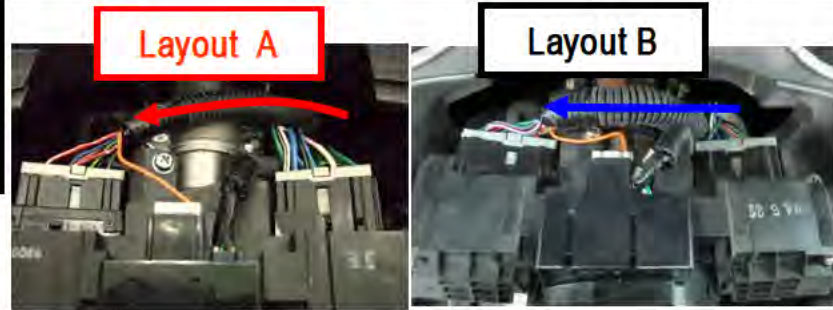
We determined that market action is necessary for Sss FIT/JAZZ only.

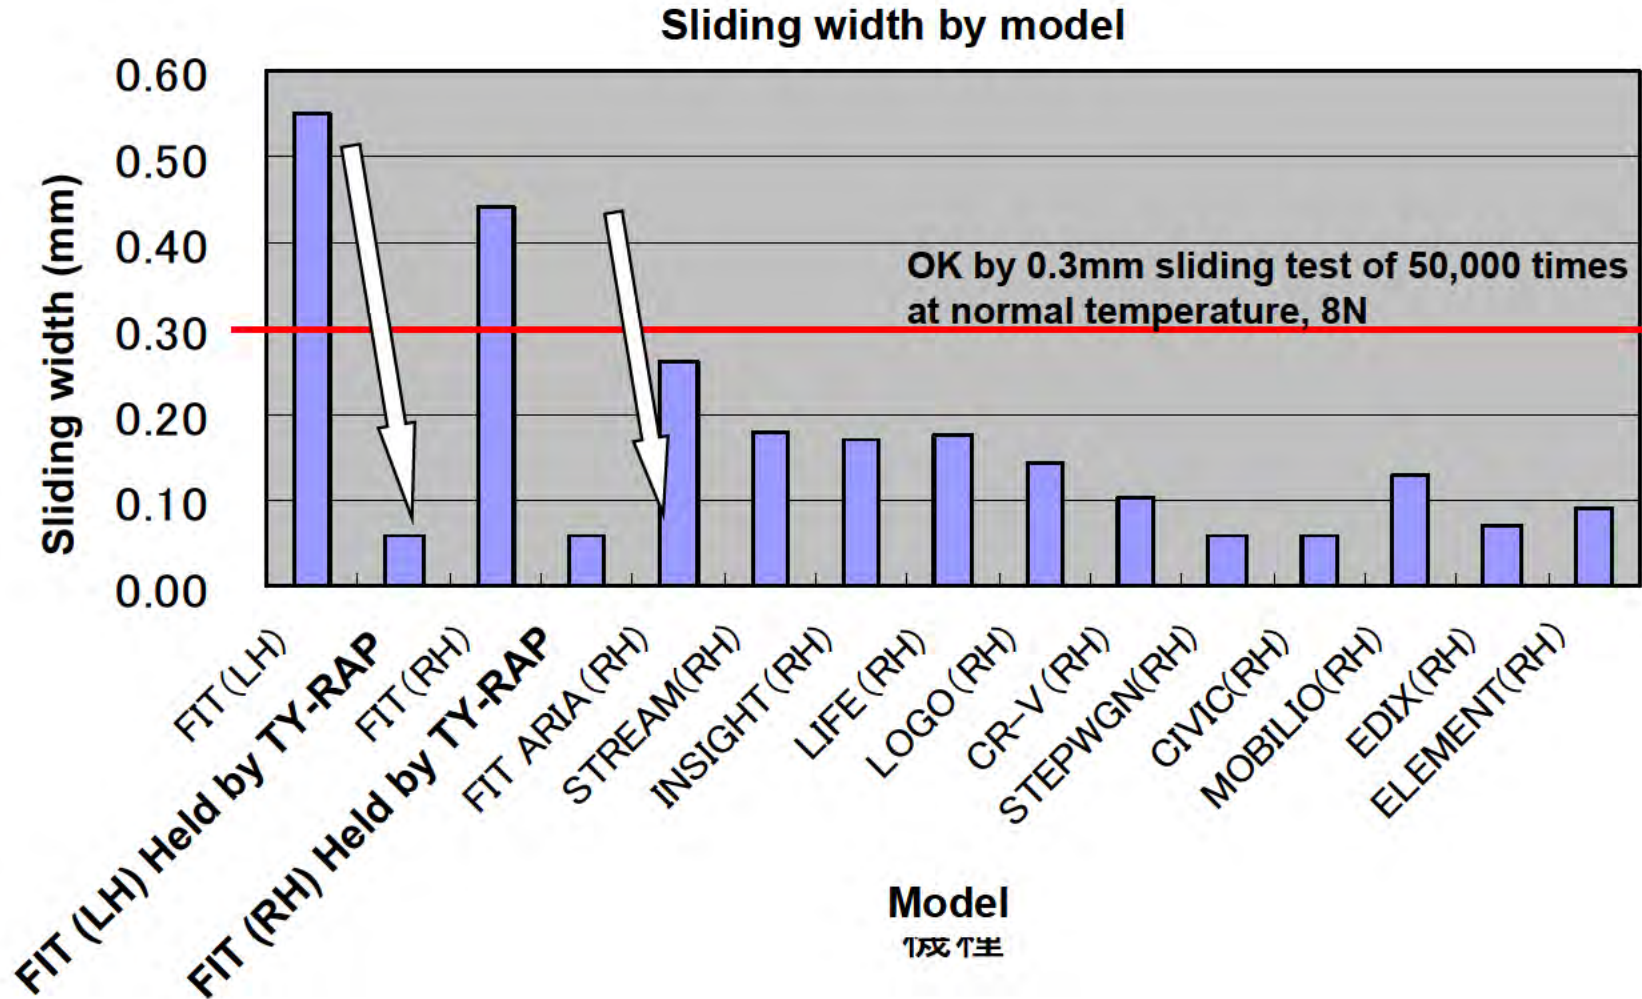
# 7.Countermeasure 7-2 On car effect confirmation on sliding prevention 25/31

Sliding width confirmation results by operation lighting switch 10,000 cycles on car

Sliding width decreased to approx. 1/10 by holding with TY-RAP to prevent sliding.

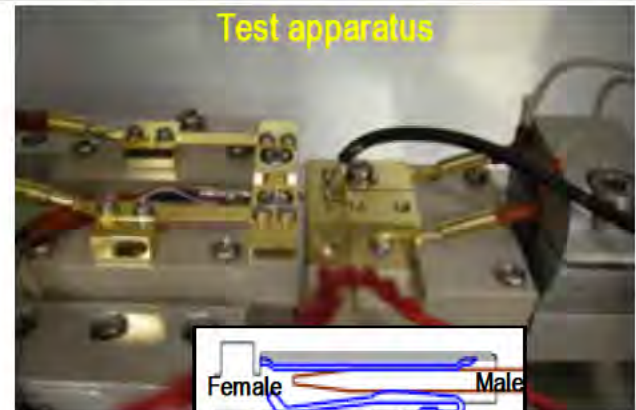
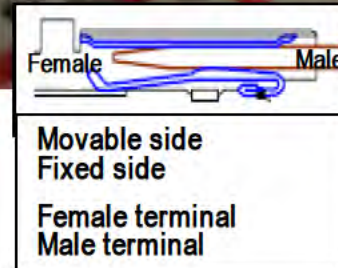
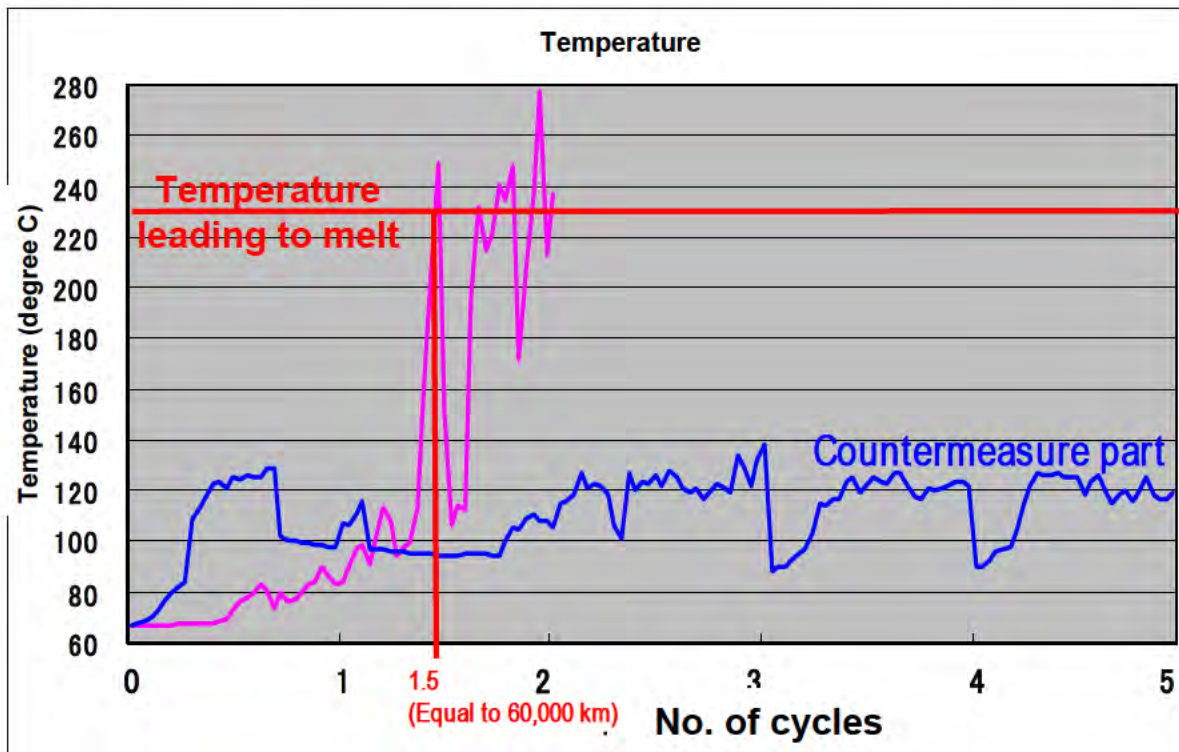
Compared with the existing part that melted by about 1.5 cycle, countermeasure part did not melt after five cycles.

Toughness is at least approx. three-fold or more compared with before.

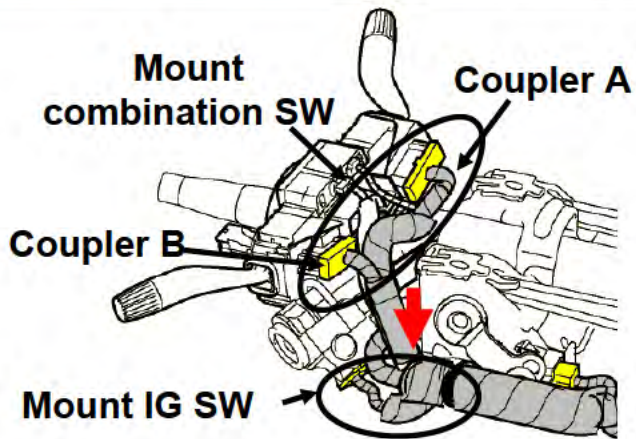
① If it is mounted in the order from combination SW to IG SW, wiring of combination SW is pulled down.

② If combination SW is mounted in the order from coupler B to coupler A, harness gets away from the coupler.

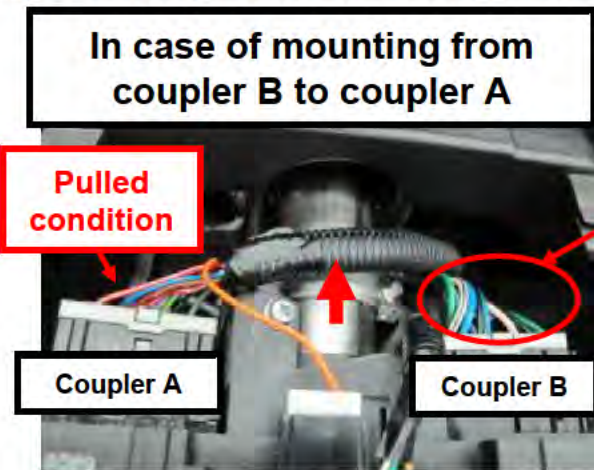
It gets away from the coupler due to rigidity in this area.

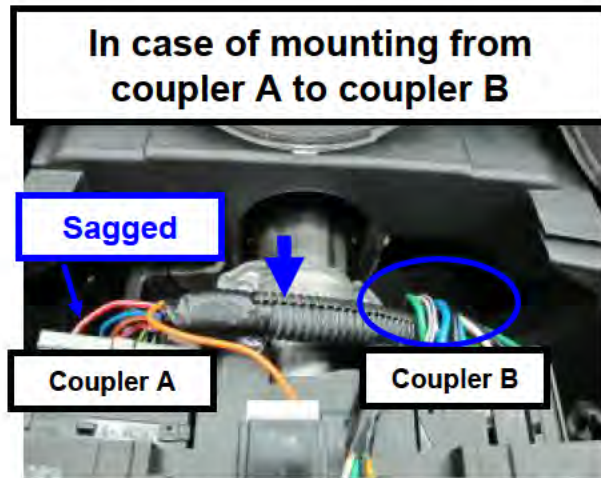
Low beam wiring is pulled because of the above mounting procedure. Sss FIT / JAZZ only is mounted in this mounting procedure.

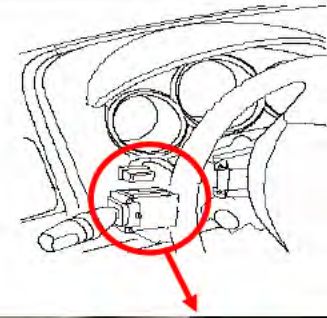
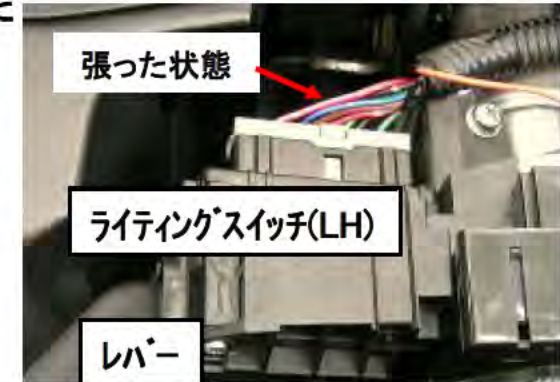
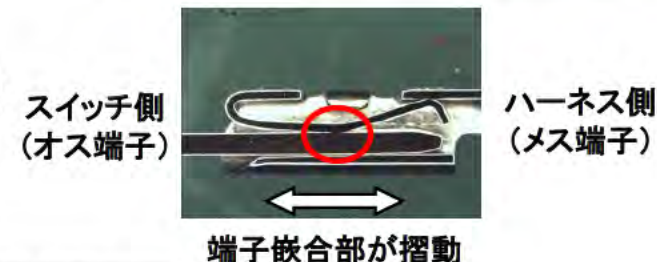
溶損したカプラーの樹脂が入り込み導通不良となり不灯になる

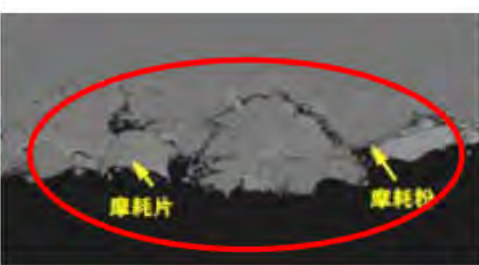
ハーネス側のメス端子			
返却品

Snメッキがなくなり、母材の磨耗粉が堆積している

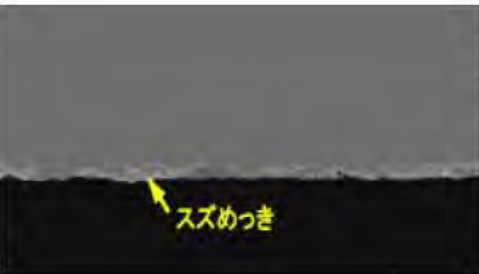
Snメッキが残り、磨耗粉はなし

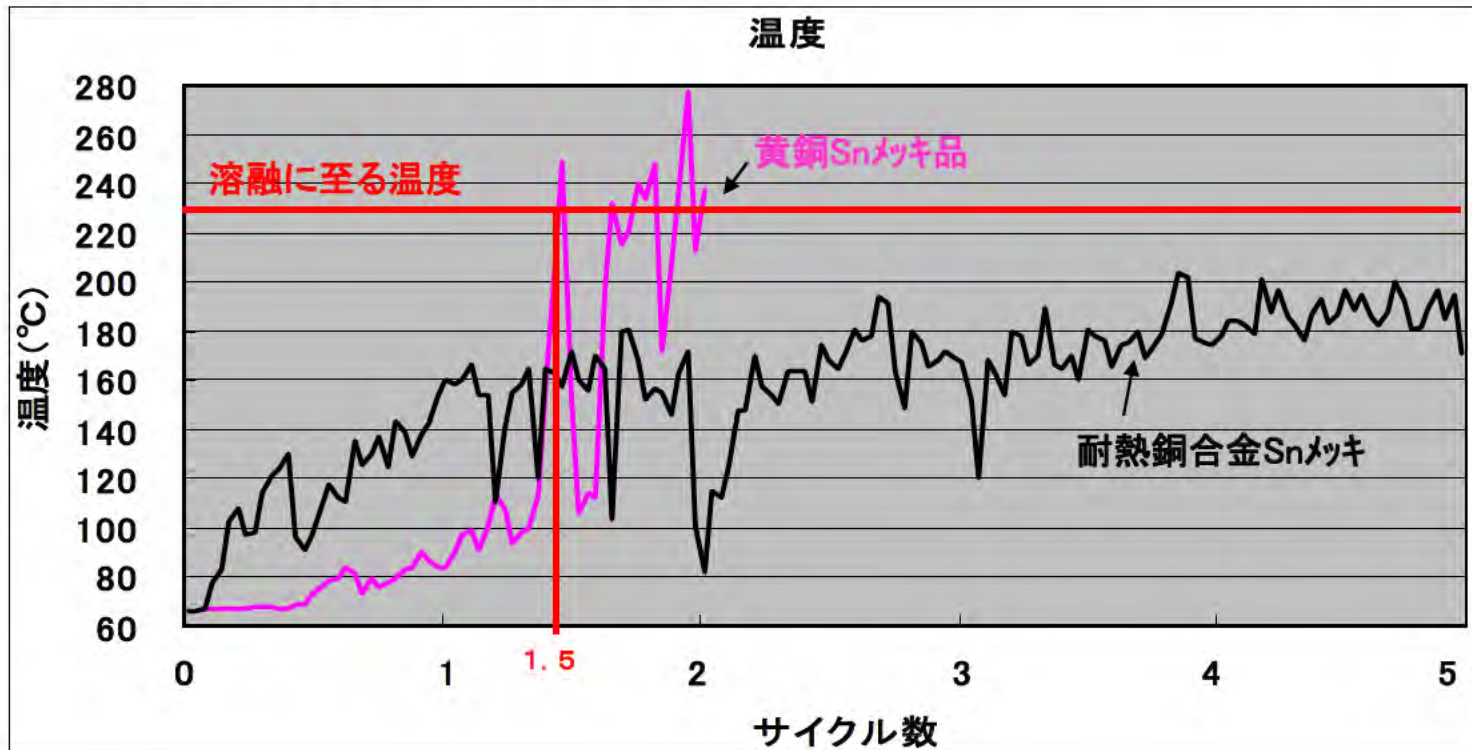
## 試験結果

約1.5サイクルでコネクタの溶融温度に至ることが判明
