EA11-012

HONDA

4/20/2012

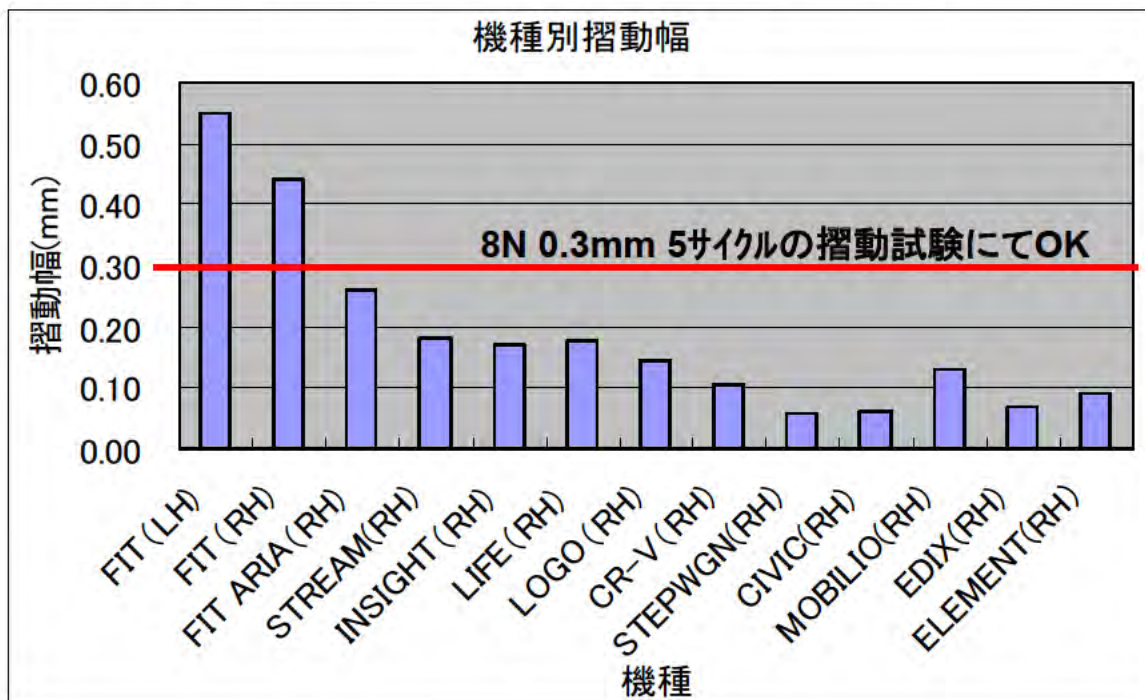
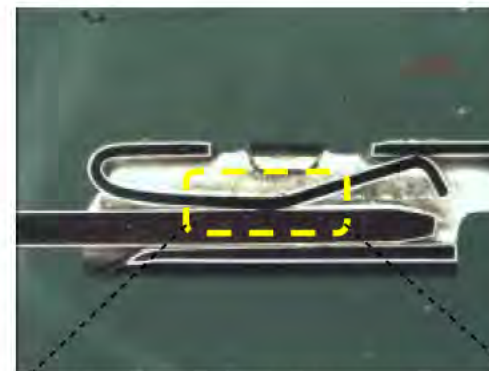
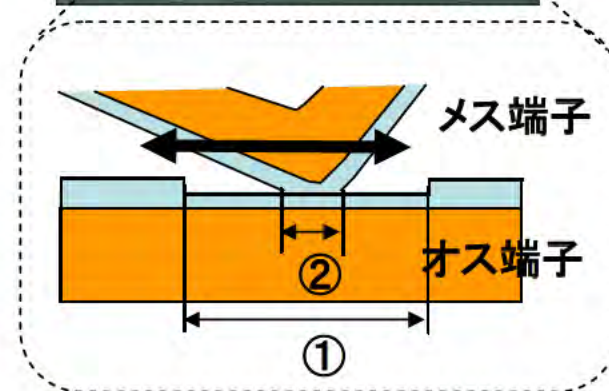
FIT/JAZZが他機種に比べ、摺動幅が大きいことが判明

摺動幅 = オス端子摺動幅①  
 - メス端子摺動幅②

FIT/JAZZの実車摺動幅は、単体摺動試験結果から得られた抵抗値増大が認められるNGゾーンにあることが判明。

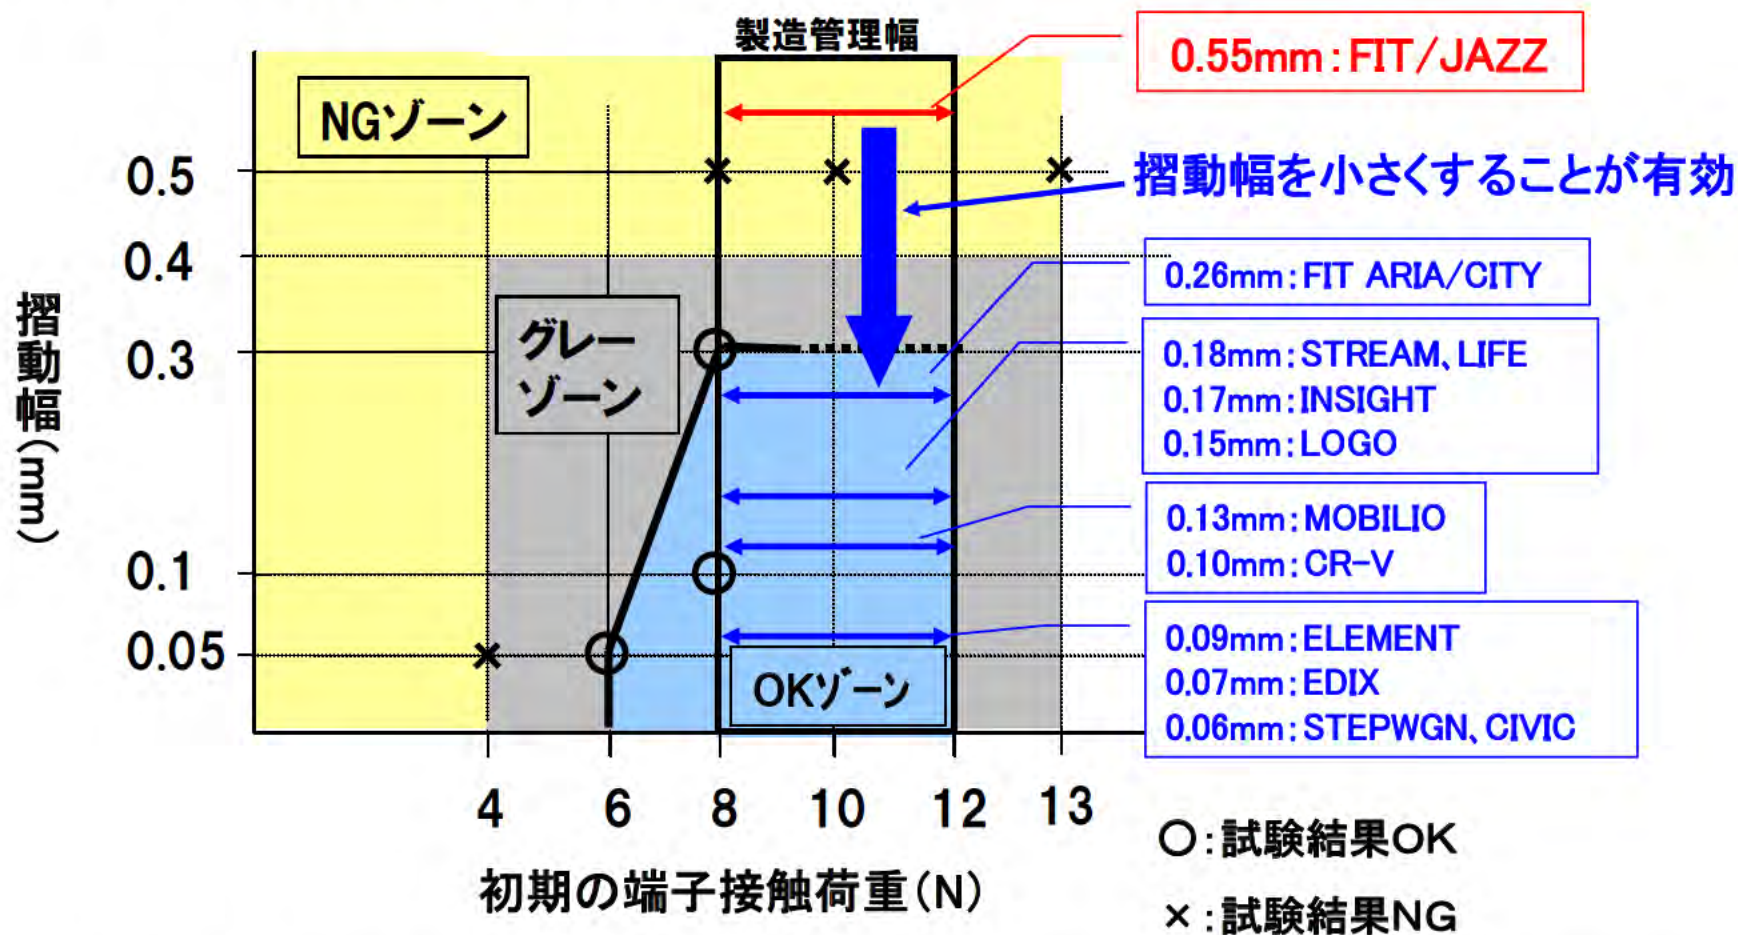
FIT/JAZZのみがNGゾーンいることが判明、また、摺動幅を抑えることが最も有効な対策である

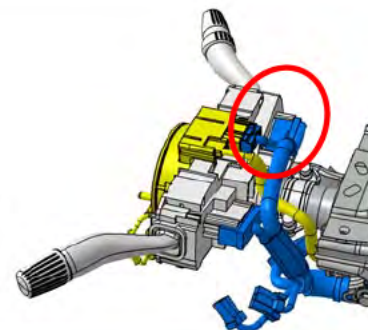
Sss製 FIT

張った状態

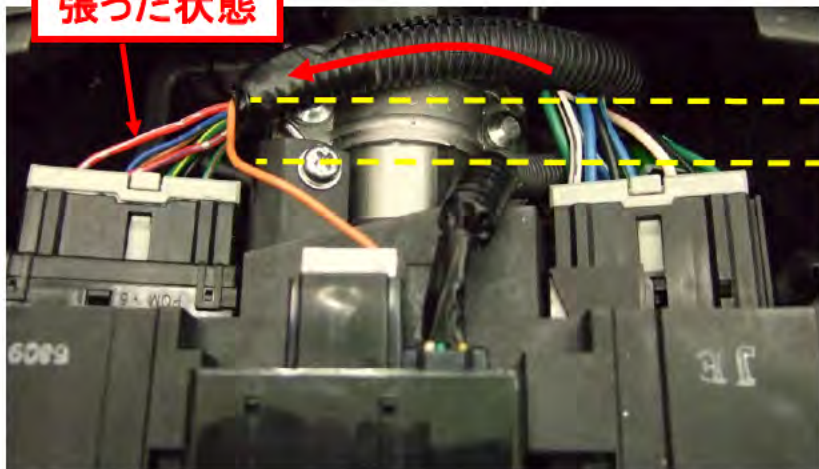
GHAC製 FIT

たるみ有り

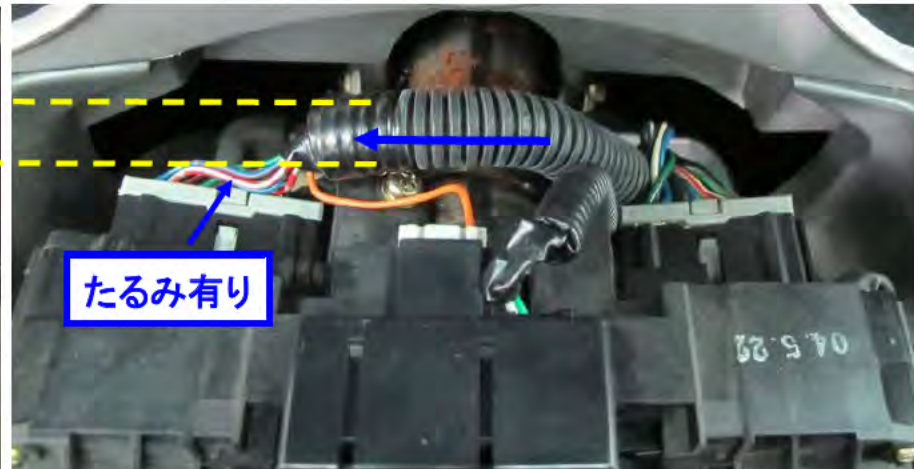
LO端子配線のたるみ量の差は、ハーネスレイアウトが原因である。

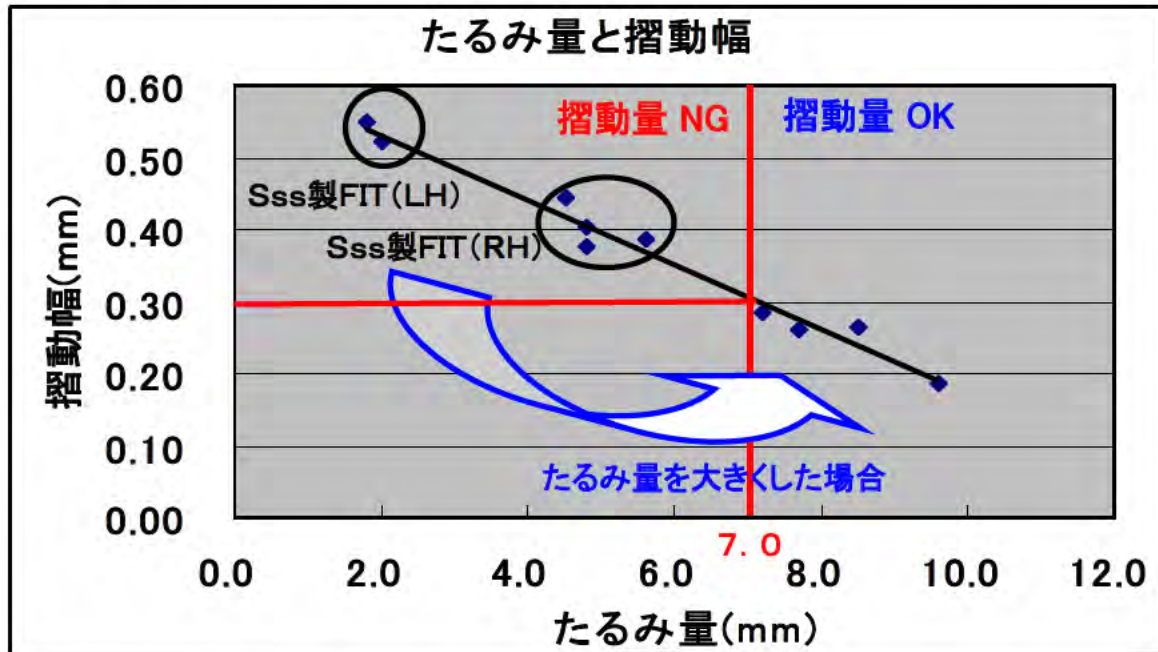
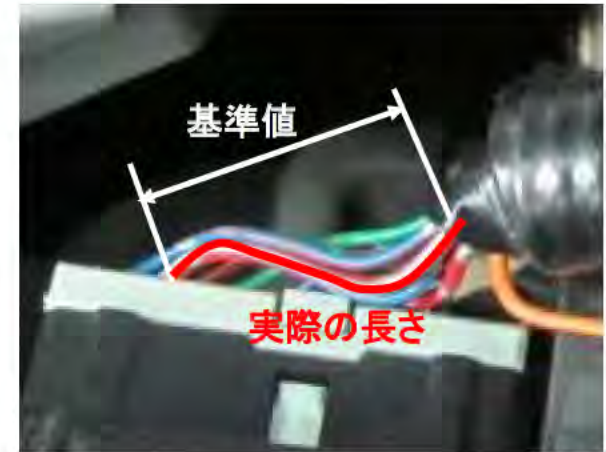
- ・Sss製のFITが他製造拠点のFITと比較し、たるみ量の違いがあることから、たるみ量と摺動幅の相関を調査した結果

たるみ量 = 実際の長さ - 基準値

たるみ量が大きいと摺動幅も小さくなることを確認

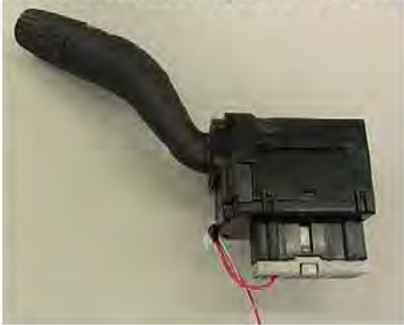
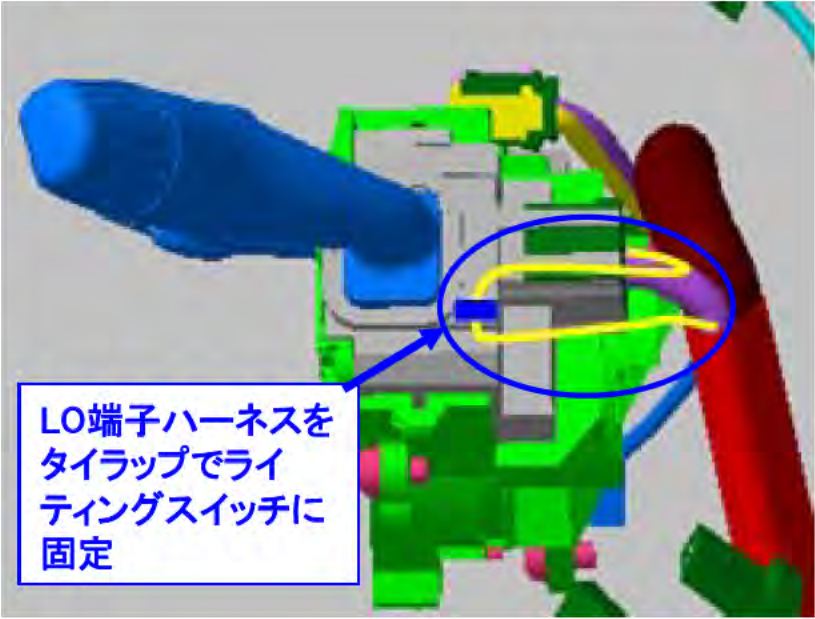
<p>LO端子ハーネスをタイラップでライティングスイッチに固定</p>																												
<p>・メス端子の接触荷重低下を抑える 母材を接圧荷重低下が小さい耐熱銅合金に変更 (現状は、黄銅)</p>	<p>接触荷重 材料比較 100°C中</p>

対策内容	備考																												
<p>・タイラップ留めによる摺動防止 たるみを確保した状態でメス端子ハーネスをライティングスイッチにタイラップで固定することにより、スイッチ操作時の動きに追従させ、端子嵌合部の摺動を抑制する（ハーネスを長くする必要あり）</p>

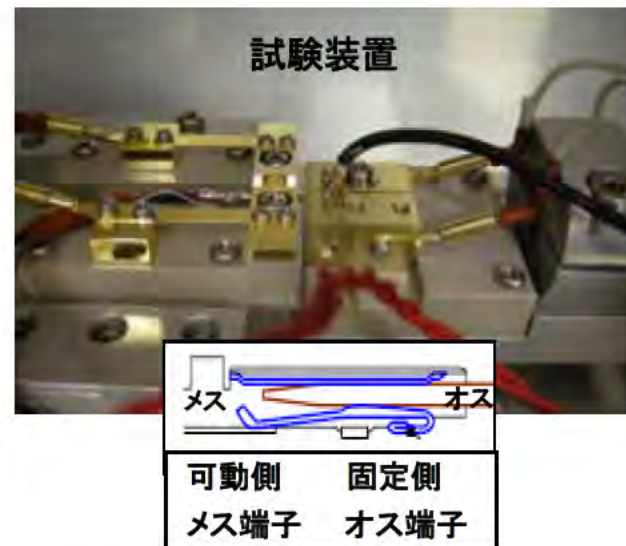
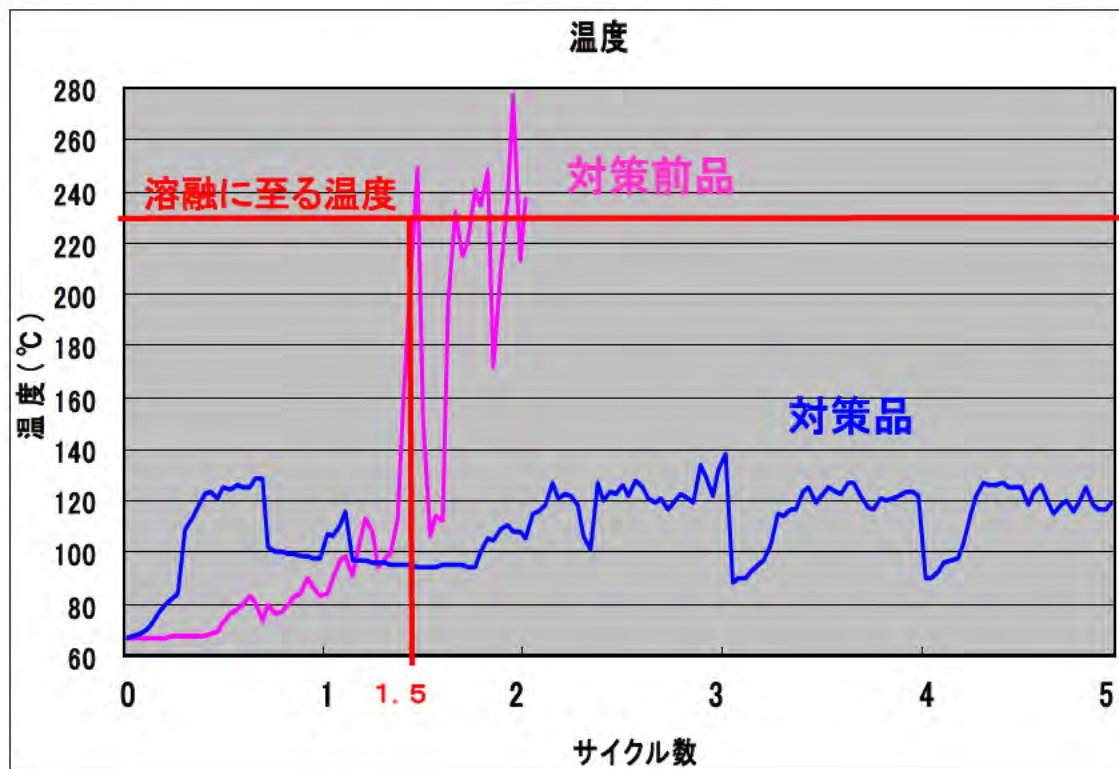
オス端子のSnメッキが磨耗により剥離したとしても、タイラップによるハーネス固定とメス端子耐熱銅合金に変更すれば、今後の使用過程において不具合が発生しないことを確認した。

従来品が約1.5サイクルで溶損に至っているのに対して、対策は5サイクルでも溶損に至らない。従来より、最低でも約3倍以上のタフネスあり。

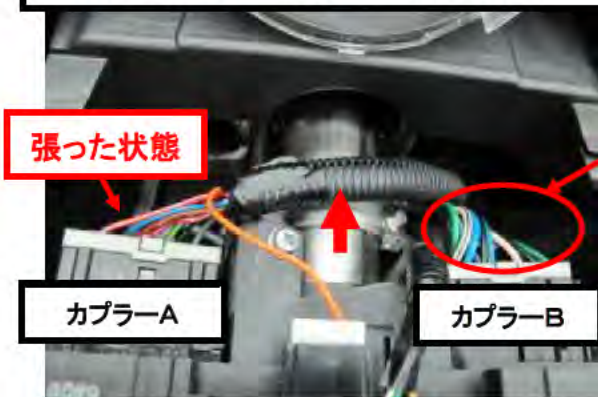
カプラーB⇒カプラーAの場合

この部分の剛性でカプラーから離れる

上記の組付手順でロービーム配線が張った状態となる。この組付手順で行っているのは、Sss製FIT/JAZZのみである

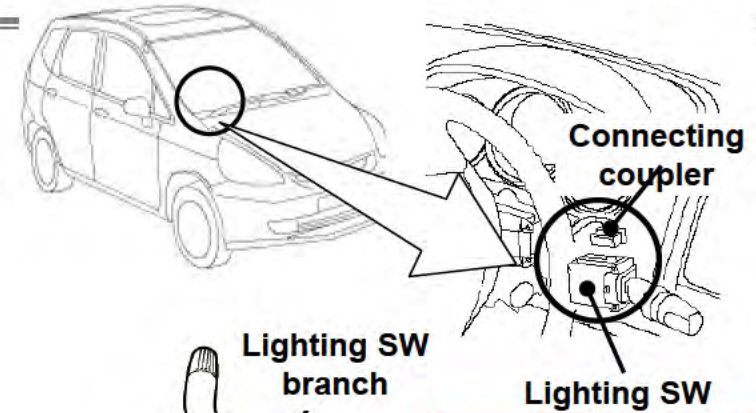
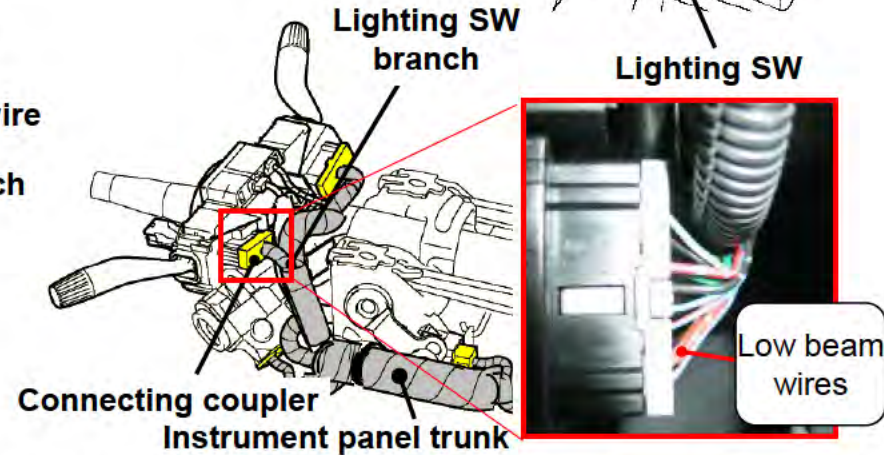
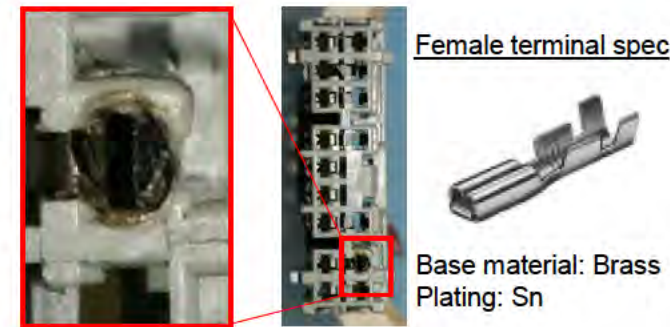
Head light terminal is melted

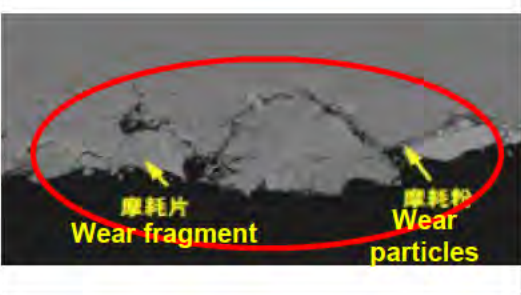
Female terminal at harness side			
Returned part

There is no Sn plating any more and wear particles of base material have accumulated.

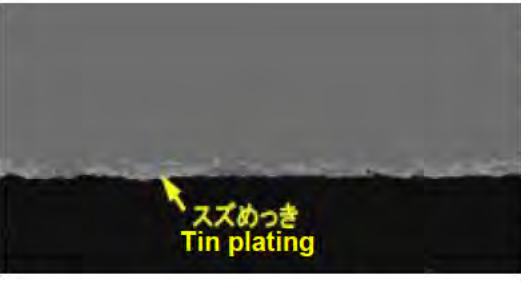
Sn plating is worn.
Non-defective part

Sn plating remains and no wear particles found.

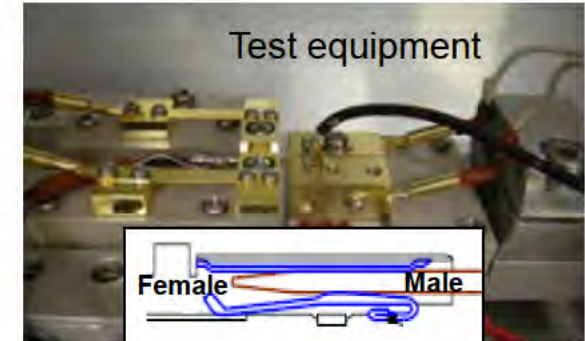
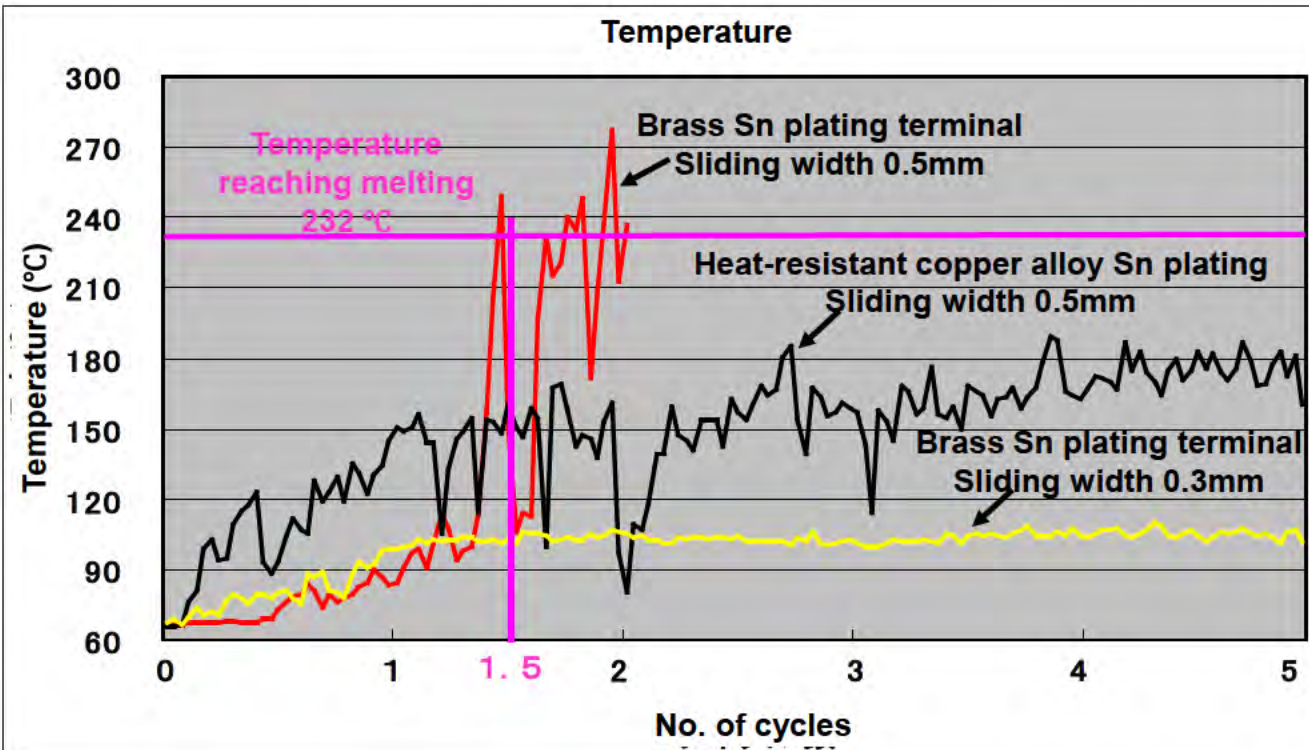
Brass terminal (Sn plating terminal) is confirmed to have achieved connector resin (PBT) melt temperature with sliding width 0.5mm/approx. 1.5 cycles.

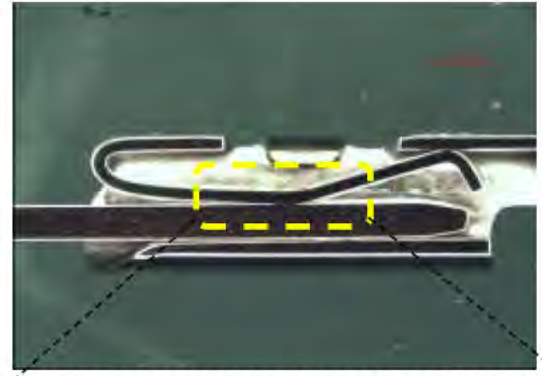
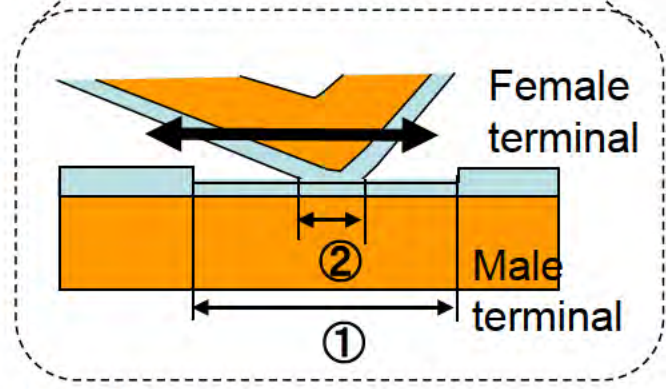
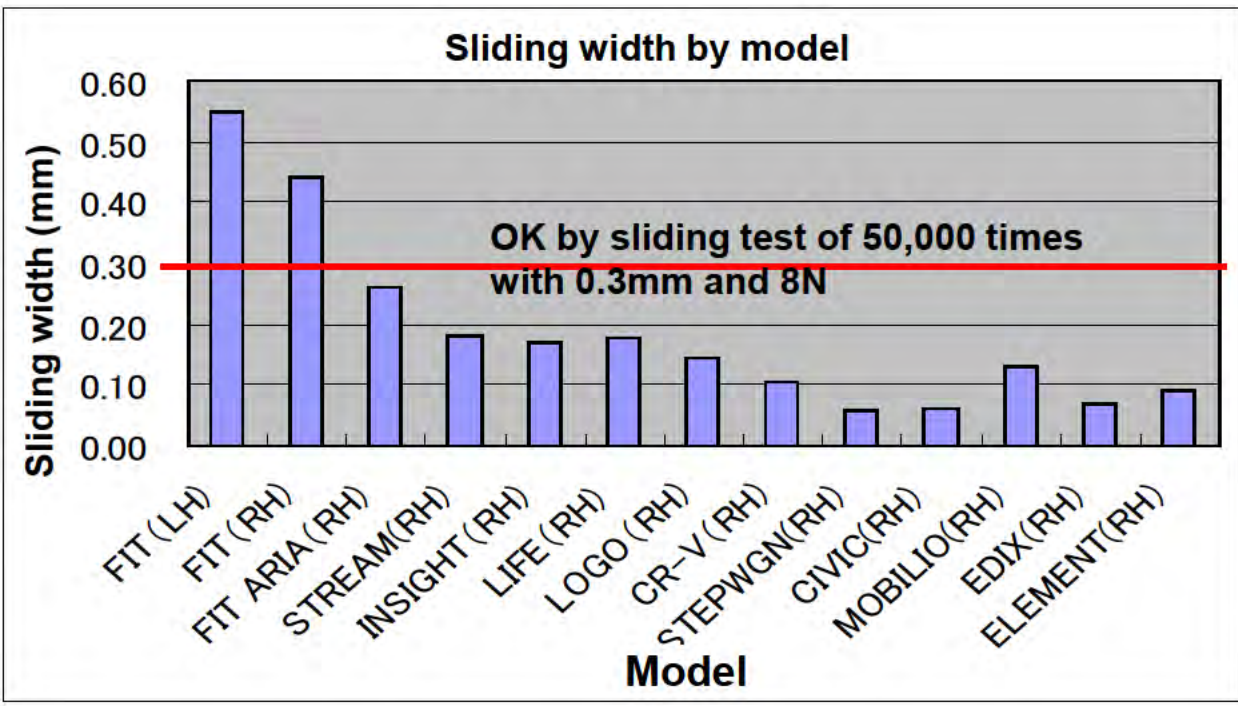
**[Measurement result]**  
 FIT/JAZZ has larger sliding width than other models.

**Sliding width=**  
 (Male terminal sliding width ①)  
 - (Female terminal sliding width ②)

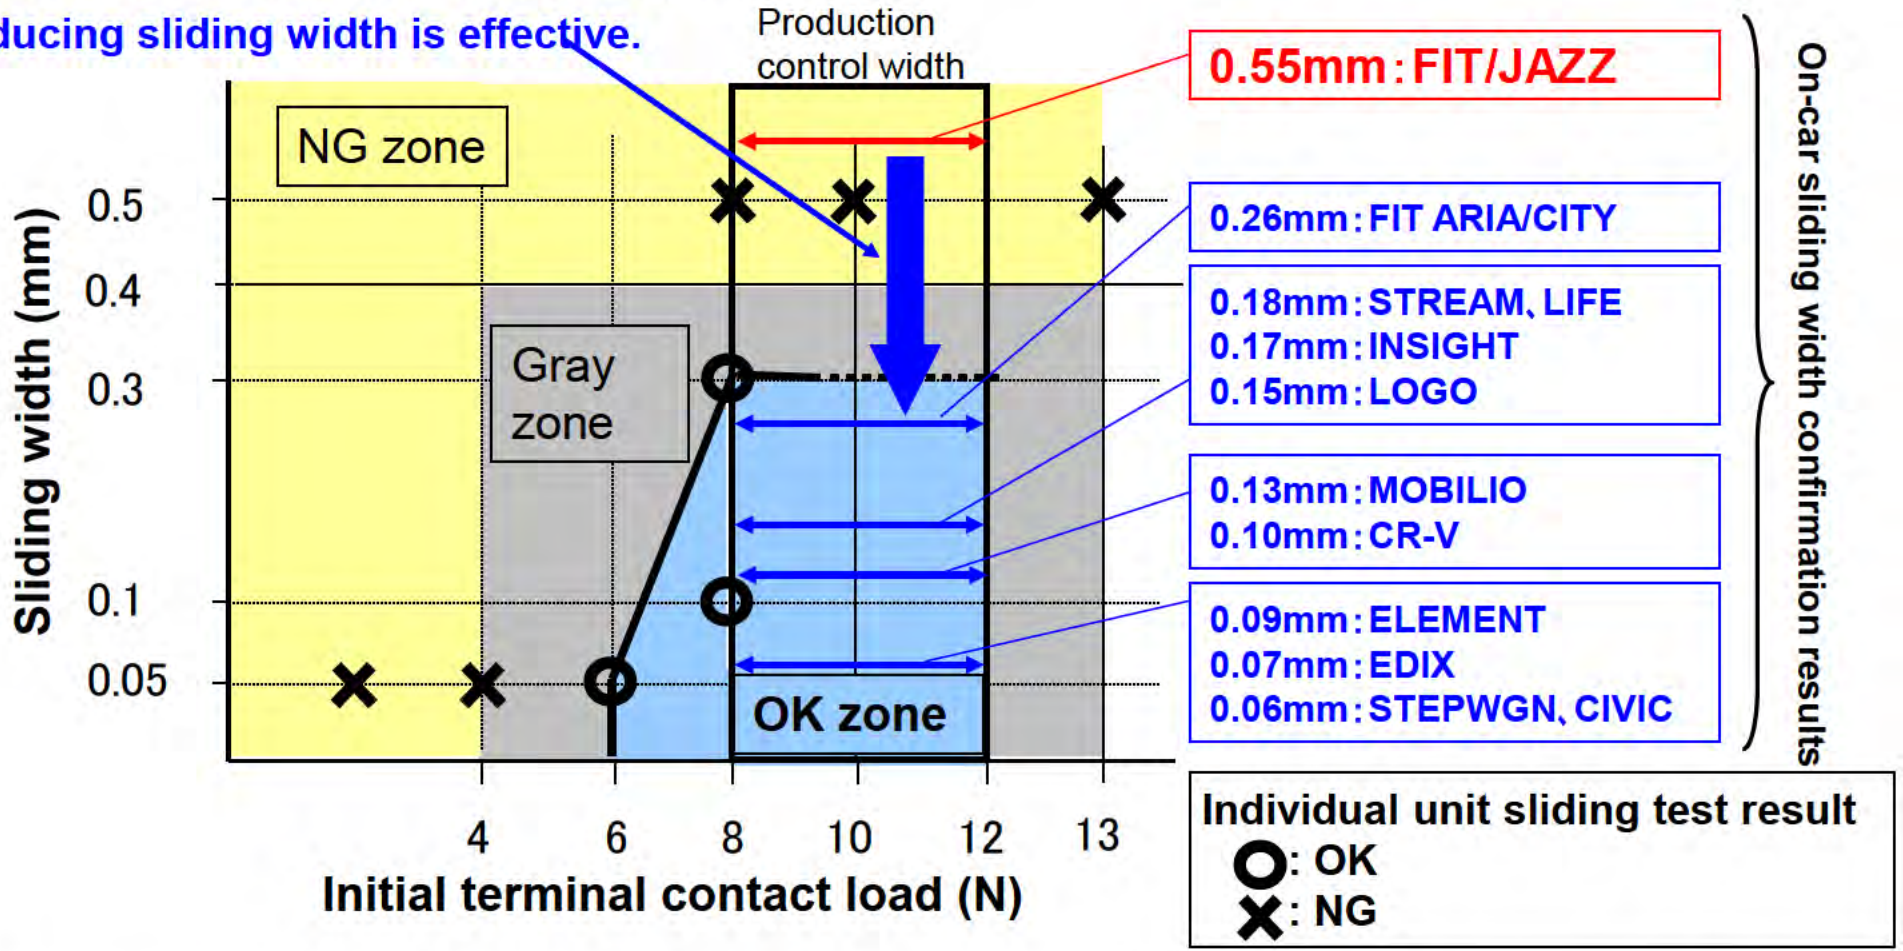
Reducing sliding width is effective.

It is confirmed that only FIT/JAZZ is in NG zone where resistance increases. Reducing sliding width is the most effective countermeasure.

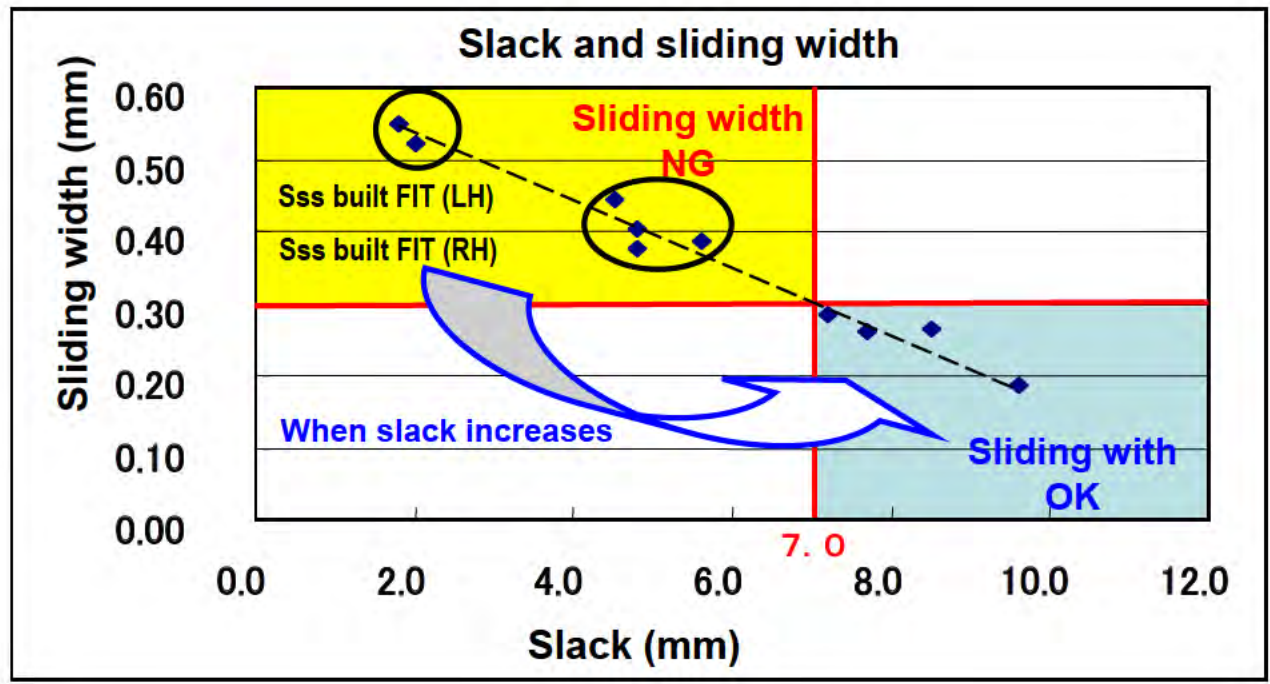
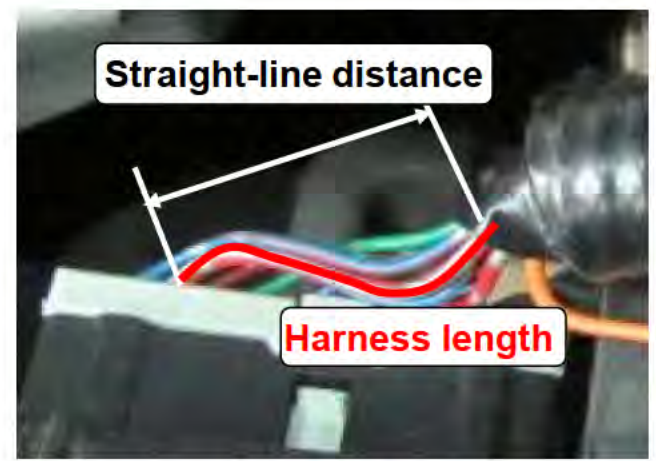
$$\text{Slack} = \text{Harness length} - \text{Straight-line distance}$$

We found that sliding width decreases when slack increases.

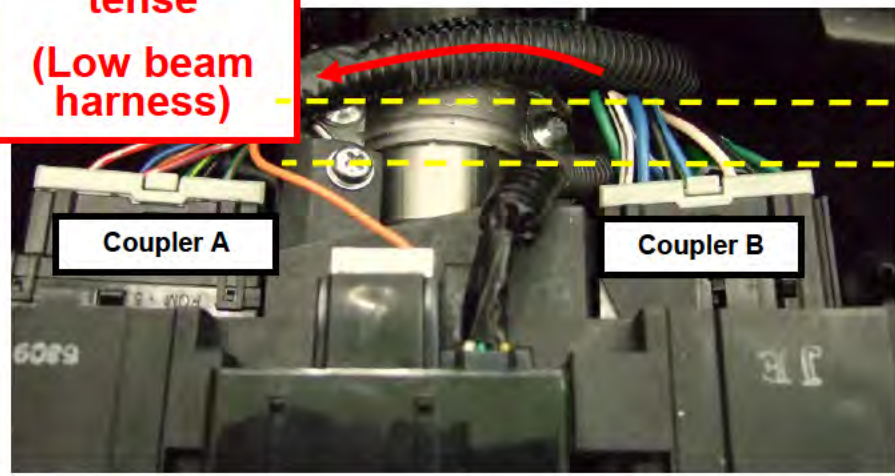
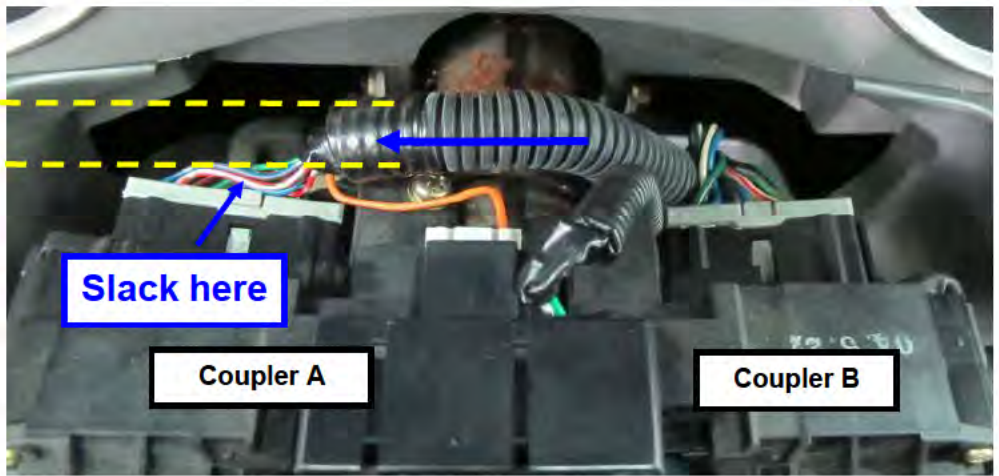
When coupler B is set first, then coupler A is set on COMBI SW side, harness comes off from coupler, and low beam harness tends to be tense.

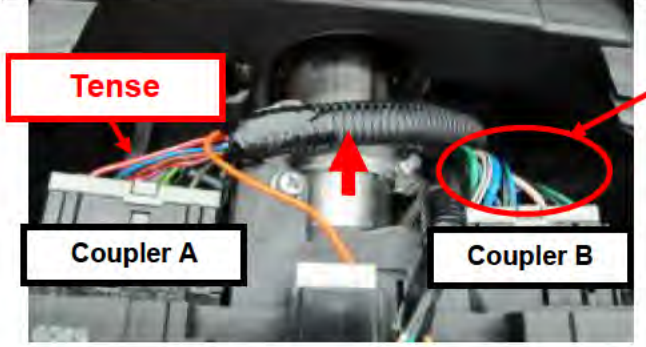
When coupler B is set, then coupler A is set

Harness routing causes harness to come off from coupler.

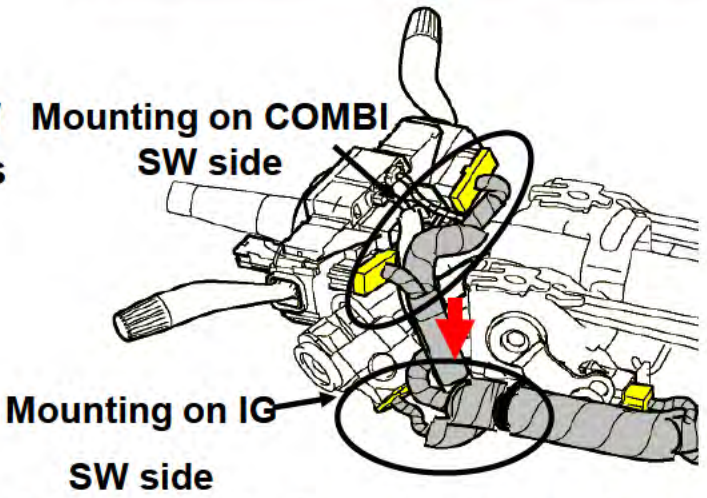
When coupler B is mounted, then coupler A is mounted on IG SW side per mounting order of Sss built FIT/JAZZ, low beam harness is tense.

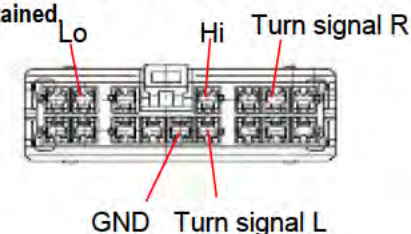
The reason why other terminals show no problem

1. Current of terminals other than Lo / Hi / GND is 3.5A when turn signal is working, and less than 0.2A when turn signal is not working.
2. Hi / GND terminal is located on the center of the coupler, so slack is maintained.

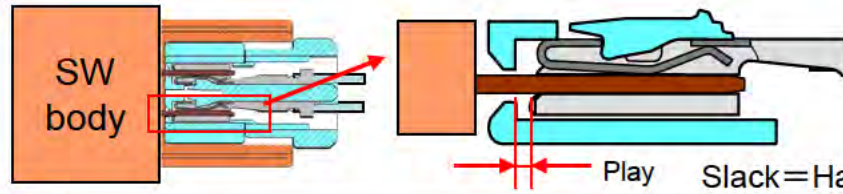
Play found between coupler and female terminal because of assembly and part tolerance.

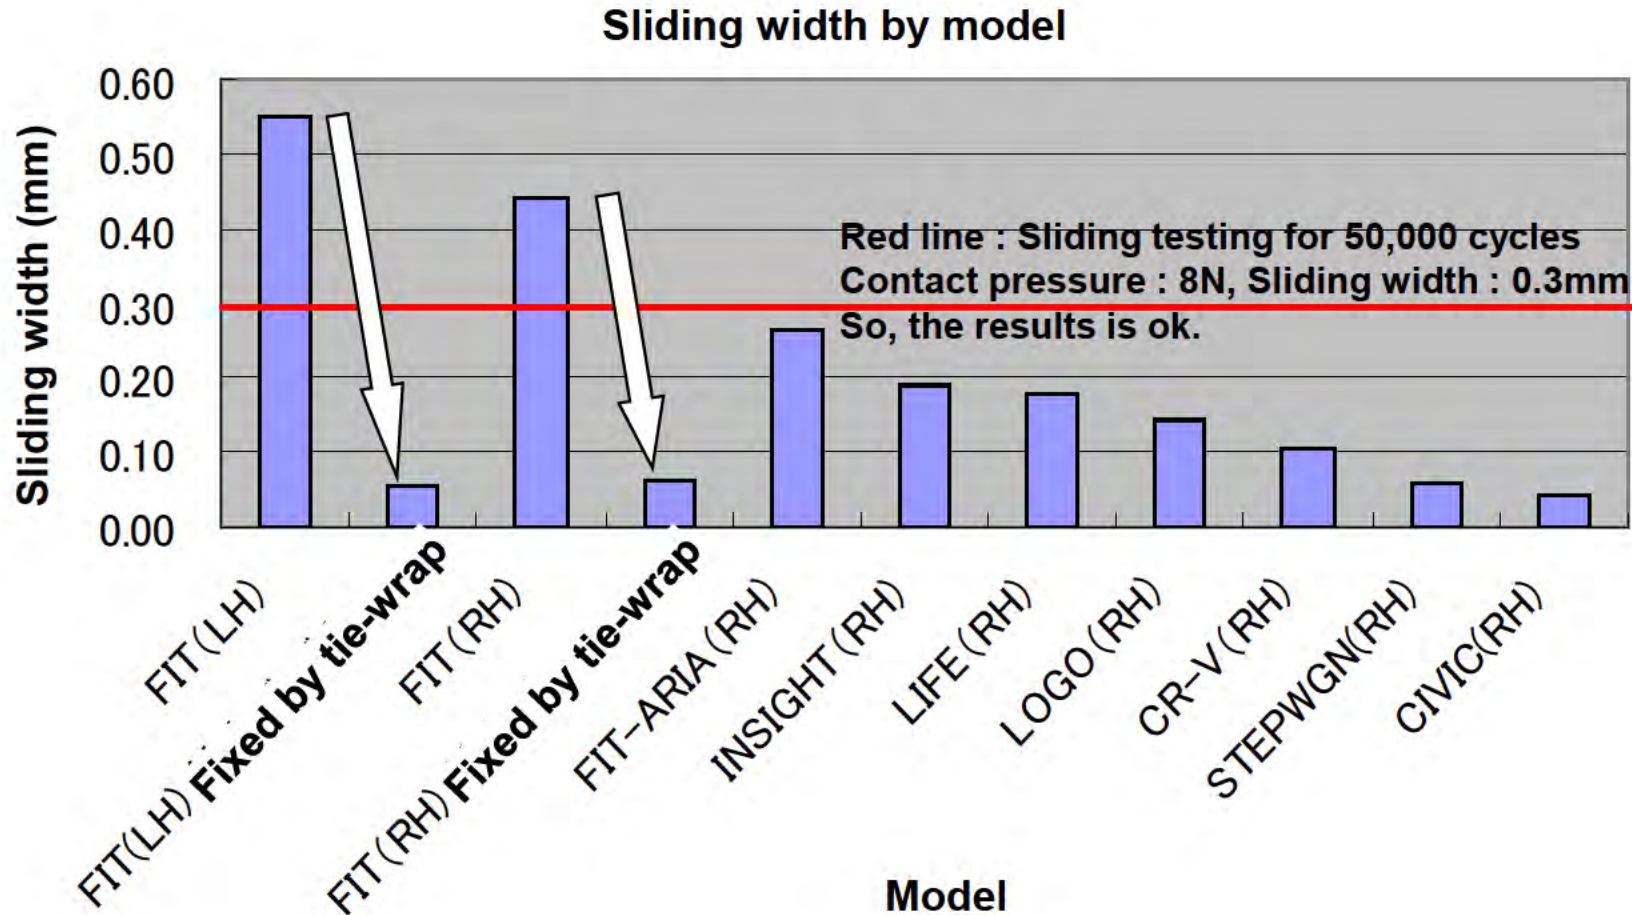
**Tie-wrap reduced sliding width to approx 1/10.**

- Confirm countermeasure effectiveness by operating lighting switch for 10,000 cycles on car.  
(1 cycle : Activate turn signal (Right) -> Neutral -> Activate turn signal (Left) -> Neutral -> Passing -> Neutral)

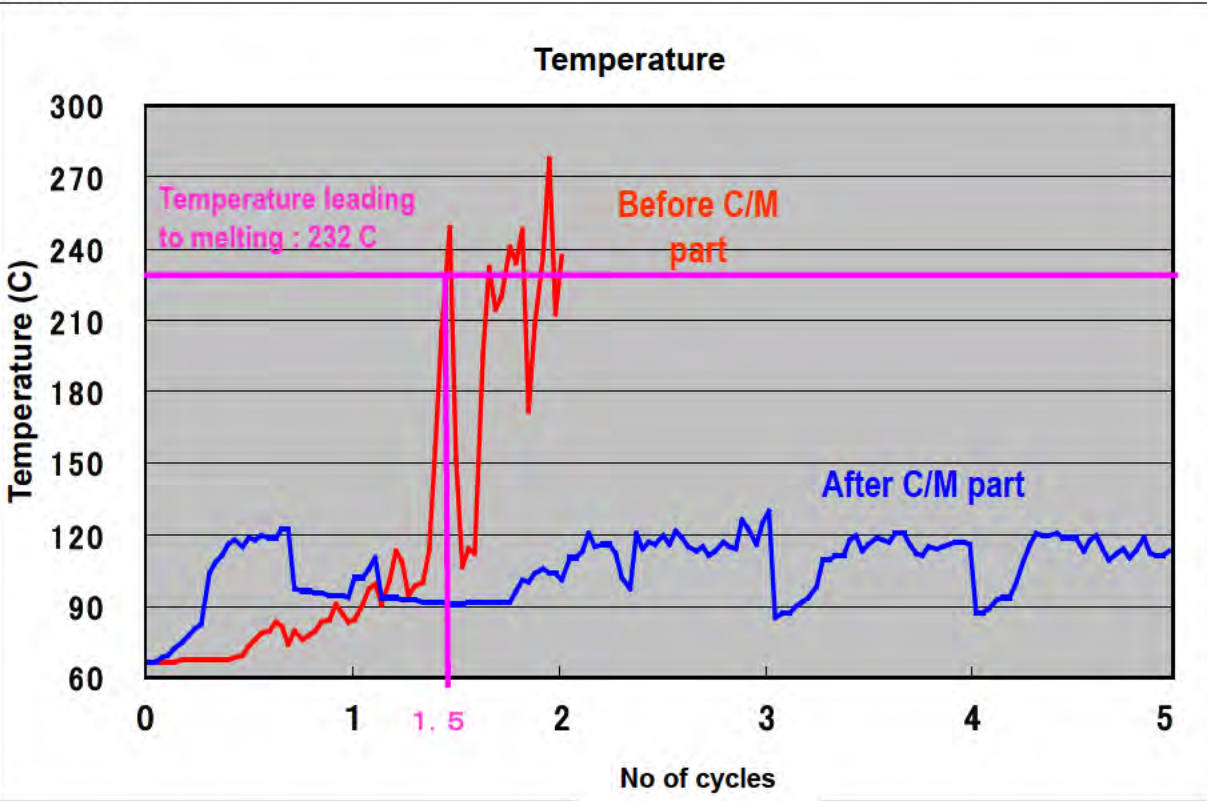
**8. Countermeasure 8-3 C/M effectiveness confirmation results by sliding testing using market action part 33/40**

We found that the failure will not occur by fixing the harness by tie-wrap and changing material of the female terminal to heat resistance copper alloy, even if Sn plating of the male terminal separates from wear.

Before C/M part : Melting damage occurs in approx 1.5 cycles.

After C/M part : Melting damage does not occur in 5 cycles.

After C/M part shows at least more than 3 fold toughness than before C/M part.

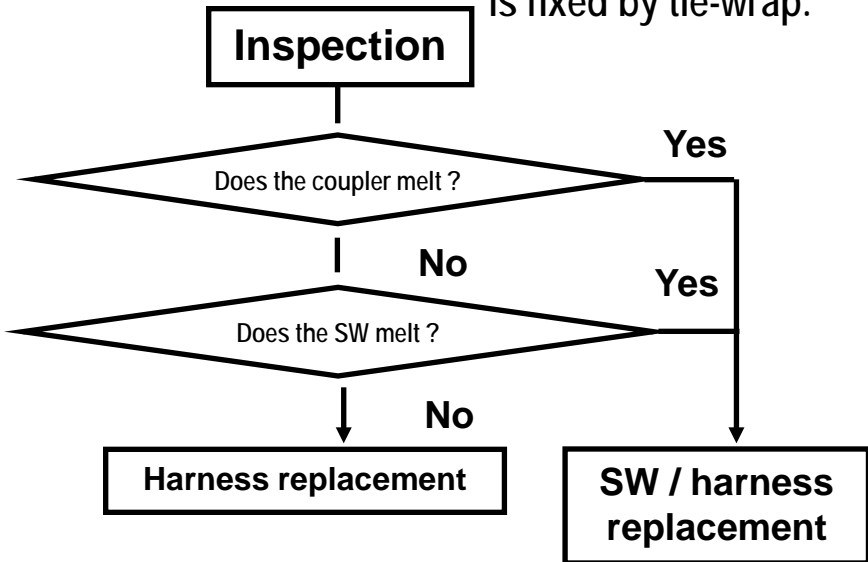
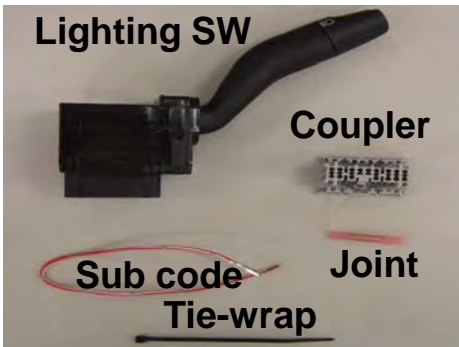
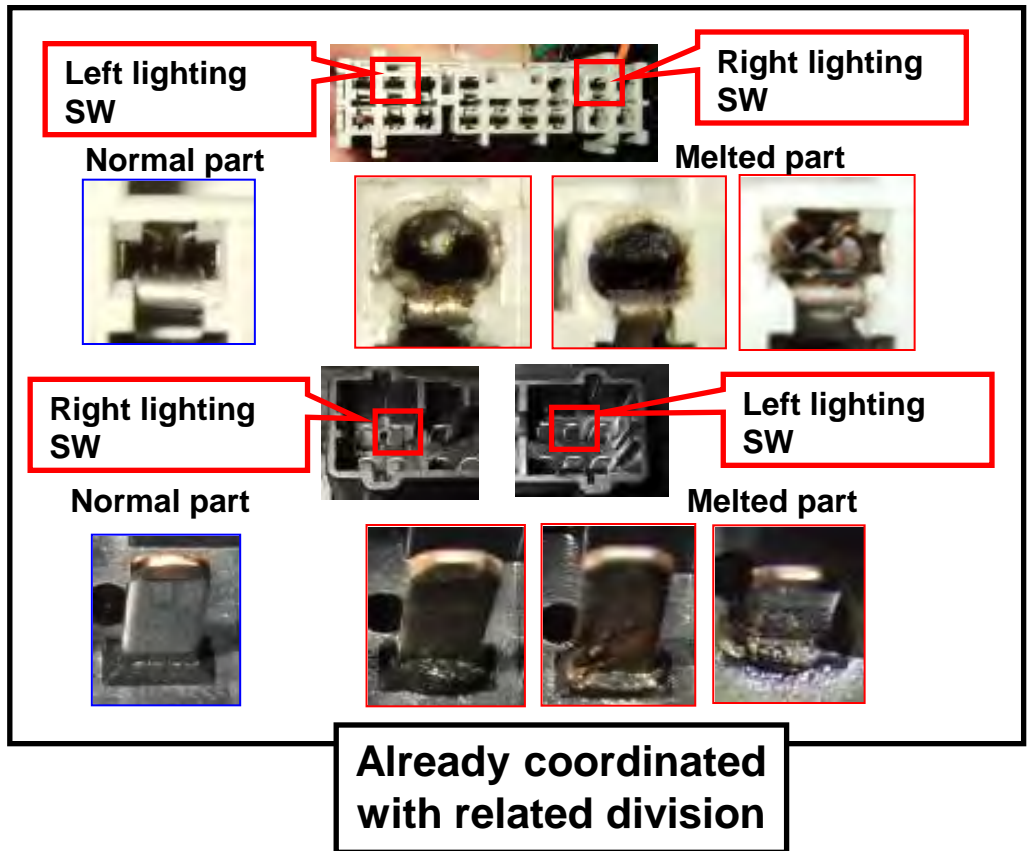
Melting damage of the Lo terminal was checked.

- ① If the Lo terminal melts, lighting switch and Lo terminal harness are replaced, and the lighting switch is fixed by tie-wrap.
- ② If the Lo terminal does not melt, only Lo terminal harness is replaced, and the lighting switch is fixed by tie-wrap.

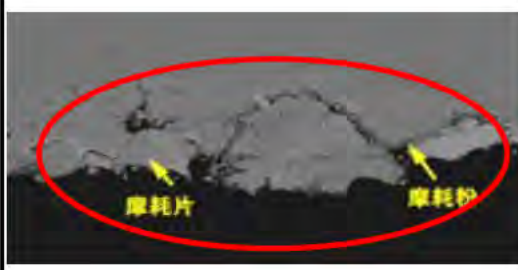
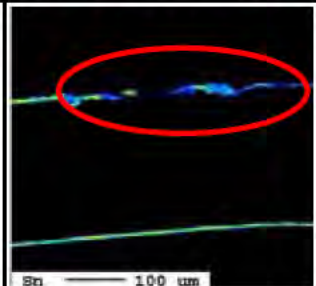
ハーネス側のメス端子				
返却品

Snメッキがなくなり、母材の磨耗粉が堆積している

Snメッキが磨耗している
良品

Snメッキが摩耗し、磨耗粉が堆積していることから、摺動の繰返しが発生している。

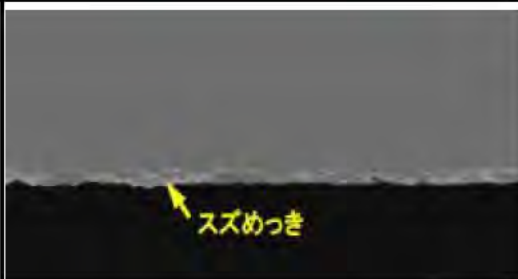
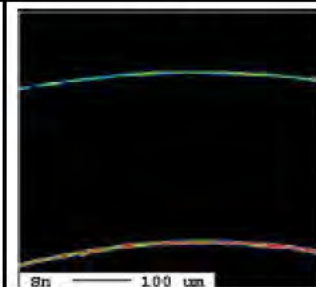
Snメッキが残り、磨耗粉はなし

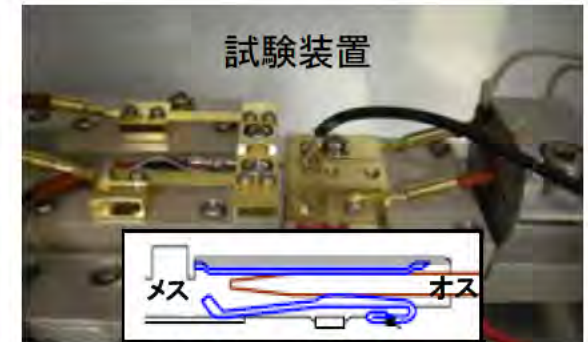
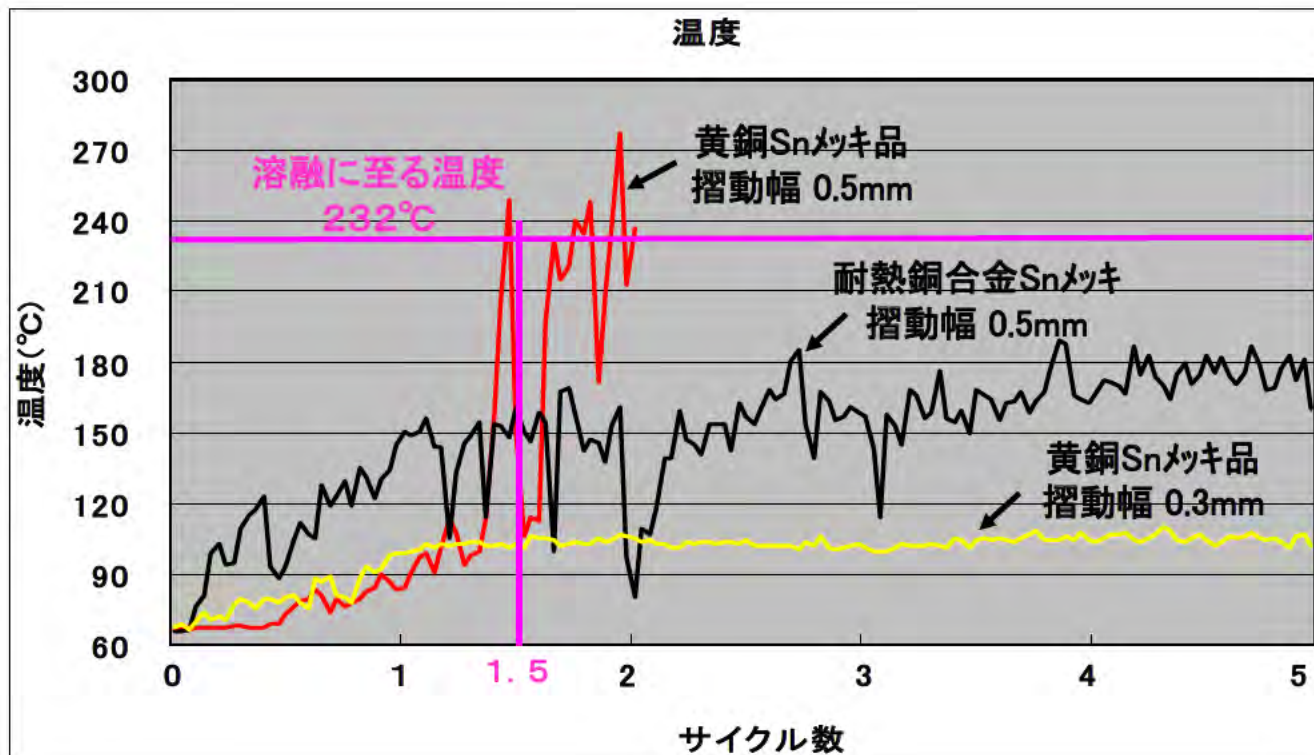
黄銅端子(Snメッキ品)は、摺動幅 0.5mm/約1.5サイクルでコネクタ樹脂(PBT)の溶融温度に至ることが判明

可動側	固定側
メス端子	オス端子
